PROVENDER MILL
FAVERSHAM, KENT
KFBR03

HISTORIC BUILDING RECORDING

An Historic Building Survey of the former Provender Mill (Belvedere Feeds), Belvedere Road, Faversham, Kent

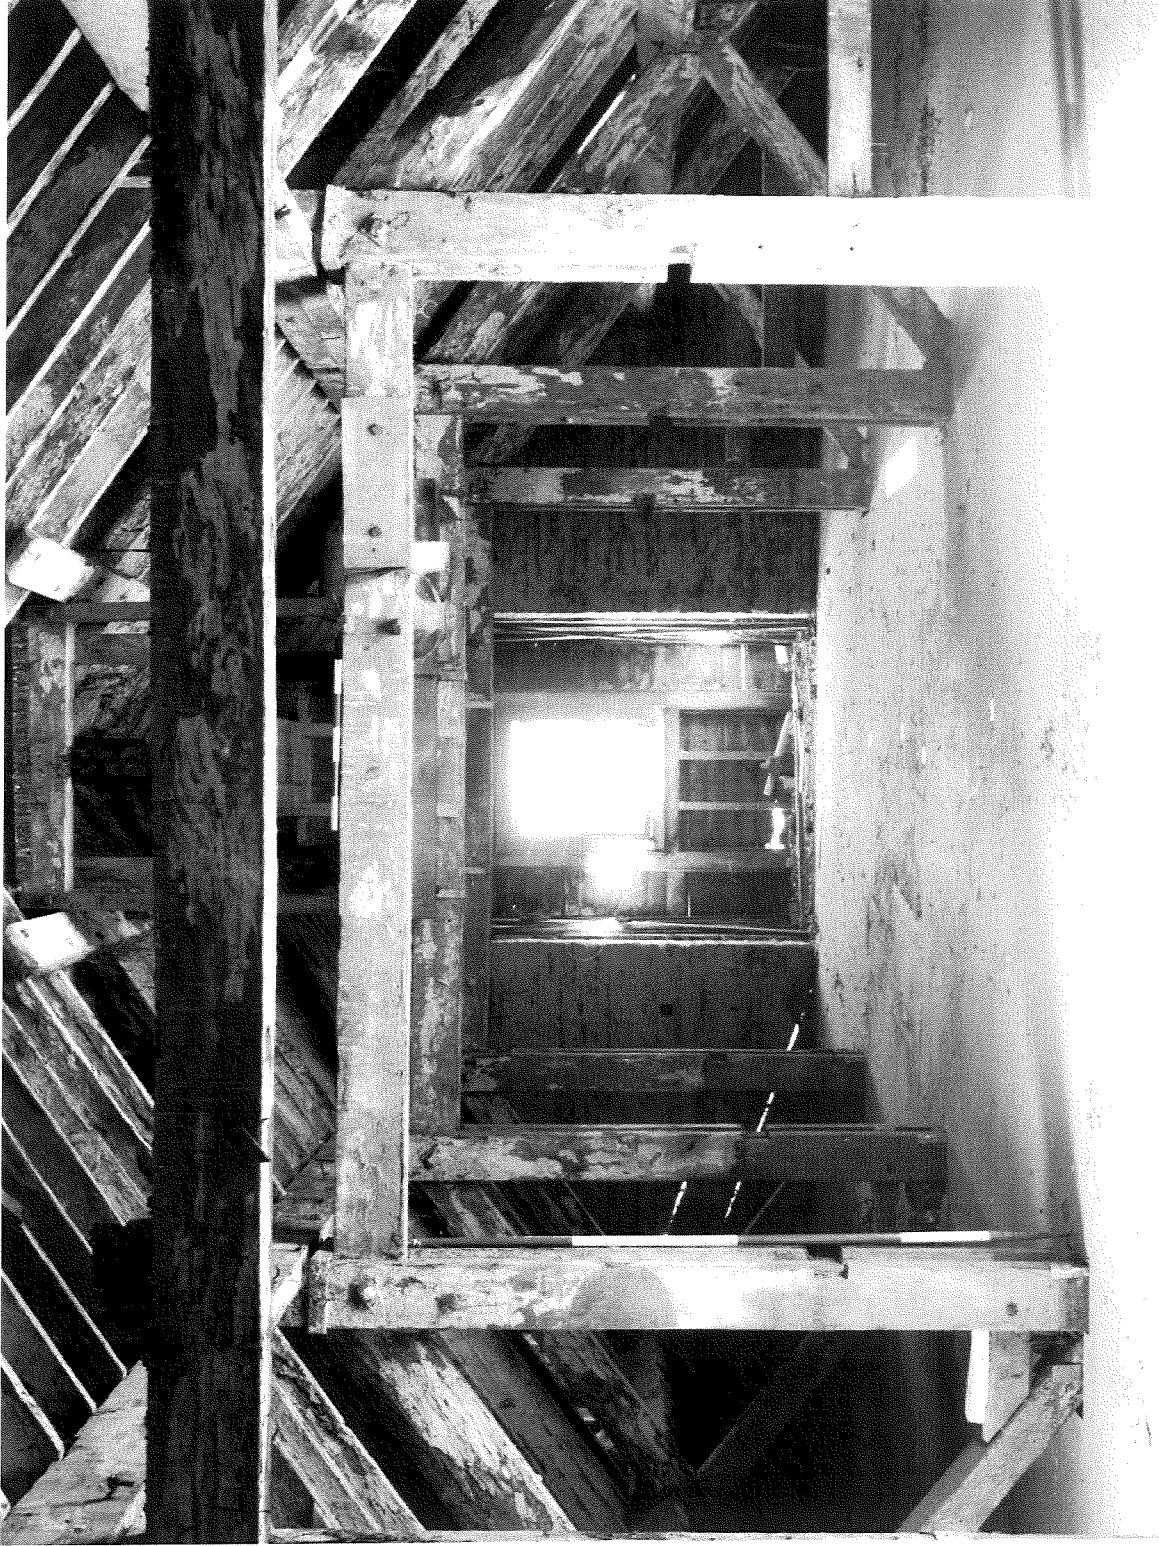
5.8.1 Two main roofs exist, with that of the main mill orientated east-west and supported on a queen-post truss and strainer beam structure (Figure 7). The principle rafters do not extend to the full height of the roof but extend to just above the level of the strainer beams. The queen posts and principle rafters support the purlins on which the common-rafters are set. The roof of the boiler house is orientated north-south and formed by an 'A' frame of timber tie beams and rafters, supported by the exterior wall of the mill and the eastern wall of the boiler house (Figure 8). The pitched roof of the main mill has three dormers projecting from the southern side with two dormers and a lucam from the northern side. The western end of the roof extends beyond the gable wall of the mill to cover a second lucam. The pitched roof of the boiler house is unadorned other than by a weather-boarded lantern located across the ridge and approximately one third of the length from the south.

Figure 7
Structure of mill roof

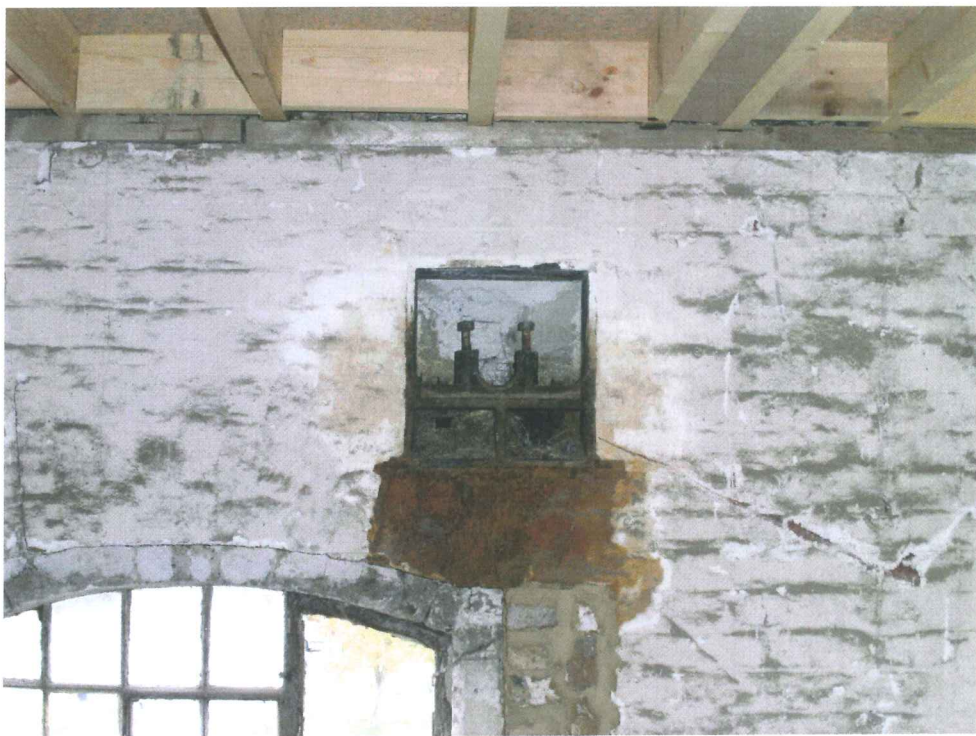
Figure 17
Bearing housing on the western wall of
the mill, second floor

with a cast iron bearing housing mounted high on the western wall (Figure 17). They were clearly elements of one of the main transfer axles delivering power to the belt pulleys. The alignment is continued to the eastern wall of the engine room where an area of brick blocking shows that a second bearing housing has been removed. The presence of this shaft may go some way in explaining the height of this storey.

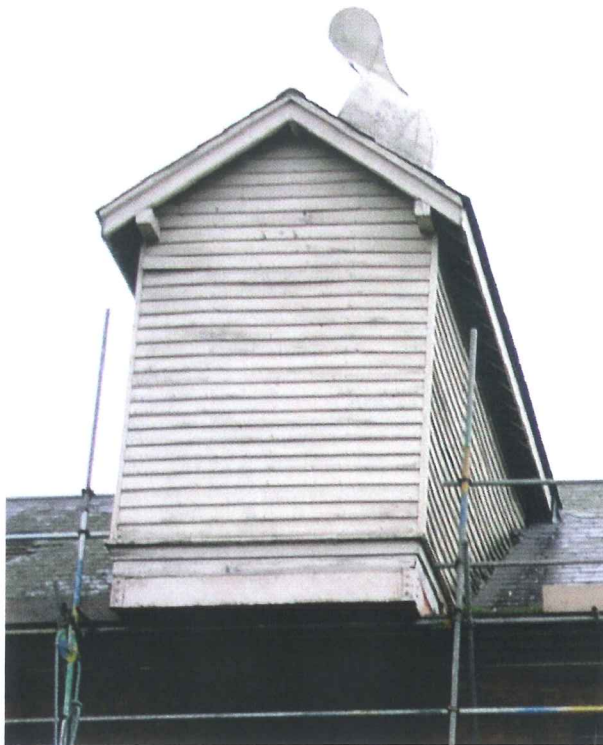
Figure 20
Exterior of the north
lucam and
dislocated cowl

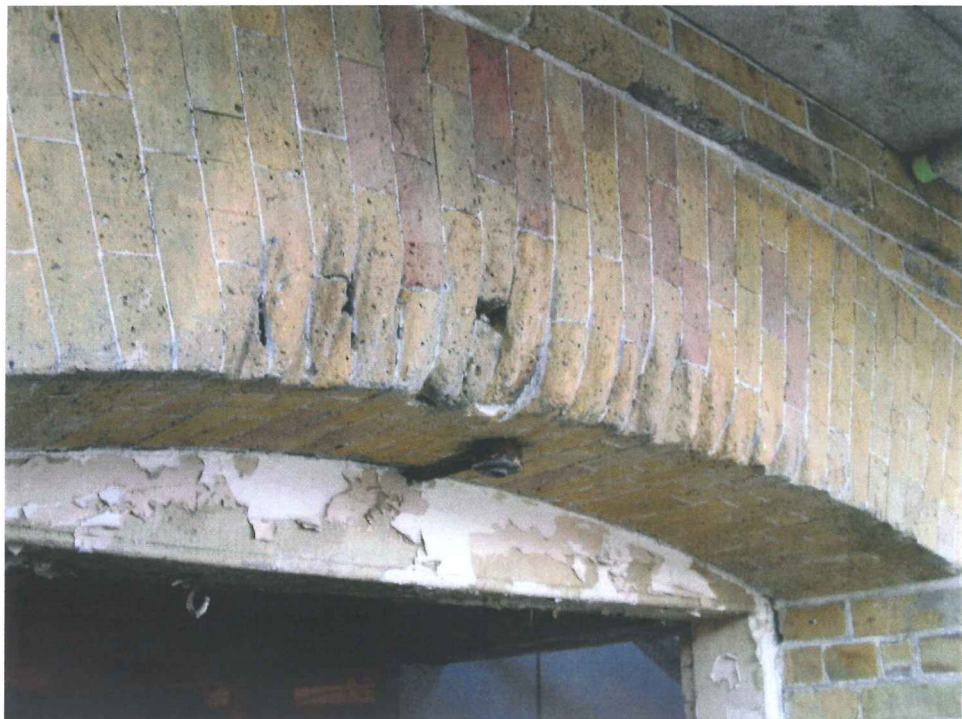
Figure 21
Rope/cable wear above the first floor loading doors
on the north of the mill

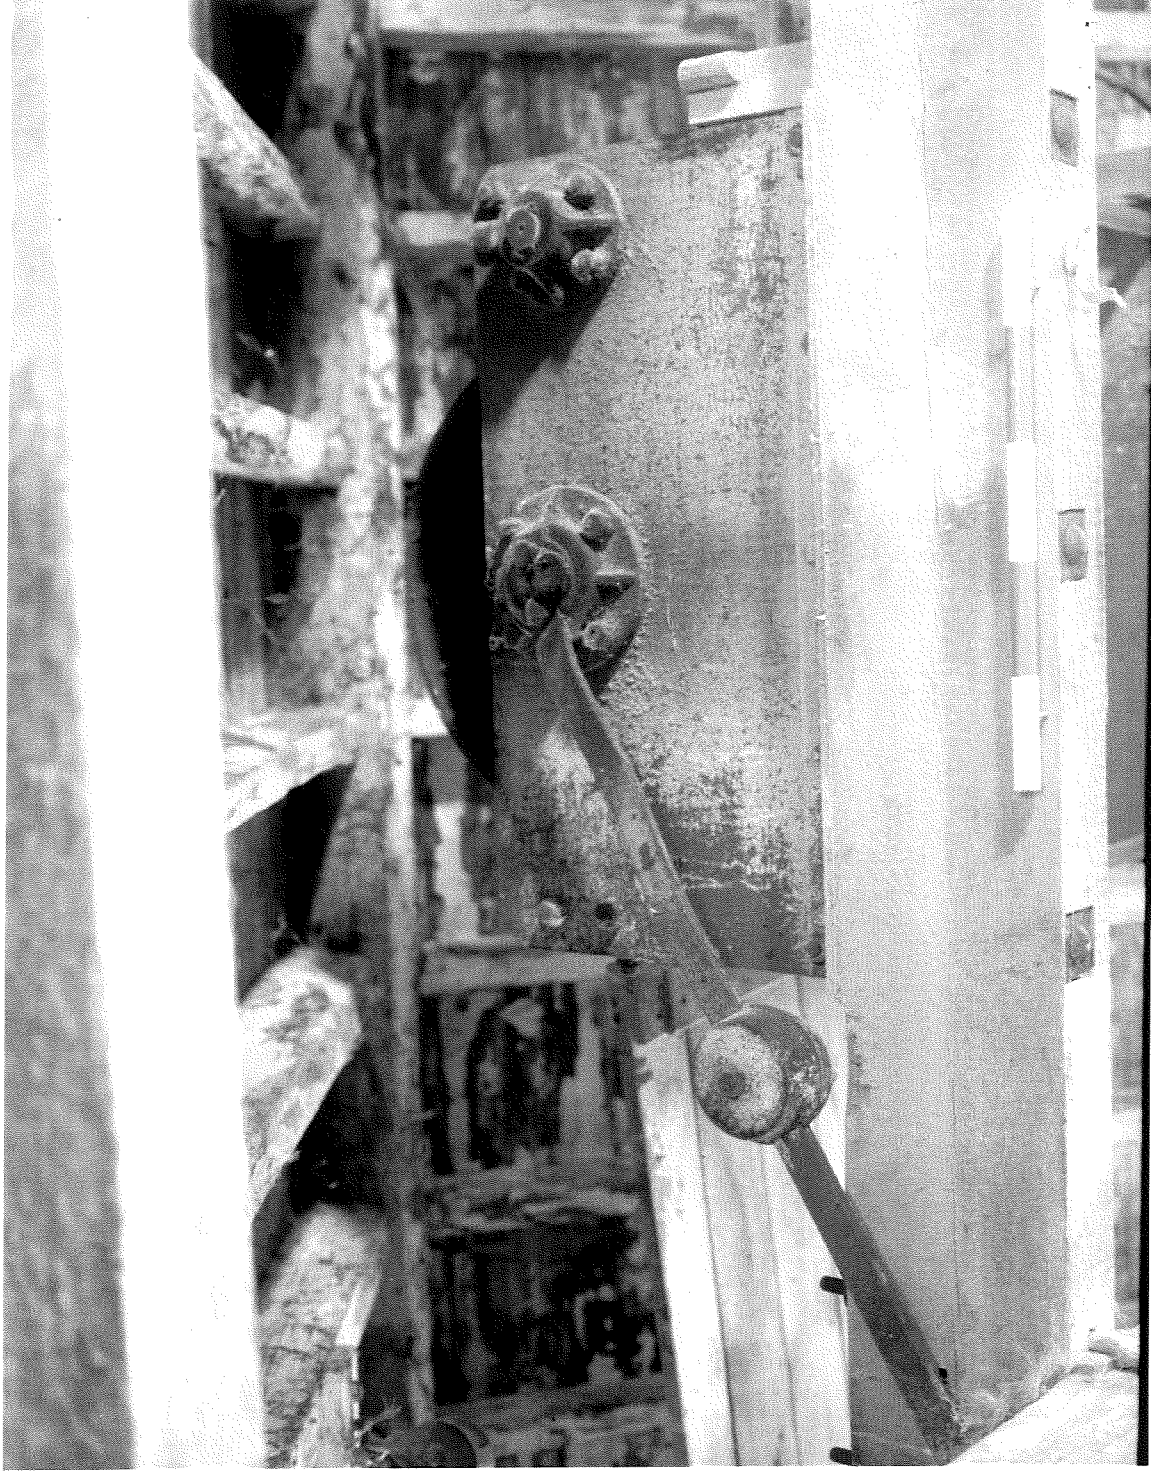
Figure 29
Clutch arm on the southside of the hoist

of a primitive clutch, as seen on the side of the casing (Figure 29). On the introduction of the electric motor the clutch was disabled as the power delivery became instant. The cable ran from the cable drum to a pulley mounted directly above the trapdoor of the lucam (Figure 26). A length of planking runs immediately below the line of the cable between drum and pulley and probably served to prevent unwanted or dangerous cable movement. At the western end of the building on the northern side of the mill, the uppermost part of a steel grain elevator enters the roof space (Figure 30). Only the horizontal screw survives with the external lift and internal machinery completely removed.
