ROYAL FESTIVAL HALL WATER TOWER

HISTORIC BUILDING RECORDING

# **Historic Building Survey of the Water Tower Between the Royal Festival Hall and Hungerford Bridge**

**Pre-Construct Archaeology Ltd, February 2005**

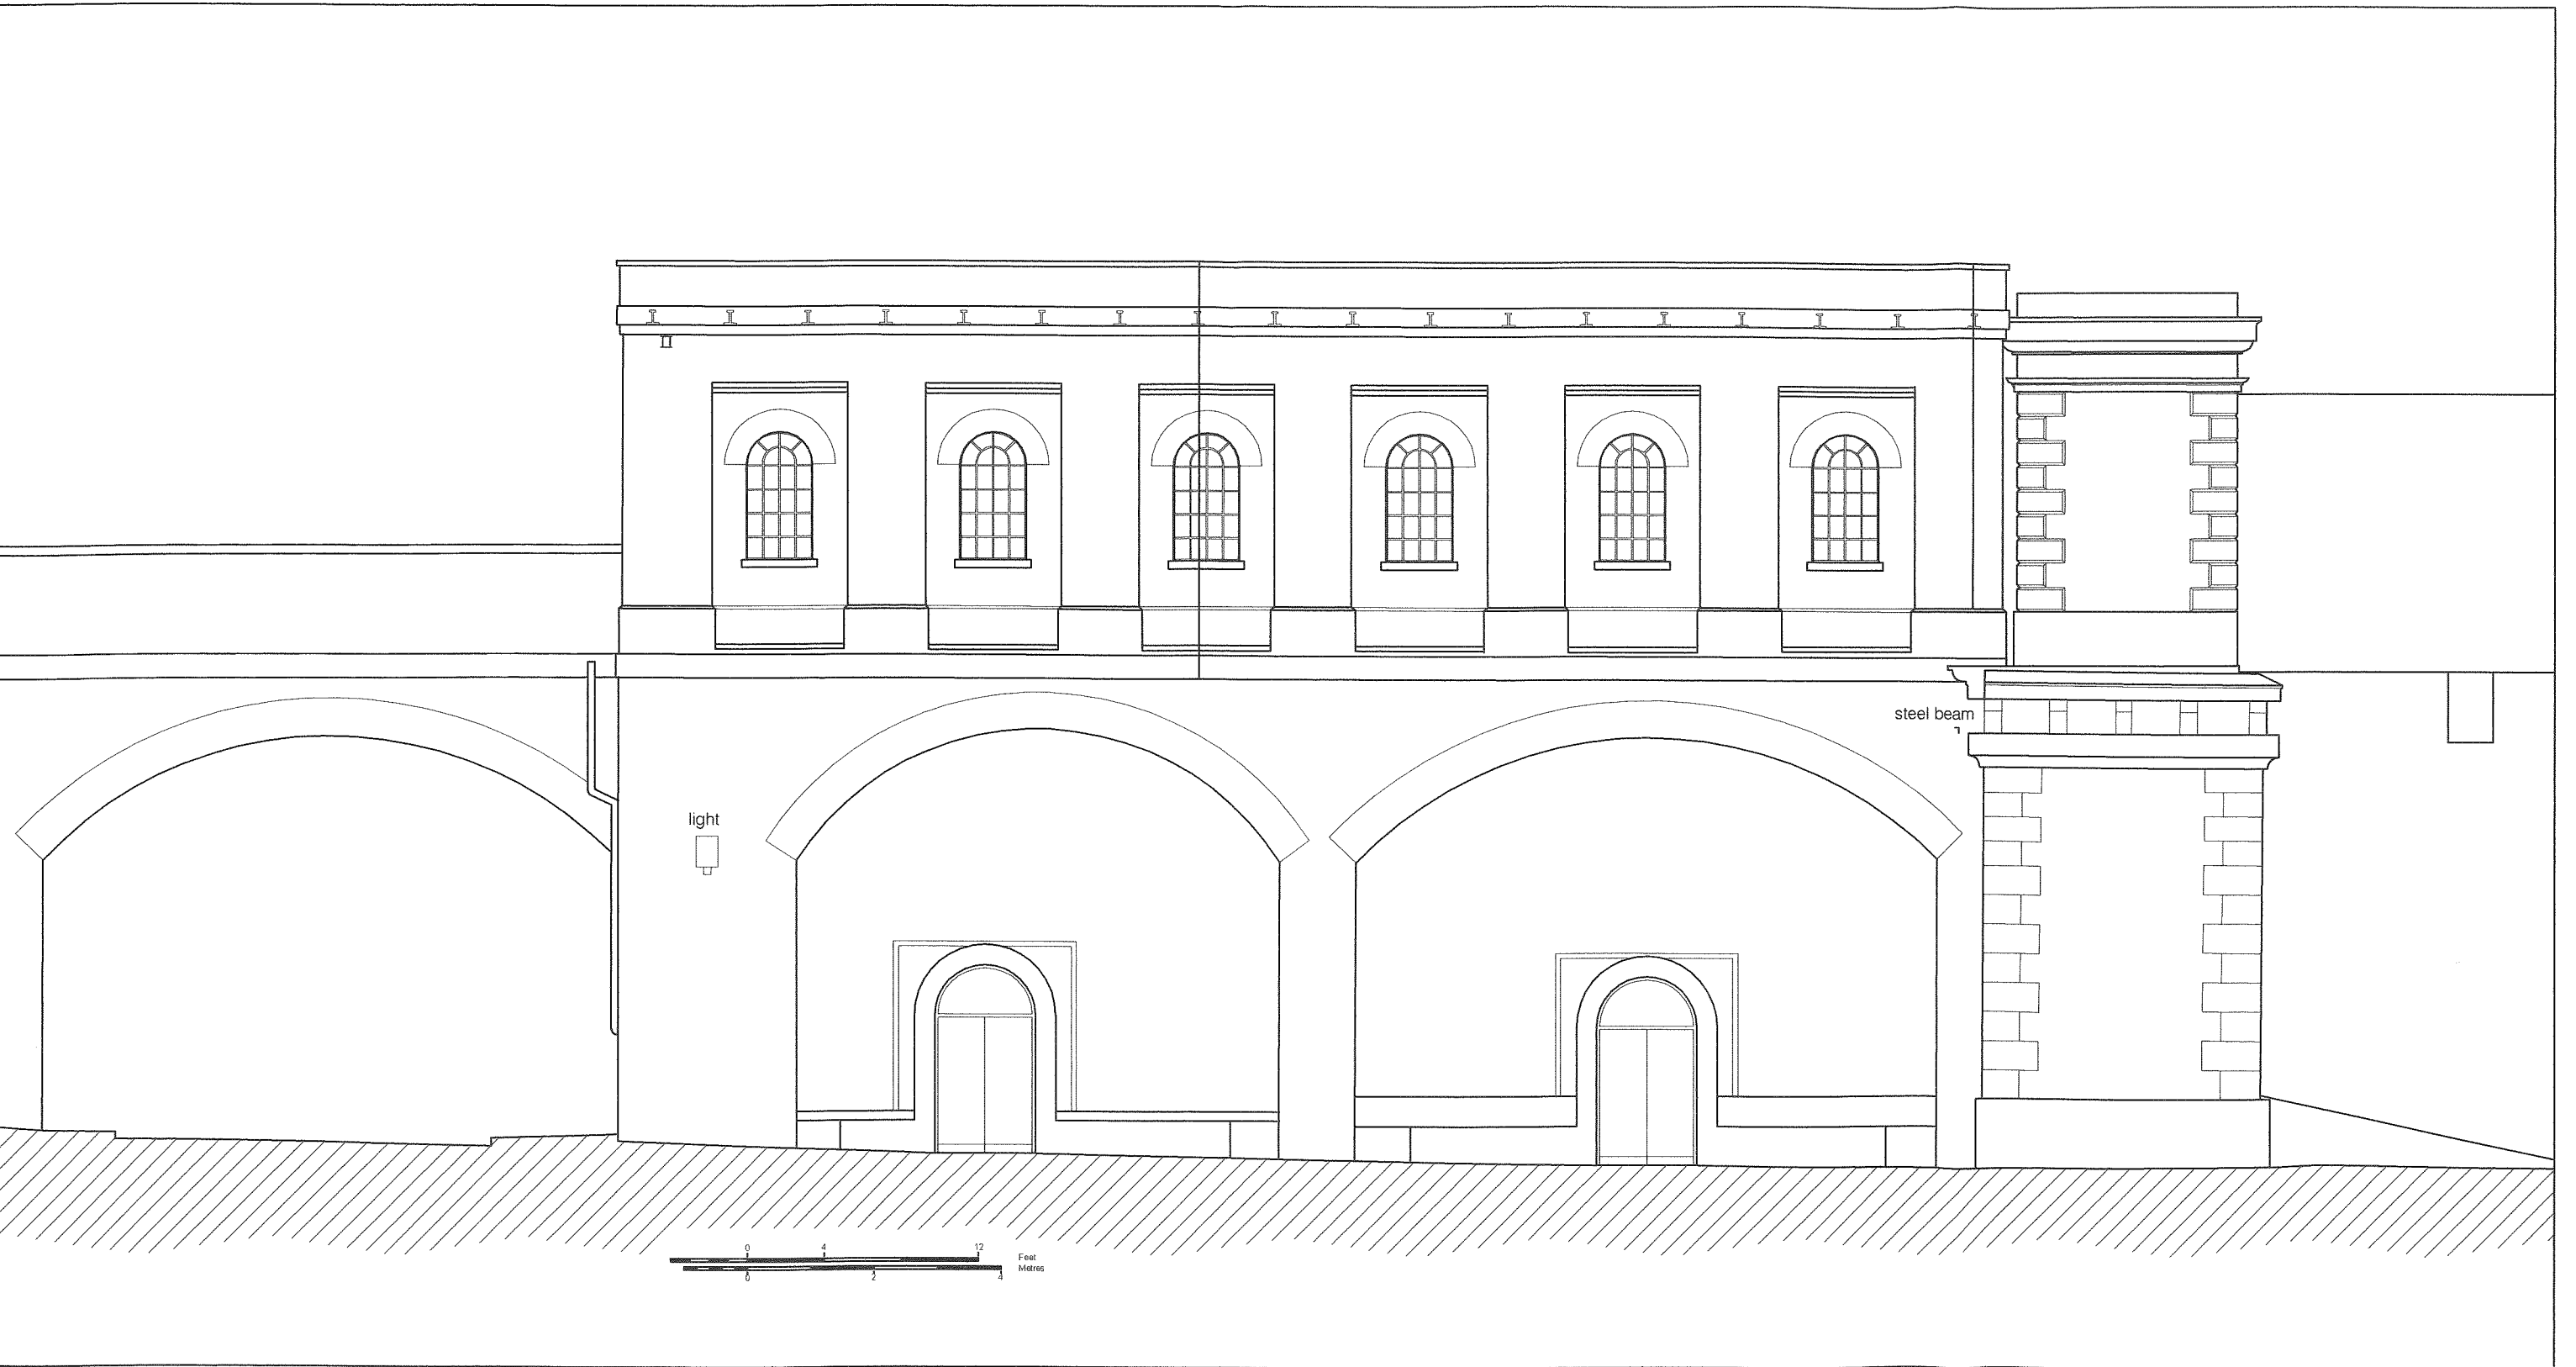
Figure 8  
North-east (Front) Elevation  
1:100

although light fittings and plumbing were evident. The northern faces of the arches (fig 8) were glazed and each had a modern brick framed arched doorway. The brickwork around the doorways extended internally as low walls.

- 6.4.9 A pair of severed steel beams were recorded high on the north elevation at its south end. These would have been added in the 20<sup>th</sup> century and formerly extended to the buildings that stood to the north, before the Royal Festival Hall was built. These, like the tie rods would have provided additional structural stability.
- 6.4.10 Most recently the spaces beneath the lower level arches were converted for use by the South Bank Centre. Within the viaduct arches there are pipes and scars of pipes. These relate to the use of the lower level arches and to the drainage of the viaduct itself. None of these pipes was found to relate to the operation of the water tower.

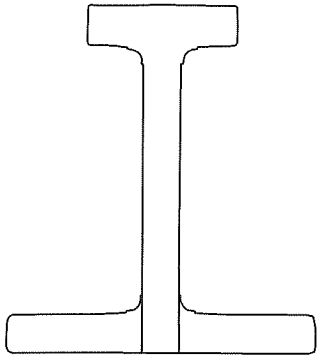
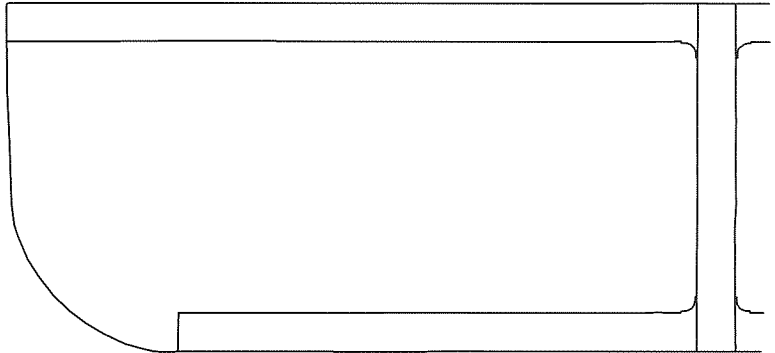
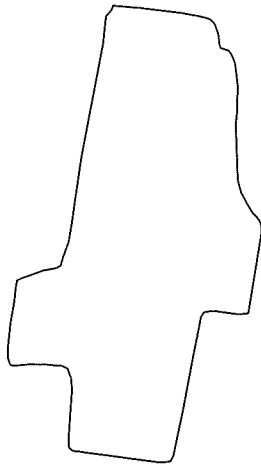
Figure 11  
Details of cast-iron beams,  
window frame and window mullion  
1:5 and 1:1

- 5.2.5 Projecting from the cornice beneath the parapet, on both the north and south elevations, were 18 Cast iron I beams (Plate 4), that had originally supported the water tank. They were set at approximately 1.22m centres and have had curved ends. Their curved ends and profiles are shown in Figure 11.

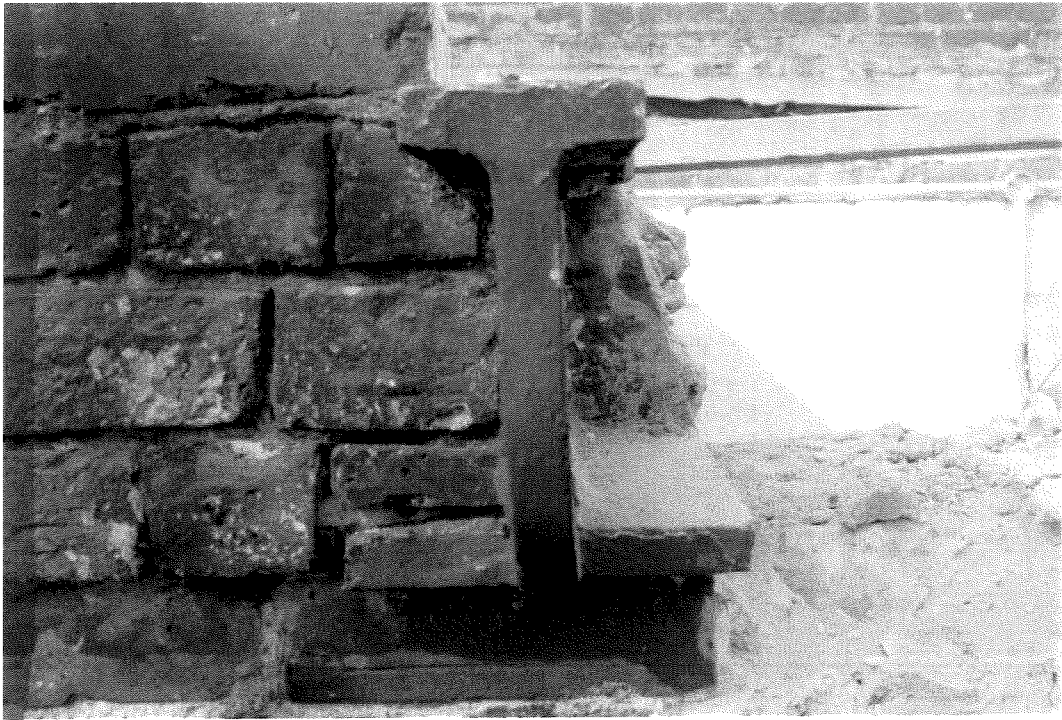
Plate 4: One of the ends of the cast iron beams

- 6.2.6 The cast iron beams would have directly supported the water tank. As with all cast iron beams the bottom flanges were wider than the top flanges to provide adequate tensile strength. The beams also had web stiffeners towards each end that were positioned to be hidden within the masonry. These would have helped support the weight of the iron tank and would have prevented the beams from moving when the tank was first erected.

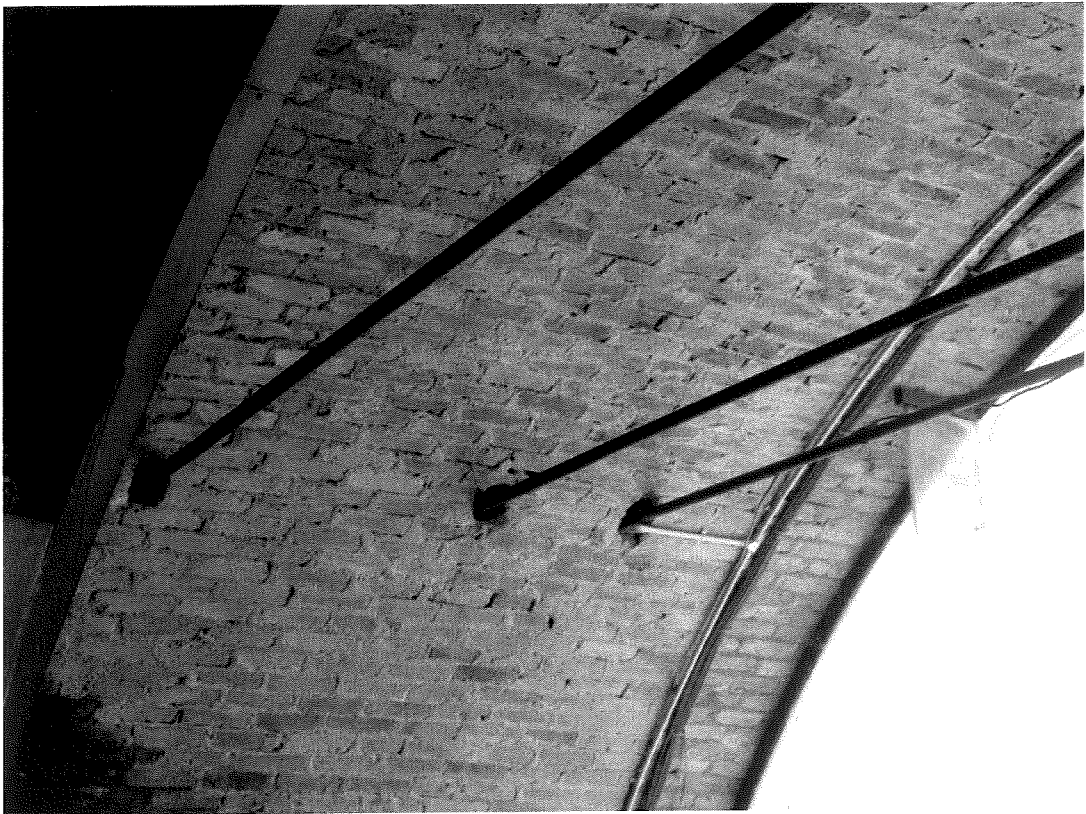
Plate 5: The system of steel tie rods

- 6.4.8 With the weight of the water tank and constant vibration from railway traffic, the structure would have been subject to stresses and there were historic cracks visible in the brickwork of the tower. During the 20<sup>th</sup> century a system of three longitudinal tie rods was inserted through the structure to stabilise it.
