**BUILDING RECORDING AT
WILLIAM KING FLOUR MILL,
DENHAM,
BUCKINGHAMSHIRE**

SITE CODE: UWKM10

OCTOBER 2010

Building Recording

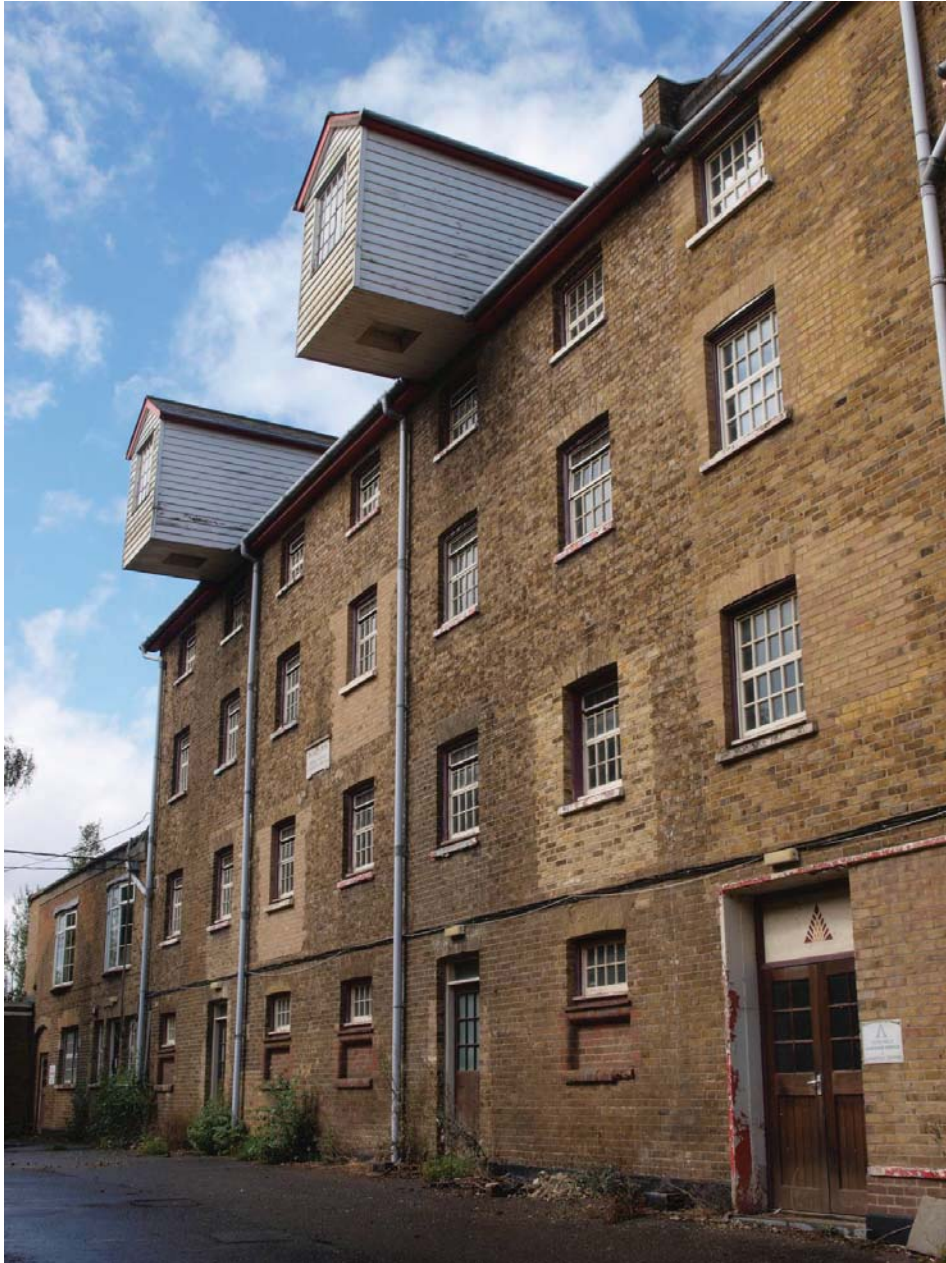
Plate 1

South elevation of Mill (see Figure 2 for location). View to north-west.

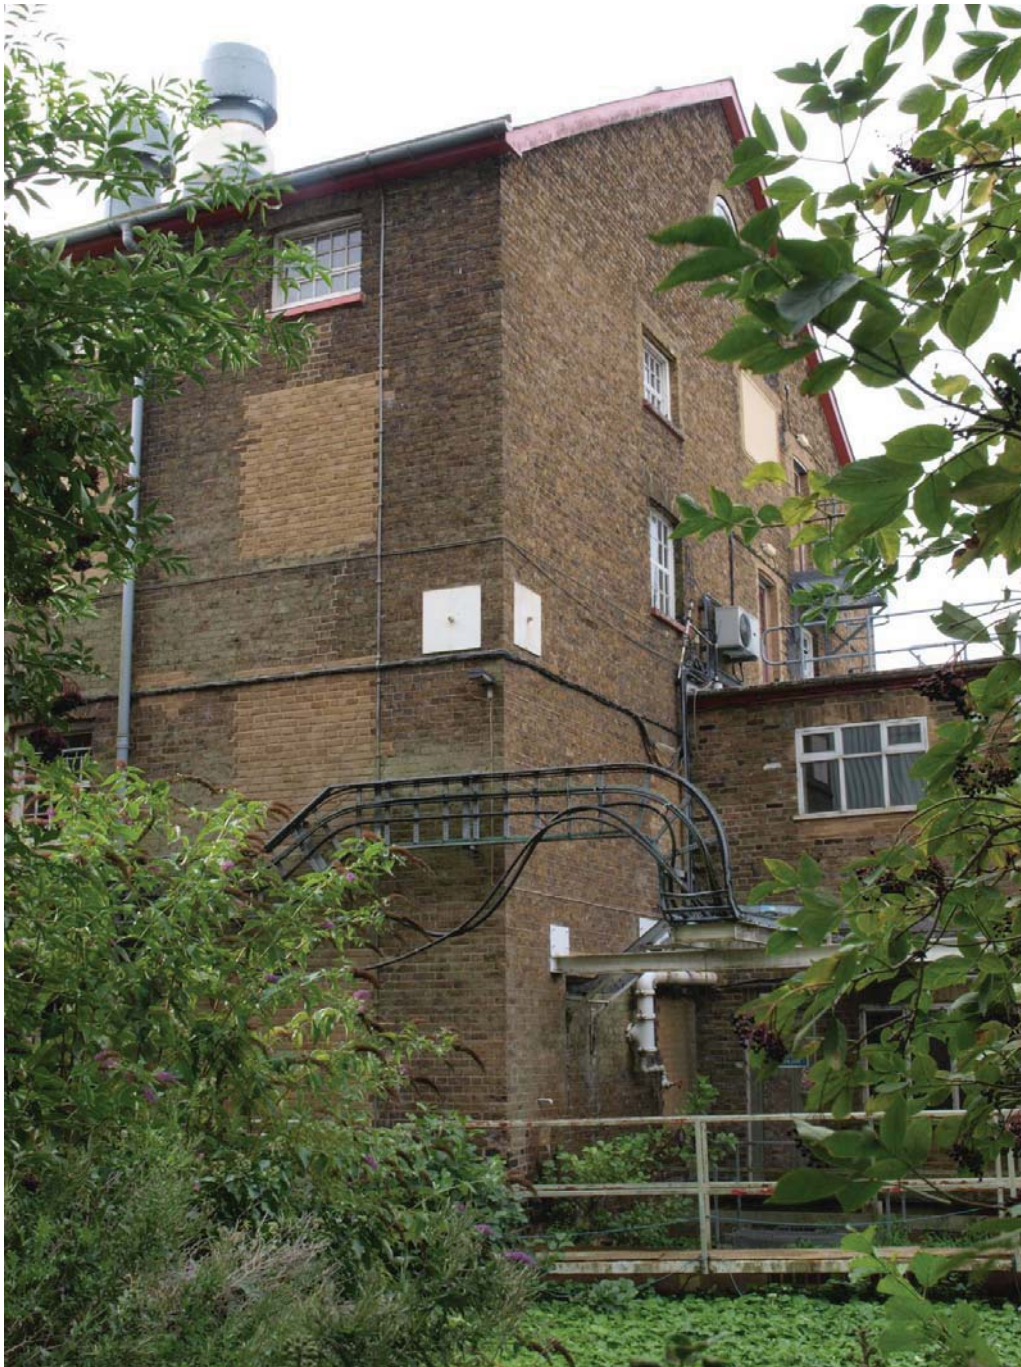
Plate 3

North (left) and west (right) elevation of Mill (see Figure 2 for location). View to south-east.

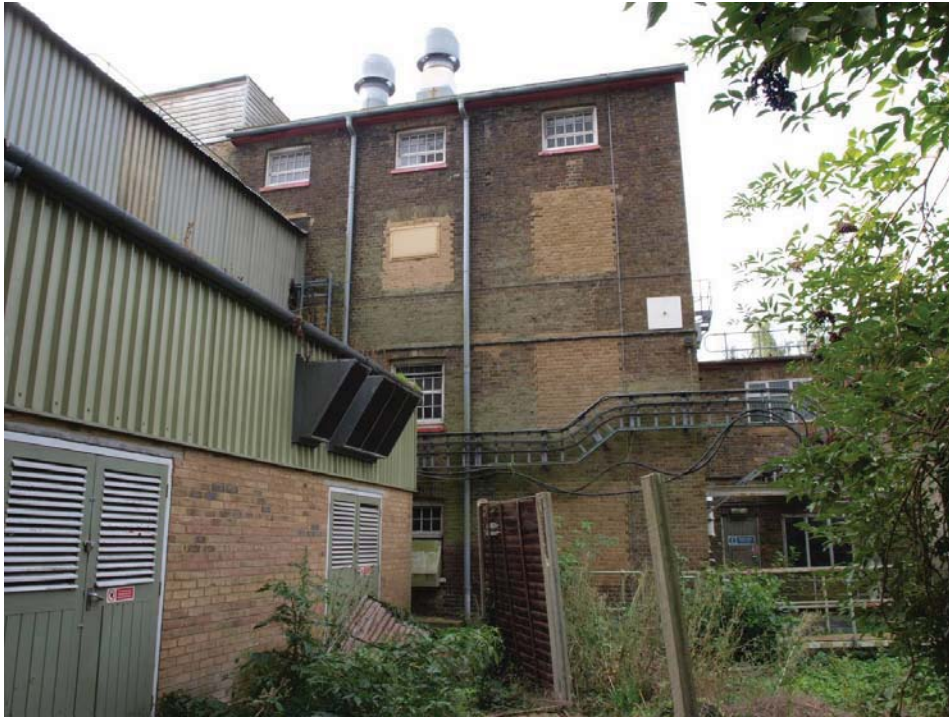
Plate 4

West end of Mill's north elevation (see Figure 2 for location). View to south-east.

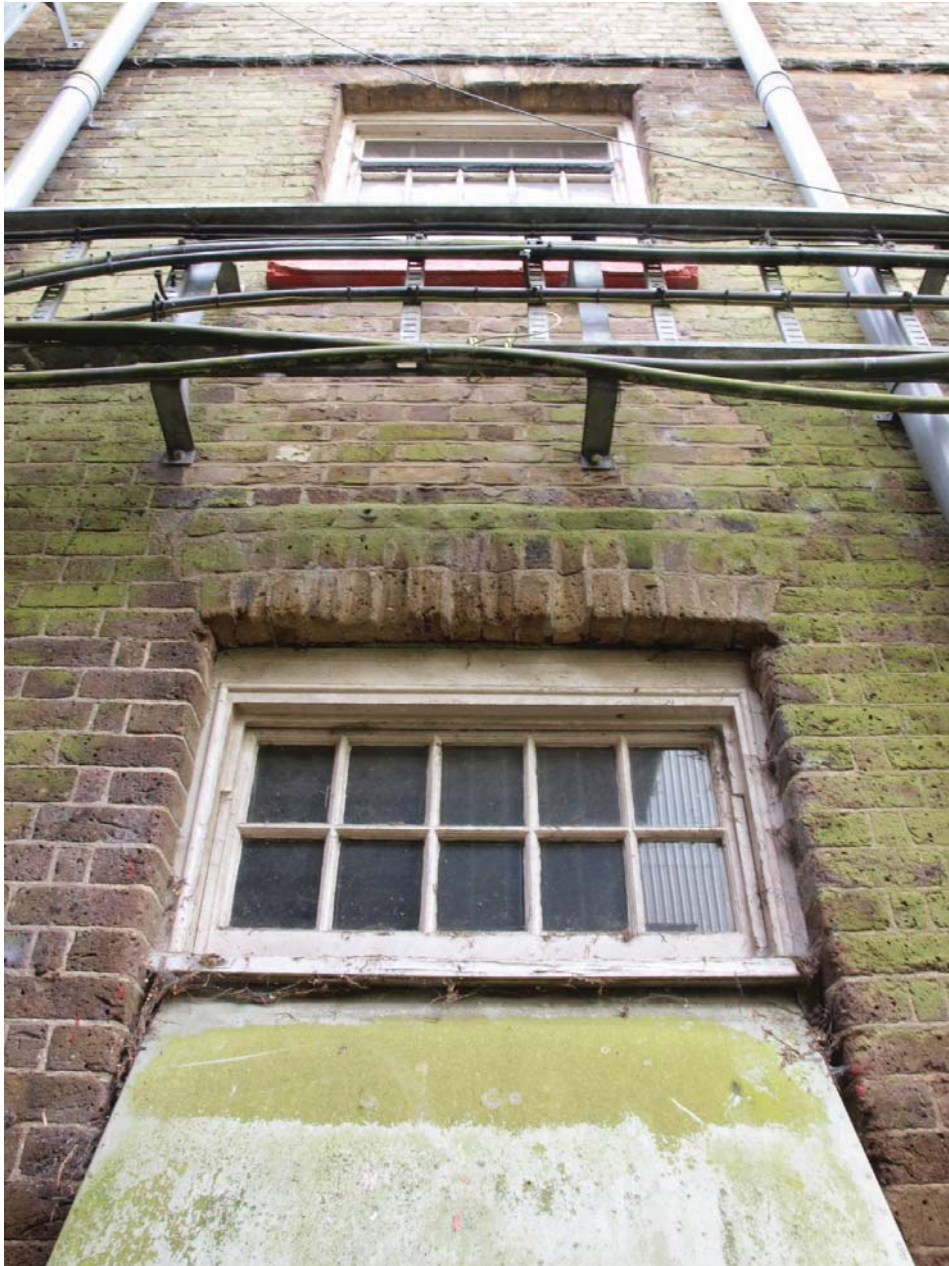
Plate 5

Detail of wear patterns on ground floor window arch in Bay2, north elevation of Mill (see Figure 2 for location). View to south.

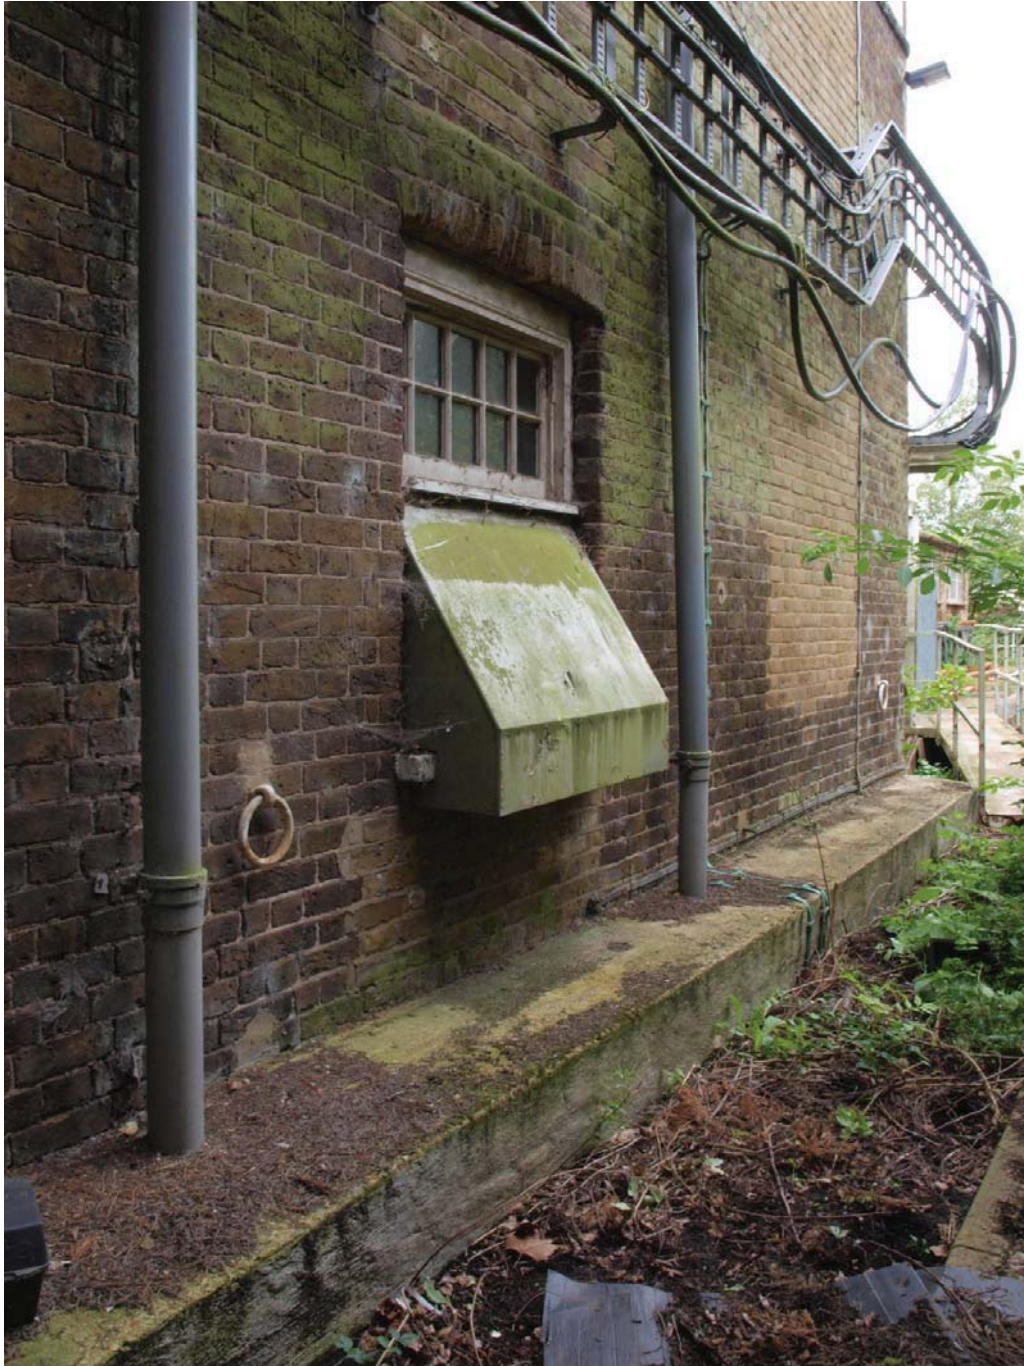
Plate 6

- 6.1.5 Other noteworthy features include two mooring rings which measured 0.17m diameter by 20mm thickness (**Plate 6**), and a tie plate adjacent to the first floor window in Bay 1. The latter was recorded at the same height and was the same size as a second tie plate observed in the west (side) elevation (**Plate 3**).

Detail of mooring rings along Mill's north elevation and in-filled dock (see Figure 2 for location). View to south-west.

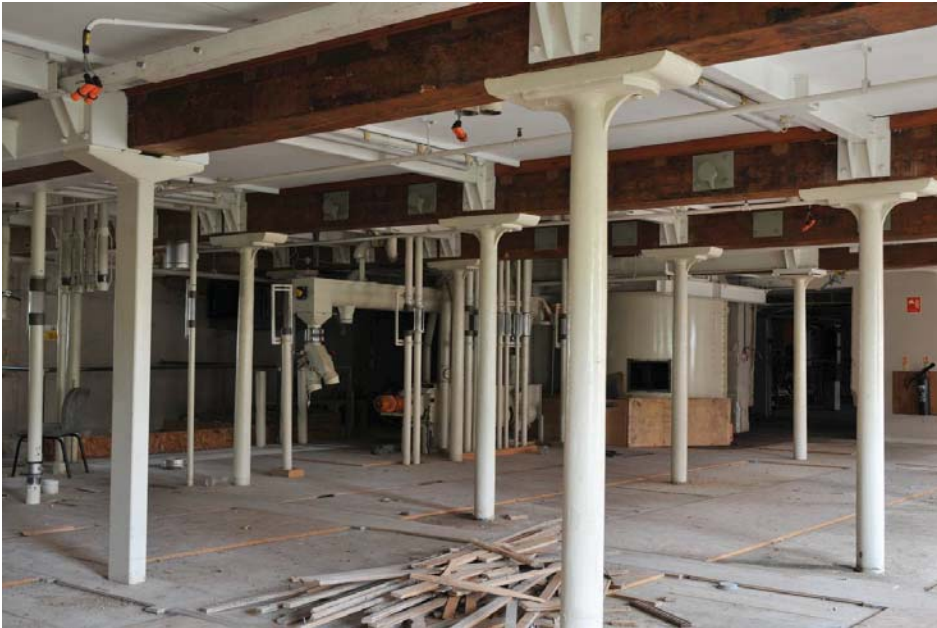
Plate 9

Combination of original and replaced columns, first floor, Mill (see Figure 13 for location). View to east-north-east.

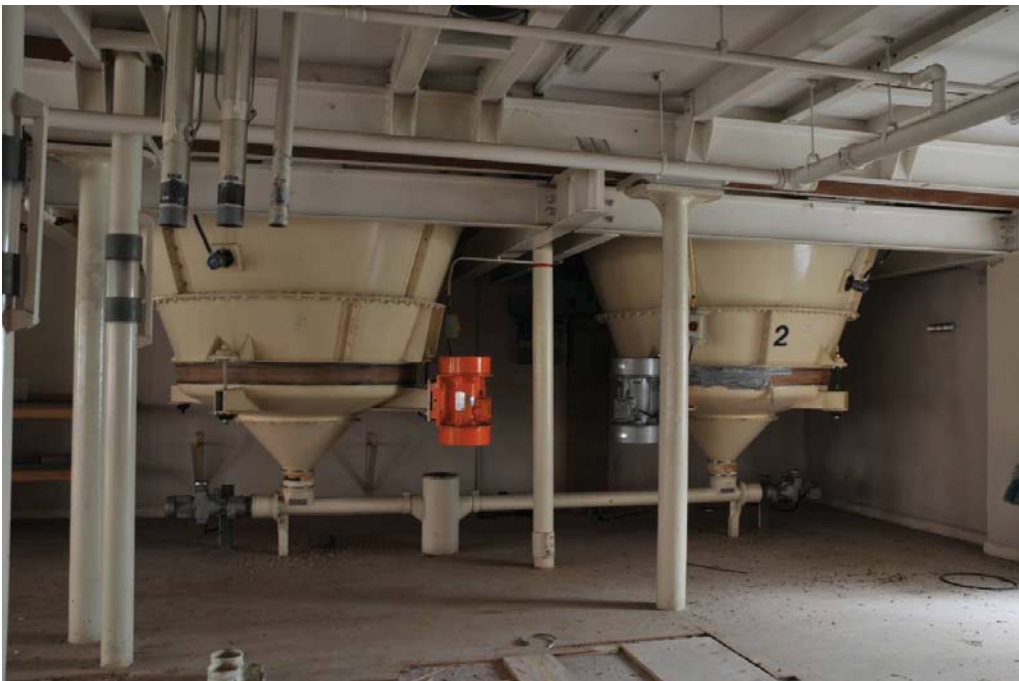
Plate 10

Grain hoppers in north-west corner, first floor, Mill (see Figure 13 for location).

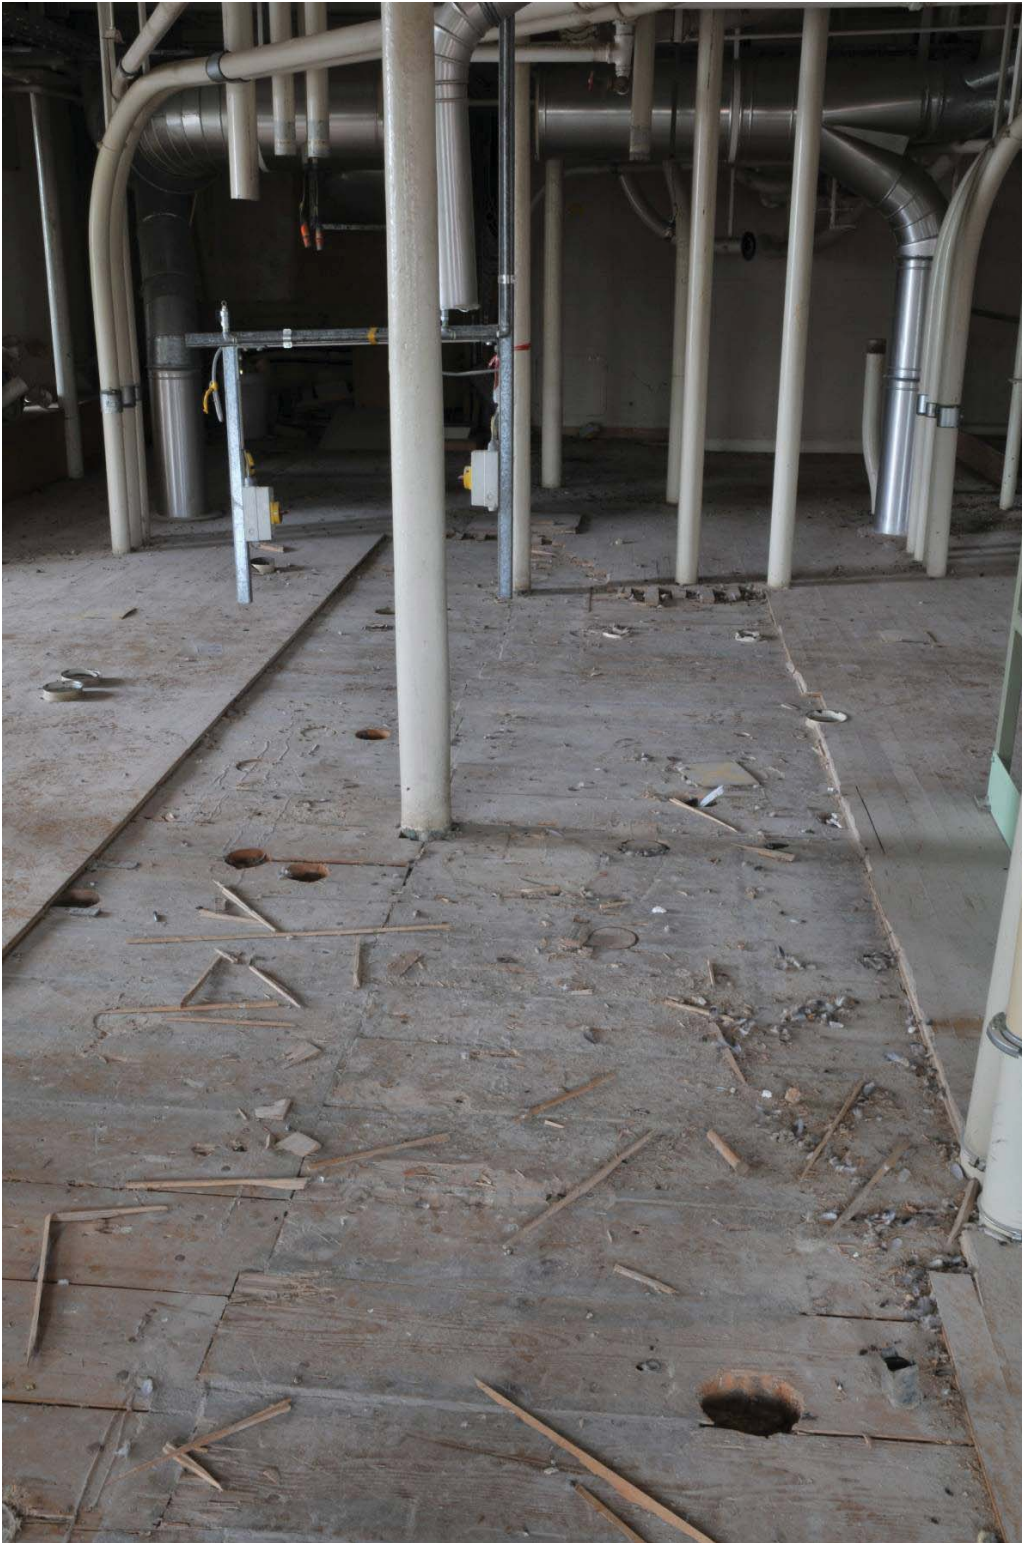
Plate 11

- 6.1.9 The layout of the second floor is comparable to the first. The floor has been reinforced with steel and replaced during the 20th century, and all of the original columns have been replaced (**Plate 11**). Replacement floorboards cover the floor (**Plates 11 and 12**). Within the north-west corner, directly over the grain hoppers are two late 20th century large hoppers (**Plate 13**).

Replacement floorboards, second floor of Mill (see Figure 14 for location). View to north.

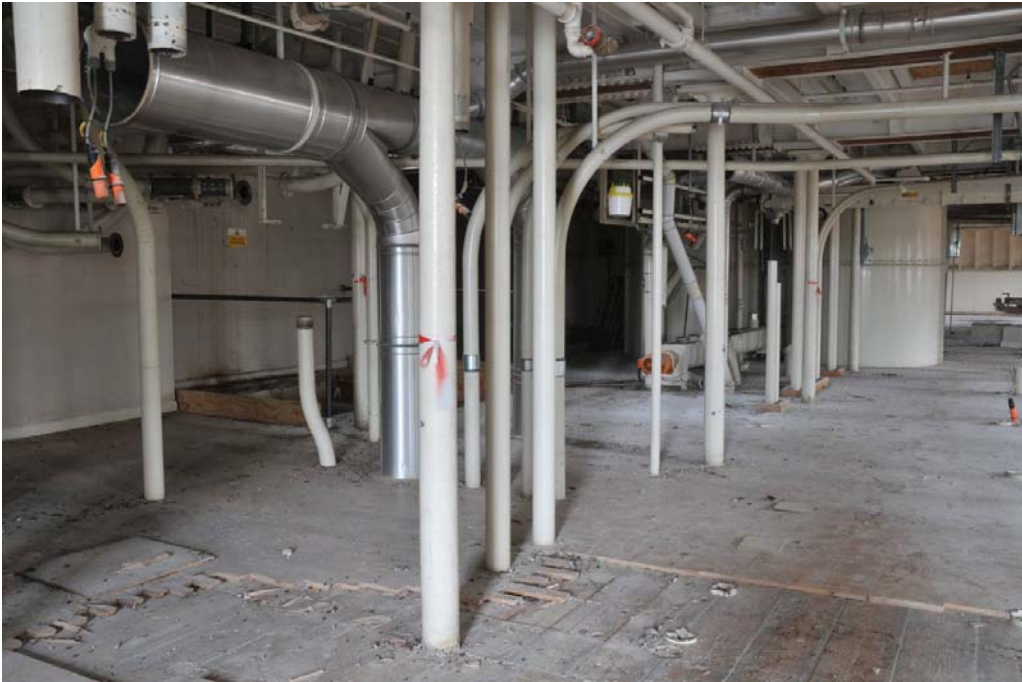
Plate 12

Second floor, Mill (see Figure 14 for location). View to north-east.

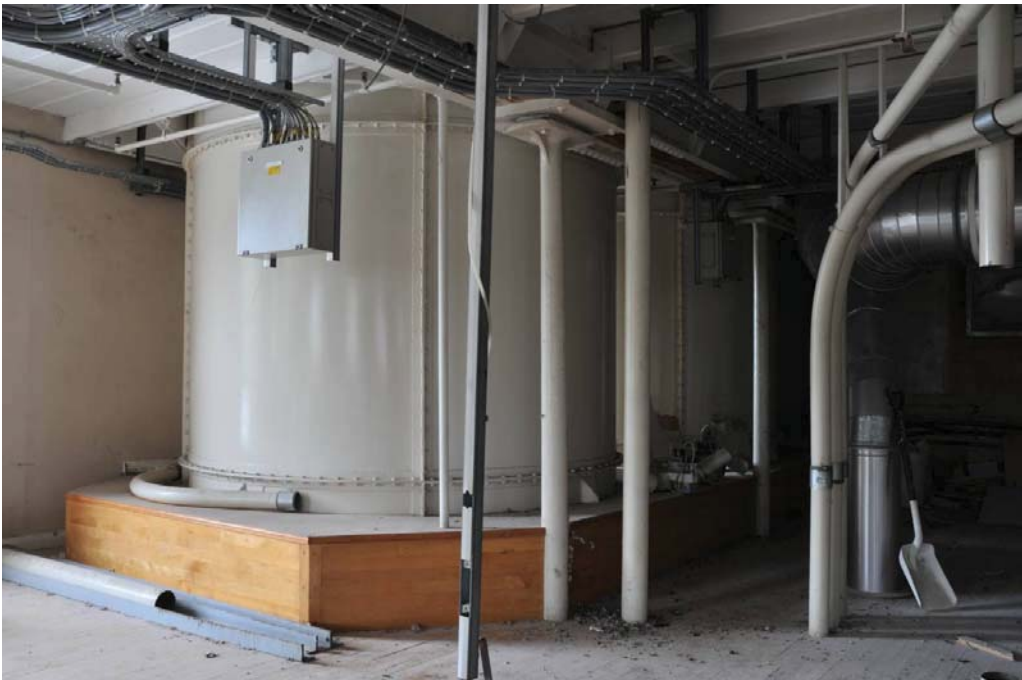
Plate 13

Hoppers on second floor of Mill (see Figure 14 for location). View to north-west.

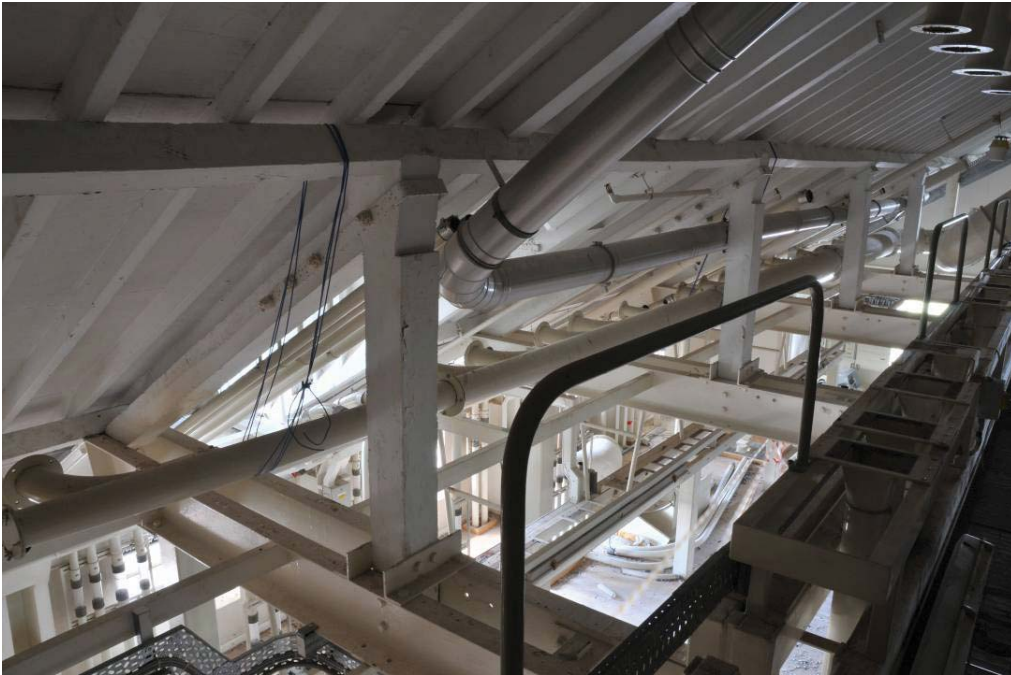
Plate 14

- 6.1.10 Numerous alterations were observed within the third floor, and comparably to the previous levels, primarily relate to the introduction of new machinery, including the reinforcement of the roof. All the original tie beams have been removed and replaced by pairs of RSJs (rolled steel joists) at the sides and all that remains of the trusses are the timber queen posts which support timber purlins (**Plate 14**). This may have been another alteration prompted by the needs of larger, modern machinery. The height of newer equipment may have prompted the need to raise the level of the roof and remove the central part of the tie beams spanning the building north-south. **Plates 15 and 16** illustrate the new steel frame, columns and roof rafters.

Detail of alterations to roof and truncation of tie beams, third floor of Mill (see Figure 15 for location). View to west-south-west.

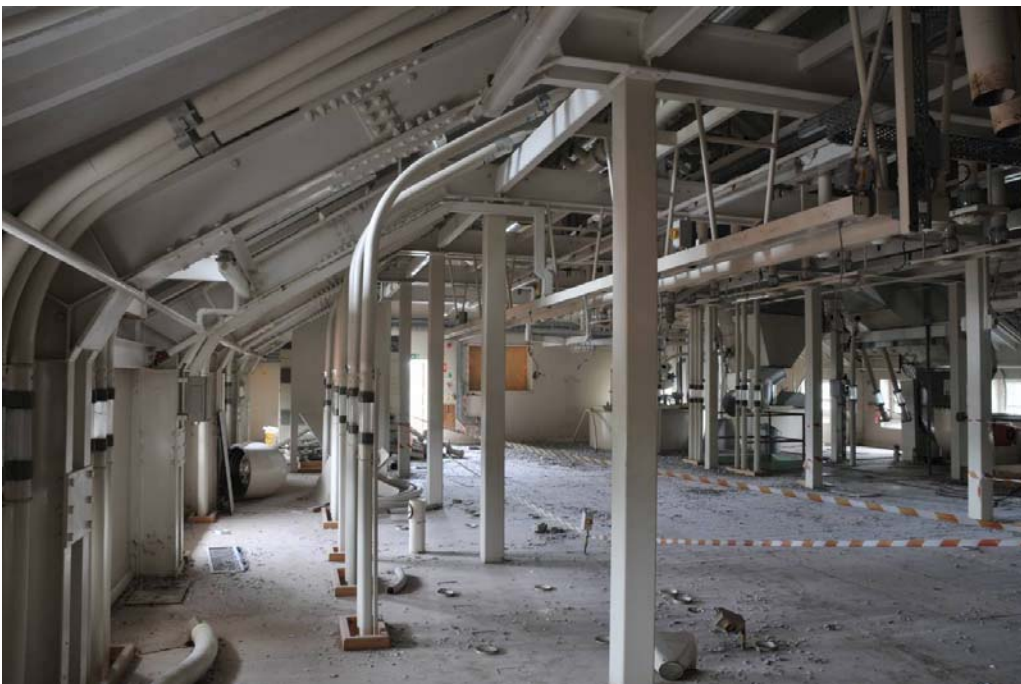
Plate 15

Third floor of Mill (see Figure 15 for location). View to west-north-west.

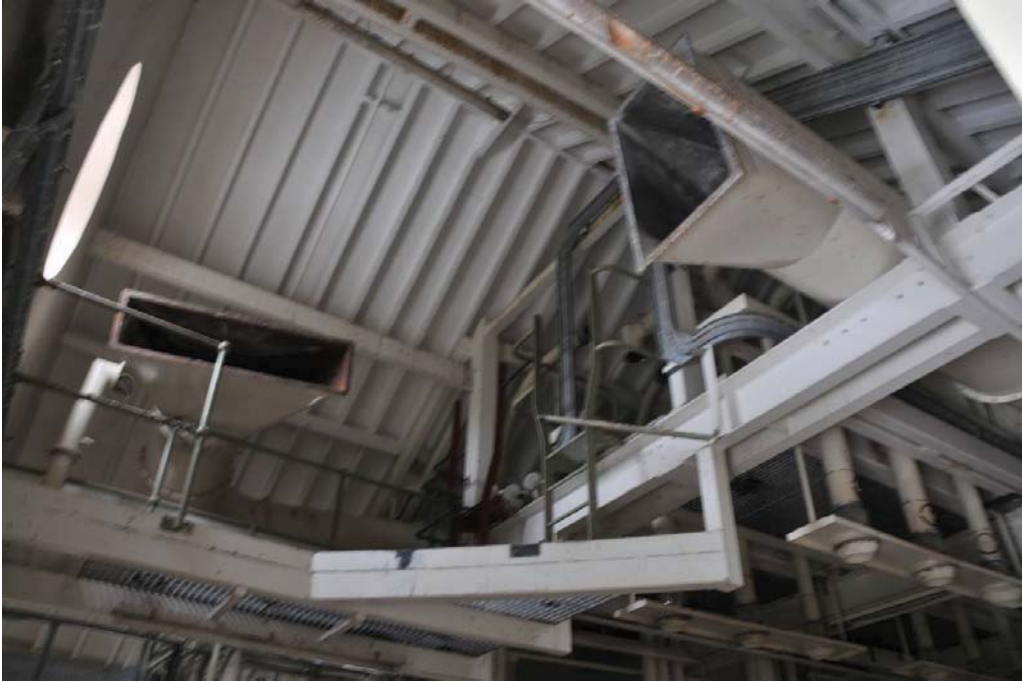
Plate 16

Detail of rafters from third floor of Mill (see Figure 15 for location). View to north-east.

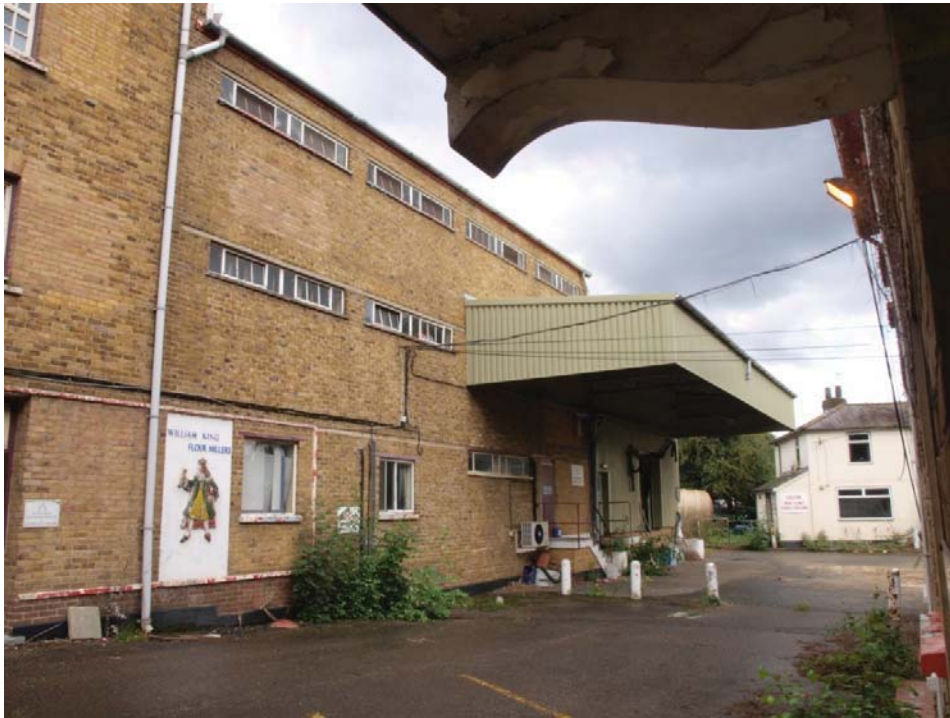
Plate 17

South elevation of Mill's early 1960's eastern extension (see Figure 2 for location), view to north-east

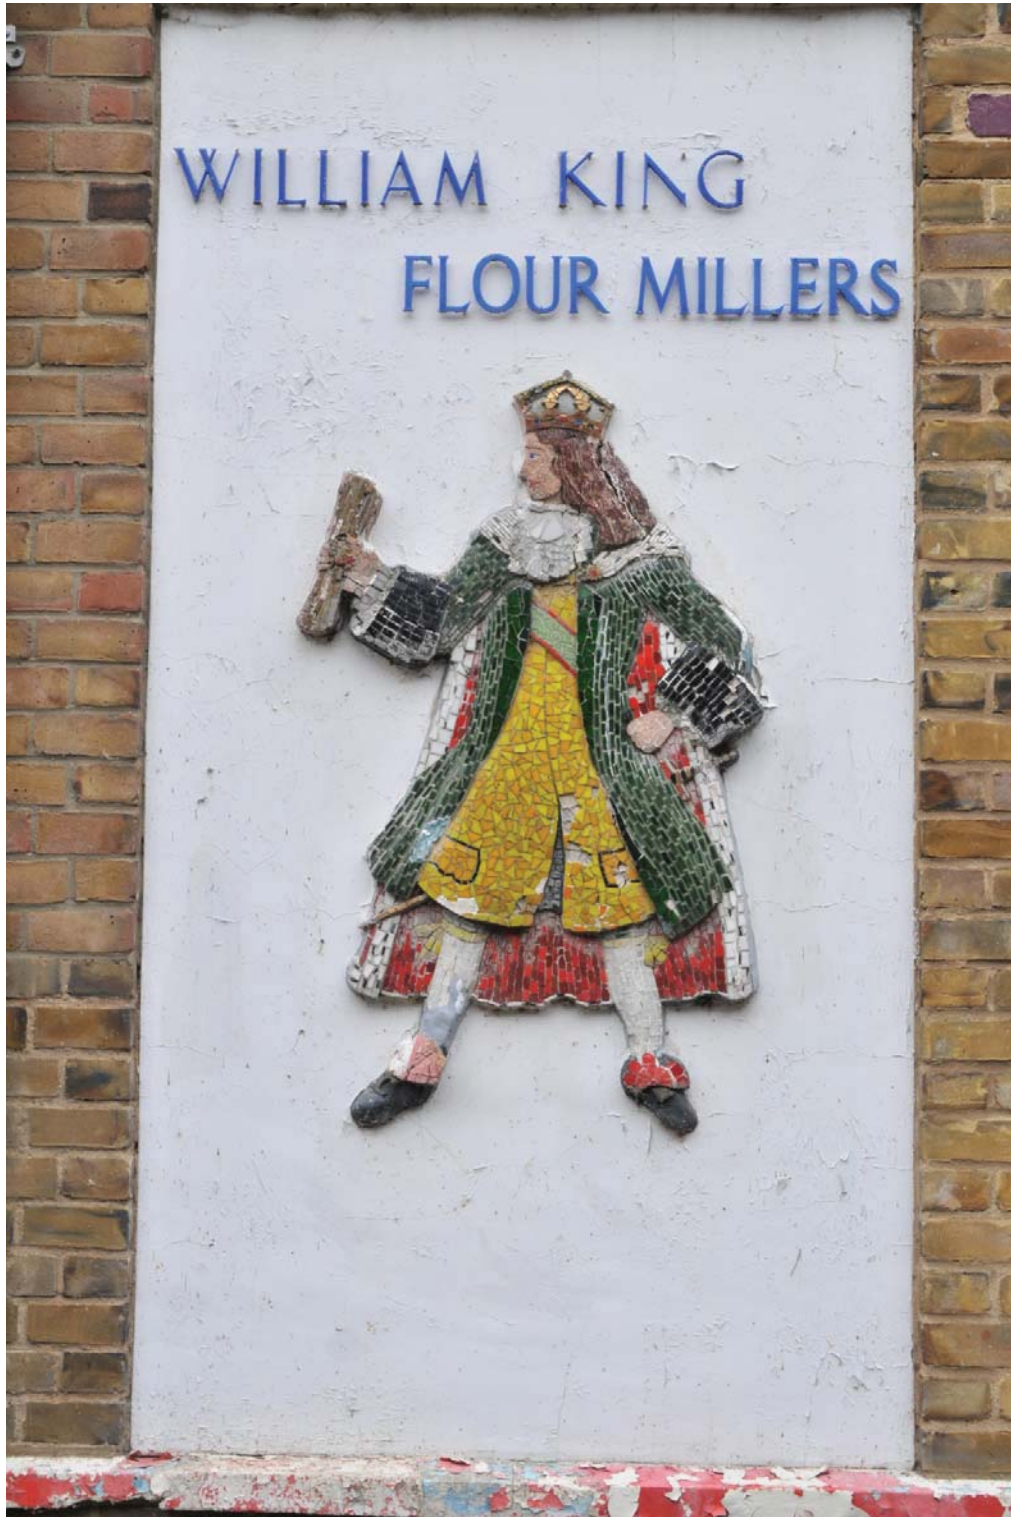
Plate 18

Mosaic on south elevation of the Mill's early 1960's eastern extension (see Figure 12 for location), view to north

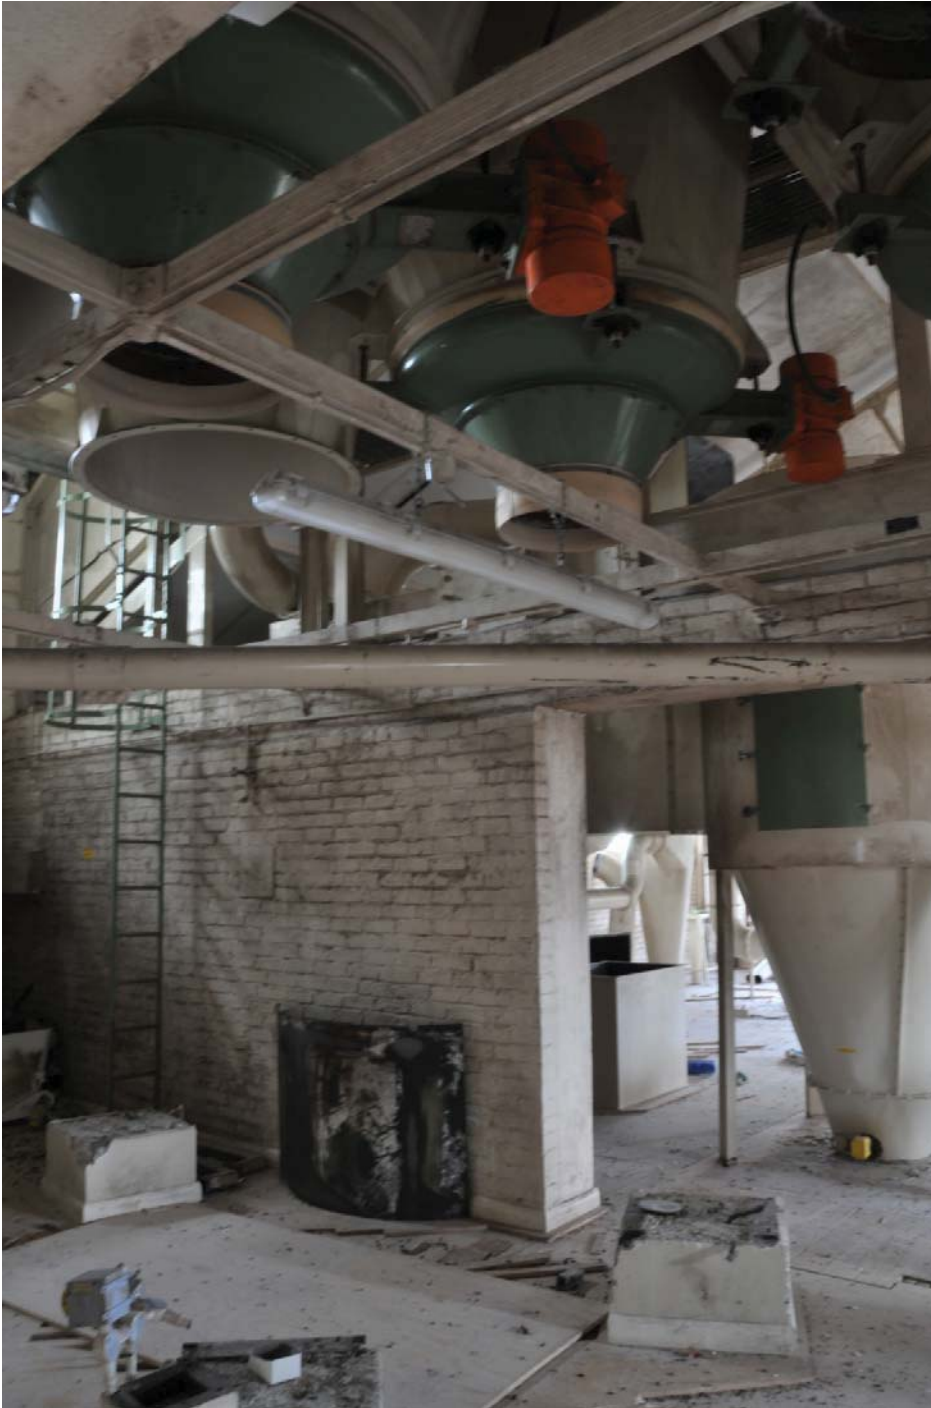
Plate 21

Brick wall on north side of second floor in the Mill's eastern extensions (see Figure 13 for location), view to north-east

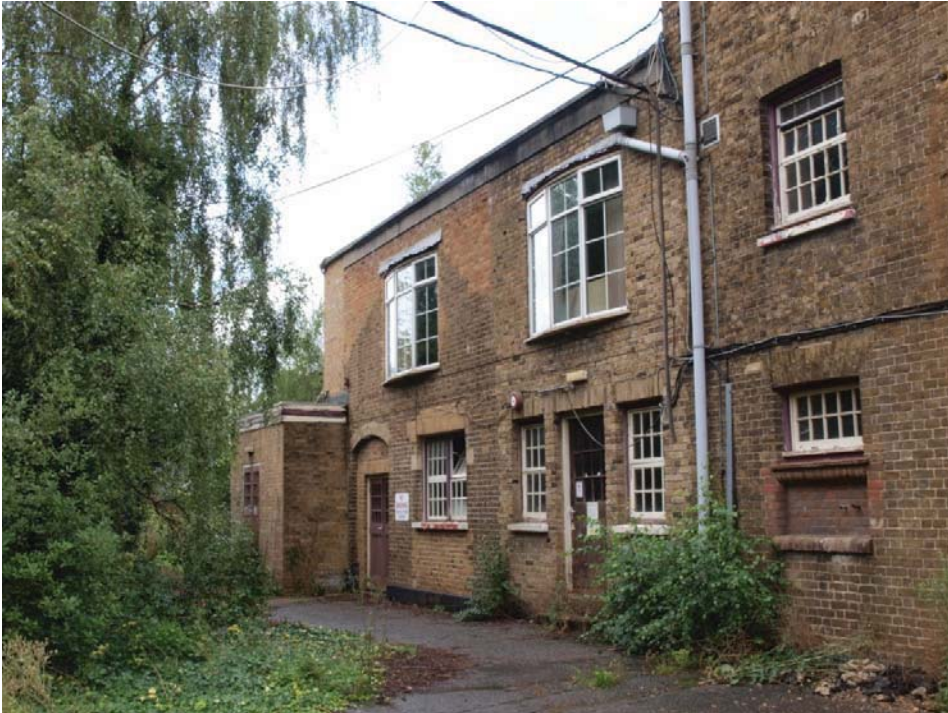
Plate 22

South elevation of the western extension of the Mill (see Figure 2 for location), view to north-west

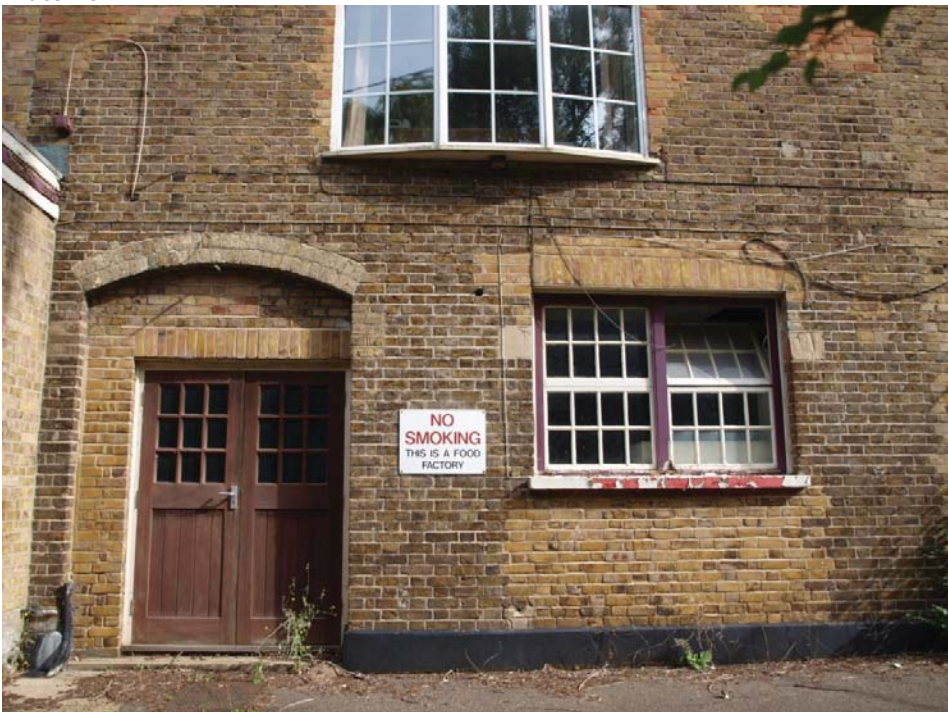
Plate 23

South elevation of Bakery (western extension of the Mill) with reduced entrance (left) and conversion of a former doorway into a window (see Figure 2 for location), view to north.

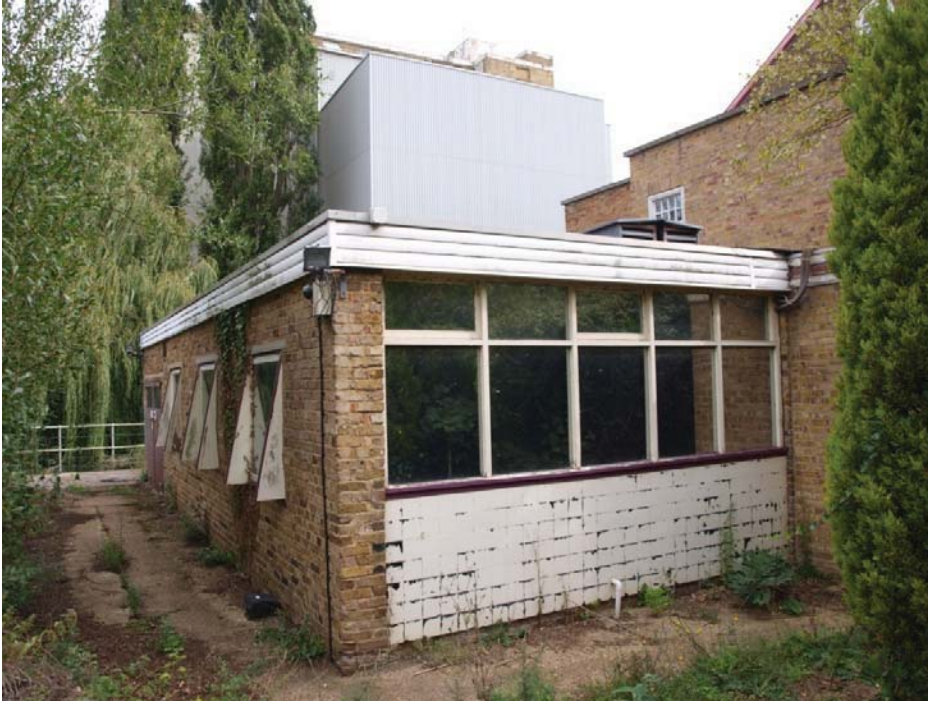
Plate 24

South elevation of the Laboratory, westernmost extension of the Mill (see Figure 2 for location), view to north-east

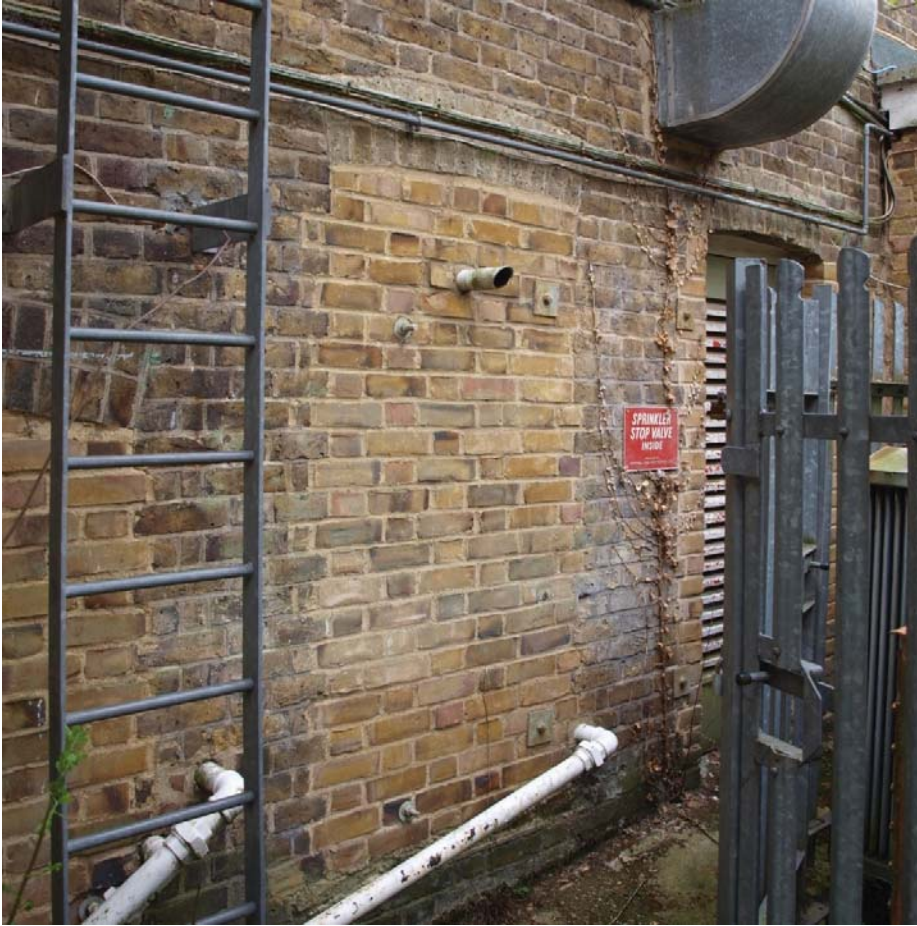
Plate 26

North elevation of western extension of the Mill (see Figure 2 for location), view to south

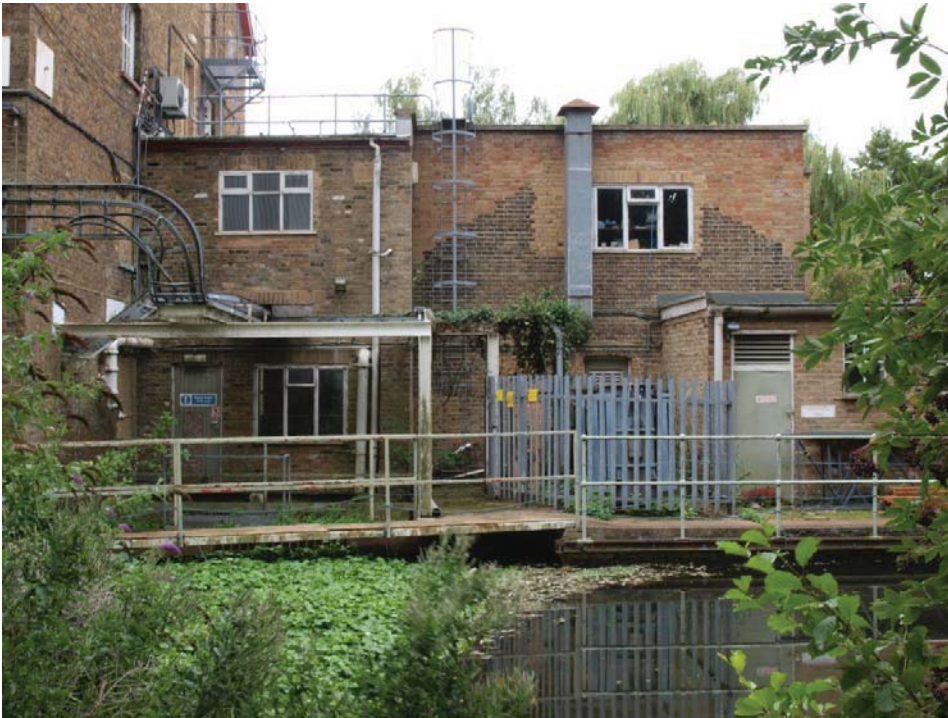
Plate 27

Western extension of the Mill, showing scar of former gable (see Figure 2 for location), view to south

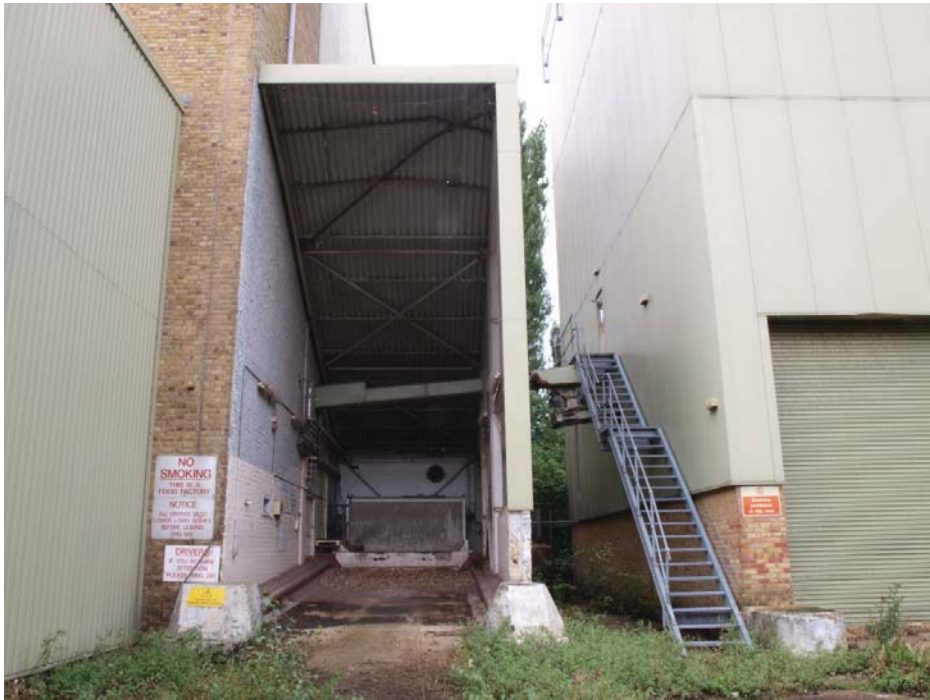
Plate 29

South loading bay, northern extension of the Mill (see Figure 2 for location), view to west.

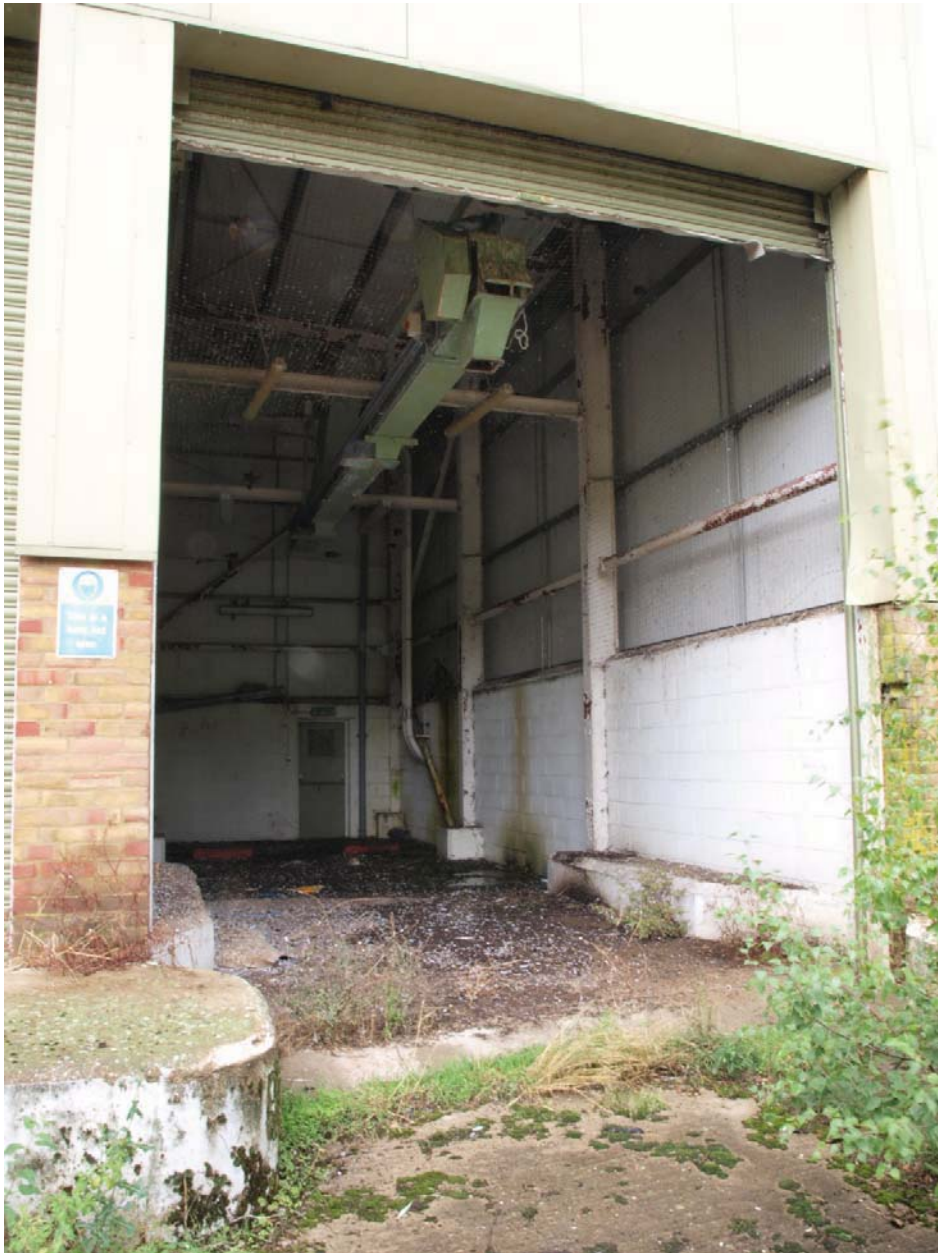
Plate 30

North loading bay and grain drops in the northern extension of the Mill (see Figure 2 for location), view to north-west

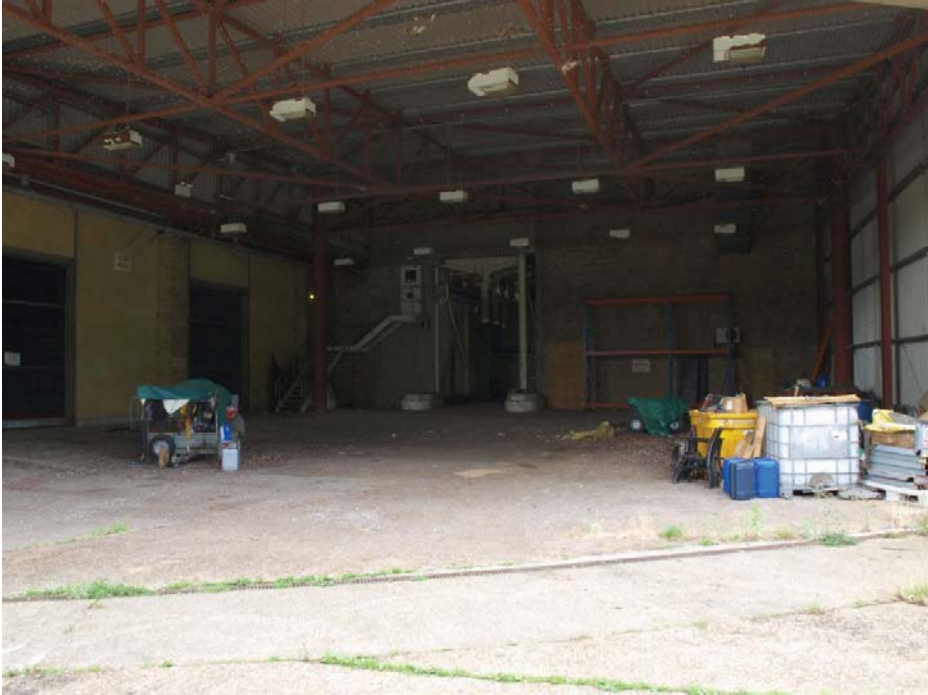
Plate 31

Flour chutes to rear (west) and vehicle loading bay in the northern extension of the Mill (see Figure 2 for location), view to south-west.
