**BUILDING RECORDING AT
WILLIAM KING FLOUR MILL,
DENHAM,
BUCKINGHAMSHIRE**

SITE CODE: UWKM10

OCTOBER 2010

Building Recording

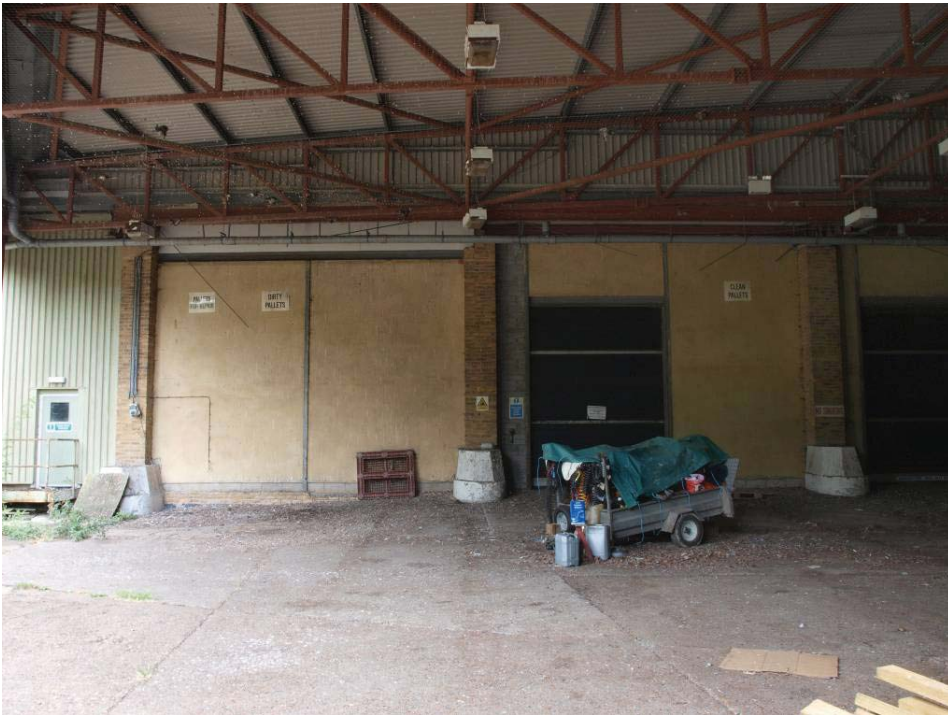
Plate 32

South elevation of loading bay in the northern extension of the Mill (see Figure 2 for location), view to south.

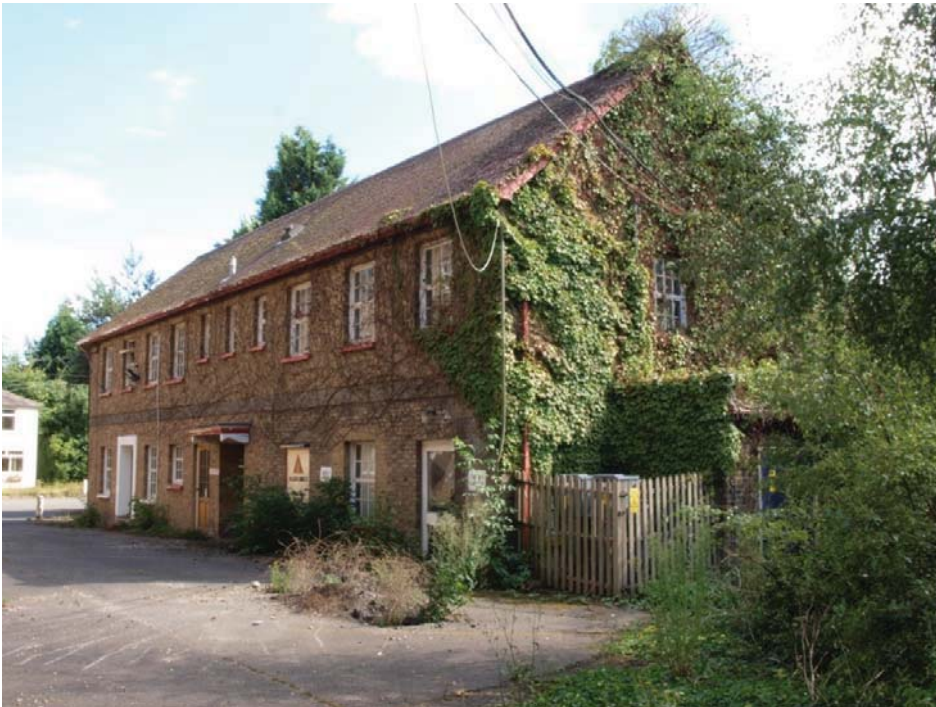
Plate 34

North Elevation of Administration Block (see Figure 2 for location). View to south-east.

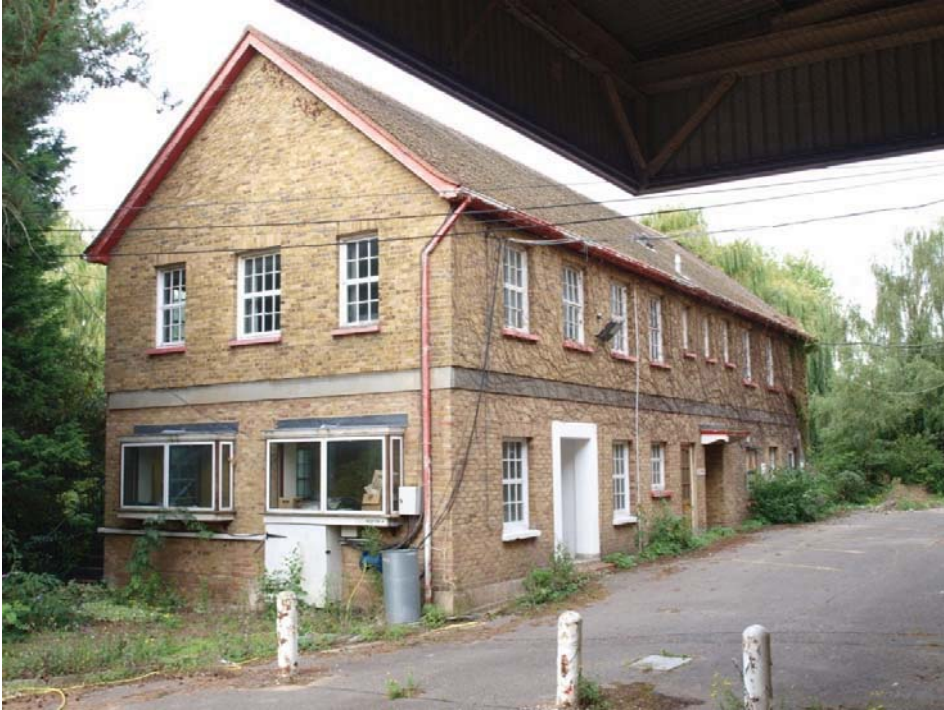
Plate 36

East (left) and north (right) elevations of the Administration Block (see Figure 2 for location). View to west-south-west.

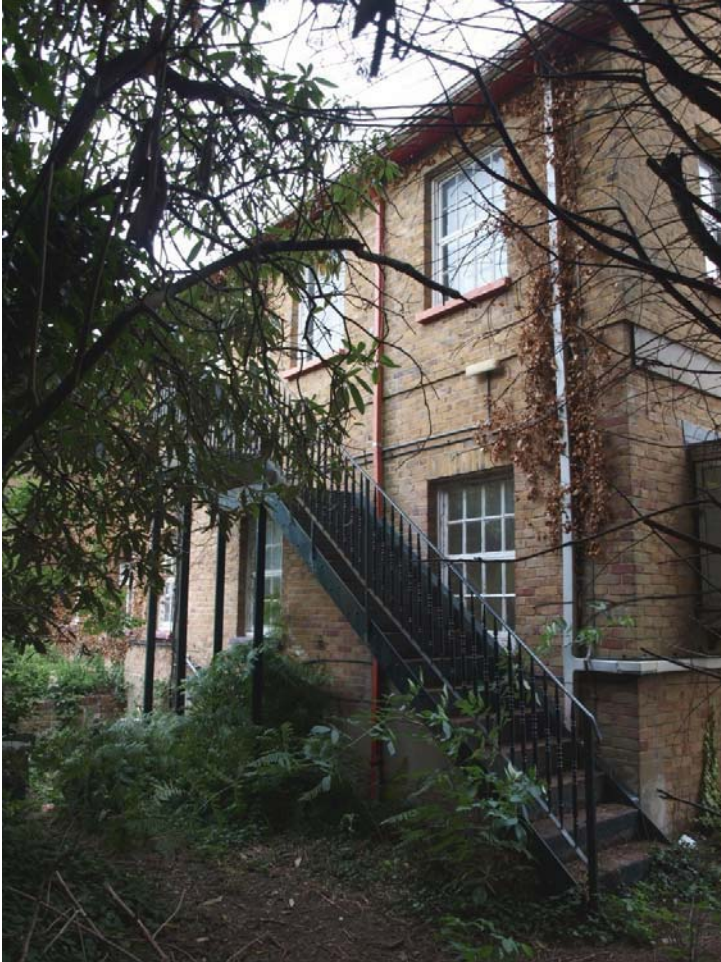
Plate 37

South elevation of Administration Block to east (see Figure 2 for location). View to north-west.

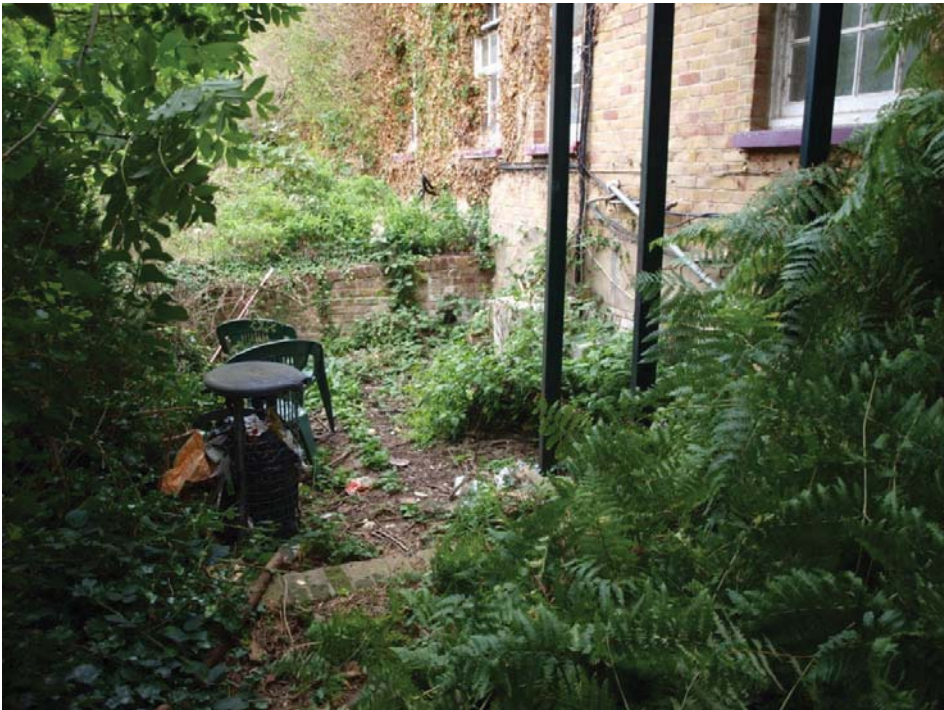
Plate 39

South Elevation of Administration Block to east illustrating former in-filled channel (see Figure 2 for location). View to west-north-west.

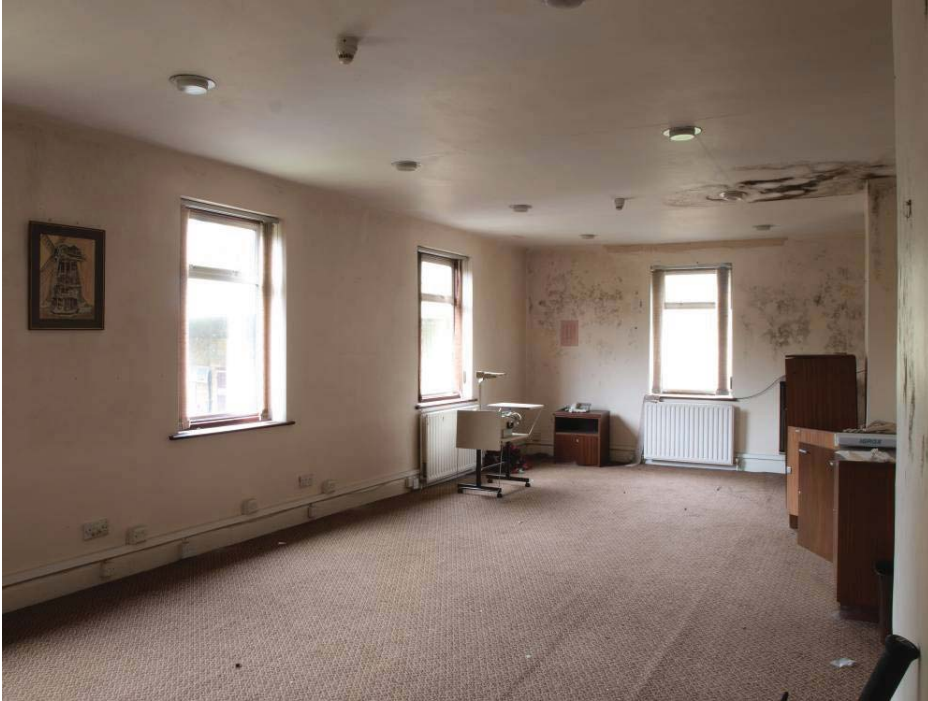
Plate 50

Boardroom, first floor, Mill House (see Figure 22 for location), view to north-west

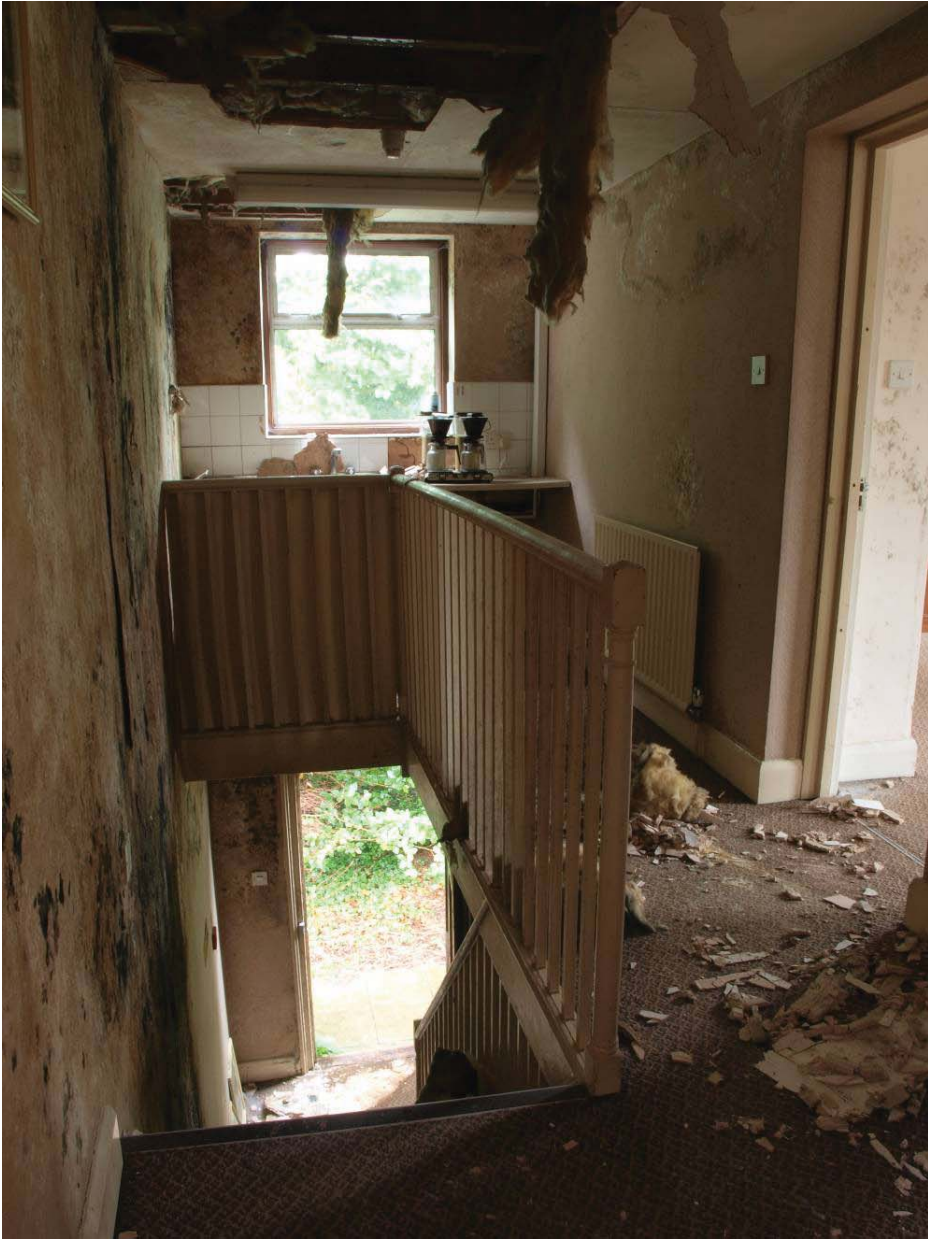
Plate 51

First floor landing, Mill House (see Figure 22 for location), view to south

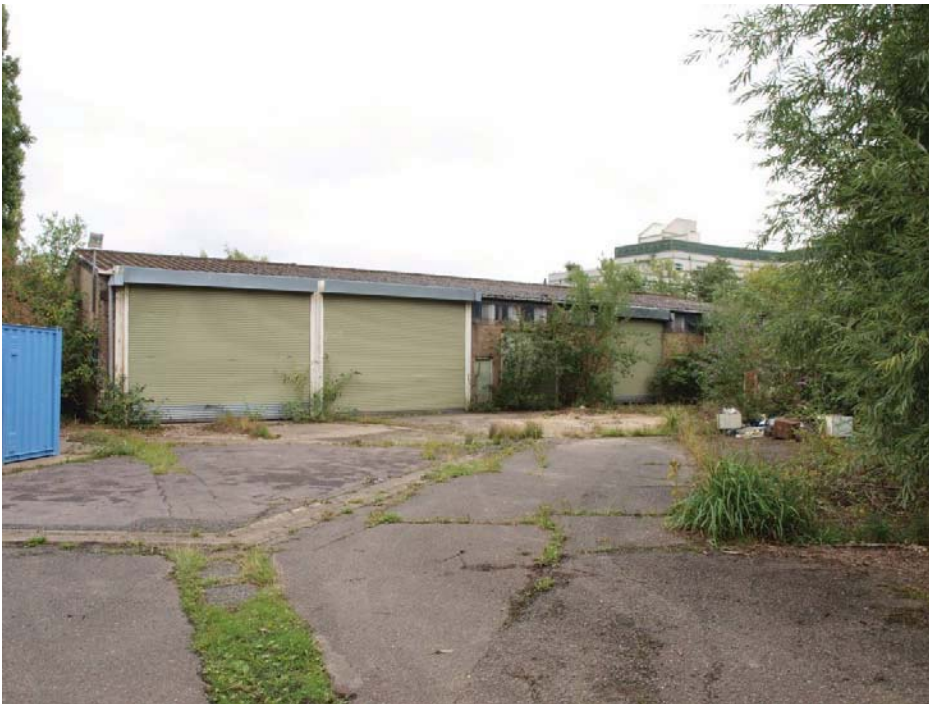
Plate 53

West Elevation of Vehicle Workshop (see Figure 2 for location). View to south-south-east.

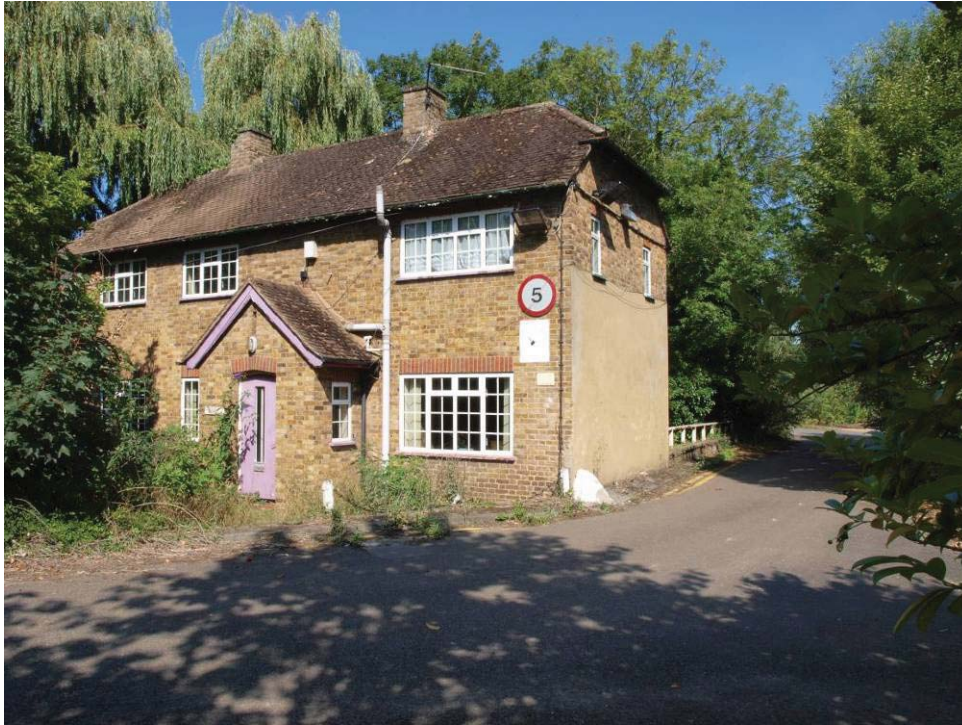
Plate 55

West (front) elevation of Midway Cottage (see Figure 2 for location), view to north-east

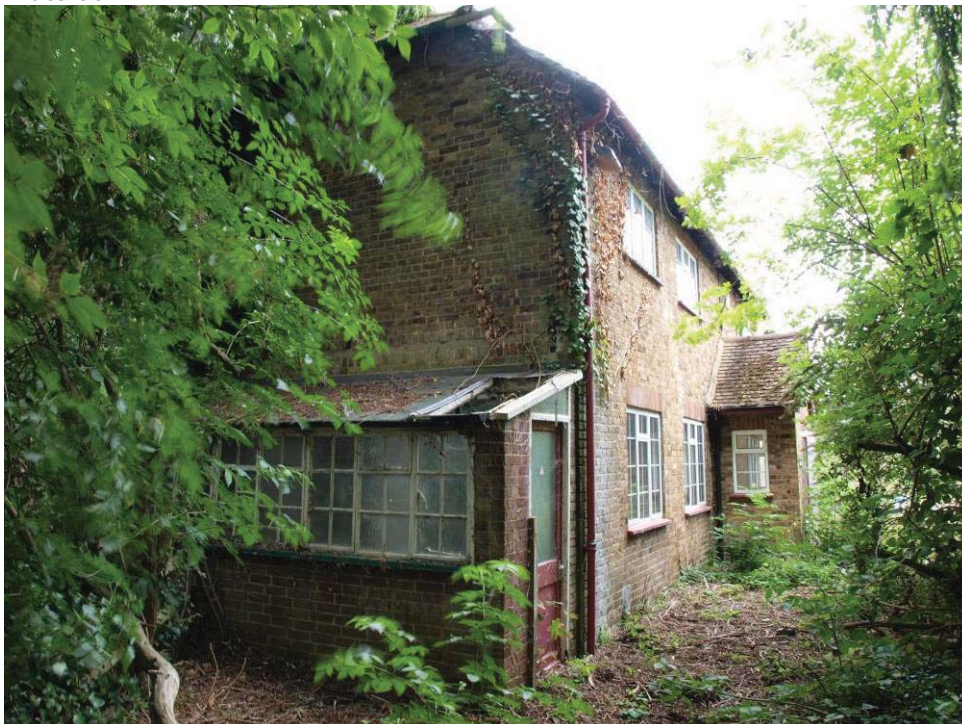
Plate 56

- 6.5.3 A small extension has been constructed along the northern elevation (**Figure 23**). This was largely built in red brick with a glass panelled lean-to roof (**Plate 56**). The windows within this extension were the only examples to retain their original wooden frames. The eastern elevation illustrates repairs to the rear two windows, but the construction otherwise appears contemporary to the remainder of the property (**Plate 57**).

North elevation of Midway Cottage and lean-to shed (see Figure 2 for location), view to south

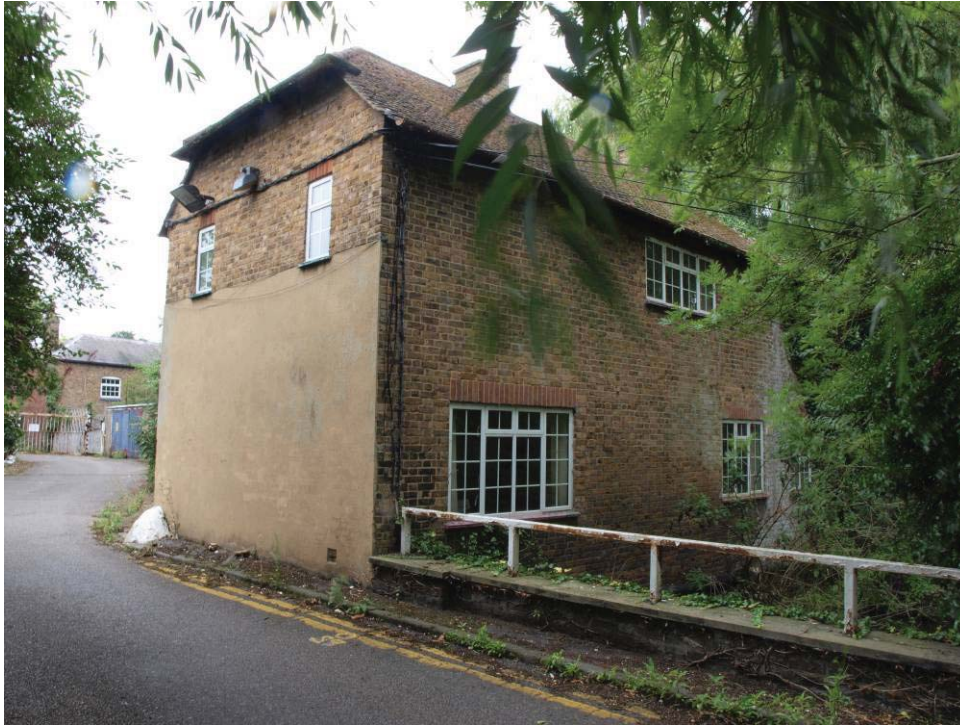
Plate 57

Side (south) and rear (east) elevation of Midway Cottage (see Figure 2 for location), view to north-west

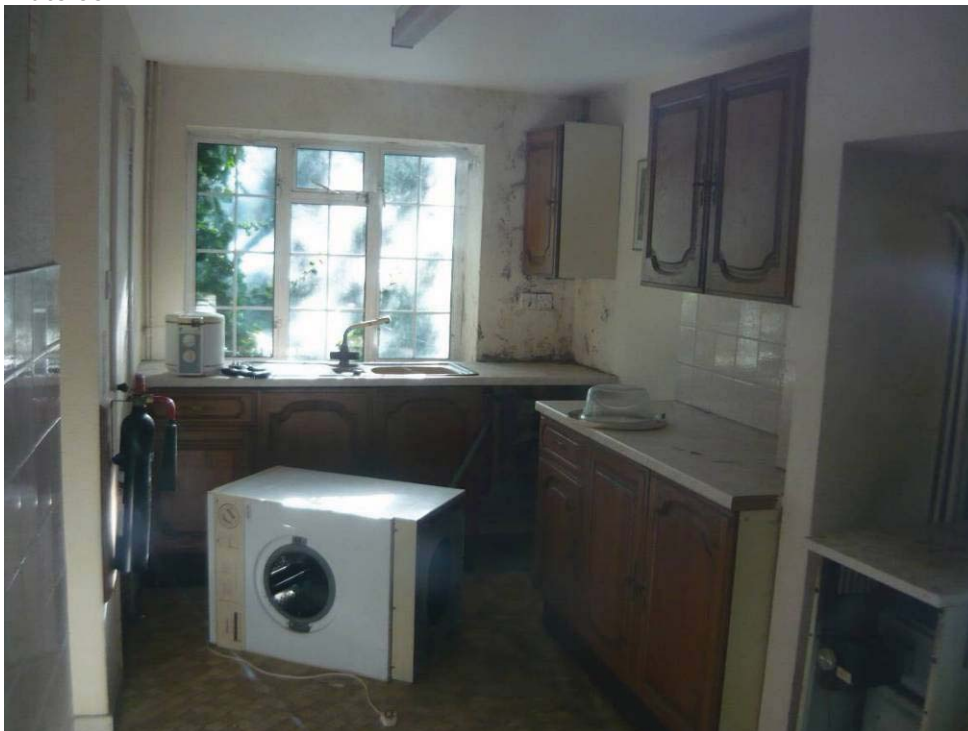
Plate 58

Ground floor kitchen, Midway Cottage (see Figure 2 for location), view to east

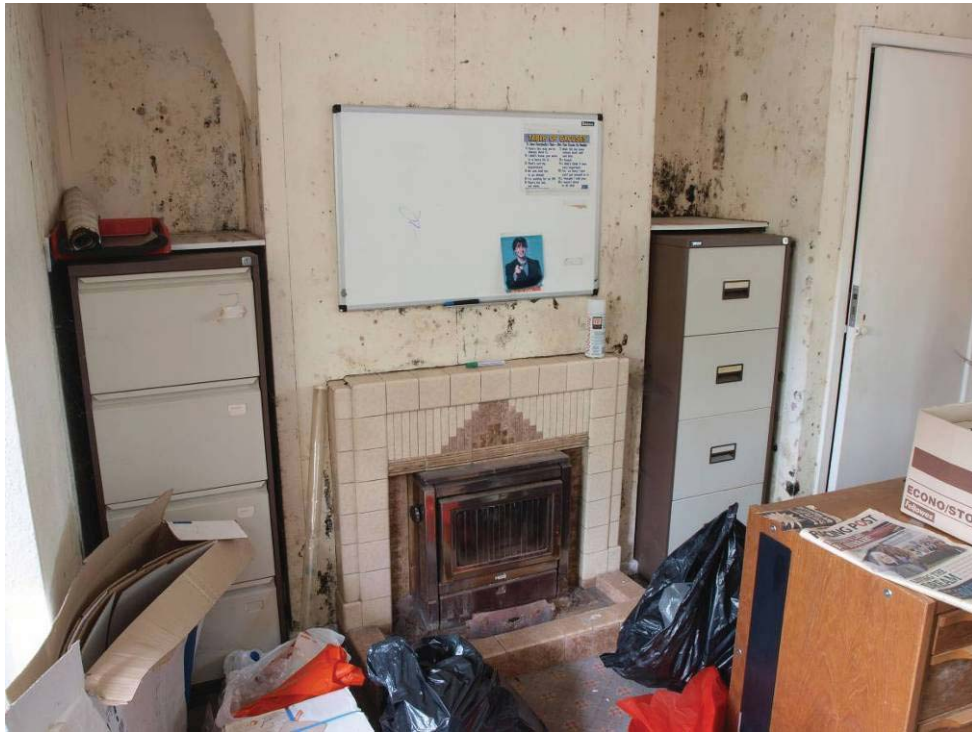
Plate 59

Living room, ground floor Midway Cottage (see Figure 23 for location), view to north

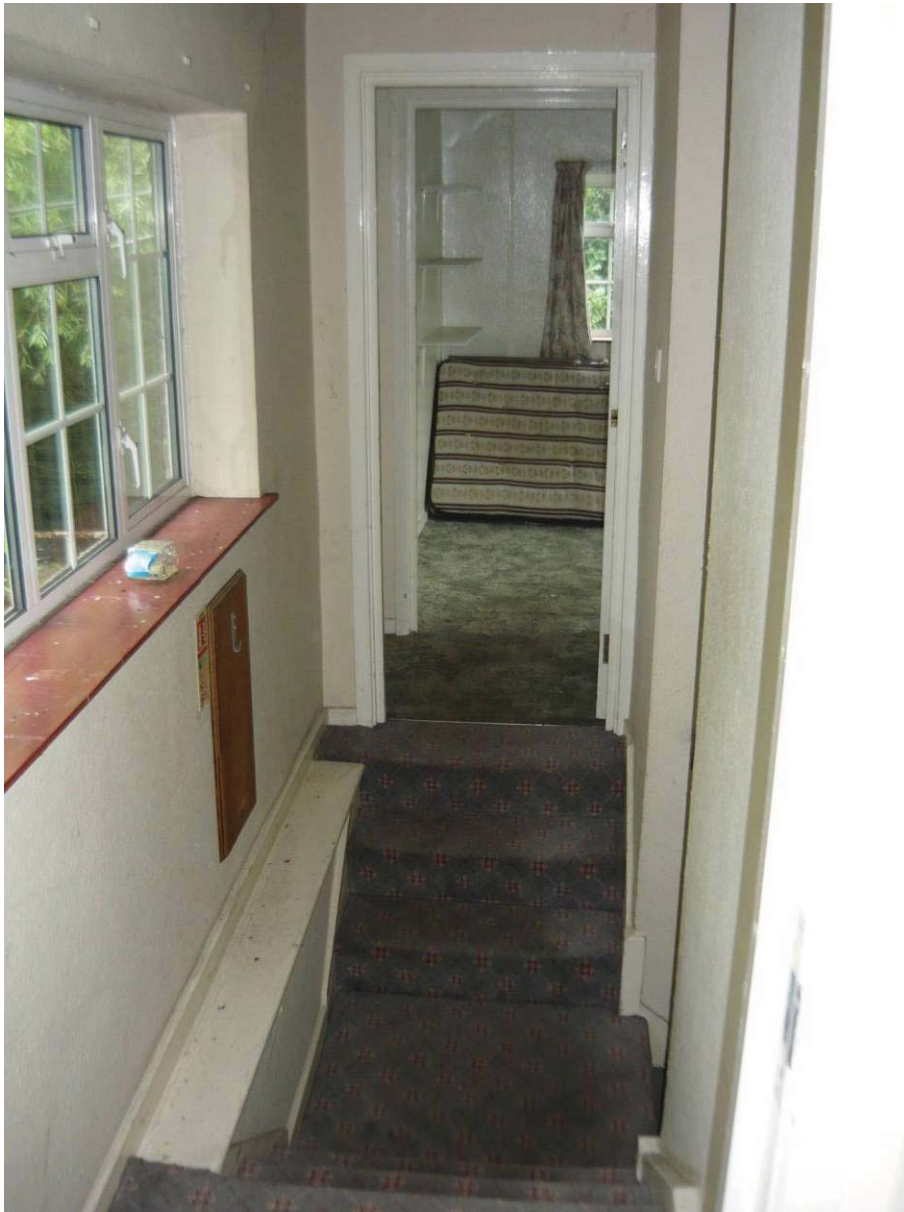
Plate 60

Landing and stairs, Midway Cottage (see Figure 23 for location), view to south

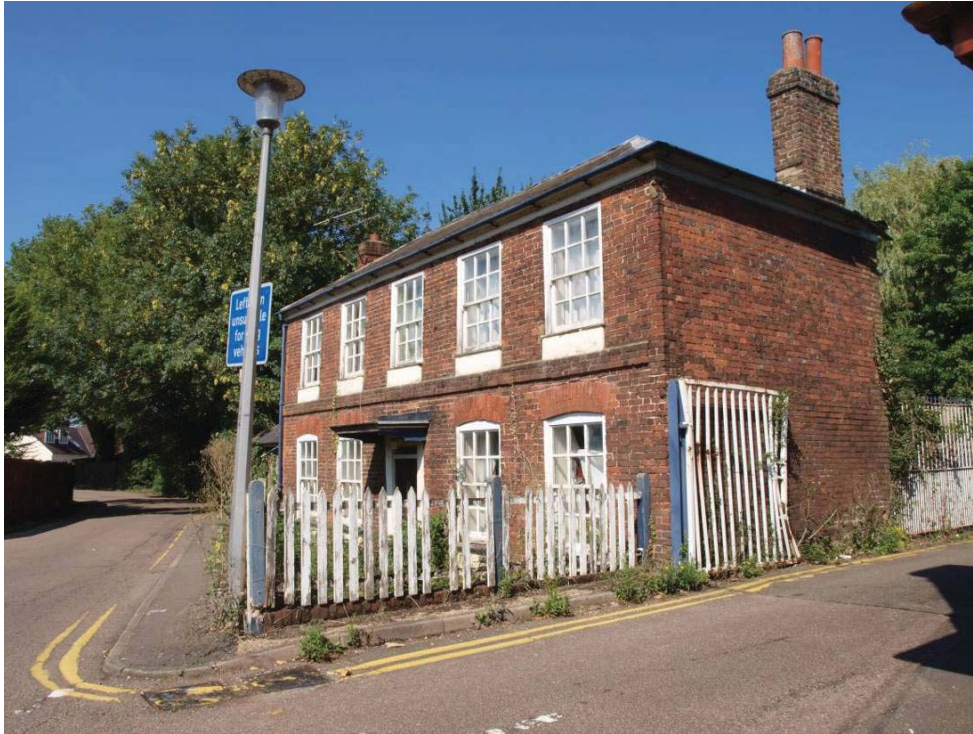
Plate 61

West and south elevations of Kingsmill Cottage (see Figure 2 for location). View to north-east.

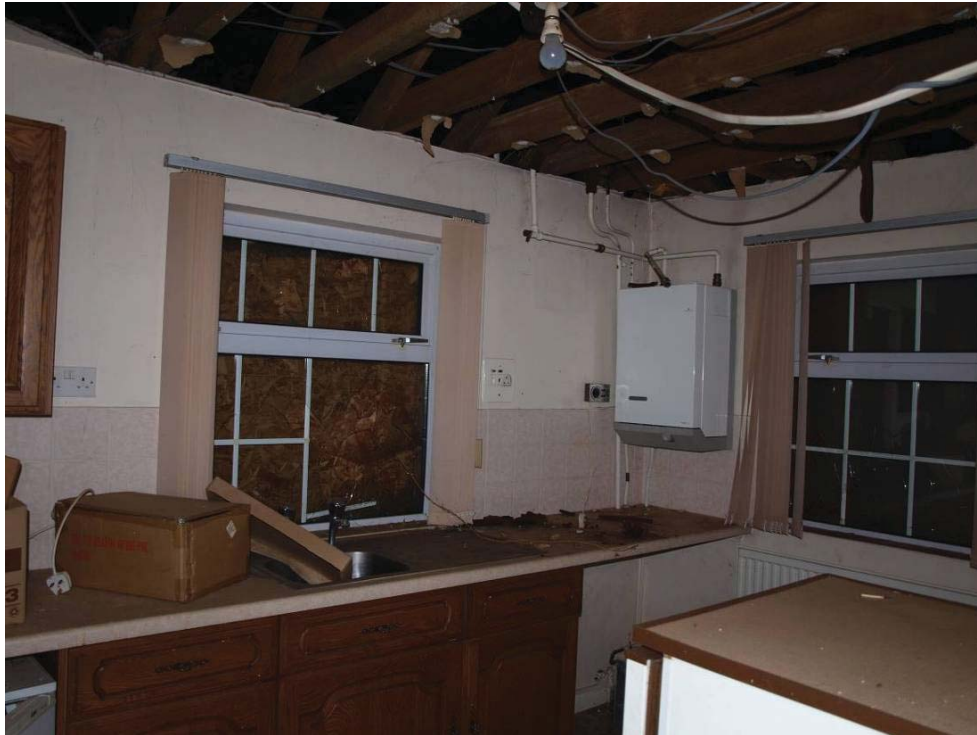
Plate 63

Ground floor kitchen, Kingsmill Cottage (see Figure 24 for location). View to north-west.

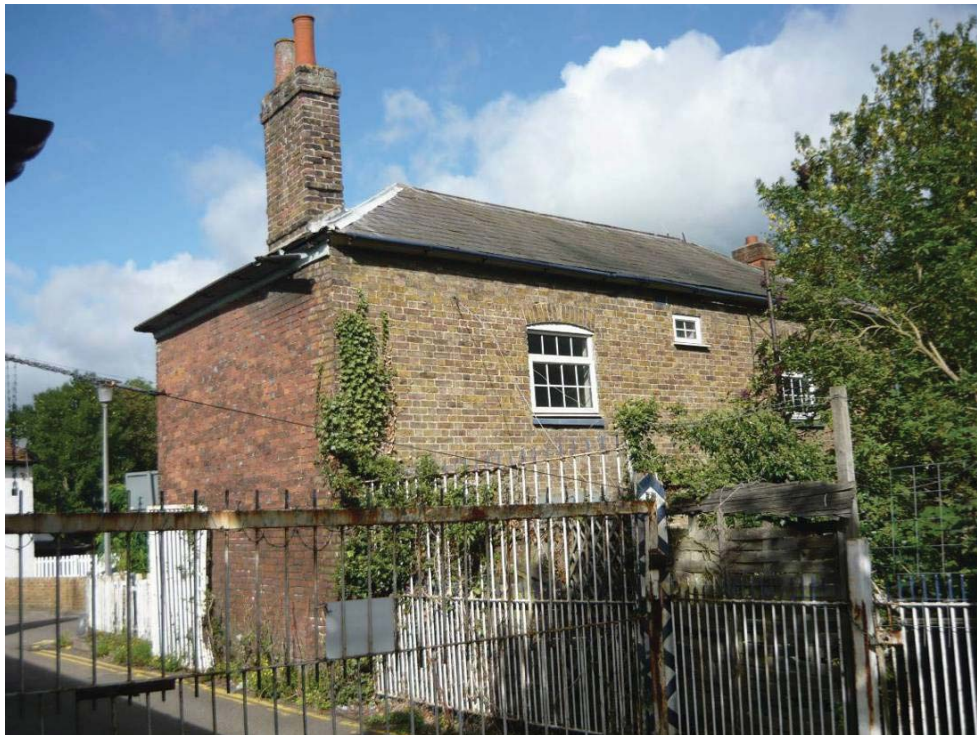
Plate 64

West Elevation, Kingsmill Cottage (see Figure 2 for location). View to north-west.

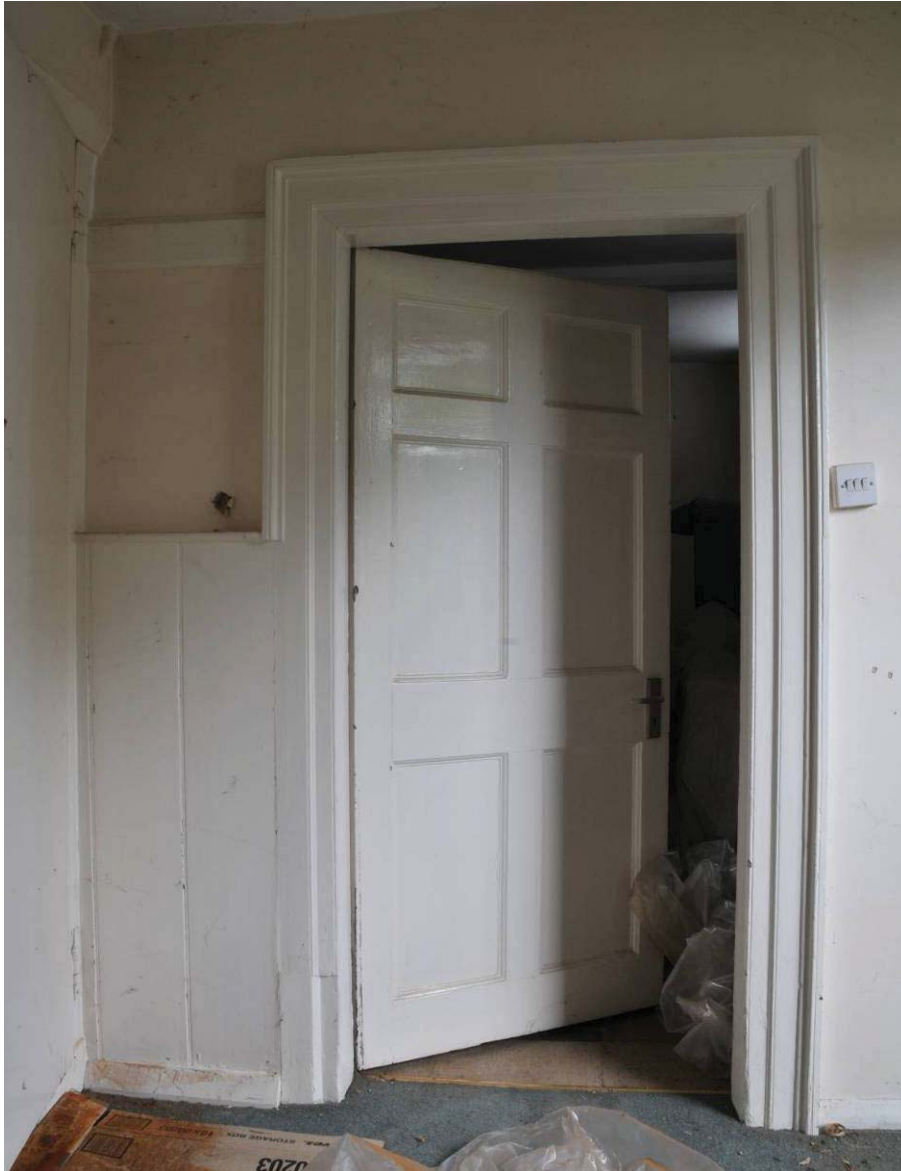
Plate 65

Original door and panelling, ground floor of Kingsmill Cottage (see Figure 24 for location).
View to south.

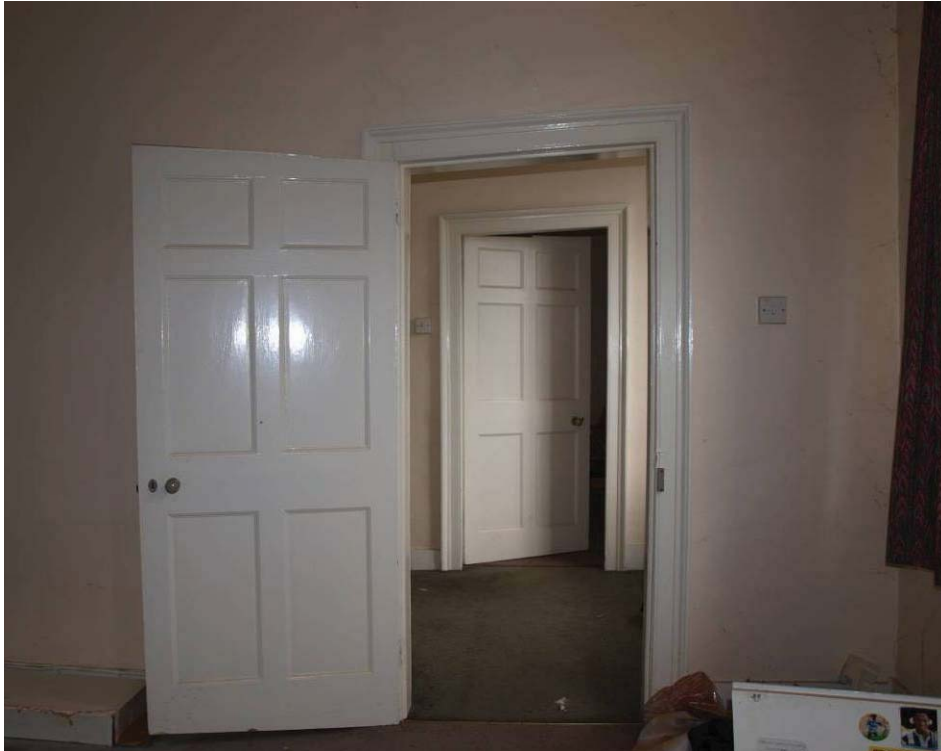
Plate 66

First floor, Kingsmill Cottage, illustrating original door fixtures and warping (see Figure 24 for location). View to south.

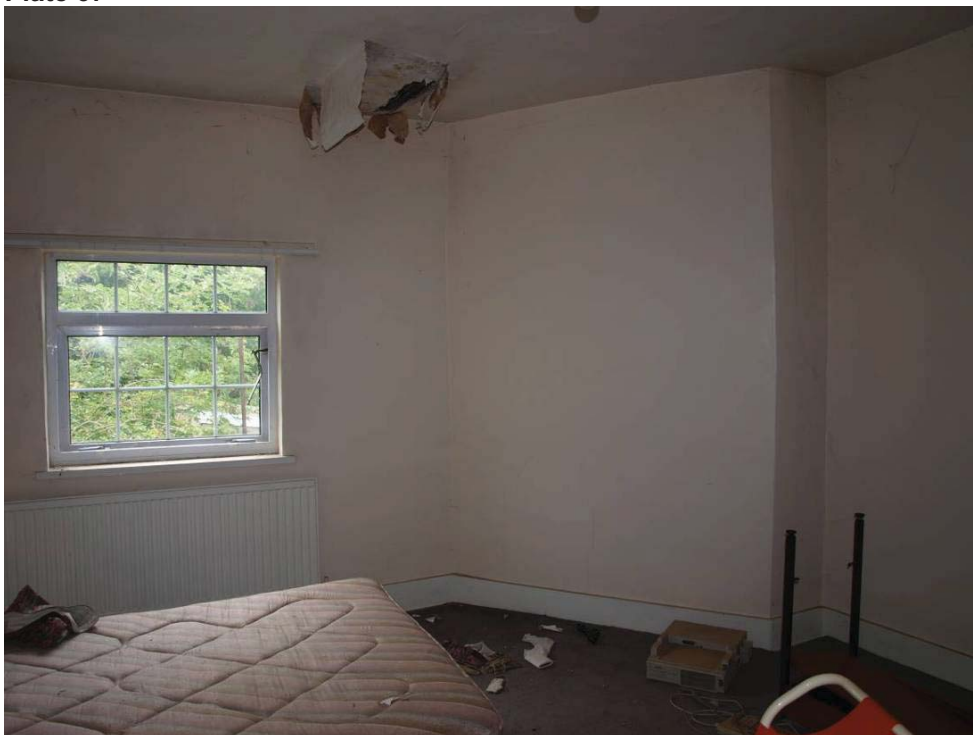
Plate 67

First floor bedroom, Kingsmill Cottage and blocked chimney breast (see Figure 24 for location). View to south-east.

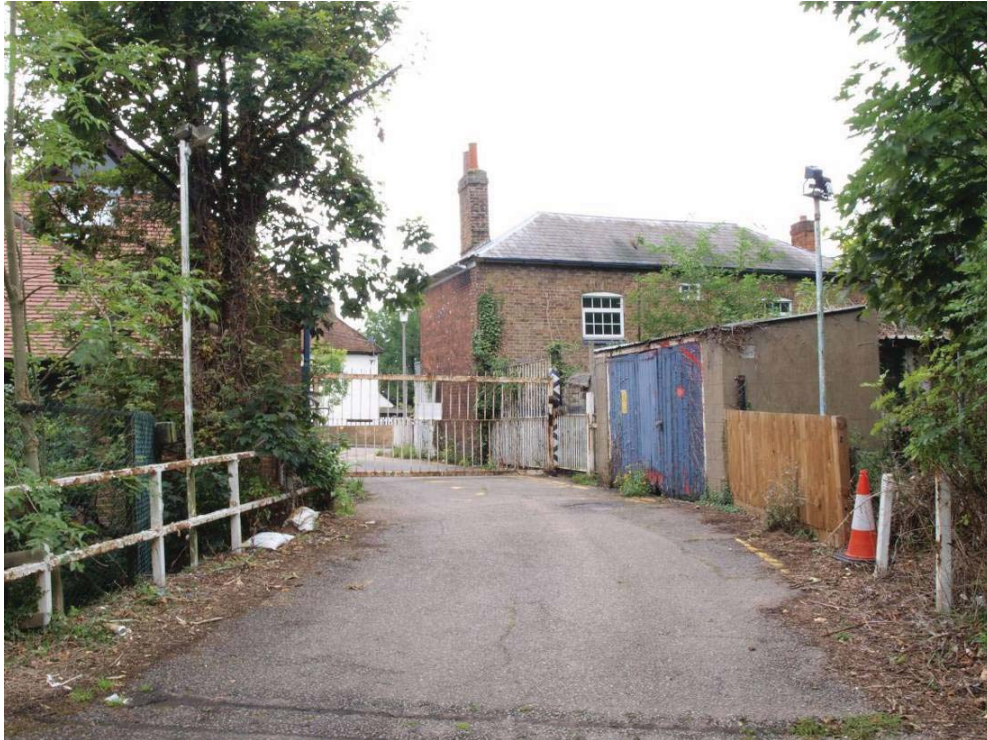
Plate 68

Rear elevation depicting both chimney stacks of Kingsmill Cottage (see Figure 2 for location). View to west.

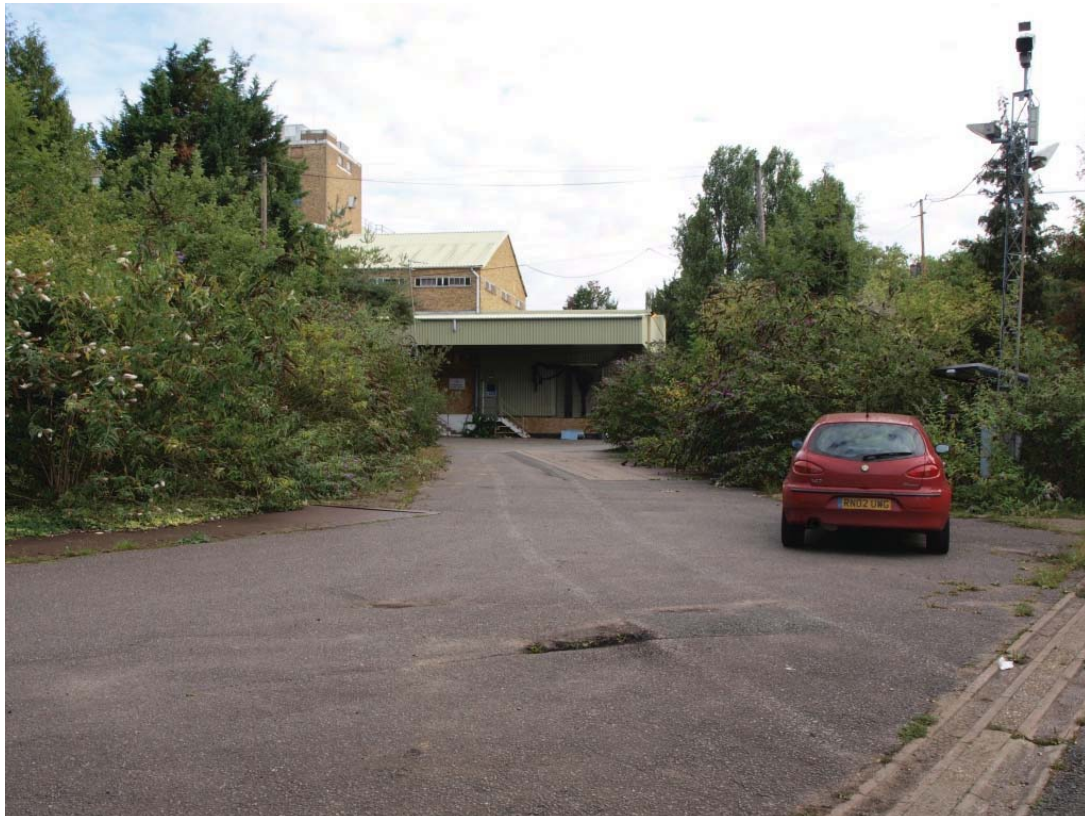
Plate 69

View of the two weighbridges looking north. The gazebo is hidden by the foliage on the left (west) (see Figure 2 for location). View to north.

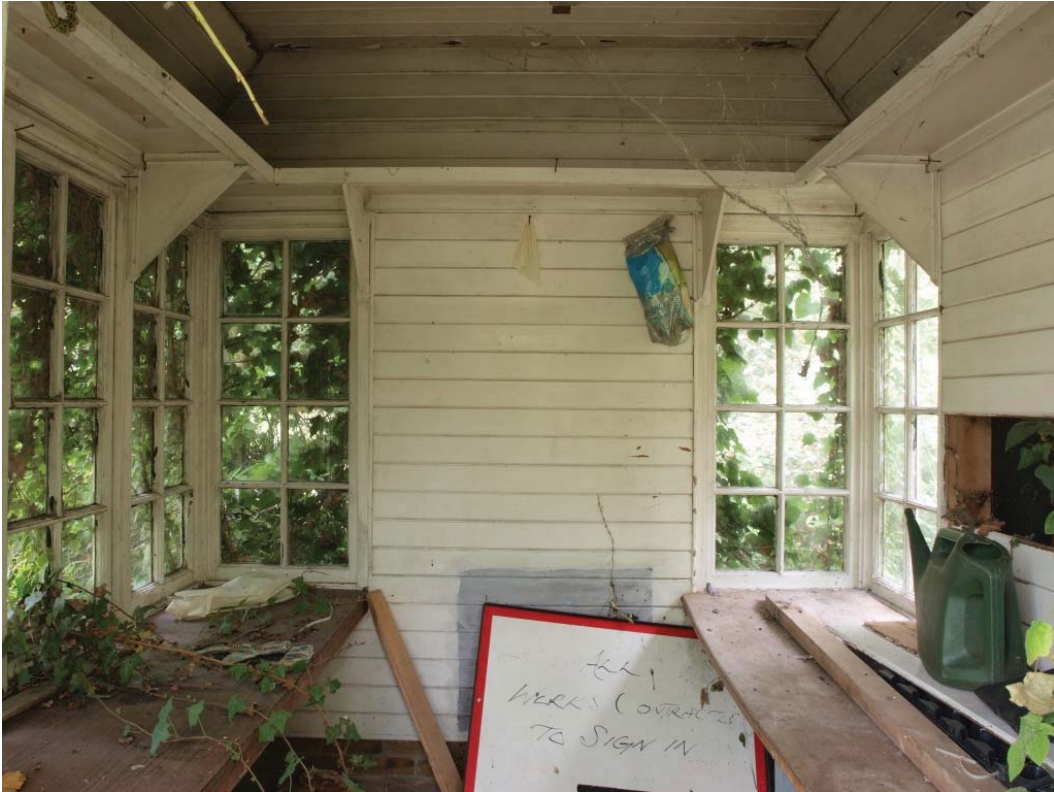
Plate 70

Interior of the gazebo. View to south-west.

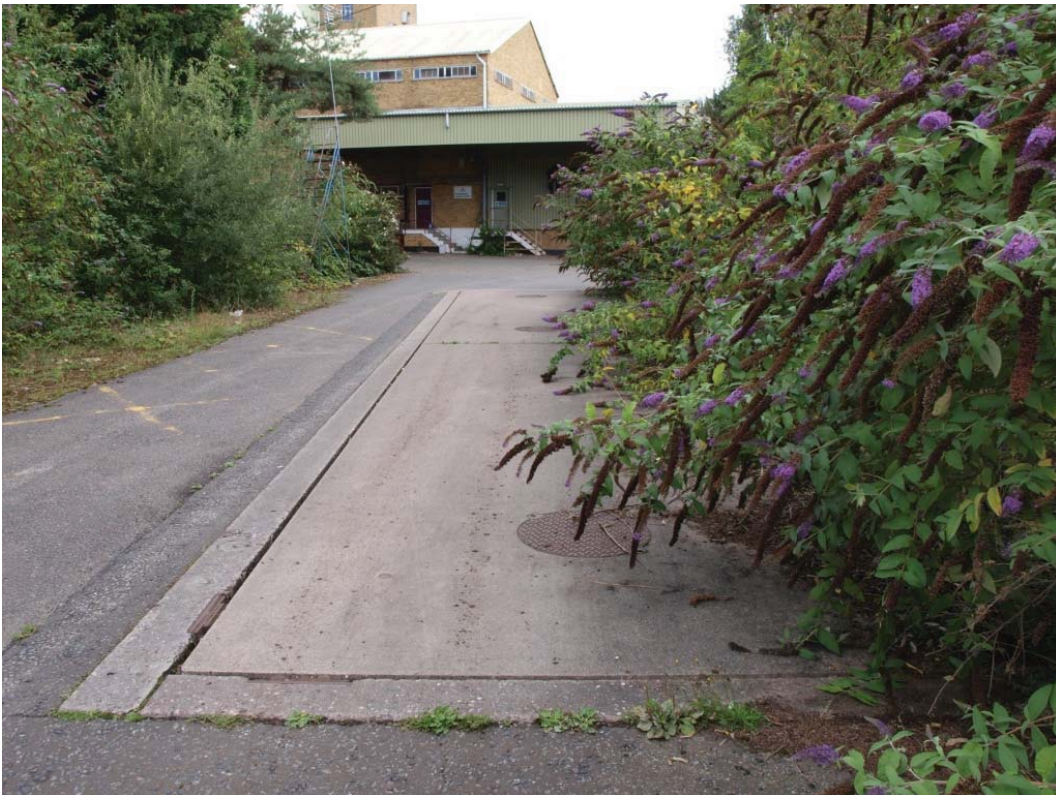
Plate 71

Northern most concrete weighbridge with centrally positioned man hole covers, looking north.

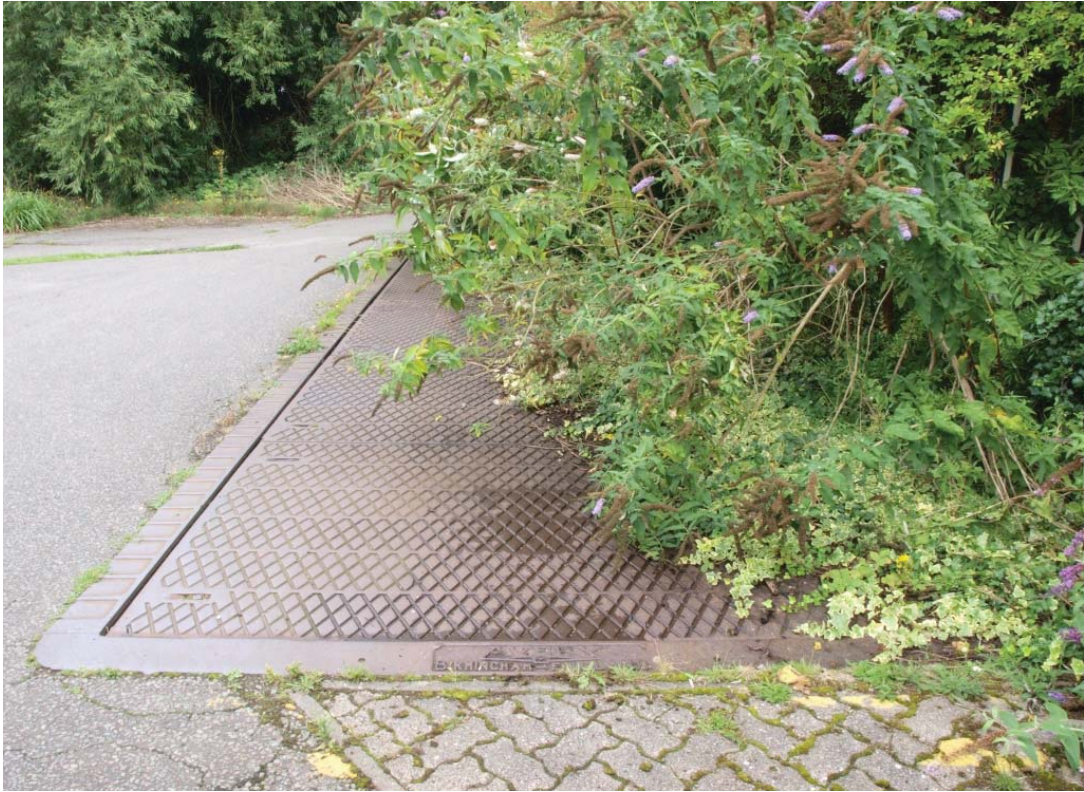
Plate 72

Southern most 'Avery' weighbridge. View to south-west.
