**Historical Building Recording at Willow Cottage  
Mill Road Battsford  
Suffolk**

Grid Reference: TM 023 541  
Planning Application No.: 3489/14  
HER No.:TBA  
Oasis No.: 212369

July 2015

This report provides a written and photographic record (English Heritage, level 2) for a fire damaged cottage known as Willow Cottage, Mill Road Battsford Suffolk (Listed building id: 1182699), prior to its rebuilding work.

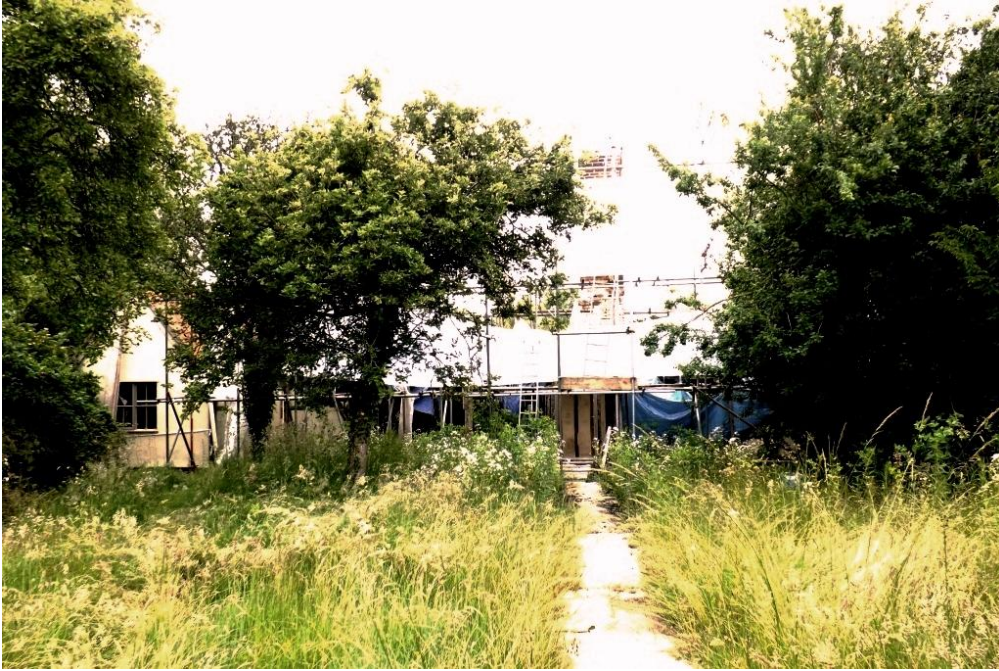
*Plate 1. Willow Cottage from the road*

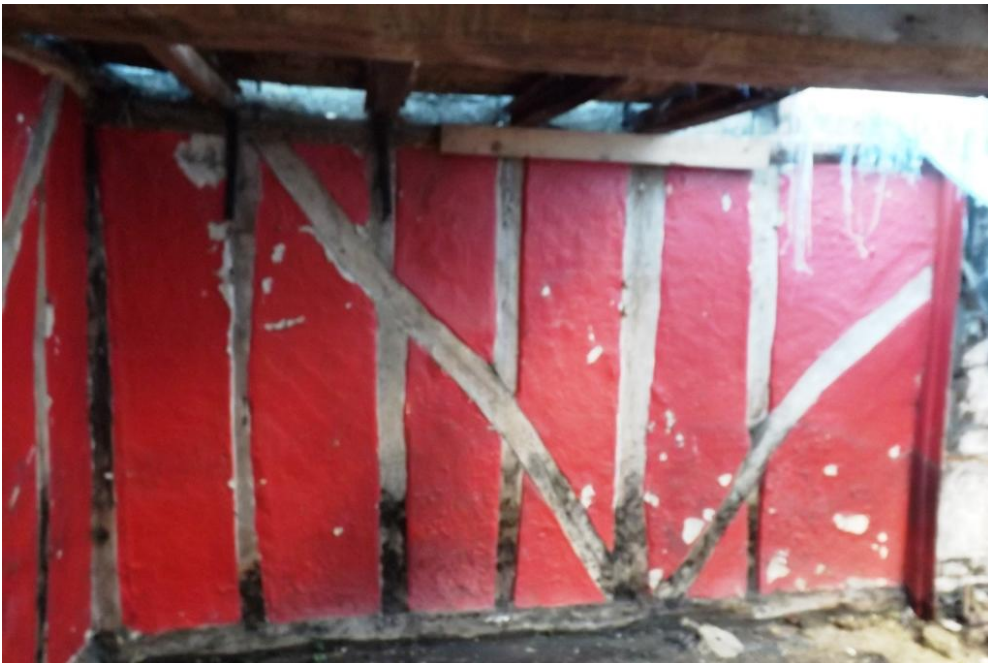
*Plate 2. Parlour end gable wall studwork*

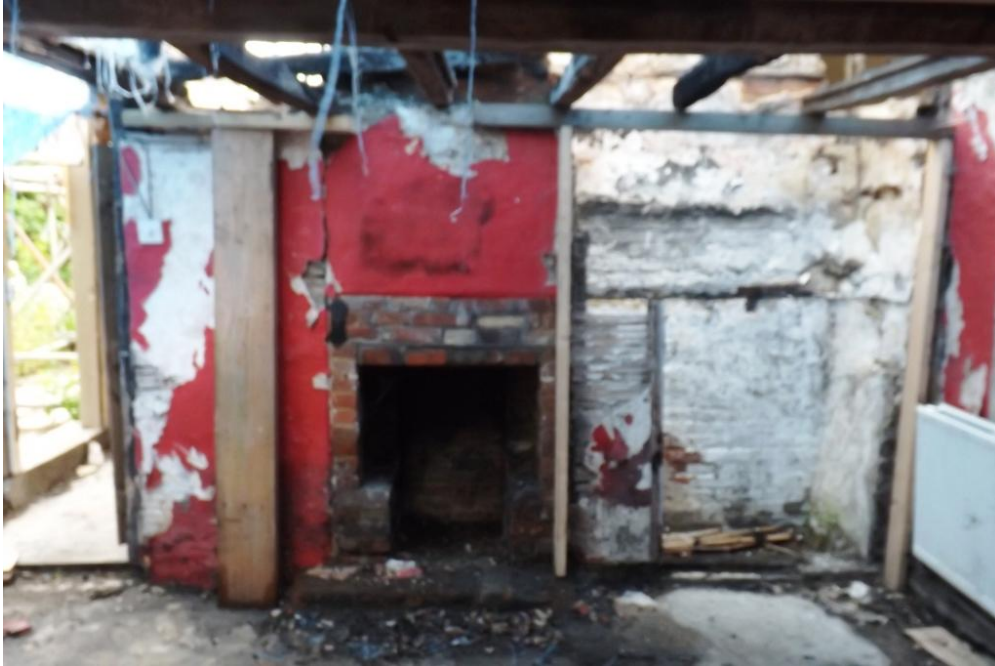
*Plate 3. Small fireplace in parlour (partilly concealed)*

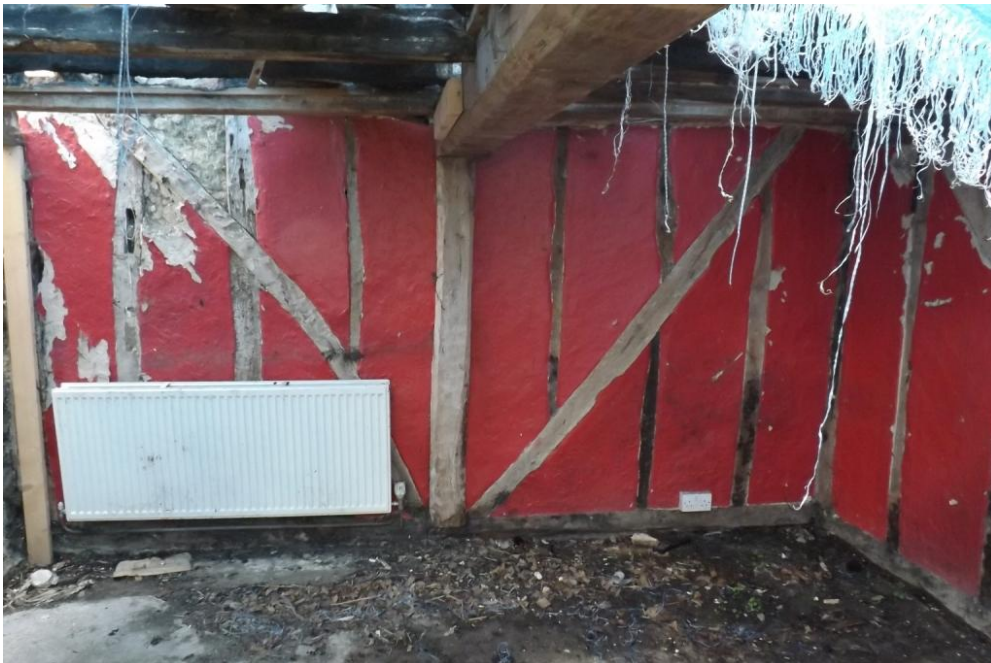
*Plate 4 . Parlour wall studwork detail*

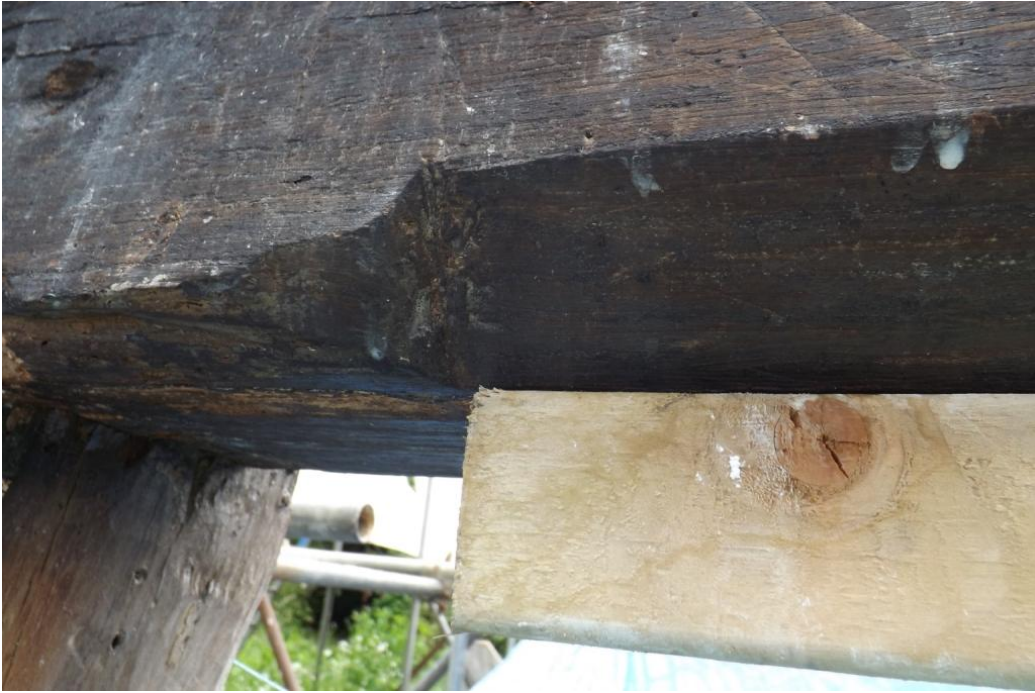
*Plate 5 Bridging beam chamfer detail and drawn-out stop in parlour*

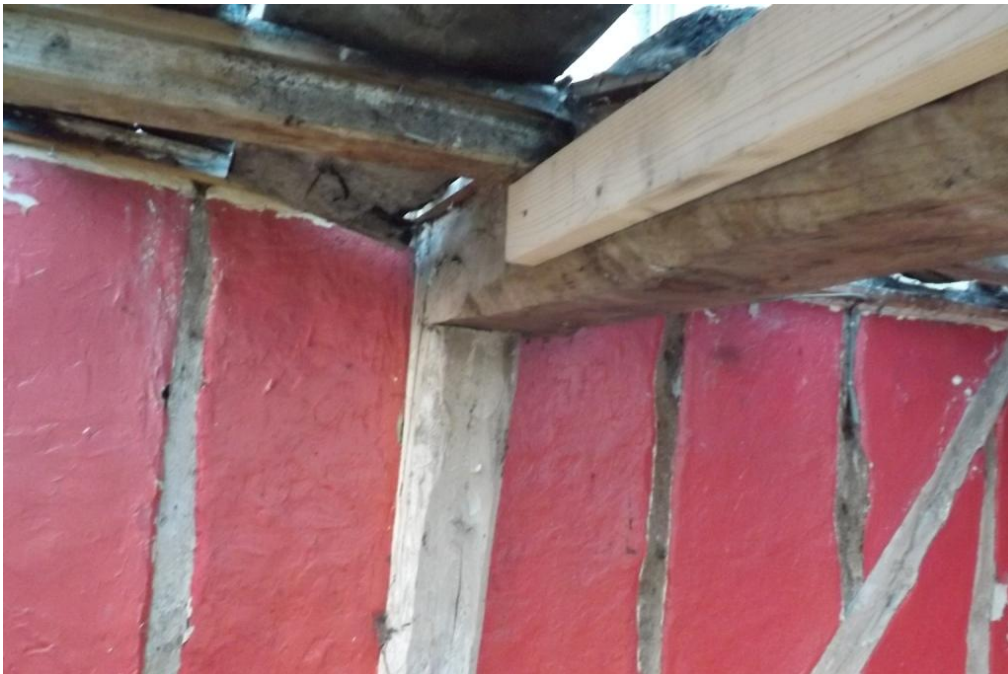
*Plate 6. Bridging beam and principal post detail in parlour*

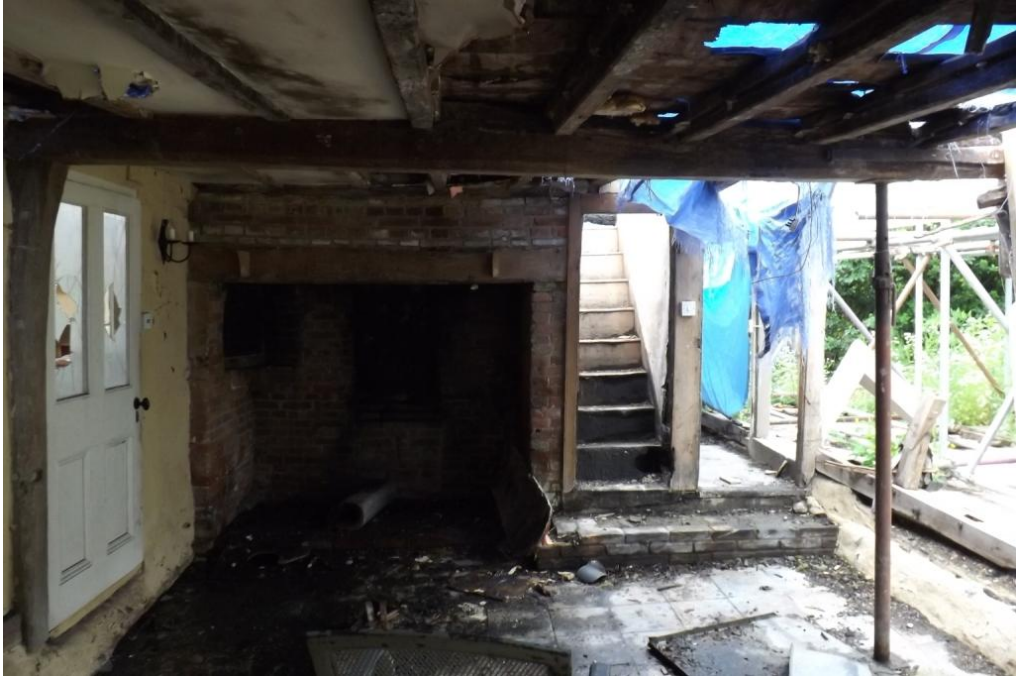
*Plate 7. The hall towards the fireplace*

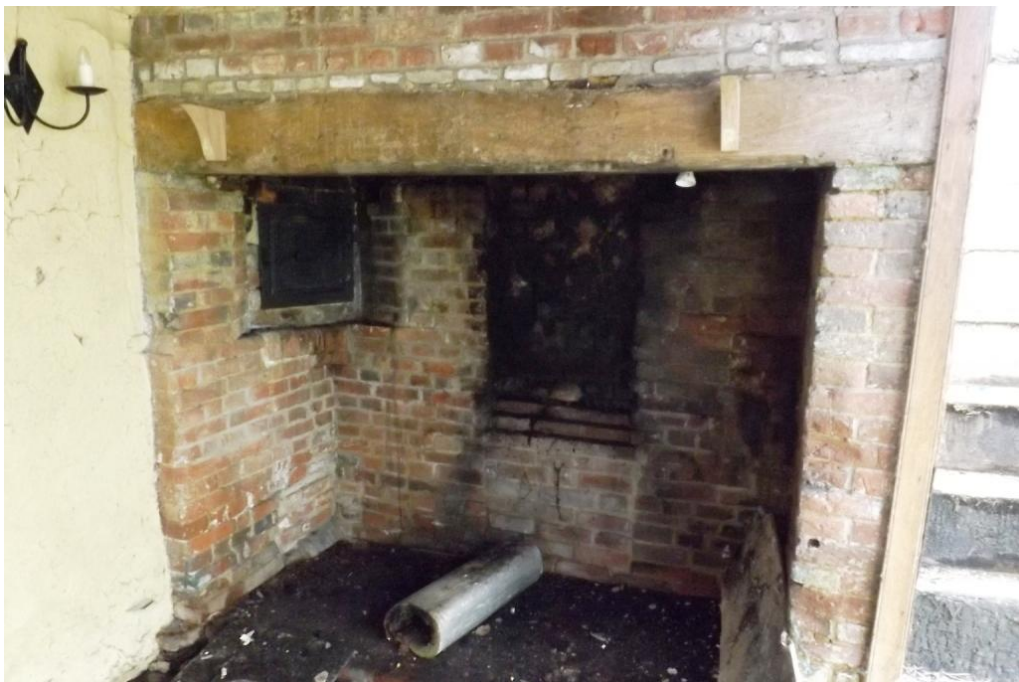
*Plate 8. Fireplace in the hall*

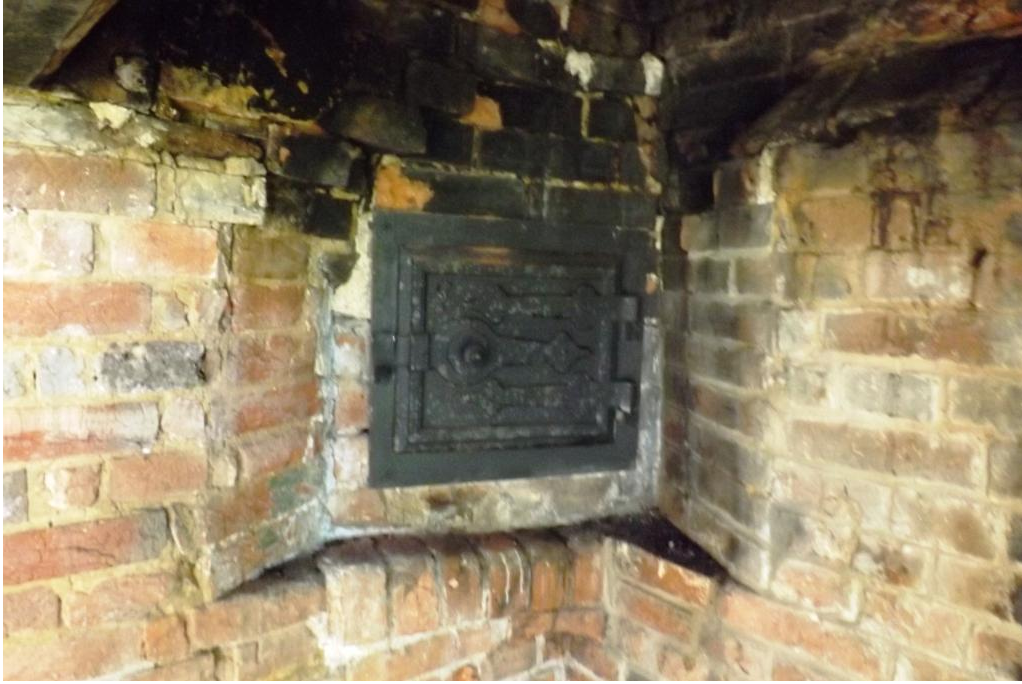
*Plate 9. Recessed oven (modern)*

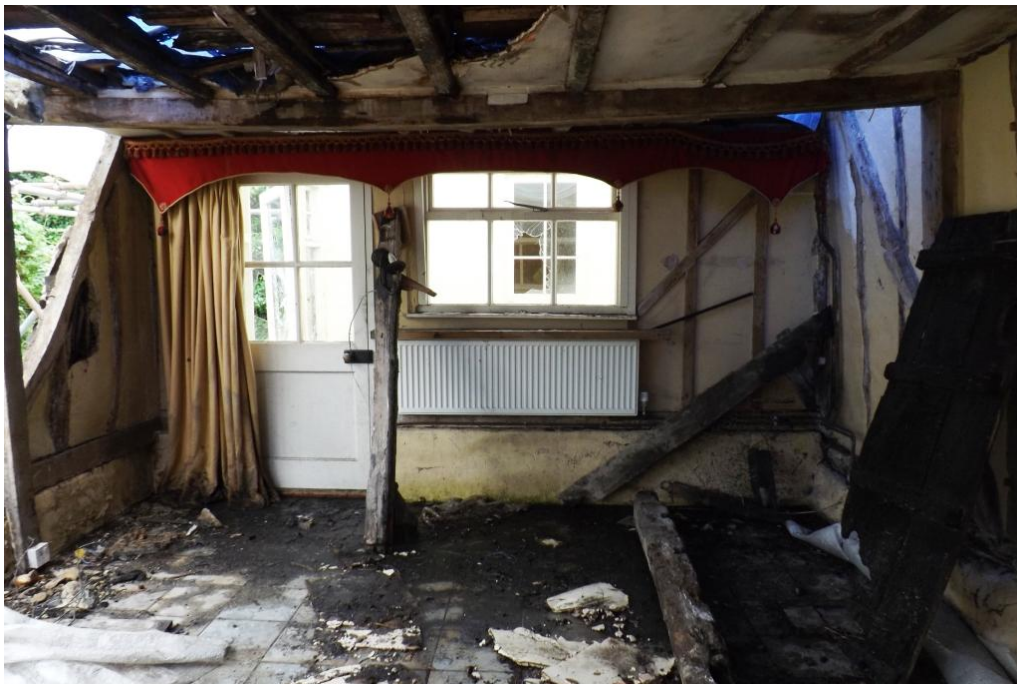
*Plate 10. Hall through to open up service room*

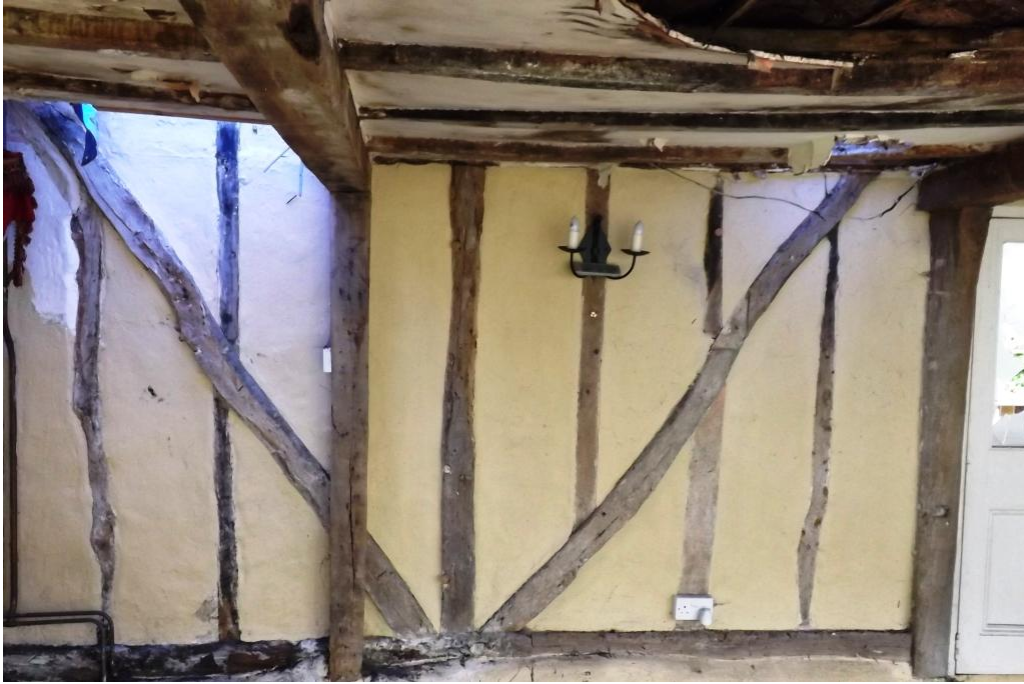
*Plate 11. Rear wall of hall and service room (on the left)*

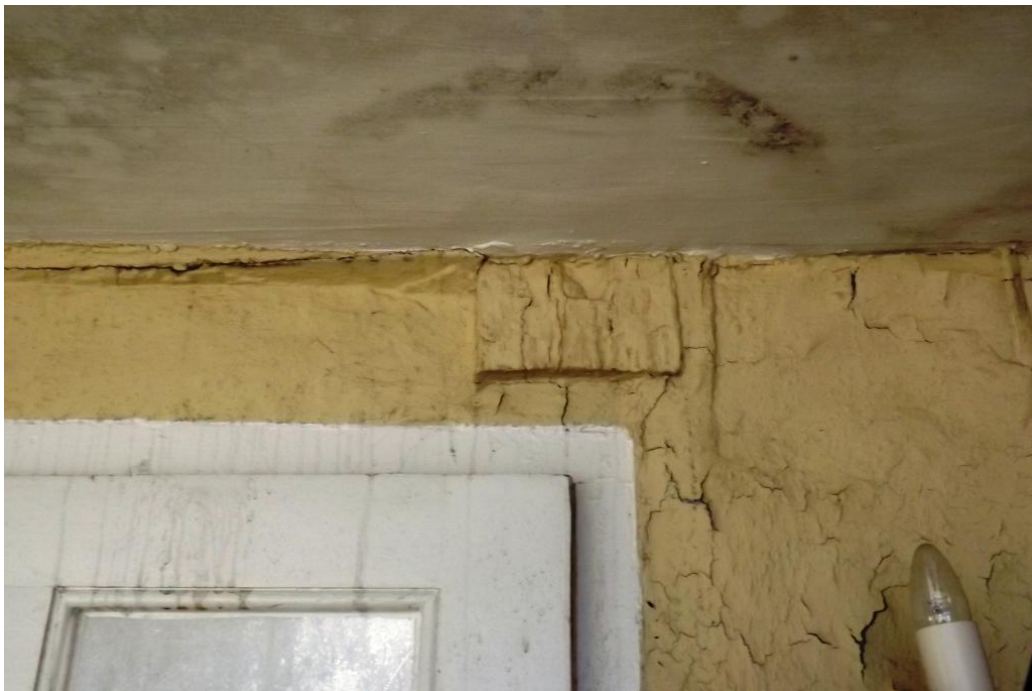
*Plate 12. Rear wall doorway post (truncated at ceiling height)*

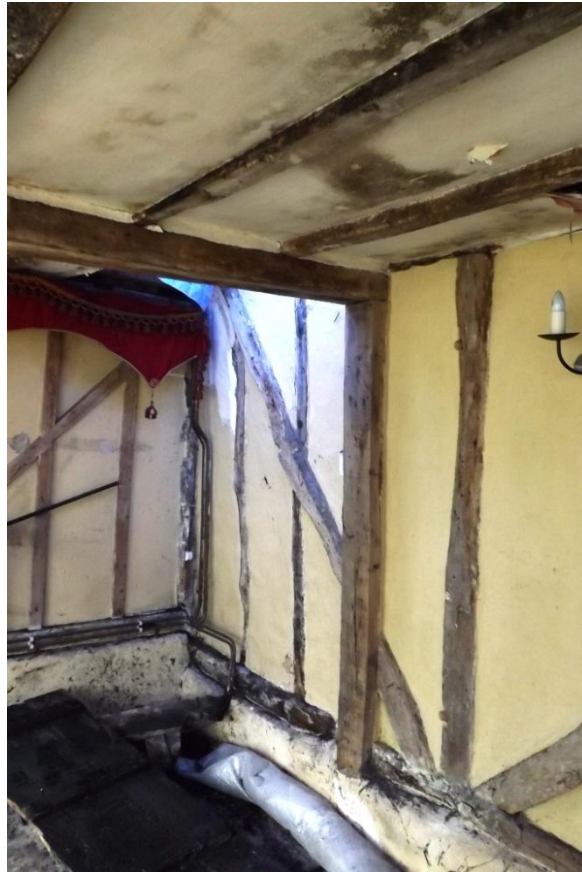
*Plate 13. Later division between hall and service room*

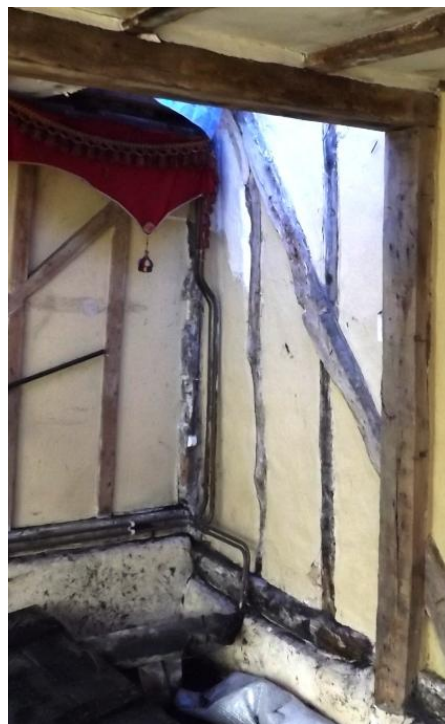
*Plate 14. Detail of storey post and joist support at service room division*

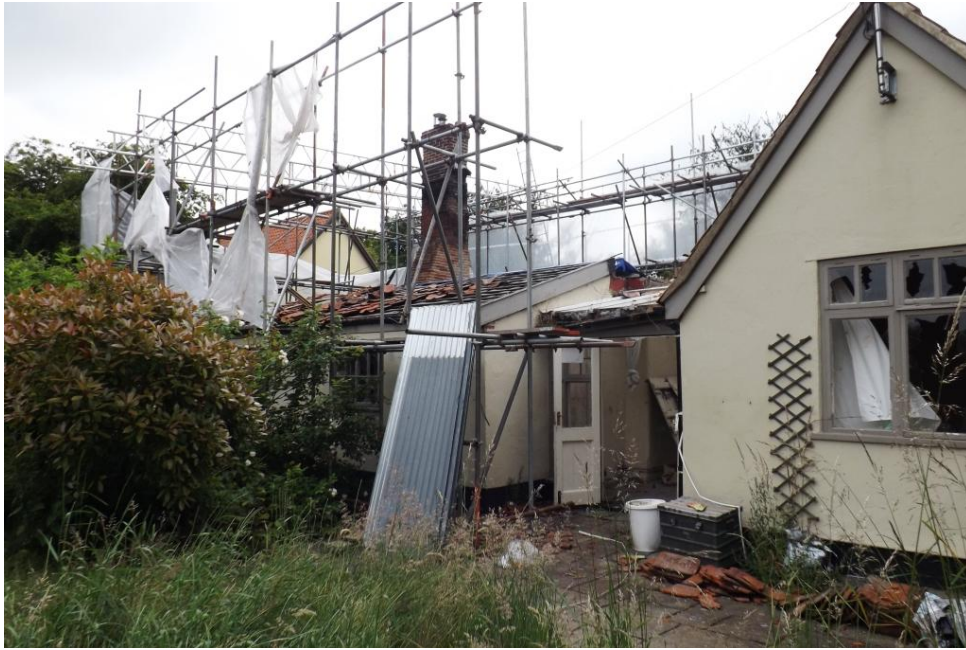
*Plate 15. Rear prospect of Willow Cottage*

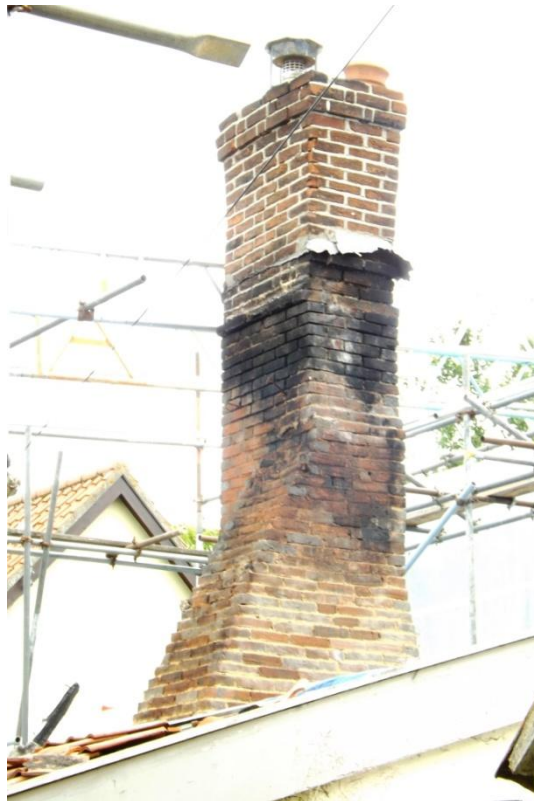
*Plate 16. Chimney stack as revealed*

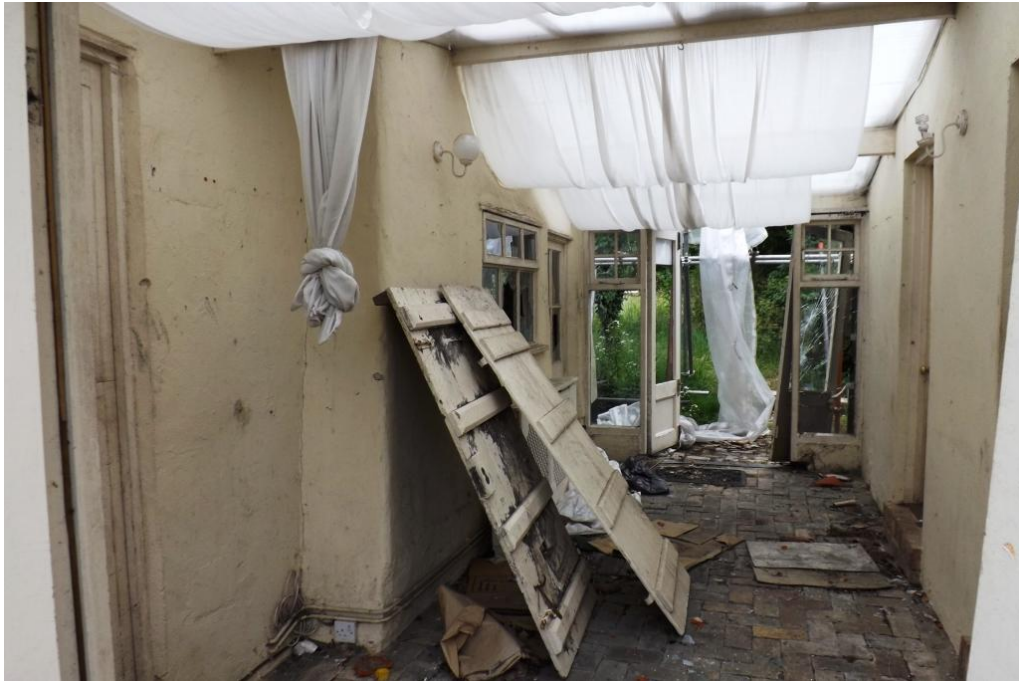
*Plate 17. The end gable wall to the left through modern connecting passage*

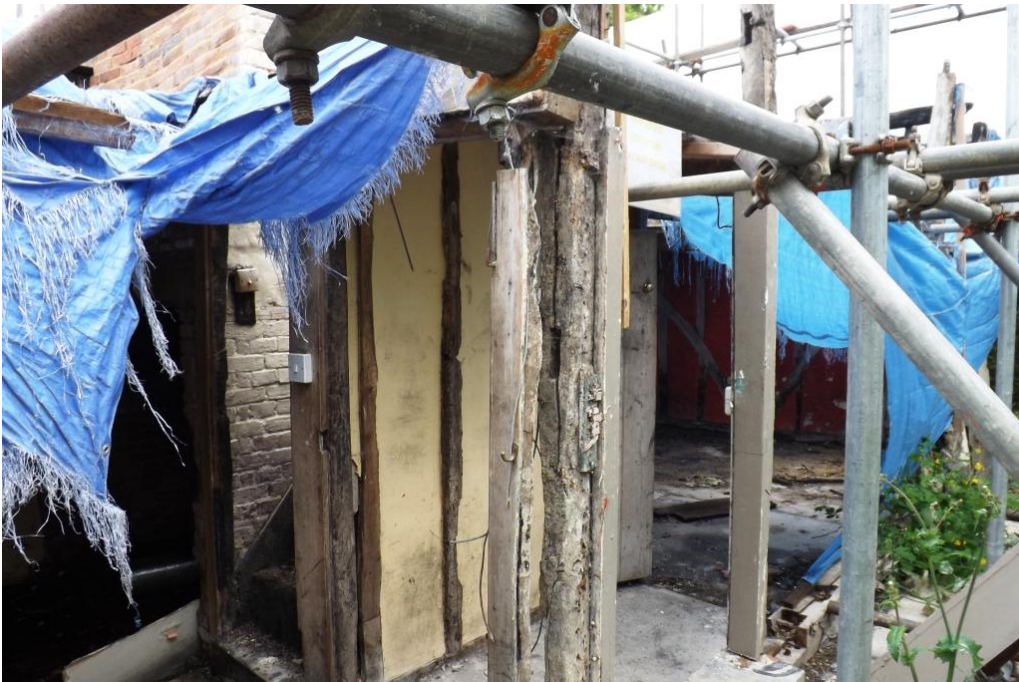
*Plate 18. Lobby entrance (front)*

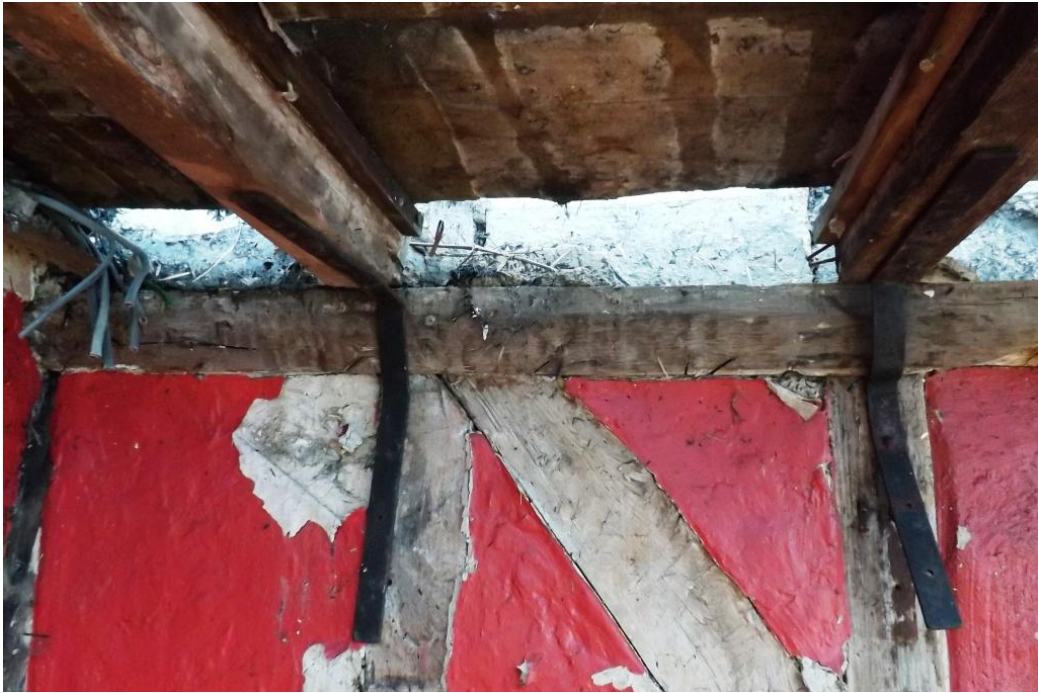
*Plate19. Detail of clamp supporting upper floor in parlour gable end wall*

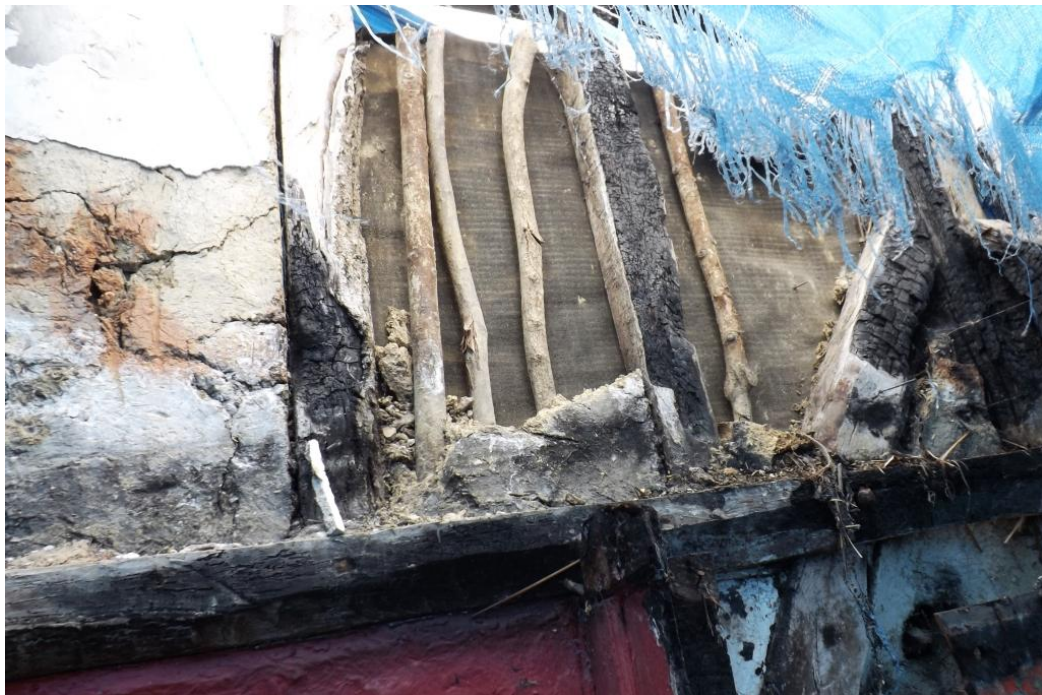
*Plate 20. Wattle and daub wall fabric as revealed in the parlour*

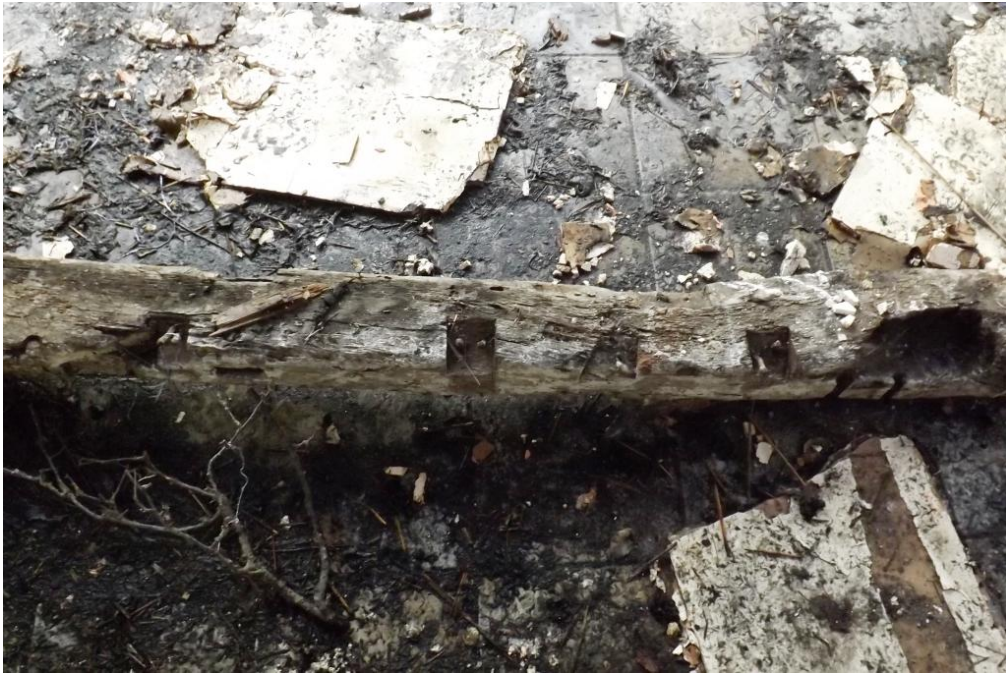
*Plate 21. The wall plate (as removed)*

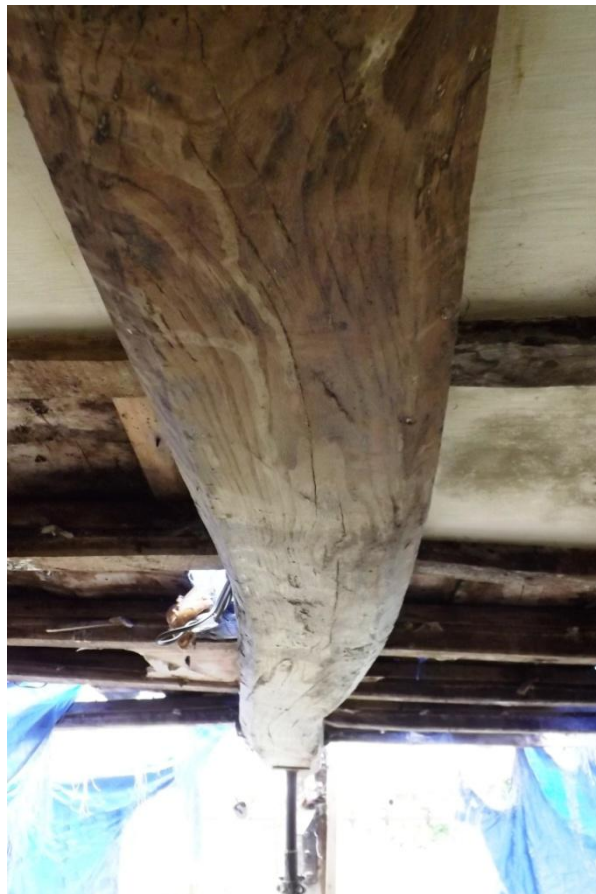
*Plate 22. Waney bridging beam in the hall*

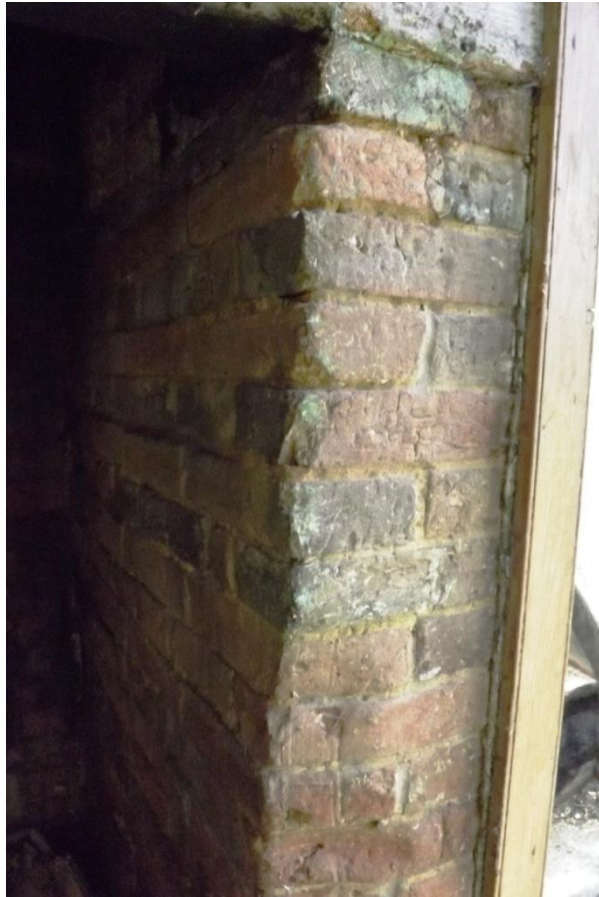
*Plate 23. Fire place (hall) brickwork detail*

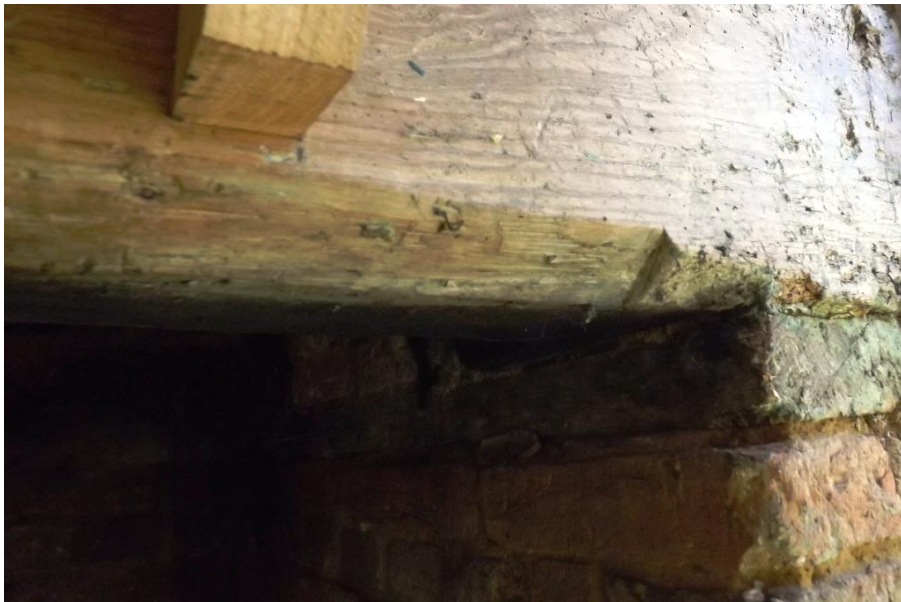
*Plate24. Fireplace bressummer beam chamfer and stop detail in the hall*
