**Historical Building Recording at Valley Farm Barn  
Brettenham Road Felsham  
Suffolk**

March 2016

## **Historical Building Recording at Valley Farm Barn**

**Brettenham Road Felsham**  
**Suffolk**  
*Archaeological Record*

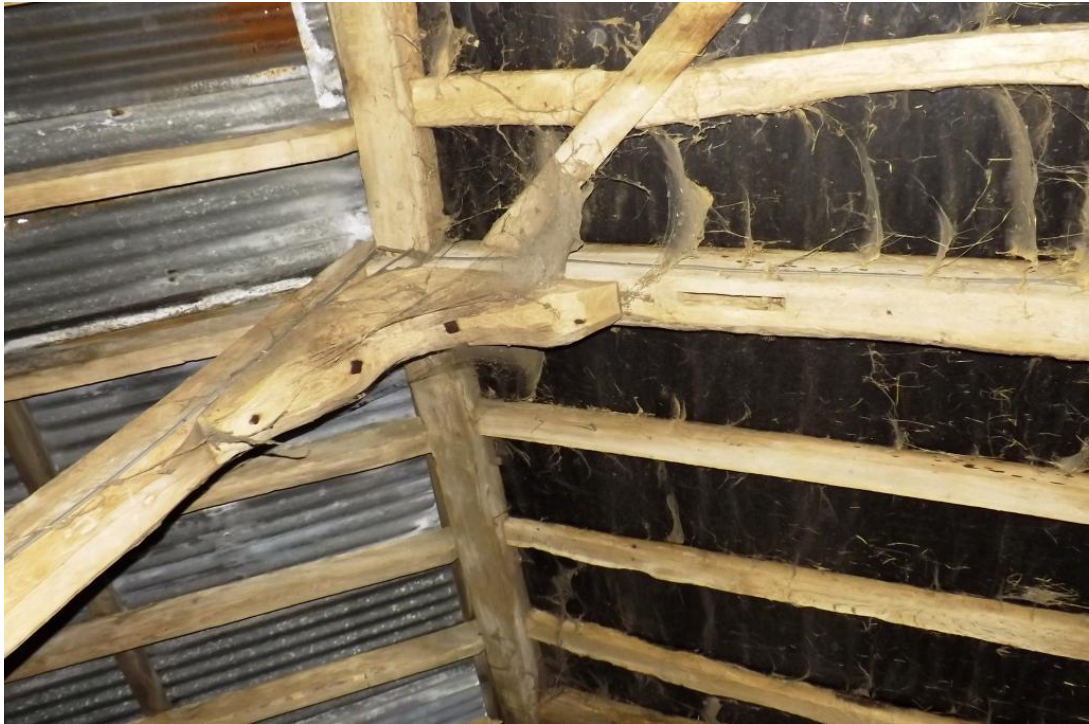
Among the dating evidence and diagnostic features within the barn are the removed arch-braces. These were removed and replaced by bolted knee braces, an improvement which allows better access for carts and storage. The modifications carried out to the barn are quite common with many barns having been enlarged in some way or another: ‘*Eighteenth-century alterations such as the expansion of barn space by taking down divisions, extending the building, adding porches or building an entirely new barn are all changes which are part of the farm’s history.*’ (English Heritage 2012). The blind tenons left behind after the removal of the lower arched braces are indicative of a barn pre-dating the early 19th century. The combination of good quality peg joints and nails point to a late 17th to early 18th century date, with nails being introduced more commonly in local vernacular architecture during the latter part of the 17th century and used fairly predominantly thereon, there are variations in construction methods and as a result there are exceptions to this.

*Plate 10. Bolted knee brace (early 19th c.) between bays 1 & 2*

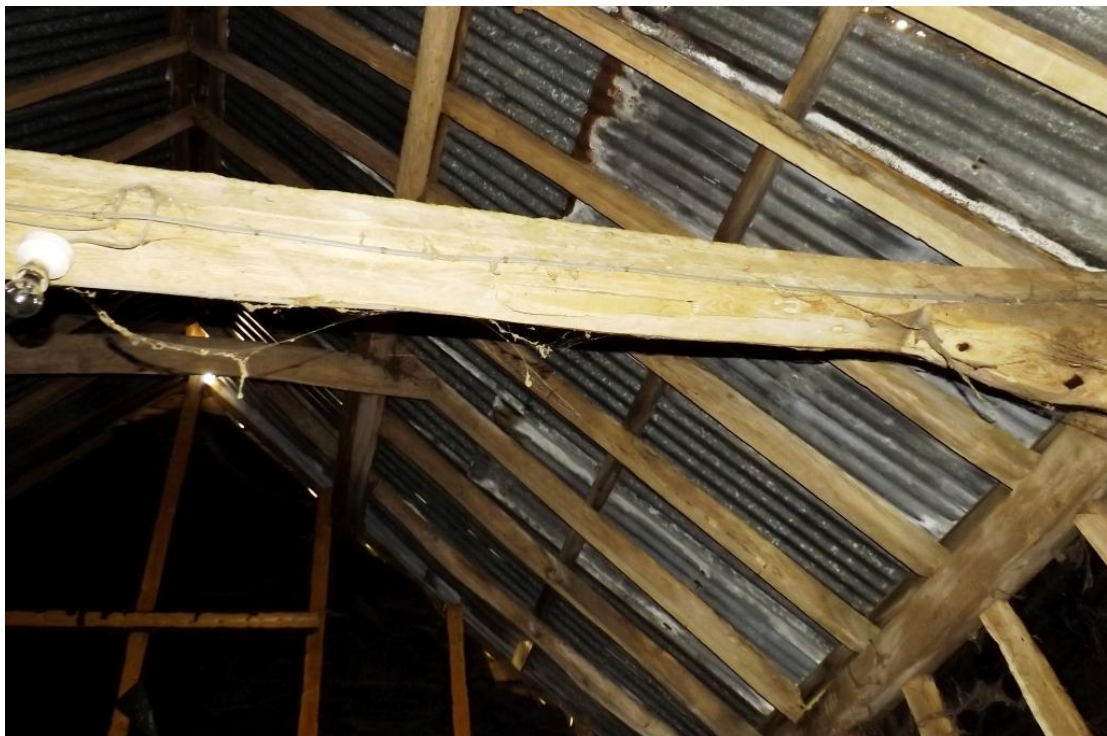
*Plate 11. Blind tenon in tie beam for the earlier arched brace*

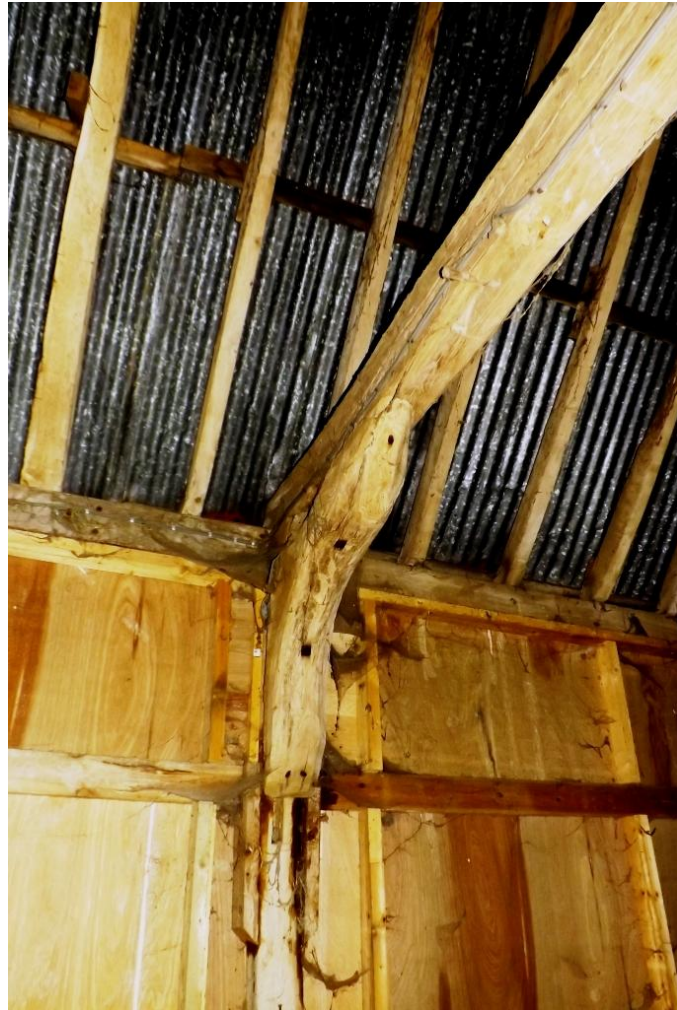
*Plate 12. Bolted knee brace over blind tenon (sawn off joint)*

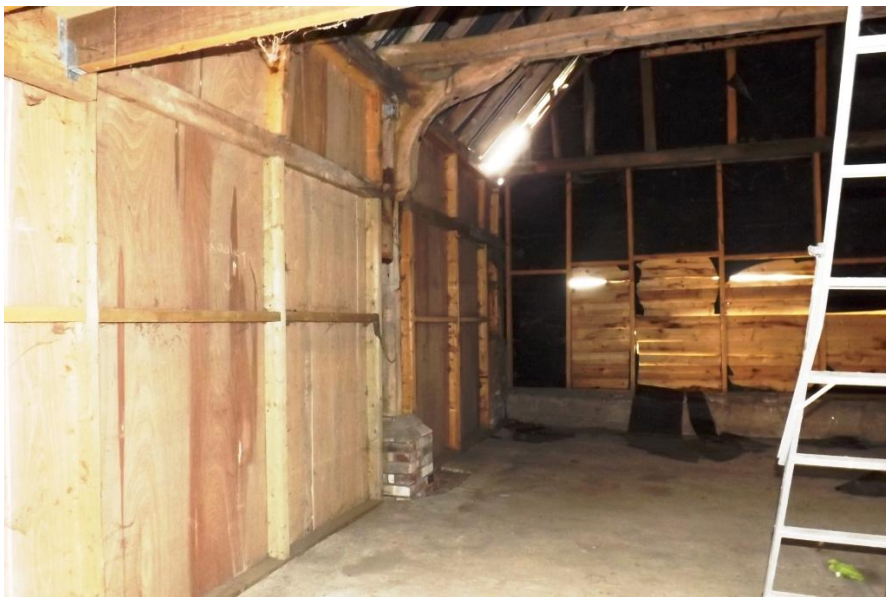
*Plate 13. Replaced wall section to east elevation and south gable end*

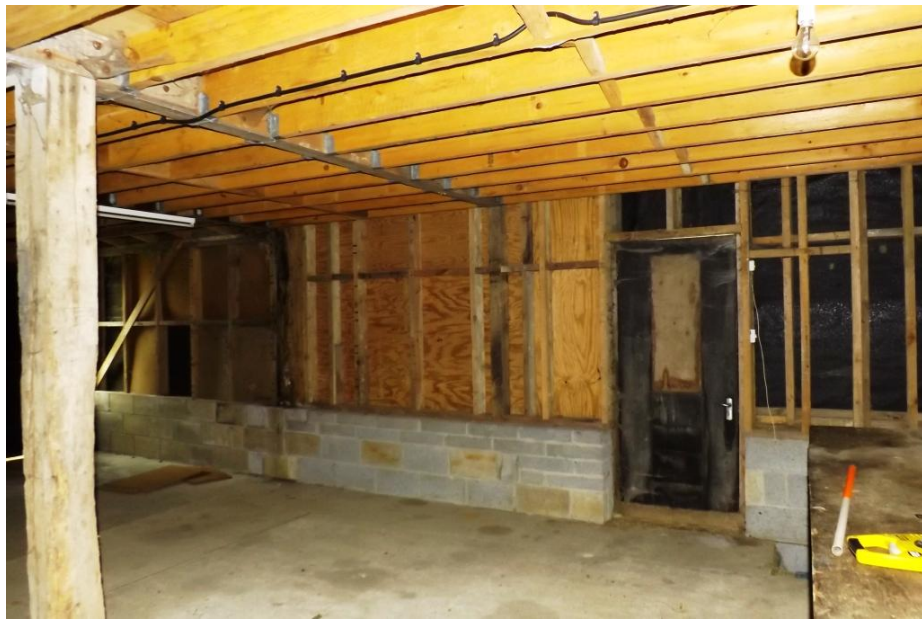
*Plate 15. South gable end wall interior (replaced work)*

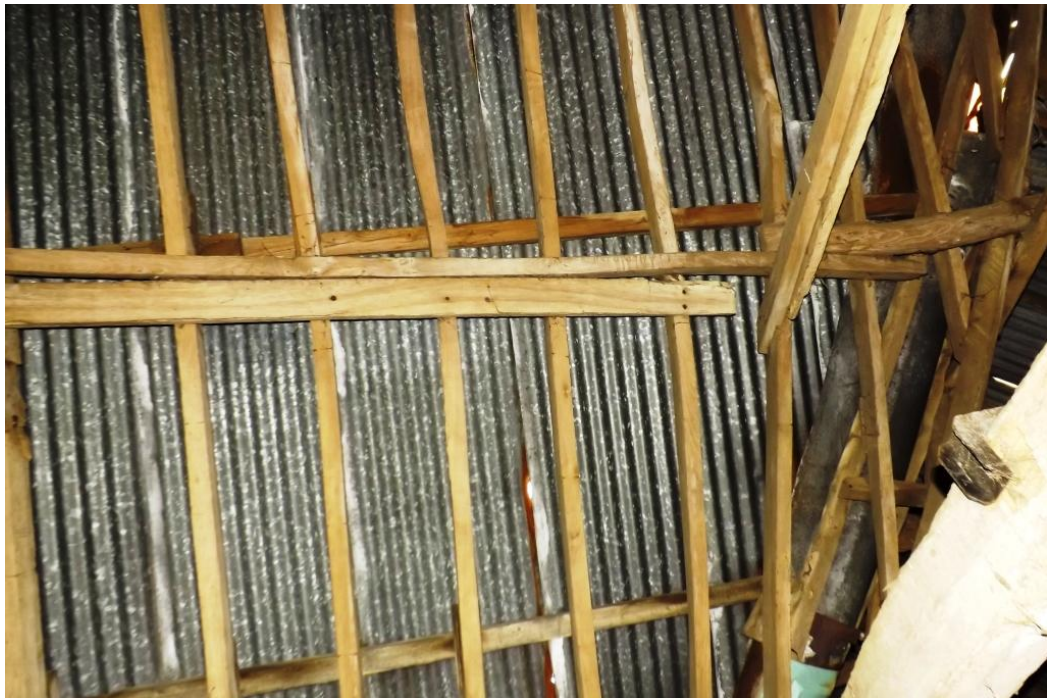
*Plate 19. Roof detail: purlins attached by nails (not on key-plan)*

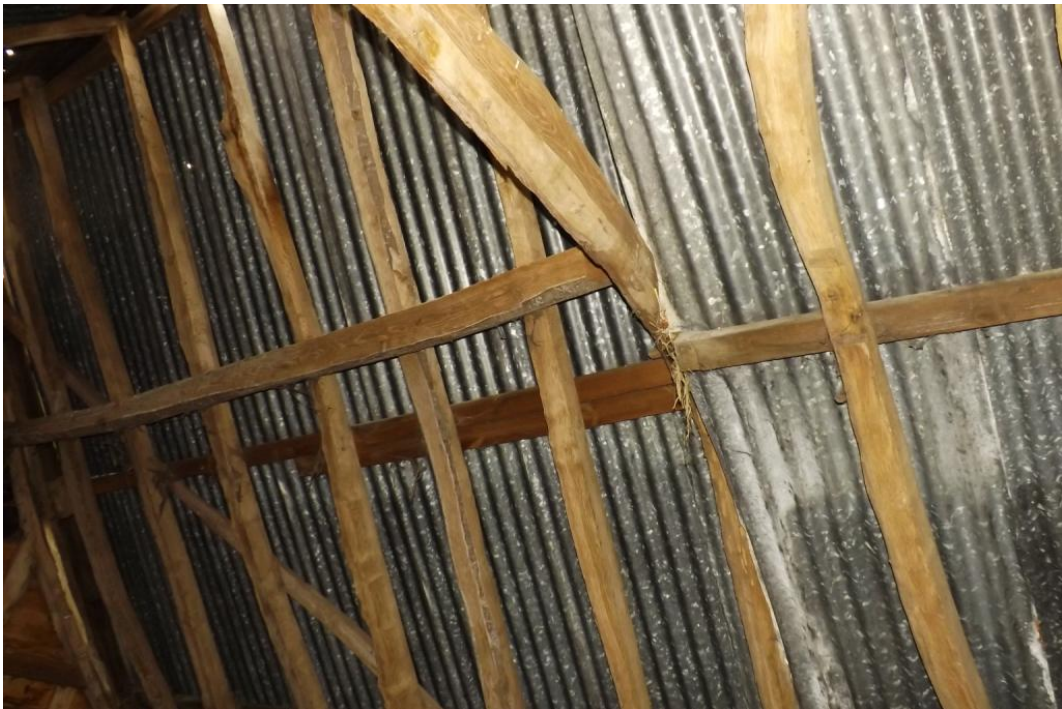
*Plate 23. Lowered roof detail at the join with the higher section-west-facing*

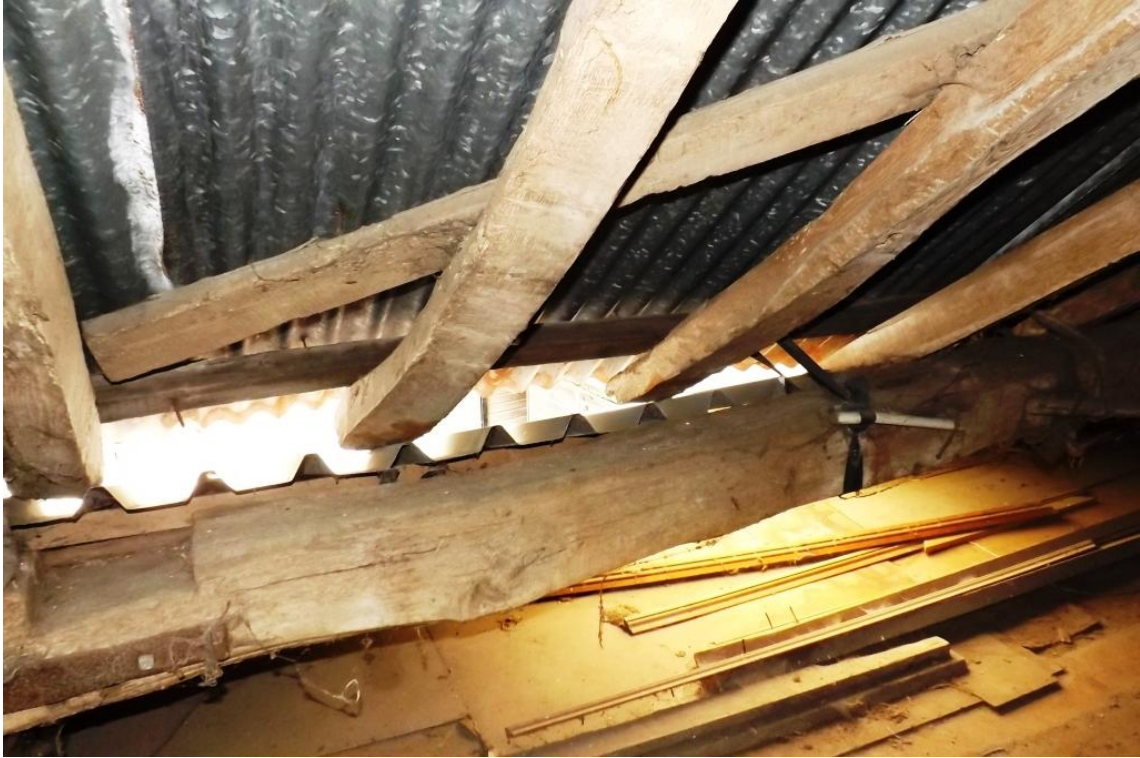
*Plate 26. Rafters no longer supported or joined to top plate  
(evidence of lowering of roof)*

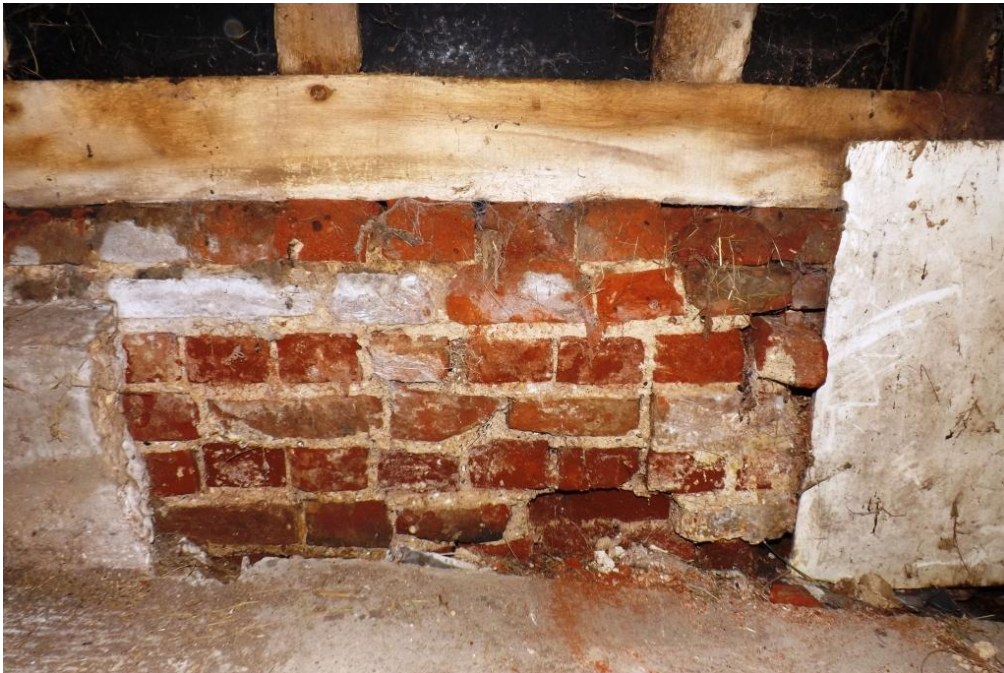
A further diagnostic feature of the barn is the bricks that form the plinth to support the farming of the barn. The brick plinth (plt. 29) is constructed mainly in *English Bond*, a common seventeenth century form that was used until the end of the 17th century, but did continue into the 18th century for a while.

*Plate 29. Brick plinth detail showing English Bond coursework in red brick (shot 31)*

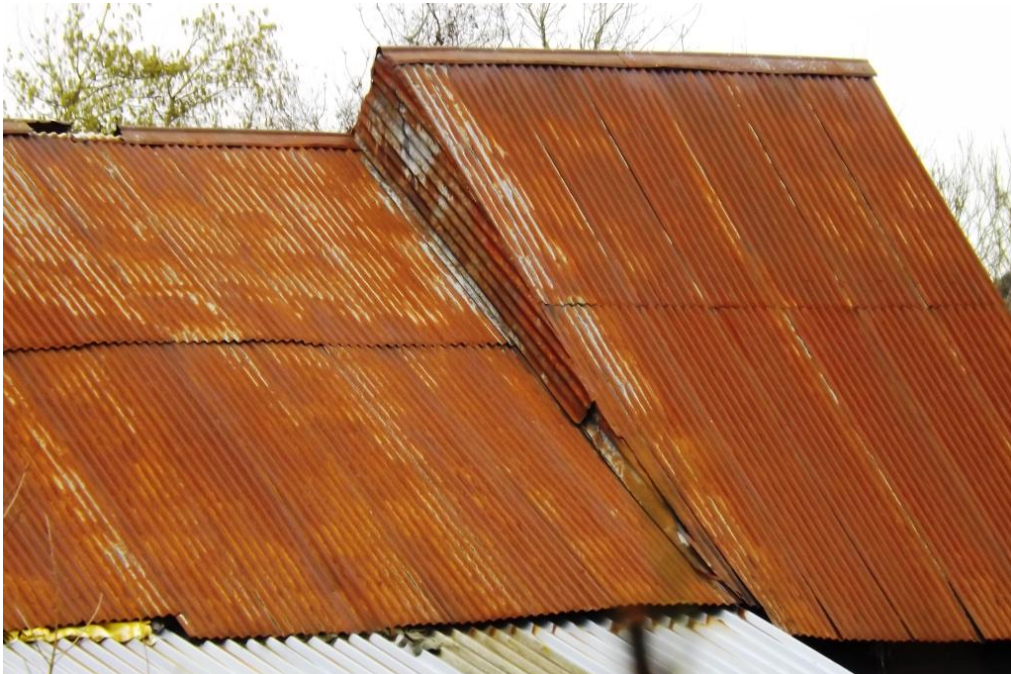
*Plate 31 Roof detail showing original height (high end and the altered lower end, from the road (shot 33))*

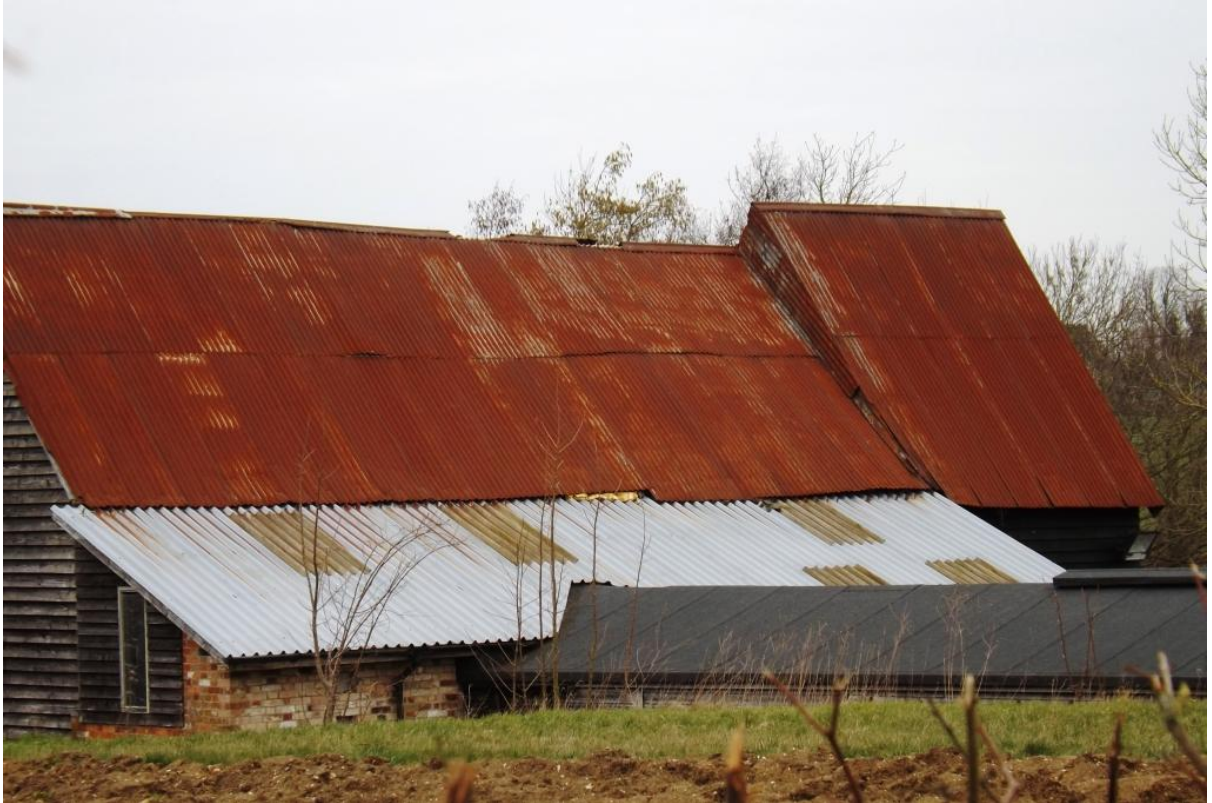
*Plate 32. Exterior of roof alteration, general view, (shot 34)*
