**Historic Building Recording:  
Grove Farm  
Barells Road  
Thurston, Bury St Edmunds  
Suffolk**

June 2021

**Historical Building Recording:  
Grove Farm  
Barells Road  
Thurston  
Suffolk**

This Historic Building Report provides a written and photographic record, carried out on the 16th of June 2021, before redevelopment takes place to convert the buildings, a stable block or cow house and ancillary buildings into two domestic dwellings, it has been produced to English Heritage Level 2 (2006), reissued 2016.

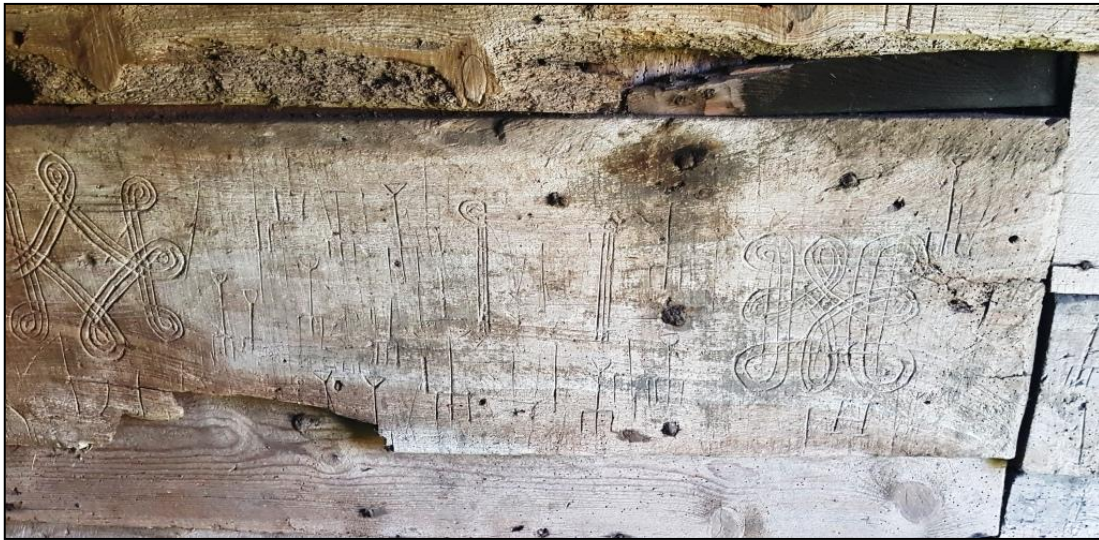
*Figure 15. Apotropaic marks: demon traps and pitch forks*

The most interesting feature of the cowhouse is the graffiti carved into the side wall panels of the northern bay, as you enter the building (location 9 on the photo-key plan). These marks are known as ``apotropaic`` after the Greek, *apotropaios*-turning away (evil). Their main function was to protect against evil spirits that might enter a building and are usually found around, doors, windows and fireplaces; in fact anywhere that an evil spirit or demon might enter, and are also known as witch marks.

The majority of the marks are grouped fairly close together and consist of pitch forks; (fig. 15 & 16) other marks consist of devil traps which are the most intricate in design that contain the never ending line to entrap spirits. Other marks are *Ave Maria*, seen as an AV monogram, (often seen as a W) which is a prayer to the Virgin Mary (fig. 16); personal initials combined or within the area of the marks would protect the person, presumably. It would be useful to deal with the types of marks individually. Firstly, the pitch forks are most uncommon and would seem to have an agricultural element to them, being a symbol of the farm-work. This symbol is used extensively and may refer to farming periods or seasons, one being inscribed for each perhaps. It is impossible to know the full meaning of these symbols but a protective one is paramount.

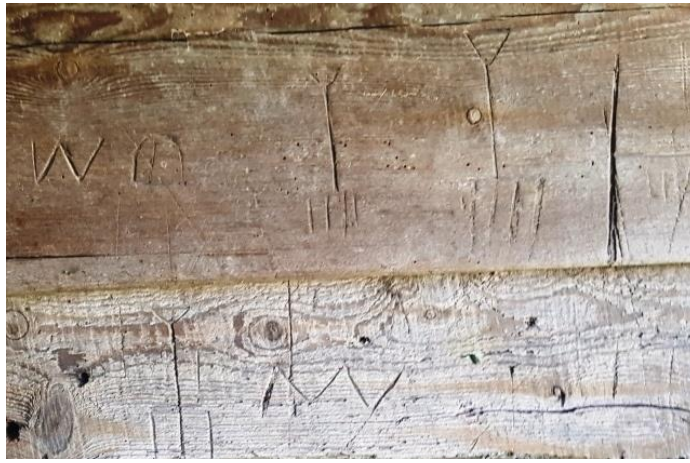
*Figure 16. AV marks; beehive or thimble?*

The next symbol is the Ave Maria monogram, seen as AV conjoined (fig. 16), being the most common in early post-medieval houses. A simple prayer for protection is the intention. By far the most interesting are the demon traps of interlace, scrolls with a continuing line within the device (figs 15, 17 & 18).

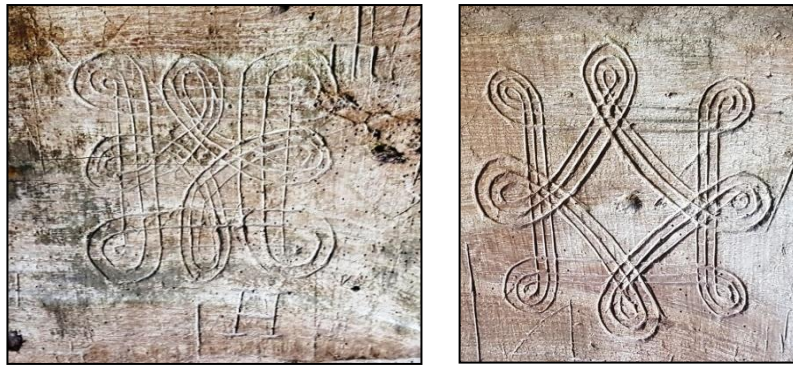
*Figure 17. Interlace devices(demon traps)*

There appears to be four of these, all different . Figure 17 displays the two main, most elaborate, patterns; there are two further examples of a more simplistic linear design (fig. 18). The most common device is the pitch fork in two varieties, one with an angular handle and another with a half-moon-shaped handle (fig.18). Further symbols include a beehive or thimble; personal initials; AV monograms, which are often seen as crudely applied angular lines (fig. 16). Finally, the owners initials are often combined as a personal protection within the context of the other marks (fig. 19).

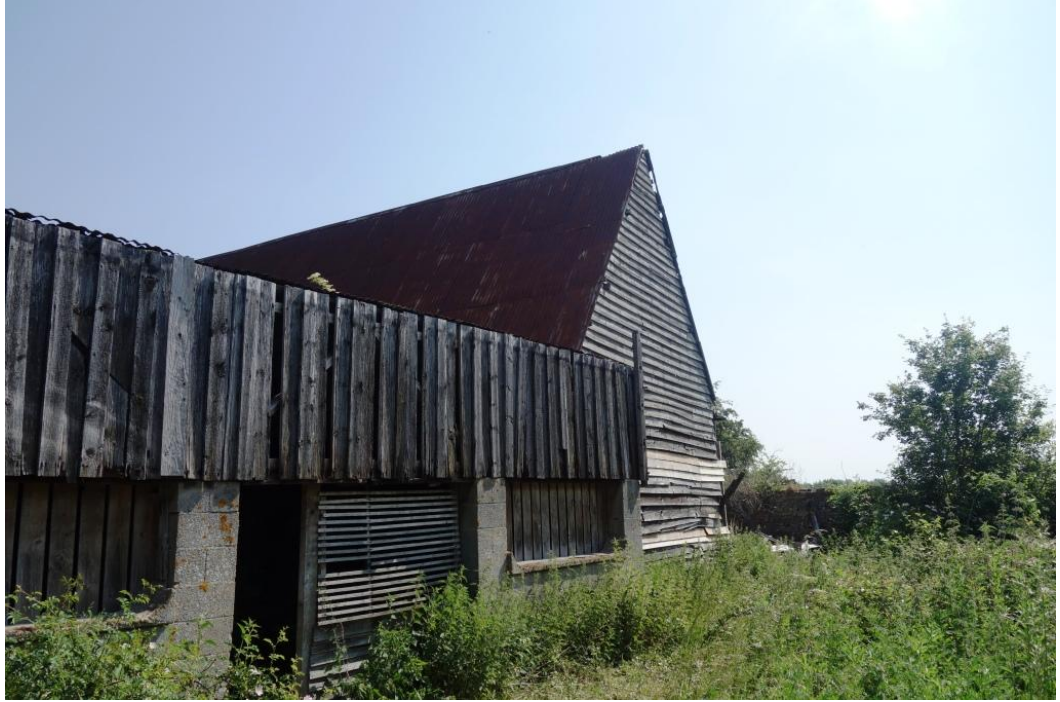
Attached to the cow house are two extensions, firstly a 20th century, breeze-block built structure with additional accommodation for animals , attached to the south-west corner of the building and a lean-to structure to the rear for general storage, which is now in a very dilapidated state.

*Plate 3. Cow house extension, c. 20th century*

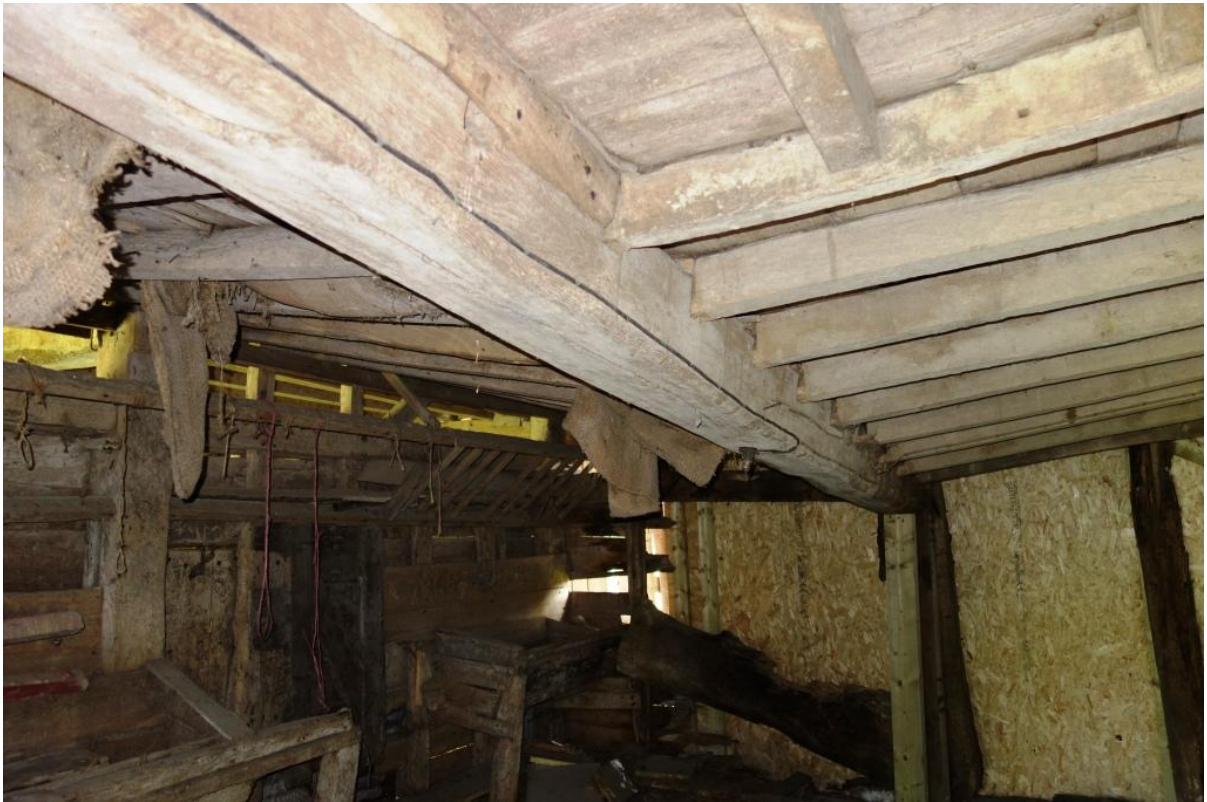
The interior of both cells retain the principal bridging beams which retain a chamfer with a simple stop carved into them at their extremities (fig. ). The southern bay ceiling has collapsed to a point where it has become unstable due to deterioration of the soul plate and brick foundation, which consists of only a few courses of hand-made red bricks (fig. ), these being typical of 17th century buildings, agricultural and domestic.

*Plate 17. Ceiling joists detail in southern cell of cow house*

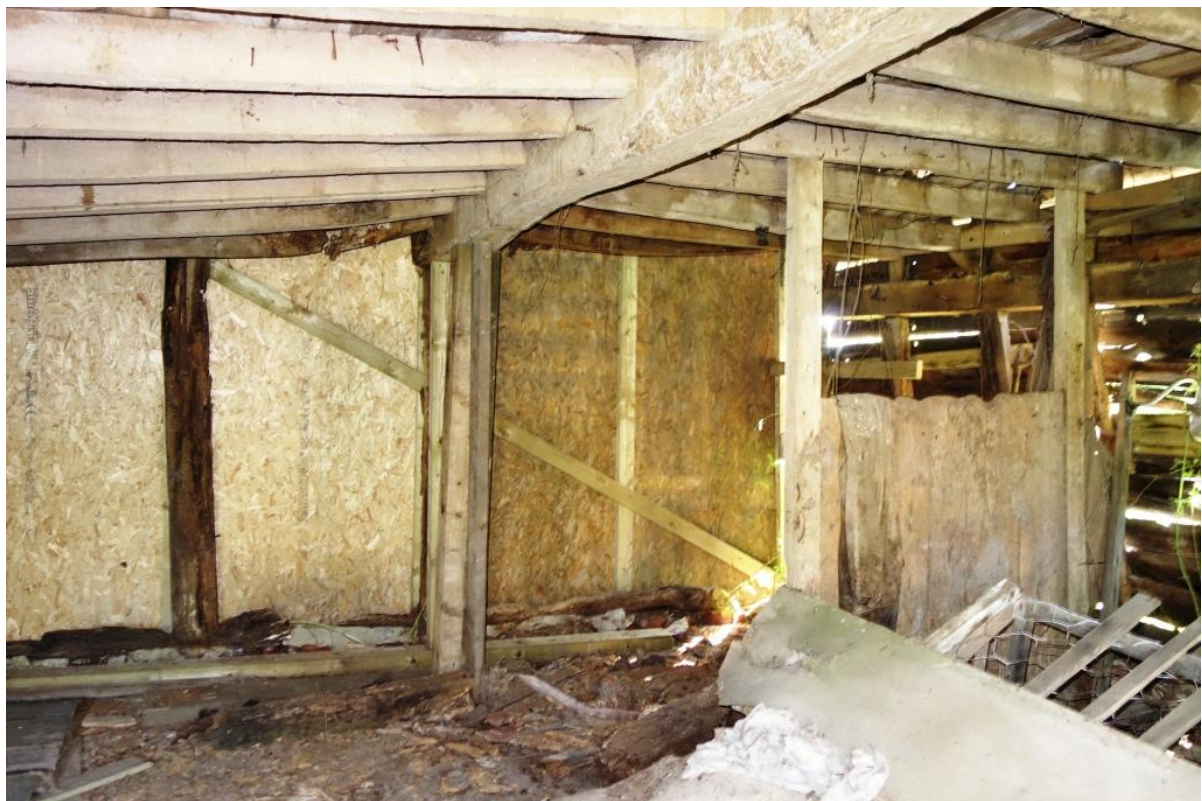
*Plate 20. General view in southern cell towards largely replaced wall*

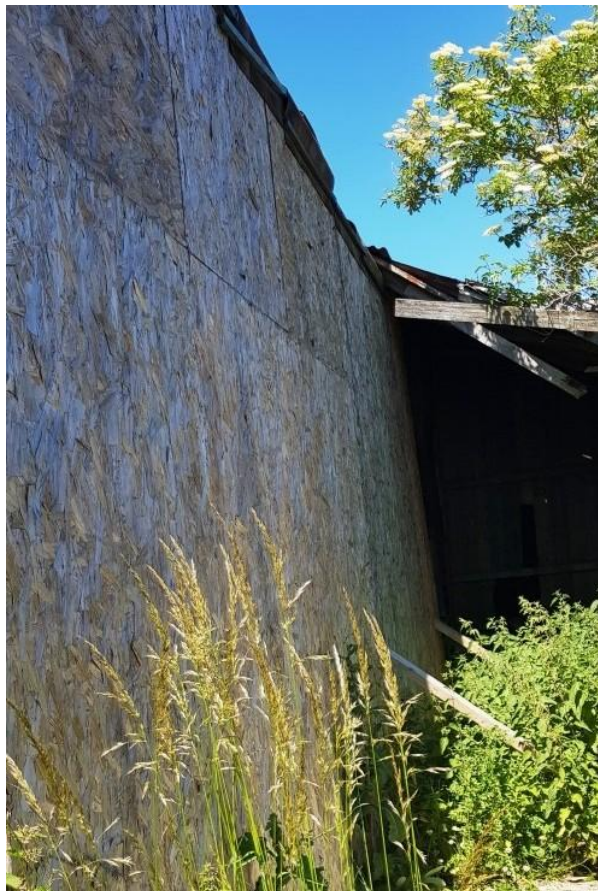
*Plate 39. Rear elevation of cow house (now boarded up)*
