Church Farm Barn The Street Thorndon Suffolk Historical Building Survey

February 2010

Archaeological record

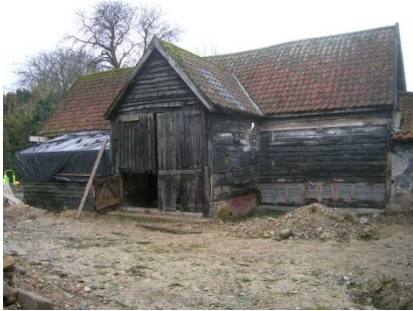
Image 11, The barn and porch facing east

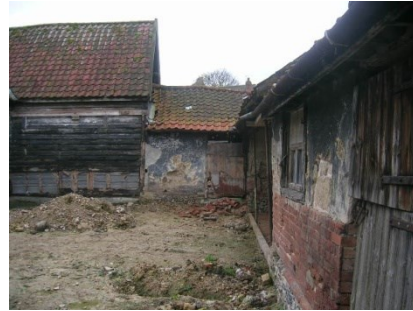
Image 26, connecting bay, facing east

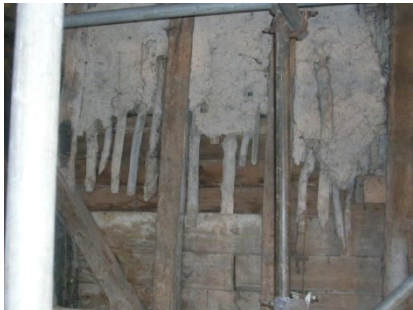
The outer covering of the barn is weather-boarding with a black, bitumen finish, and appears original. The interior finish of the walls and timber-frame infill was lathe and plaster, some of which still survives in the west wall.

Image 20, Detail of lathe and plaster wall
in main barn

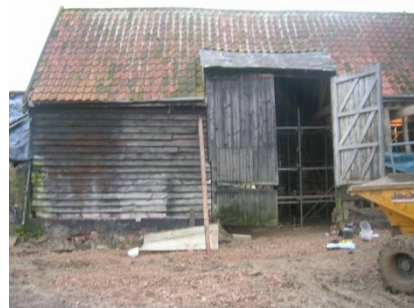
The doors to the barn are of the traditional opposing double door type. The west facing door measures 3.5 metres wide by 2.8 in height and for the east-facing door, 3.56m high by 3.5 m wide metres high is the larger of the doorways (this is also the entrance with the porch).

Image 19, west facing door of barn

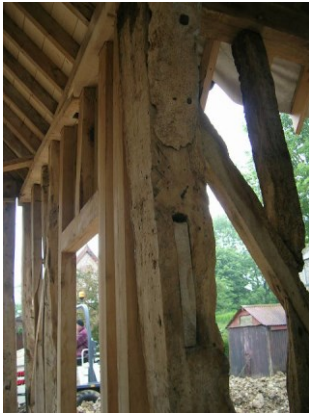
The origins of the main barn (2) are likely to be c. late seventeenth-early eighteenth century. This can be evidenced by the mixture of nail fixings for the scantling and peg joints for the main box frame, and suggests a cross-over of the two jointing methods seen in buildings of this date. Remains of the original lathe and plaster infill were noted, and are also typical of this period, with cut willow vertical poles retained by twine and covered with a daub render. Further evidence that the barn was either refurbished or completely rebuilt over an existing barn structure was seen from the archaeological monitoring report for this site. The report showed that a stone course, possibly an earlier footing, was recorded below the connecting range, also an organic deposit was recorded in two areas of the footings, which could be evidence for an earlier building being used for stock holding.

Image 2: Detail of sawn away brace in storey post of main barn

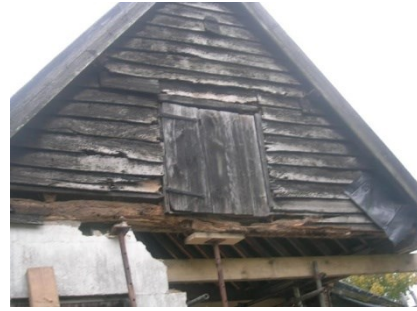
Both end gable walls have a loft door, presumably allowing access to hay lofts at each end of the barn (no longer extant). The north-facing hayloft door was converted to a window, now partially blocked by the connecting range or barn extension, while the south-facing hayloft door still retained its original pair of doors. A lead fire insurance plaque was also noted high up on the south-facing gable end wall.

Image 27: Hayloft door on south facing gable end of barn

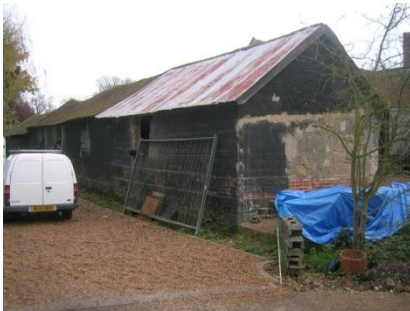
Image 8: East-west range from the west

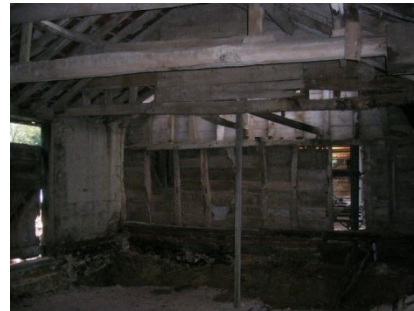
Image 23: Interior of connecting bay (5)

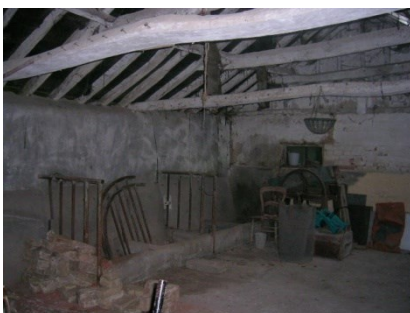
Image 13: Interior of east-west range (7)

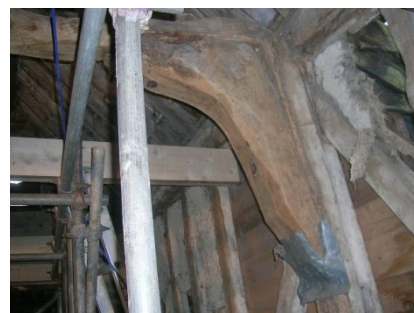
Image 5: Detail of bolted knee brace in main barn
