Historic building recording at Natson's Farm, Bow, Devon

Report No. 16-09

October 2016

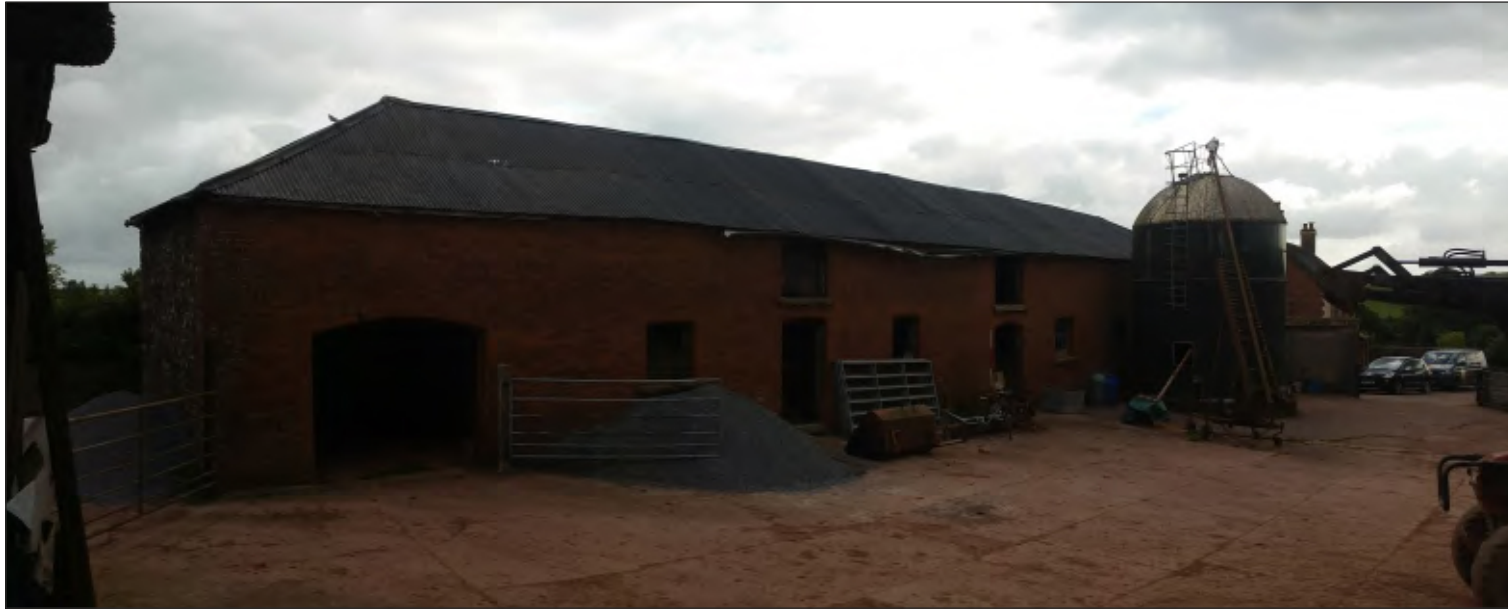
Fig. 11 General view of barn. 2m scale. Looking northeast.

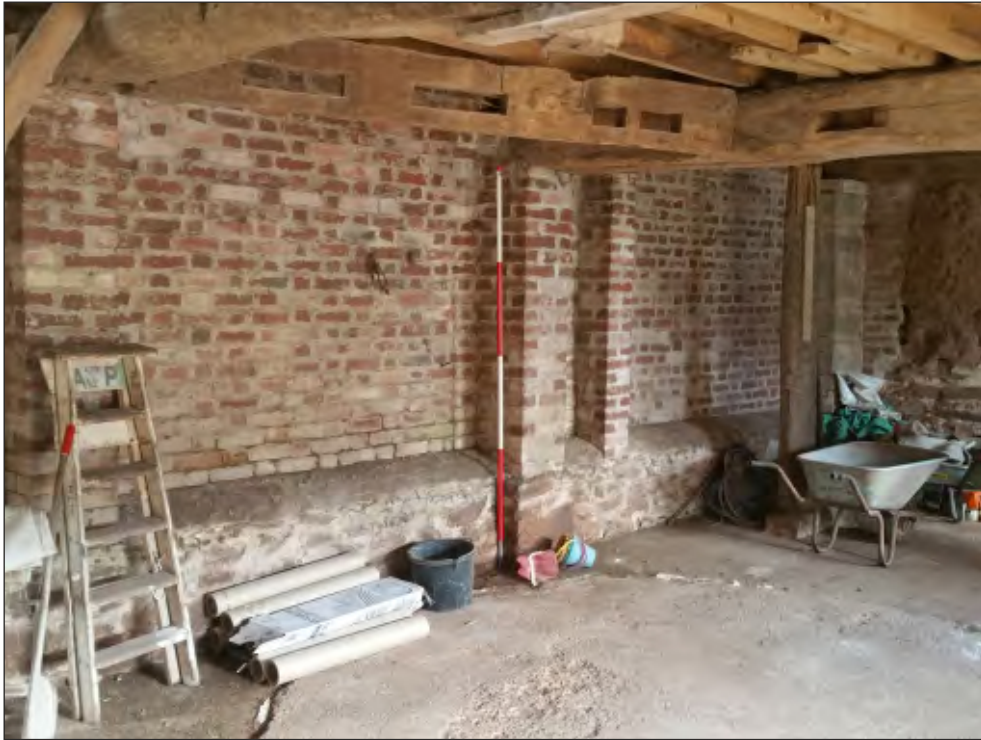
Fig. 14 General view of rear wall showing rebuilt section. 2m scale.
Looking northeast.

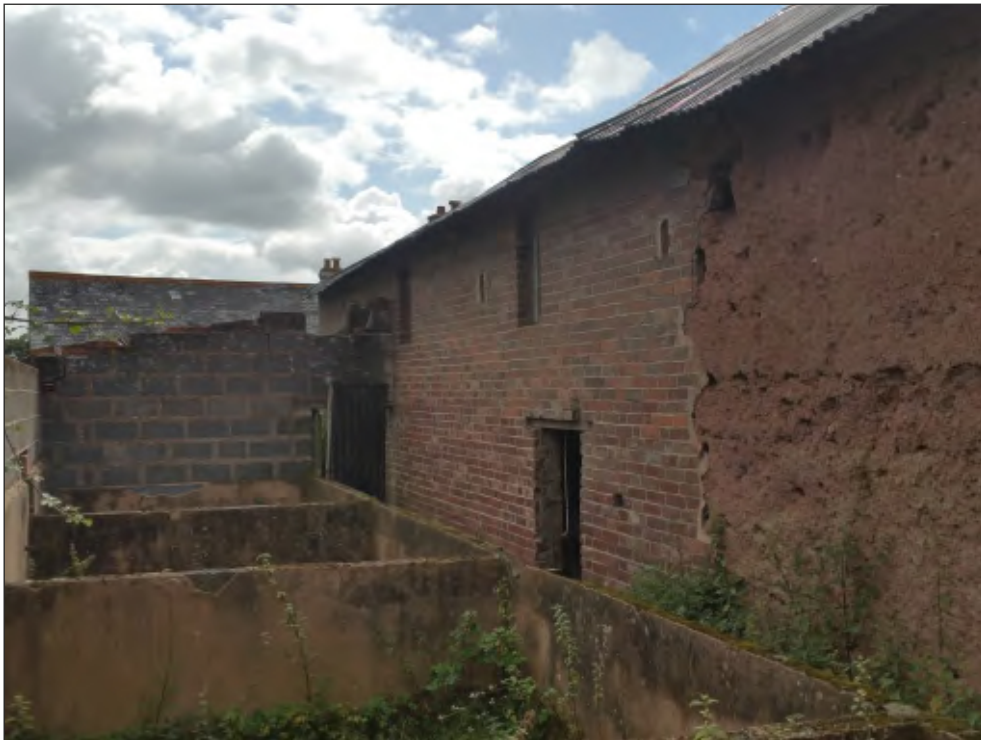
Fig. 15 General view of rear elevation showing rebuilt section. Looking
southeast.

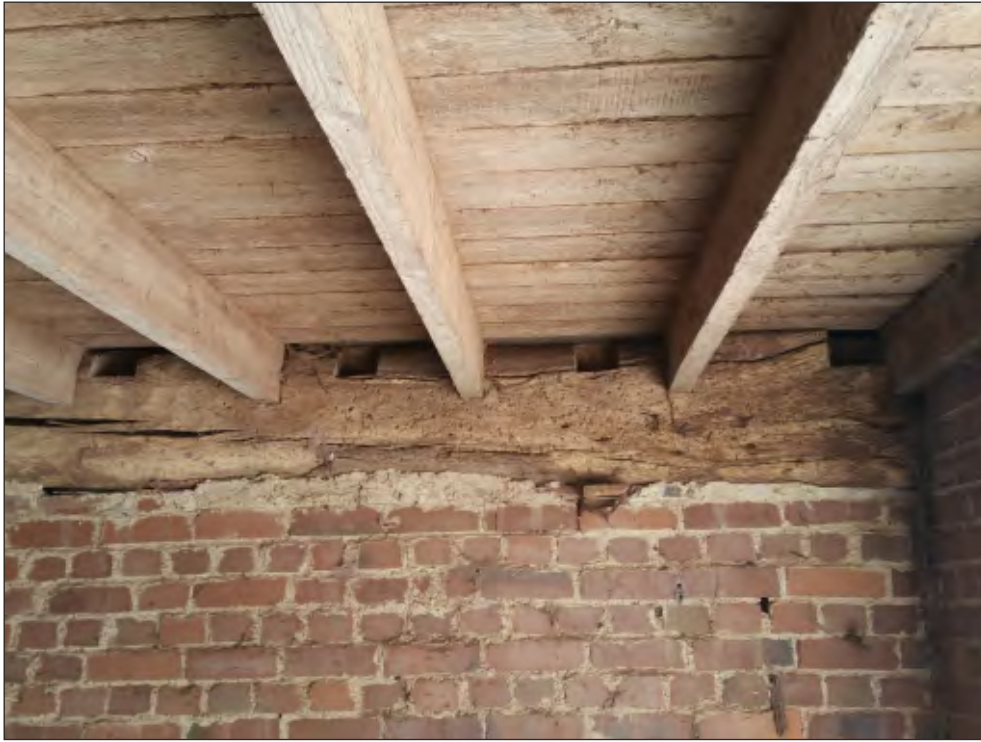
Fig. 21 Close-up showing earlier floor truss and later floor. Looking east.

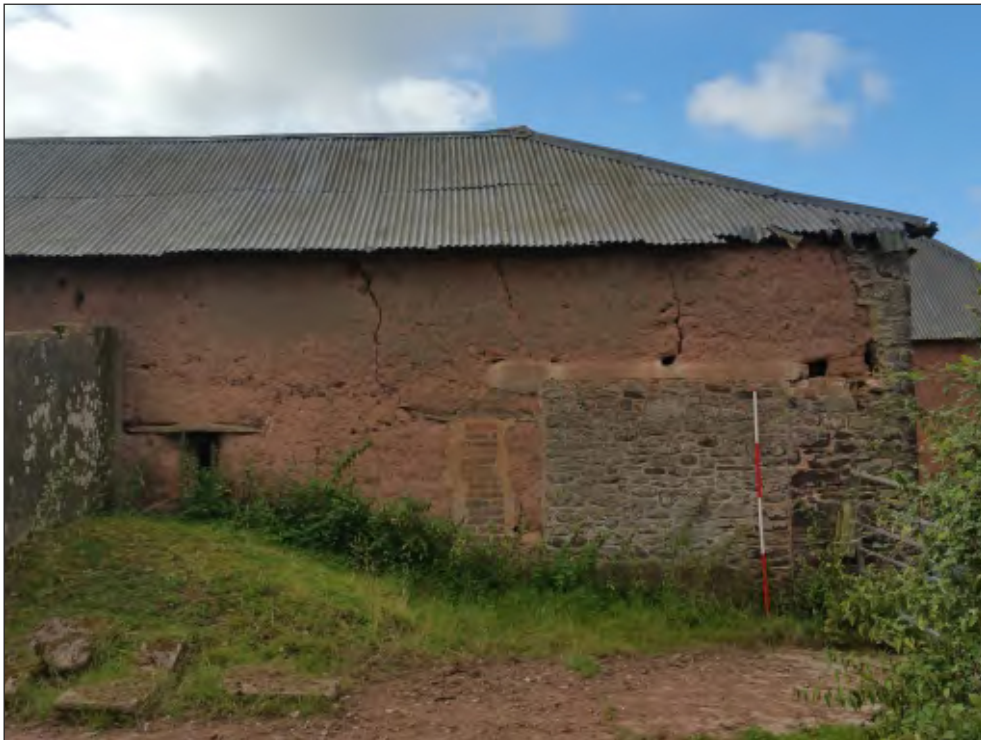
Fig. 22 General view of rear elevation showing blocked openings. 2m scale. Looking south.

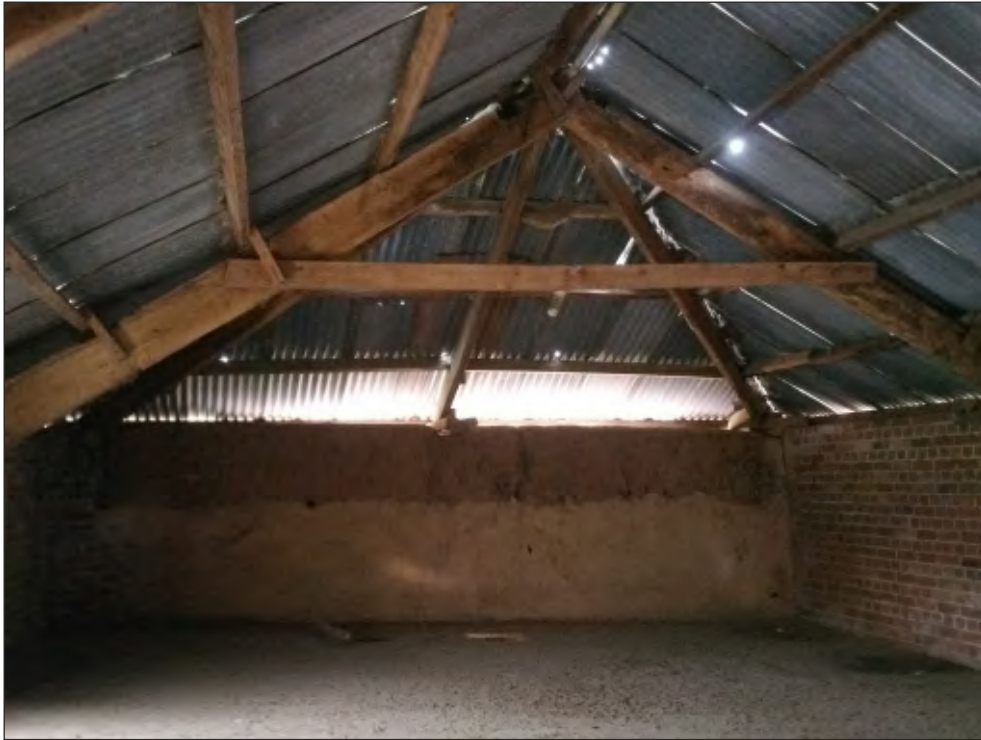
Fig. 23 General view of eastern end showing original cob elevation and later brick re-fronting. Looking east.

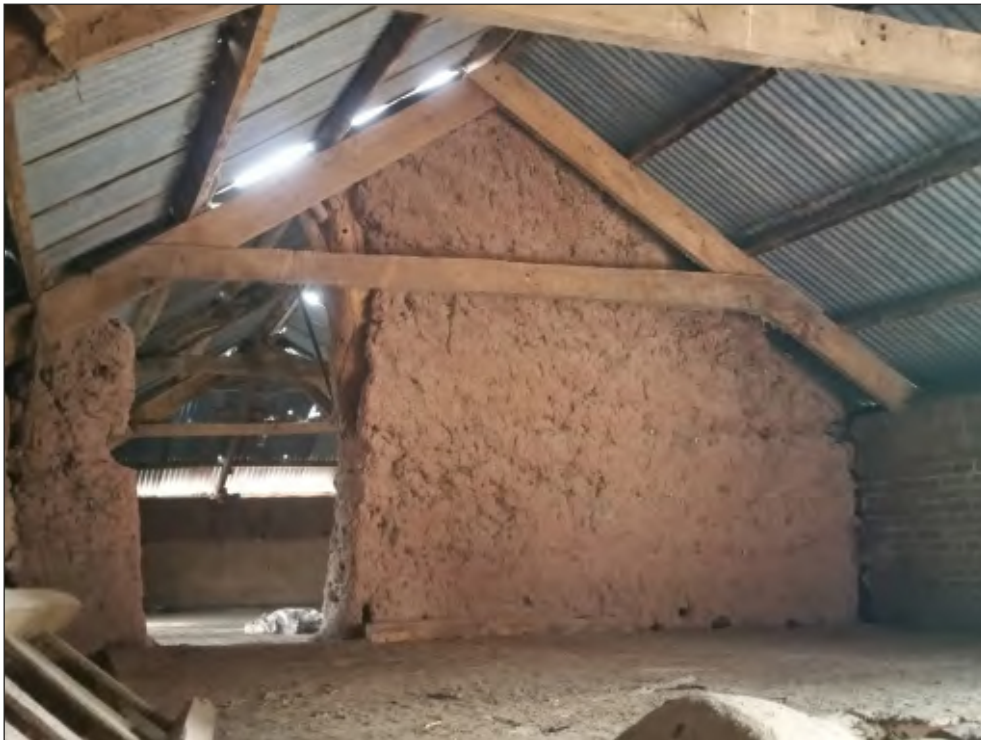
Fig. 24 General view of cob partition running to the apex with later opening. Looking east.

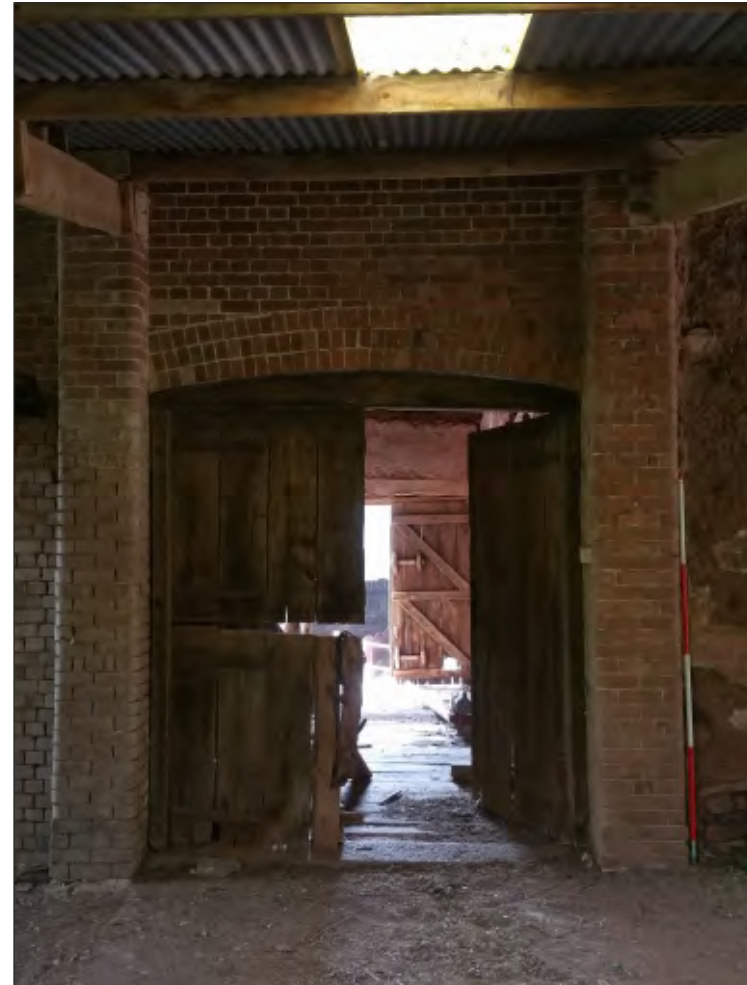
Fig. 30 General view of rebuilt west doorway (field side). 2m scale. Looking east.

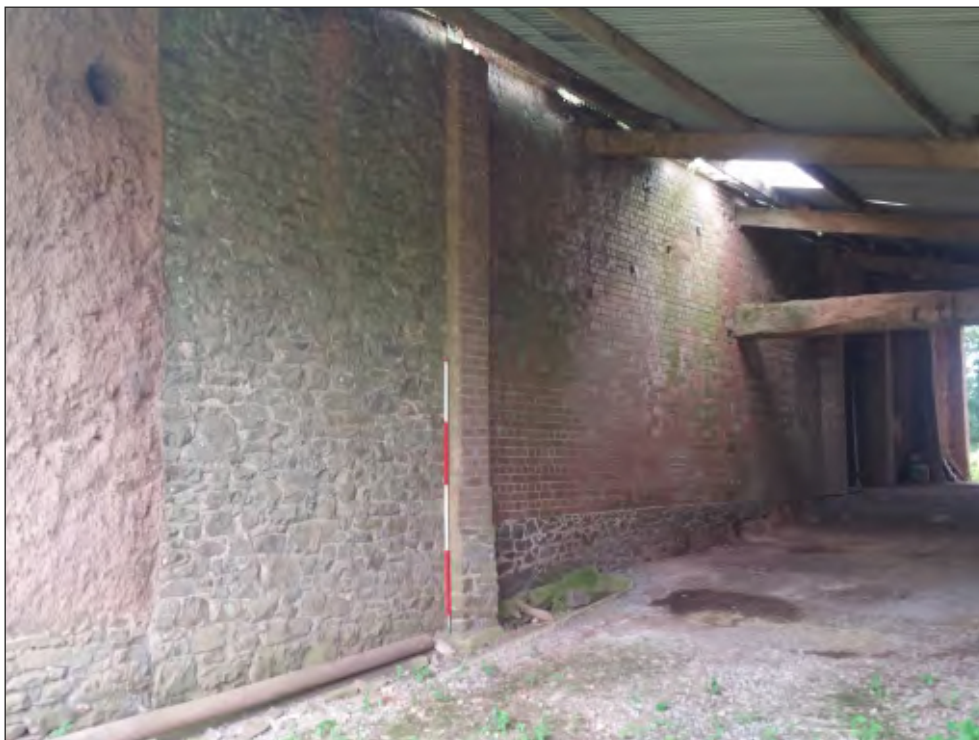
Fig. 31 General view of rear elevation showing blocked northern doorway (left) and rebuilt section (right). 2m scale. Looking southeast.

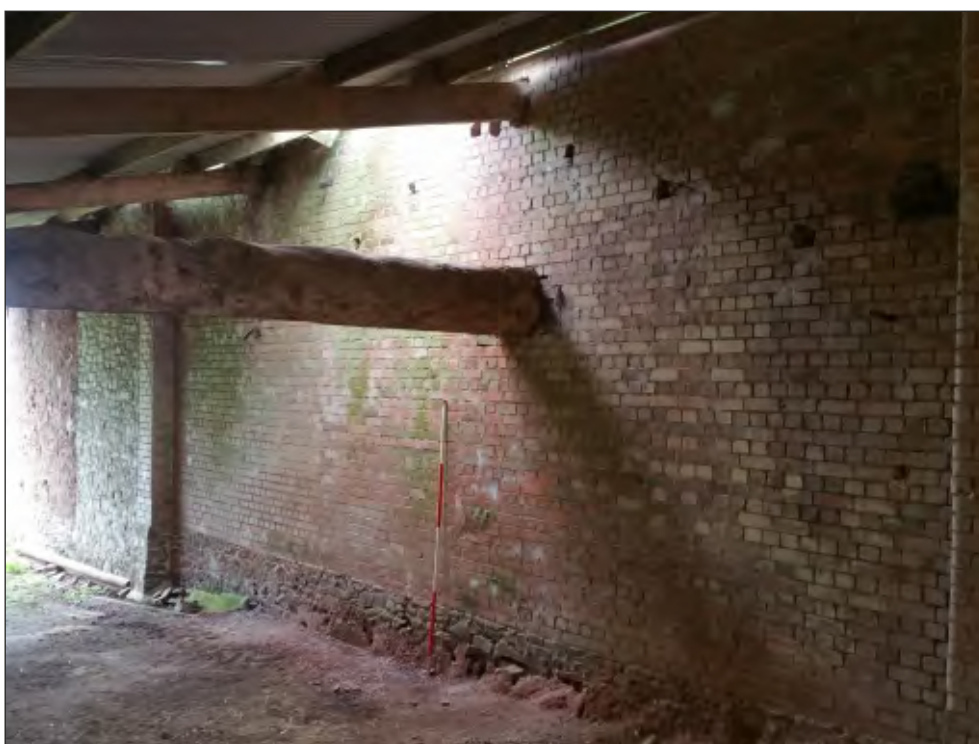
Fig. 32 General view of rear elevation showing earlier roof line. 2m scale. Looking northeast.

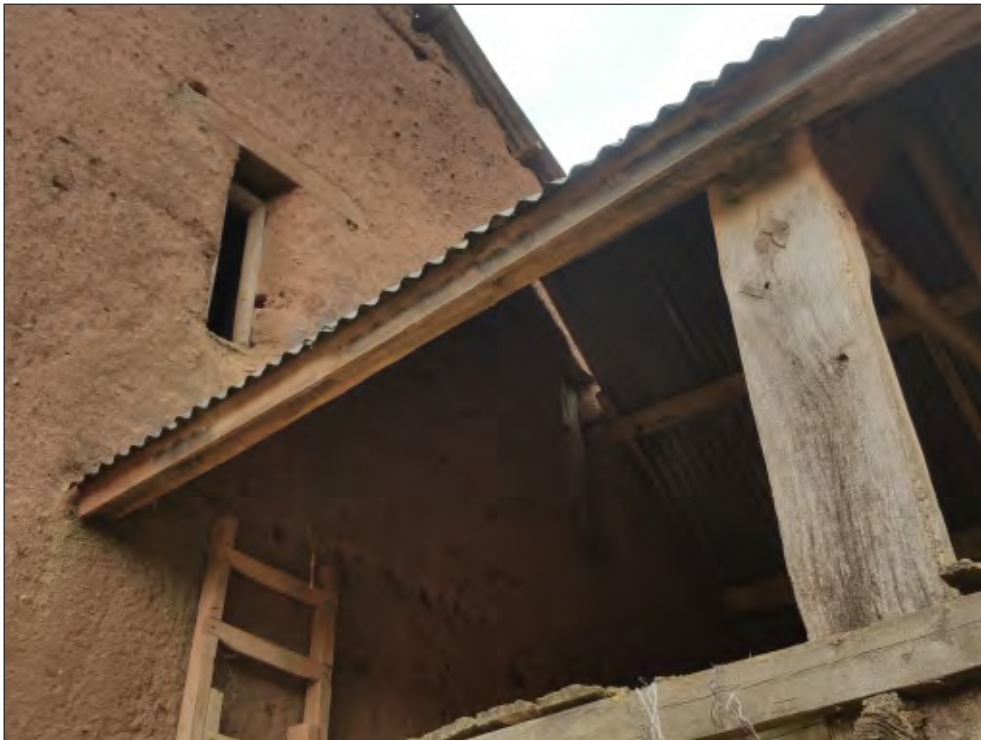
Fig. 36 Close-up of northern elevation showing blocked window and earlier roof line. Looking southwest.

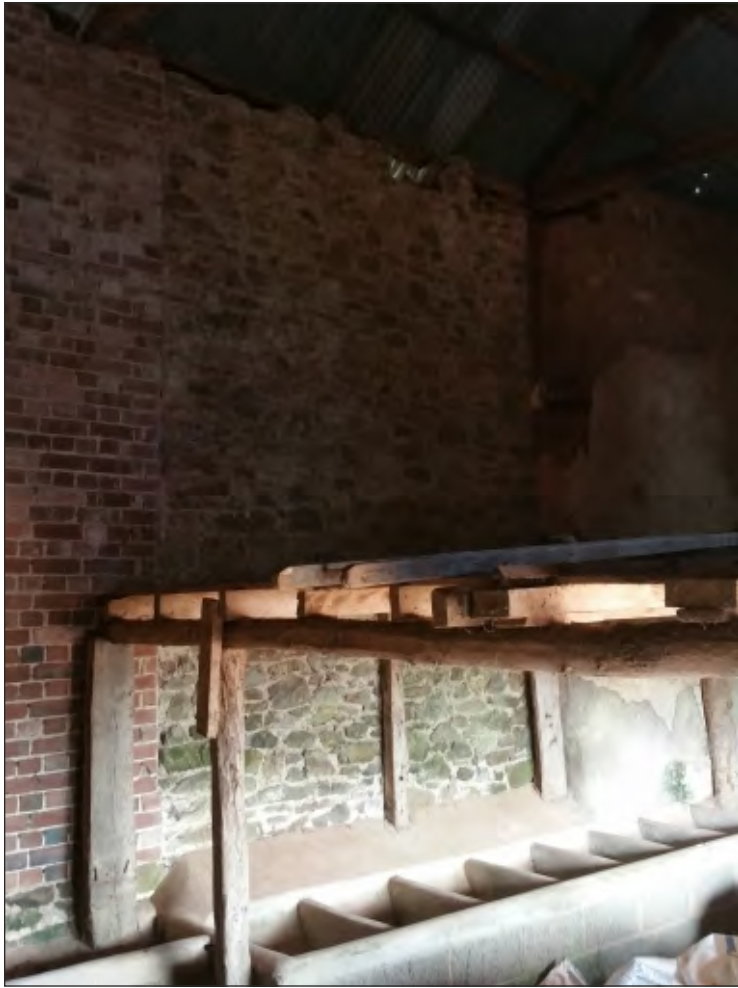
Fig. 43 General view of blocked doorway in lower threshing barn. Looking northwest.

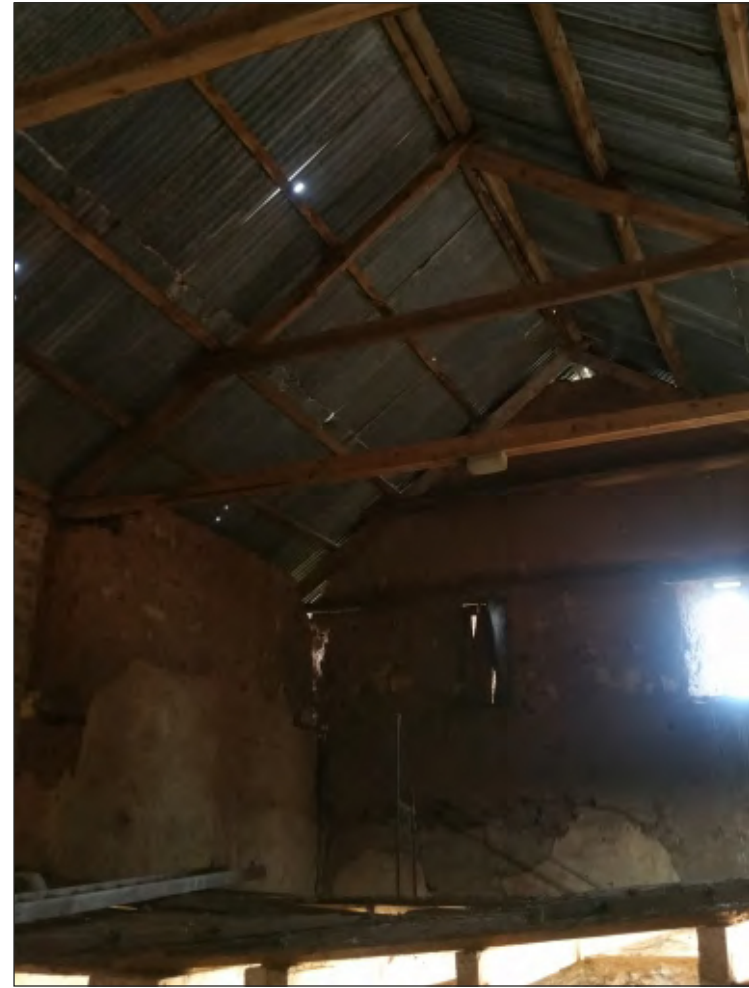
Fig. 44 General view of north elevation of threshing barn showing blocked window. Looking north.

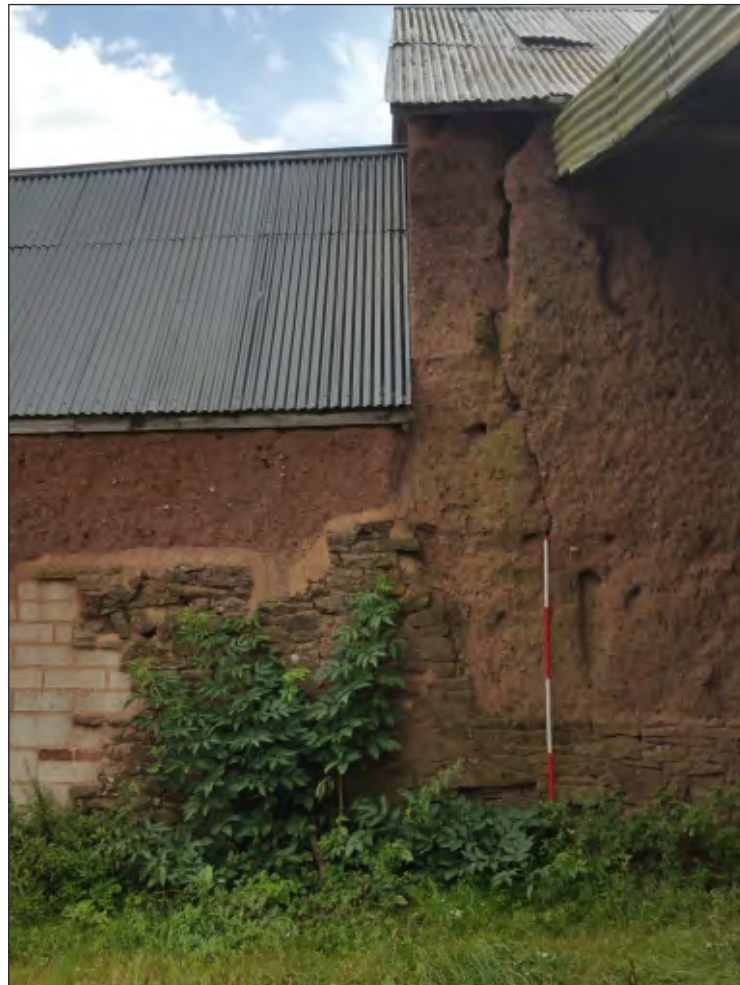
Fig. 46 Close-up of junction between threshing barn and linhay showing difference in height of stone foundations. 2m scale. Looking east.
