Historic building recording at Staddons, Walkhampton, Devon

Report No. 17-03

OAKFORD ARCHAEOLOGY

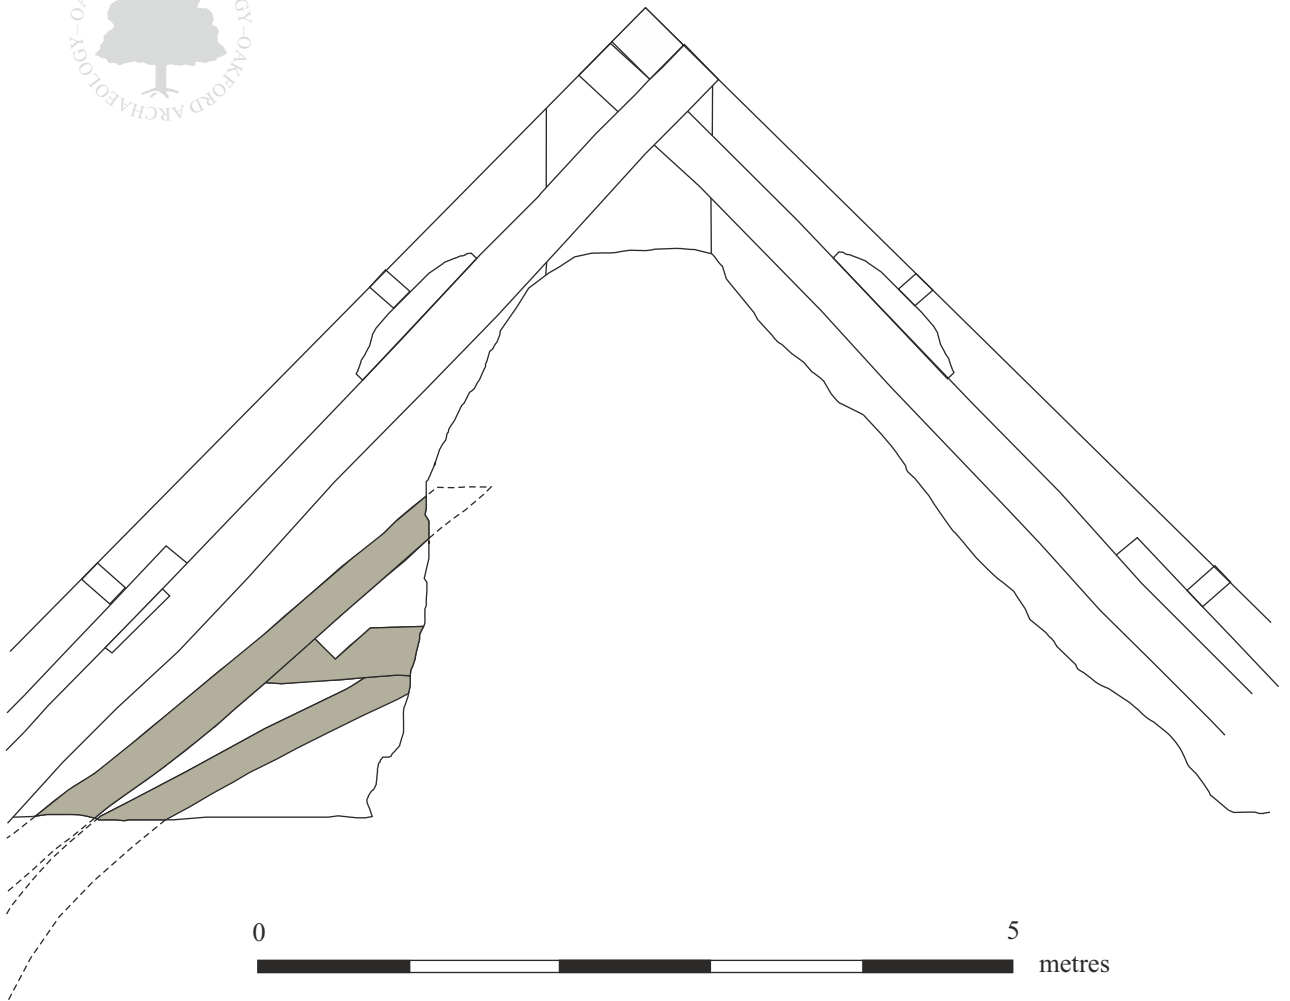
Fig. 8 Section showing medieval roof truss (grey) and later roof arrangement.

In the late 18th or early 19th centuries the majority of the roof of the house was removed and replaced, leaving only one part of one truss of the original 14th-century roof intact. The reason for this alteration is not known, but it seems likely to have been made to improve the headroom in the first-floor rooms. The rebuilding of large sections of the front and rear walls of the building may also have necessitated the replacement and renewal of the roofs.

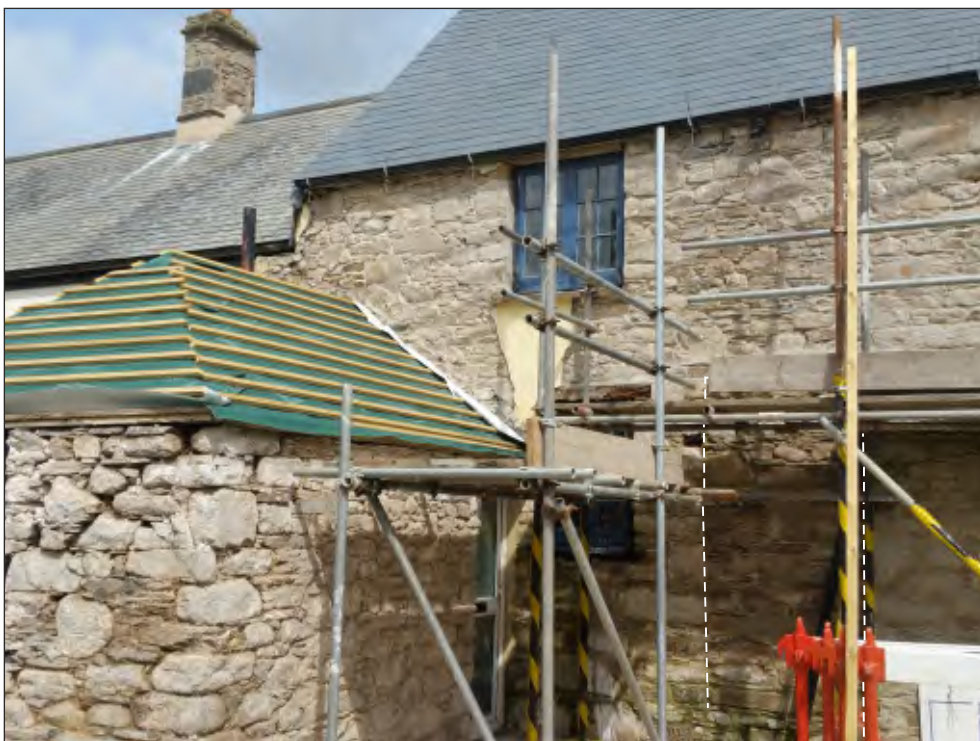
Pl. 2 General view of western end of Staddons after removal of render showing blocked doorway into room G4 (right). Looking northwest.

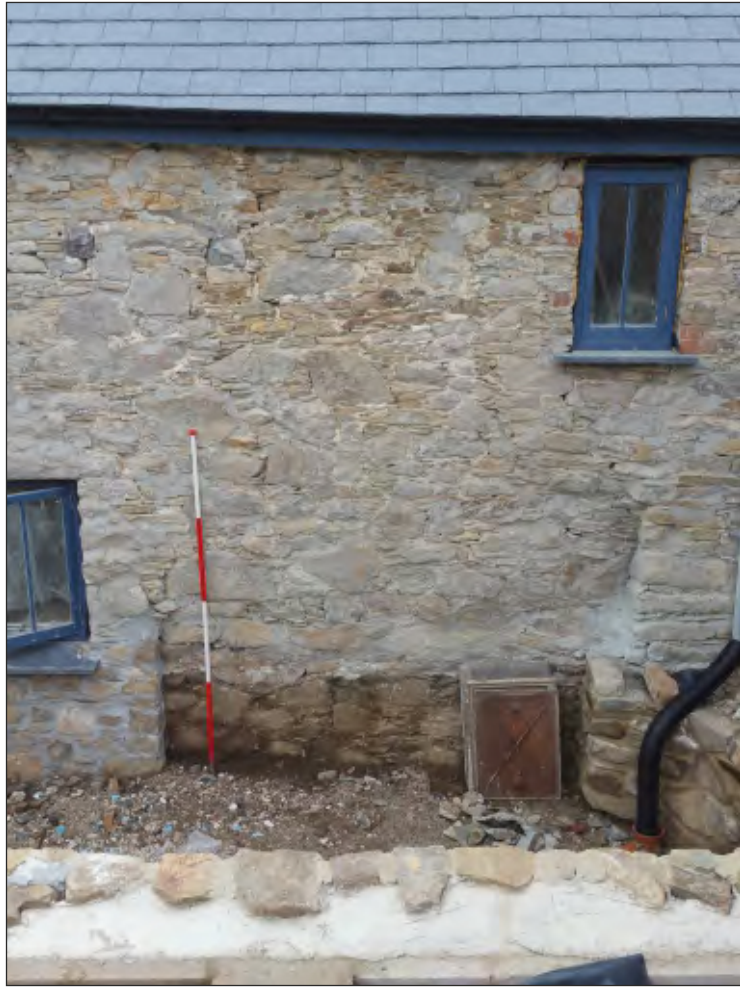
Pl. 5 General view of blocked opening at rear of room G2 after removal of render showing protruding masonry to the left and right defining the original opening. 2m scale. Looking south.

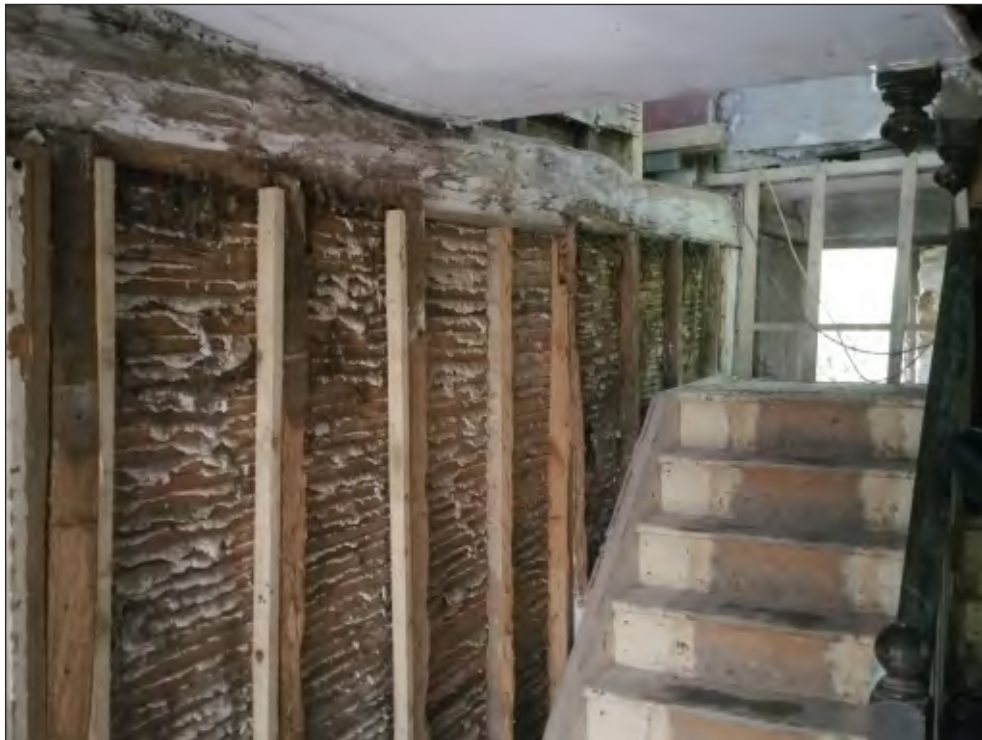
Pl. 8 General view of partition between corridor G3 and room G4 showing blocked doorway in the centre and the random door included within the partition behind the staircase. Looking northwest.

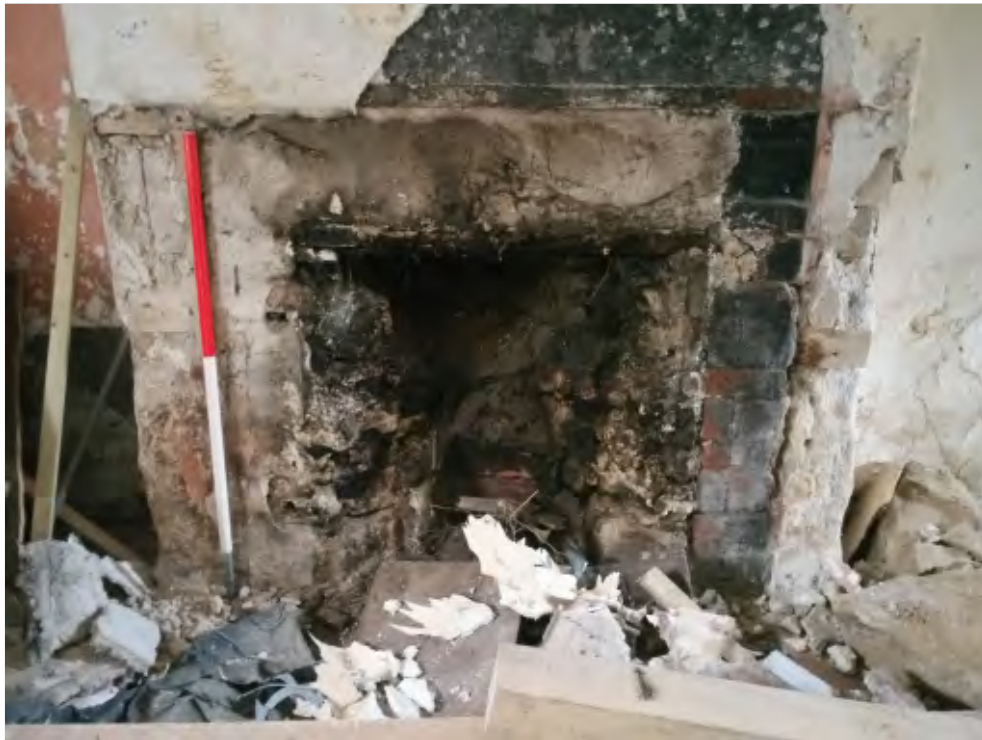
Pl. 10 General view of fireplace in room G4 showing stone jamb (right) of medieval fireplace. 1m scale. Looking west.

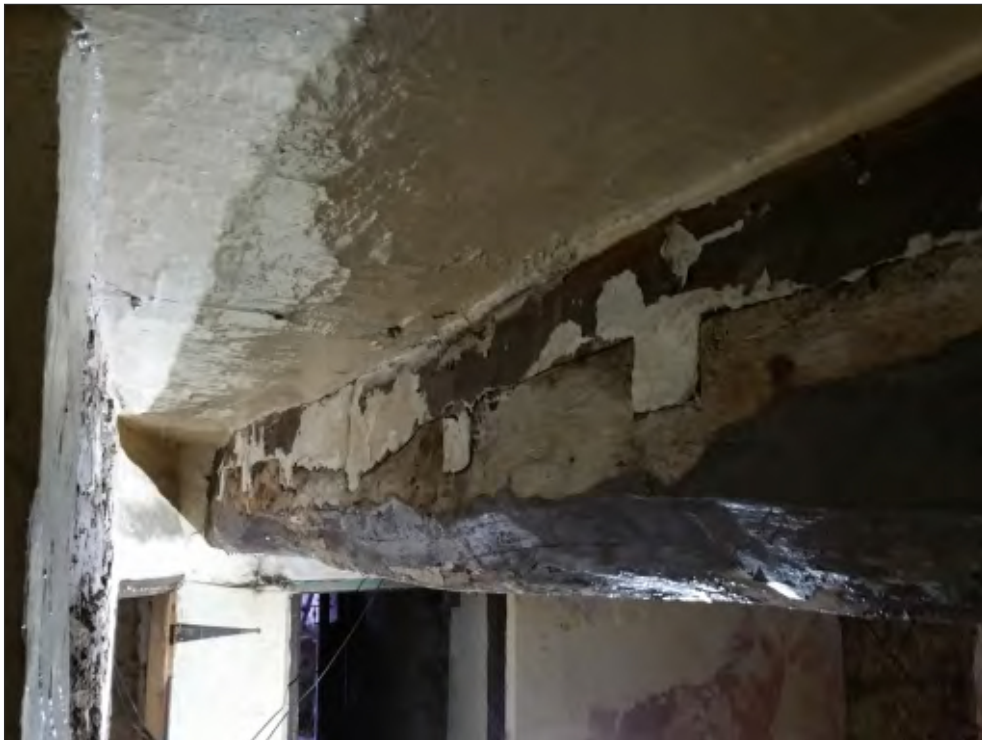
Pl. 16 Close-up of former jetty bresummer beam in room G6 showing infilled joist holes and the raising of the main beam height to insert the later floor above. Looking northeast.

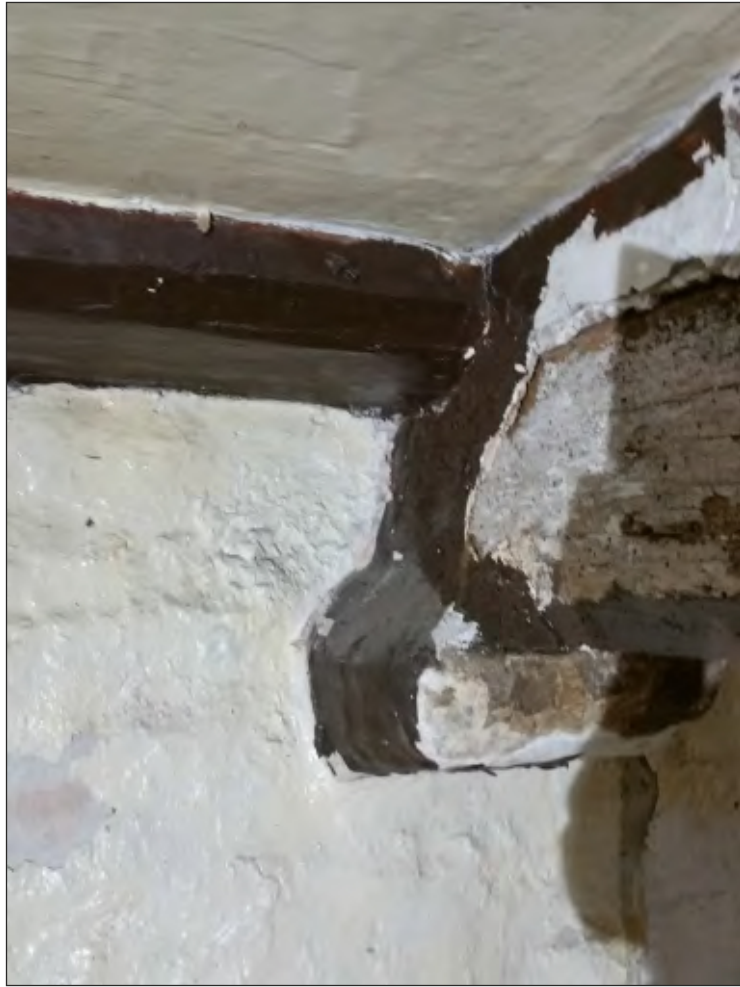
Pl. 17 Close-up of large beam in G6 supported on stone corbel, small beam supported in south wall and additional timber above beam to raise the floor level consistently throughout the first-floor. Looking northeast.

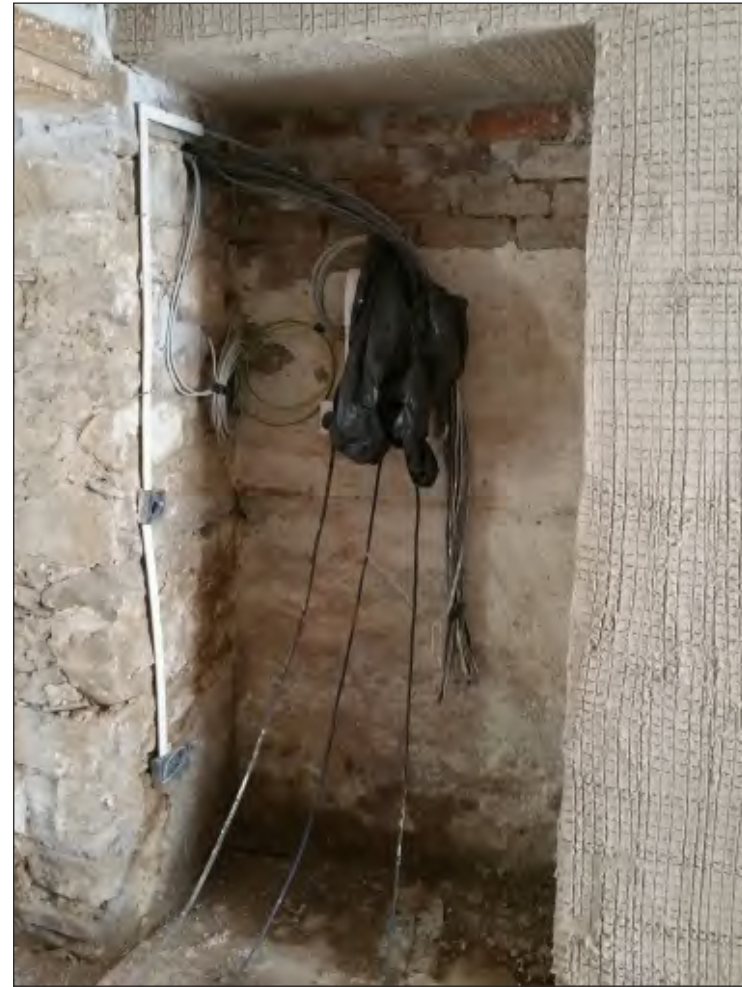
Pl. 18 General view of blocked doorway in north-eastern corner of room G6 showing late 19th century brick blocking. Looking northeast.

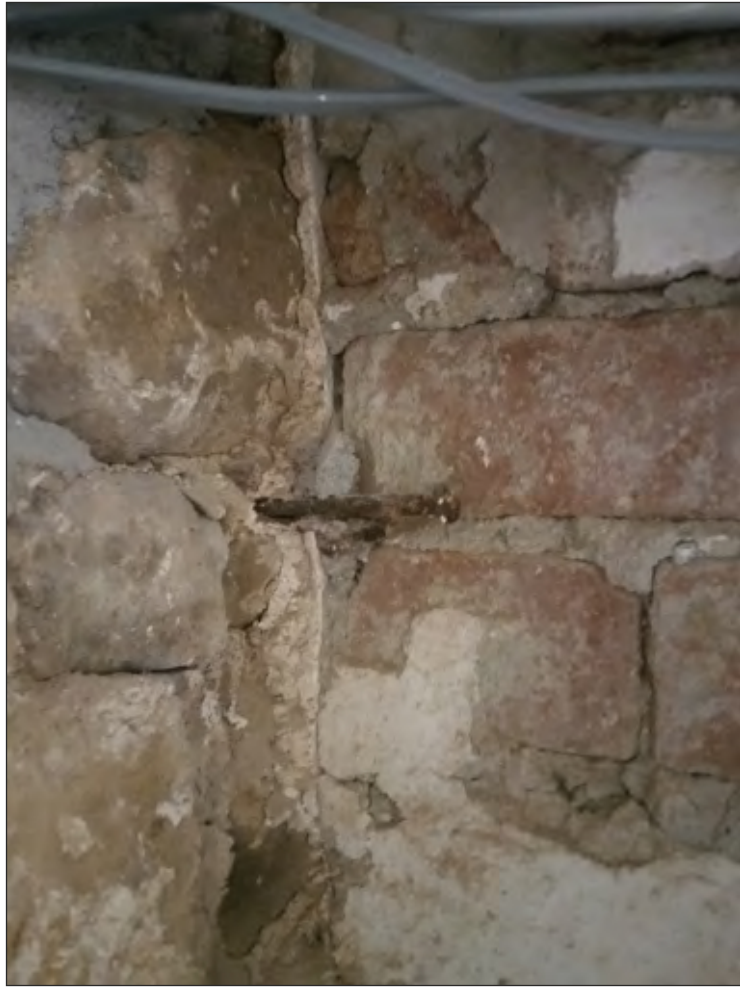
Pl. 19 Close-up showing later brick blocking of doorway in east elevation of room G6 butting up to earlier plaster. Looking northeast.

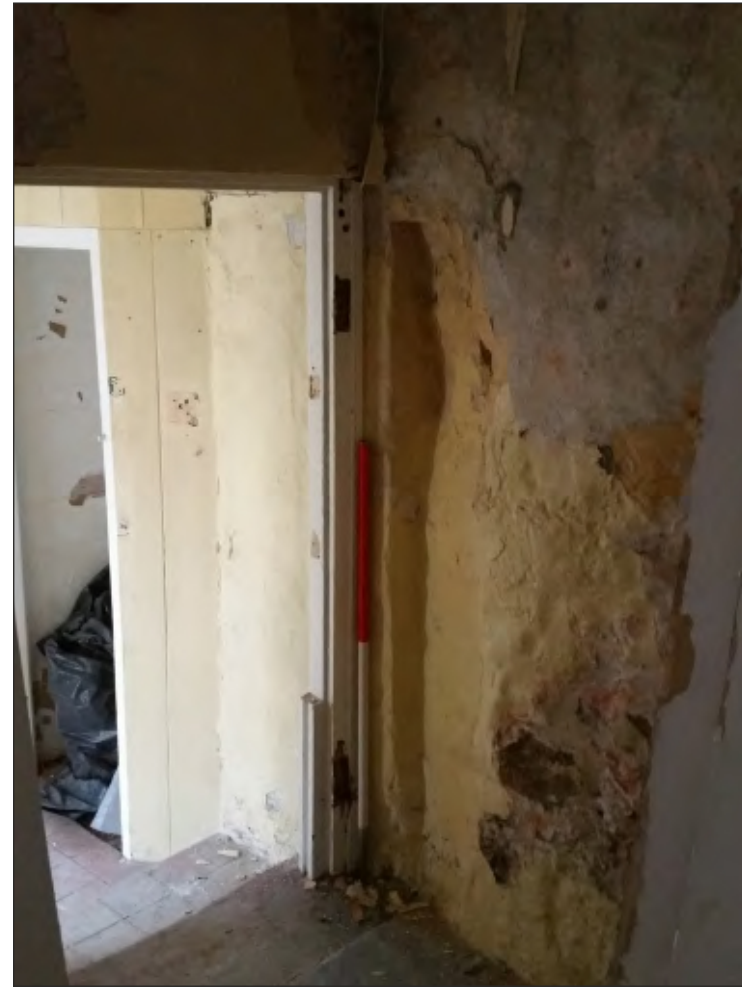
Pl. 20 General view of wall scar between rooms G1 and G2 indicating the possible location of a stair turret. 1m scale. Looking southwest.

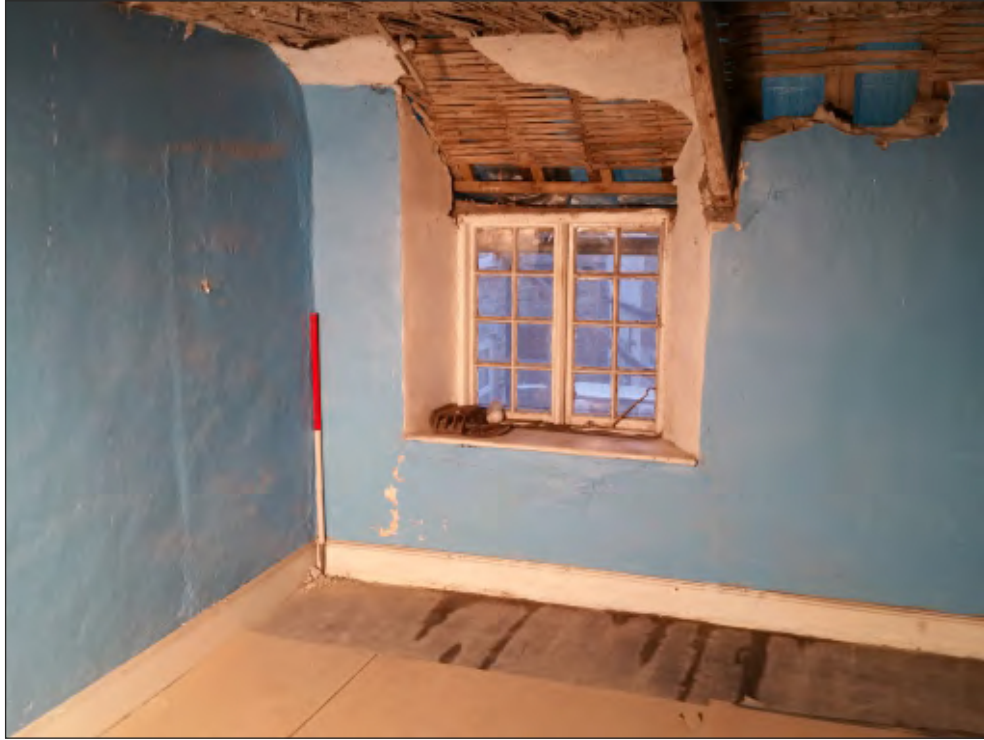
Pl. 25 General view of room F6 showing blocked doorway in eastern partition and window. 1m scale. Looking southeast.

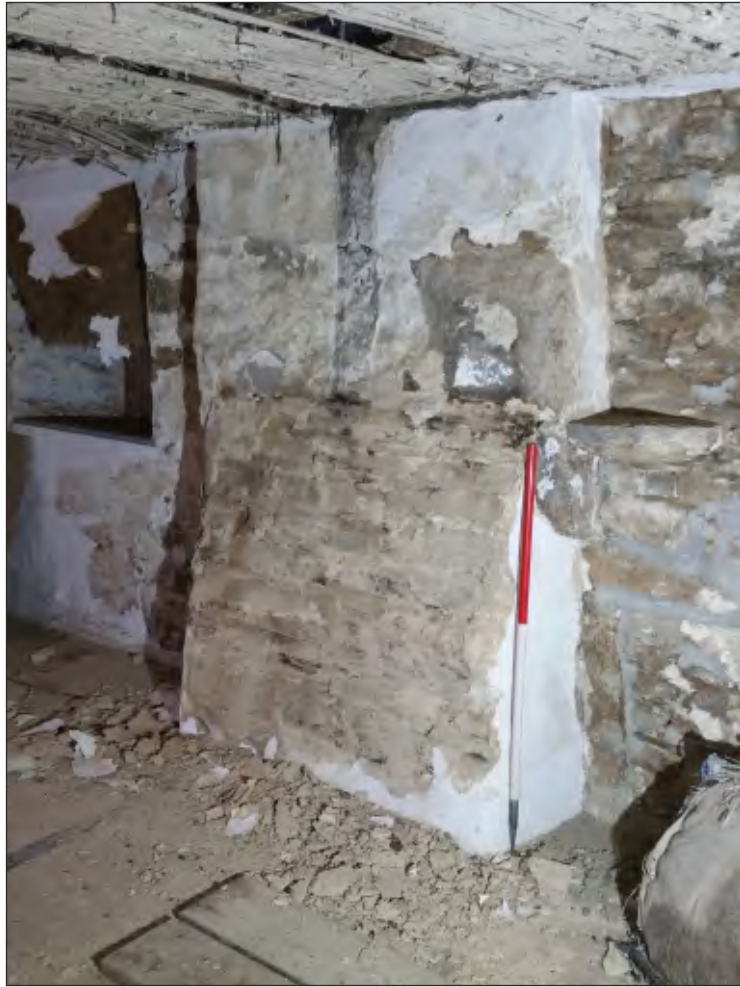
Pl. 29 General view of blocked medieval window (left) and medieval fireplace with later blocking in room F1/3. 1m scale. Looking southwest.

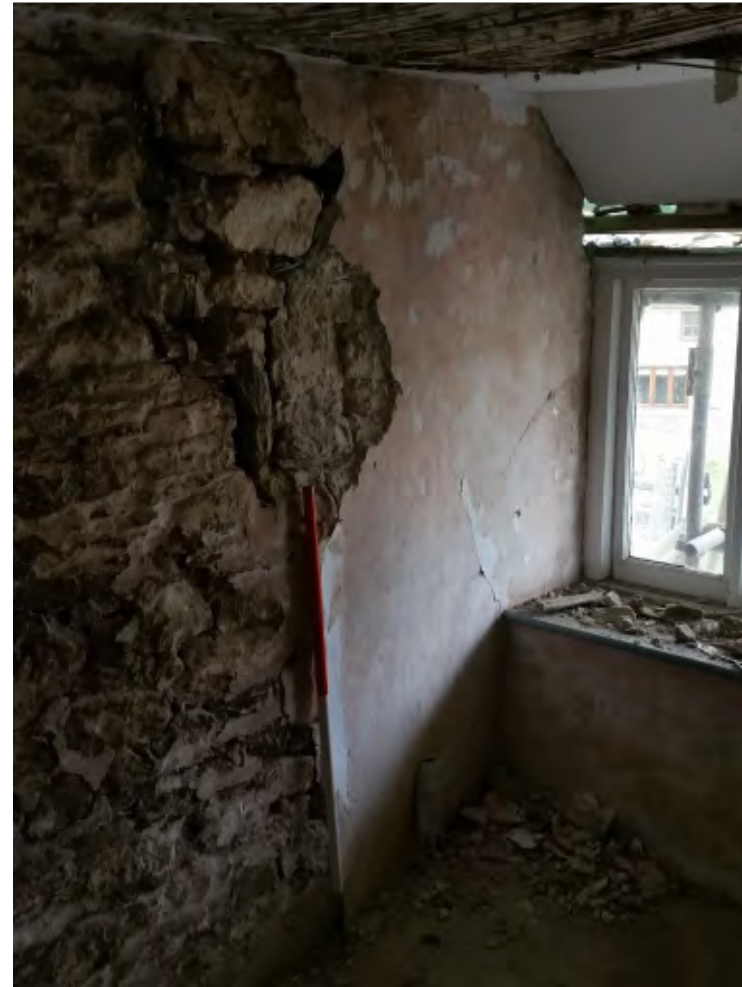
Pl. 30 Close-up of vertical building break showing re-fronting of the western end of Staddons House. 1m scale. Looking southeast.

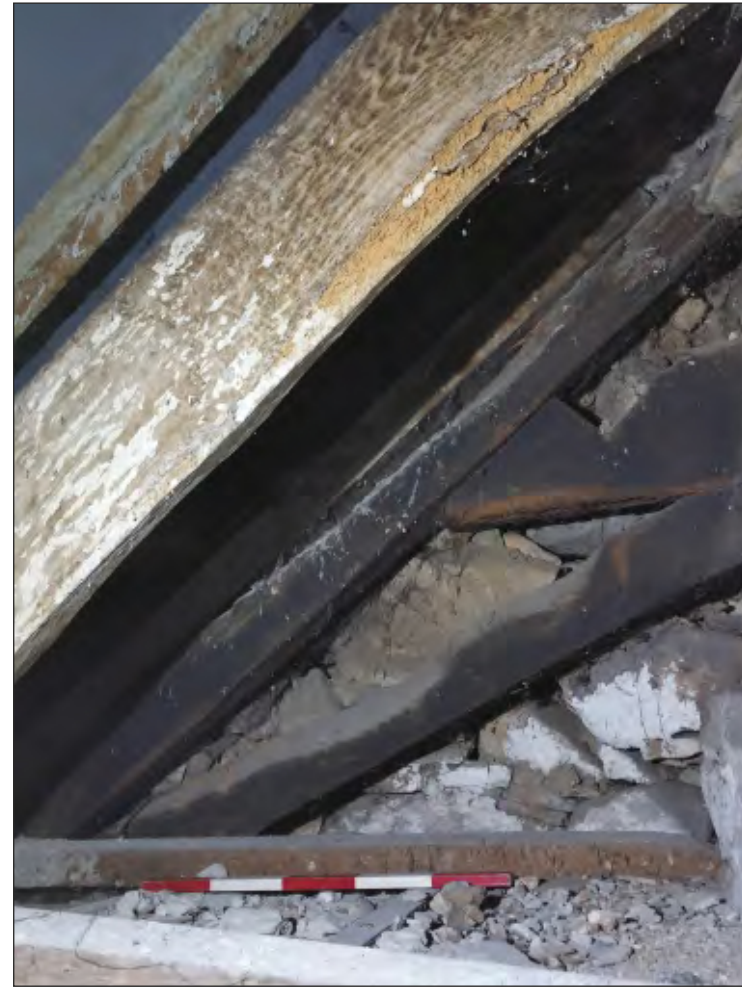
Pl. 32 Close-up of medieval roof truss clearly showing notch for clasped purlin. 0.5m scale. Looking east.
