BENTHALL HALL FARM

Benthall, Broseley, Shropshire

Historic Building Record and Assessment, 2017
(Vernacular Building Survey)

Report Ref.: 2017_001.v2.FINAL

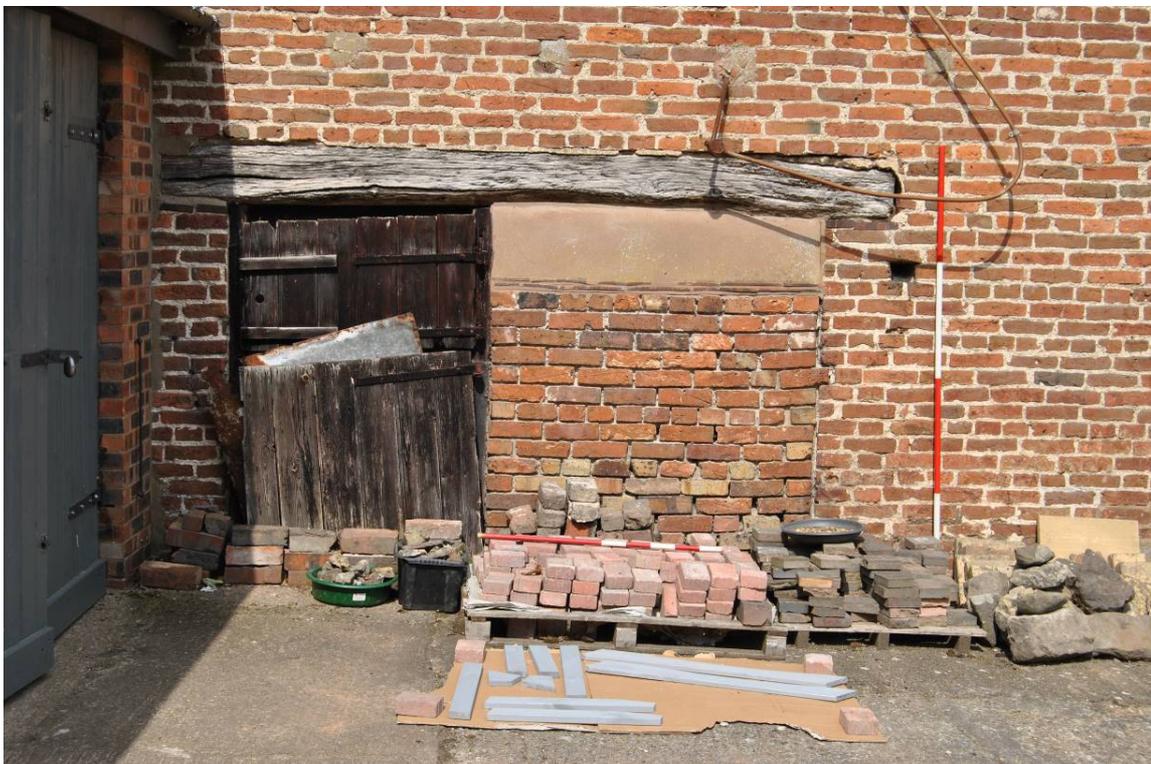
Plate 28: Ground-level opening at Bay 4, blocked in two phases.

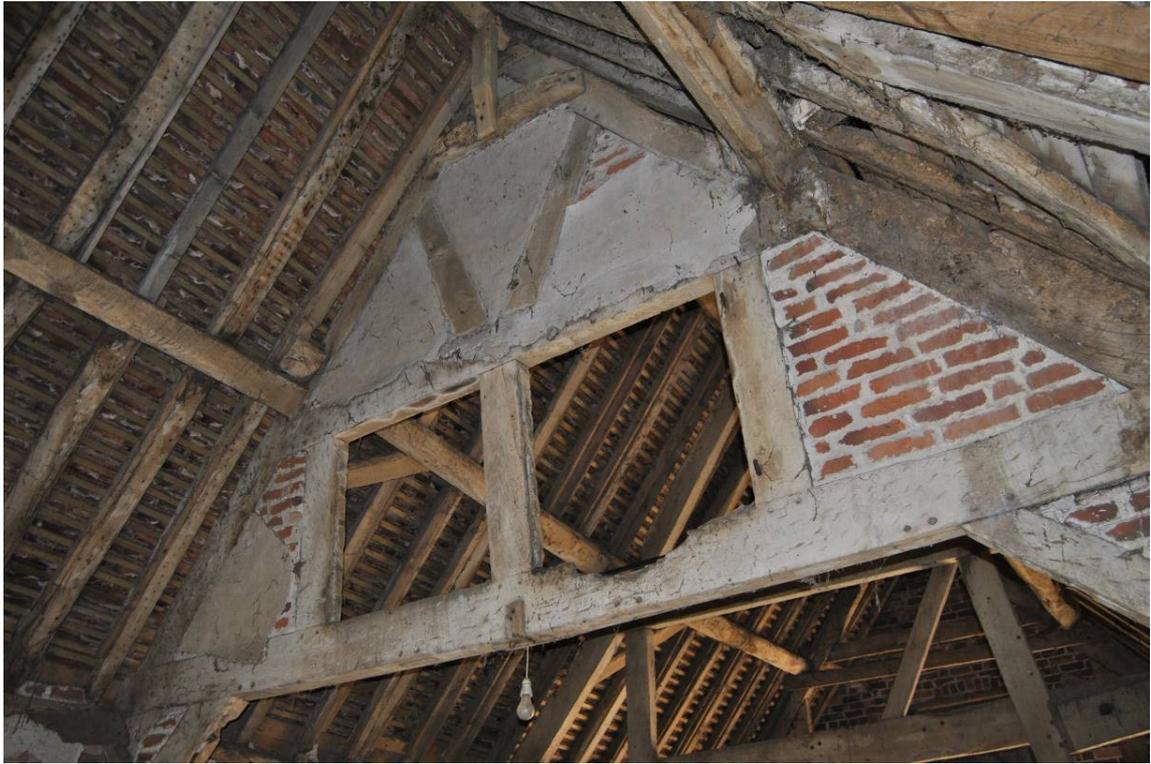
Plate 77: Building F, southern truss T1 (south face) with rendered brick-nogging infill.

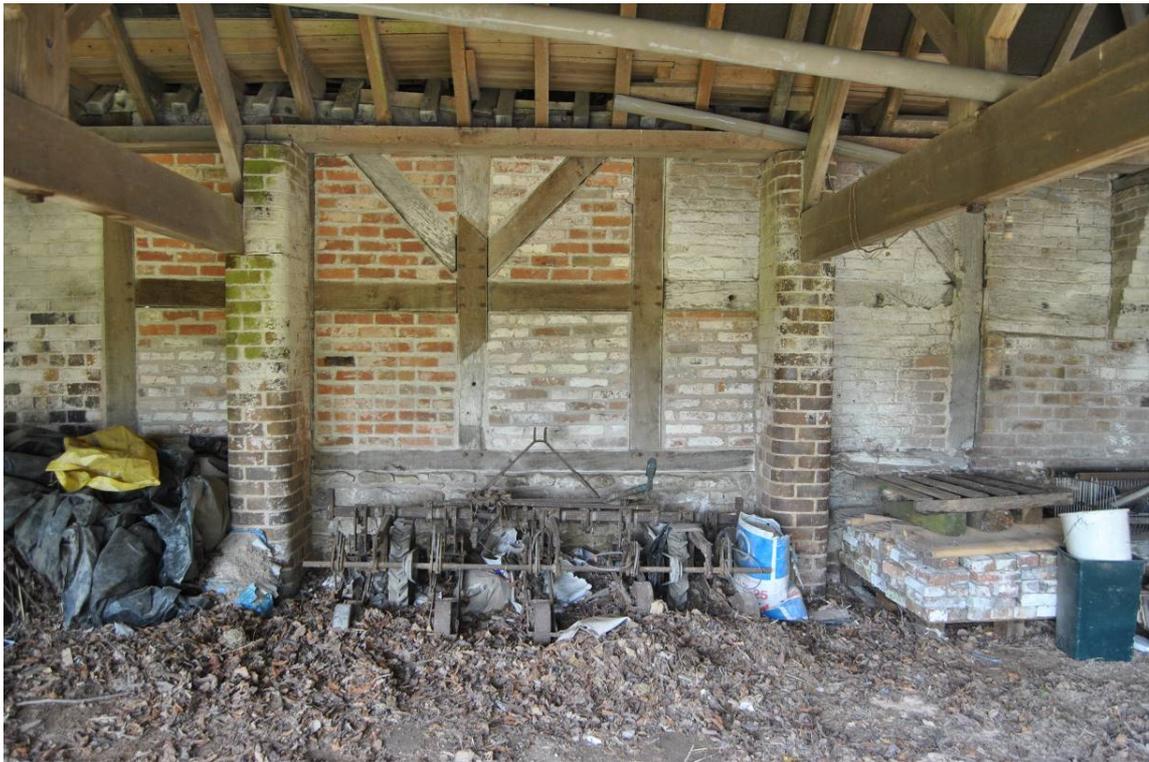
- 7.7.5 The **west elevation** (visible internally, and from within shelter shed **G**; see Plate 87), closely reflects the arrangements of the east elevation, though the timberwork here has been subject to extensive repair with little original fabric surviving. Again, the elevation has been extended to both north and south.

Plate 87: Timber-framing (much repaired) of Building F, exposed to rear (east) side of cart shed G.

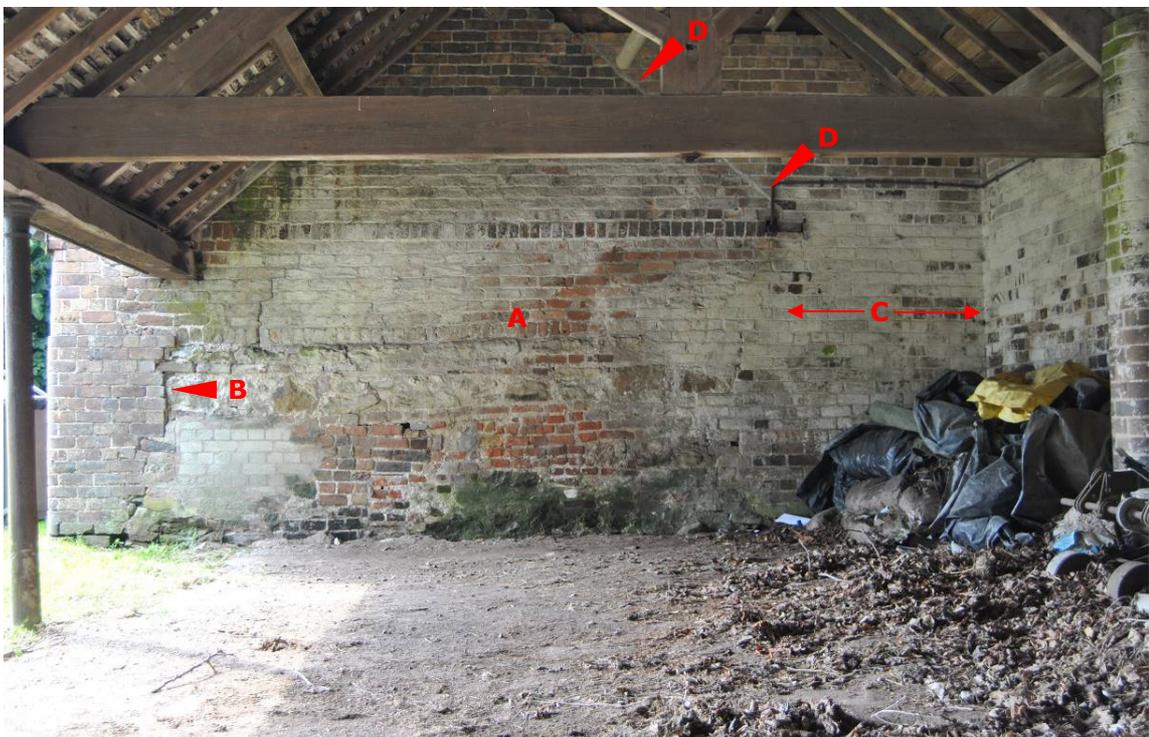
Plate 88: Cart Shed G; multi-phase brickwork of north wall incl. (A) limit of rebuild and (B) former gable of Building H.

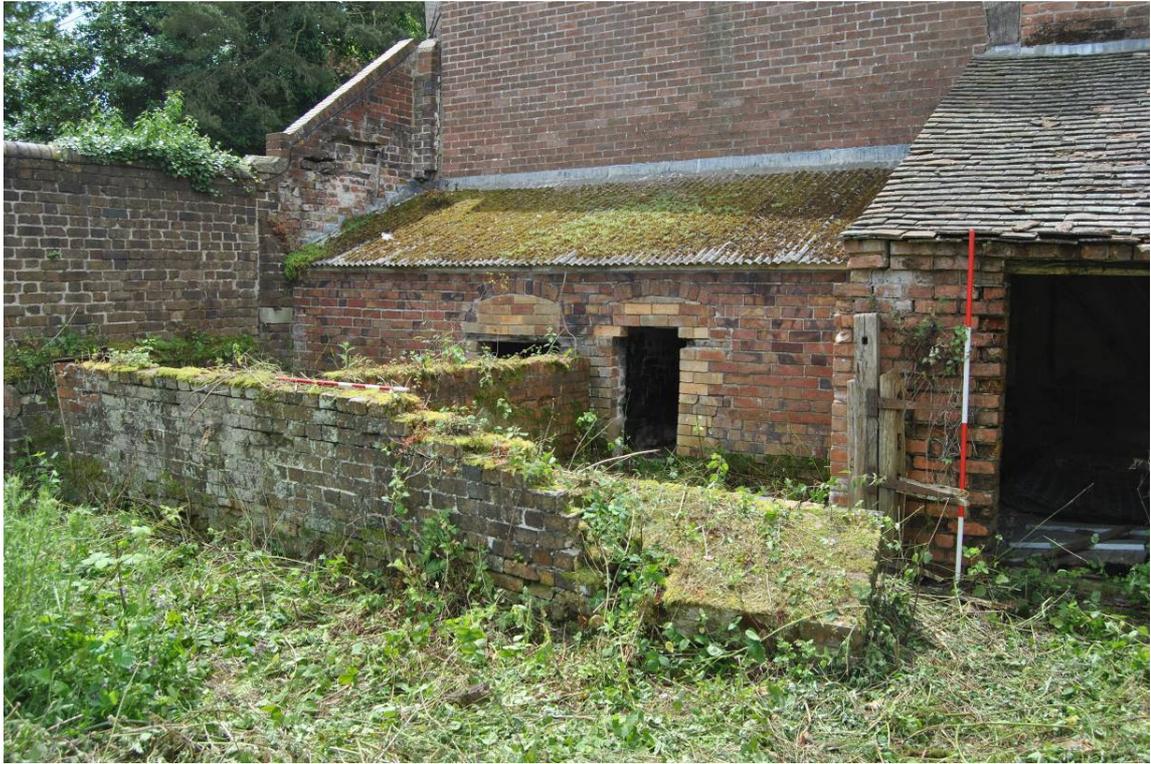
Plate 108: Pens / sties L with outlet wall (partly collapsed), looking south-west.
