FARM BUILDINGS AT MOSELEY OLD HALL

Featherstone, South Staffordshire Historic Building Record, 2019

Historic Building Record, 2019

Site Name: Farm Buildings at Moseley Old Hall, Featherstone, South Staffordshire

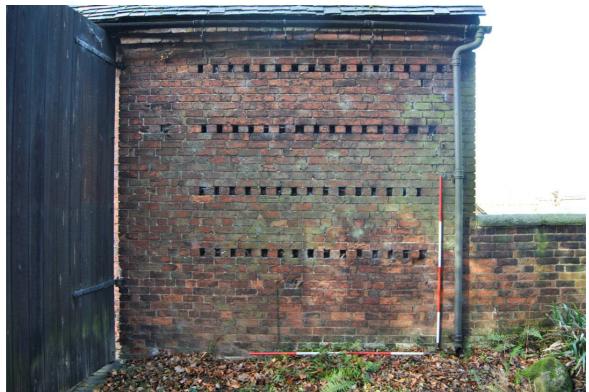
Plate 12: Barn A1, east elevation, Bay 4 in distinct brick with vent holes.

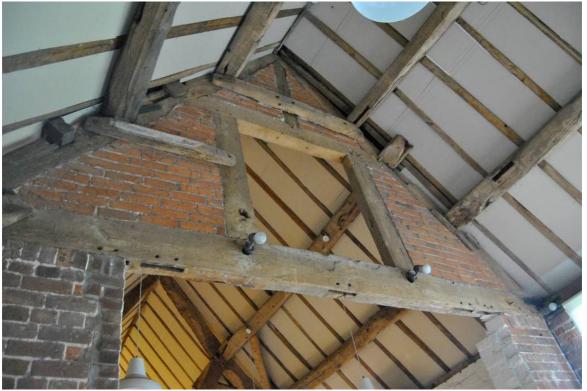
Plate 22: Truss T3 to south side of threshing bay (NB. pegging and empty mortices to soffit).

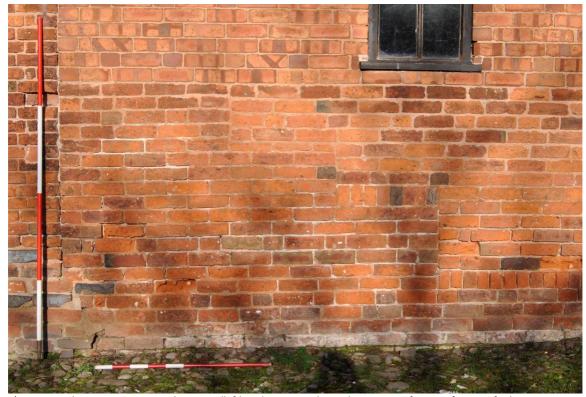
Plate 49: Cowhouse B meeting Feed House C (left) in clear, vertical straight joint; significance of series of other vertical/horizontal straight joints/building breaks (to right thereof) unclear.

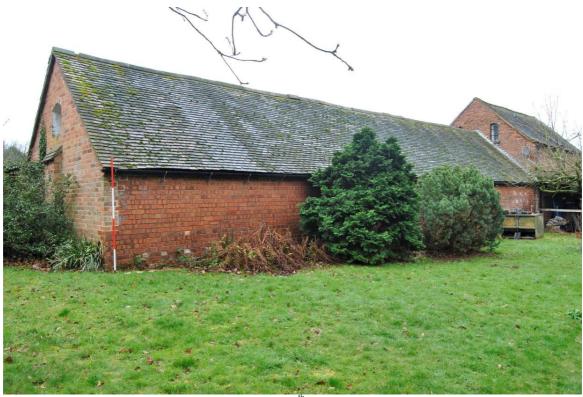
Plate 54: North elevation of cowhouse B, entirely rebuilt in C19th-EGW brick.

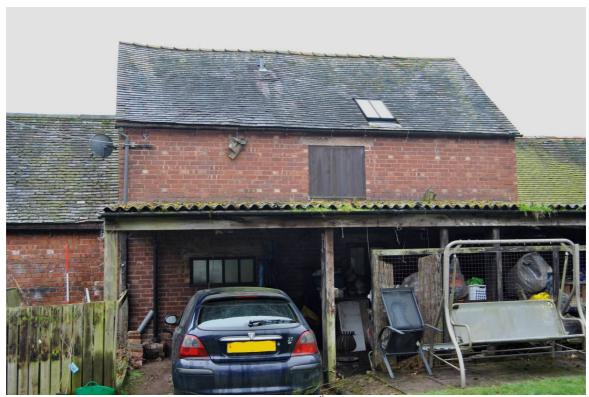
Plate 70: Feed House **C**, north elevation, entirely rebuilt in mid-C20th brick.

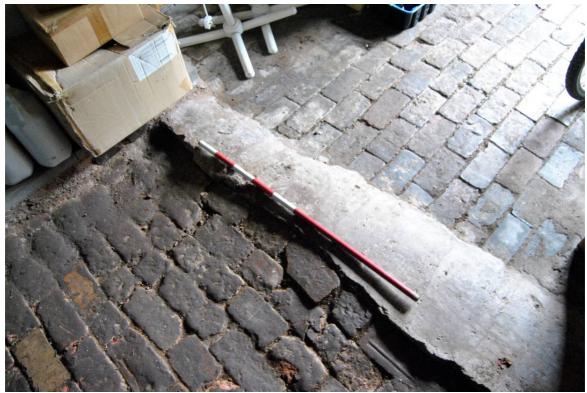
Plate 98: Change in brick flooring to either side of concrete patch indicating line of former transverse partition.

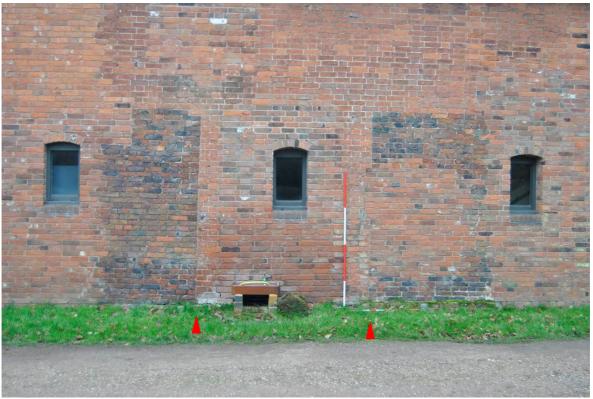
Plate 102: Coach House F; areas of early (darker) brickwork to north elevation, to either side of blocked door at Bay 3/4, (relic jambs marked with arrows).

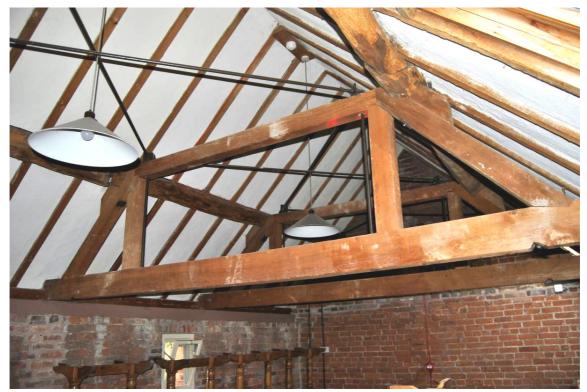
Plate 121: Replacement queen-strut roof truss (T2); NB. Fe tie rods and cross-bracing.
