BARN NORTH OF MORVILLE HALL

Morville, nr. Bridgnorth, Shropshire

Historic Building Photographic Record, 2019

Shropshire Council Planning Application Refs. **19/03448/FUL**; **19/03449/LBC**

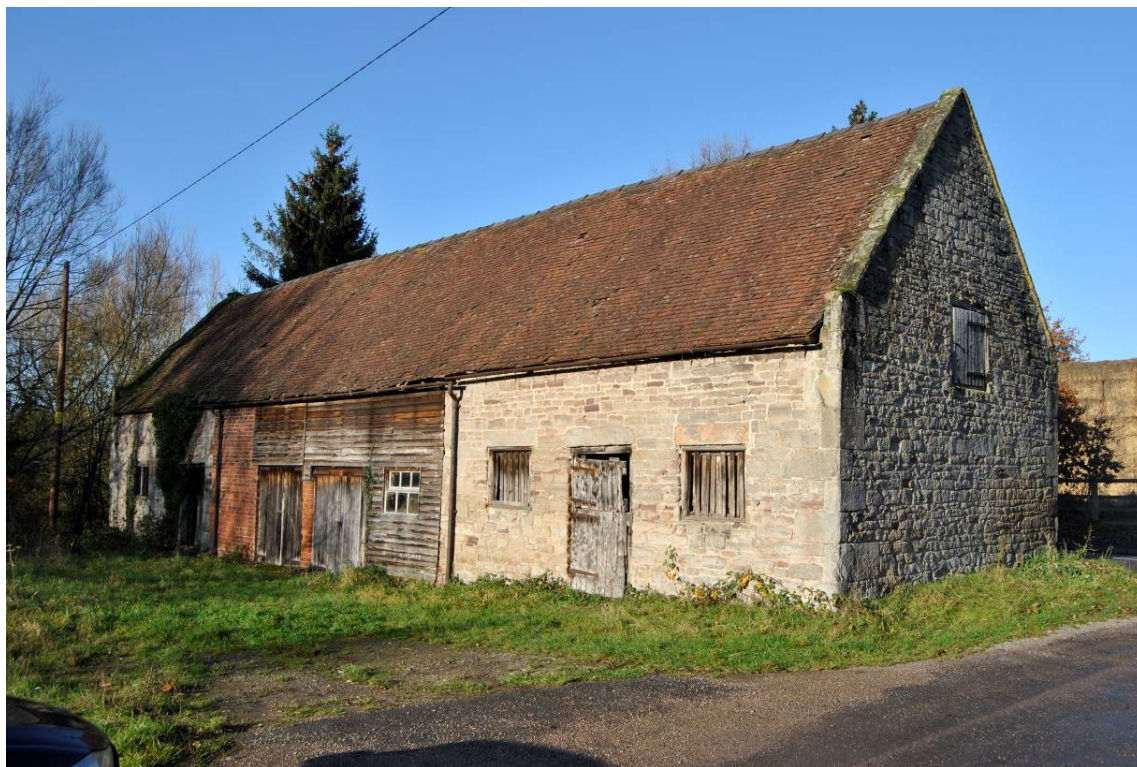
Plate 1: General view, south elevation (oblique) looking north-west.

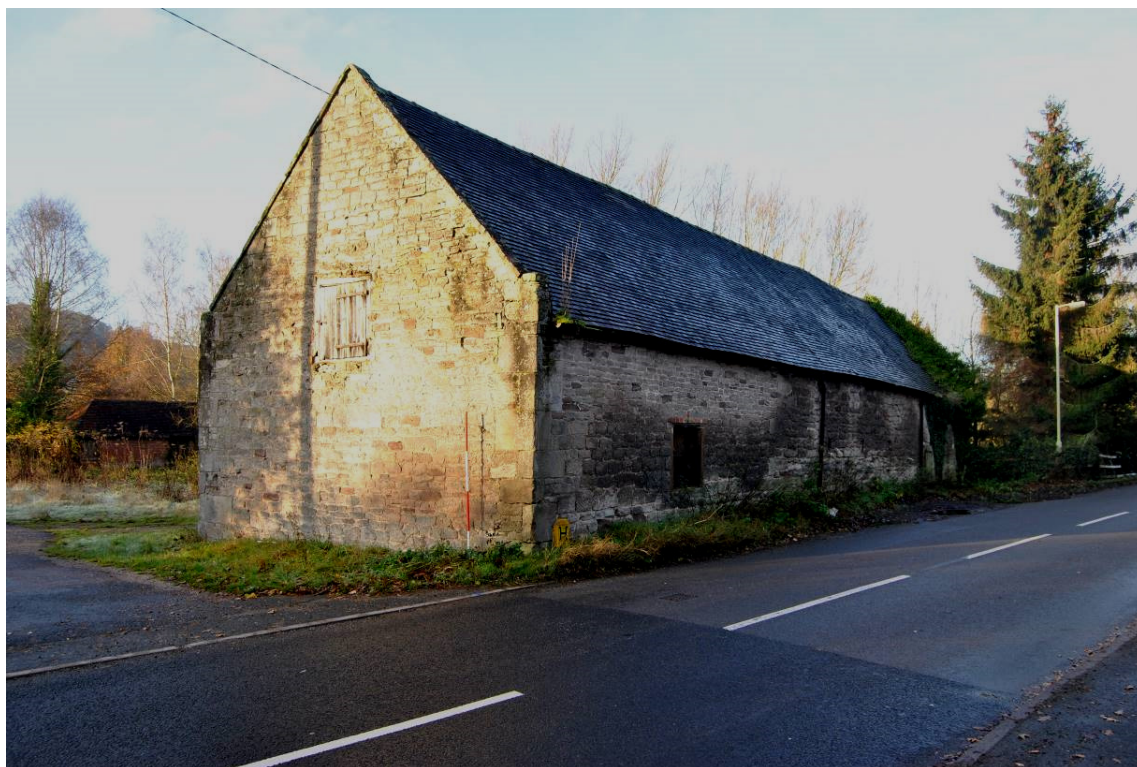
Plate 2: General view, north elevation (oblique) looking south-west, with B4368 Ludlow Road to foreground.

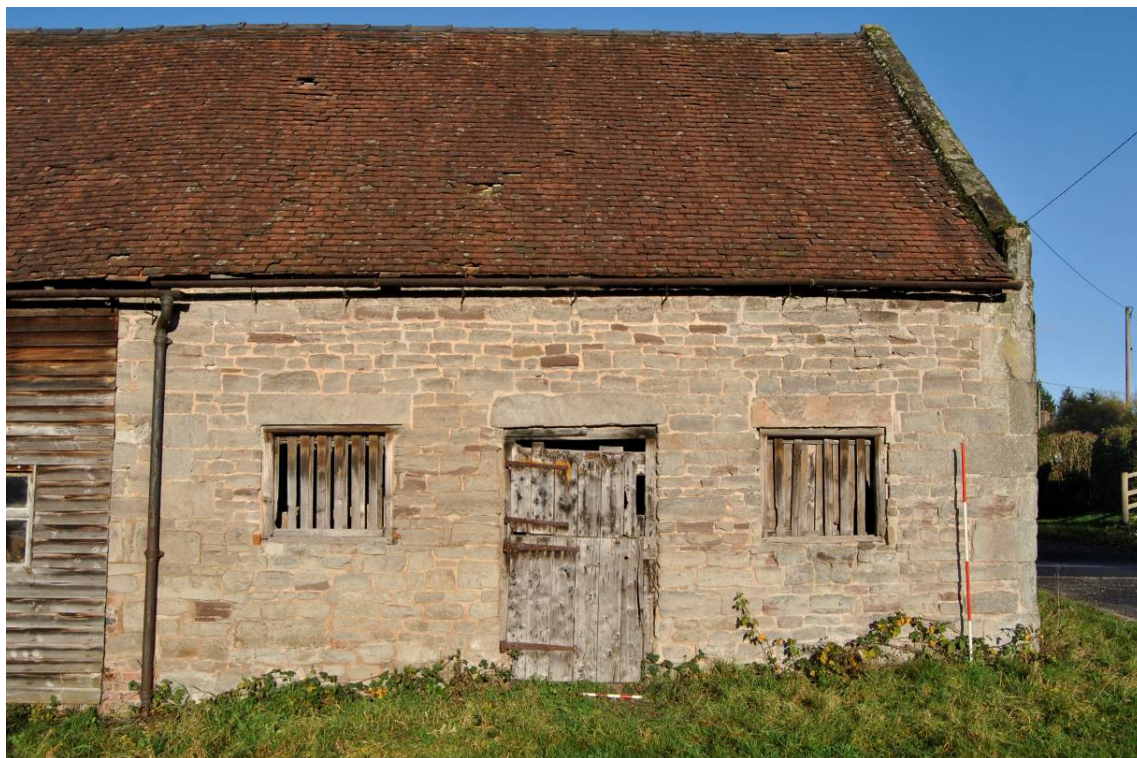
Plate 3: Eastern block [A]; south elevation.

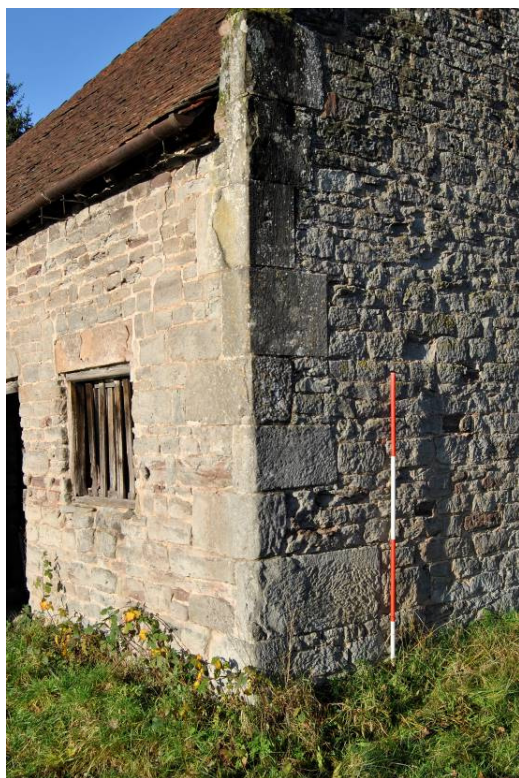
Plate 7: Detail of quoins to SE angle.

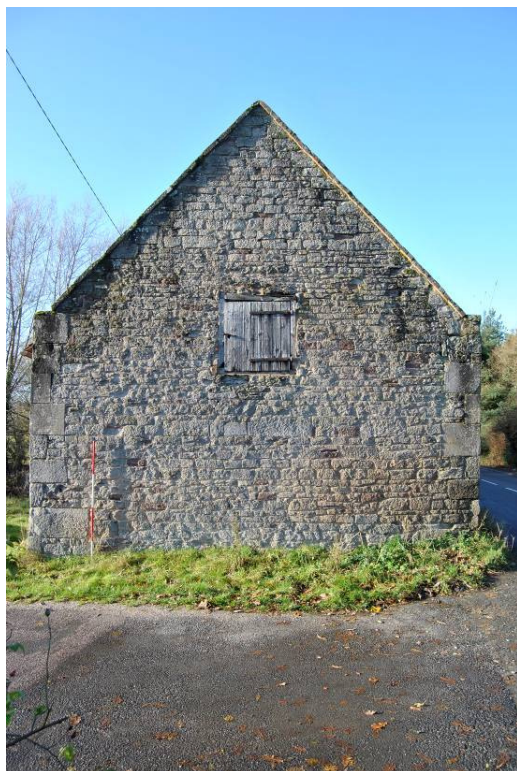
Plate 9: East gable end (?upper section rebuilt).

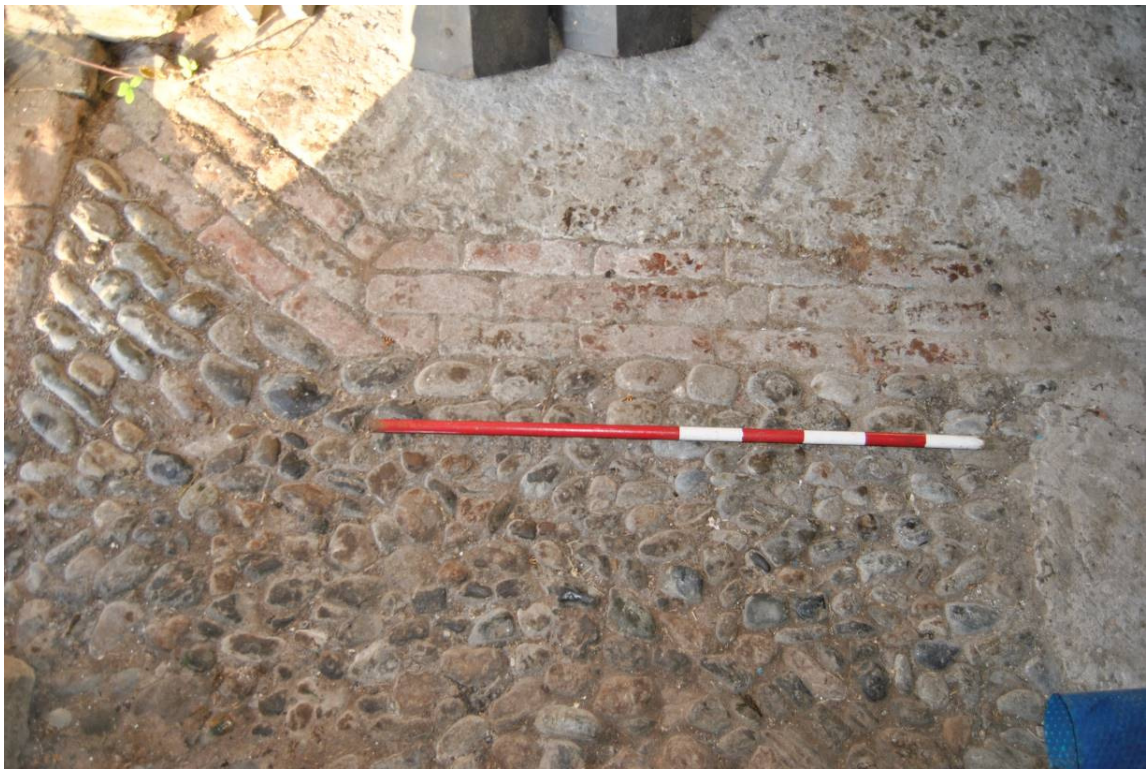
Plate 19: Detail of surviving cobbled floor with brick-lined drainage channel.

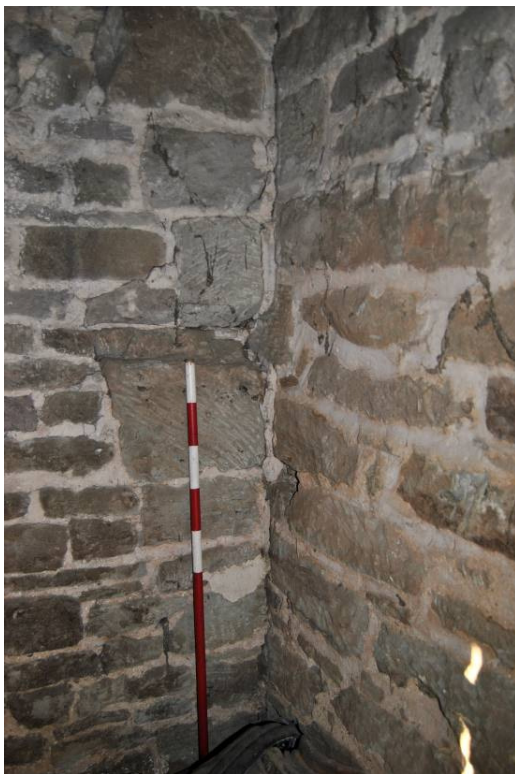
²¹ As noted elsewhere, and particularly evident internally (Plate 20), the lateral walls of **A** and **C** are clearly built up against the pre-existing eastern and western gable ends of block **B**.

Plate 20: South wall (left) abuts west wall (right).

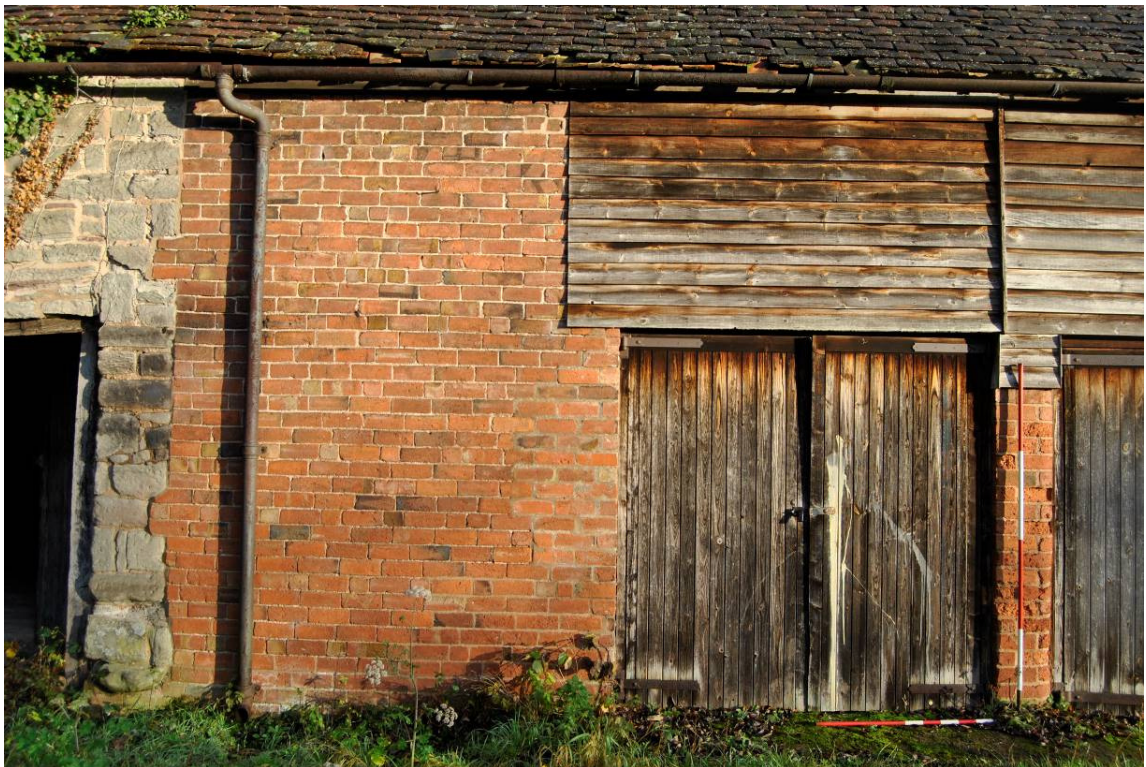
Plate 35: Block [B] (west); doors [d3] with brick patching to western jamb.

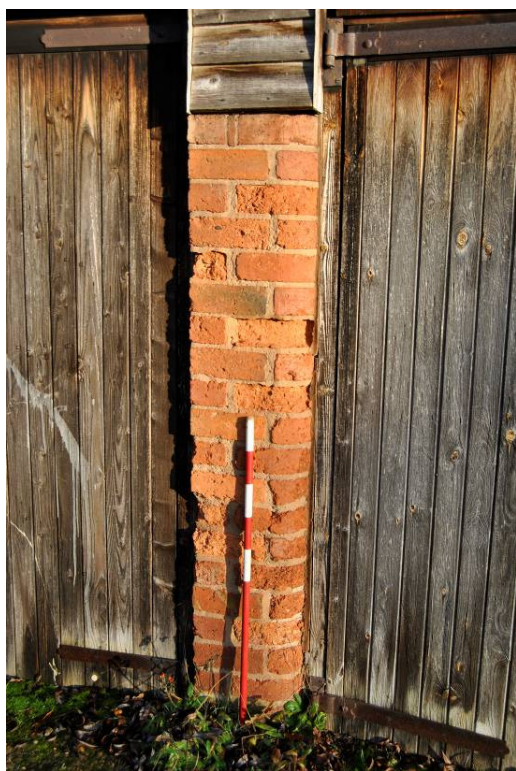
Plate 36: Brick pier between [d2/3]; NB. bull-nosed to east, plain to west.

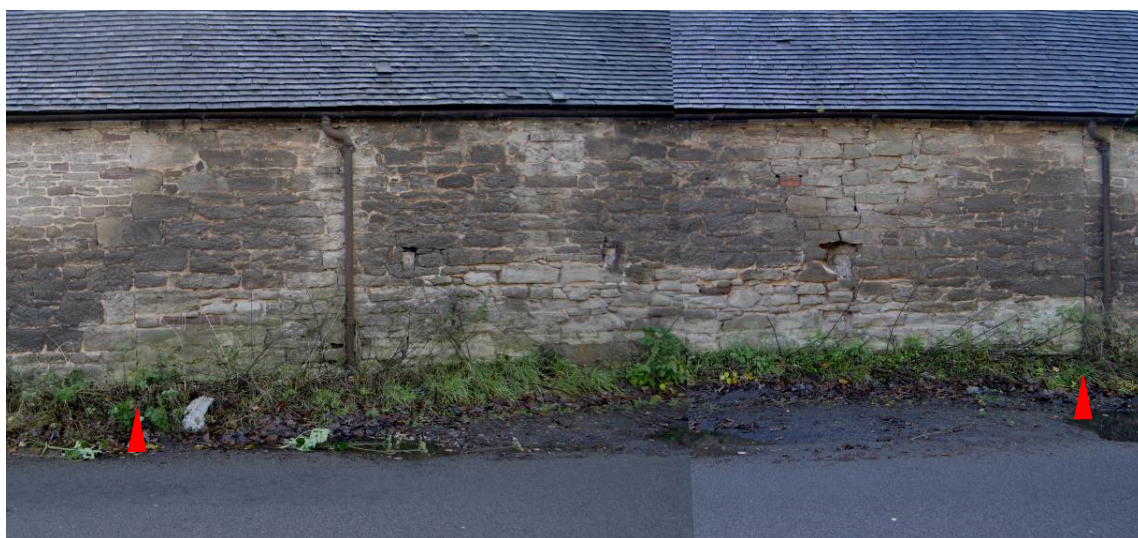
Plate 37: Central Block [B]; north elevation to road (SJs to east and west marked with arrows).

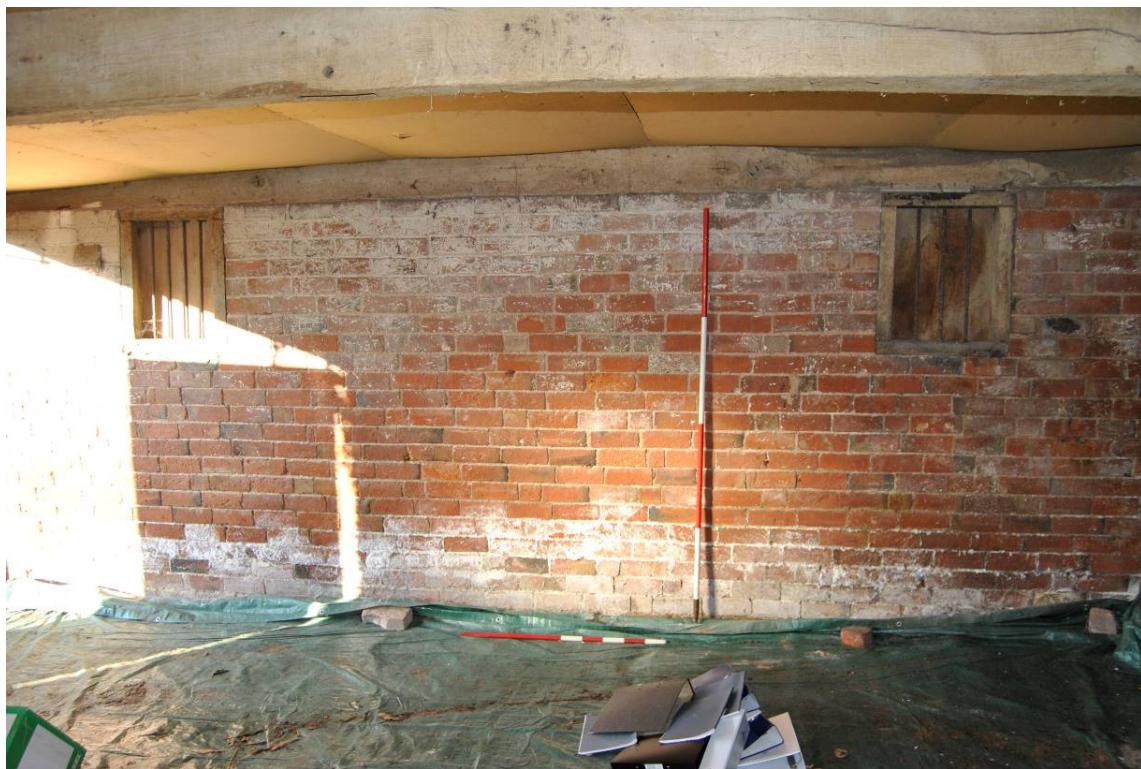
Plate 40: Inserted, transverse partition to west side of [G2].

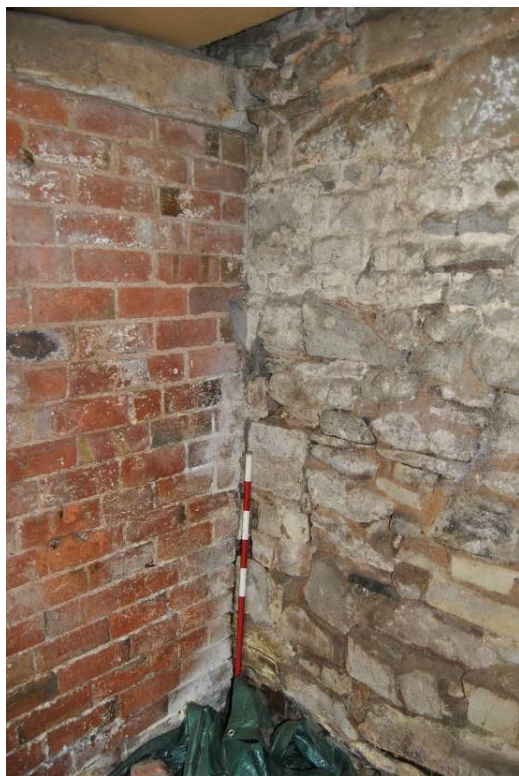
Plate 41: Brickwork partition abuts north wall.

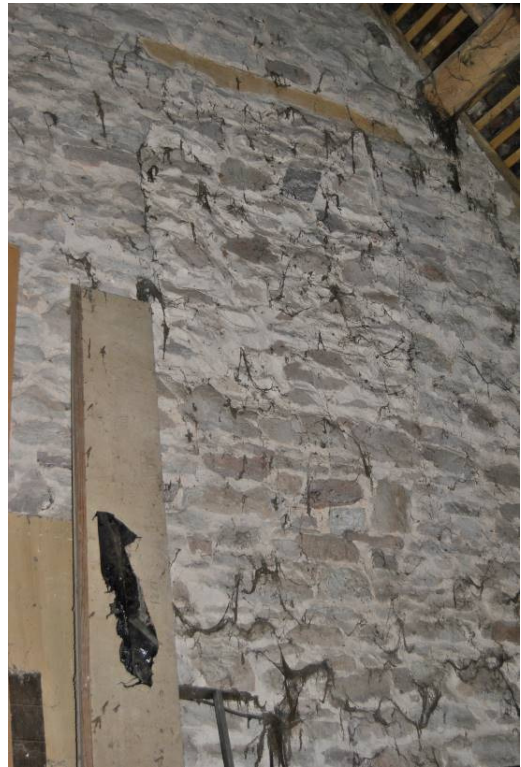
Plate 53: Blocked pitching door [w11] to west wall.

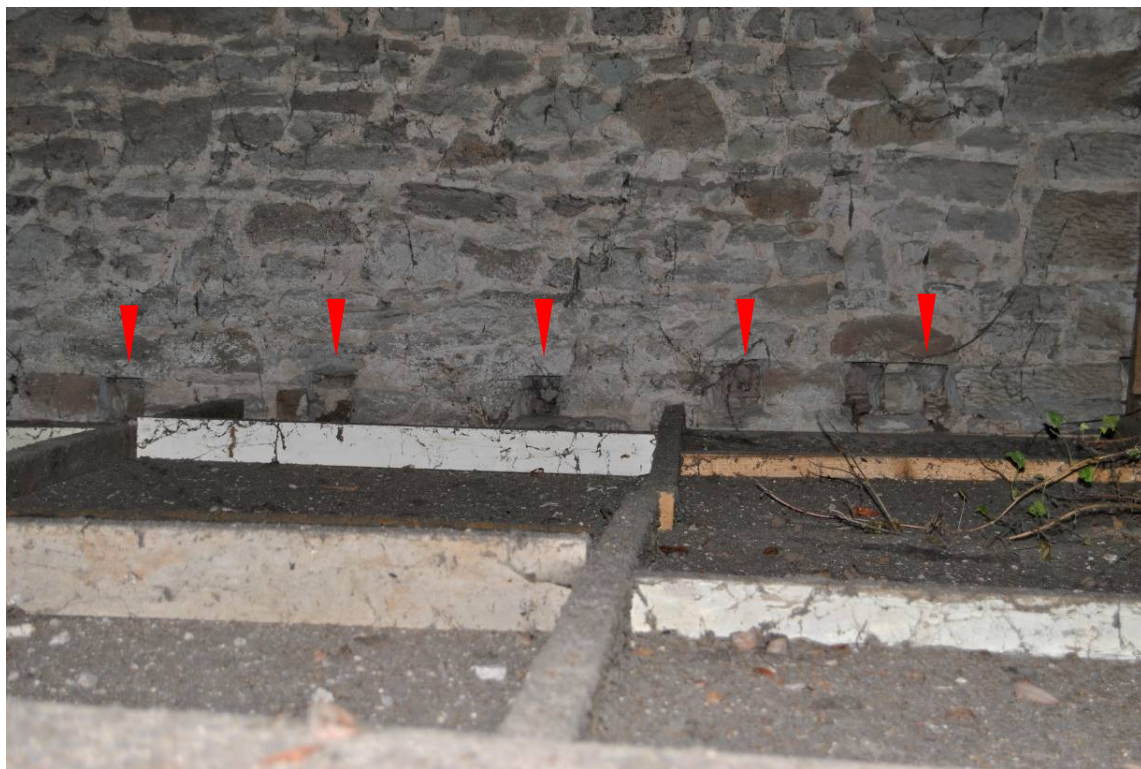
Plate 55: Redundant joist sockets visible above suspended ceiling.

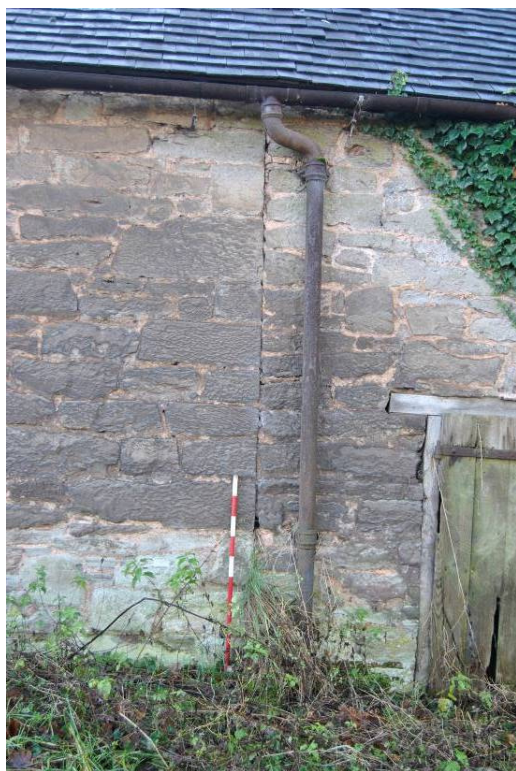
Plate 61: SJ at junction of [B] (left) and [C] (right).

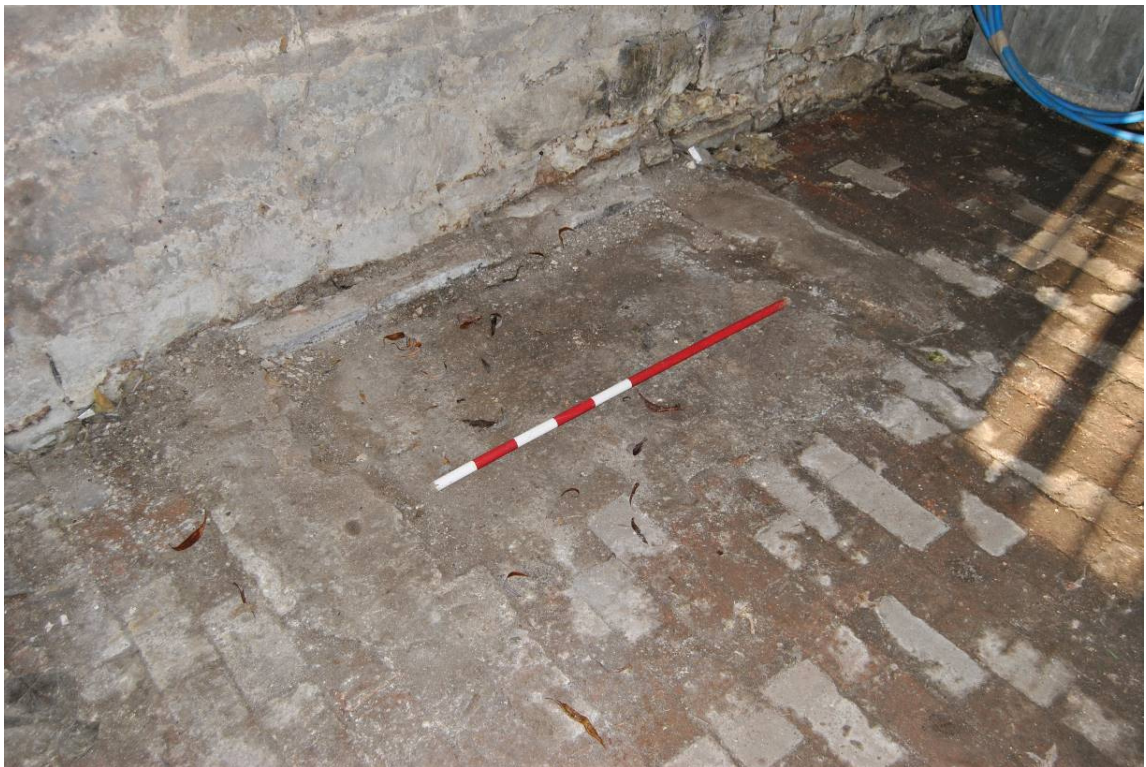
Plate 73: Concrete pad against west wall for former article of plant (?a.c. motor).

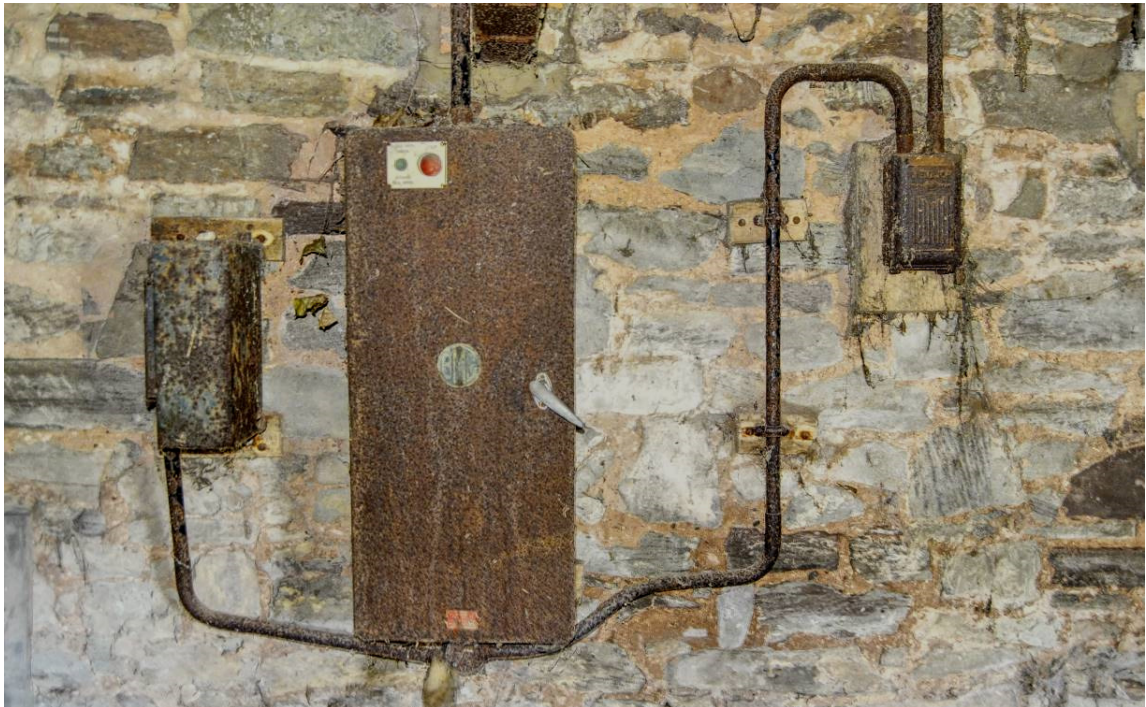
Plate 74: Electrical switch-gear by Brook Motors Ltd of Huddersfield, north wall [G4].

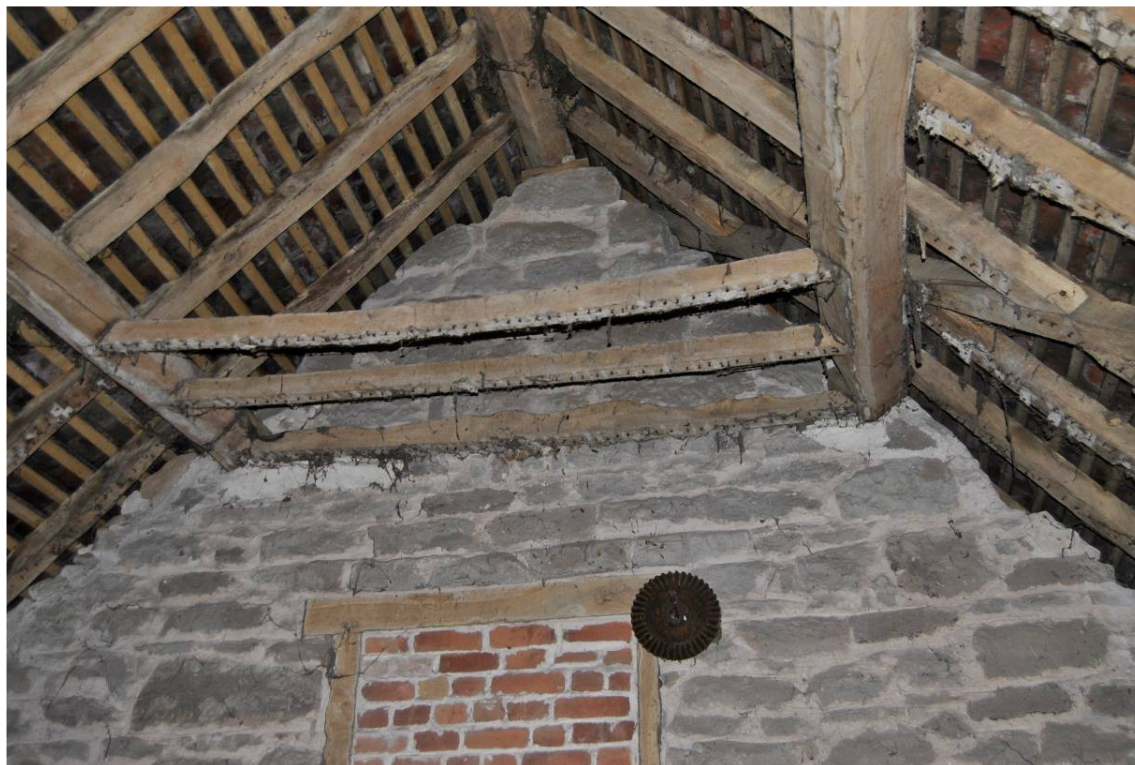
Plate 84: Ceiling joists extending between upper purlins with evidence for former L&P render.
