## **UPPER BLAEN FARMHOUSE (BLAEN-OLCHON)**

Llanveynoe, Longtown, Herefordshire

**Historic Building Record, 2021**

Herefordshire Council Planning Application Ref. P191674/F: Condition 11

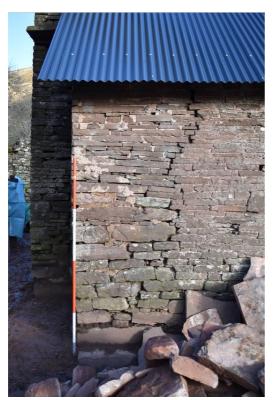
Plate 6: Staggered crack at SW angle.

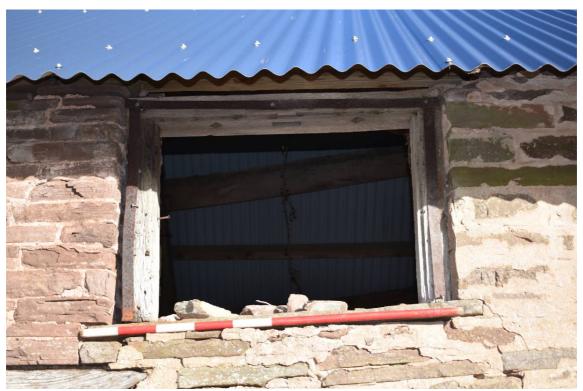
Plate 10: Window [w11]; note mortices to soffit of lintel.

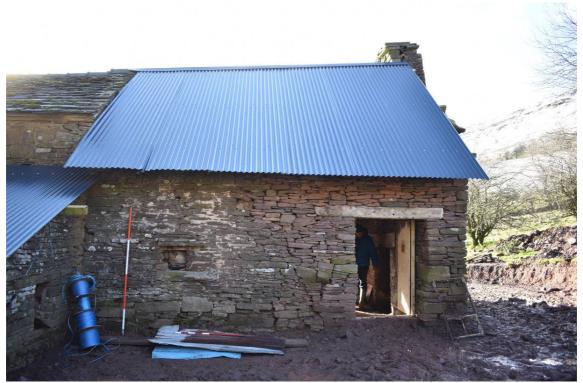
Plate 19: North elevation, west end (including rebuilt section of wall around door [ED3] at north-west angle).

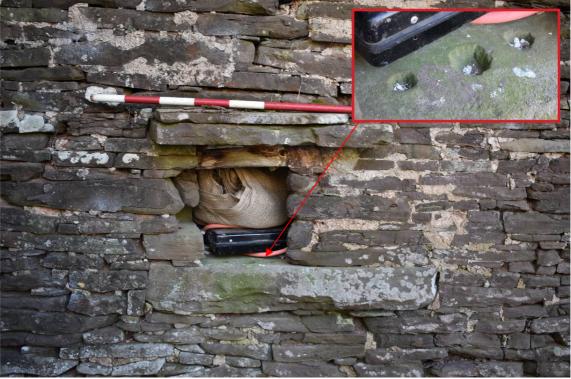
Plate 20: Window [w5] with inset detail of stave holes to stone cill.

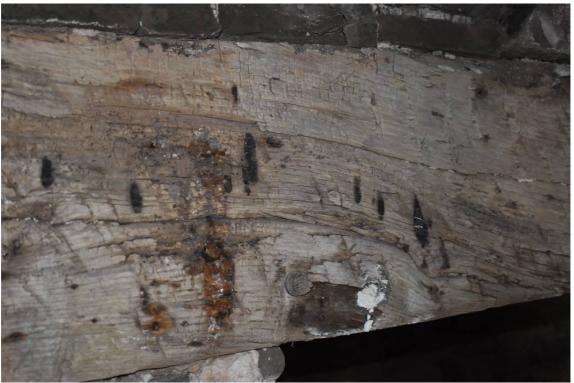
**Plate 46:** Detail of taper burns to FP bressummer and 'hacking' to accept plaster render.

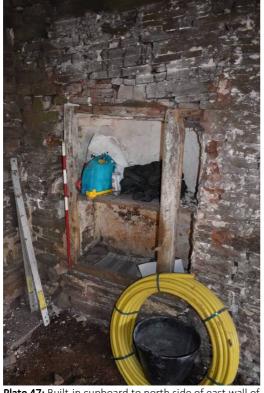
Plate 47: Built-in cupboard to north side of east wall of [G1] (?former window).

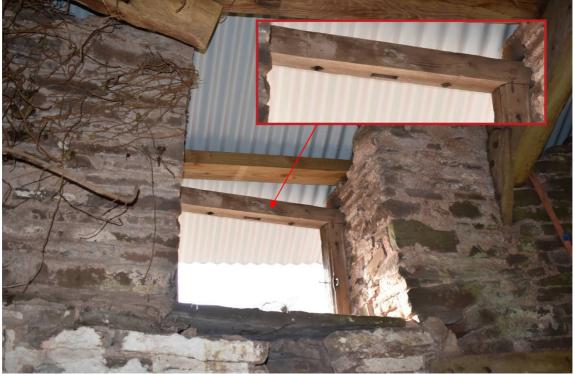
Plate 49: 1F window [w11]; note central mullion mortice and 'diamond' stave mortices to soffit of lintel (inset).

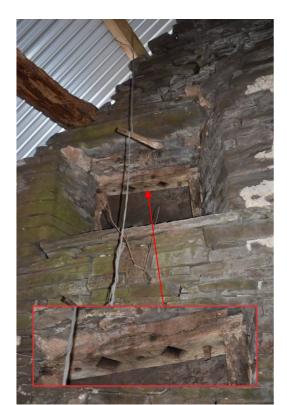
**Plate 50:** Blocked window [**w**12]; note mullion mortices to soffit of lintel (inset).

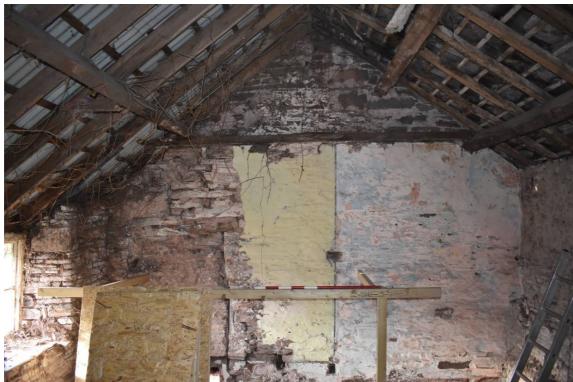
Plate 74: 1F room [F1], west wall; note render evidencing removed partitions and blocking of low door to left.

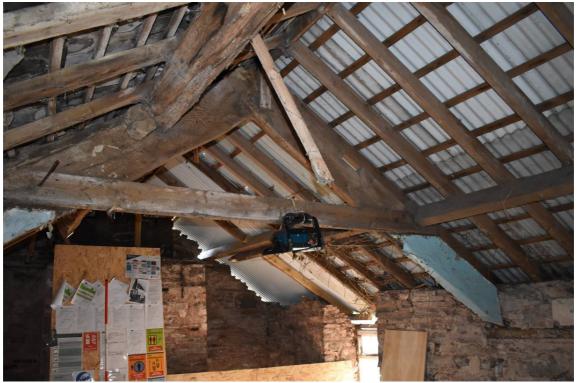
7.2.20 The roof over the eastern end of the range is again of two bays, here significantly wider at 11½ft., with a central truss broadly similar in its rudimentary detailing to that over the western end of the building (Plate 79), with which it is assumed to be broadly contemporary, and thus may have been simply re-used when the roof was raised. The truss originally supported two tiers of trenched side-purlins (Plate 81; replaced),<sup>63</sup> and the bridled apex (here single-pegged; Plate 80) is notched to carry a ridge piece. Principals are again embedded into the lateral walls, here sitting upon a timber bearers set into the stonework, and lack any form of primary transverse tie; a secondary collar has been bolted to the west face of the truss (Plate 79) to support an underdrawn ceiling (removed) and though a primary collar mortice survives to the southern principal (Plate 82), this is not reflected to the north, suggesting either a re-used timber, a phase of modification or a change in design during construction. In its current state, the southern slope of the roof is clad in corrugated iron sheeting,<sup>64</sup> though the northern slope retains substantial stone slab secured on wide common rafters (Plate 83).

Plate 79: Truss over eastern range, note applied secondary collar for lath and plaster, underdrawn ceiling.

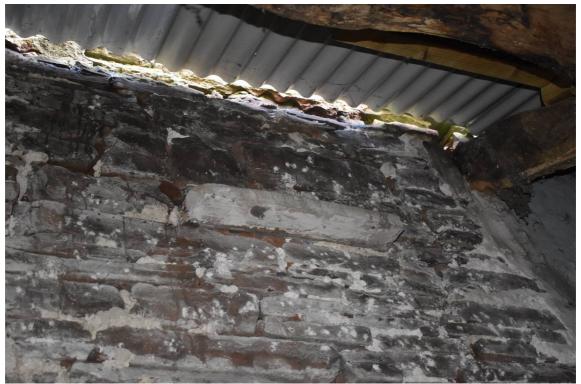
Plate 90: High-level blocked window with projecting stone cill, visible from dairy extension, room [G5] (see Plate 78).
