South Tyneside NHS Foundation Trust
Integrated Care Hub, South Tyneside
Hospital
Building Photographic Survey
October 2014

Project: Integrated Care Hub, South Tyneside Hospital
Client: South Tyneside NHS Foundation Trust
Job Number: A089106
File Origin: [Building Survey Report_final.doc](#)

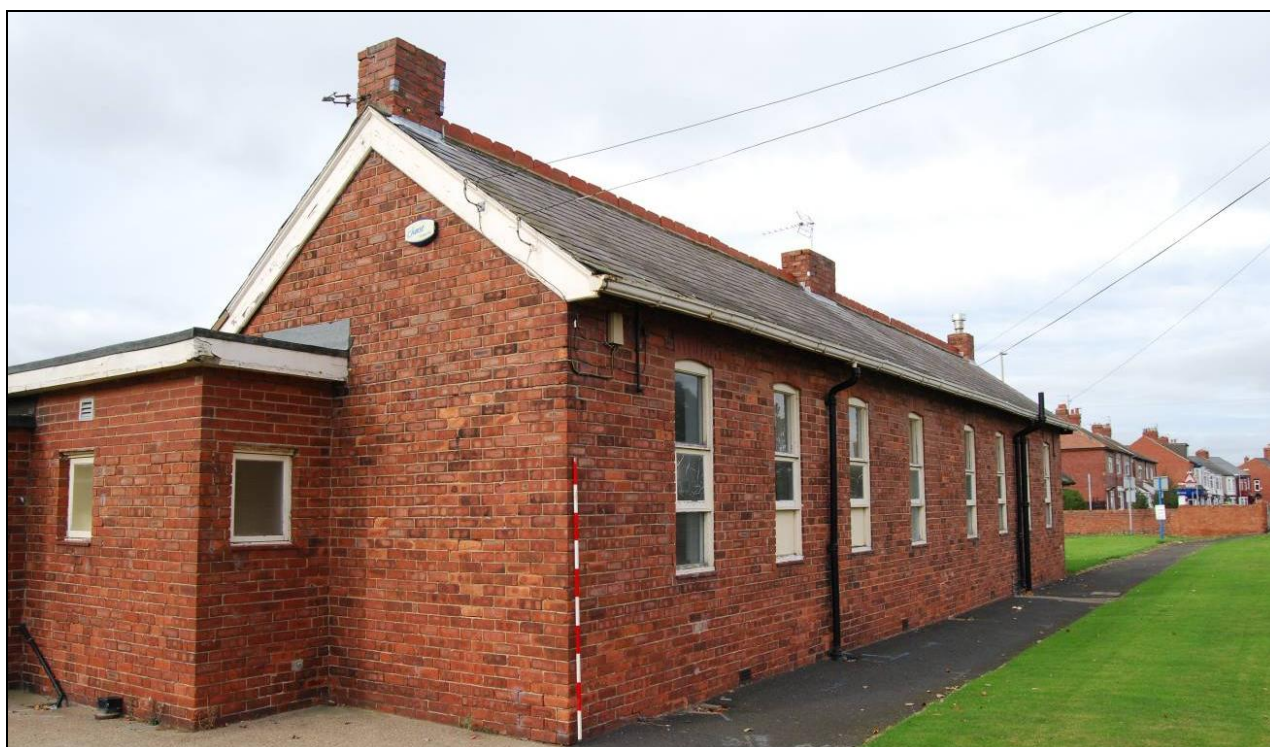
Plate 1: View from the southeast of the building, showing the northeast and southeast elevations, with original windows along the northeast facing wall, and original coal shed along the southeast facing gable (the windows are a later addition and the roof has been replaced in the past). The chimney stacks, main roof and ridge tiles are also original.

and considered to be an authentic part of the original construction, though different to that proposed in the adopted designs (DT.JHM 204/6(3)). The presence of mixed glazing along this elevation suggests ad hoc replacement of panes over the years (Plate 1 and 2).

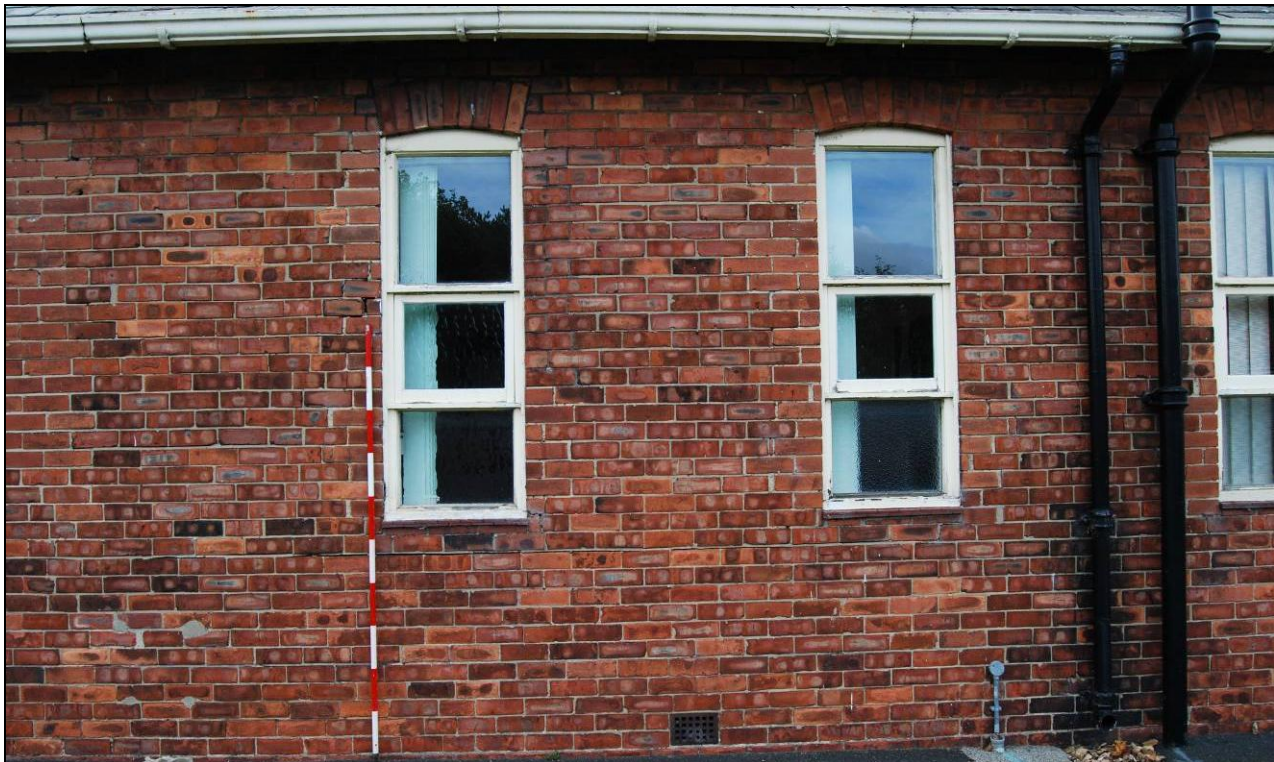
Along the northeast facing exterior wall are eight identical, narrow windows: the openings are original, with tile sills and arched brick lintels formed of vertical stretchers. The frames are wooden and look to be early 20th century in style, but may have been replaced in the recent past. The original designs for the building only included four windows along this elevation; however, the eight present windows are evenly spaced

Plate 2: facing southwest showing detail of windows along the northeast elevation, with original openings, tile sills and arched brick lintels. The guttering and downpipes are modern.

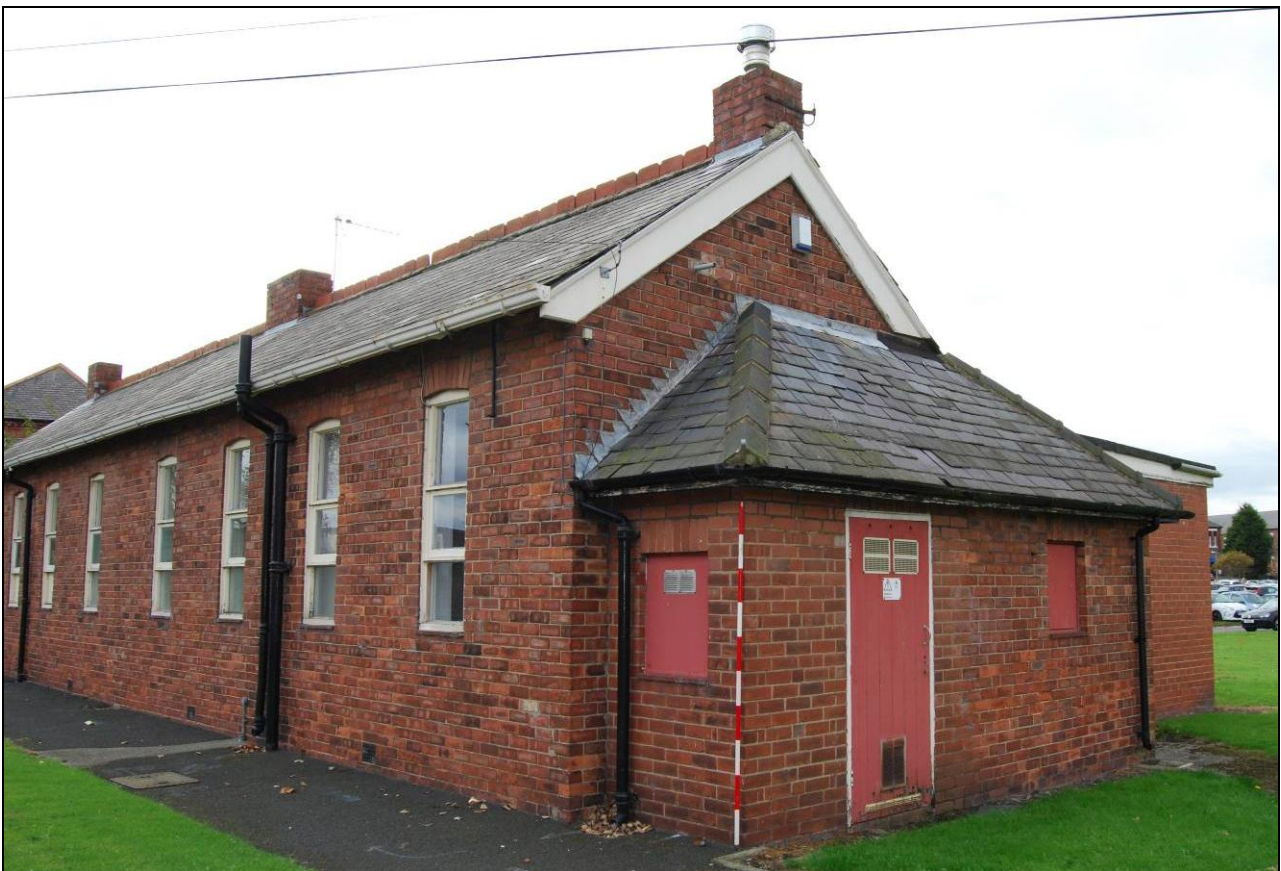
Plate 3: view from the northeast of the building facing southwest and showing detail of the exterior of the original WC and sink room with more modern plant room extension in the foreground and modern office extension to the rear. The original windows along the northeast elevation are visible. The junction between the original WC room and porch is apparent in the change in fabric.

The northeast facing extension window mirrors the original windows through provision of an arched brick lintel. The smaller window on the northwest facing wall is within the fabric of the original building, and the opening looks contemporary with the other original windows. While this opening is not marked on the design plan of the property, it is considered original and may represent a modification to the design. The extension houses plant for the office, while the original WC and sink area can be accessed internally (via a corridor which follows the original veranda) and currently form a store room.

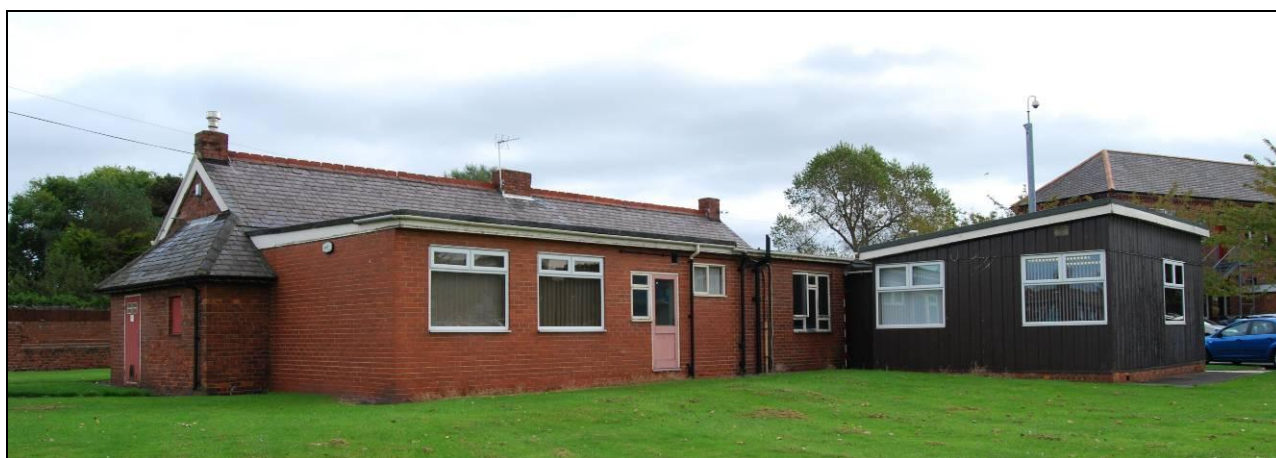
Plate 4: view from the northwest of the building facing southeast and showing detail of the exterior of the original WC and sink room with more modern plant room extension to the left, and two phases of modern office extension to the rear at the centre and right. The redbrick extension is of post-WWII date (1954), while the timber clad extension is of 1970s date.

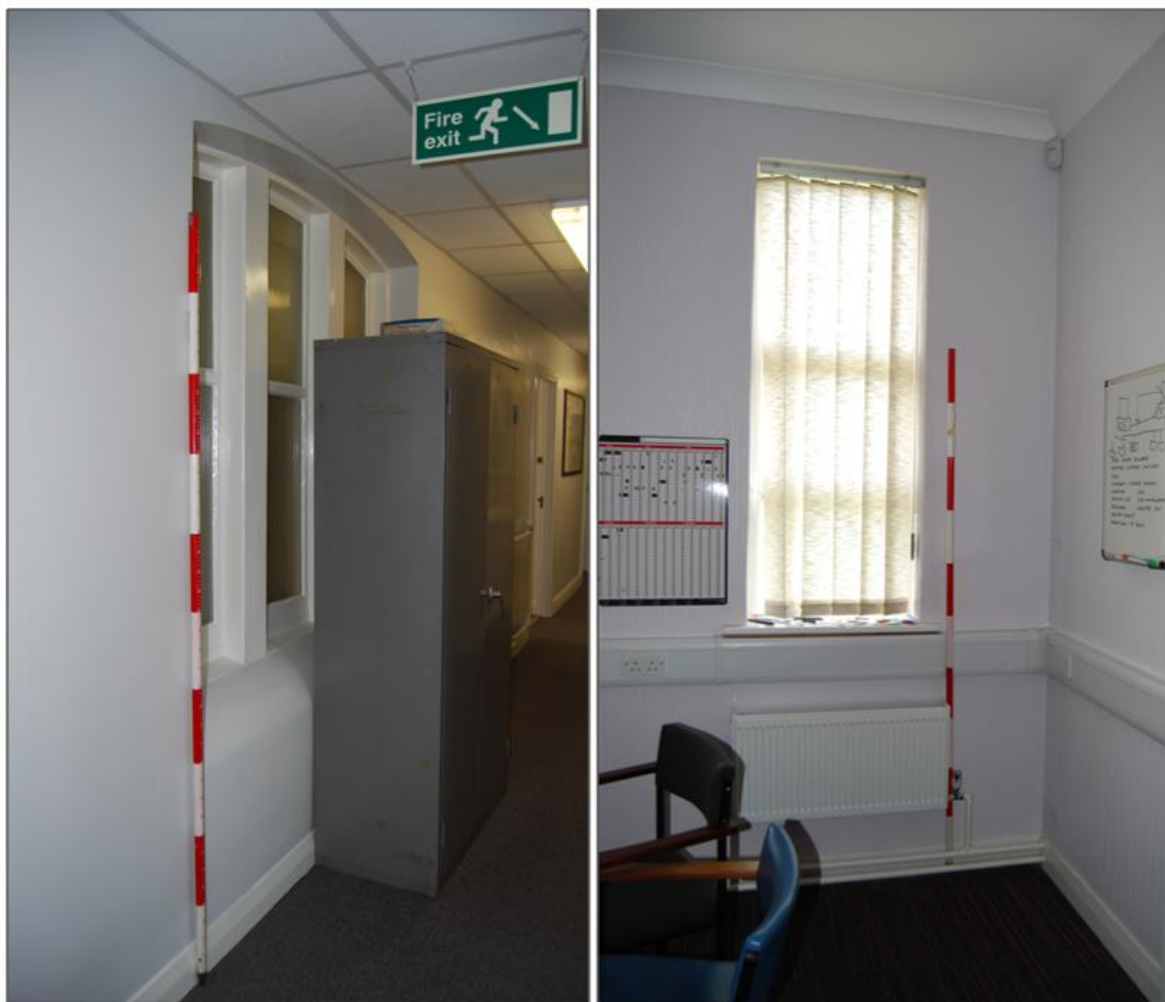
Plate 5: Left: view from 12 - the corridor (originally the veranda) with original exterior window visible between the corridor and office 4; the opening is blocked in office 4. Right: view within office 5 showing retained features: original height ceiling, cornicing and original exterior window opening.

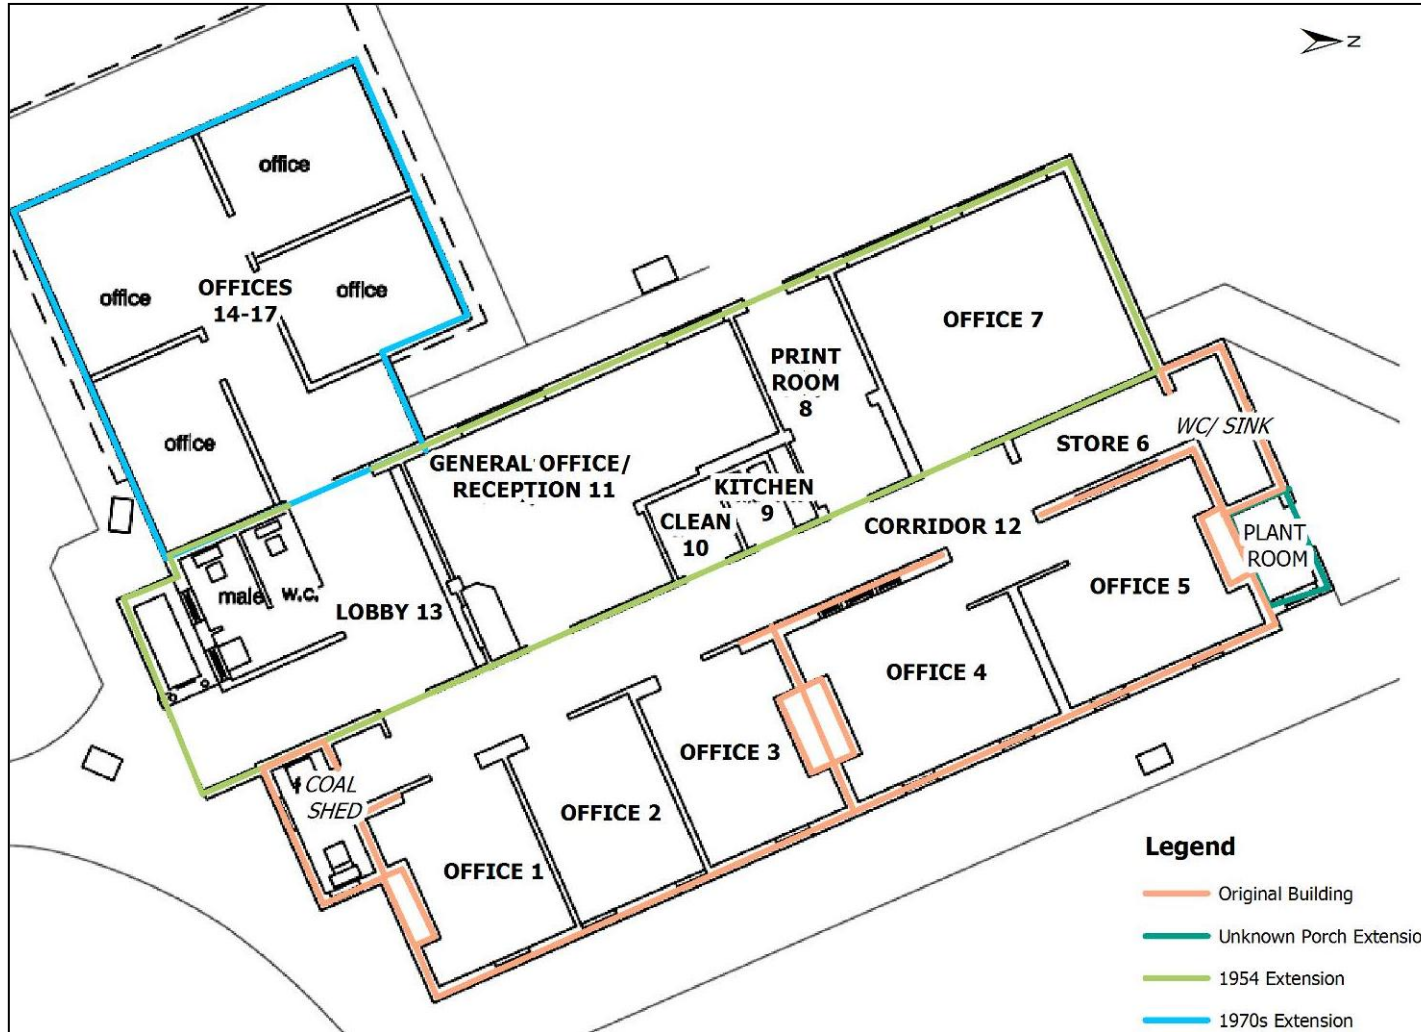
The original fabric is preserved in the main range of rooms 1-5 of the building, the store (originally the WC and sink) and the female WC (originally the coal store), while the present corridor is formed from the original veranda. This matches the roof profile, which is pitched to the extent of the veranda, but is flat over the modern extension (rooms 7-13). The roof of the female WC (originally the coal store) appears to have been replaced at the same time as the new porch extension was added along the southeast face of

Phased plan of the existing building showing current layout and development over time.
