Archaeological Monitoring Report. Lartington Hall, Co. Durham.

For John and Shona Harper-Wilkes January 2020

AE0106-2020

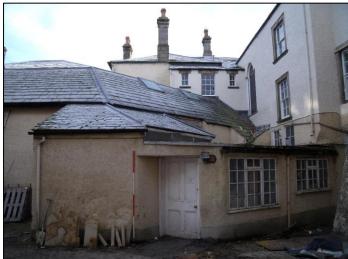
Plate 6 (left). Single storey structures in the south-east corner of the courtyard on the site of the 18th century kitchen block. These were a mixture of mid-19th century and later construction and alteration. These demolished as part of the consented works to allow for logistically better arrangements for access and utility.

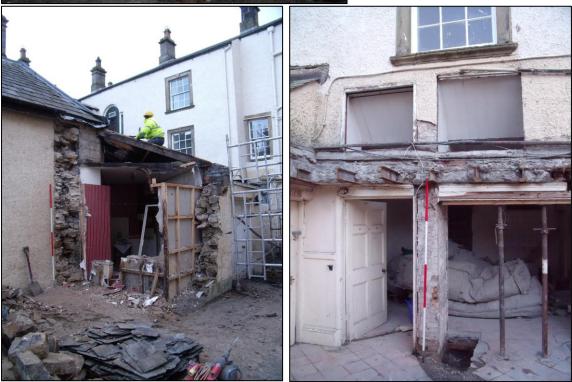
Plate 7 a, b (above). Demolition of mid-19th century and later single storey buildings looking south east and south. While the rear of the structure used steel joists to support a concrete roof and appears 20th century (above right), the mostly northerly elements (see above left) were of stone rubble and lime mortar construction beneath a modern render. The Grand Corridor of 1861/3 had been built around the east end of the north wall of this building and so must post date it. It therefore seems likely this small part of the structure was a part of the early post-1800 service buildings and kitchen range.

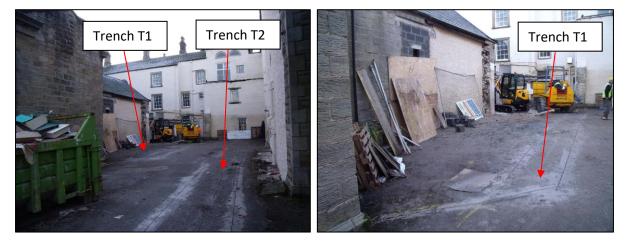
Plate 8 a, b (above). Both views looking south and with the west wall of the Grand Corridor to the left. Showing the location of the two trenches T1 and T2.

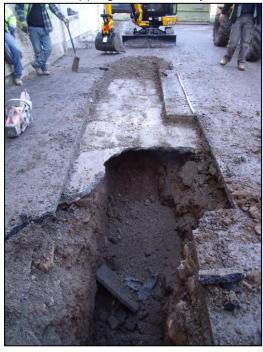
nade it unsafe to enter and so all observations were made from ground level at the side (plate 9). The unconsolidated nature of the ground can be attributed to this being the site of various phases of kitchen and service wings from at least the 18th century onwards demolished in c1979. Scarring on the surviving west wall of the servants' quarters which now serves as the east wall of the hall's north-west wing (G16), appears to tally with the northern range shown on Buck's drawing of 1720³. This was subsequently incorporated into a new kitchen range and revamped servants' quarters in 1861.

Plate 9. Trench 2, looking north with surface partially removed showing the loose and unstable material beneath the tarmac and concrete courtyard surface.

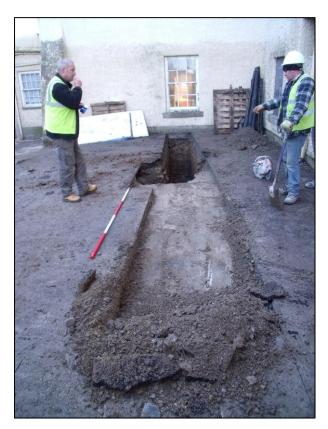
Plate 11. Trench 2, (above), looking south towards north wall of the Hall; and (right) showing the insubstantial depth and size of the foundation of the Hall's north wall.

At the southern end of Trench 2 it abutted the rear (north wall) of the Hall adjacent to the small passage next to the backstairs (G10). The foundation of this wall was exposed and seen to be no more than 200mm in depth and seemingly within a narrow E-W construction cut.

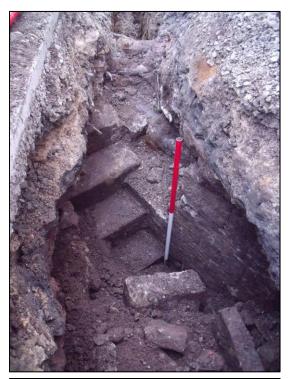
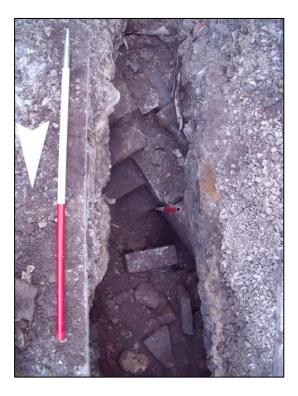
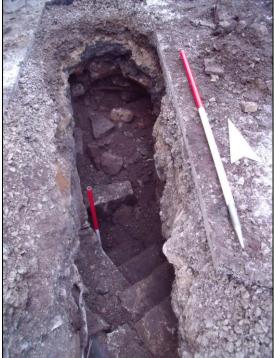
At the northern end of Trench 2 clearance of the unconsolidated demolition rubble revealled a narrow set of stone steps descending from south-east to north-west and against a stone wall of the same alignment (plate 12). Whilst there was no artefactual evidence to date the structure it does accurately equate with a small rectangular building set on a different alignment to the main Hall. The structure is not visible on the 1st editon OS surveyed in 1854, but does appear on the 2nd editon. It seems likley this was built as part of the improvements to the Hall designed by Hansom in 1861-3 and functioned as a boiler house to heat the new rooms.

Plate 12. Trench 2, northern end showing steps and wall leading to a cellared area thought to have been a boiler house built as part of the improvements to the Hall designed by Joseph Hansom in 1861-3. (top left) looking south, (top right) looking down, (bottom left) looking north, (below) 1897 OS 6" survey showing the conjectured boiler house (circled).

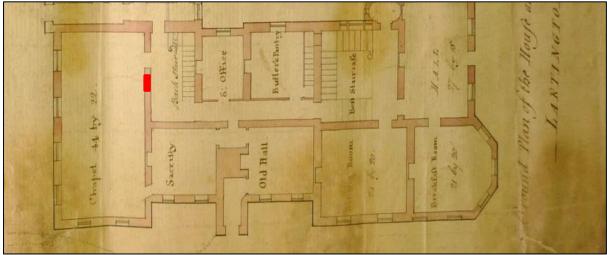
Figure 21. Extract from a plan of c1800 (DRO D/HH7/4/238), showing the location of the blocked two light mullion window identified in the opening up works on the pre-chapel west wall of the Hall. At this date not indicated and so presumably already blocked.

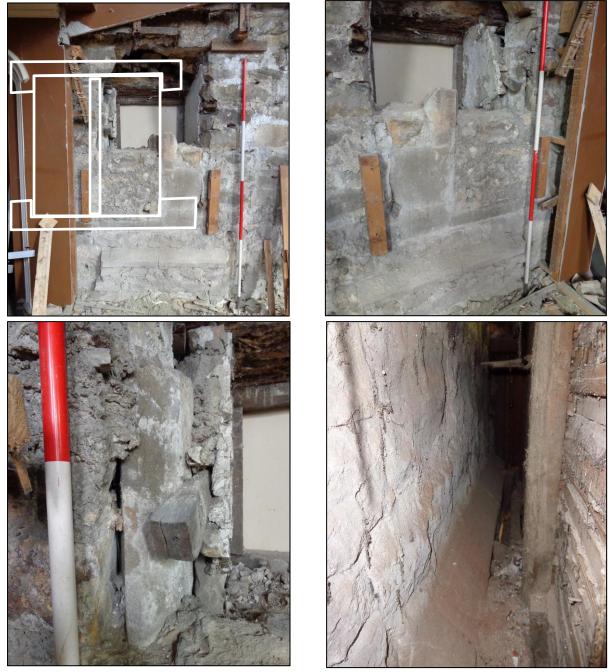
Plate 22. (Clockwise from top left) exposed but damaged two light mullion and transom window in the former west outside wall of the Hall prior to the construction of the chapel in the late 18th century. The window and plinth course below it appear identical to those on the projecting entrance tower on the Hall's south front which is dated 1623. The outline of the window is shown in white. (top right) the same window showing the later rectangular, wood framed and plastered window opening driven through the wall. (bottom right) looking south behind the lathe and plaster 19th century wall of the chapel and showing the 17th century west wall of the hall and its distinctive plinth course. (bottom left) the central mullion of the blocked window with later white plaster work.

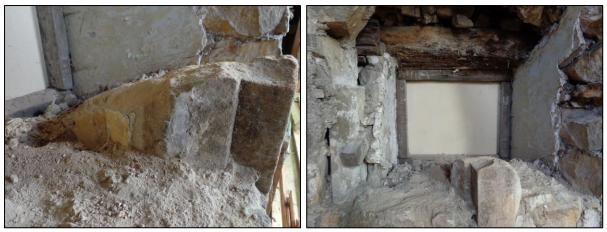
Plate 23. (above left) South side of the blocked and damaged 17th century mullion window in the chapel's east wall showing a small fragment of early plaster with yellow ochre decoration. (above right), later rectangular insertion through the wall with wooden frame and plain white plasterwork and seemingly creating a link from the chapel to the sacristy. The creation of this opening resulted in the damage to the 17th century mullion window which had by that point been blocked.

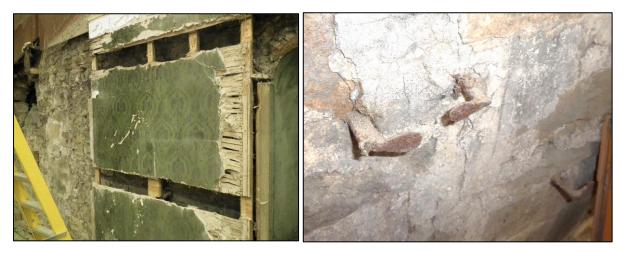
Plate 24. (above left) 19th C lathe and plaster with decorative painted stencil work on battens attached to the former west outside wall of the 17th century Hall. (above right) iron brackets behind the 19th c decoration and possibly to retain some form of panelling for an earlier chapel decorative scheme.

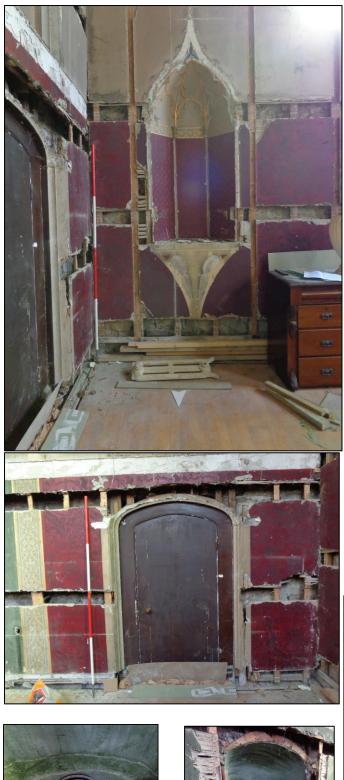
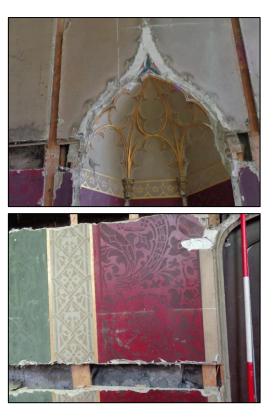
The Introduction of the squash court structure into the chapel in the late 20th century had caused significant damage to the existing decorative scheme with many projecting plaster work finishes hacked off or mutilated. Nevertheless the scheme was still very legible and consisted of late and plaster battened walls covering over the stone walls of the Chapel which showed no sign of earlier decoration or plasterwork save from some iron clamps along the east wall which may have had an earlier function of supporting and retaining panelling (plate 24). The lathe and plaster walls were covered with a painted and stencil decoration of repeated geometric shapes in red and green with white, gold and silver detailing and highlighting.

Plate 25. Various views of the chapel taken in 2014 after removal of the 20th C squash court showing the revealed mid-19th century decoration and the extent of the damage caused by the squash court. (bottom left), two views of a heater within a niche on the east wall and still in-situ. (below) a view in 2020 showing how the damaged decoration was conserved behind a new ventilated plasterboard wall.

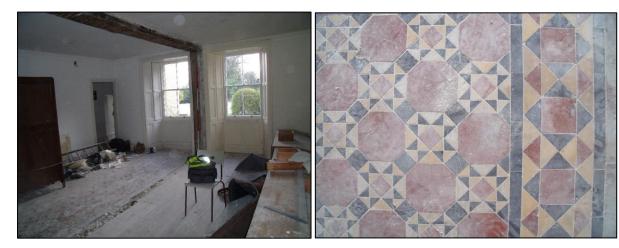
the current scheme of works revealed the major N-S centrally placed beam holding up the first floor. On the underside of this beam were the markings of lathes (plate 28) indicating the presence of earlier plasterwork around the beam. No evidence was present as to the complexity, detail or date of this decoration.

Plate 28 Room G9, formerly a principal room of the 17th C Hall. (Clockwise from top left) looking SE showing floor scar left by removal of the later N-S partition wall, with 19th C encaustic tile floor to the east. (Above right), detail of the encaustic tile floor. (Right) scars from earlier lathe and plaster to the central supporting beam. (below right) view of room in 2012 prior to building works looking SW showing 18th C fireplace and steps to the chapel (Below left) view of the room in 2020 after building works.

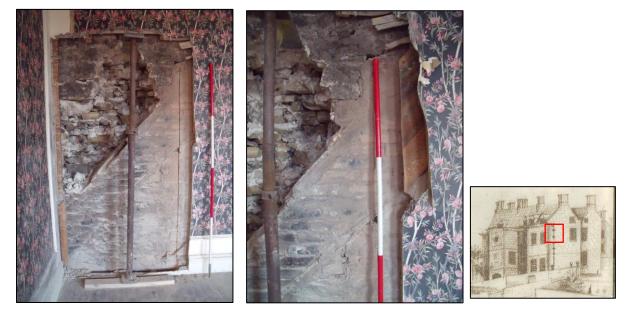
Plate 29. West wall of principal bedroom F6A showing revealed quoins of pre 18th century hall east wall (shown on insert of Buck drawing of 1720, and later inserted flue for ground floor room G6a

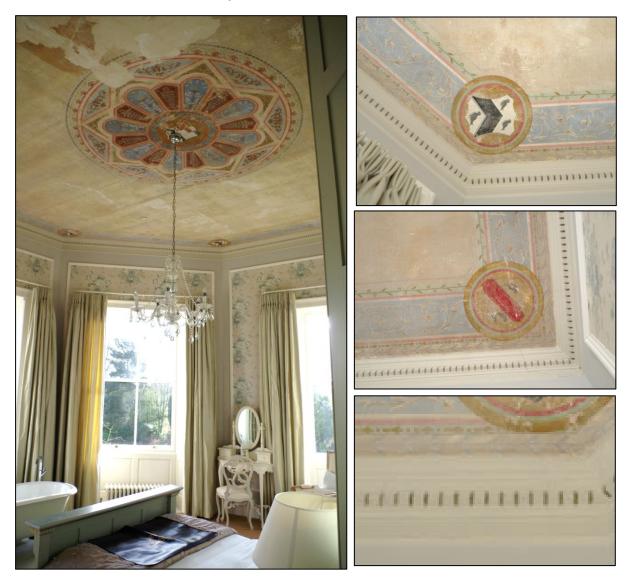
Removal of woodchip lining paper from the ceiling of this room, probably applied in the early 20th century, revealed a decorative scheme consisting of a number of heraldic shields relating to the Appleby, Lawson, Maire, Silvertop and Witham families which are also evident in the stained glass work on the Best Staircase and in the Chapel. On this basis it seems likely this scheme is of a similar mid-19th century date, and part of the works carried out by Joseph Hansom on the instruction of Msgr Witham around 1859-63.

Plate 30. Room F6a looking south east (above left), showing the mid-19th century painted ceiling revealed during restoration works. The scheme is likely to be of c.1859-63 during improvements by Msgr Witham and includes heraldic shields of related Catholic families who had previously owned the Hall. Prior to the building works this was covered by an early 20th century wood chip wall paper.

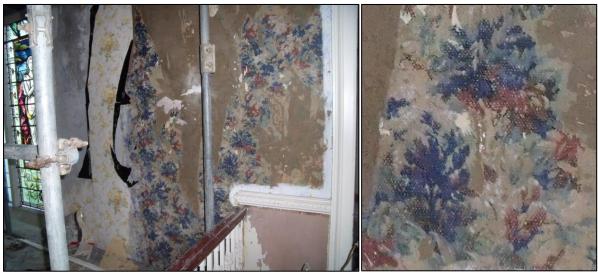
Plate 31. The Best Staircase F7 looking at the north wall of the first floor landing where removal of 20th century wallpaper exposed an earlier wallpaper of blue and red repeating floral print (detail above right) Plate 32. (below), The Best Staircase ceiling showing the cleaned and restored (January 2020), stained glass of the top lit family heraldic design introduced by Msgr Witham in 1859.

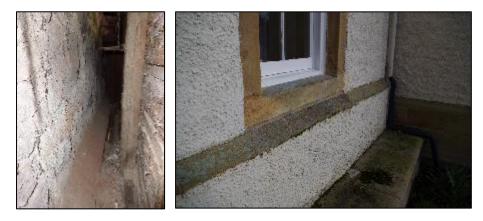
Plate 35. (far left) plinth course revealed in former outside west wall of the Hall/East wall of Chapel and identical plinth course on the south elevation of the Hall dated to 1635 (near left).
