**Coldrach Farm Steading, Drymen:  
Historic Building Recording Survey  
Project 3646**

## **Coldrach Farm Steading, Drymen: Historic Building Recording Survey**

**Project Number:** 3646

28/03/2013

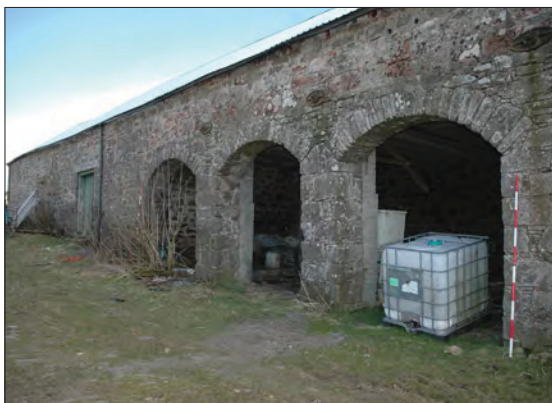
- 7.4 The west facing exterior of the building was bonded stone with six entrances to the interior. A timber double-door entrance provided access to the storage area at the north of the building. Three cart-arches are in the central section (Figure 4; Plate 1), and two further entrances at the south-west were also probably cart-arches, but had been enlarged to accommodate modern farm machinery; these were boarded-up, making the south interior inaccessible.
- 7.5 The harling on the south and east facing elevations was relatively intact, although patches were missing from both walls (Figures 3 & 8; Plate 2), and a vent had been created on the upper portion of the south-facing wall for the electricity supply.

Plate 1: West facing elevation of Building 1.

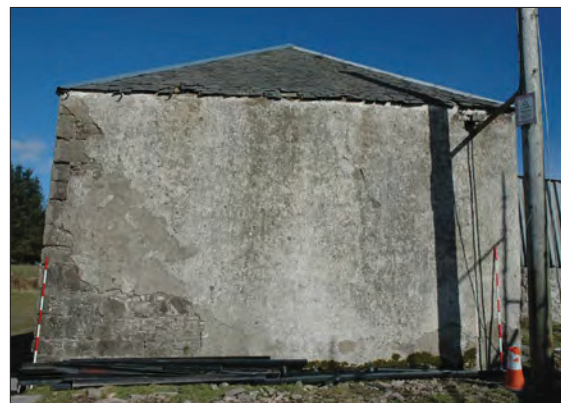
Plate 2: Harling and exposed stones on south facing elevation of Building 1.

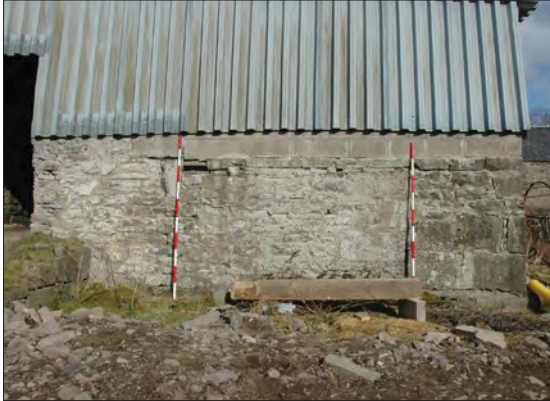
- 7.6 A modern lean-to animal shed of breeze-block, timber and corrugated steel construction adjoined the eastern side of Building 1 (Figure 8; Plate 3), and incorporated an existing stone wall that formed its southern limit. A window or gap on this earlier wall had been blocked-up and capped with breeze-block (Figure 3; Plate 4). The lean-to shed has one gated entrance from the courtyard.
- 7.7 The roofs on the west side of the building and on the modern animal shed were of corrugated steel, and were in a good state of repair. Graded slate roofs on the east and south sides of the building were found to be in a reasonable condition, with slates missing only from the first few rows from the bottom edge.

Plate 3: Blocked-up window in lean-to component of Building 1.

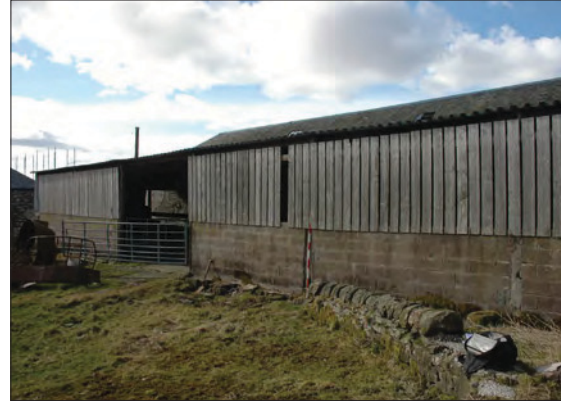
Plate 4: East facing elevation of Building 1.

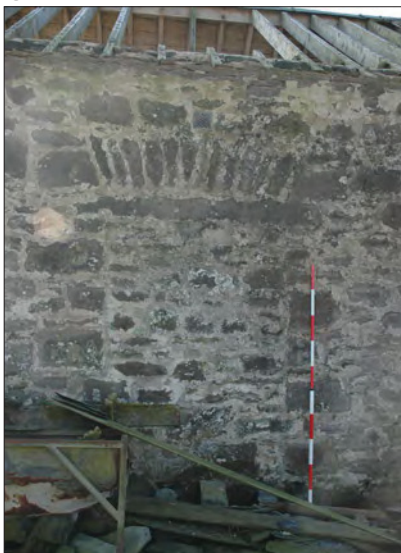
- 7.8 The building is of bonded stone with five entrances from the north exterior, two of which are now blocked-up (Figure 5; Plate 5), and two from the courtyard, one of which is blocked-up (Figure 3; Plate 6). On the north elevation are two sliding-track barn doors with wooden lintels, one sliding-track door with a wooden lintel, one block-up sliding-track door with a wooden lintel and one blocked-up door with stone lintel and splayed stone headwork. From the courtyard, one entrance has a wooden lintel and the other, which is blocked-up, has a stone lintel and splayed stone headwork.

Plate 5: Blocked entrance with splayed stone headwork. Building 2, north elevation.

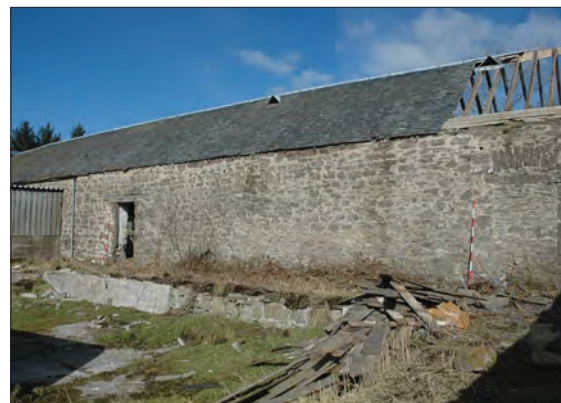
Plate 6: South facing elevation of Building 2 with blocked-up entrance on right.

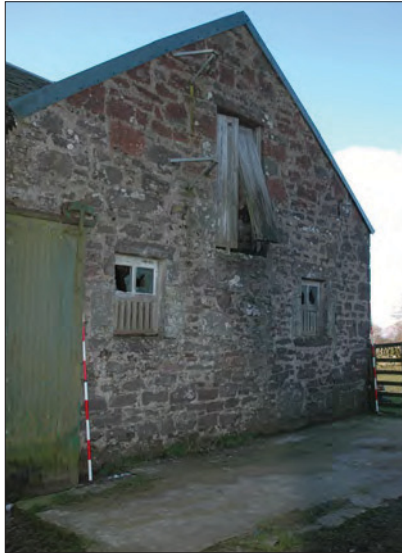
- 7.9 The north elevation has five windows in total; two small windows below a large shuttered window on the north gable-end (Figure 5; Plate 7), and two sash windows on the central section, both of which have stone lintels and splayed stone headwork. The easternmost of these windows has been partially blocked-up (Plate 8).

Plate 7: Arrangement of windows on Building 2, north gable end.

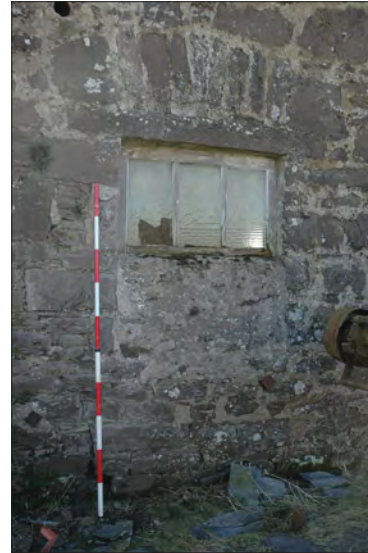
Plate 8: Partially blocked window on Building 2, north elevation.

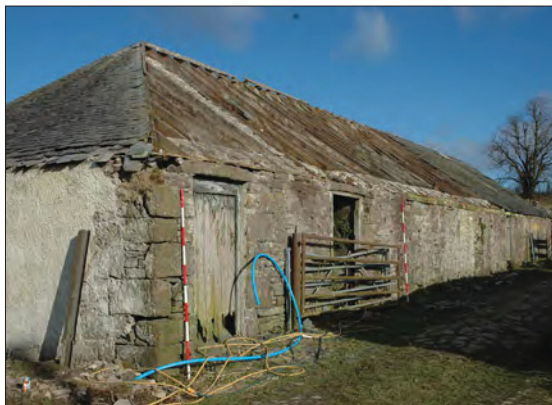
7.11 The building is of bonded stone and breeze-block, and has six entrances from the east exterior, two of which are blocked-up, and five on the courtyard side. On the east-facing elevation (Figure 6; Plate 9), are three wooden single-width doors and one wider wooden door at the east end of the building. Two further single-width doors have been block-up (Plate 10). The two southernmost doors have stone lintels, while the remainder appear to have wooden lintels. The entrances on the courtyard side (Plate 11) comprise two gated entrance gaps at the northern end, one wooden single-width door and one sliding-track door in the central section and one wooden door at the southern end; the latter was inaccessible during the survey.

Plate 9: View of east side of Building 3.

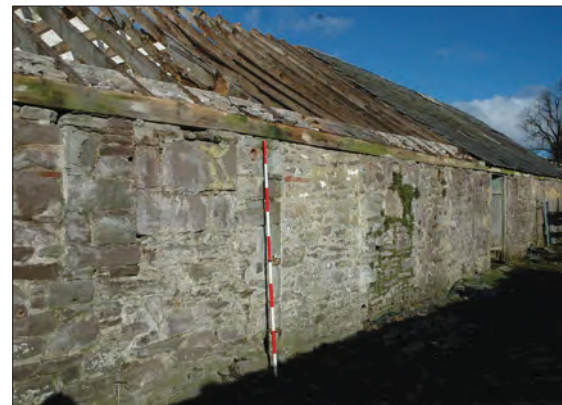
Plate 10: Block-up doors and window on Building 3.

7.12 There are six windows on the east elevation, all of which are blocked-up.

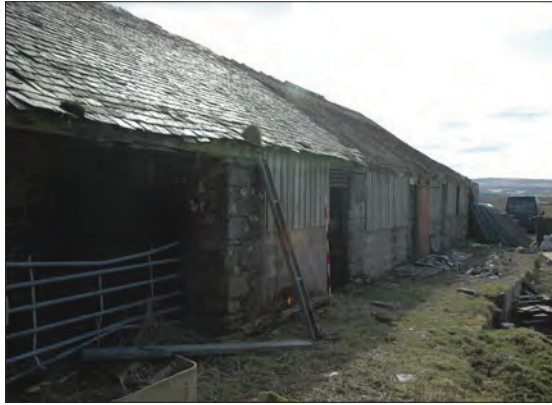
Plate 11: View of courtyard side of Building 3.

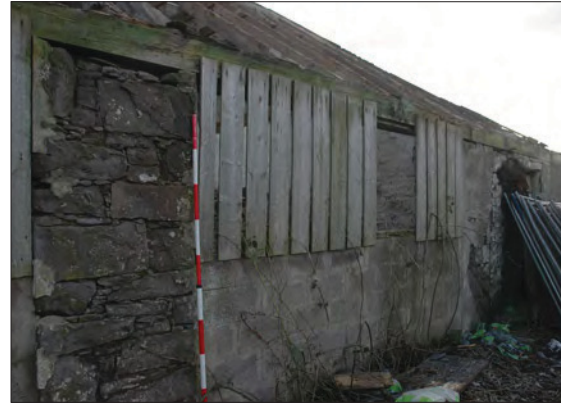
7.13 On the courtyard side, the frontage of the building has been altered. Gaps between the stonework have been in-filled by half-height breeze-block walls with timber slats above (Plate 12).

Plate 12: Breeze-block and timber slat wall.

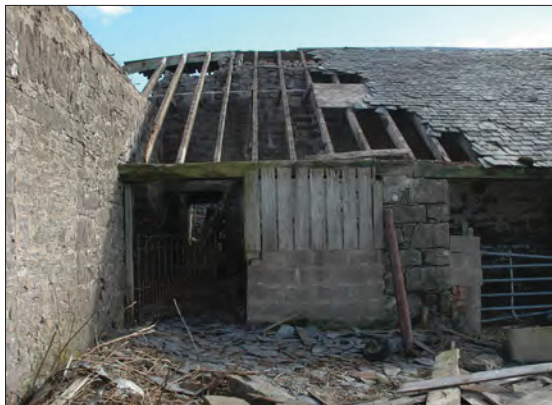
7.14 The roof of Building 3 is in a very bad state of repair and the graded slates are only extant in the central section. Structural timbers are visible on the northern and southern sections (Plates 13 & 14).

Plate 13: Roof timbers visible at north of Building 3.

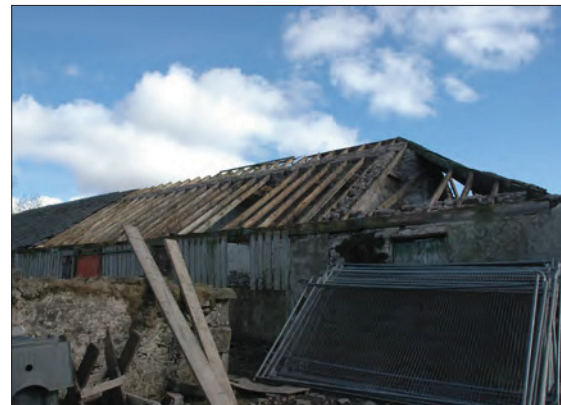
Plate 14: Roof timbers visible at south of Building 3.

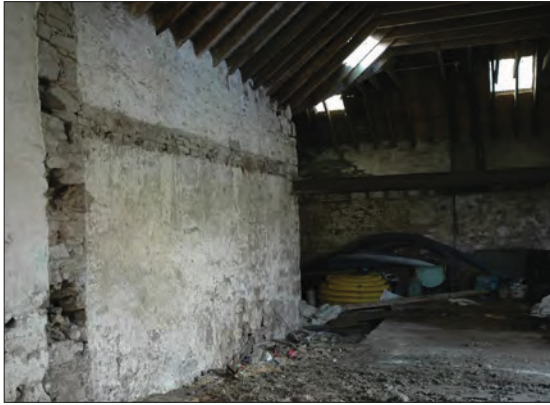
Plate 15: Former partition between Buildings 1 and 2.

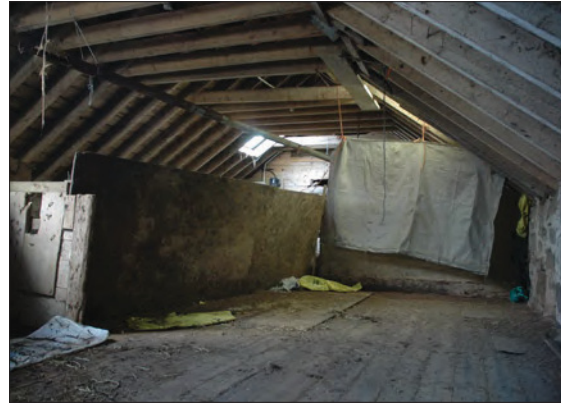
- 7.16 Concrete stairs at the south-west of the northern area lead to a storage room located above the central section of the building (Plate 16). This room had temporary wooden partitioning at the southern end, but was not fully surveyed as the wooden floor was considered to be unsafe.

Plate 16: Upper storage space in Building 1.

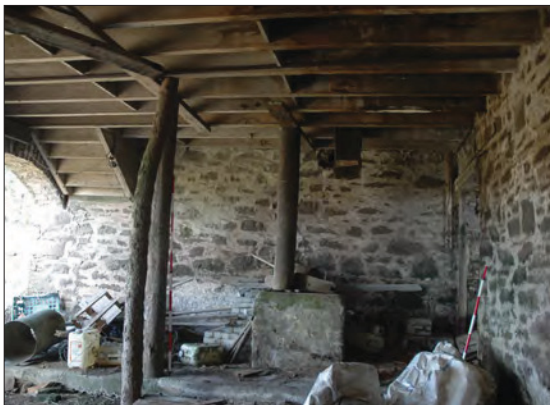
- 7.17 Below the upper store was further storage accessed from the lean-to animal shed and from the exterior cart-arches. Three wooden posts (Plate 17) and breeze-block columns constructed to the rear of the cart-arches (Plate 18) provide additional support for the upper store.

Plate 17: Wooden support posts in Building 1.

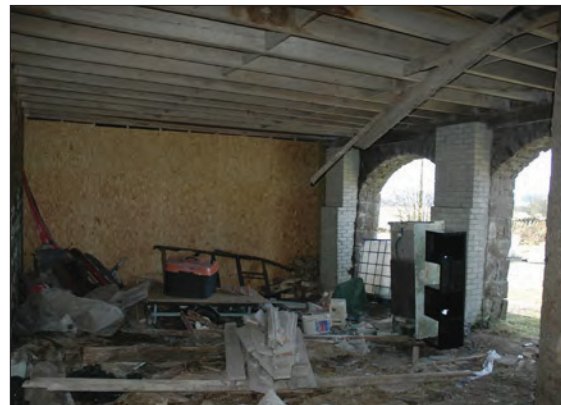
Plate 18: Breeze-block support columns in Building 1.

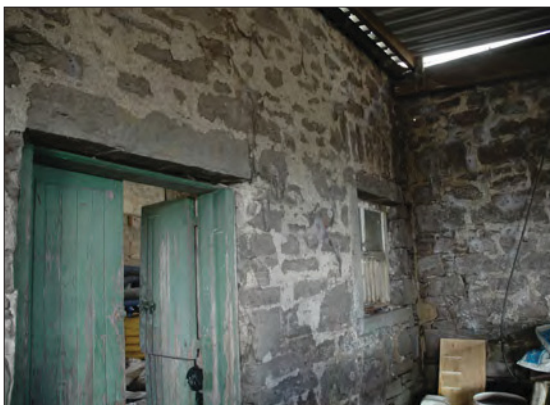
- 7.18 The lean-to animal shed is built out from the original east wall of the building and has two access points to the exterior, one to the courtyard and one to the road (Figure 8). On the original wall are two wooden doors with stone lintels, one leading to the northern area of Building 1 and the other to the central cart-arches. The southernmost of the two windows on this wall is just below roof height, has stone lintel and sill and is barred on the exterior with vertical and horizontal iron bars. The other window has stone framing, sill and lintel with splayed stone headwork (Plate 19).

Plate 19: Door and window on original exterior wall of Building 1.

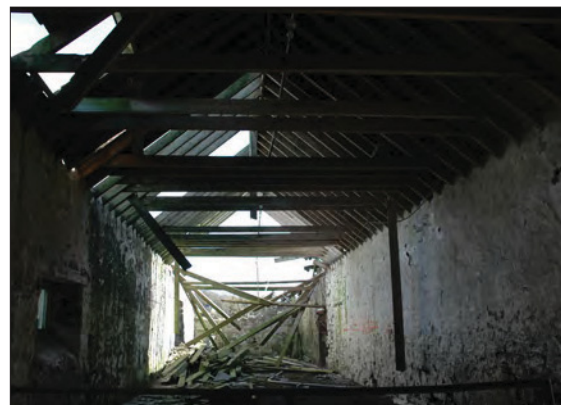
- 7.10 The roof of Building 2 is of graded slate, and is in a poor state of repair. The roof and supporting timbers are entirely missing at the eastern corner, having collapsed into the interior of the building.

Plate 20: West end of Building 2 showing collapsed roofing.

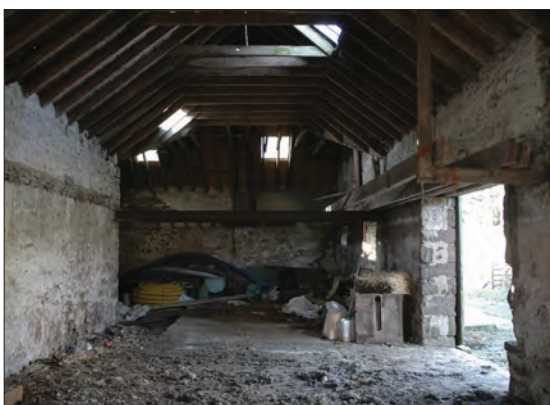
Plate 21: East end of Building 2.

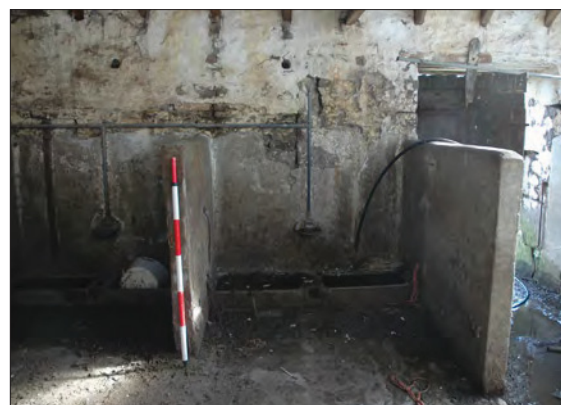
Plate 22: Animal stalls in Building 3.

- 7.20 Building 3 is stone-built with whitewashed/limewashed walls and concrete floors throughout. It is sub-divided on its long axis and has a separate room at its southern end. The long eastern room contains 12 concrete-built animal stalls with water bowls and feeding troughs (Plate 22), and a drainage channel runs for almost the full length of the building. At the southern end of this room is a larger animal byre, with access to the exterior and steps at the west wall leading up to the main room.
- 7.21 The western area of this building is divided into two, with a further eight animal stalls on the south and a byre with access to the courtyard on the north. The animal stalls here also have water bowls and feeding troughs, and a drainage channel runs for the length of the southern half of this area. There is no direct access to the exterior from the animal stalls.
