Catrine Weir, Catrine, East Ayrshire Data Structure Report Project 3811

Data Structure Report

On behalf of: Covanburn Contracts

Project Number: 3811

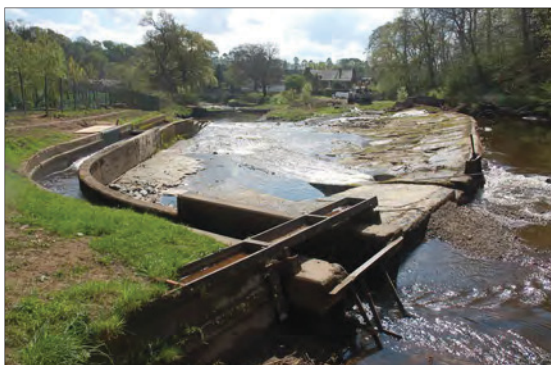
Plate 1: General view of weir and fish pass.

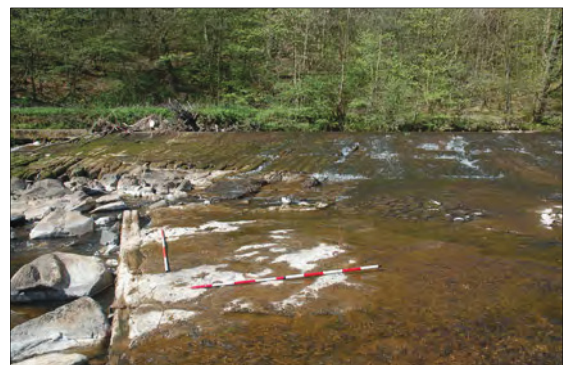
Plate 2: Shot of weir crest and cribs.

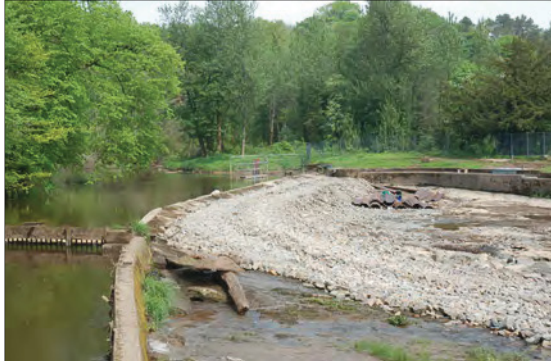
Plate 3: Construction access track across weir spillway.

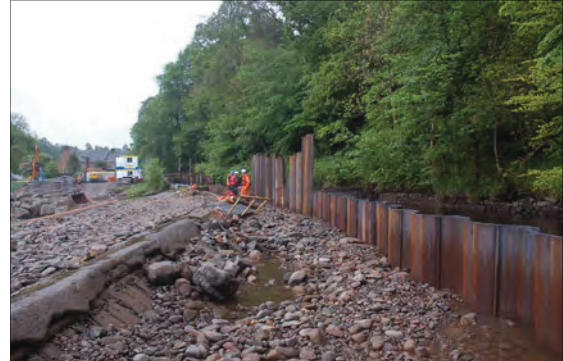
Plate 4: Cofferdam in situ and river bed material pre-excavation.

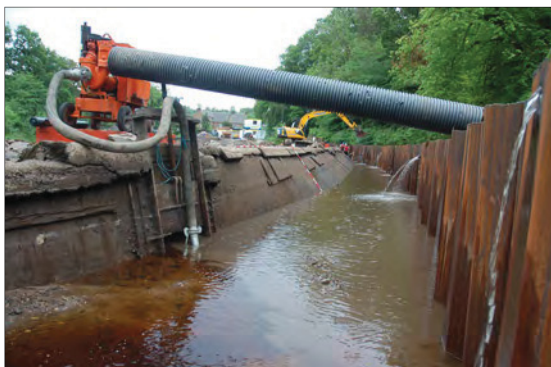
- 7.3 The weir face (003 and 004) which stretched from the trash screen to the modern fish pass measured 57 m in length and was constructed using a series of abutting pitch pine wood planks placed vertically. These planks measured between 0.23 m – 0.28 m in width, 0.95 m in length (although not fully exposed) and 70 mm - 100 mm in depth (plate 5). One plank was removed (plate 11) and revealed a total length of 2.5 m with a tapered bottom edge probably used to secure it within the river bed sand and gravels. These planks were secured to the main structure beneath using iron spikes and nails. Several areas of possible 'repair' (007) were positioned intermittently along the length of the face, which gently curved in a north-west/south-east direction with a slight change in direction 45 m from the north-west end as the face approached the lade (figure 2, plates 5 and 6). These 'repair' sections were constructed of shorter planks of wood fixed to the weir face using nails. One section also contained a narrow horizontal strip of wood beneath which the short sections were attached (figure 2, plate 6). These 'repair' sections also contained chamfered (tapered) edges at their top end nearest to the crest and measured between 0.23 m – 0.28 m in width, 0.59 m – 1 m in length and between 20 mm and 60 mm in depth, with the 2 mm end at the top. These additional sections of wood were initially presumed to be repair, however, several sections were missing and on inspection there did not appear to be any damage to the weir face beneath. It was therefore presumed that these additional wood sections were possibly added as a means of adapting or re-directing the flow of water across the face, whether this was to subtly change the direction of flow or decrease turbulence is unknown. The weir face planks to the east of the penstock were in relatively poor state of repair with much erosion and rotting at their top ends located just below the weir crest and gapping in-between the planks and would have resulted in water leakage through the weir structure (plate 11).

Plate 5: Weir face showing its construction and change in slope from north-west to south-east.

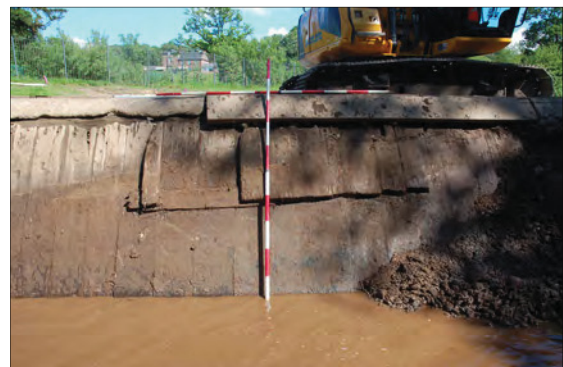
Plate 6: Close-up of 'repair' section 007 to weir face.

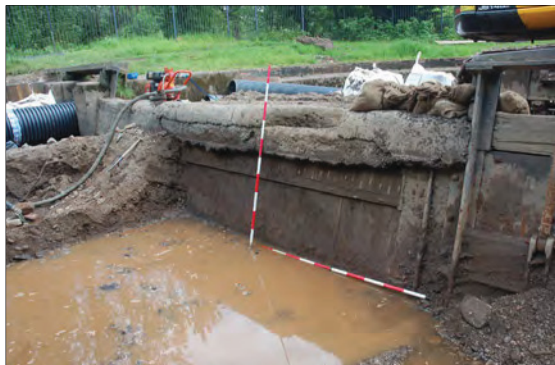
- 7.4 The weir face (003 - plate 7) to the north-west of the penstock (010 - plate 8) differed slightly in construction to that of the south-east (004) containing a narrow horizontal batten of wood along its mid-length, which was absent from 004. Its planks were also positioned in a more upright vertical position, as opposed to the south-eastern side where they became gradually more angled from north-west to south-east (plate 5). This increase in angulation appears deliberate and was possibly used as a means of controlling the flow of water across the weir face. The wood in this area appeared to be in a better state of repair with no obvious plank erosion. At the rear of section 003 a horizontal batten of wood (016) measuring 4 m in length and 0.1 m in width was located. This was positioned immediately behind the top section of the weir face and only partially observed.

Plate 7: Weir face to west of penstock 003.

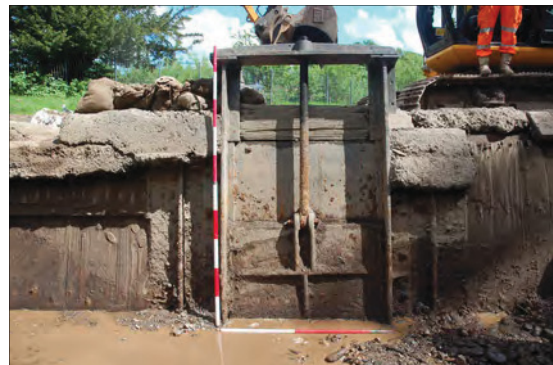
Plate 8: Penstock.

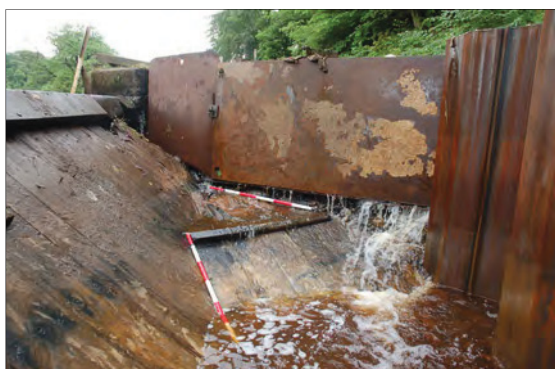
- 7.5 At the trash screen end of the weir and abutting both it and the weir face was a raised, horizontal platform of wood (008 - plate 9). It was constructed using a series of planks, which measured 0.23 m – 0.25 m in width and had a narrow strip of wood positioned across its surface. It measured 0.12 m in width, 2.2 m in length (although not fully exposed) and 60 mm in depth. Puddle clay (009) appeared to seal the timber in this area, and probably represents a continuation of the weir face as it meets the lade.
- 7.6 A black, patchy, thin bitumin coating was evident on the weir face in several areas and was probably used as water-proofing agent (plate 10).

Plate 9: Weir face at trash screen with horizontal wood 008.

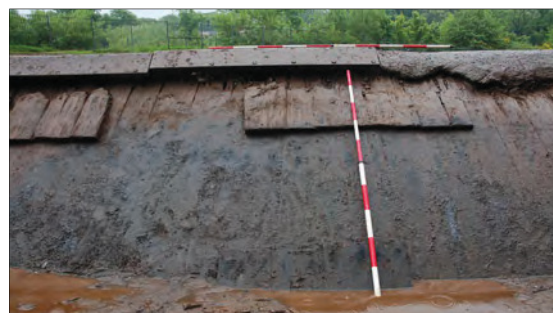
Plate 10: Bitumin coating 009 on weir face and repair section 007.

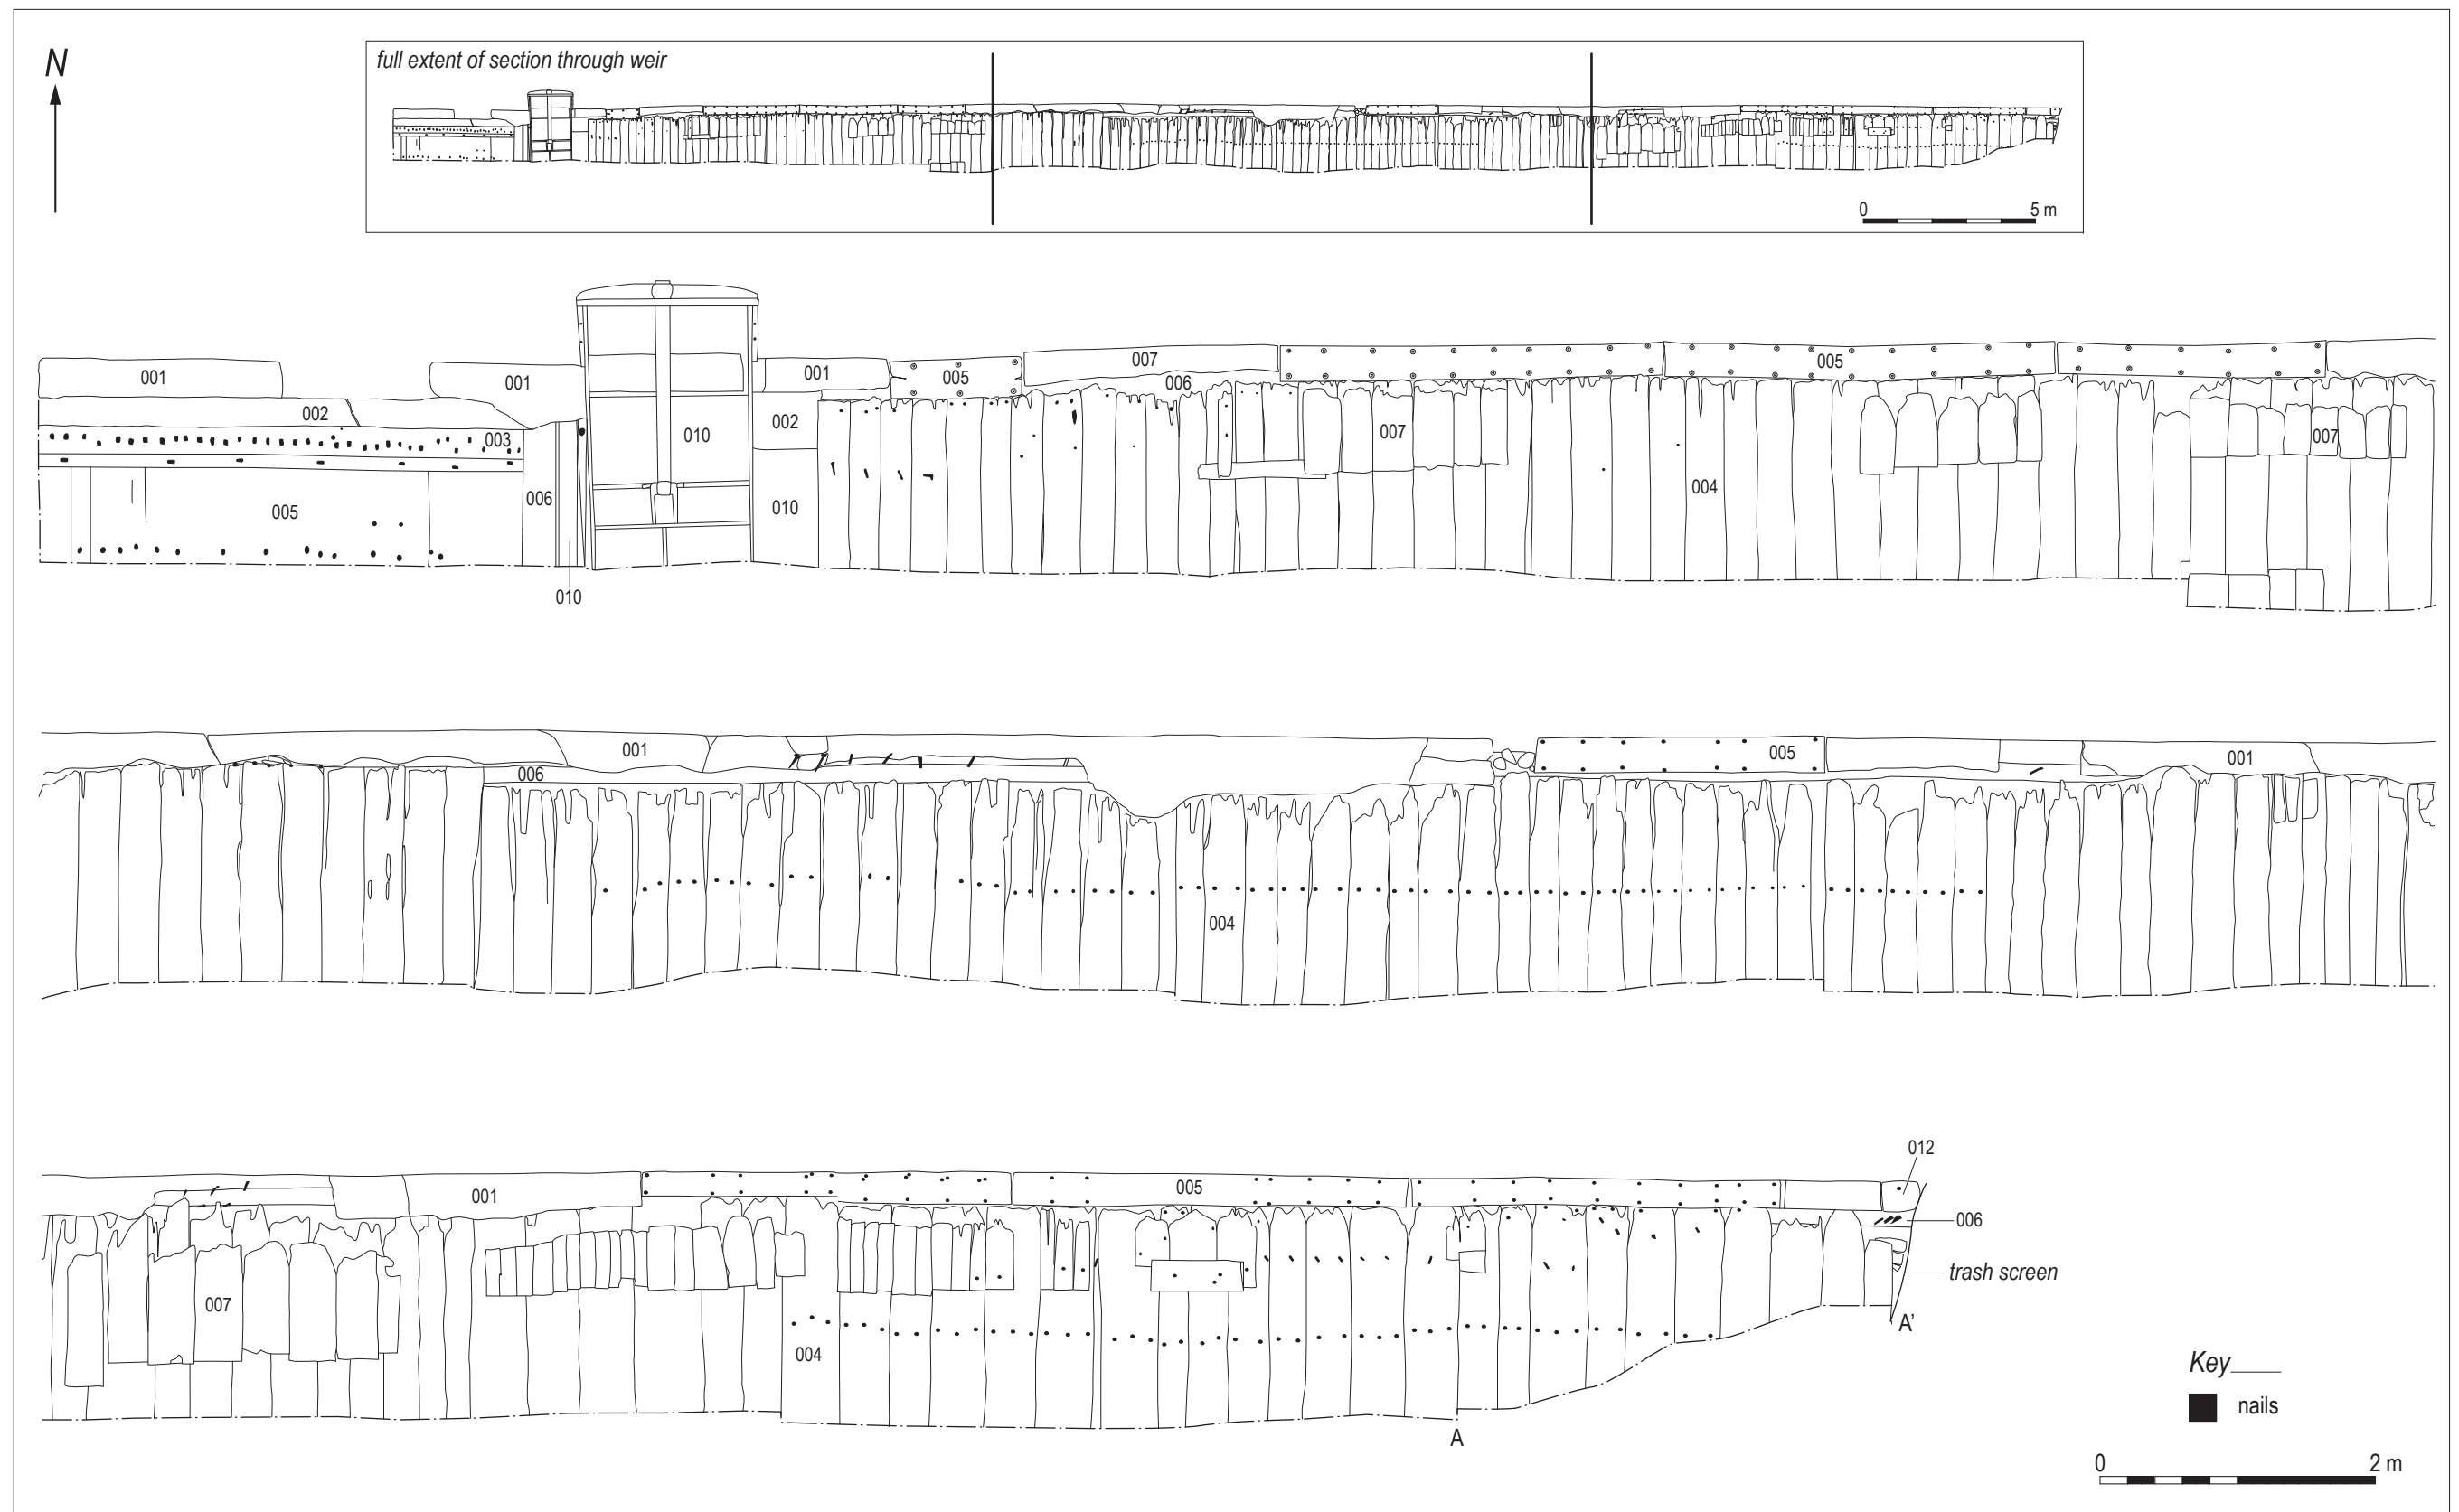
Figure 2: Face of Weir.

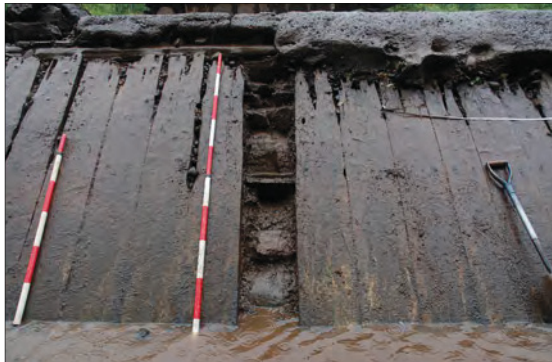
Plate 11: Packing material and structure beneath removed weir face plank 004.

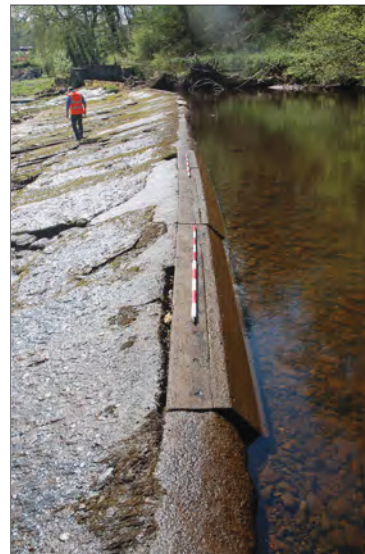
- 7.7 The weir crest appears to have been heavily repaired and modified over the years using a variety of material including concrete (001) and greenheart wood (005). The most recent repairs were in 2002 using greenheart wood, which was bolted into place (plate 12). Only one section of the original weir crest (012) has survived to the present day and remains in situ at the trash screen (plate 13) and comprises a curved cast iron plate.

Plate 12: Crest repairs.

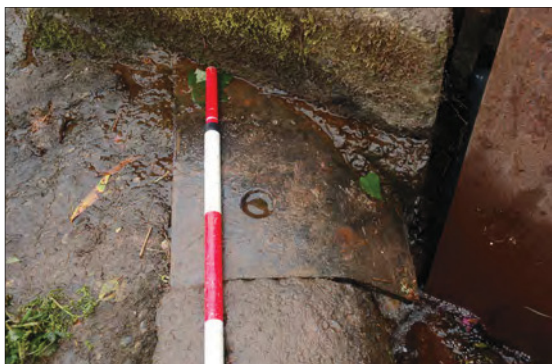
Plate 13: Original weir crest plate 012.

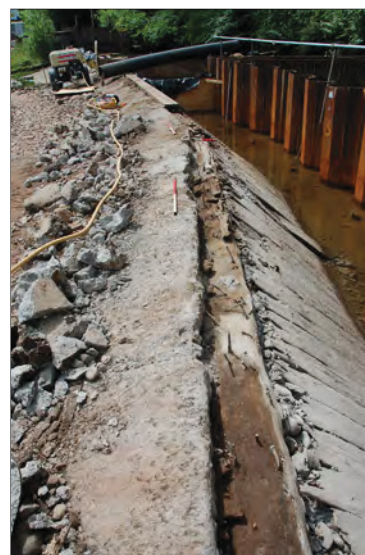
- 7.8 The concrete and wood repairs were removed by hand from the weir crest and exposed a linear 'intel' beam (006) along most of its length and positioned laterally to the flow of water. It appeared to be a continuous beam with only one break observed towards the trash screen end where the crest turns towards the lade (plates 14 and 15). It appeared to be bolted into position in this area, although other bolts were noted along its length as were numerous nails. The beam

measured c. 40 m in length, 0.3 m in width and 0.4 m in height and was roughly rectangular in shape. It was not observed to the rear of weir face (003) although this area was not fully exposed.

Plate 14: Partially exposed lintel beam 006/018.

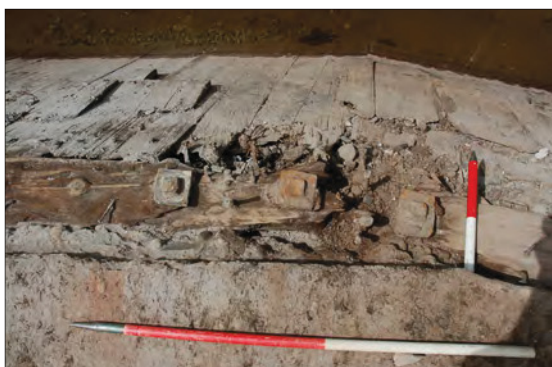
Plate 15: Bolts securing lintel beam at its change in direction near to lade.

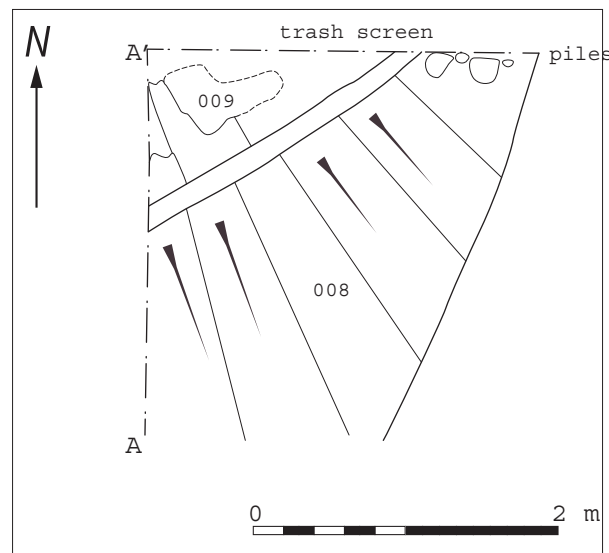
Figure 2: AirWface at trash screen.

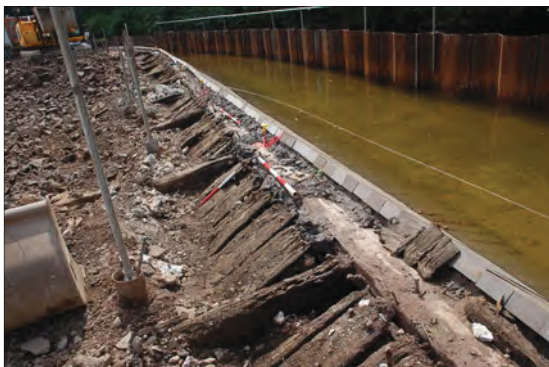
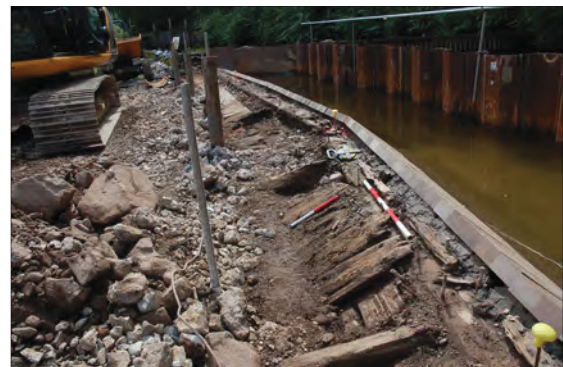
- 7.9 Further concrete was also removed from the upper reaches of the weir apron/spillway (close to the weir crest) which revealed more of its crib structure. Ten planks (019) were positioned longitudinally to the water flow (orientated north-east/south-west) and measured 0.25 m in width and 0.1 m in height and were regularly spaced at 2.5 m intervals along the weir crest. They were angled at 45 degrees from lintel beam 006, which they abutted and were fixed to by nails. These planks formed the upper level of the crib sides, which were then filled with rubble (plate 11). Within most of the cribs adjacent to the weir crest were horizontal planks (021) measuring 0.16 m in width and 50 mm in depth (plates 16 and 17). Their length was not observable although was presumed to be 2.5 m as this was the size of the cribs orientation north-west by south-east. Attached onto these were similar beams (020) positioned vertically. These measured 0.25 m in width and 20 mm in depth. These planks were very eroded at the lintel beam end with much gapping in-between. The structure below these planks was not observable although was probably filled with rubble (plate 11).

Plates 16 and 17: Side planks of crib structure 019 and internal upper planks 020 and 021. Metal plates in background 025.

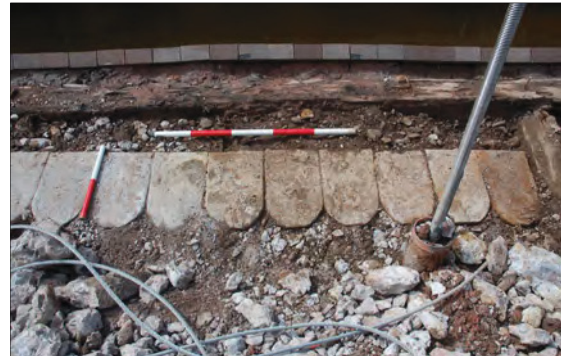
- 7.11 Immediately to the east of the trash screen and on the spillway of the weir close to the crest a linear row of 33 cast iron plates, all abutting each other was uncovered. Their function is

unknown although due to their close proximity to the crest and lade they may have been used to secure or strengthen the structure in this area. Each plate measured 0.5 m by 0.15 m with a depth of 50 mm (plate 19) and appear to be a possible later addition to the weir structure.

Plate 19: Close-up of metal plates 025.
