**Redlees Quarry, Blantyre  
Data Structure Report  
Project 3491**

## **Redlees Quarry, Blantyre**

### **Data Structure Report**

**Project Number:** 3491

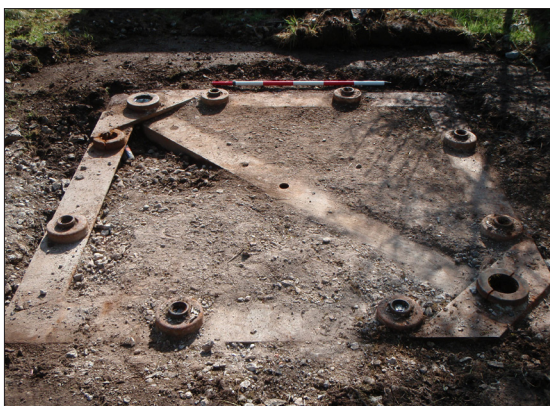
7.1.2 Battery E5 appeared to be of the same type noted elsewhere in the site. Much of the concrete covering the base itself had already been removed by vandals in an attempt to retrieve the metal fixtures (Plate 1); Evidence of damage from a portable metal saw was noticeable on the metal base. Once completely uncovered a square base of 2.2 m in length was revealed. This appeared to be of cast iron construction with no noticeable joins or welds. A cross member lay underneath, diagonally running under the base in an east/west orientation (interestingly this was not seen on the later construction E6). The iron structure itself appeared to be made of L-shaped cast iron 0.2 m in width with by 0.1 m in depth. The iron appeared to have an overall thickness throughout of 10 mm – however only small sections had been completely uncovered during the vandalism. A number of circular mounting points were sited along the base at regular intervals – eight of these appeared to be of the same shape and size 0.18 m in diameter. At the east and west corners a small reinforced section lay on top of each corner containing what appeared to be a larger and more pronounced circular mounting point – again of 0.18 m in diameter. The iron footing itself was covered throughout by a layer of concrete 50 mm in thickness with only the circular mounting points protruding through. The only visible points on the surface would have been these ten circular mounts – however acts of vandalism had revealed the underlying framework itself. One of the eight circular mounting points had been dug showing it continued underground to an unobserved depth – this possibly saved the structure itself from more damage or even removal and theft. The interior of the battery was constructed of concrete which had been laid over and around the metal mounting points.

Plate 1: Battery E5, detail of footings from south.

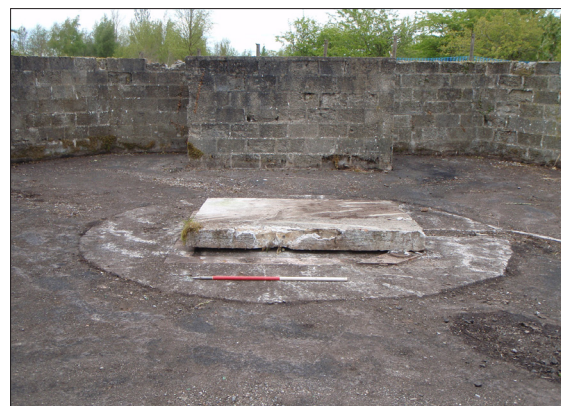
7.1.3 Battery E6 appeared to be of a different design from that seen elsewhere on the site. The interior fittings were once again of cast iron construction and included a square frame of 2.2 m in length and 0.2 m in width, with no evidence of a diagonal cross member. The topsoil removal revealed the metal structure sitting flush with the concrete base poured around it. The concrete base had not been damaged and again followed the same format as the footing seen in Battery E5 (Plate 2). The metal structure had eight circular mounting points 80 mm in diameter, although these ran flush with the footing itself and did not appear to protrude as in the case of battery E5. The base also had two more substantial circular mounts again in opposite corners atop a reinforced plate. These mounting points were 0.17 m in diameter and protruded 30 mm above the surface of the concrete. This base also appeared to have a slot running through the side of it, built into the concrete. This 0.24 m wide slot was of unknown depth but ran 1.1 m into the centre of the mount and 1.1 m out with.

Plate 2: Battery E6, detail of emplacement after clearance.

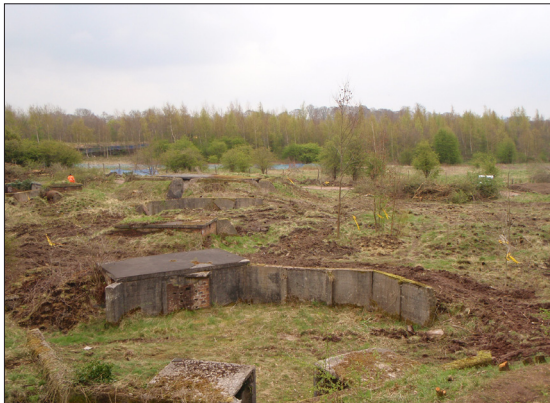
7.2.1 The second phase of work started with the removal of vegetation and foliage throughout the interior of the full site (Plate 3). Many of the trees (Hawthorns) appeared to be relatively substantial in size, possibly having been left to grow over a long number of years when the site became derelict. The trees themselves were removed by mechanical excavator, or by hand if deemed too close to the structures themselves. The removal of these root systems – although shallow, did break through the topsoil touching the subsoil and existing layers of archaeology in some places. Disturbance to the tracks and paths, which were constructed of compacted tar/bitumen and in some cases poured concrete, was limited.

Plate 3: General shot of site clearance from west.

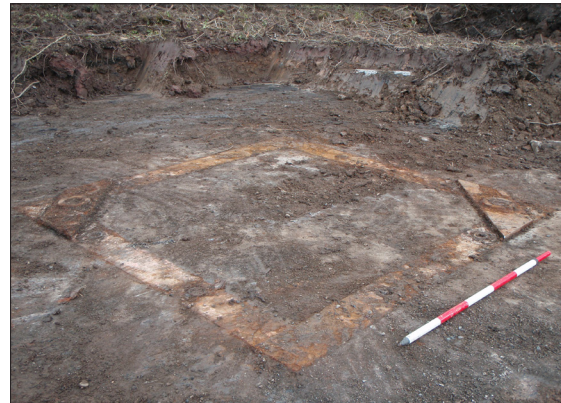
7.2.4 The original location of Battery E1 was previously unknown; it was suggested to have been located in the north-east of the site – near to the original entrance. On the removal of rubble overburden – the base of the structure was found intact (Plate 4). Only the metal base and footings of the gun were still in situ within their concrete base. The surrounding walls of the structure however had not survived. The extent of the base of the structure was cleaned back and recorded and reburied in situ to avoid any theft of the metal fixtures. It was noted that the layout and footings of this structure matched that seen in Battery E6 (*Type 2*) – the latter type addition to the site. The metal appeared to be in very good condition, with many of the mounting points showing signs of the original grease in situ – this suggests that the structure itself was demolished and buried relatively quickly with little evidence of it being left open to the elements. There was no sign of any of the large reinforced sections of walls in the rubble overburden suggesting that they could have possibly been removed from the area. This battery stood alone from the rest of the batteries, being a later addition to the site – and had no direct association with any magazine building.

Plate 4: Battery E1, detail of base.

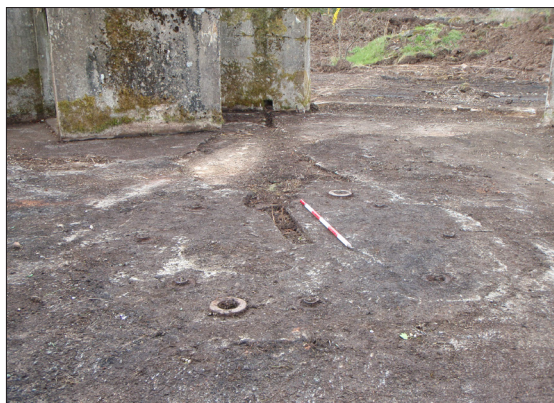
7.2.5 Battery E2 was located to the south-west of Battery E1. This was one of two emplacements joined to a larger magazine area. The overall condition of the outer walls of the structure was very good. On the initial removal of the earth banking surrounding the walls, it was noted that olive green paint survived on the walls exterior behind the earth banking. This suggests that the battery existed without the earth banking for an unknown period of time – before these were added as a later addition. The earth banking rose to a height of 1.3 m and in some cases extended 2.2 m out from the wall, gently sloping upwards. In section it was noted that the bank was constructed with compacted sandstone rubble fragments with clay and topped with soil. At the base of the wall, a ceramic drain ran round the perimeter of each structure. This battery was of a different type to that seen at Battery E1. This twinned with Battery E3 and connected to a larger magazine building by small curved concrete path or run. The metal fixings were found to be present (Plate 5) and, subsequently exposed before re-burial in this emplacement. They were of a different type to that seen in Battery E1

Plate 5: Battery E2, gunmount fixings from north.

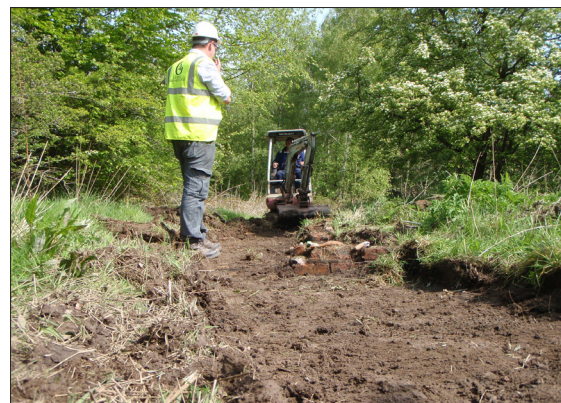
- 7.2.14 An additional ancillary building was partially recorded to the north-west of the main battery complex on 21<sup>st</sup> May. This red-brick building survived as the lower two to three courses of brick at NGR NS 68105 59955 (Plate 6). All of the bricks used in this building were marked with 'GAROWHILL', a local early twentieth century brickworks, which ceased to operate in the 1950s, about a decade after this building was built. The rectangular building measured 4.75 m by 6.6 m and showed evidence of one doorway and two possible windows on the west elevation. The doorway was marked with an instep measuring 1.65 m wide, possibly a double door, with numerous shards of square-mesh wire-reinforced glass and metal fixings scattered along the west edge of the building at this point. Two more isolated scatters of the same type of reinforced glass were found 1.5 m apart along the western wall, perhaps representing former window positions. A concrete feature built against the north wall of the building measured 1.1 m by 3 m with red-brick detail at the north edge. The route of the public pathway skirted the edge of this building and so only limited investigations were carried out. The remnants of this building will remain *in situ*.

Plate 6: Uncovering of red-brick building to northwest of main battery, from south.
