**Harlaw Reservoir, Balerno
Data Structure Report
Project 3788**

Data Structure Report

On behalf of: Harlaw Hydro Ltd

Project Number: 3788

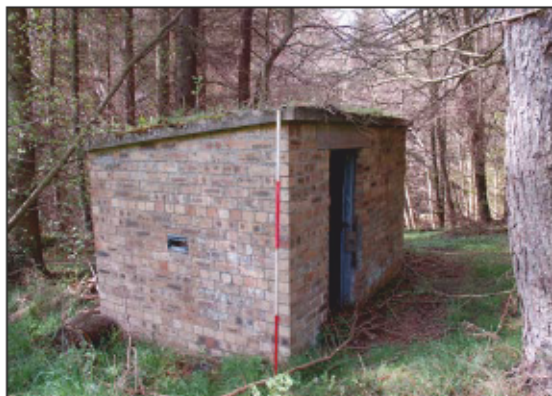
Plate 1: Building 1, from the east.

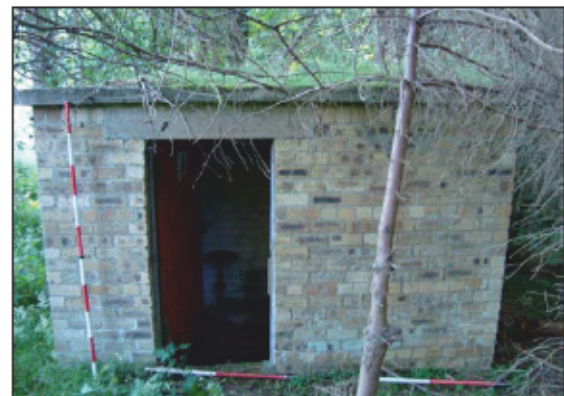
Plate 2: Building 1, from the north-east, cast-iron valve is visible on the rear wall of the building.

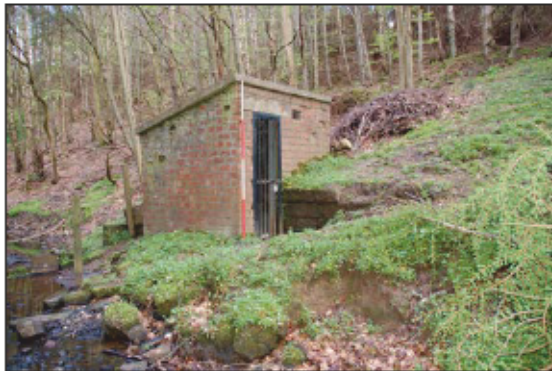
Plate 3: Building 2 with sandstone revetting wall, from the south-west.

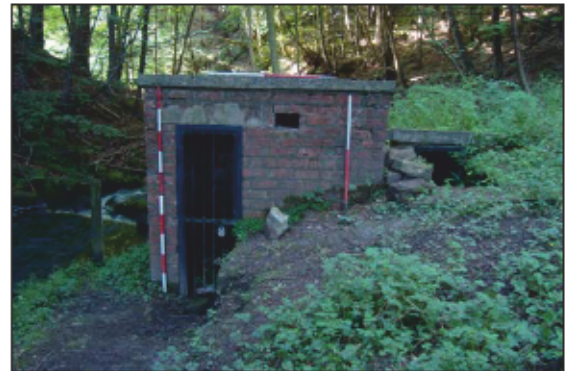
Plate 4: Building 2 and Building 3 just visible to the right of Building 2, from the south-east.

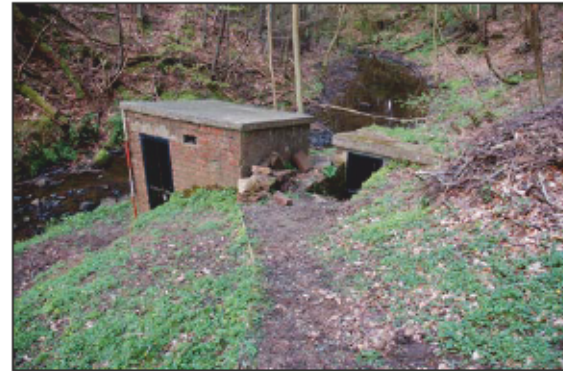
Plate 4B: Building 2 and Building 3, from the east-south-east.

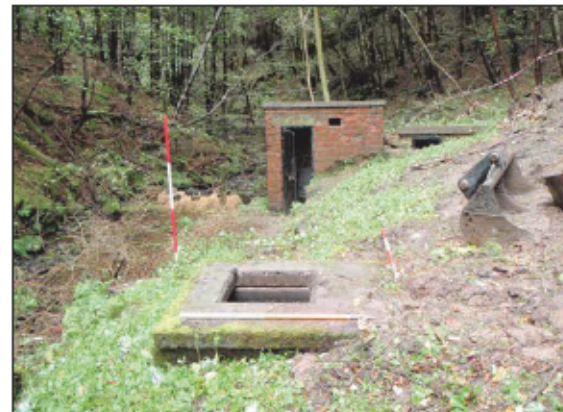
7.4.1 Building 4 was located to the south of Buildings 2 and 3 and comprised a brick and concrete built manhole. The external measurements of the structure were 1.43 m long by 1.32 m wide; the structure was visible to a depth of 0.48 m. The top of the chamber was covered by a concrete slab capping the brick walls of the structure into which was set a square cast-iron manhole cover embossed with makers name 'ENTEC'.

Plate 5: Building 4, brick and concrete manhole with cast-iron cover removed. Buildings 2 and 3 to rear of frame. From the SSW.

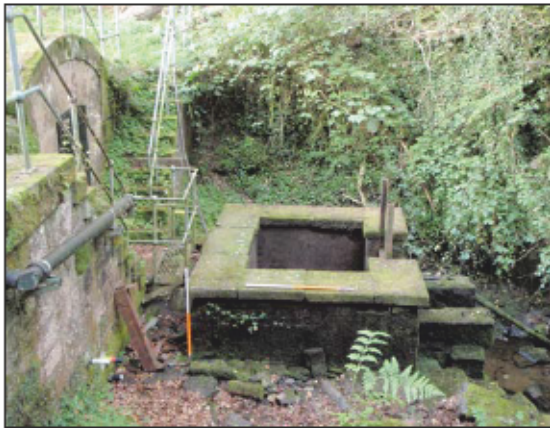
Plate 6: General view of Building 5, from the north-east.

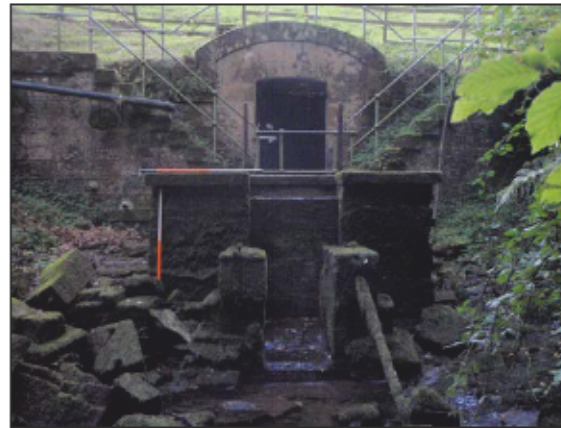
Plate 7: General view of Building 5, rubble spread left of frame may represent the site of the earlier electricity turbine. Rear of frame the sandstone wall revetting the base of the bank of the dam with a valve chamber compartment, from the north-west.

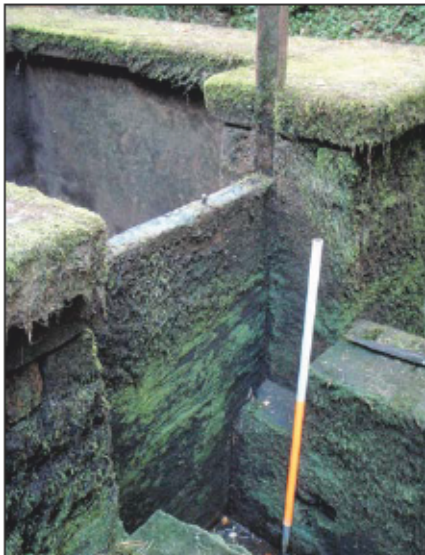
Plate 8: Detail of wooden sluice gate controlling flow of water to waterwheel mounted on projecting sandstone walls on the north side of Building 5. Part of a semi-circular scar made by the water wheel is visible to right of and below the base of the ranging rod, from the north-west.

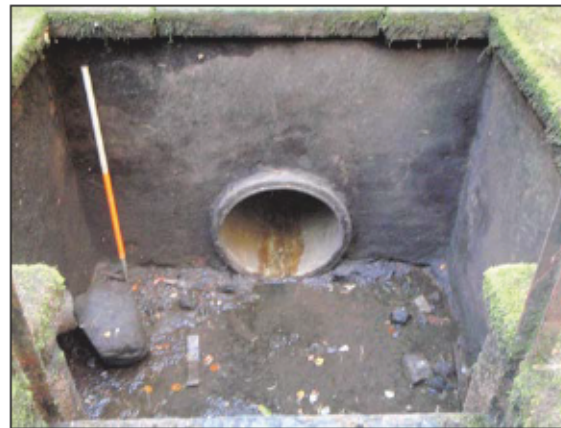
Plate 9: Inlet pipe to tank, from the north-west.

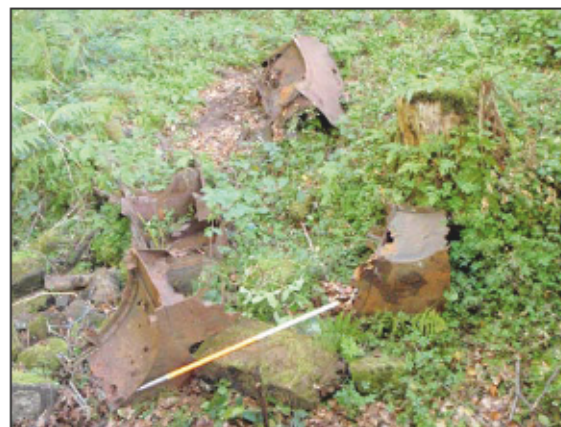
Plate 10: Remnants of the water wheel metal paddles which would have driven the earlier turbine.

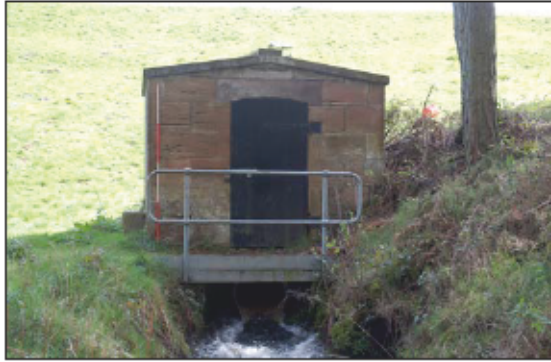
Plate 11: Building 6, from the north-west.

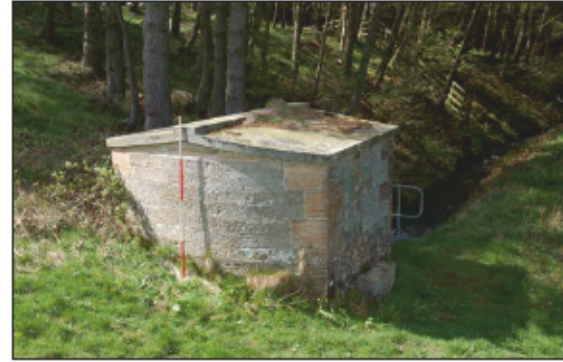
Plate 12: Building 6, from the south-east.

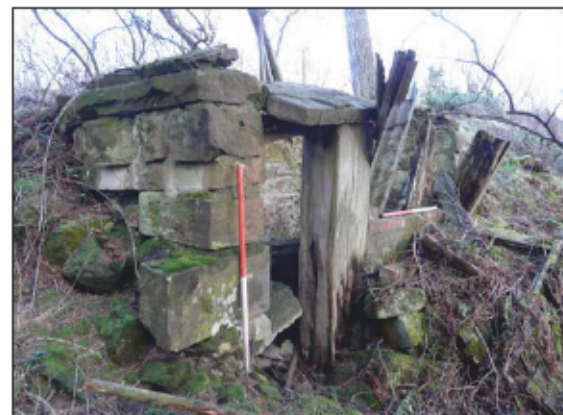
Plate 13: Building 7.

leaning outward. Externally the building measured 3.95 m long by 1.8 m wide and stood 8 course of stone in height 1.8 m. No access was gained to this building. Immediately in front of the building was a pile of masonry rubble that was covered in moss and vegetation.

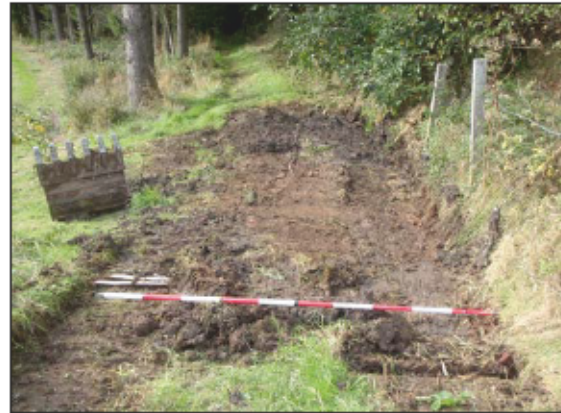
Plate 14: General view during topsoil stripping to form temporary access road.

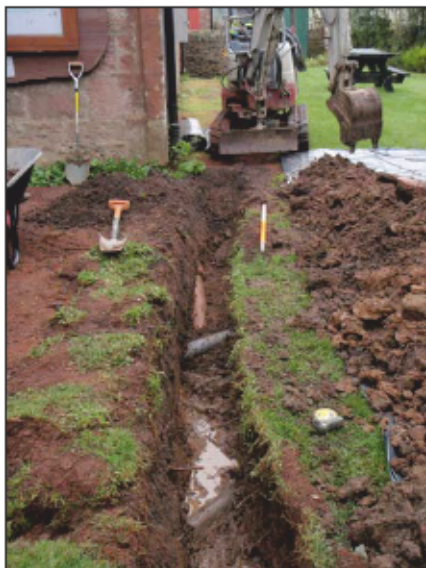
Plate 15: General view of services in the fibre optic cable branch of the service trench in the visitor centre garden, from the north-west.

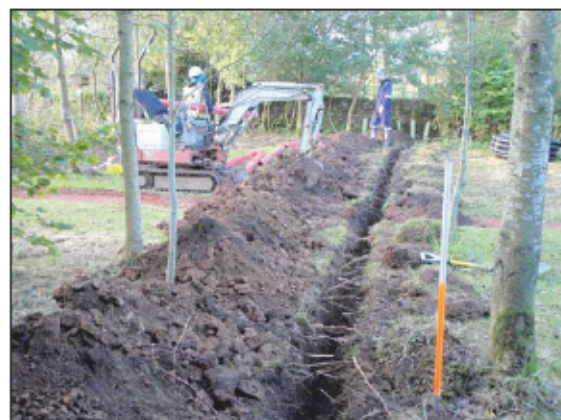
Plate 16: General view of the north-east to south-west electric cable trench in the visitor centre garden, from the north-east.

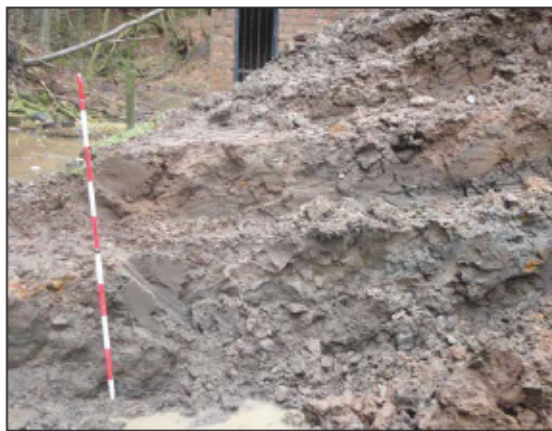
Plate 17: South-south-east facing section of the turbine base trench.

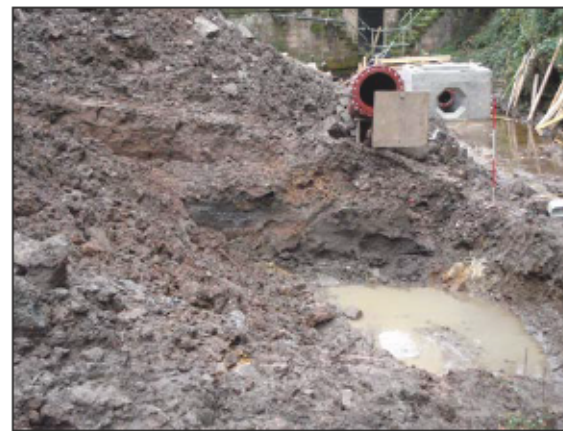
Plate 18: North-north-west facing section of the turbine base trench, water supply pipe and flood release valve top right of frame.

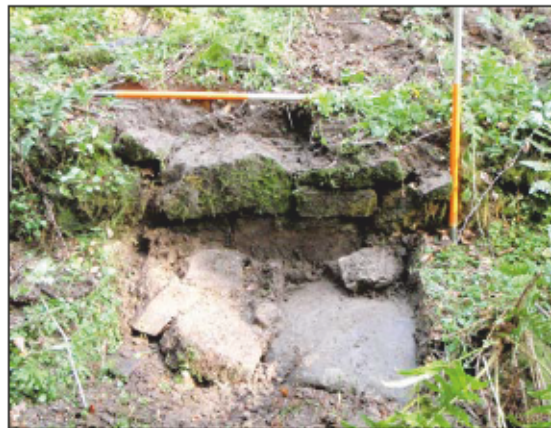
Plate 19: Bank revetting wall 1001 at the base of the bank along the eastern edge of the outfall, from the west-south-west.

- 9.2 The watching brief recorded a revetting wall along the east edge of the most eastern outfall which appeared contemporary with the construction of the dam and formation of the outfalls.
