Hallside Farm, Cambuslang
Standing Building Survey and Evaluation
Project 4068

Hallside Farm, Cambuslang

Standing Building Survey and Evaluation

Project Number: 4068

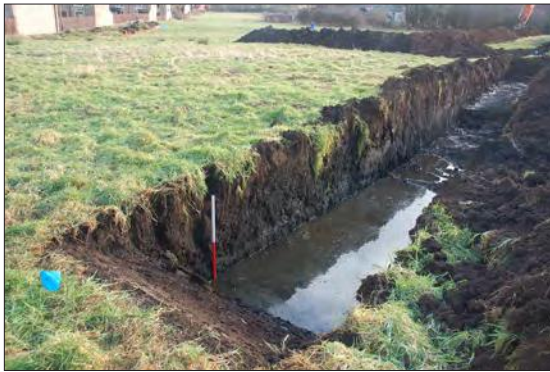
- 7.3 The western periphery of the site was characterised by a lower waterlogged peat deposit (003). This dark brown/black peat deposit varied between 0.40 m and 1.0 m in thickness and contained waterlogged root and wood inclusions. This deposit was revealed in Trenches 1 to 4 and 13 and 14.

Plate 1: Detail of deep waterlogged peat deposits (Trench 1)

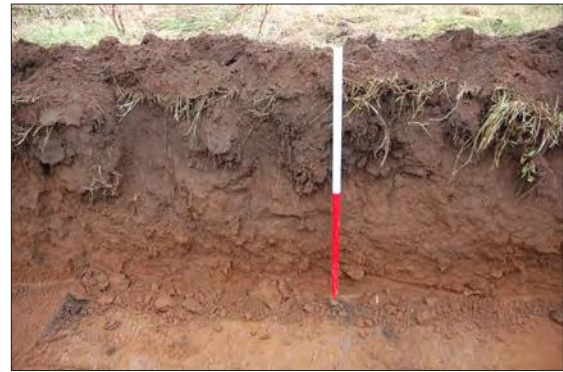
- 7.2 The topsoil encountered 001 varied throughout the evaluation area ranging from 0.30 m to 0.45 m in thickness. The topsoil consisted of a dark brown silt disturbed layer with evidence of relatively modern twentieth century ceramic fragments (not retained) and plastic throughout. Deeper deposits were noted to the east of the development area with a significantly thicker pre-existing topsoil or makeup layer 004, below topsoil and overlying the sterile subsoil in trenches 17 to 22. This lower topsoil consisted of a thick brown loam layer measuring between 0.30 m and 0.45 m thick. It appeared relatively sterile in nature with no evidence of modern disturbance.

Plate 2: Detail of deep topsoil deposits (Trench 19)

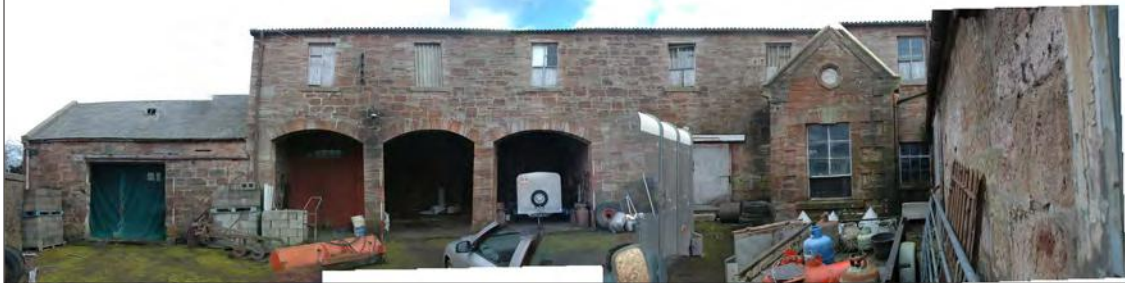
- 7.7.2 The west facing elevation of the building (elevation 2, Figure 2) consists of a one storey byre (Figure 4; Plate 9) to the north of the elevation. The byre has a large opening where a sliding door has previously existed, the metal bar structure is still visible above the entrance way (Plate 10). There is a thin horizontal stone vent found to the south of the door and a smaller opening found below the sliding door metalwork. The roof of the byre is constructed from slate and includes one metal window. It is suggested that the byre is a later edition to the main barn, where it abuts the two storey barn structure chamfering can be seen on the lower quoins.

Plate 9: Merged photographs showing west facing elevation of the main barn, annexe & byre.

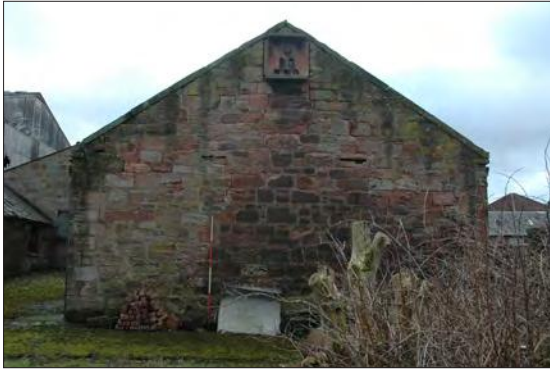
- 7.7.5 North facing elevation 6 of the main barn is a gable end shows evidence of weathering on the stonework with considerable amounts of moss found at the base of the elevation. Below the peak of the elevation a dovecot is visible (Plate 13). In line with the base of the roof line two horizontal linear stone vents can be seen. Elevation 8 consists of a semi coursed predominantly grey stone structure and relates to room 3 in figure 2 (Plate 14). It is a gable end of the later structure that has been added to the main barn and has a corrugated iron roof. There is a large central timber double door within the elevation that abuts the join between elevations 8 & 9 and a timber single door to the west.

Plate 13: General view of north facing elevation 6.

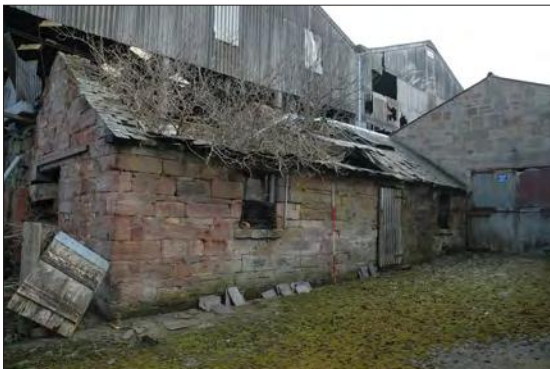
- 7.7.6 Along with the addition of rooms 3 & 4 (Figure 2) to the main barn structure a further structure can be found to the north of elevation 8 (Plate 15). This is a single storey stone barn structure which consists of two rooms. Due to the decay of the building internal photographs were limited to views visible through the open windows. On the west facing elevation (elevation 9) two window openings and a door are visible. Whilst the stone work for the structure is in relatively good condition, the slate roof has been mostly destroyed due to a tree growing within the structure. The north facing elevation (elevation 10) contains a door opening, the western edge of which is in relatively good condition however the eastern edge shows considerable damage where the building abuts the modern barn (Plate 16).

Plate 15: General view of rear barn.

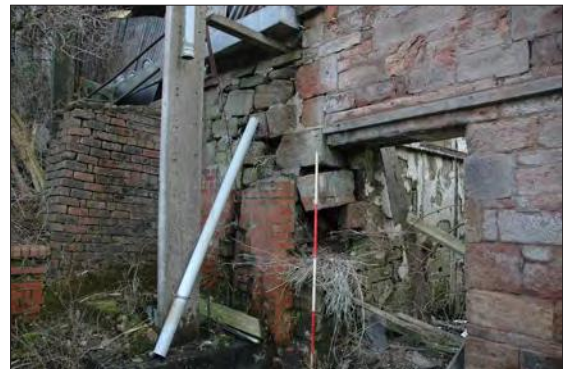
Plate 16: Elevation 10 doorway detail.

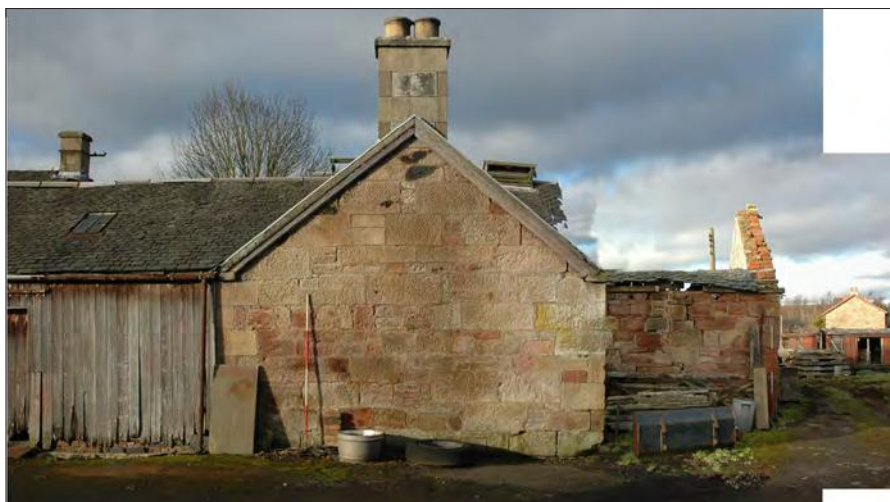
7.9.1 The boiler house is constructed of a T-shaped semi-coursed stone building with a timber panelled extension to the south west. It is in a poor state of repair with two areas of collapse visible on the northern pitched roof (Figure 6; Plate 26). The roof is constructed of slate tiles and is visible further along in elevation 11 (Figure 2). There are four timber vents remaining on the ridge of the roof, two of which are in good condition. There is also a stone chimney stack visible but no pots. On elevation 15 there is evidence of repair to the structure of the wall evident in the presence of large areas of mortar filled cracks. There are three stone circular vents visible along the top of the wall. The stonework for elevation 13 appears to be in good condition however the adjoining timber panelled structure has suffered from damp at its base (Plate 27). A chimney with two pots is visible central to the stone gable. There are two large openings on the timber structure, a timber sliding door and internal door. Due to the dangerous nature of the building no internal data was recorded. Elevation 11 is in good condition. A single timber door and timber framed window are visible (Plate 28).

Plate 26: Merged photograph of eastern end of south facing elevation of the boiler house.

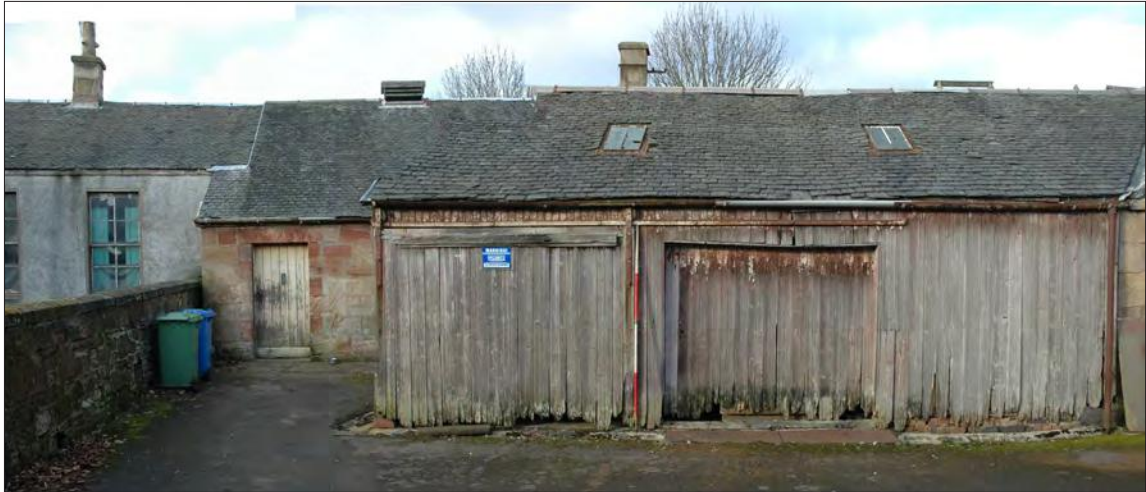
Plate 27: Merged photograph of western end of south facing elevation of the boiler house.

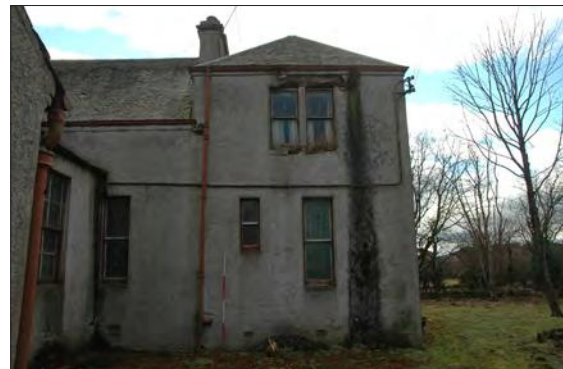
Plate 35: General view of farmhouse elevations 21 & 22.

- 8.6 To the west of the main building a single storey stone boiler house/shed is visible. This appears to be contemporary to the second phase of the main barn complex as a similar shaped structure can be seen on the Ordnance Survey first edition map (Plate 8). The main construction of the boiler house is a T-shaped stone structure with slate roof. The structure is in a poor state of repair (Plate 26). The majority of the roof has collapsed and there is evidence of structural damage to elevations 15, 16 & 17 as a result (Plates 26, 30 & 31). The Southern T-shape of the building has been extended with a timber panelled structure with a pitched slate roof. The roof is in good condition however the timber is showing signs of erosion due to water ingress. To the west of the boiler house a later two storey farmhouse can be seen. The farmhouse is linked to the boiler house via a single storey structure. The construction and condition of the farmhouse is in a relatively good state of repair. The structure is entirely rendered so it is impossible to identify the nature of building materials used in its construction. There is some evidence of water damage to the building due to damaged guttering and as a result some of the rendering

has degraded (Plates 35 & 37). Due to the unstable structure of the boiler house, access was not gained to carry out a survey of the interior.

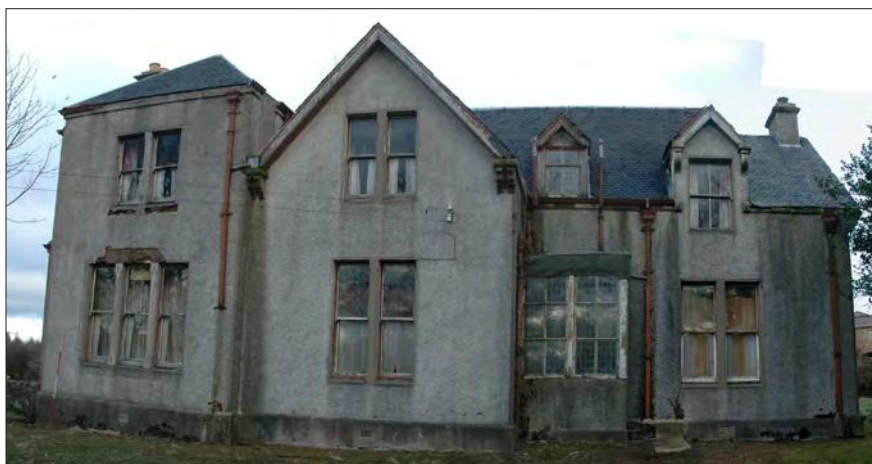
Plate 37: Merged photographs showing farmhouse elevations 24 & 25.

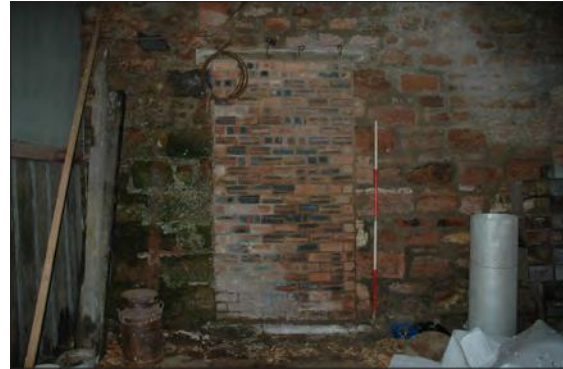
created through the recess on elevation 33 to create a vent for the adjoining byre. To the rear of the room on elevation 34 a bricked up doorway can be seen along with a vertical vent (Figure 3; Plates 52 – 53). Timber beams and metal support columns can be seen in the ceiling supporting the timber floor above.

Plate 52: Detailed view of blocked door on elevation 34.

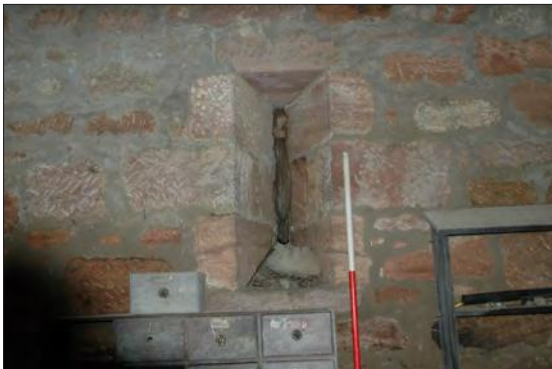
Plate 53: Detailed view of blocked vertical vent on elevation 34.

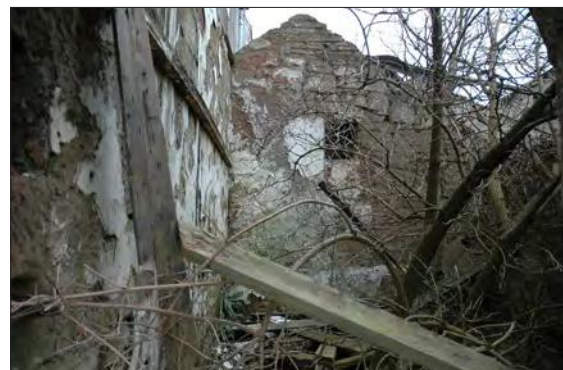
7.20.1 There are two separate rooms identified in the rear barn but due to its present unstable structure no internal measurements were obtained. The two rooms extend over an area of approximately 11.5 m by 3.2 m and are accessible from the courtyard at the rear of the byre (Plate 64). Where possible photographs were taken through windows and doorways but the vegetation and dilapidation of the building made it impossible get clear views of the structures found within.

Plate 64: Interior of rear barn 2.
