Walled Garden and 8 Acre Field, Edmonstone Estate Data Structure Report Project 3955

Data Structure Report

On behalf of: Wintertree Software Inc.

Project Number: 3955

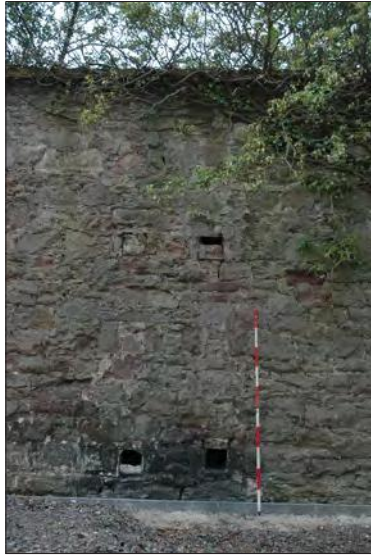
Plate 1: Square iron vents for internal heating system.

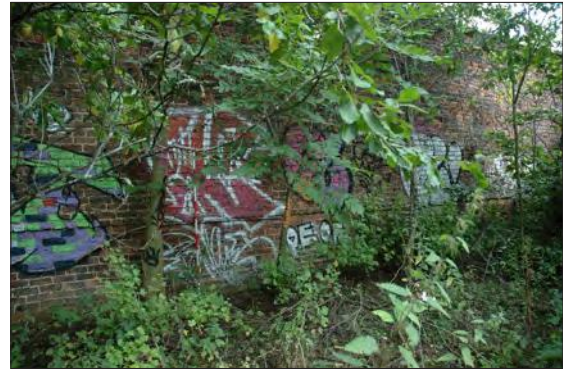
Plate 2: Hand cut bricks, north-east wall interior.

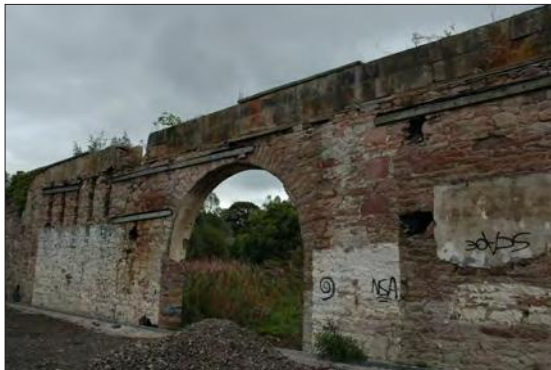
Plate 3: Entrance archway in north-west wall showing vertical vents, exterior elevation.

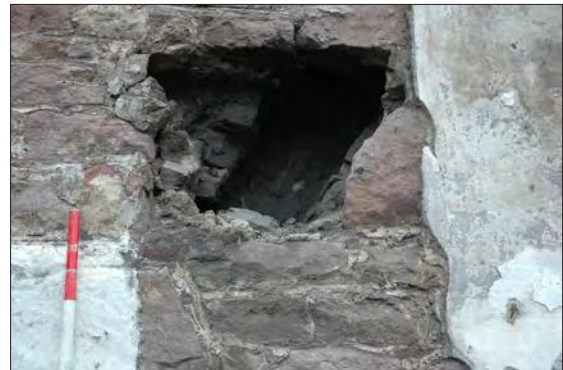
Plate 4: Detail of internal vent system.

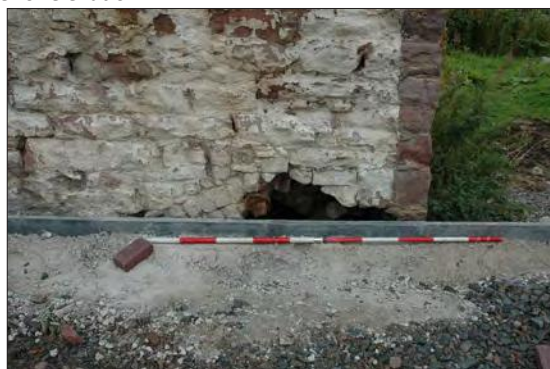
Plate 5: Detail of small blocked splayed arch.

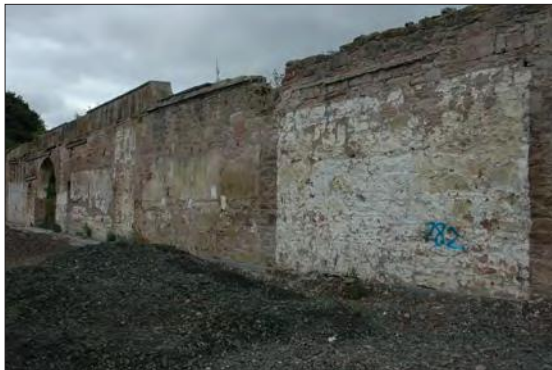
- 7.5.3 In addition to this there is evidence of several 'lean-to' structures having been constructed against the exterior of the north-west wall, all of which seem likely to have been later additions, probably twentieth century, and likely smaller buildings such as sheds or greenhouses. These are represented by areas of either paint or plaster work which appears to have been applied to the interior of the structures. Four distinct areas of this are visible, possibly representing four separate structures, although three of these lie adjacent to each other to the west extent of the wall and may represent divisions within a single lean-to, measuring between 5.2 m and 6.2 m in width (Plate 6). There are various fixtures present which are likely related to the later use or construction of these structures such as iron rings set into the stonework and a series of wooden beams set around the area of the archway which have the remains of plastic sheeting attached. Within one of the 'interior' lean-to areas to the west extent two modern blocked openings just above ground level are present, measuring 0.65 m by 0.75 m and likely related to the modern use of the lean-to.

Plate 6: Locations of later 'lean-to' structures, north-west exterior elevation.

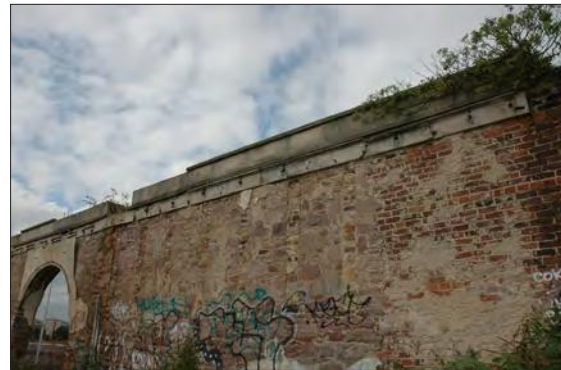
Plate 7: North-west wall interior elevation showing plasterwork.

- 7.5.4 The interior elevation of the north-west wall appears to indicate quite clearly the location of the former glasshouse structure on this side through a variation between stone and brick work, with the interior area having been of the same red sandstone brickwork as the exterior elevations, and the stretches beyond to the north and west of the same hand cut brickwork as the north-east and WNW interior walls, incorporating the heating system (Plate 7). The same vertical vents are visible as on the exterior, although these have been partially plastered over to the west of the archway, with some appearing to have been re-appropriated and used as later fixtures; this may have been later within the same structure. Various iron fixtures are also visible at the upper level set into a cement plaster coating which may have held or supported roof panels; again these seem unlikely original fixtures, but may represent later use of the glasshouse structure after the heating system fell out of use. The open archway sits centrally within what appears to be the area of the former glasshouse structure, implying that this may originally have contained a doorway of some kind which could be sealed; no evidence of this was noted, but may be obscured by the later surviving plasterwork on the arch interior.

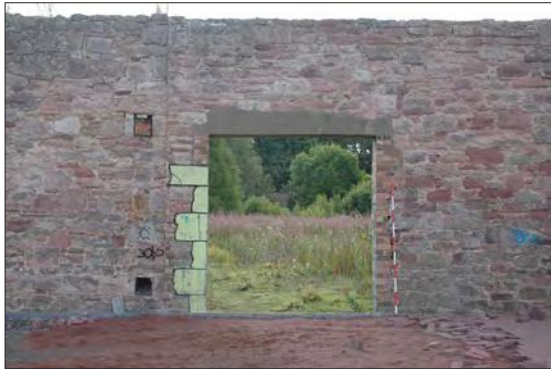
Plate 8: Entrance within west-northwest wall.

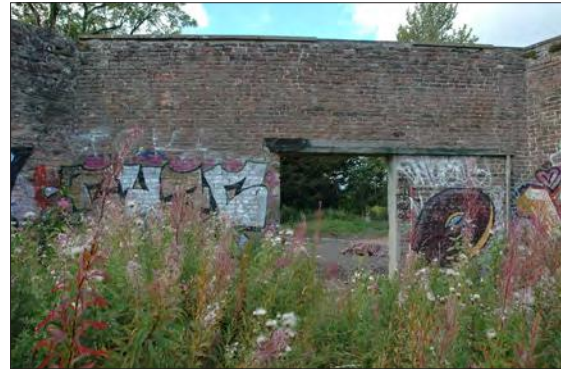
Plate 9: West-southwest wall internal elevation.

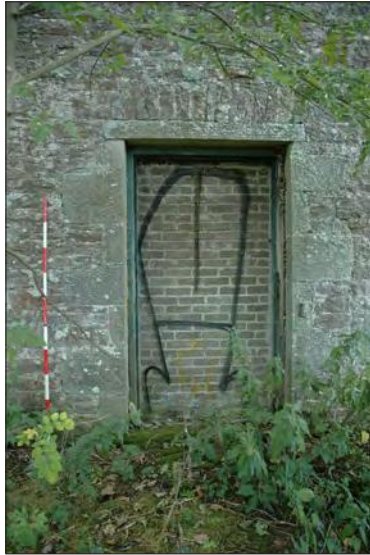
Plate 10: Doorway within south-west wall, interior elevation.

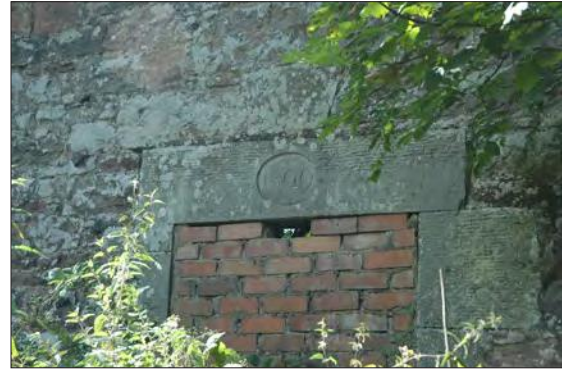
Plate 11: '1809' date inscription above south-east wall doorway: exterior elevation.

8.2 Also significant is the date of '1809' inscribed above the south-east doorway exterior. Given that both the doorways present to the south appear to be incorporated as original features, and as discussed above, the earliest cartographic depiction of the Walled Garden dates from 1828 with no such structure appearing on Johnson's 1777 plan (Plate 16), it could be reasonably suggested that this may represent the date of the original construction of the Walled Garden. Further survey of the exterior of the south-west wall if this is to be cleared and made accessible may reveal a similar inscribed date above the doorway here.

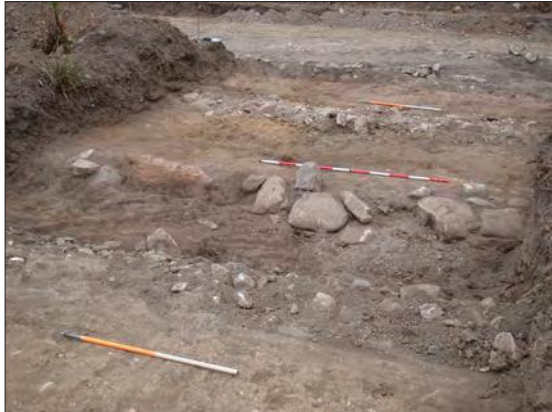
Plate 14: Linear wall, ditch and drain features within trench 6 from the south-east.

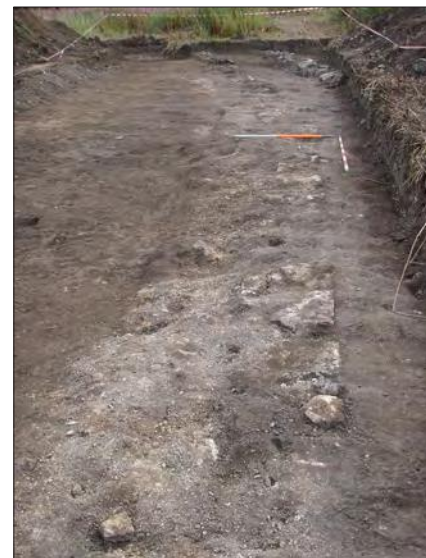
7.12.3 Wall 6005 is constructed of yellow sandstone and is visibly faced on the south-facing side (Plate 15). There is some degraded mortar between the stonework, implying that the blocks were at least partially bonded; these are sub-rounded and sub-angular in shape, measuring up to 0.5 m by 0.35 m by 0.15 m. The feature survives to a depth of 0.44 m, with no real cut distinguishable in the trench, and is 0.45 m-0.6 m in width. The feature curves from a more north-east/south-west orientation to more of an east-west alignment which was visible for the length of trench 6. The wall appears to be set into the corresponding ditch [6006]/(6007) at the south, likely constructed at the same time with the ditch possibly abutting the wall; this was similarly seen in the continuation of the features within trench 13. The wall likely represents an old estate wall, possibly even the boundary wall; as with the other features encountered here, it runs roughly in the vicinity of the former main road towards Edinburgh depicted on Roy's map of 1752-55 and Johnson's plan of 1777 before it was re-routed to the south along the existing route of the A7.

Plate 15: Stone wall [6005] from the west.

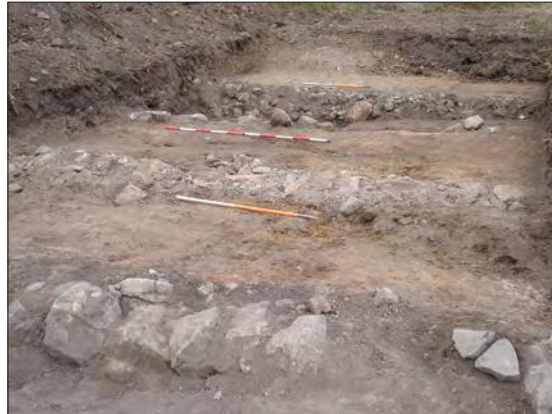
measuring 0.28 m by 0.17 m to 0.5 m by 0.35 m, surviving to 0.3 m depth and 0.65 m in width (Plate 17). It is possible that these two dry stone features represent the the route of a path or trackway, serving as boundary walls, however these features were not present in trench 13 and it is possible that they either continue to the south-west without curving off towards the west, or else may have terminated or been disturbed beyond this point. The stones [6008] are bounded on the south extent by a patchy red sandstone deposit (6009), which is a maximum of 0.35 m in width and 90 mm in depth and appears to be washed degraded sandstone; a similar deposit (6011) is visible to the north of stone feature [6012]. The stones [6012] are truncated by a shale drainage channel containing a square ceramic drain.

Plate 17: Linear features [6008]-(6015), from the north.

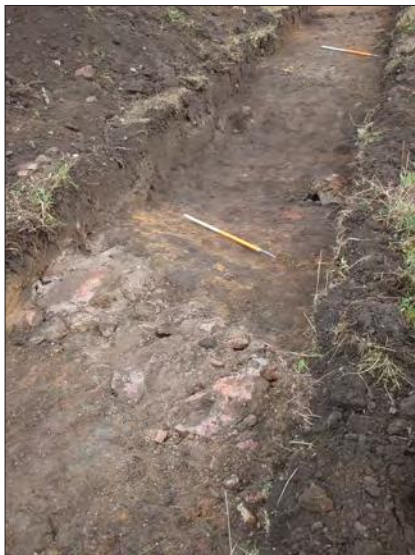
7.15.1 Several linear features were uncovered within trench 13, all of which appear to represent the continuation of the features encountered within trench 6 (Plate 18). These were initially hand cleaned, and then a sondage was machine excavated to establish stratigraphy and depths. These consisted of feature 13004, a linear band of irregular pink sandstone blocks measuring up to 0.51 m by 0.37 m, 0.84 m in width and with large voids between stones; this was orientated east/west and appears to be a continuation of the cundy drain [6010] encountered in trench 6.

Plate 18: Features (6004)-(6010) in trench 13 from the south-east.

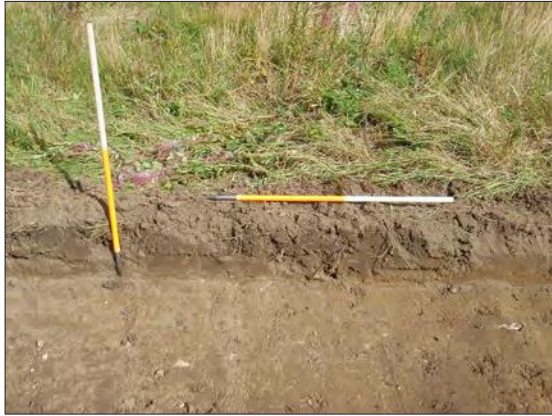
7.17.1 A likely stone pathway was revealed at the south-west extent of trench 25, aligning with the south-west wall on an east-west orientation (Plate 22). This consisted of three parallel deposits, including unbonded irregular stones [25004] measuring up to 0.37 m by 0.2 m in length and 0.14 m by 0.56 m in width and may represent a disturbed area of kerbing at the southern extent of the pathway or may have served as drainage for the path. The compact red-brown crushed gritty sand (25005) at 0.65 m wide formed the remains of a likely pathway surface contained within the stones either side, while the large irregular flat mixed sandstone boulders [25006] measuring up to 0.52 m by 0.28 m formed a flat surface to the north of the feature at 0.7 m width, likely kerbing or an edging surface to the compact (25005). The whole feature measured 1.68 m in width, and seems likely to be a former pathway leading around the edge of the Walled Garden. The feature was set into the upper ploughsoil (25003) at only 0.26 m below ground level implying it may have been in use relatively recently.

Plate 22: Pathway within trench 25 from the north.

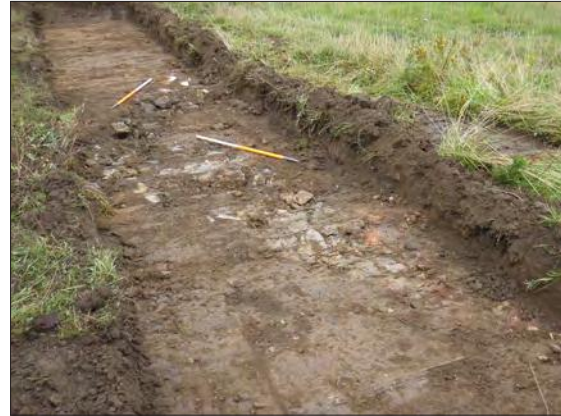
Plate 23: Glasshouse structural remains [26004]-
(26007).

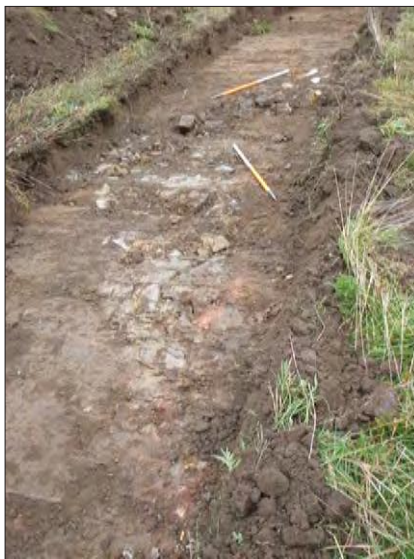
Plate 24: Detail of brick post [26004] and
division [26005].

7.18.3 In addition three small 'division' walls [26005] were revealed which are orientated north-west/south-east and appear to be made of the same bricks (Plate 24). These were thin at only one course wide, and were 0.51 m in length, surviving to around 4 courses or 0.35 m in height. These are too insubstantial to be structural, and likely served some kind of internal function such as support or dividers for raised planting beds.

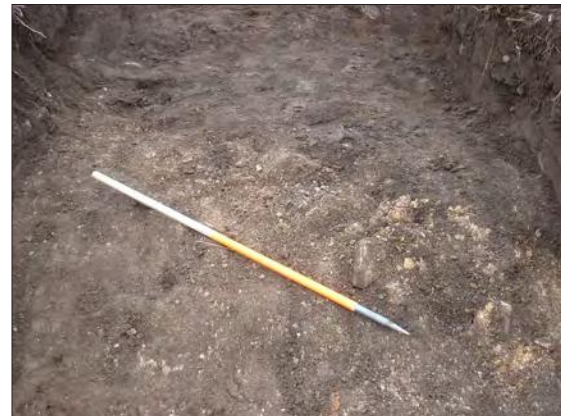
Plate 25: Stone slab floor [26006] from the north.

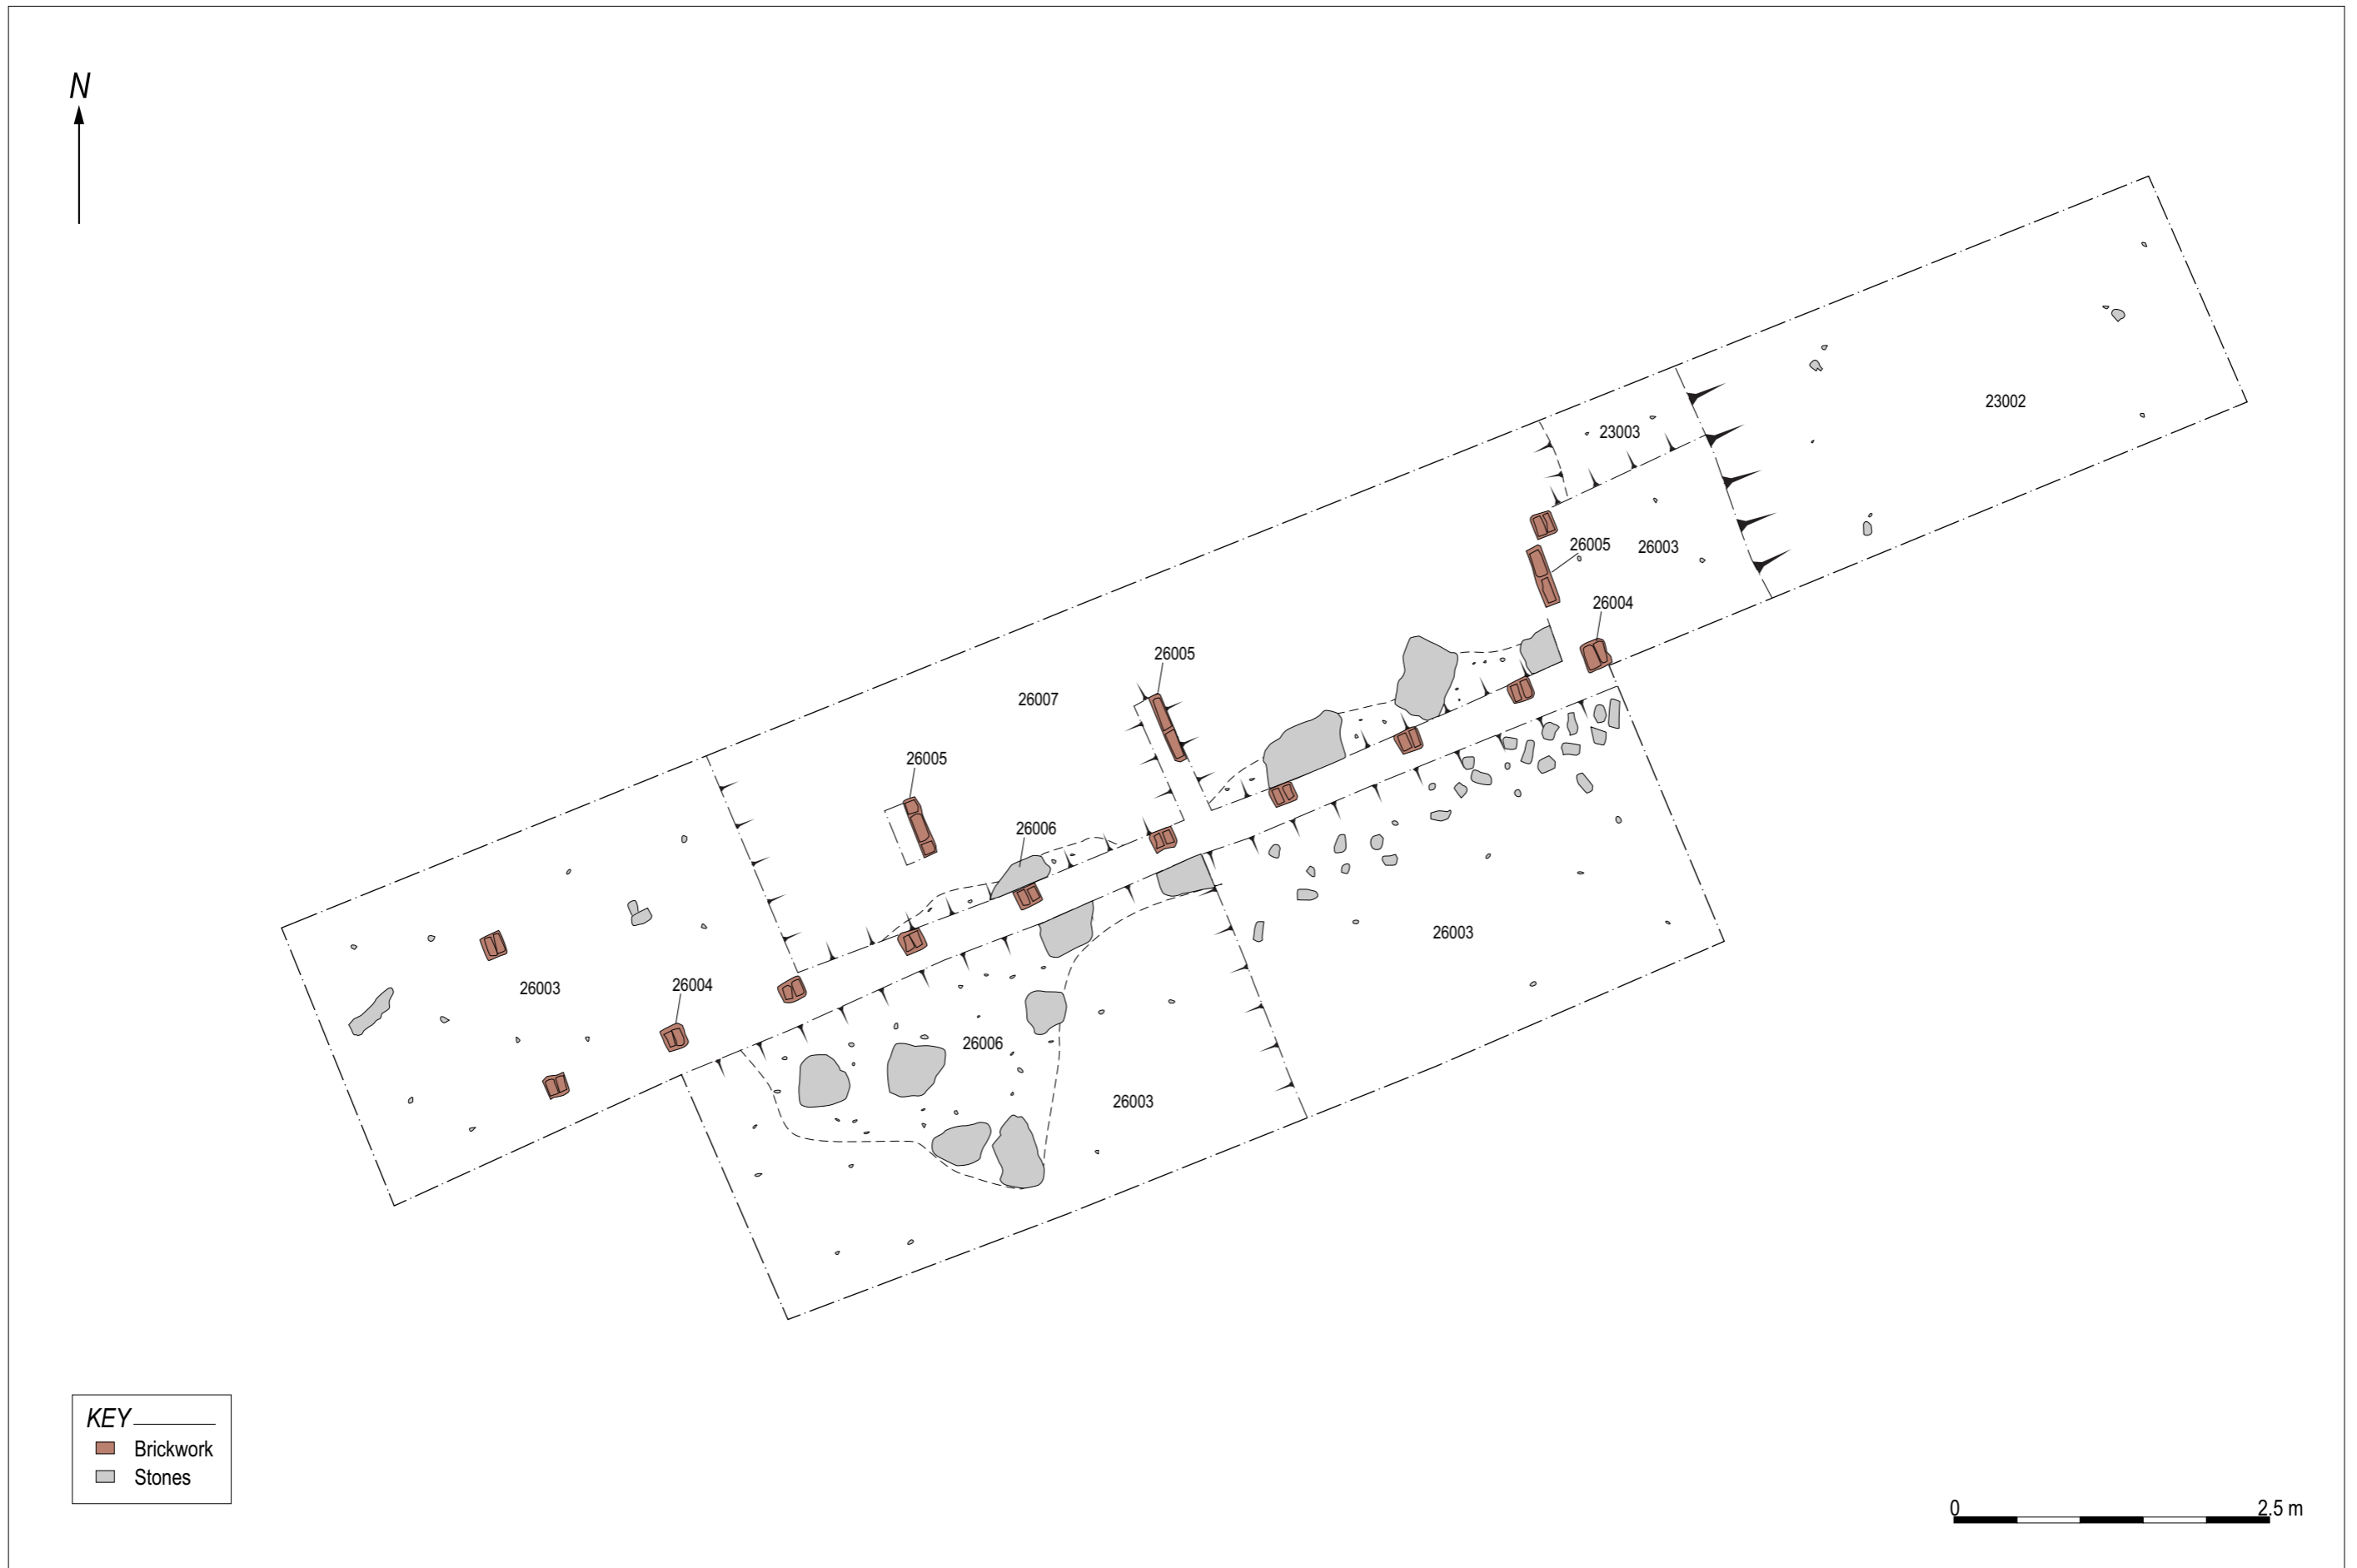
Figure 4: Trench 26 plan showing structural features [26004]-(26007).

7.18.2 The structural remains consist mainly of a series of bonded brick posts [26004] orientated north-east/south-west along the length of the trench, parallel to the north-west wall, which likely represent the exterior extent of the structure to the east. A total of twelve of these were revealed, with two seen returning towards the north-west, both at the extent of the plaster work to the north, and towards the north side of the archway to the south. The posts are formed of courses of two bricks alternately arranged to form a 0.26 m by 0.26 m post, situated around 0.92 m apart; these survive in general to roughly 4 courses and appear to be partially demolished at the upper level (Plate 24). The brick dimensions are 0.25 m by 0.12 m by 70 mm; no manufacturer's stamps were visible but these were industrially produced. Given that the posts sit above the stone floor [26006] it seems that these are more likely supportive than foundational, and may have had some other material in between, or have supported an upper roof covering.

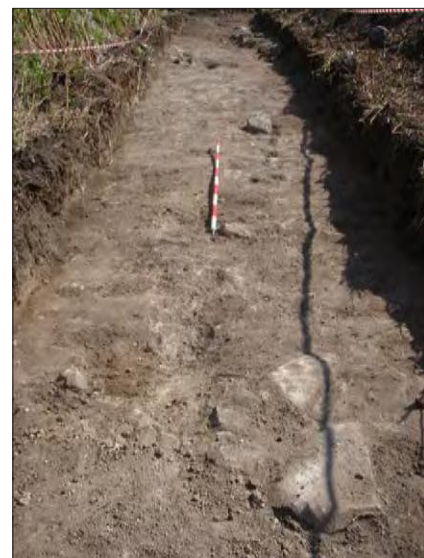
7.20.1 Further structural remains were also uncovered within trench 28 (Plate 26), although these are likely relatively modern at only 0.15 m-0.25 m below ground level. These comprised of what appears to be a single structure [28004] which likely abutted the WNW wall, as the foundations uncovered are situated running parallel to this, only 2.8 m to the east; however no corresponding marks were visible on the wall.

Plate 26: structural remains [28004] within trench 28 from the north.

7.20.3 The structure is likely twentieth century, possibly even connected to the later market garden use of the Walled Garden, and fully demolished at ground level.
