**Halbeath, Dunfermline, Phase 1,
Heritage Statement
Project 5211**

On behalf of: Geddes Consulting

Project Number: 5211

Report by: Maureen C. Kilpatrick

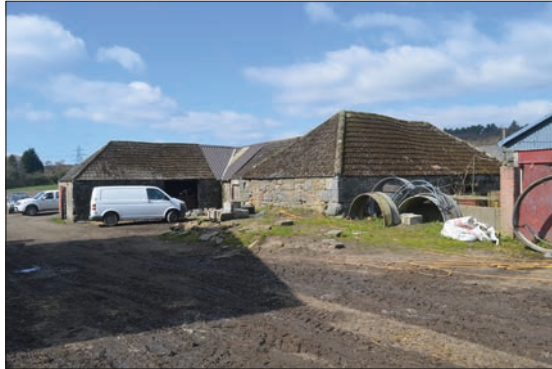
7.1.1 The steading was a C-shaped building comprising a single storey set around a courtyard area (Figure 4, Plate 1). It was constructed of roughly rectangular yellow/brown sandstone blocks 001 with larger, dressed sandstone quoin stones 008 at each corner (Plate 2). Many of the external stones had surface weathering and spalling, with degraded and missing mortar noted in several areas. The stones in the lower courses of the West Range adjacent to a drainage gully were particularly badly affected (Plate 3). In several areas of the building, eroded mortar had been patched using cement. Several areas of the external walls had collapsed, with masonry missing at North Range elevation 4 (Plate 4), where one section had been partially repaired using bricks, and elevation 6 of the East Range where there were obvious gaps in the stonework. North Range elevation 8 contained a large crack on its external masonry.

Plate 1: General view of steading

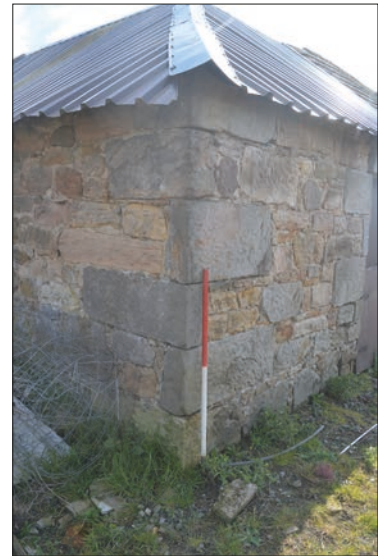
Plate 2: Quoin stones at north-west corner of steading

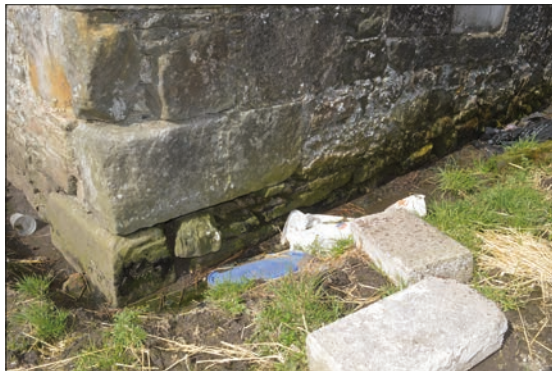
Plate 3: Missing mortar on east wall of West Range

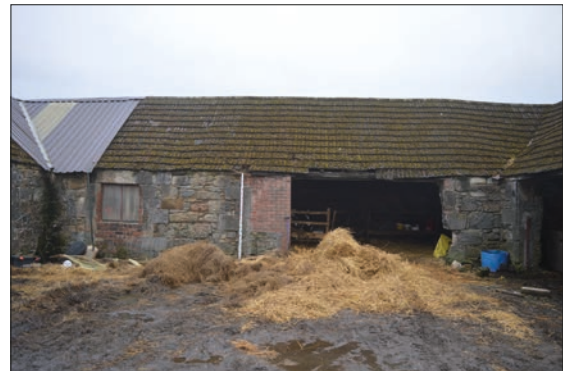
Plate 4: Repair to south exterior wall of North Range

- 7.1.2 The North Range measured 23 m in length, the East Range 11 m and the West Range 15.5 m externally. The exterior walls were 0.56 m thick and between 2.1 m and 2.6 m high.
- 7.1.3 The steading's hipped roof was covered in concrete tiles (003) with half-round ridge tiles held with strips of lead. Cast iron sheet valley guttering overhung the eaves of the roof and drained into water butts below. Several tiles were missing, particularly in the North Range elevation 4 exposing the wooden lintel below (010). The roof had notable sagging in several areas and moss covered many tiles. In several sections of the West and North Ranges, the tiled roof had been replaced with corrugated sheeting (Plates 4 and 5).

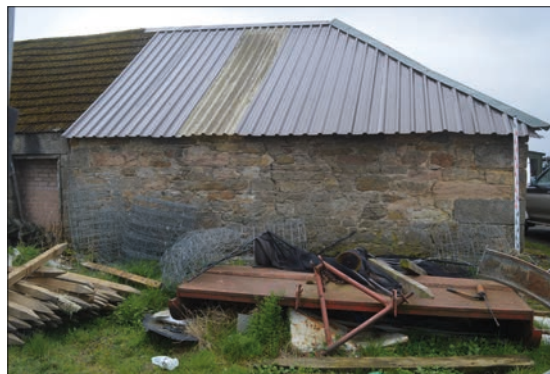
Plate 5: Corrugated sheeting on roof of North Range and crack in stonework

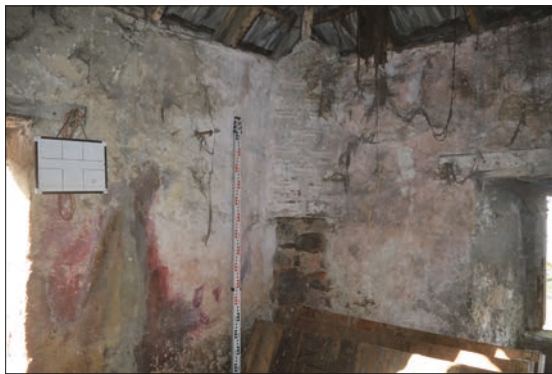
7.1.5 The West Range rooms were roughly square in shape, with the southern room (Room 1) measuring 4 m by 4.5 m and the northern room (Room 2) 4.5 m by 4.5 m. Room 1 walls were covered in a very degraded and patchy lime wash although much of the stone work was exposed. In its southern corner was a brick chimney structure measuring 0.45 m in width and 1.1 m in length. This had been added at a later date, although no external vent was evident (Plate 6). The chimney extended from the top of the wall, where it met the roof, to half way down the wall where it ended, presumably at a point where a heater or wood burner had been located. The chimney bricks had been plastered over and white washed. Room 1 had windows on opposite sides which had 0.5 m deep internal window recesses (Plate 7). The west window measured 1.26 m by 1.22 m and the east window measured 1.26 m by 1.09 m. The remains of plaster and lath were visible at the top head frame of the west window. The east window had been blocked-up using breeze bricks (Plate 8). An entrance located at the south measured 2 m by 1.05 m with the door jamb projecting 50 mm around the doorway (Plates 8 and 9). Plaster and lath covered the door lintel frame and the ceiling, which was much degraded with the underlying roof timbers mostly exposed.

Plate 6: Room 1 of West Range with white wash on walls and brick flue in south-west corner

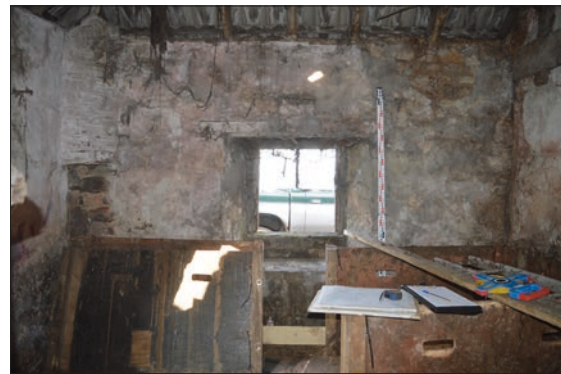
Plate 7: Internal window on west wall of West Range, room 1

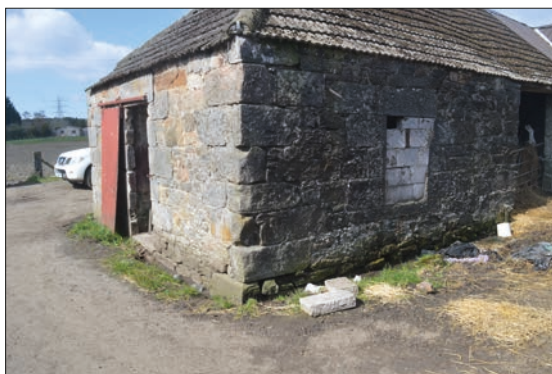
Plate 8: East wall of West Range showing blocked window and doorway

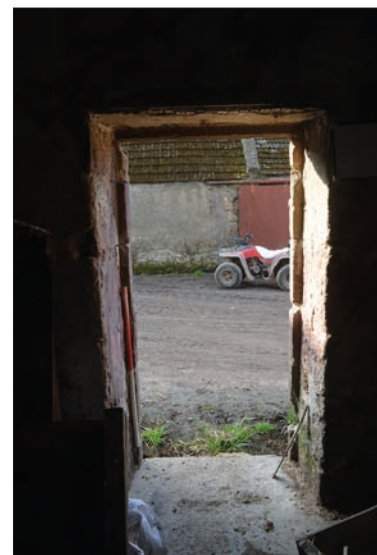
Plate 9: South interior wall of West Range showing internal door jamb surround

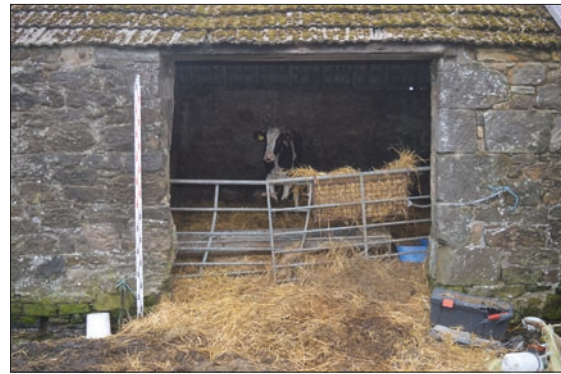
7.1.7 On the eastern wall of room 2 was a large doorway 2 m high with similar projecting door jambs of 50 mm. Its lintel was a large wooden plank 010 rather than stonework found in the smaller doors and windows throughout the steading. This room was in use as a byre and contained a young calf (Plate 10).

Plate 10: East wall of West Range showing wooden lintel over doorway

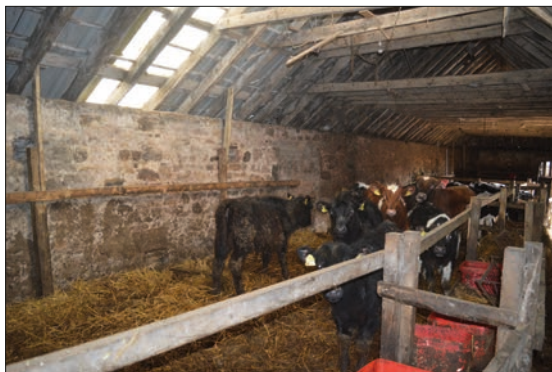
7.1.8 The North Range contained the largest internal space at 21.5 m by 4.5 m. Not unlike Room 2, this was in use as a byre containing young calves (Plate 11). The walls had been white washed although most of the stonework was exposed. This range had brick-blocked doorways at the north, south and east with those at the south and east now functioning as wooden-framed windows, although only that at the south contained glass (Plate 4; Figure 5). The doorway on the west wall was a modern wooden half door with metal hinges (Plate 12). On the south wall, was a large doorway 2.7 m wide with a projecting door jamb on its eastern side only. The western side was very degraded and had been rebuilt using brick (Plate 4). The door lintel was a large plank of wood 010 which had been partially exposed at its eaves due to several missing roof tiles. Above each door and window were large rectangular roughly dressed lintel stones (005 and 006) which ranged between 1.23 m and 1.6 m in length, and measured between 0.31 m and 0.36 m in height. The lower window sills were slightly smaller in size although of similar stone. The door and window jambs were constructed of similarly dressed stone.

Plate 11: Room 3; North Range

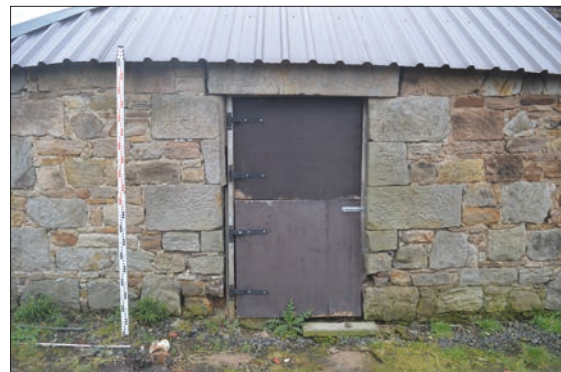
Plate 12: West wall of West Range showing door

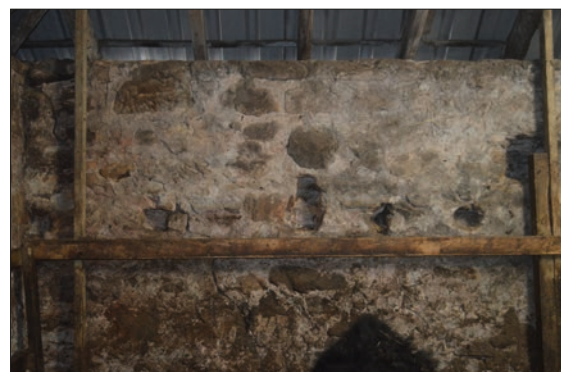
7.1.9 At the west end of the northern internal wall were six roughly square beam slots approximately 2 m above the floor level (Plate 13). Only one beam slot was observed on the opposite wall, 1.45 m above ground level. It measured 0.17 m by 0.2 m with a depth of 0.16 m. These are, presumably, the remains of a possible loft, although from the near absence of beam slots in the southern wall, the loft might have been more akin to a mezzanine floor that did not stretch the full width of the building. Unfortunately, due to the presence of livestock, the floor in the North Range could not be inspected for any architectural features.

Plate 13: Beam slots at southern end of North Range

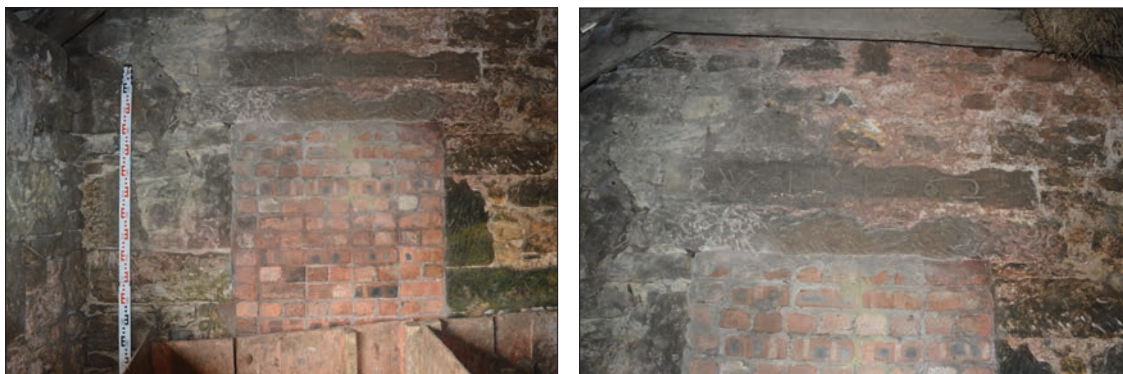
7.1.10 Room 4 was located in the East Range and measured 6 m by 4.5 m. It was similar in construction to the other rooms and had previously been used as a byre, although was empty of livestock at the time of the survey. It contained one brick-blocked doorway in the north wall which measured 1.73 m by 1.6 m. Above the nineteenth century door lintel was an older lintel which had presumably come from an earlier structure. It was inscribed 'RW – IL 1662' (Plates 14 and 15). On the room's west facing wall was a large doorway with chamfered surround. It measured 2 m in width and had a large wooden door lintel 010, similar to those in the North and West Ranges.

Plates 14 and 15: Brick blocked doorway in Room 4, East Range with inscribed lintel

- 8.4 The seventeenth century lintel stone incorporated into the steading may be a remnant from an earlier building which occupied the site, possibly that recorded by Blaeu and Gordon in 1662.

- 9.1 Following the Level 2 HBR survey of Wester Whitefield steading and former farmhouse, GUARD Archaeology would recommend that no further archaeological mitigation is required for these two structures.
- 9.2 We would, however, recommend that the inscribed lintel stone be retained and appropriately incorporated into the Phase I development.

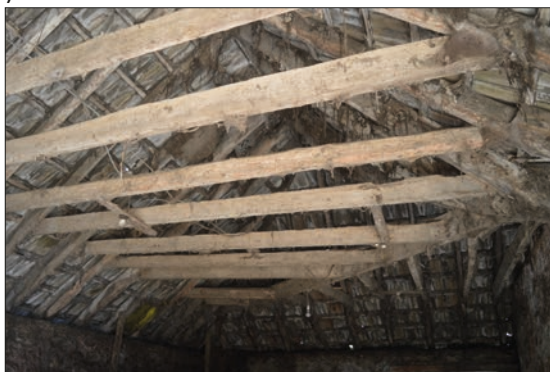
7.1.11 The internal roof was mostly exposed in all the rooms, except the remains of some plaster and lath and rafters in Room 1 of the West Range. The roof was A-framed with side purlins 013 and was positioned directly on the walls. The roof tiles 003 sat directly on the A-frame with no roof battens present (Plate 16).

Plate 16: A-frame roof

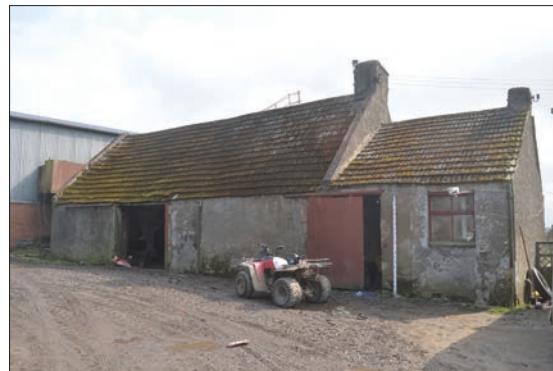
7.2.1 The farmhouse was axially related to the steading on its southern side and was also a single-storey building (Plate 17). It was rectangular in shape and measured 15.5 m by 6.5 m externally and comprised two rooms (Figure 6). The walls were of similar construction to the farmstead, comprising yellow/brown sandstone 015 with mortar. Externally, much of the wall surface was covered with pebble-dash concrete render 011. The render was degraded in several areas, revealing the underlying stone.

Plate 17: North exterior wall of farmhouse

7.2.2 The roof was gable ended with the smaller room having a lower lean-to roof (Plate 17). The roof was covered with tiles 003 similar to the steading roof and had significant moss growth. Two chimneys were positioned at the gable ends of both rooms. The eastern gable end was 5 m high, while the western gable end was approximately 4.5 m high.

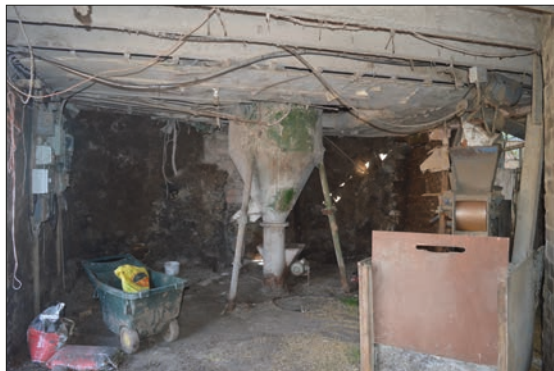
7.2.3 The larger room measured 10.2 m by 5.2 m internally with the walls being 0.54 m thick. Internally, the room had been much adapted and was now used as a milling shed. A large hole in the south wall led to the grain silo situated outside (Plate 18). A modern brick wall (Plate 19, Figure 5) divided the room in its south-west end. This area could not be accessed as it was being used to store farm machinery. This brick wall obscured the fireplace, a blocked window and a bricked-up doorway. Both the window and doorway could only be observed from the exterior (Plate 20).

Plate 18: Larger room at east end of farmhouse

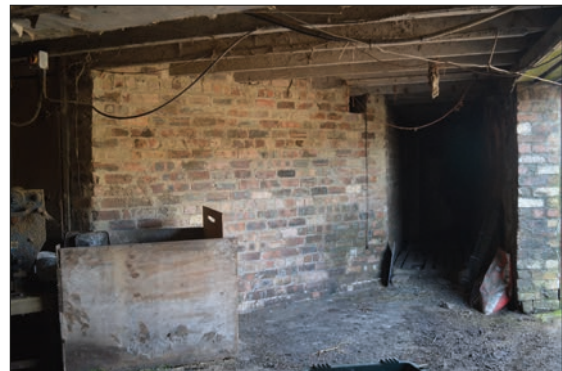
Plate 19: Brick wall in large room of farmhouse

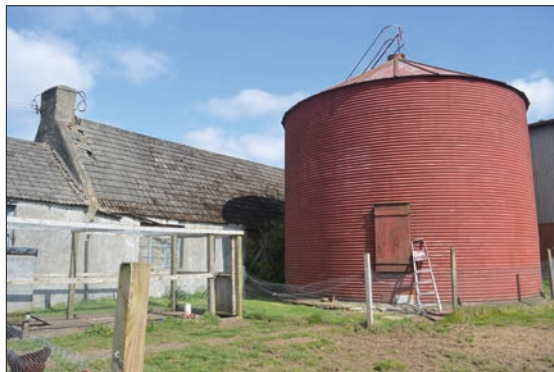
Plate 20: South exterior wall of farmhouse

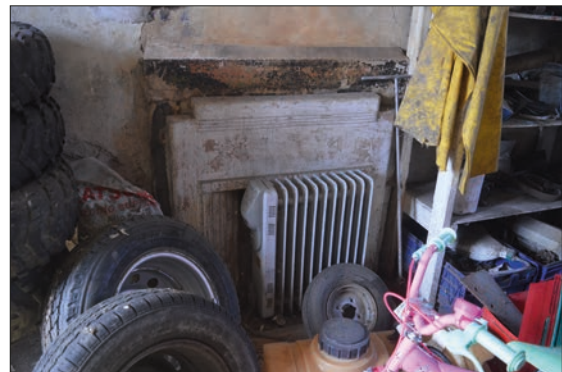
7.2.4 The smaller room measured 4 m by 5 m internally. A fireplace on its western wall was partly obscured by a later fire surround and modern heater (Plate 21). The walls were plaster and the ceiling comprised the remains of plaster and lath. Sash windows with wooden surrounds and deep recesses were located on the north and south walls; these measured 1.58 m by 1 m. An external doorway on the north wall was 2 m high and 1.2 m wide.

Plate 21: Fireplace in small room of farmhouse

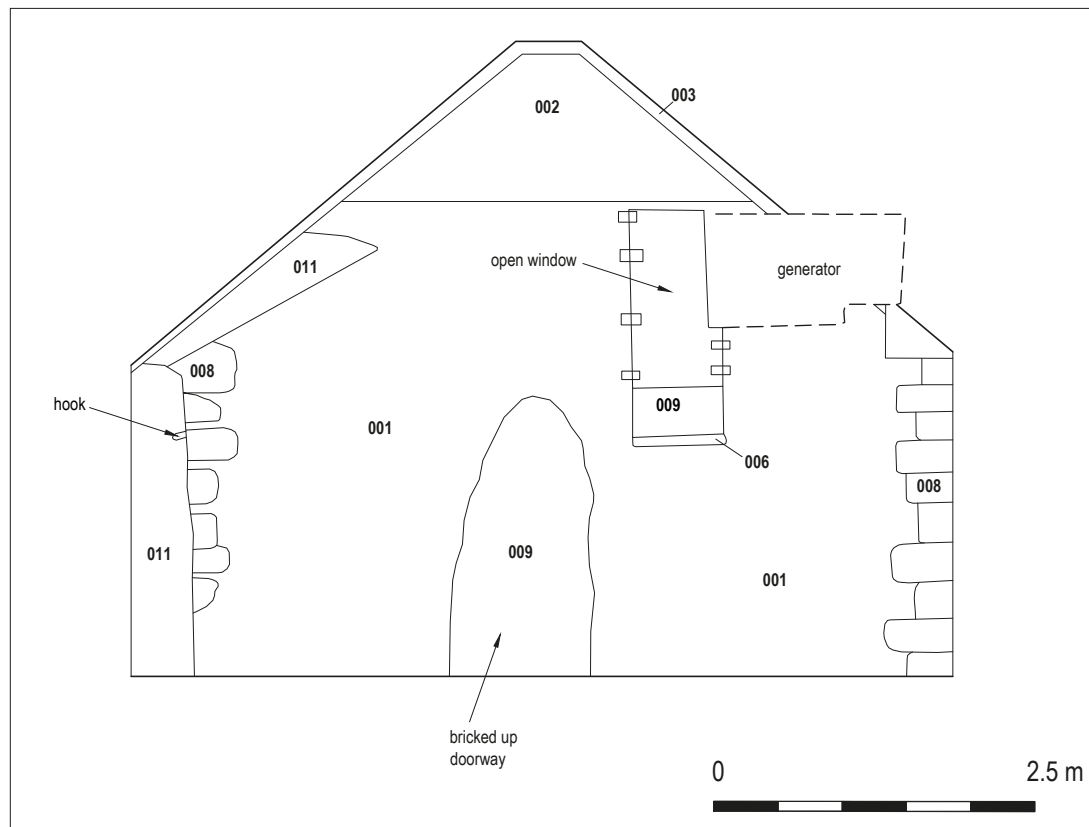
Figure 7: Eastern gable end of Building 2 (Farmhouse)

7.2.5 On the eastern gable end were the remains of a much-degraded brick-blocked doorway with many of the surrounding stones either absent or loose (Figure 7). A small step was noted inside the house at the position of the doorway. A window in the gable end had been partially blocked with the same stone used to construct the building. Much of the stonework above the window was missing and a large metal tank was positioned in this area although it was not completely fixed to the wall. The top of the gable end was covered with corrugated iron sheeting.
