SUMMARY

1. INTRODUCTION

Cumbria County Council Historic Environment Service (Development Control) was consulted by West Cumbrian Rivers Trust regarding the demolition of a series of former bridge abutments and piers associated with the former Cockermouth and Workington Railway near Camerton, Cumbria (figure 1).

The study buildings are located at three locations; NY 039 307, NY 046 306 and NY 049 303.

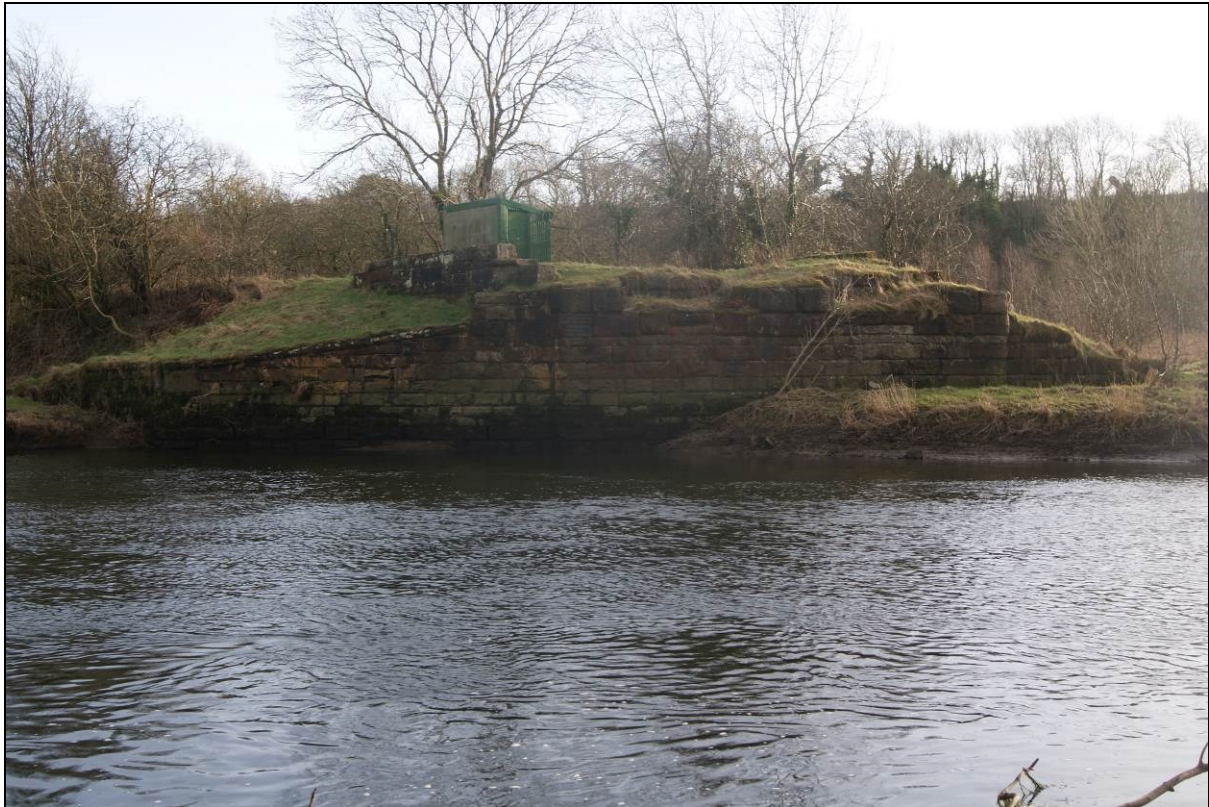
The eastern bridge abutment appeared to be in good condition and fully extant (figure 11) located at NY 04882 30399.

Silt had accumulated in front of the bridge abutment suggesting that the southern side of the river had developed into slow moving water.

Figure 11. Elevation of the eastern abutment, Ribton High Bridge

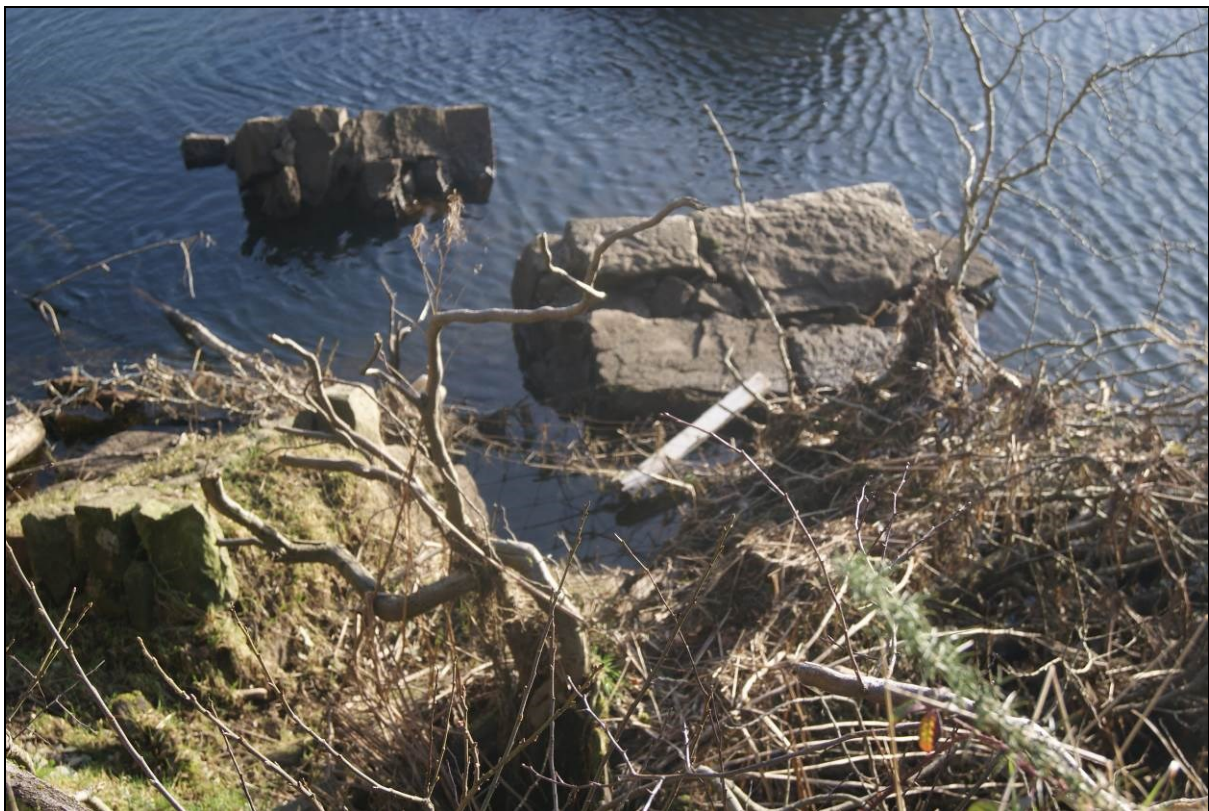
The western bridge abutment (NY 04940 30375) had been totally removed by river erosion (figure 13). Forming obstructions within the river, bonded blocks were littered in close proximity, some resting on the western bank of the river.

Figure 13. Remnant masonry blocks that had formed the western bridge abutment

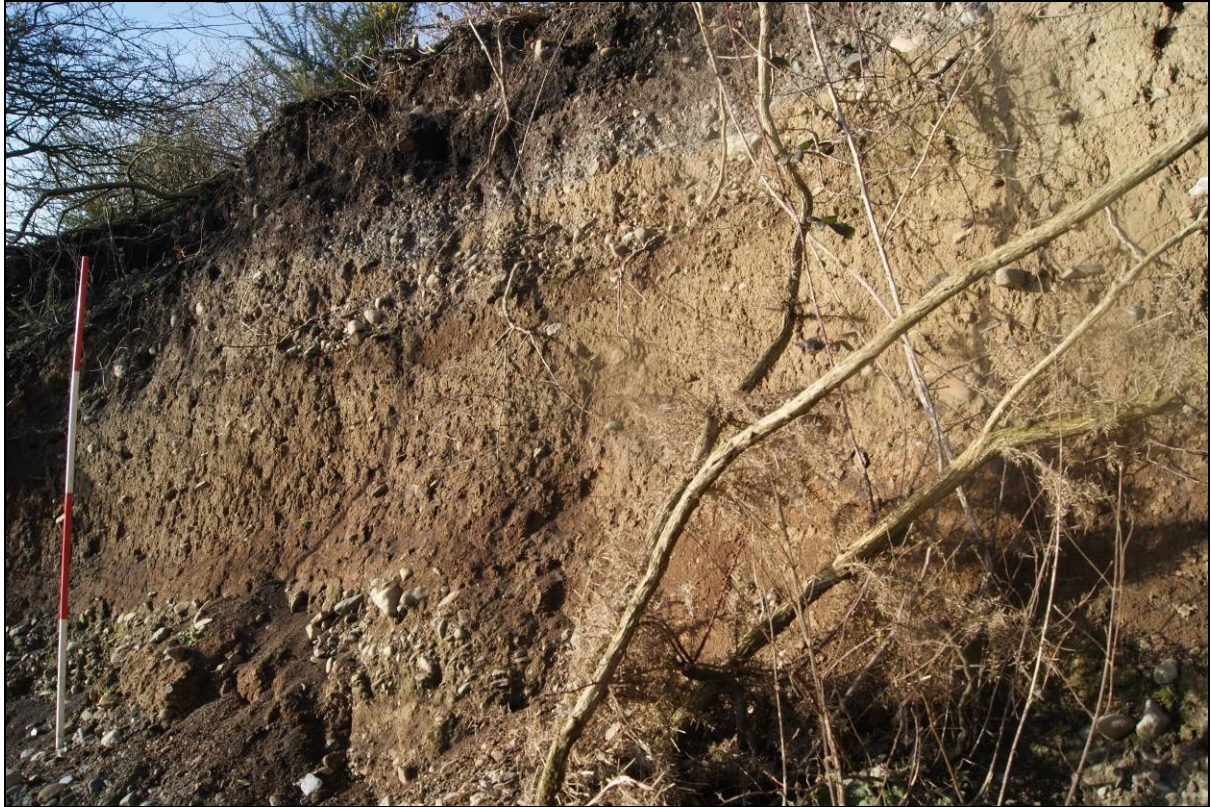
Erosion by the river had produced a steep section partly illustrating the embankment formation that conjoined the lost bridge abutment (figure 14). This comprised of a band of gravel approximately 0.40m in thickness overlying a thick deposit of homogenous light brown clay measuring 1.50m in depth that rested above gravel. It was not entirely certain whether this material was natural drift geology or re-deposited clay, dumped to form an embankment.

Figure 14. Eroded bank, location for the former western bridge abutment

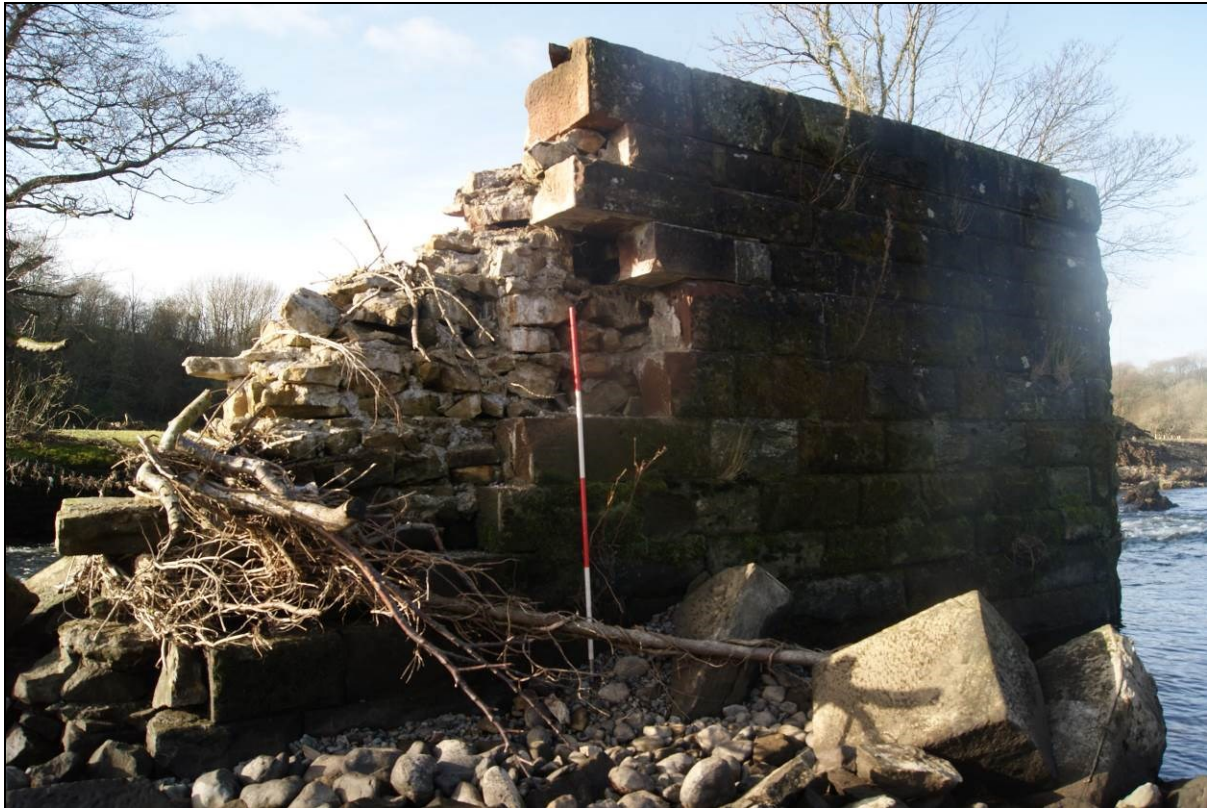
Pier 5 was located within the river channel and had been severely damaged on its southern flank by an errant tree (figure 31).

Figure 31. Pier 5 showing eastern elevation

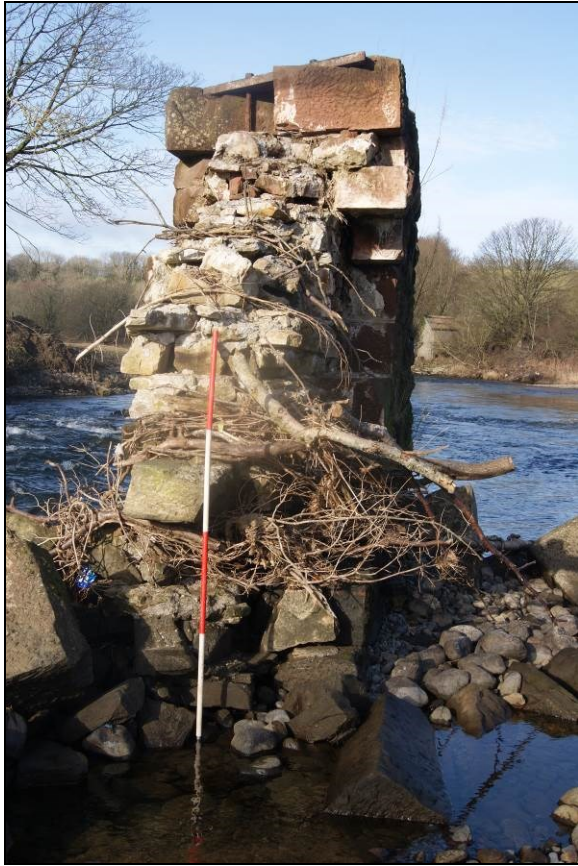
The pier was constructed from a skin of eleven courses of concordant, rough-hewn, red sandstone blocks with a rubble core that had been consolidated with poured concrete (figure 32).

- Both northern and southern ends possessed pointed faces facilitating the efficient flow of the river albeit the pointed southern face now destroyed by flood damage.
- The top course consisted of dressed stone blocks.
- There was no architectural embellishment present.
- The southern end had been bolstered by later concrete and stone on the western side.
- At the top of the pier were bolted iron plates.

Figure 32. Southern elevation, Pier 5

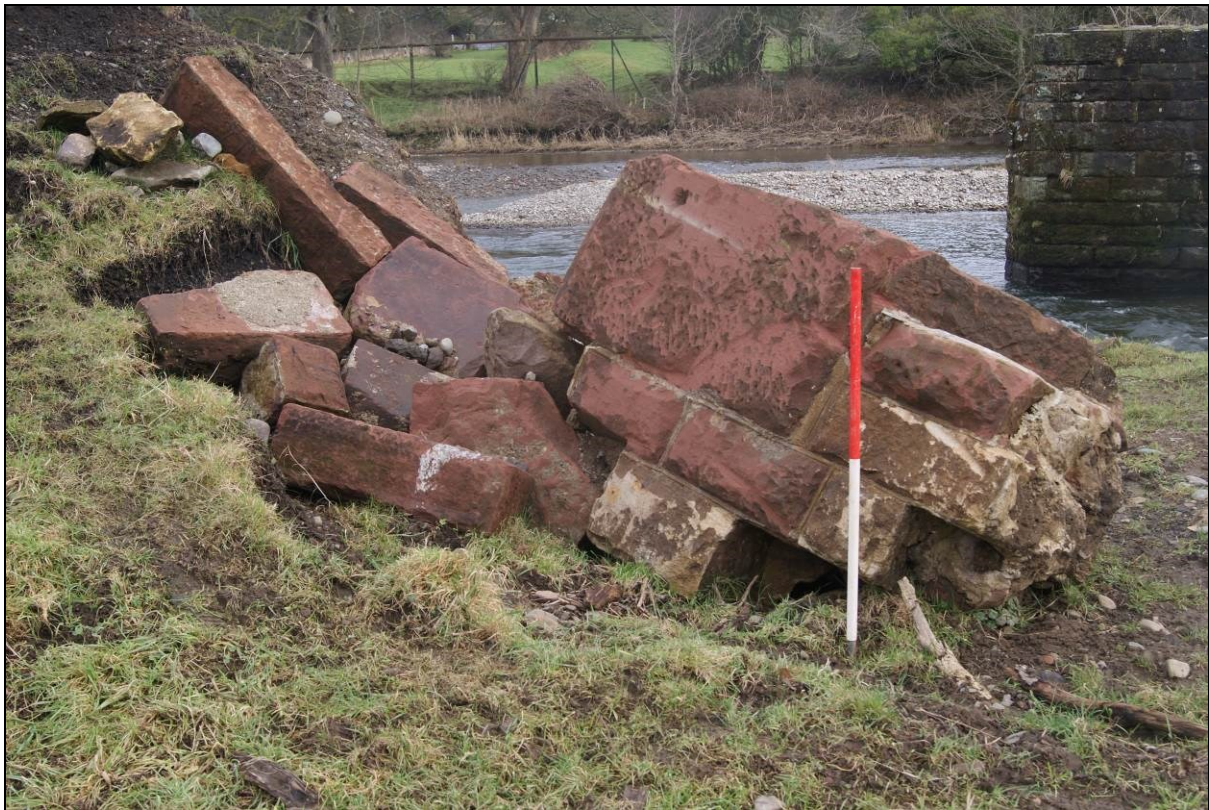
Figure 34. Debris from the former western bridge abutment

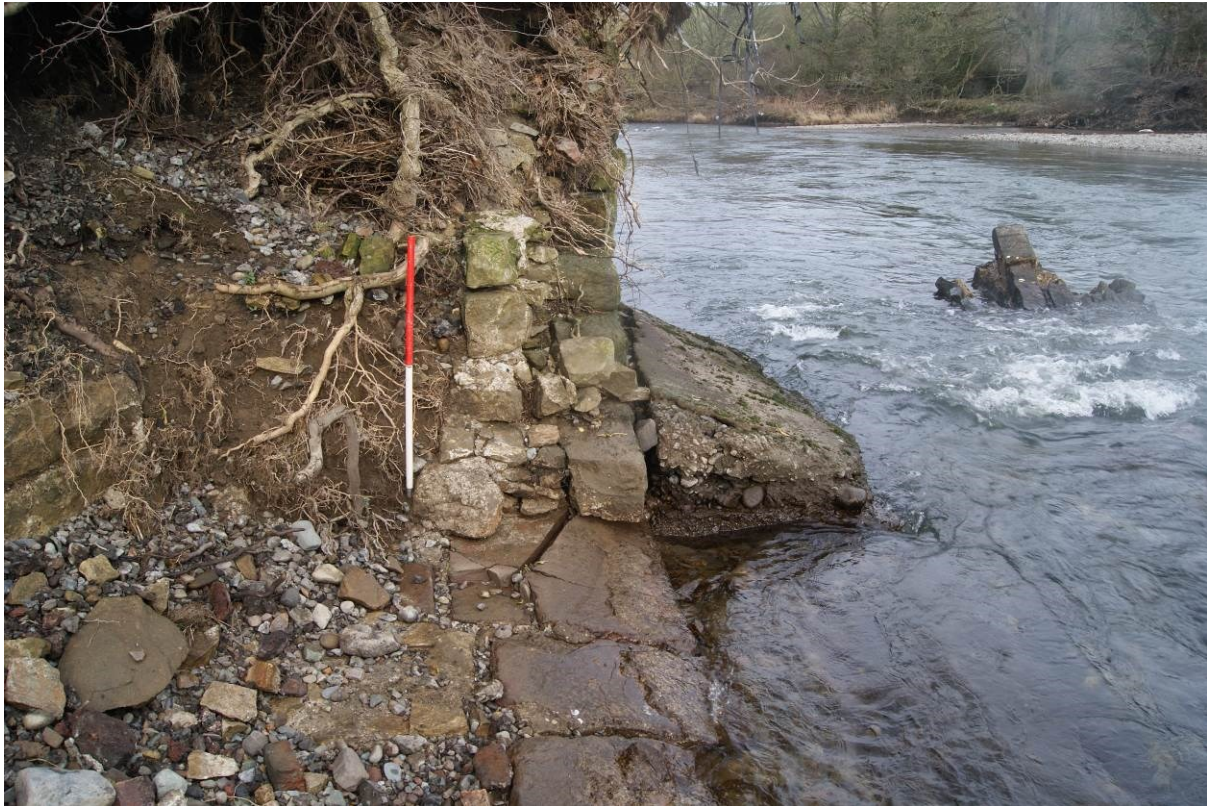
In cross-section, the retaining wall for the bridge abutment appeared to be crudely constructed. The base of the wall appeared to comprise red sandstone blocks forming a wide plinth. The overlying wall was poorly grouted onto this plinth consisting of an outer red sandstone skin and an inner rubble-stone wall. Within this void, rubble core had been deposited (figure 35).

Figure 35. Western bridge abutment showing a cross-section through the former stone wall skin

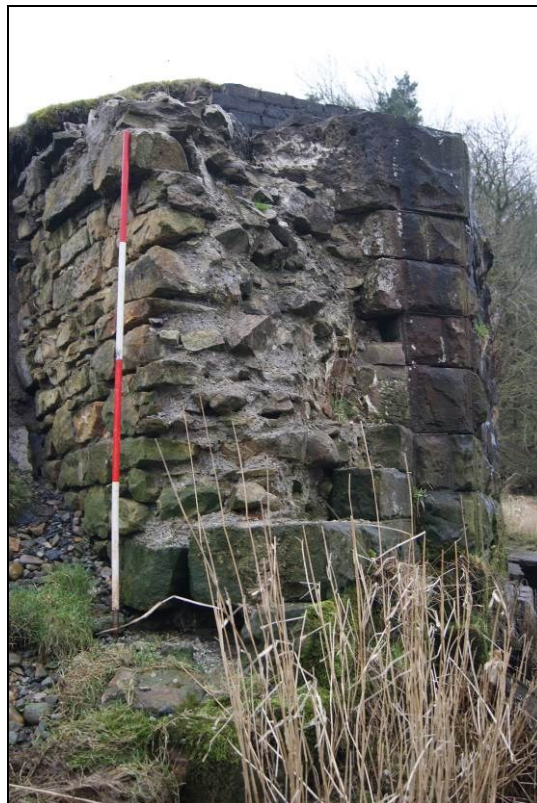
Figure 40. Cross-section through bridge abutment fabric

On the north side of the bridge abutment, the river has removed part of the building fabric thereby illustrating an outer skin of red sandstone and a coarse inner yellow rubble sandstone wall filled with rubble core consolidated by poured concrete (figure 40). This configuration was 2.00m in thickness.

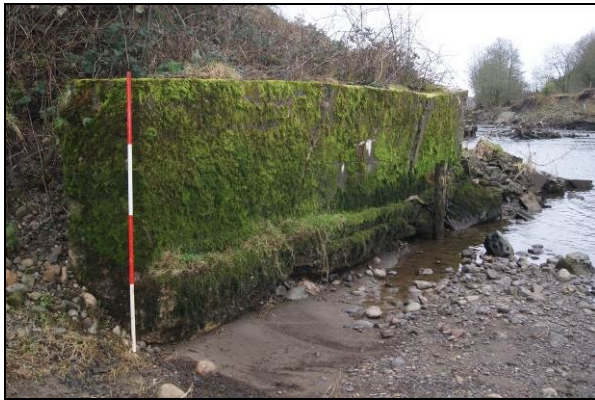
Following the retaining wall eastwards, this area was liable to flood damage. In 1922 the embankment was bolstered by a concrete retaining wall measuring 9.60m in length, 2.00m in height and 0.80m in thickness that only partly survives (figure 41), the masonry wall now lost.

Figure 41. Extant concrete wall built in 1922

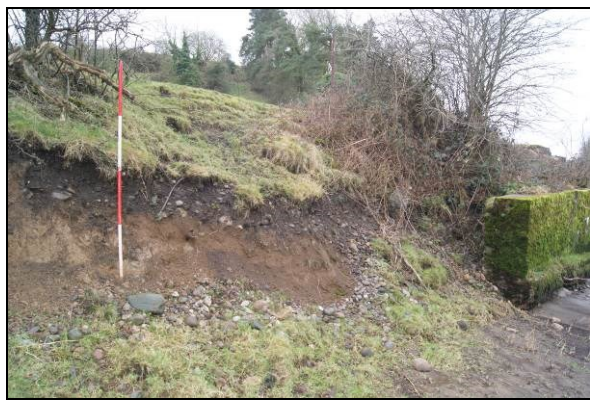
This flank has been undermined where it meets the embankment, revealing a horizon of coarse sand or gravel overlain by a linear bank of light brown clay surmounted by a thick spread of cinders (figure 42).

Figure 42. Partly robbed embankment

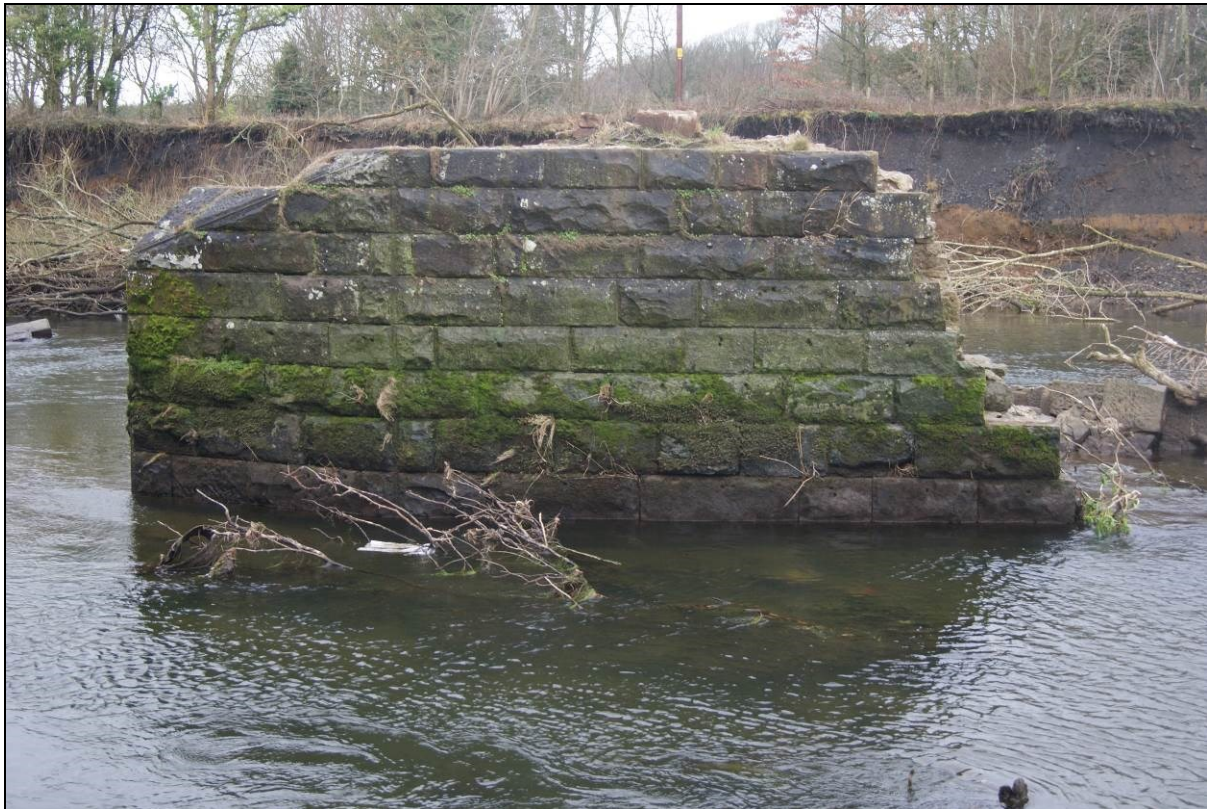
Figure 46. Southern elevation of Pier 1, Camerton Bridge

The pier was constructed from a skin of at least eight courses of concordant, rough-hewn, red sandstone blocks with a rubble core that probably had been consolidated with poured concrete. The tail of the abutment had been severely damaged by flood damage (figure 46).

- The western end possessed a pointed face facilitating the efficient flow of the river whilst the pointed eastern face was destroyed by flood damage.
- The top course consisted of dressed stone blocks.
- There was no architectural embellishment present.

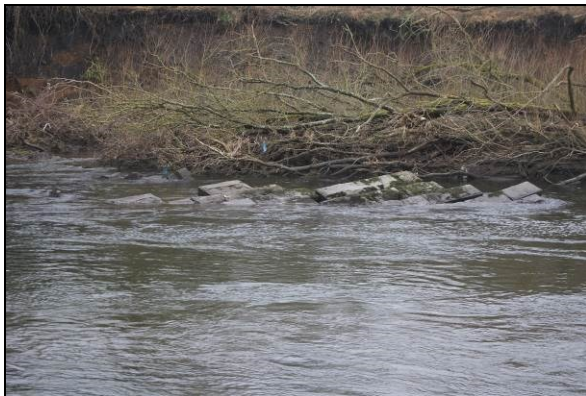
Pier 2 had been completely destroyed by flood damage with just some of the toppled superstructure still visible (figure 47).

Figure 47. Location of fallen Pier 2

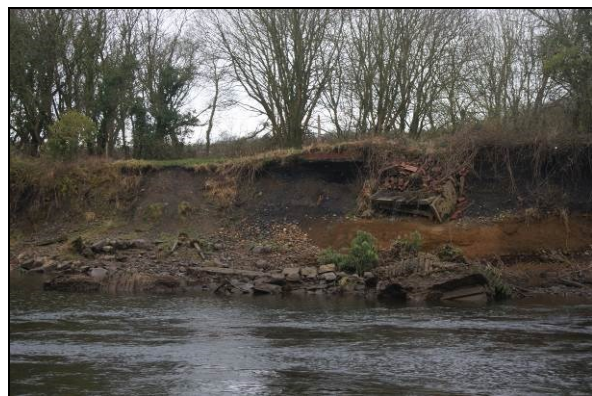
The western bridge abutment (NY 03885 30610) had been washed away by flood action leaving only some fallen masonry and a section in the bank showing natural sand and waste from the former Camerton Colliery (figure 48).

Figure 48. Location of former western abutment
