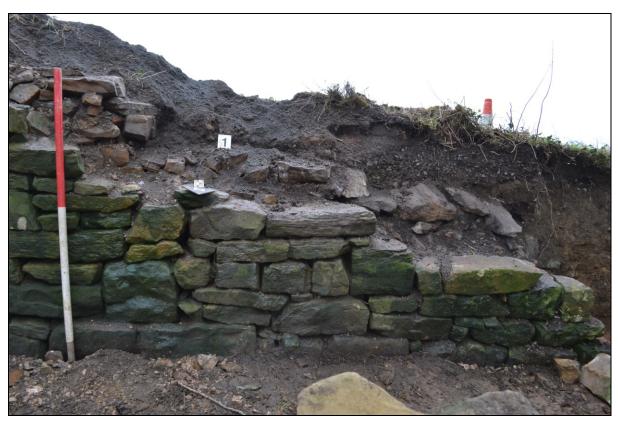
Figure 5. Intervention 1 following removal of loose and extraneous masonry

The retaining wall at Intervention 1 (NY 57608 64785) was found to be in relatively good condition and that only the upper masonry required removal.

The retaining wall was reduced by approximately 0.60m in depth from road height over a 1.50m length (figure 5). The remains of the Scheduled Monument was not exposed at this location.

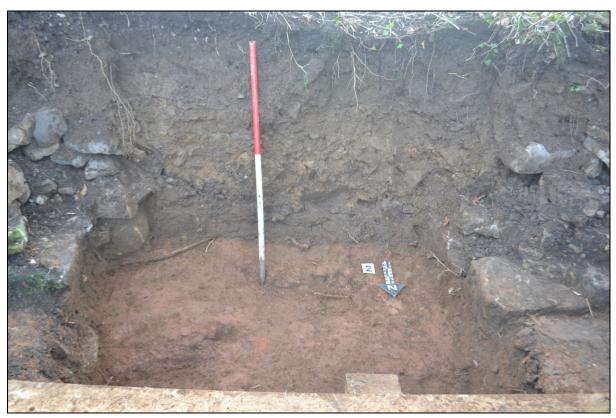
Figure 6. Intervention 2 following removal of the retaining wall

The retaining wall at Intervention 2 (NY 57605 64784) was found to be in poor condition and the masonry required removal down to foundation level. The intervention measured 4.00m in length with a stretch measuring 1.50m in length and 1.20m in width reduced to a depth of 1.25m examined in detail.

The footing for the retaining wall comprised of a 0.80m wide base formed from two large stones. Above the foundation was a rear southern wall built against the side of the construction trench respecting the road (figure 11). The narrow gap within the construction trench was backfilled with light brown silty clay sealed by 0.45m of topsoil (figure 6).

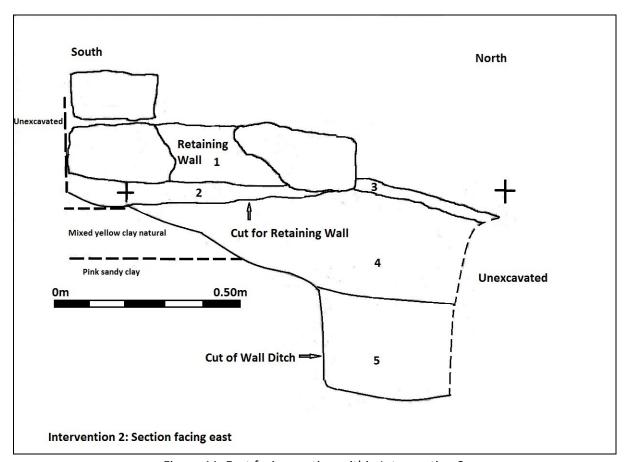
Figure 11. East facing section within Intervention 2

- This linear cut was filled by slightly pink, yellow-brown sandy clay silt 5 with occasional pink sandy clay and occasional angular stone (figures 11 and 12).

- A further deposit of fine yellow brown clayey silt 4 sealed fill 5 and represented a tertiary fill within the linear cut (figures 11 and 12).
- The side of the road and fill 4 was truncated by the insertion of the construction cut for the retaining wall 1 that appeared to rest upon yellow brown clayey silt 2 (figures 11 and 12).

- Humic soil and silt 3 accumulated against the retaining wall since 1870 and physically rested above fill 4 (figures 11 and 12).

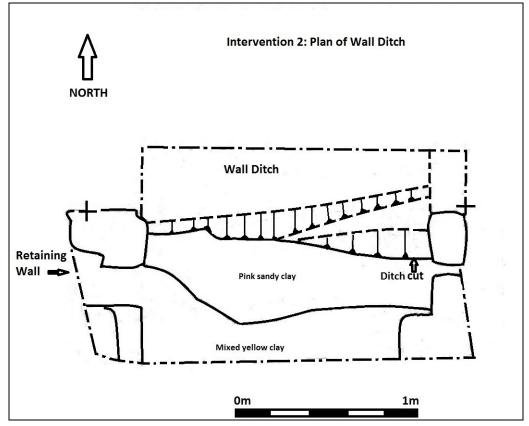
Figure 13. Plan of Intervention 2

Respecting and directly beneath the northern face of the retaining wall was an east-west aligned linear cut (figures 7, 8 and 13).

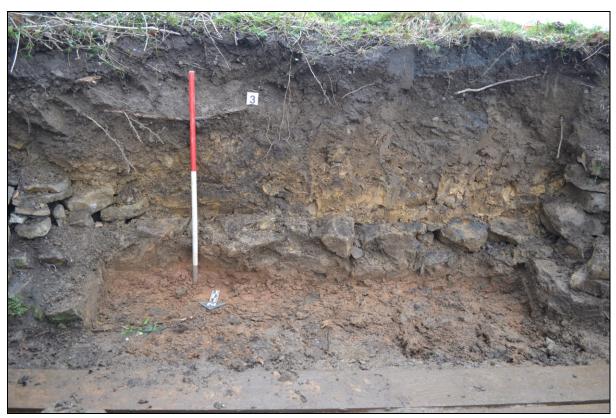
Figure 14. Intervention 3 following removal of the retaining wall

The retaining wall at Intervention 3 (NY 57597 64780) was found to be in poor condition and the masonry required removal down to foundation level. The intervention measured 4.30m in length and 1.20m in width reduced to a depth of 1.20m.

The footing comprised of a 0.80m wide base formed from sets of two large stones. Above the foundation was a rear southern wall built against the side of the construction trench respecting the road. The narrow gap within the construction trench was backfilled with light brown silty clay sealed by 0.45m of topsoil (figure 14).

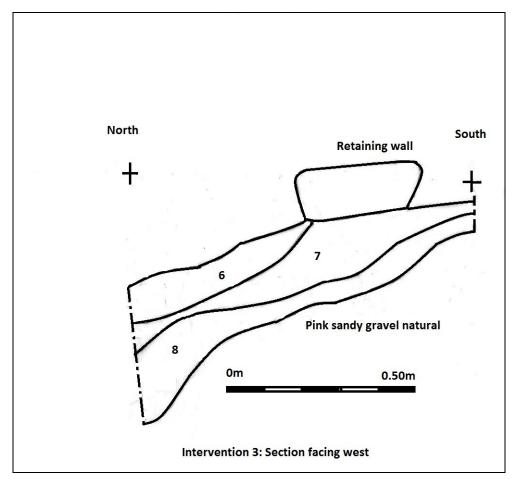
Figure 17. Section facing west within Intervention 3

- A linear east-west aligned cut (figure 15)comprising of a 45° angle southern slope to an unseen base (figure 16). The ditch was 0.50m in depth and at least 0.80m in width.
- This linear cut was filled by basal fill yellow silty clay 8 (figure 17).

- A further deposit of light yellow brown silty clay 7 sealed fill 8 and represented a tertiary fill within the linear cut (figure 17).
- The side of the road and fill 7 was truncated by the insertion of the construction cut for the retaining wall 1 (figure 17).
- Mid to dark brown humic silt 6 accumulated beneath the retaining wall and physically rested above fill 7(figure 17).

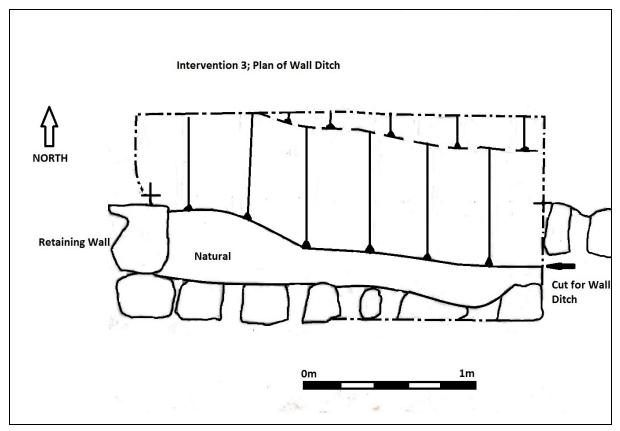
Figure 18. Plan of ditch within Intervention 3

Respecting and just forward of the northern face of the retaining wall was an east-west aligned linear cut (figures 15 and 16) that penetrated pink sandy clay drift geology.

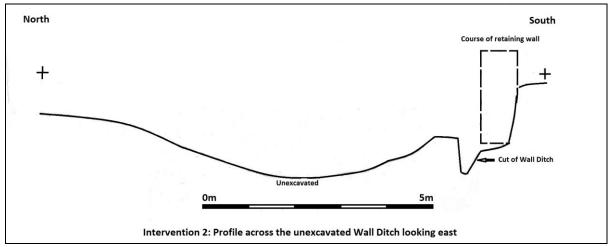
Figure 19. Profile across the wall Ditch

A profile was surveyed across the known Wall Ditch up to the retaining wall that noted that the base of the shallow ditch was approximately 0.10m above the surface of the upper fill of the Wall Ditch (figure 19).

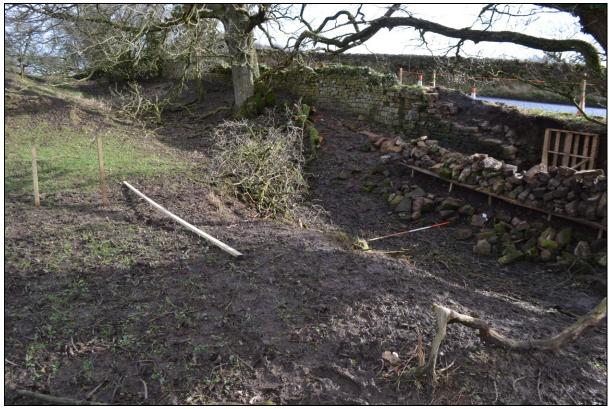
Figure 20. Wall Ditch as at present with the retaining wall

Possibly, the Wall Ditch had a slight shelf on its southern side or a second ditch that had subsequently become truncated or collapsed into the deeper Wall Ditch which clearly had silted to a great degree (figure 20)..
