## SUMMARY

### 1.1 Project origins

Permission is being sought by the executors of the estate of the late David Burnett for the demolition of a Grade II listed barn whose structural condition has rapidly deteriorated in the last four years.

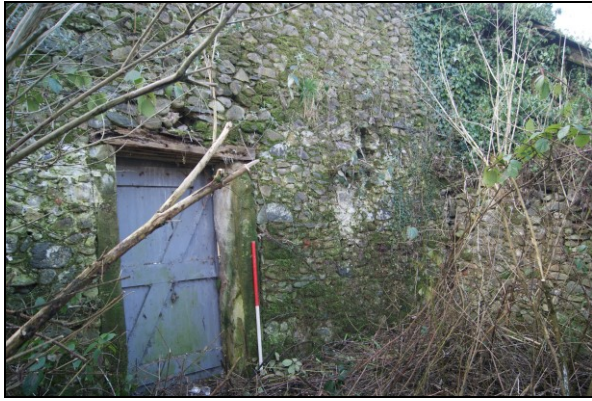
Figure 6. Interior of Room 1

Room 1 measured 4.90m x 3.50m and was covered in rubble the result of the roof and floor joists having collapsed and compromising the integrity of the structure.

The interior walls had not been treated leaving a surface of rounded river cobbles bonded by a lime mortar (figure 6). The principal ingress appeared to be from the north with a rear entrance within the south wall, an arrangement that confirmed its agricultural use as the main proportion of traffic would have been from adjacent fields rather than the Manor House.

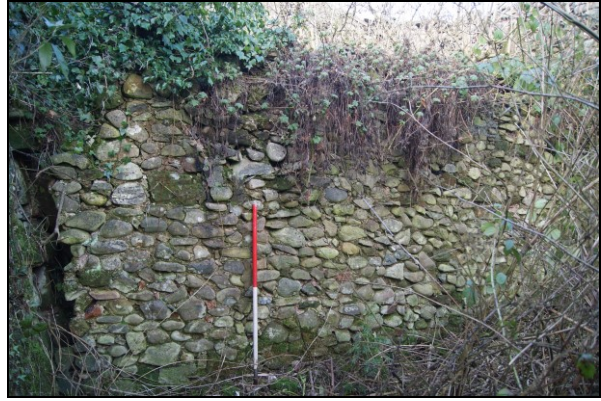
Figure 7. Partition wall on west side of Room 1

A partition wall formed from rubble-stone and rounded river cobbles between Rooms 1 and 2 also measured 0.45m in width and stood to a height of approximately 2.00m. This wall was probably not originally keyed into the southern elevation as this exterior wall had fallen forward and had become detached from the partition wall (figure 7).

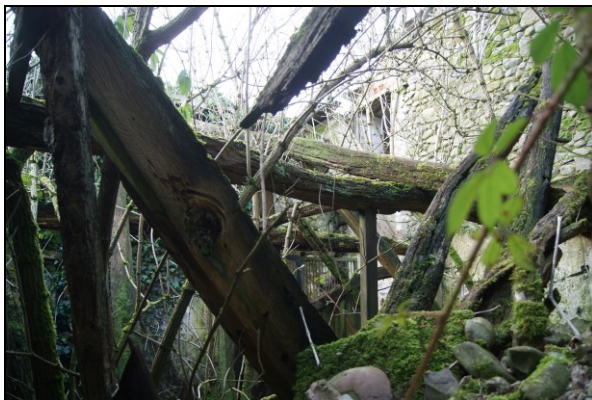
Figure 8. Room 2 showing horse stall

Room 2 was inaccessible as rubble and debris blocked the only entrance into the room. The room measured 7.00m x 3.90m, the interior lacking plaster render or lime wash. A horse stall was visible within the room suggesting that this may have been stables (figure 8).

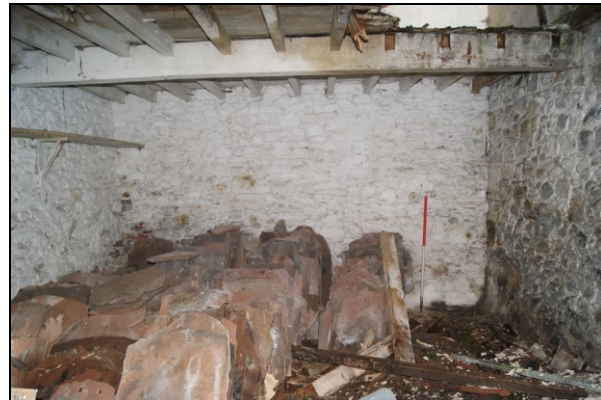
Figure 9. Room 3, lower floor

Room 3 was accessible and had been split into two levels the upper being in a very dangerous condition and negating further observation. The ground floor room measured 3.60m x 4.90m and possessed a low wooden ceiling 1.80m in height formed from timber planks and joists. The interior had been finished in lime, the floor being cobbled (figure 9). A wide door 2.50m in length strongly suggested this was a shed for carts or a carriage.

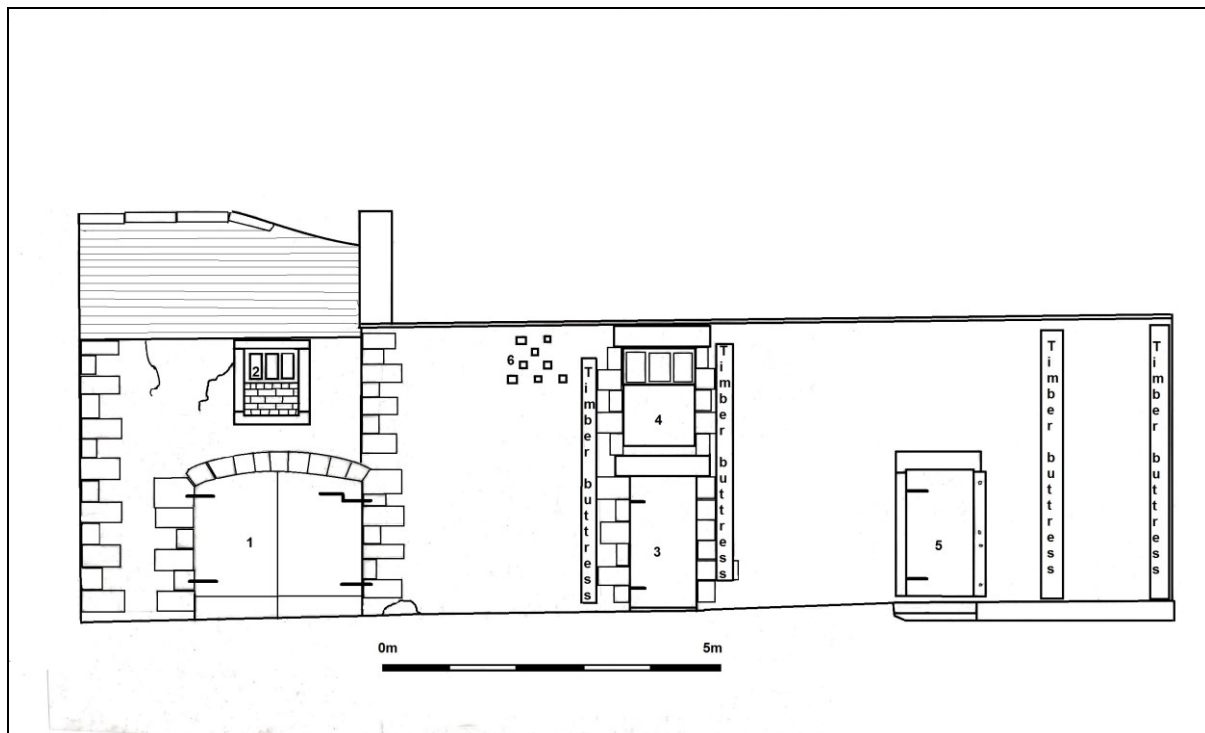
Figure 10. Southern elevation of the barn

The elevation was in a poor state of repair with clear cracks within the stonework of the western annex (figures 10 and 11).

The original building encompassing Rooms 1 and 2 had fallen forward perhaps by as much as 0.20m and was largely unsupported by the remaining building. Four timber buttresses now prop the building and are preventing further collapse of the fabric (figures 10 and 11).

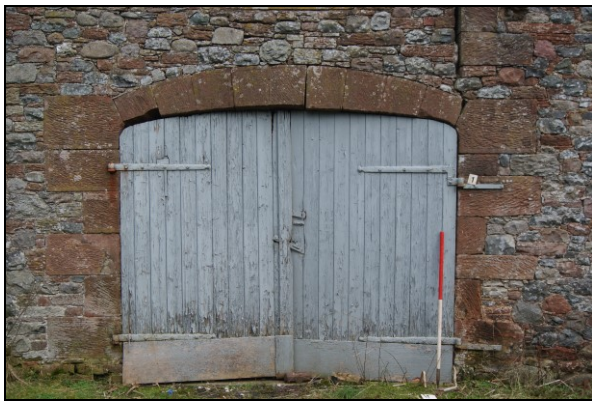
Figure 12. Cart door (1) to annex

1. The door to the annex measured 2.50m in width and 2.10m in height. Consisting of double-doors made from tongue and grooved planks it possessed external hinges and had been repaired. The door jamb was formed from red sandstone stone blocks forming quoins, the eastern side utilising the existing earlier western gable. A shallow arch 0.30m in thickness was formed from nine voussoirs, the end voussoir keyed into the western gable necessitating the removal of one quoin (figure 12).

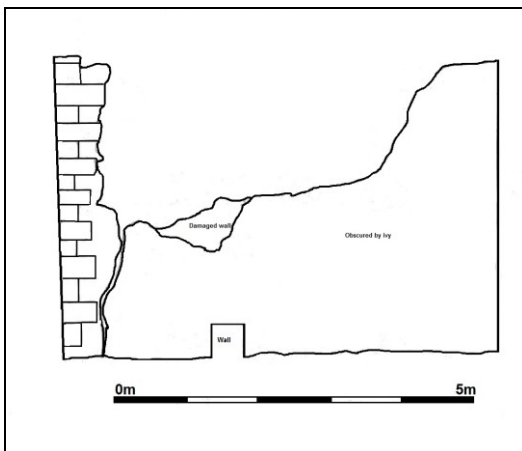
The eastern elevation was in a serious state of disrepair and stood to a minimum height of 2.00m. The southern elevation had completely fallen away from the returning wall leaving a crack up to 0.10m in thickness (figure 18).

Figure 18. Eastern elevation of stone barn    Figure 19. Oblique view showing denuded eastern gable

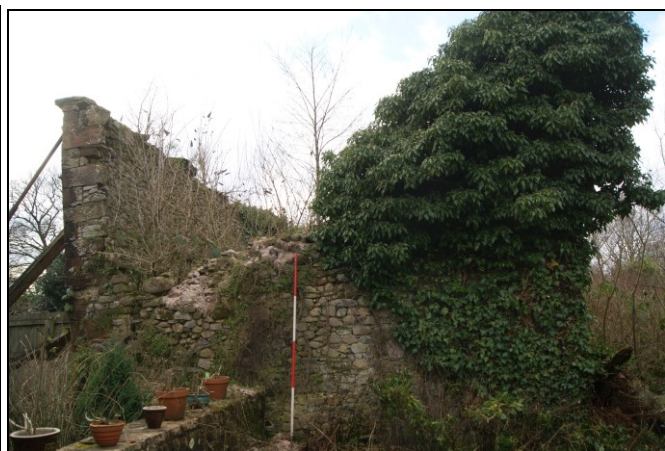
The eastern gable was formed from rubble-stone filled by a rubble core to form a wall 0.45m in thickness. The elevation was covered in ivy totally obscuring the north-eastern corner although it appears highly probable that red sandstone quoins enhanced the building. No architectural features were visible within the façade (figure 19).

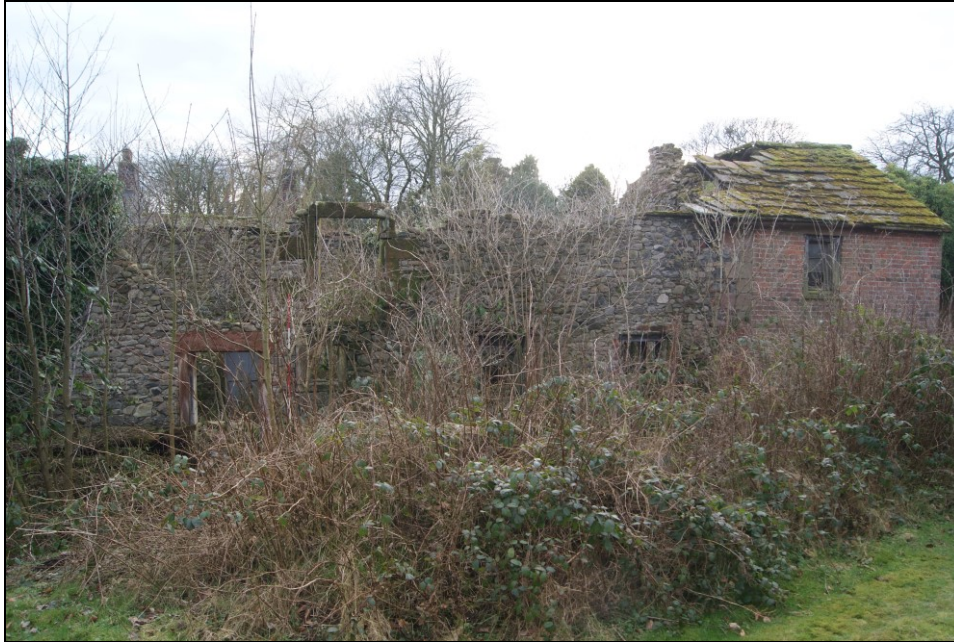
Figure 20. North elevation of barn

The northern elevation had also been seriously denuded with much of the fabric of the upper floor collapsed and in a ruinous state. The eastern end of the elevation was obscured by ivy whilst scrub prevented close examination in front of the façade (figure 20).

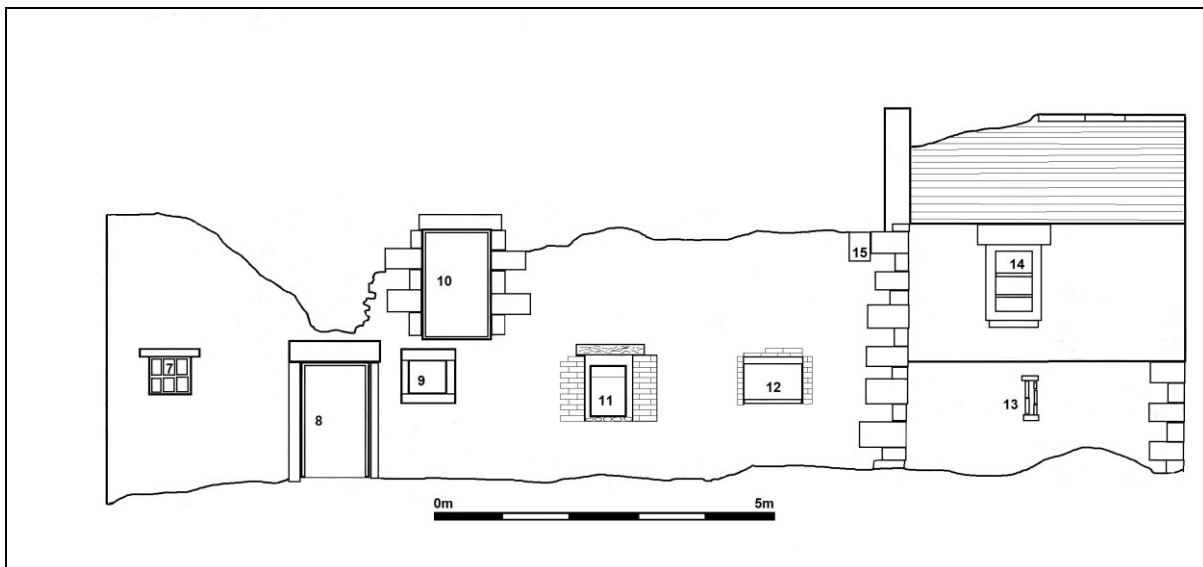
Figure 21. Northern elevation of stone barn

The shell of the building comprised rubble-stone fixed with a creamy lime mortar in places re-pointed and repaired. The walls measured 0.45m in thickness (figure 21).

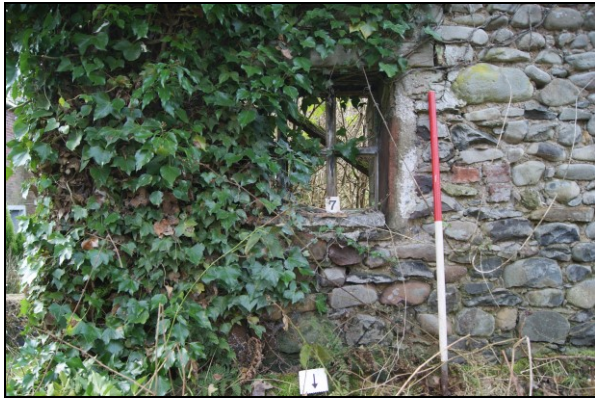
Figure 22. Window (7), Room 1

7. An eastern window lighting Room 1 measuring 0.54m x 0.70m consisting of a timber lintel with a red sandstone surround. The sill has been replaced in cement, whilst *ad hoc* cement

repairs have occurred around the stone surround. The timber window frame may have been original but no glazing remains. The frame yielded six lights measuring 0.25m x 0.18m (figure 22).

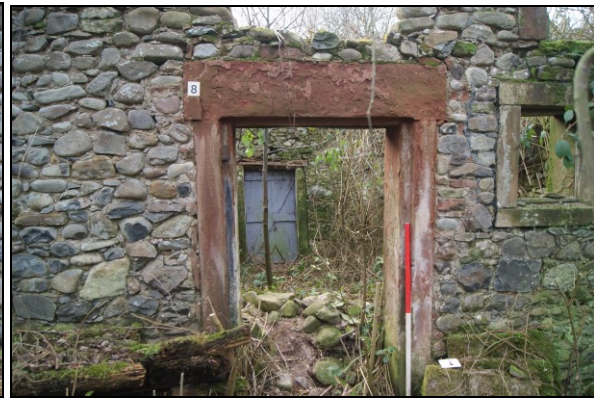
Figure 23. Door (8), Room 1

8. Access to Room 1 was through a red sandstone doorway measuring 1.70m x 0.90m. The surround was 0.15m in width with a rebate that accommodated a hinged door now missing. An undecorated red sandstone lintel measuring 1.35m x 0.30m surmounted the door (figure 23).

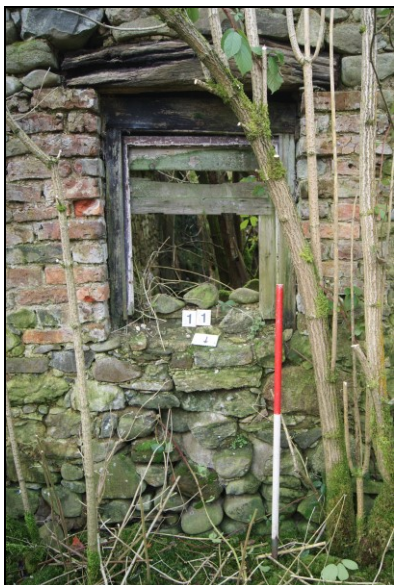
Figure 26. Window (11), Room 2

11. A central window lighting Room 2 measuring 0.98m x 0.75m. The surround comprises of coursed, hand-made brickwork surmounted by a decayed timber lintel. The sill is represented by rubble-stone. The window was partially filled by an uneven timber frame, partly boarded suggesting a later adaptation (figure 26).

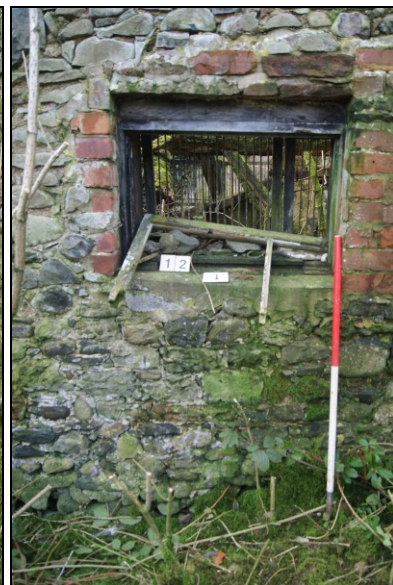
Figure 27. Window (12), Room 2

12. A western window lighting Room 2 measuring 0.90m x 0.65m. The surround comprises of coursed, hand-made brickwork surmounted by a repaired rubble-stone lintel. The sill was represented by finished cement render above rubble-stone. The window was filled by a timber frame with a grille, partly boarded, suggesting a later adaptation (figure 27).

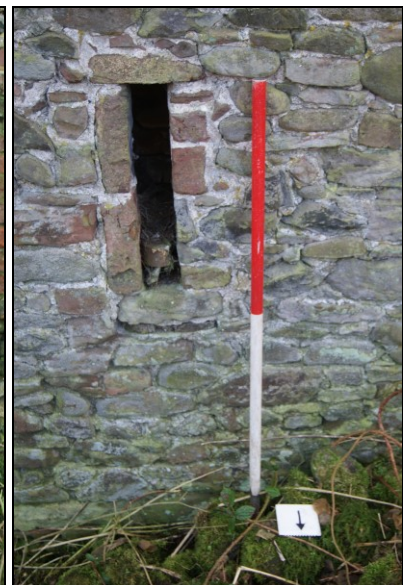
Figure 28. Air vent (13), Room 3

13. An air vent served Room 3 measuring 0.65m x 0.20m formed from squared red sandstone (figure 28).
14. An upper window serving the first floor of Room 3 measuring 1.15m x 0.80m. The window was formed from a timber surround yielding a casement window bearing three glazed lights measuring 0.25m x 0.50m. The lintel was formed from plain red sandstone but the sill was ornate consisting of sandstone dressed to form a ledge with raised relief below. Almost certainly this item came from an earlier building of some architectural pretension most probably pre-eighteenth century (figure 29).

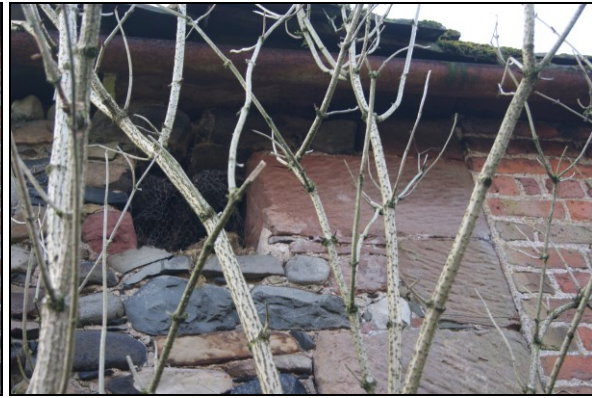
Figure 30. Vent (15), Room 2

15. An *ad hoc* air vent measuring 0.30m x 0.50m serving the upper floor of Room 2 apparently formed from the removal of a stone block within the masonry (figure 30).

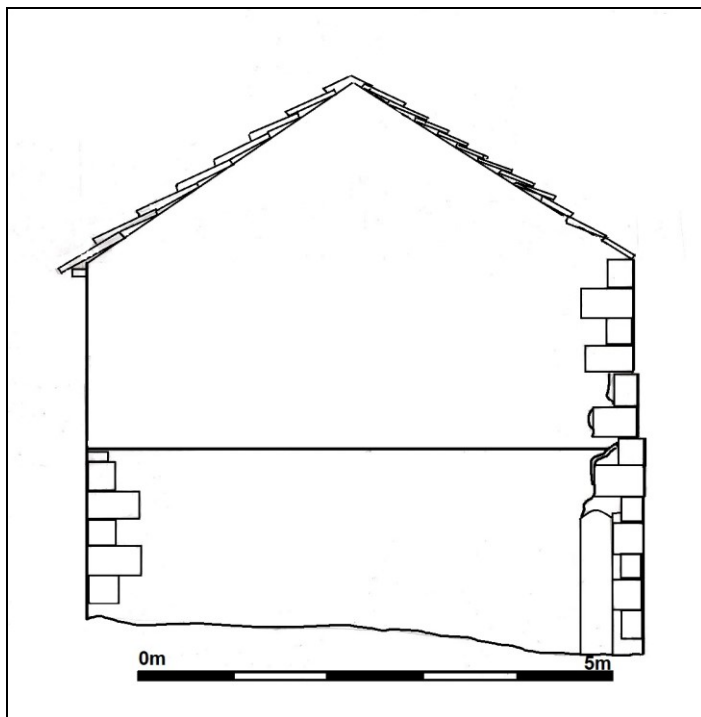
Figure 31. Western elevation of stone barn

The lower half corresponding to the ground floor of the annex was formed from rubble-stone and measured 0.45m in thickness and stood approximately 2.00m in height. Red sandstone quoins framed the elevation, continuing to the roof-line on the southern side. This configuration suffered from a wide crack, bowing the southern end and seriously compromising the fabric of the building (figure 31).

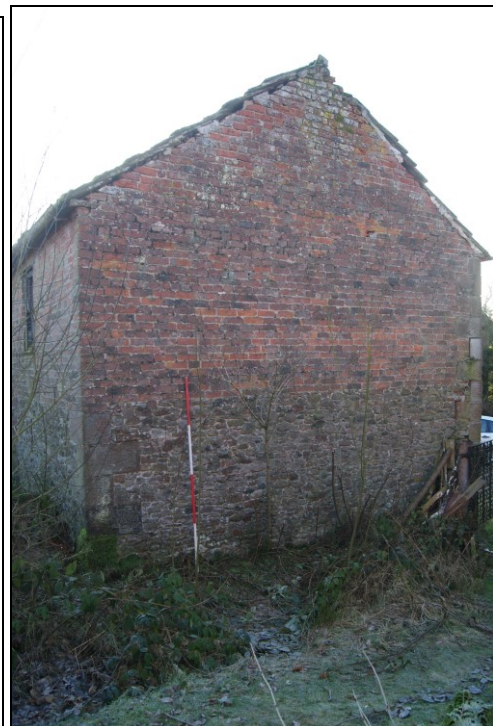
Figure 32. Western elevation of barn

The upper half was constructed in red brick, English Garden Wall style (Spence 1994, 58) and continued to the ridge (figure 32).
