**Wiltshire Archaeological and Natural History Society
Archaeology Field Group**

**Report of Survey of Barn Ground Barn,
Bottom Farm, Malmesbury, Wilts.**

April 2007

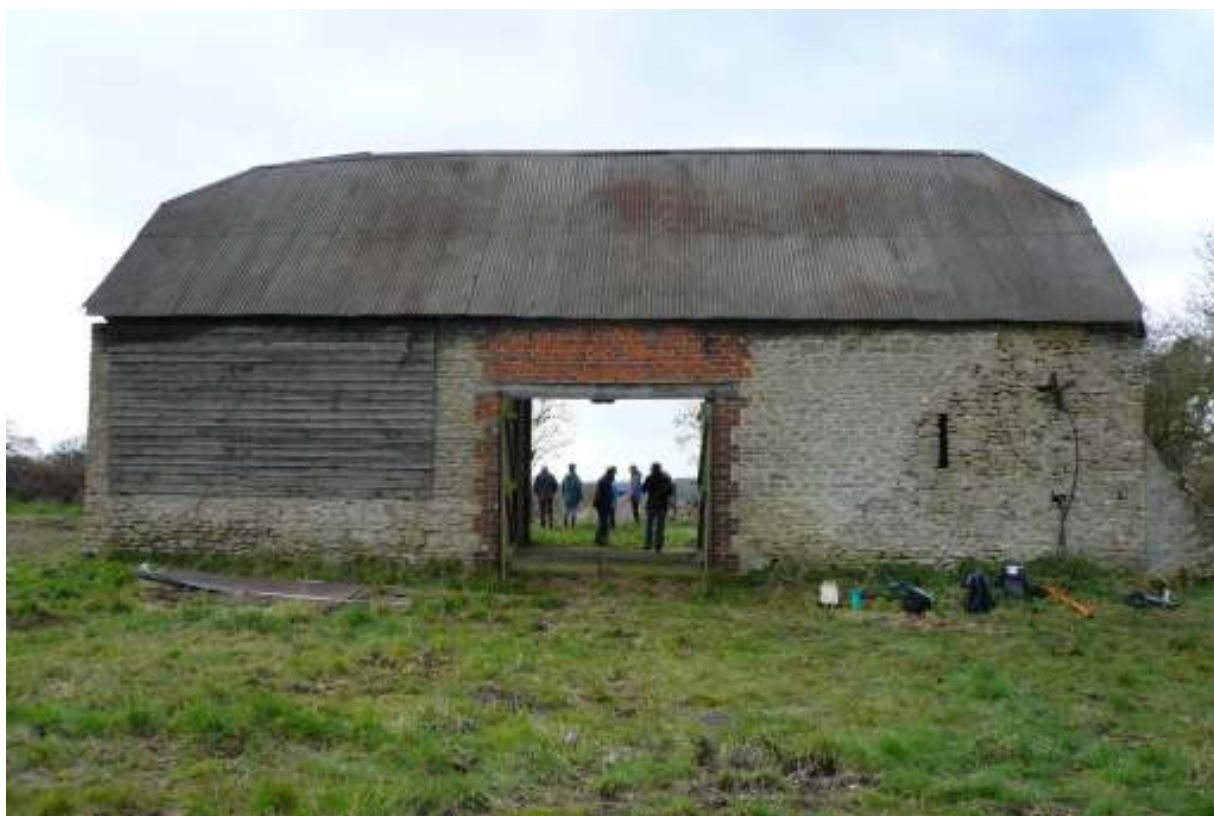
Barn Ground Barn, eastern aspect March 2007 (© Brian Clarke)

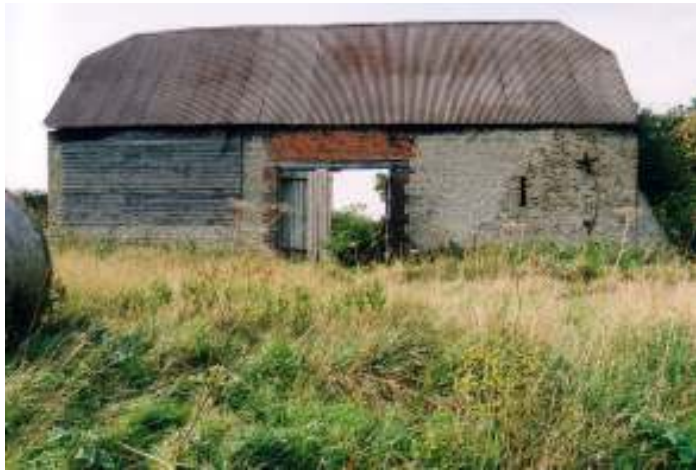
Figure 2. Barn Ground barn,
eastern aspect, August 2006
(© Christina Staff).

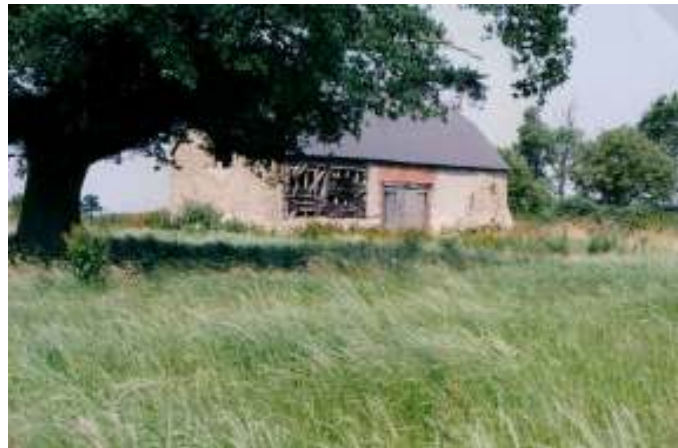
Figure 4. Barn Ground Barn,
southern aspect, July 1989
(© Christina Staff).

The barn probably dates to the first half of 19th century and is now considered a remote barn, but it may once have been part of an outlying farmstead. Constructed from coarse rubble, oolitic limestone, possibly from a quarry on the same estate such as that at ST 928 826. The northern side of the western aspect has a course of cut stone blocks at ground level. Later repairs are of brick and breeze block. It has a rectangular plan with 5 bays and timber lintels. The hipped roof is much repaired with reused timber and is currently covered with galvanised corrugated iron. It is possible that if it was built in the early 1800's it may originally have had an early corrugating iron roof, as corrugating iron is said to have been invented by Henry Palmer (1795-1844) in 1828 (<http://www.corrugated-iron-club-info/iron1.html>). The east facing wall has double plank doors with iron hinges. The brick surround may be a later infill as the doorway on the west side is larger. There is a weatherboard infill to the southern side of the door which is post 1989 (Figures 2 and 3) and a ventilation opening to the northern side of the door. A buttress supports the eastern end of the northern wall. The southern end of the barn is currently in a state of disrepair but had a pitching hole in 1989 (Figure 4.).
