Dover Castle, Water mains

Watching-brief report

Project Code: DCWM-WB-14

Report No: 2014/35

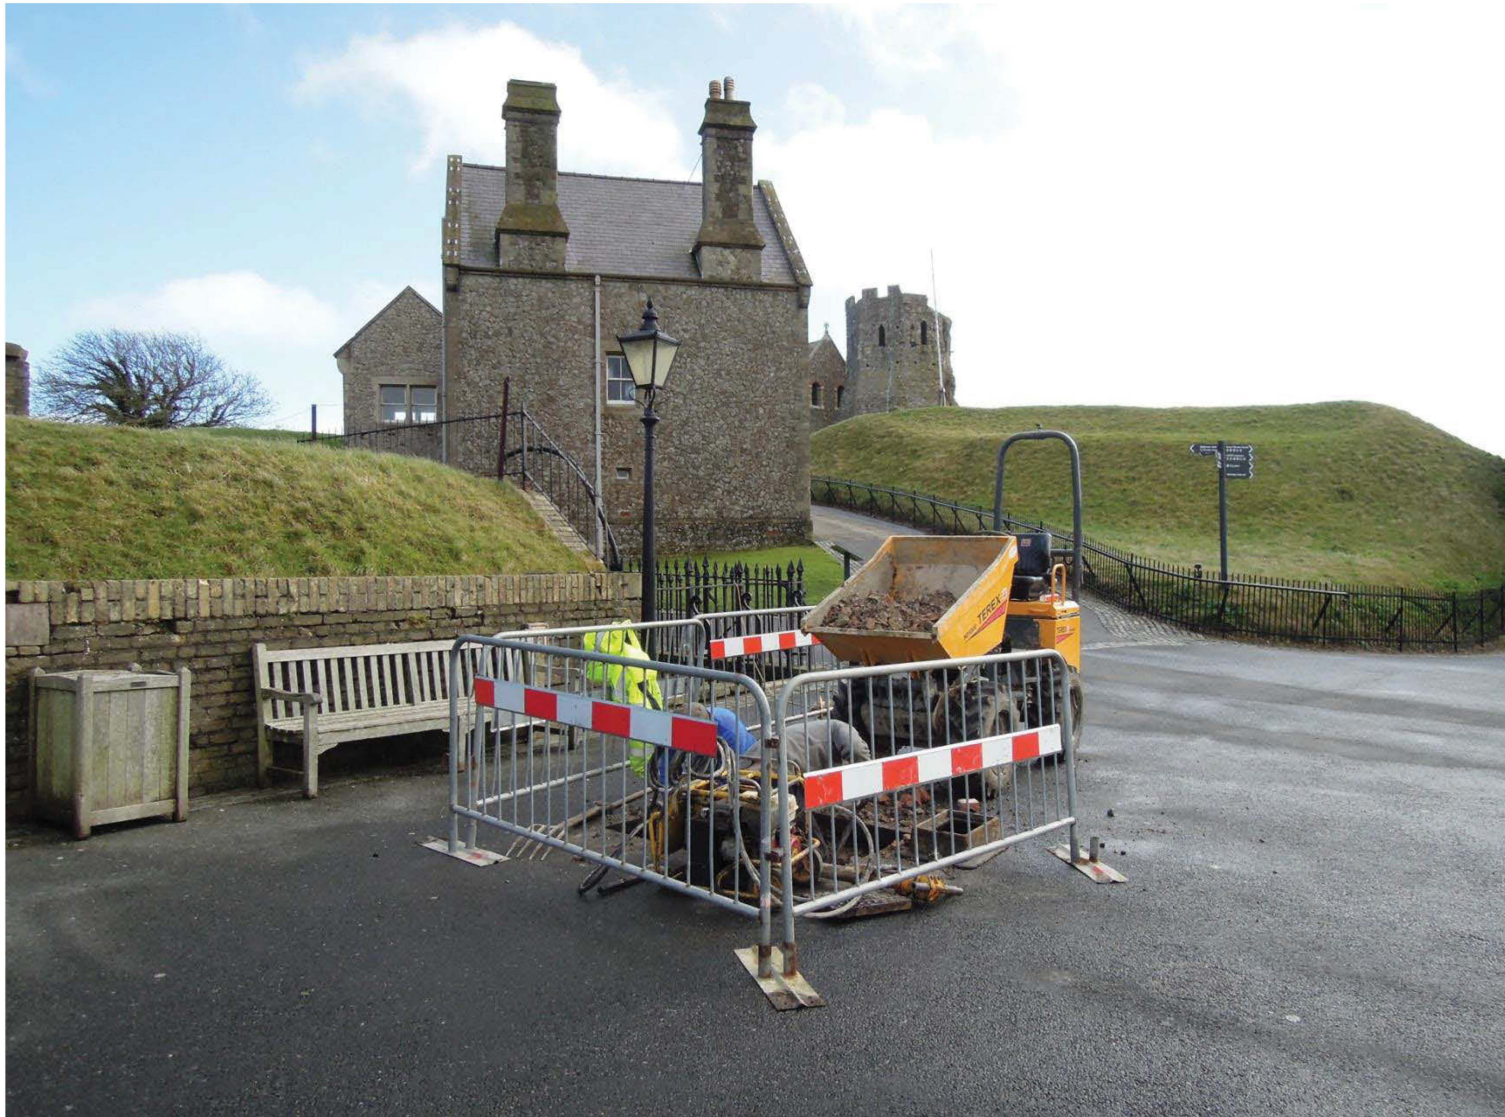
Plate I General view of Pit 2 in Harold's Road, looking south-east

4.2.1 Palace Green is the modern name given to the open space south of the Keep Yard and was formerly part of the Castle's middle ward. It represents another important area of the Castle. The damaged hydrant is located to the south of Palace Green proper, towards the south-eastern end of Harold's Road, immediately to the south-west of the 1790s well house (Figs 1 & 3; Plate I), NGR 632538 141858. Ground level here is at 107.12m above Ordnance Datum.

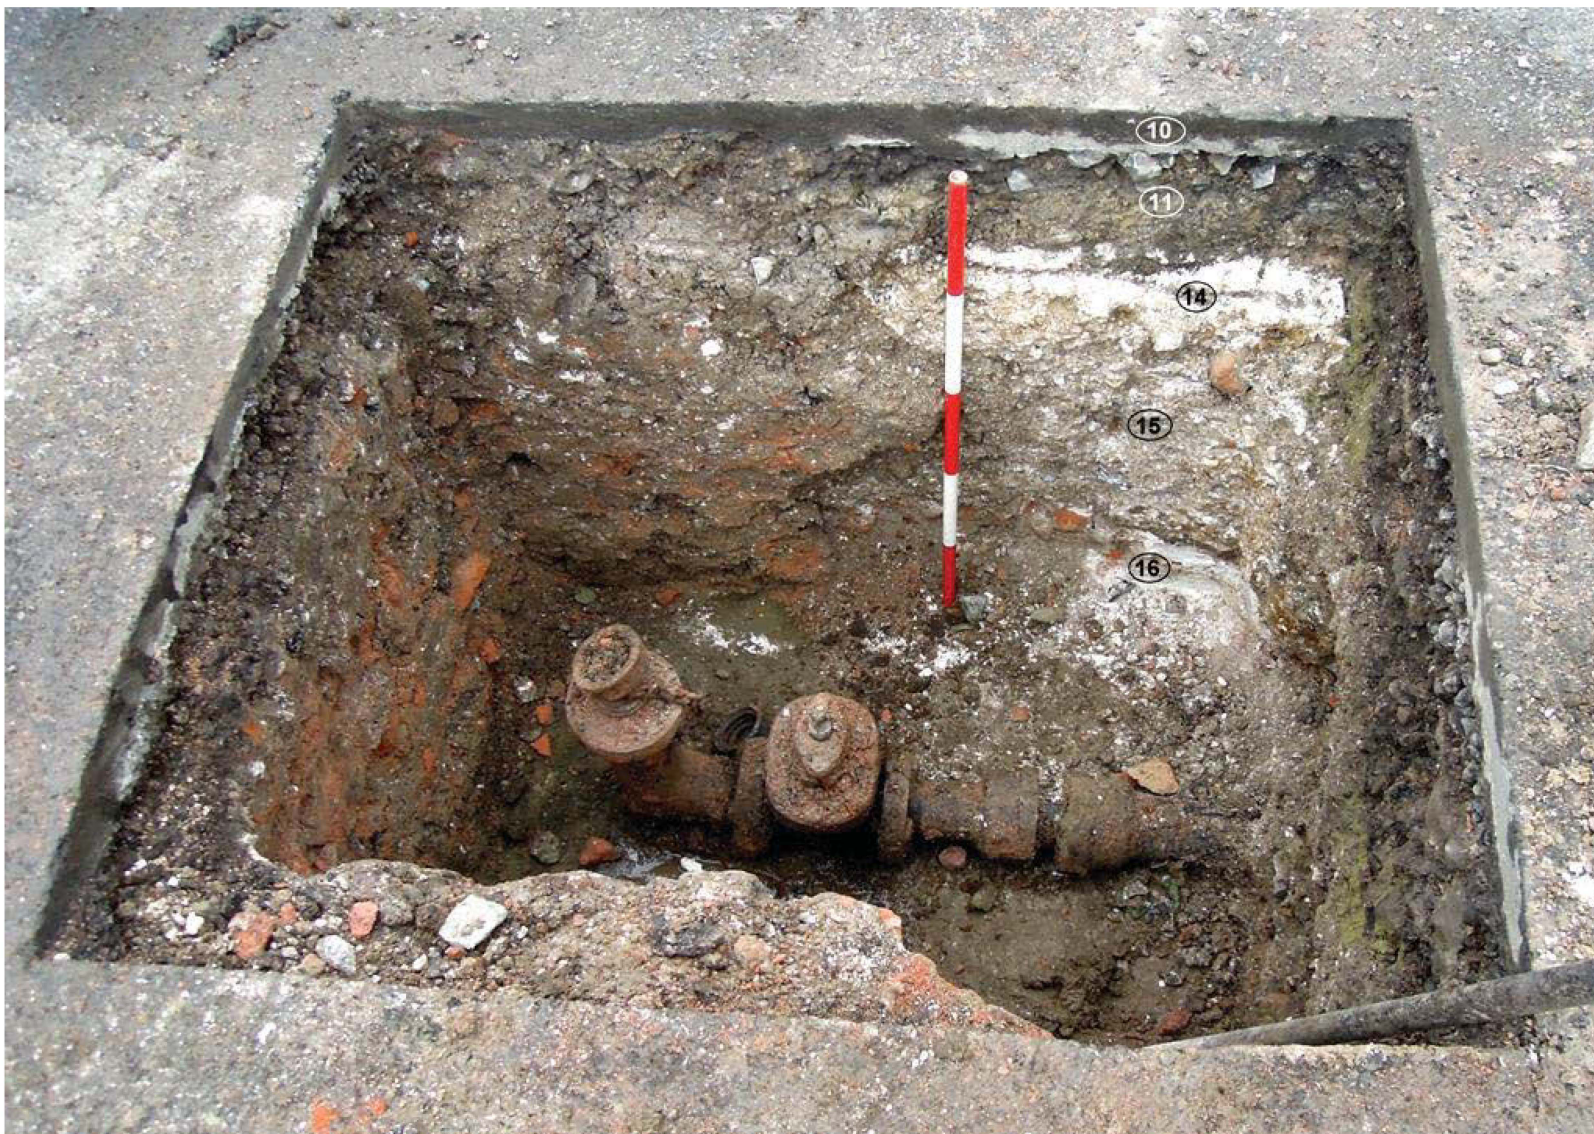
4.2.5 Along the north-western side, adjacent to the north corner of the excavated pit, a length of the modern pipe trench filling (12) peeled away to reveal a narrow section of the stratified deposits through which the trench had been cut. This was briefly examined but effectively lay outside the area of Pit 2 (Plate II).

4.2.6 At the base of the exposed sequence, the top of the natural chalk (Context 17), was revealed at a depth of about 1.02m (c. 106.10m OD). Above this was a 0.15m thick layer of well-compacted chalk rubble containing occasional pieces of eighteenth- or nineteenth-century orange-red brick (Plate II, Context 16). In turn, this was sealed by a thick dump deposit of mixed light grey-brown clay, containing frequent small chalk lumps, moderate numbers of small sub-angular flints, some flint pebbles and moderate amounts of small red brick fragments (Plate II, Context 15).

4.2.7 Above the dump deposit (15), three successive layers of rammed chalk rubble separated by two grey loam layers (Plate II, Context 14) appeared to represent a series of walking surfaces separated by thin tread layers. The total thickness of these chalk surfaces was about 0.10m and the top of the highest one lay at a depth of 0.17m below present ground level.

5.3 The thick dump deposit recorded in the Harold's Road pit (Context 15) could represent up-cast associated with the digging of the adjacent well, c.1796; a process which will have generated a significant quantity of spoil.

Plate II Detail of north-west face of Pit 2 showing stratified deposits exposed (Contexts 14, 15 & 16). Scale, 1 metre
