Newstead Farm, Quarry Street, Woolton, Liverpool, L25 6DY (20F/0184)

A Programme of Historic Building Recording

Document No: 3491.R02a July 2020

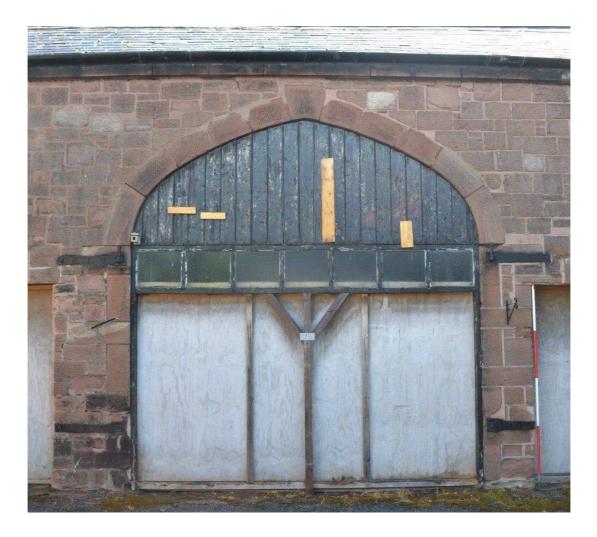
Plate 11: Detail of the blocked-up cart-entrance with multi-centred arch. Note secondary, lower set of carcass hinge leaves, and exposed pintles of the upper set of carcass leaves.

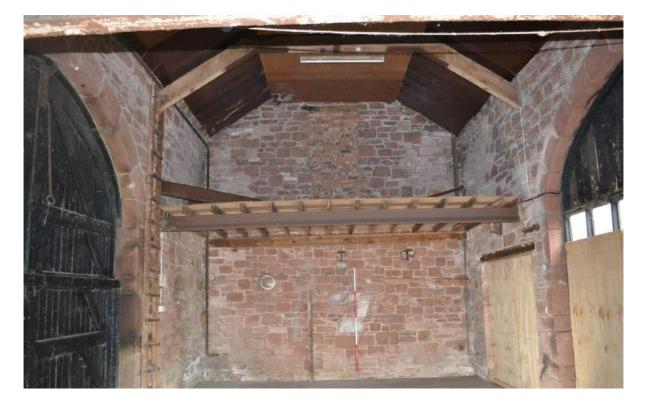
Plate 16: Sightline to the southern wall, showing inserted mezzanine floor on longitudinal joists in turn supported on a timber beam attached to the wall and a rolled steel joist the ends of which have been inserted into the wall of the east-facing elevation. Also shows ladder access and infilled doorway at first floor level into the wing of the farmhouse

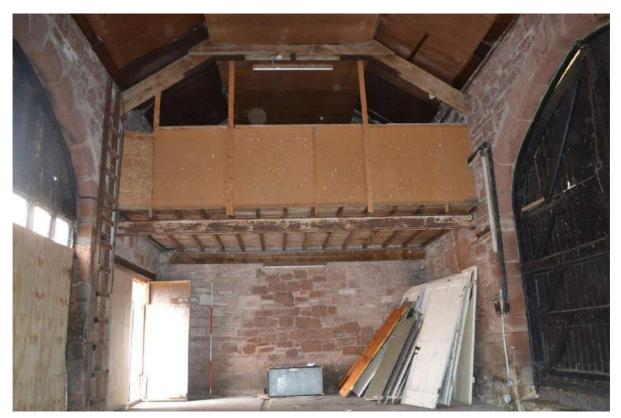
Plate 17: Sightline to the northern wall, showing inserted mezzanine floor on longitudinal joists in turn supported on a timber beam attached to the wall and a rolled steel joist the ends of which have been inserted into the west-facing east-facing walls. Also shows ladder access.

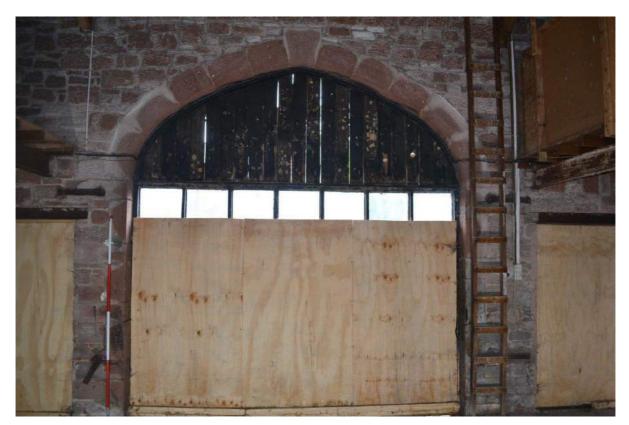
Plate 19: Inside details of the blocked cart-entrance doorway in the west-facing elevation.

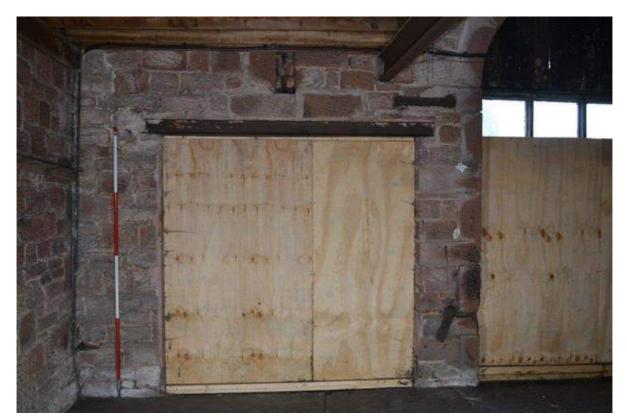
Plate 21: The inserted doorway in the elevation opening onto the farmyard (east-facing) showing rolled steel joist lintel

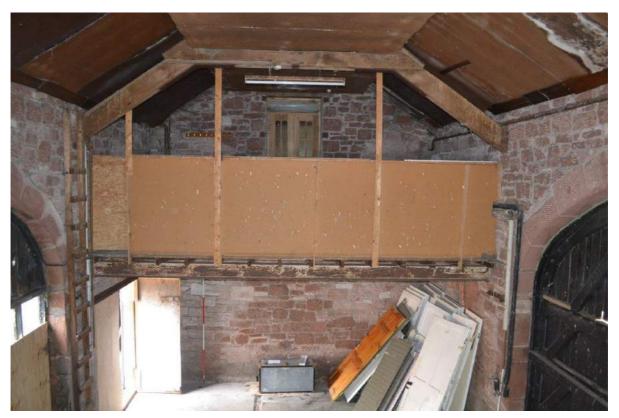
Plate 23: Sightline to the mezzanine floor at the northern end of the barn highlighting the joists, rolled steel joist and safety boarding. Also visible are the *porte-fenêtre* into the first floor of the stable.

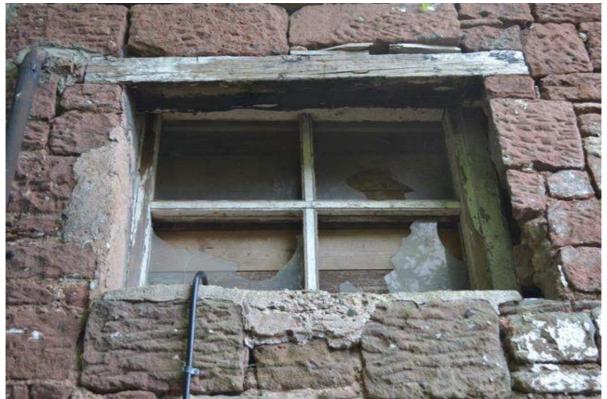
Plate 40: Sightline to the first floor widow opening in the north-facing elevation of the stable, with timber lintel, no sill, timber window frame and broken glazing.

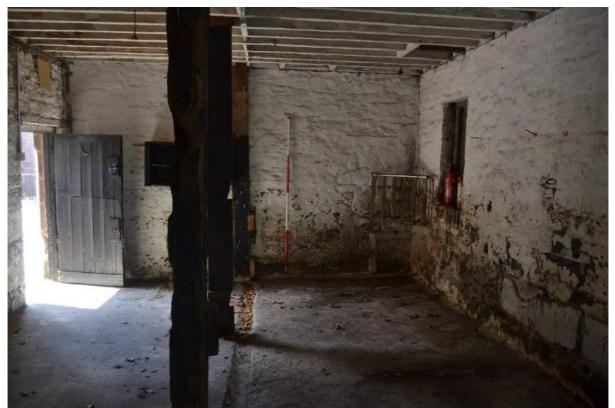
Plate 45: Sightline within the ground floor of the stable towards the wall dividing the stable from the workshop. Showing the concrete floor, the two posts defining the stalls, the corner hay rack, the joists supporting the first floor and the channel in the floor to direct urine etc. to the drain.

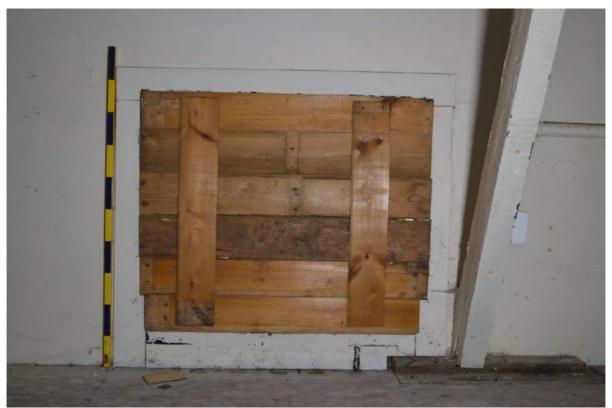
Plate 55: Stable first floor, detail of boarded window in the north-facing flank wall. Possible pitching eye, but unusual in that it does not face the yard and does make sense with respect to the building which onve ran along this north-facing elevation. Scale = 1m

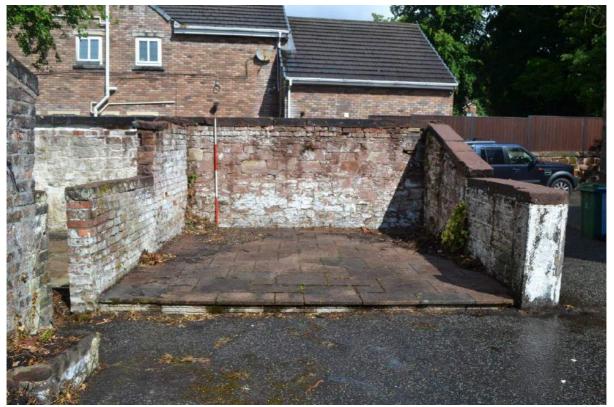
Plate 100: Sightline to the north, into the western bay of the pigsty from the farmyard. The wall forming the exercise yard, which probably contained the feed chutes, the wall to separate the loose box from the exercise yard and the third and fourth stalls are all no longer extant.
