Historic Building Recording

No. 1 HARRINGCOURT HOUSE,
HARRINGTON LANE,
PINHOE

By R. W. Parker

REPORT No. 2016-03

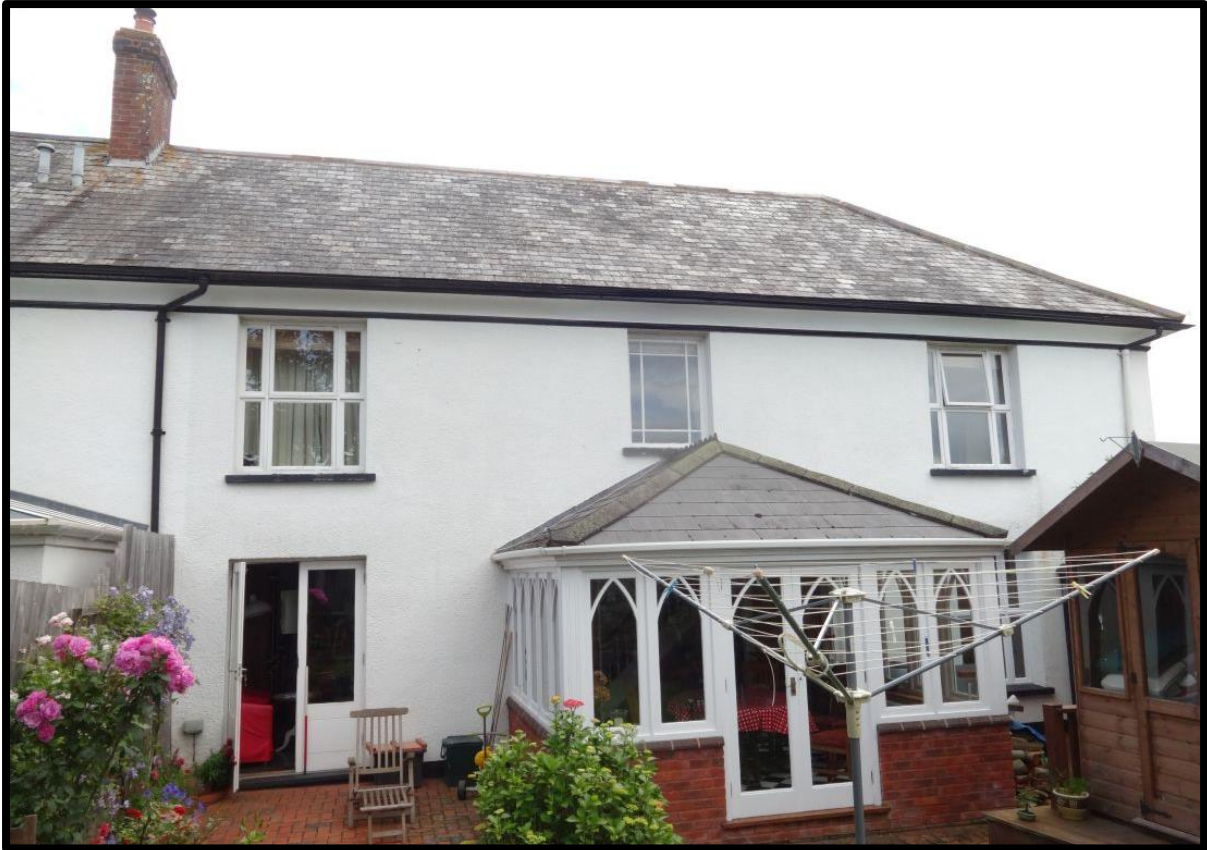
Fig. 4 West elevation of the farmhouse showing the modern replacement windows and the covered cornice of late 17th- early 18th -century type running below the roof at eaves level.

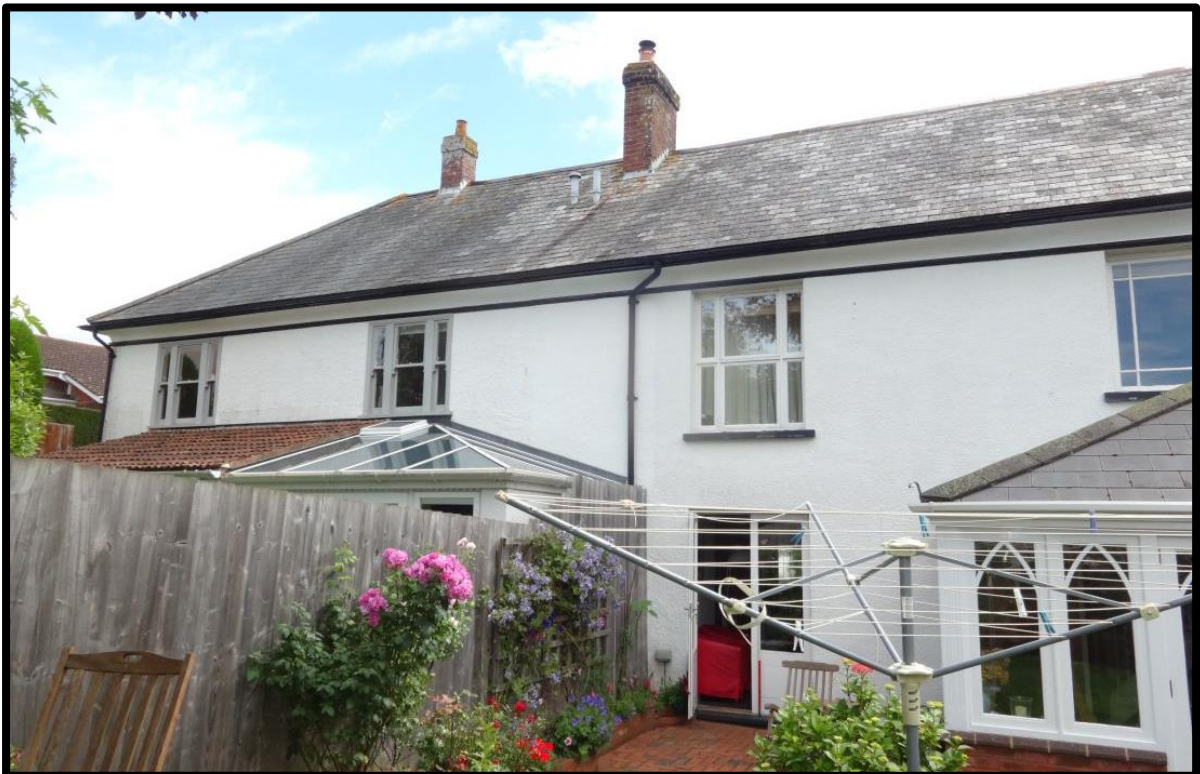
Fig. 5 West elevation of the northern part of the farmhouse, now a separate property, showing tripartite sash windows and the coved cornice continuing across the whole façade.

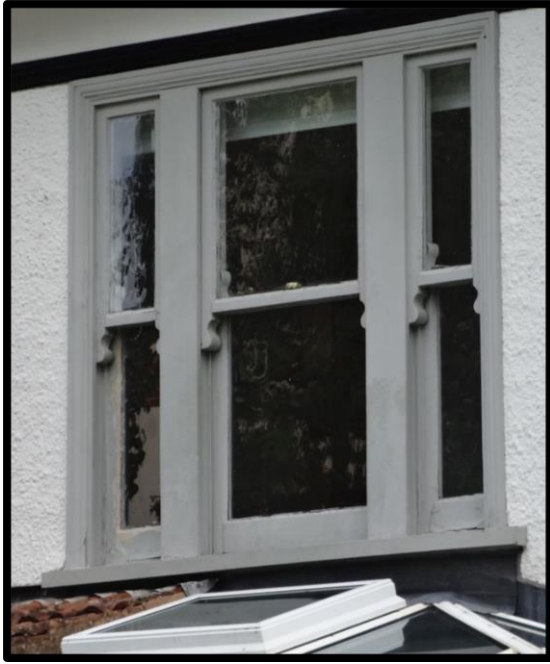
Fig. 6 Detail of the late 19th-century tripartite sashes in No. 2 Harringcourt House, possibly dating from the alterations of 1892.

The windows inserted at No. 2 in the 1890s (Fig. 6) are typical of the period in that they have bold 'horns' below the bottom and top rails of the upper and lower sashes respectively, and were designed for plate glass without subdivision by glazing bars. These may have replaced earlier tripartite sashes with glazing bars, like those seen in many late 18th and early 19th-century houses in Devon. An example of a house of c.1790-1800 in Tiverton, with the earlier form of tripartite sash is shown in Fig. 8. The tall, square proportions of the window openings at No. 1 are, however, also suggestive of an earlier form of window. The typical window of the late 17th and early 18th century (the period suggested by the coved cornice at the summit of the façade) would have been a 'mullion-and-cross' window typified by heavy wooden mullions and transoms and leaded iron casements hinged from austere simple timber frames. An example of a window frame from Yarde Farm in Malborough parish, dating from 1718, is shown in Fig. 9. This occupies a rather taller opening than the windows at Harrington Farm, but mullion-and-cross sashes of similar date and squatter proportions survive in the upper storeys at Pinbrook House at the western end of Harrington Lane, and also at Fordmore, Plymtree, illustrated by Cherry in her paper on 17th- and

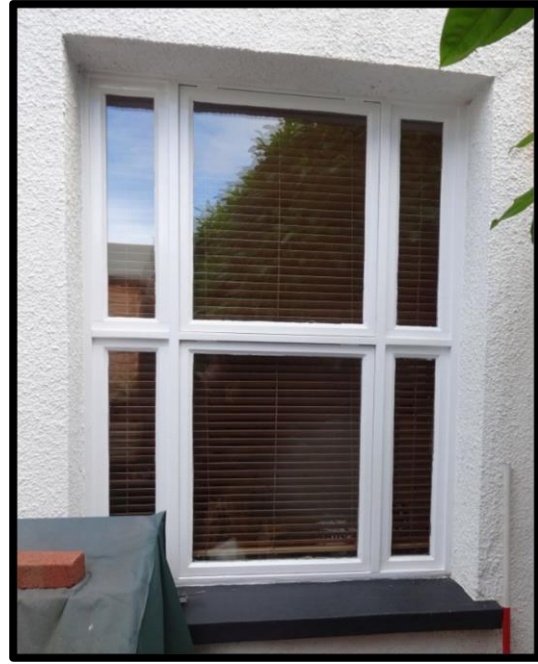
Fig. 7 Detail of one of the modern tripartite top-hung casements, probably inserted in place of earlier sashes in c.1987.

century windows, but hinged to open from the top (Fig. 7). The window openings of No. 1 are slightly taller and squarer in proportion than those in the neighbouring house and it is possible that there were slightly taller tripartite sashes or, perhaps, an older form of casement window (see below). Over the roof of the modern conservatory, which masks what may, formerly, have been the main entrance of the house, is a narrower window with thin glazing bars forming margin lights (Fig 4). This is also a modern replacement, though perhaps more accurately replicating its predecessor.

In the 1980s the house was converted into two dwellings. This involved the loss of some of the original detail of the first-floor rooms, and also perhaps of the entrance portico, though some 19th-century doors appear to have been reused and their fixtures retained. Sadly, many of the windows in the west and south facades were renewed with most unsuitable modern top-hung casements at this time.

The current proposals are for alterations to the roof space, to create a new inhabited loft with an *en-suite* bathroom, lit by roof lights, accessed by a staircase within the area now occupied by cupboards between the head of the present stairs and the main southern bedroom. The fenestration of the house would also be repaired and replaced, with more sympathetic double-glazed windows.

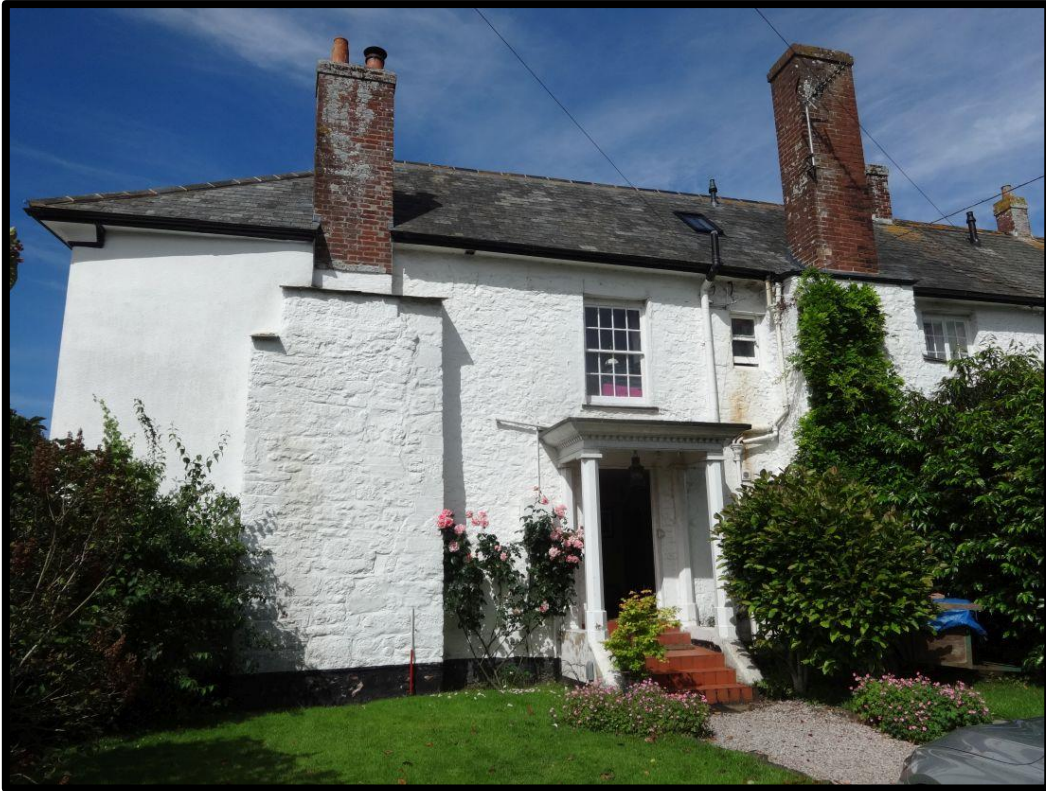
Fig. 10 East elevation of the farmhouse, showing the enormous chimney stacks and the portico.

The east elevation of the farmhouse (Fig. 10) betrays its probable earlier date. This elevation is dominated by two very large chimney stacks flanking the front door and leaving very little room for fenestration. The stacks are of stone construction with later brick upper sections and both seem wide enough to have accommodated a fireplace on each storey. The windows of this façade have been squeezed in around the stacks, and include a pair of very small windows with ‘*Art Deco*’ leaded glazing on either side of the kitchen fireplace in the northern stack. Inspection of the fireplace, described below, shows that these have been cut into the fabric and that the original, broad, opening of the fireplace has had to be narrowed to accommodate them.

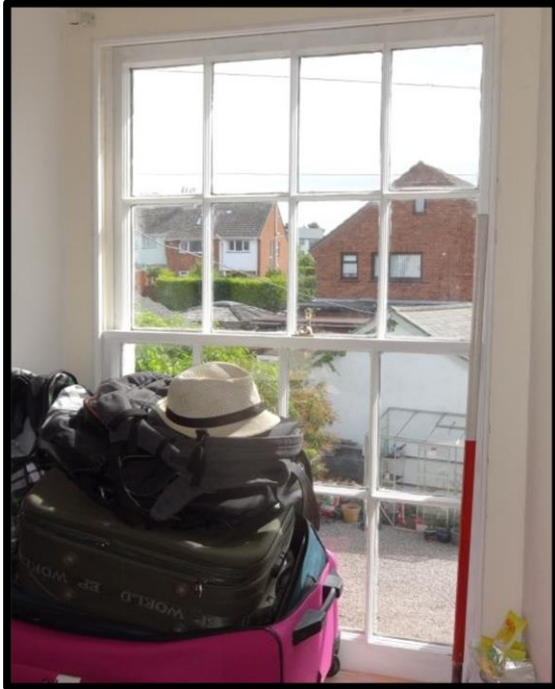
Fig. 11 Detail of the early 19th-century sash in the bedroom on the east side of the house, showing narrow glazing bars with typical mouldings of c.1800.

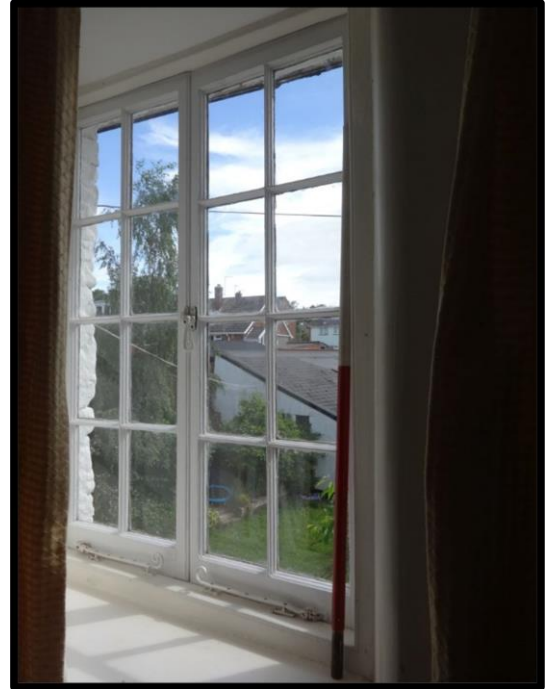
Fig. 12 The early 19th-century casement window in the north bedroom, with similar narrow glazing bars and 20th-century window furniture.

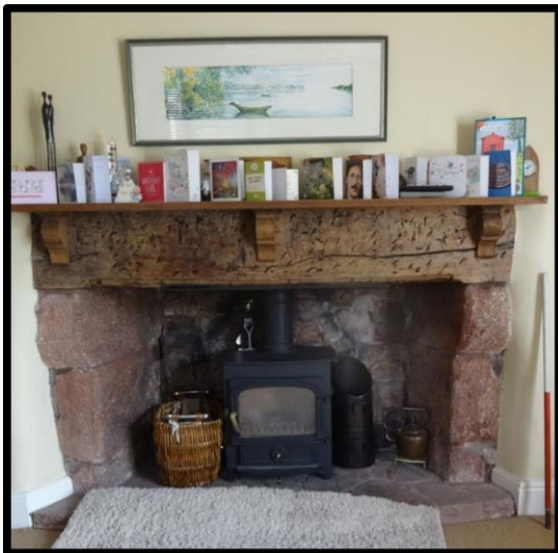
Fig. 13 The fireplace in the ground-floor drawing room, showing the curved stone brackets of local breccia supporting the timber lintel. This fireplace is possibly of 16th-century date.

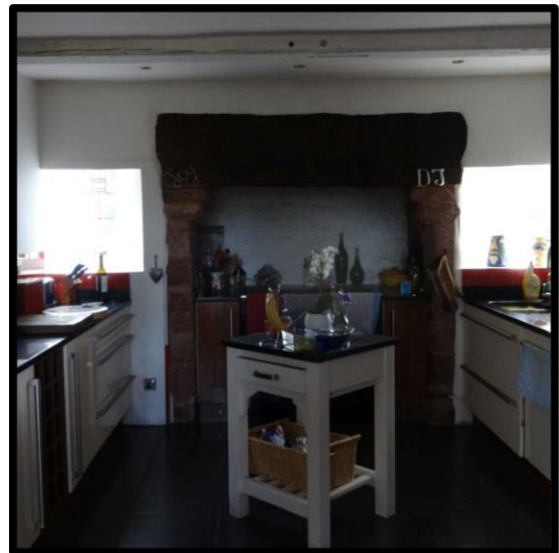
Fig. 14 The fireplace in the ground-floor kitchen, showing the truncated lintel, cut to accommodate two small side windows, and the rebuilt stone jambs beneath.

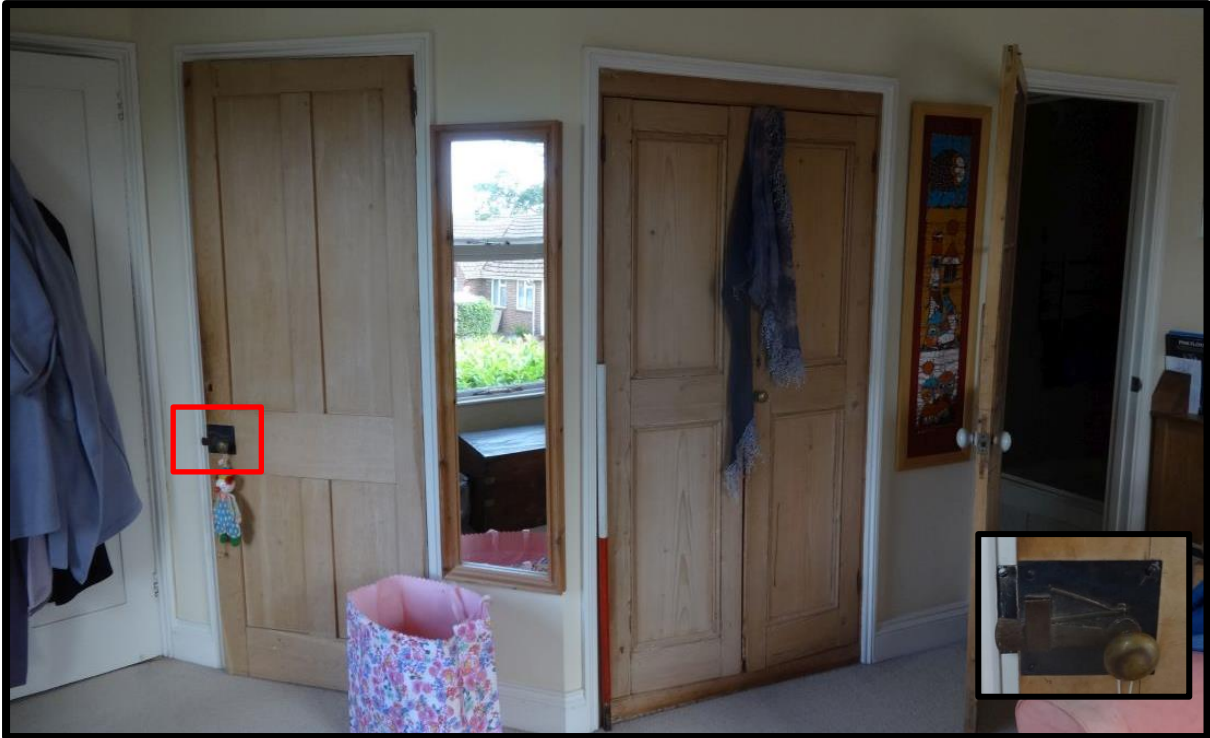
The first floor has been more heavily altered, but seems, again, to reveal its plan as of three more-or-less equally-sized rooms, the middle one of which appears to have been unheated, and probably contained a staircase. At present the northern part of the house is divided into a small bedroom, and bathroom, in the eastern part of the house and a larger bedroom to the west. South of this is a large landing and a further bedroom, occupying the area above the main entrance. At the south end of the house is a very large bedroom and a rather confusing area between the room and the staircase, now occupied by many cupboards and a small *en-suite* bathroom. This is the area in which it is proposed to construct the new staircase. There are few surviving historic features on this storey and nothing as early as the fireplaces on the ground floor. The cupboards in the southern bedroom retain a number of historic doors, one of which has a sprung latch of 18th-century date (Fig 15 and inset).

Fig. 15 View of the cupboards in the southern first-floor bedroom showing, historic doors reused in this position, one of which retains an 18th-century style sprung latch (inset).

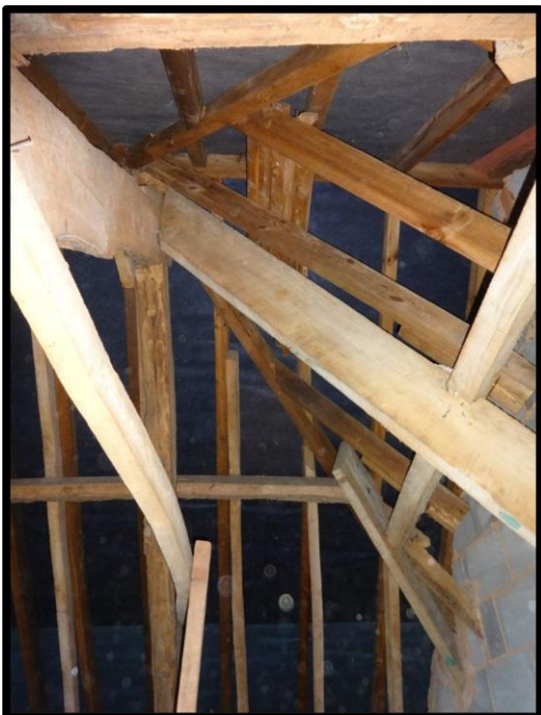
Fig. 16 Detail of the hipped gable at the north end of the house showing the original roof structure overlaid by later roof timbers.

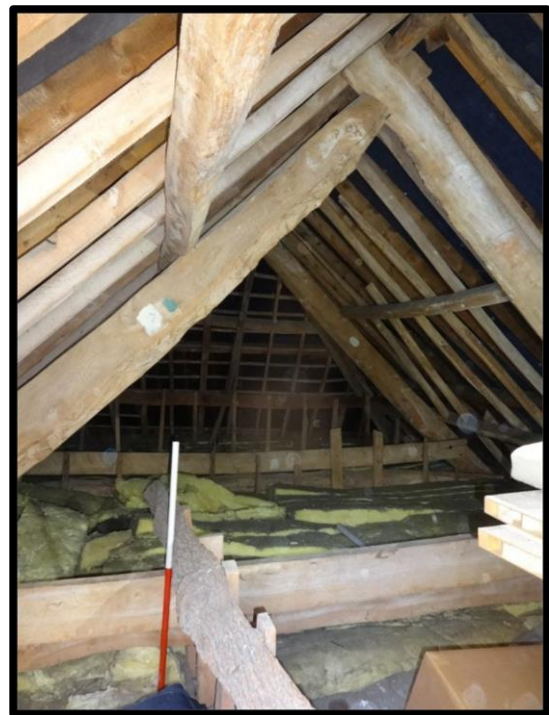
Fig. 17 View within the roof space showing the form of the trusses, and parts of partitions or timber 'stiffeners' protruding in to the roof space.

Running through the centre of the bay from purlin to purlin is a high level horizontal timber resembling a collar, beneath which are a series of small ties. This structure may have been inserted to stiffen or support the ceiling structure (Figs 17, 18).

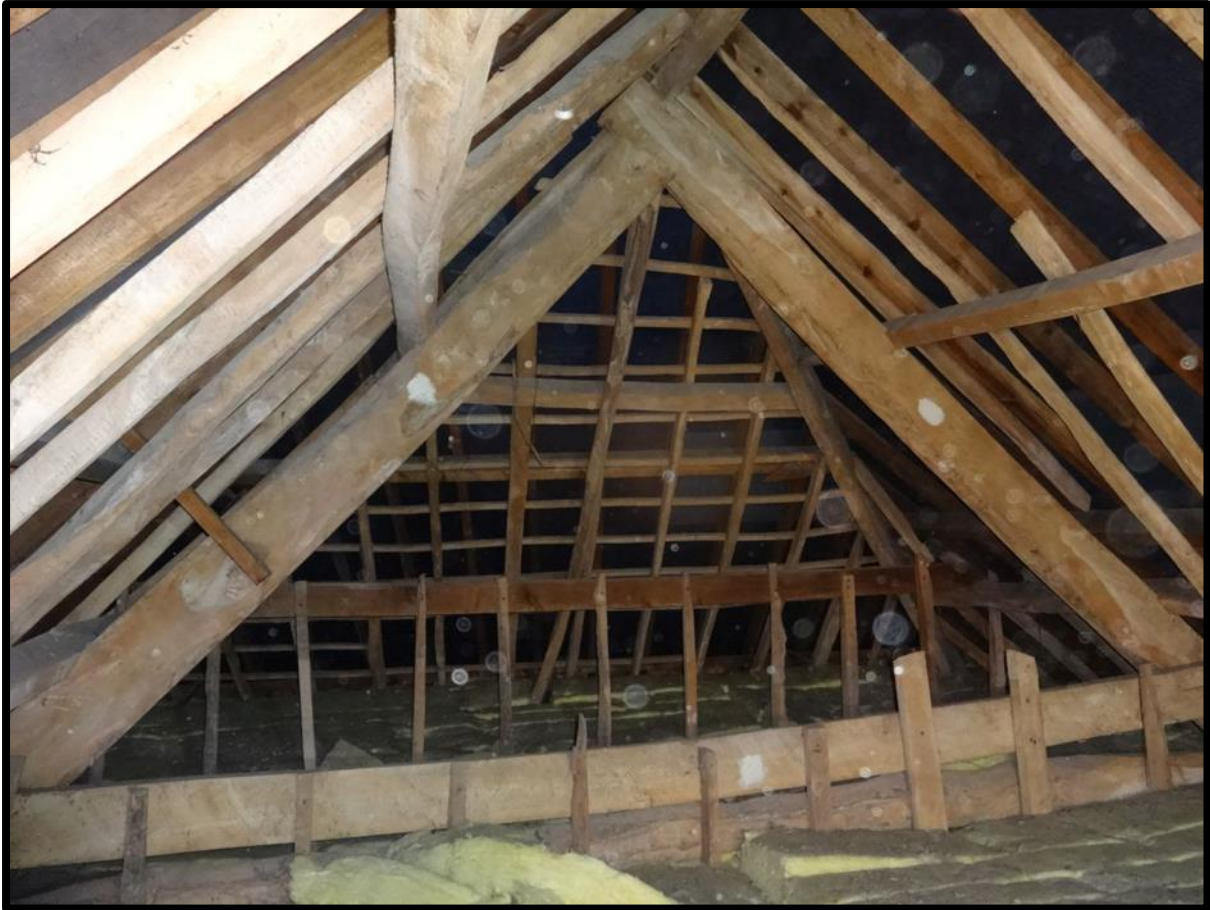
Fig. 18 Detail of the southern end of the roof showing Truss I, the remaining battens beyond and a possible partition protruding within the roof space.

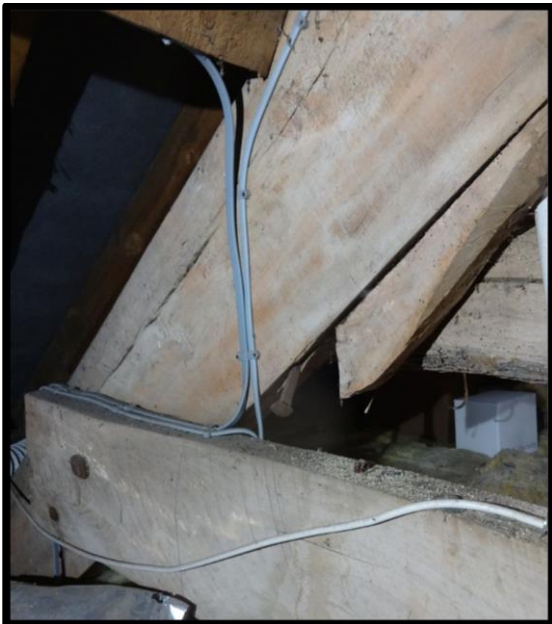
Fig. 19 Detail of the eastern foot of Truss III showing a timber cleat or wedge applied to the underside of the truss which may have related to a vertical post, now removed.

Attached to the underside of the truss just below the modern collars are a pair of small wedge-shaped gussets or cleats (Figs 19, 20). The eastern of these is cut as though to butt against the side of a vertical post, now removed, which may have formed part of an earlier partition dividing the upper storey of the house. The western one has a flat underside, as though it braced the principal from the top, rather than the side of such a vertical stud. These vestigial timbers might have represented short 'queen-posts' linking the principals to a tie beam at a lower level, or they may have formed vertical elements in stud partitions, now removed. These anomalous features strongly suggest that partitions at first-floor level are not primary to the house, but that the original partitions and perhaps also the ceilings, were removed and replaced with the present ones during a period of alteration to the house.

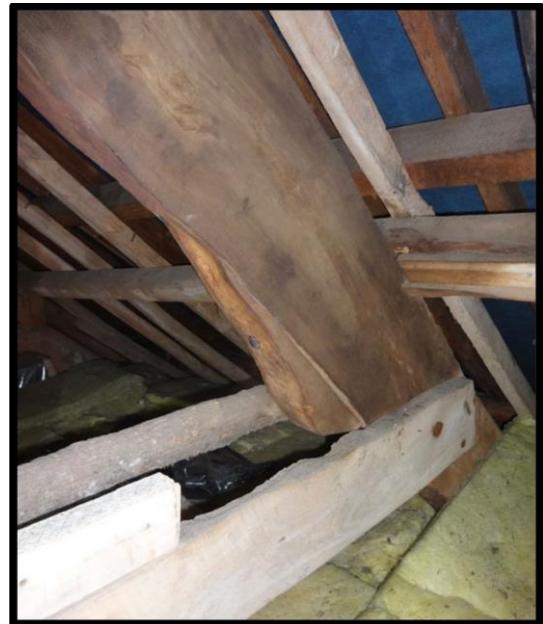
Fig. 20 Detail of the western foot of Truss III showing a similar timber cleat or wedge, now redundant, but perhaps part of an earlier partition.
