Historic Buildings Survey

**FARM BUILDINGS AT BUTTERFORD,
NORTH HUIISH, DEVON**

By R.W. Parker

REPORT No. 2011.04

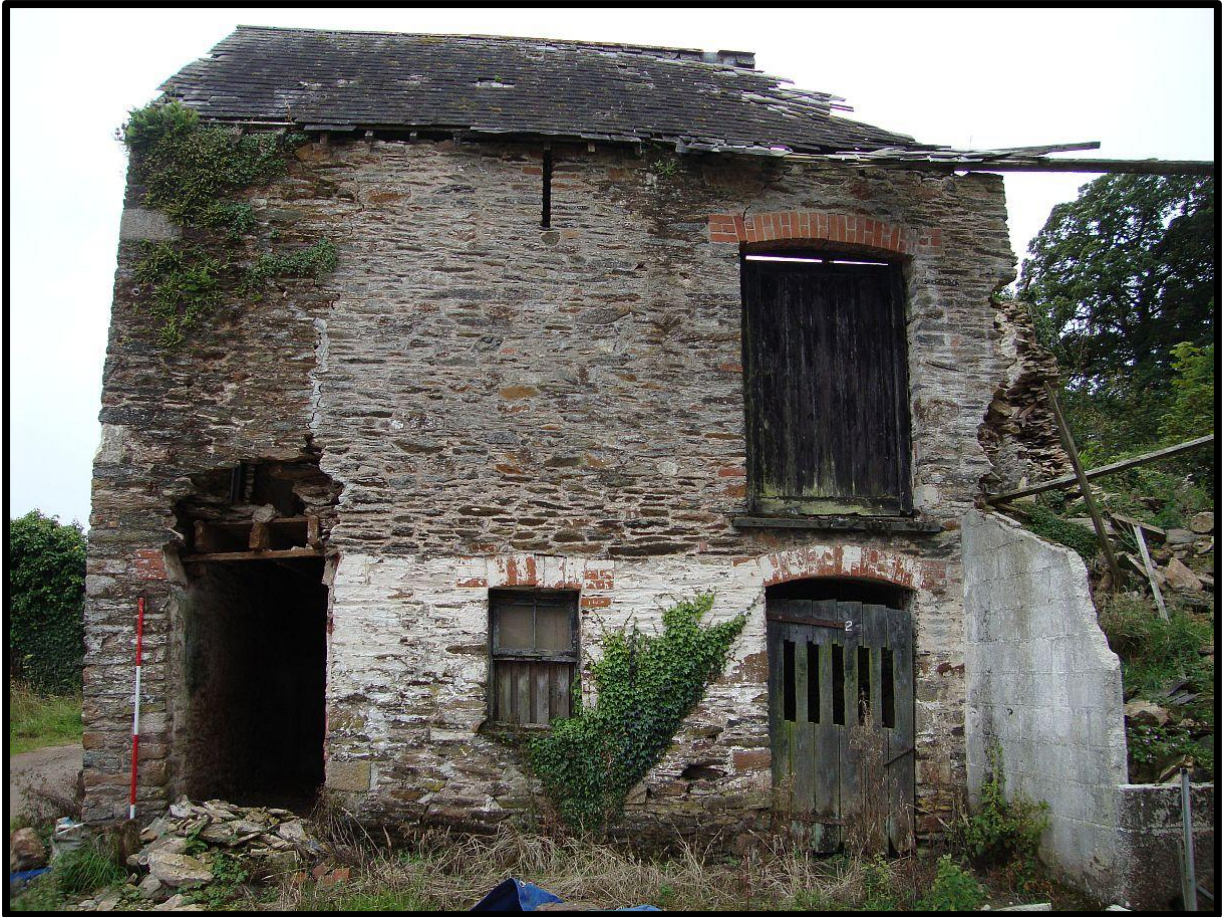
The facade to the farmyard or stable court is of local shale and slate, incorporating some large blocks of granite and limestone (Fig. 5). The upper part of the north-eastern elevation has a narrow ventilation slit near eaves level and a wide loading door. The lower part of the elevation has a pair of doorways, alternating with a pair of windows, though one of these is now wholly obscured by fallen rubble. The window embrasures have splayed interiors, but the doorways have rectangular jambs arranged in an unusual manner: one of the jambs is rebated so that the wall appears to be constructed in two skins, whereas the opposing jamb is not rebated in the same way, but has, instead, a single projecting block of granite forming a door-stop to prevent the door from swinging inwards. The doors to the loft on the upper floor have wooden frames and are hung to open inwards. The doors to the ground floor were arranged to open outwards, hung on pintles in the rebated jamb without frames and with long strap hinges. Several doors survive; these are of planked construction, each plank being cut to a narrower width near the head to provide a ventilation grille. The openings have brick-arched heads of bright red bricks, probably dating from the late 19th or early 20th century.

Fig. 5 View of the north-eastern elevation of Barn 1, showing the character of the window openings and masonry and the poor state of structural repair.

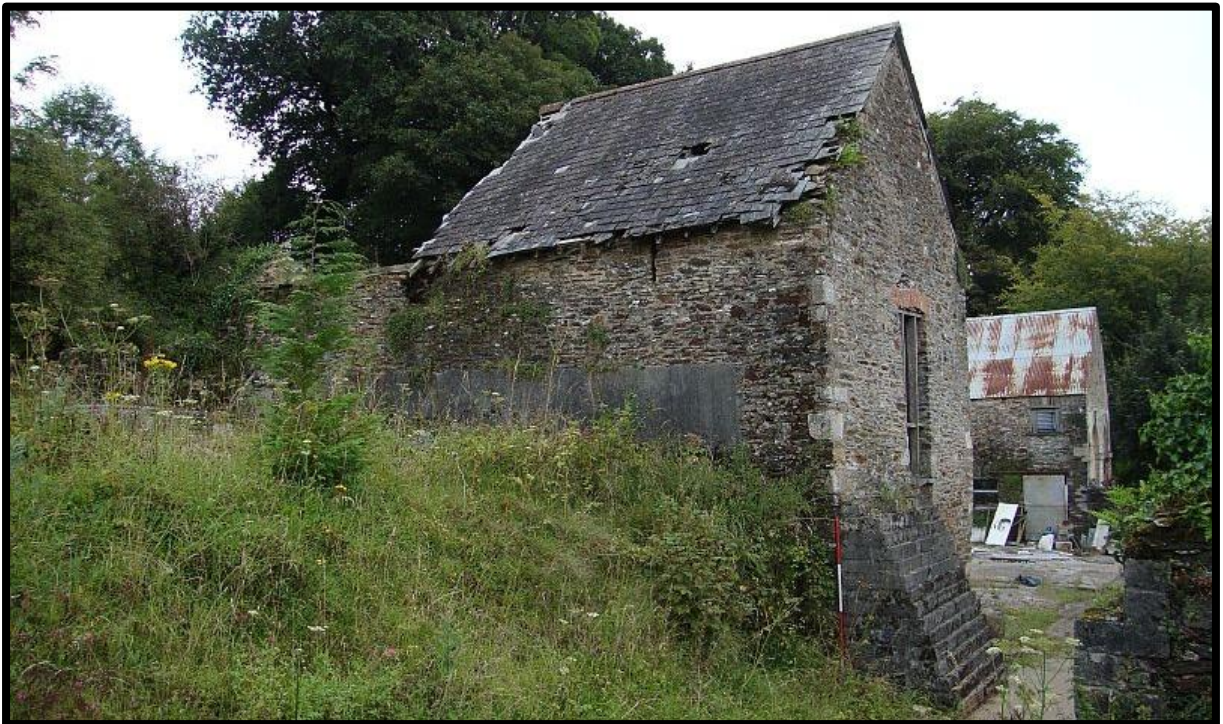
Fig. 6 View of Barn 1 from the south, showing the rising ground to the southwest and north west, the occasional granite quoins and the concrete buttressing of the gable end.

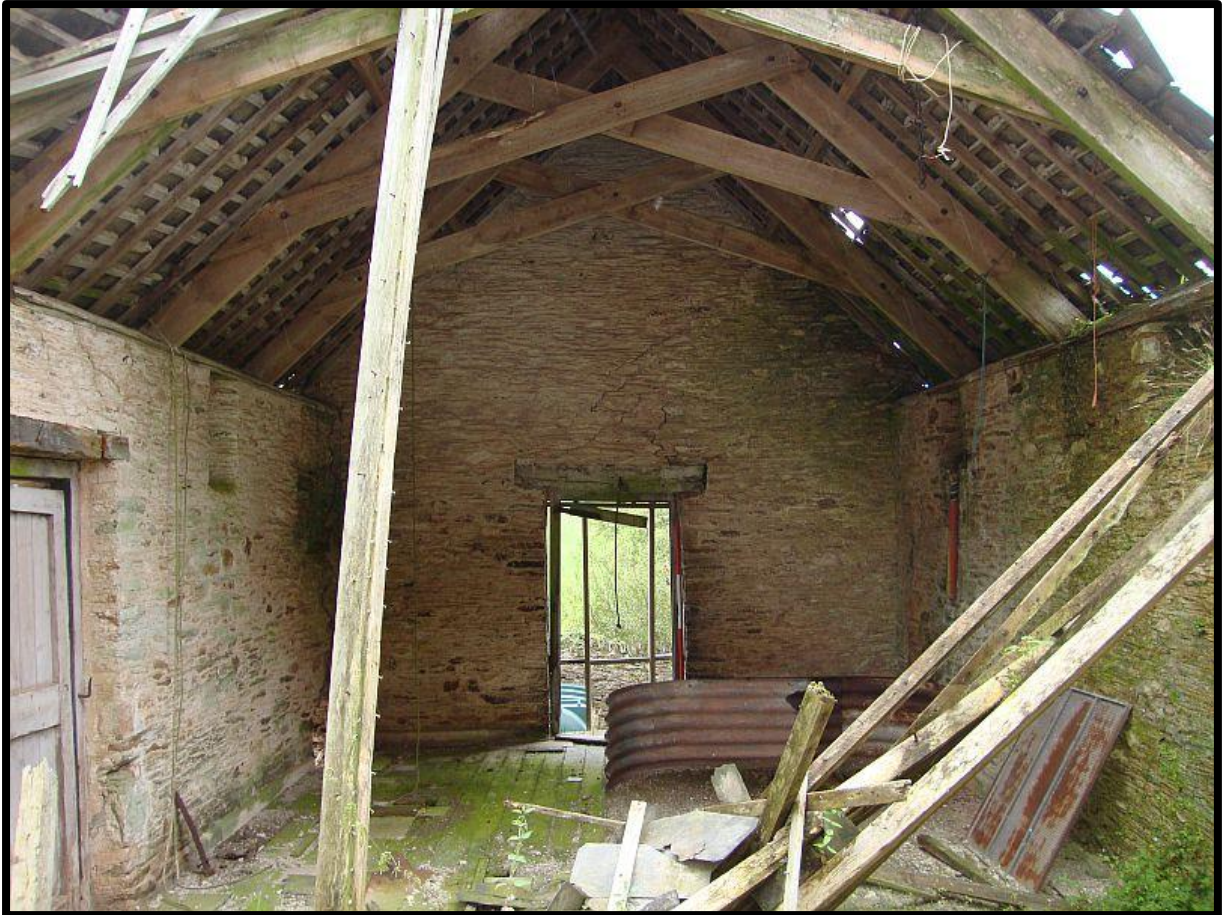
This room cannot be entered safely as much of its floor and roof have collapsed. It was a single large space with unrendered walls and an open roof (Fig. 7). The roof is of scissor truss form and plainly dates from the early 20th century at the earliest. The principals rest on angled timber wall plates and are halved and nailed together at the top. The scissor braces are applied to opposite sides of the principals and secured to them by bolts. There is a wooden spacer between the scissor braces at the point where they cross, secured with a further bolt. There is only one pair of purlins, on each side of the roof, and a plank ridge. The roof is rafted and battened, the slates apparently held in place by a wedge of mortar adhering to the underside, though this appears to supplement nailing as many of the fallen slates show signs of nail holes.

Fig. 7 View of the first floor room within Barn 1, (looking south-east) showing the early 20th-century roof structure.

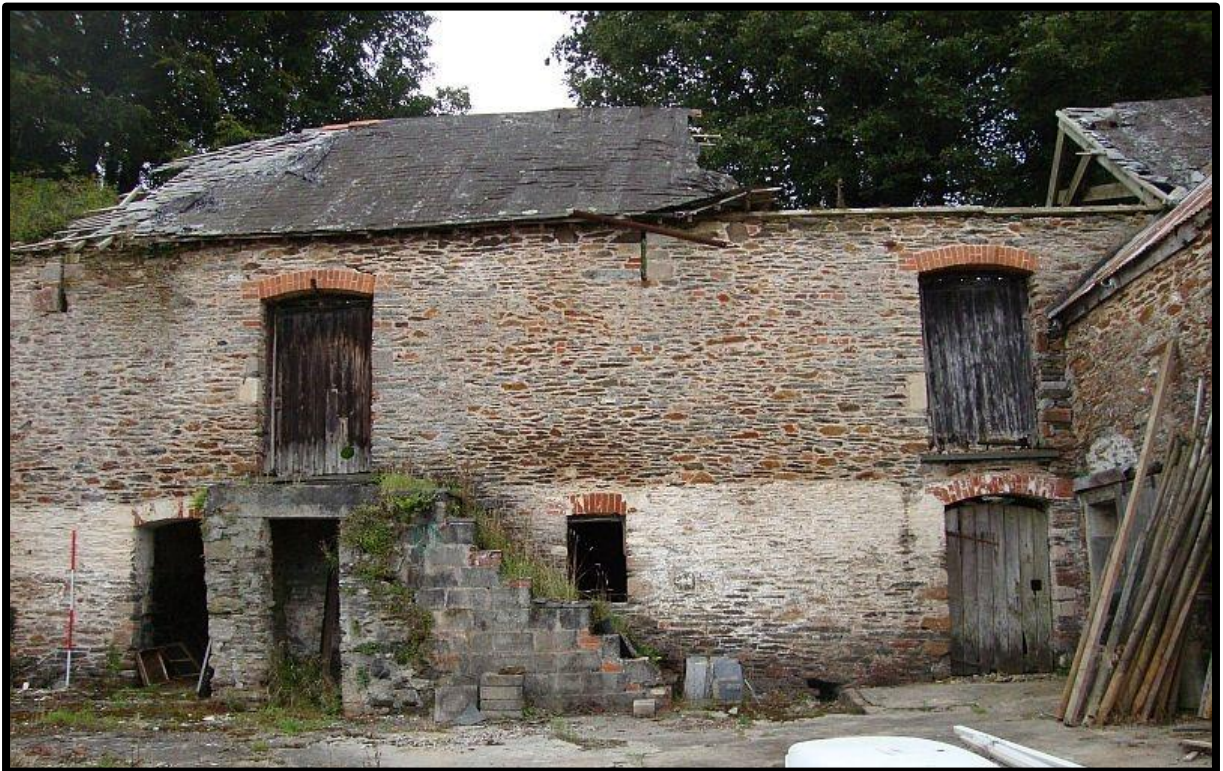
This is a very large and handsome barn with an irregular façade towards the farm yard (Fig. 8). The upper storey has three small ventilation slits and two large loading doors, one of which is approached by an external stair at the centre of the façade. In its present form the stair is modern, but part of the structure is stone built, butting against the barn wall. This appears on the 1906 map and may be a late 19th-century addition. The doors may originally have provided a draught for hand threshing or winnowing, though the presence of a horse-engine house implies that mechanised threshing was also employed. The lower part of the elevation has two doors and two windows, alternating, and very widely spaced. The doors are of the unusual rebated form previously described, with projecting blocks forming doorstops. One door remains, simply planked and without ventilation slits.

Fig. 8 Part of the south-eastern elevation of the long barn or Barn 2, looking north-west.

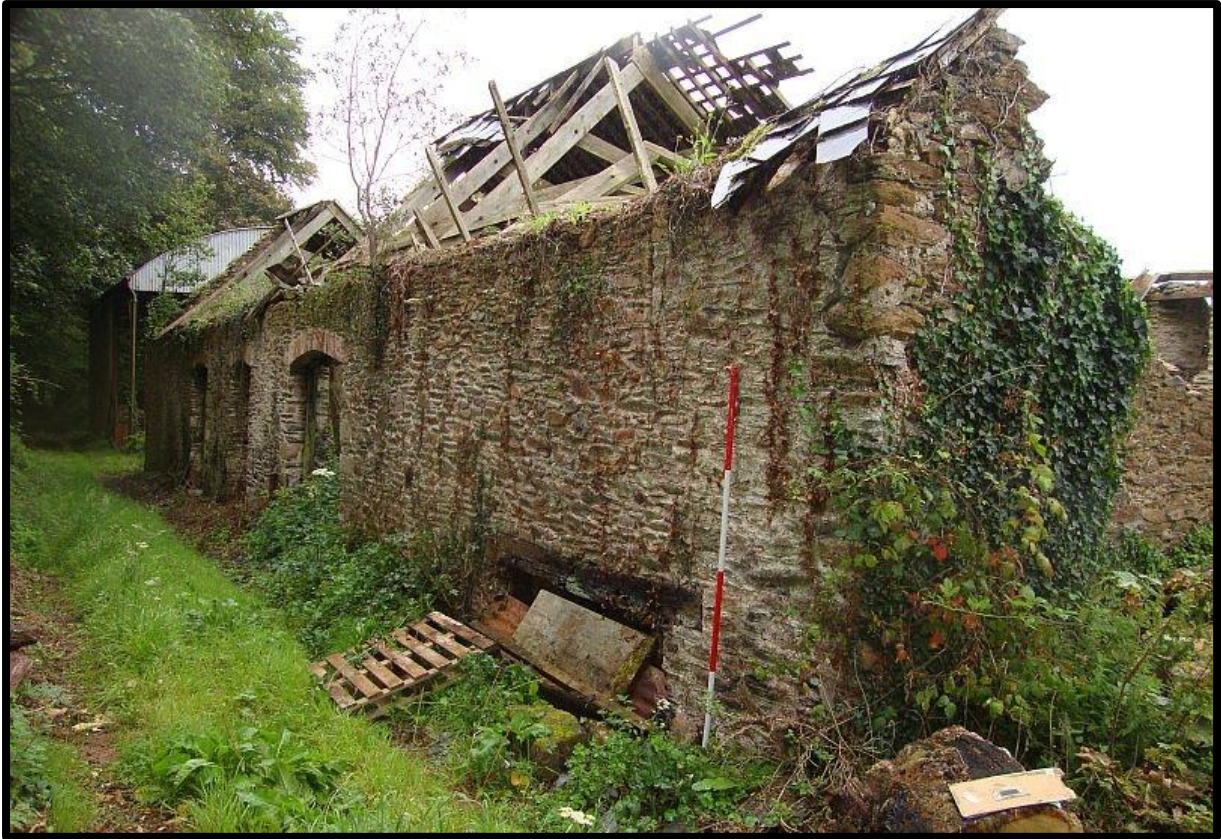
Fig. 9 View of the north-western elevation, looking east, showing the chute to the root store in the foreground and the archways to the service road on the left.

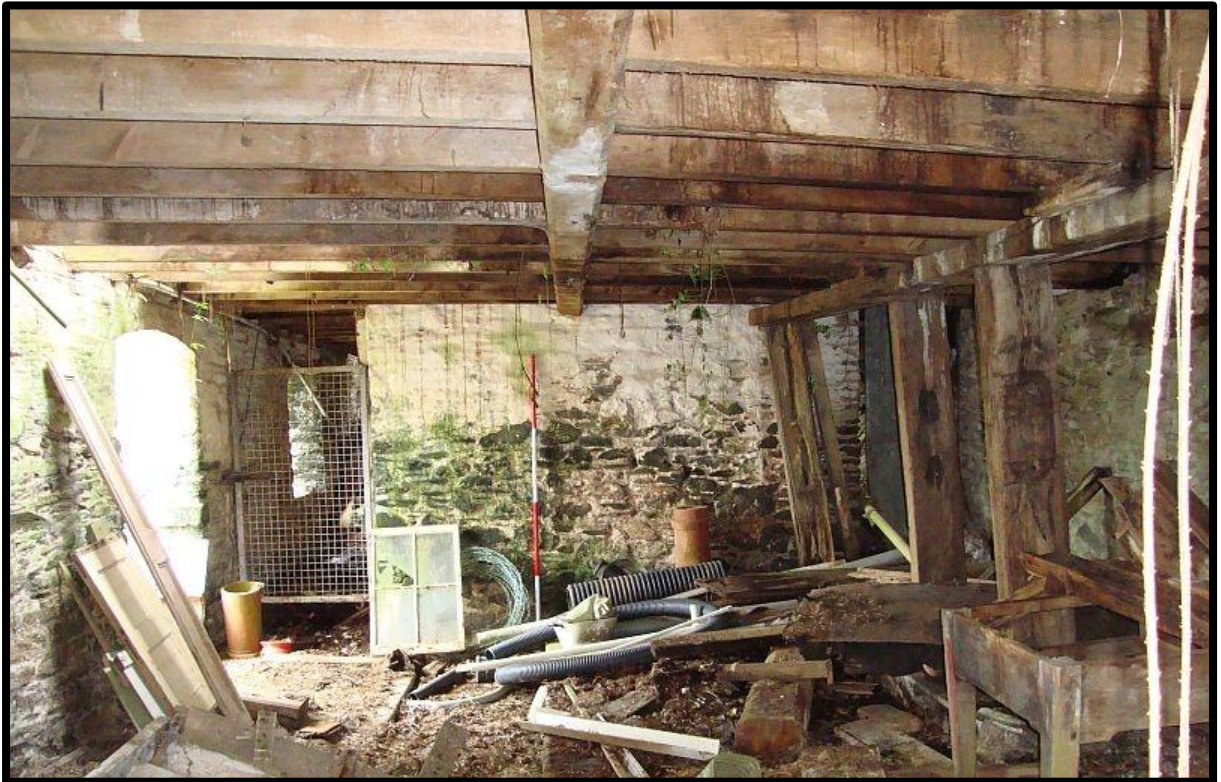
Fig. 10 View of the interior of the ground floor room, or shippon, within Barn 2, looking south west, showing the remains of the head walk on the right and sockets for stall posts in the central trimmer below the joists.

From this room two doorways opened onto the adjacent section of barn, which appears to have been designed as a shippin or cow shed (Fig. 10). One of the doors led to the head walk or feeding passage, and the other from the root store to the circulation area outside the cattle stalls. Neither opening retains a door.

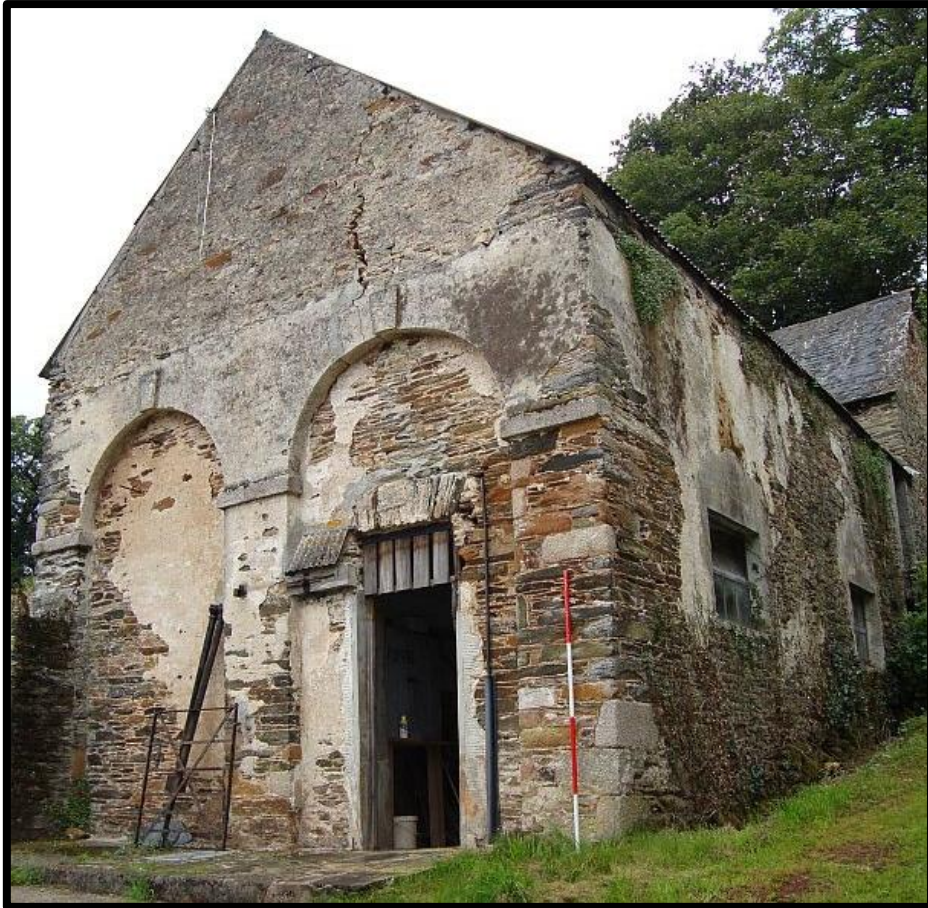
Fig. 11 South-eastern elevation of Barn 3 showing the architectural treatment of the end wall and the original plaster, which appears to preserve the scar of a timber cornice below the later gable.

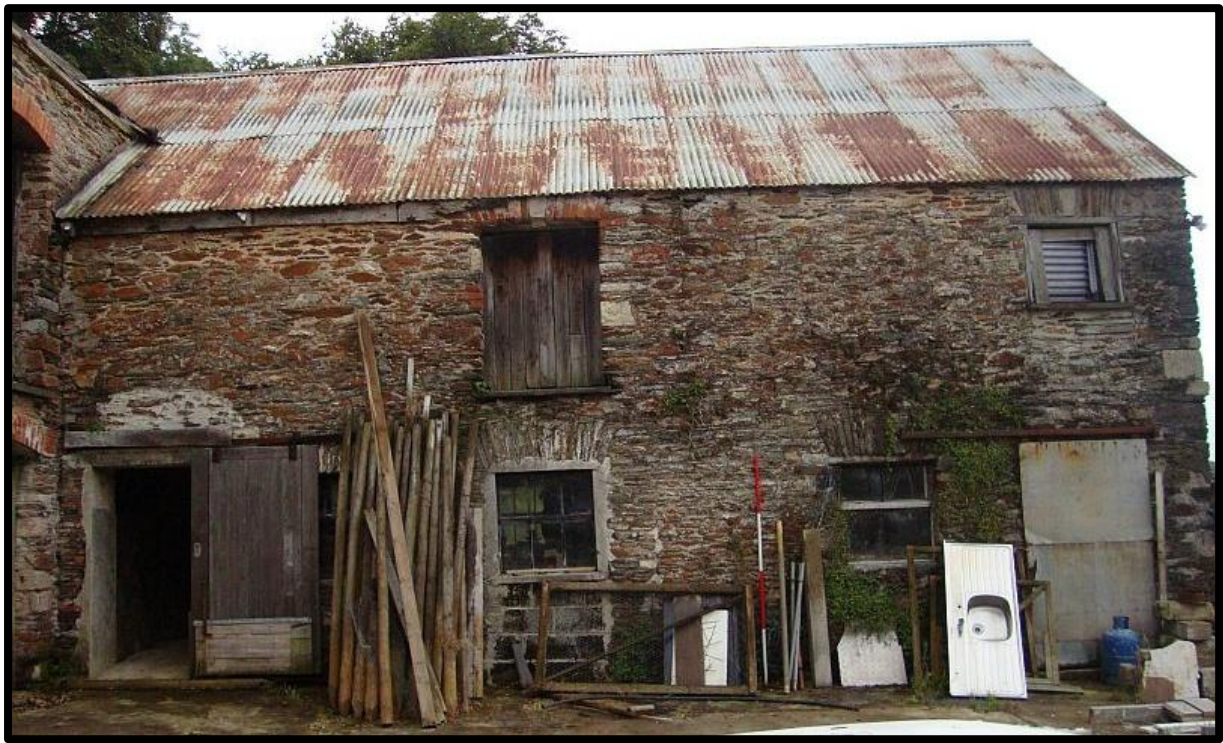
The south-western wall contains evidence of a series of doorways and windows, six in number, more or less regularly spaced and opening into the yard (Fig. 12). The original openings appear to have had flat arches of radiating slate voussoirs; however, two of the doorways have had their stone arches cut out and replaced with concrete lintels. Two other

Fig. 12 South-western elevation of Barn 3, showing the irregular pattern of openings and variety of materials employed, which is perhaps the result of successive phases of alteration.

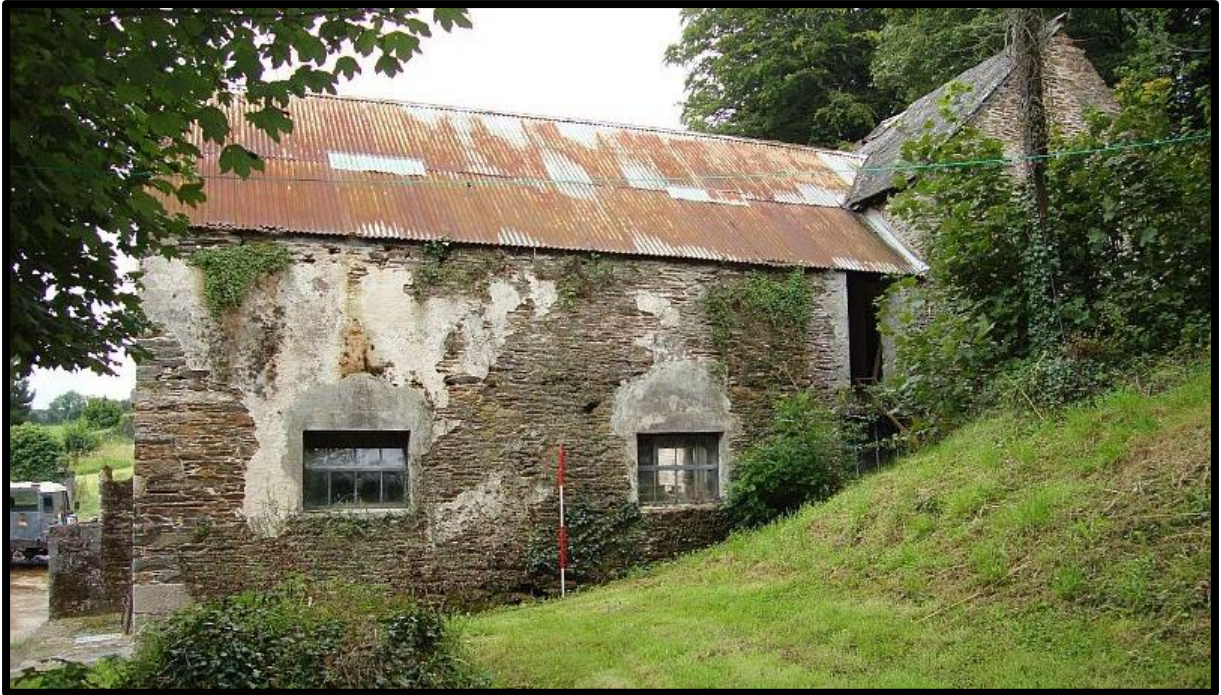
Fig. 13 North-eastern elevation of Barn 3, showing traces of early render and evidence of alteration to the window openings, which may have been repositioned at a lower level.

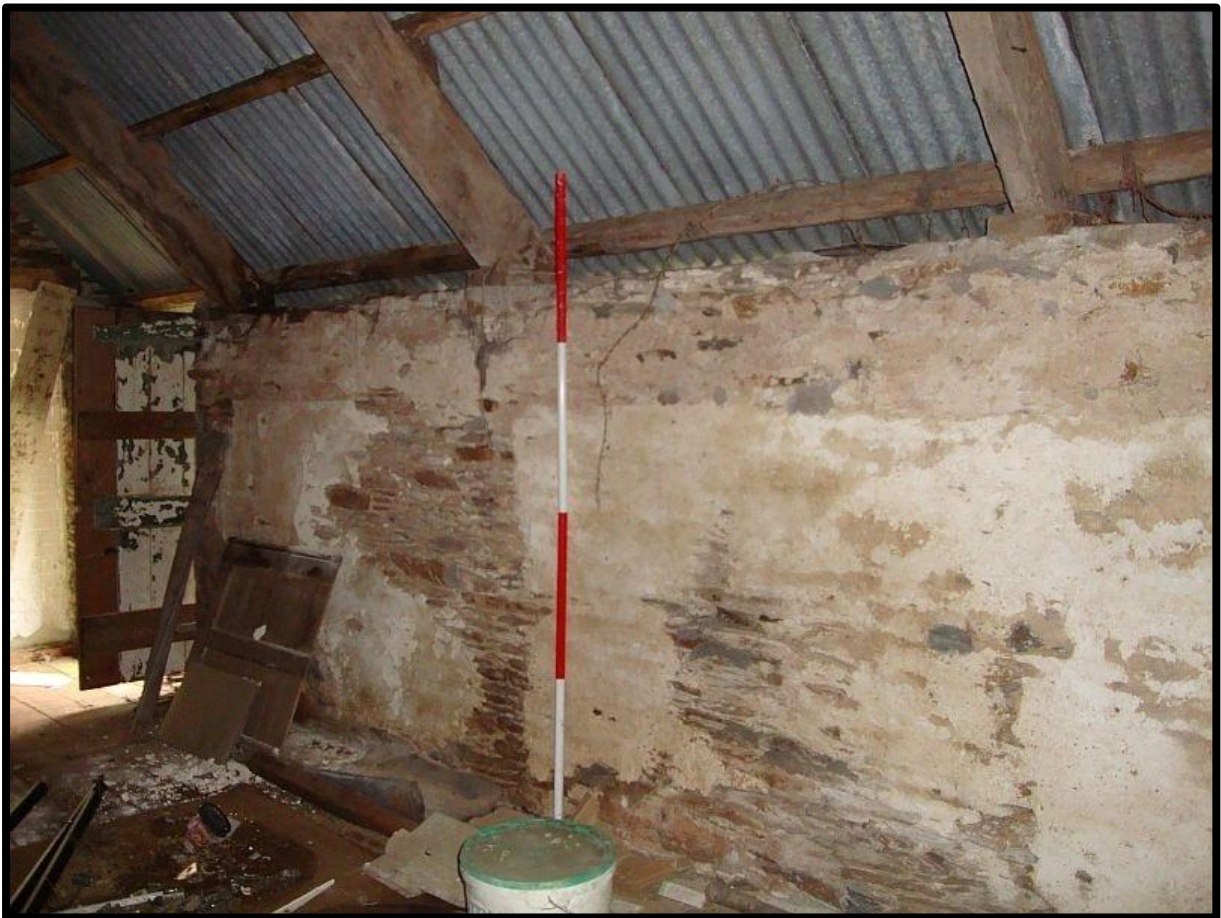
On the first floor the remains of plaster on the lower part of the walls reaches to within a short distance of the eaves (Fig. 14). This may imply that there was formerly a higher ceiling just below the tie beams or springing of the original roof. This would conflict with the level

Fig. 14 Detail of the north-eastern wall, internally, at first-floor level, showing the discontinuity of the early plaster to the full height of the wall, implying a vanished ceiling, and traces of one of two internal partitions dividing the interior. The present first floor must be an insertion.

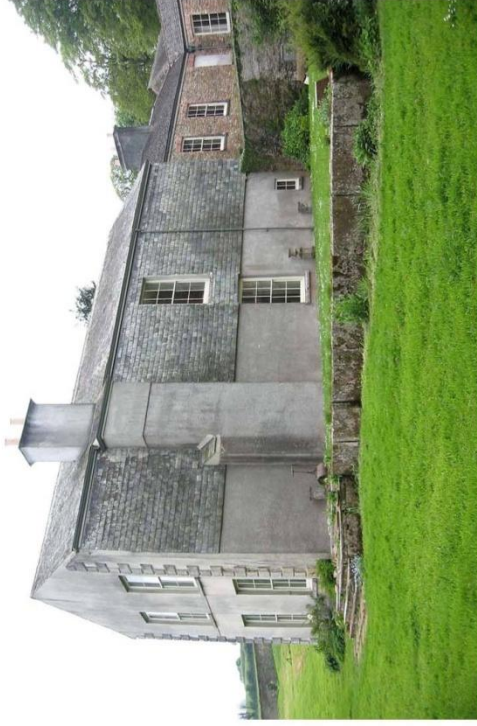
Plate 3: Butterford House in 2007

The Portland stone plinth and steps of the south-east front are clearly visible in the foreground, with the truncated ground and first floor of the south-west part of the 1792 mansion behind. The cut stone quoins are clearly visible. The chimney stack in the foreground heated the entrance hall: the upper is a 1950s-60s reconstruction. Note the late 18th and early 19th century rubble and brick service wings behind, which survive to their original height. Compare this view with the complete house in Plate 1.
