Historic Buildings Survey

**WEST FORDE FARM,
CHERITON FITZPAINE, DEVON**

By R. W. Parker

REPORT No. 2012.04

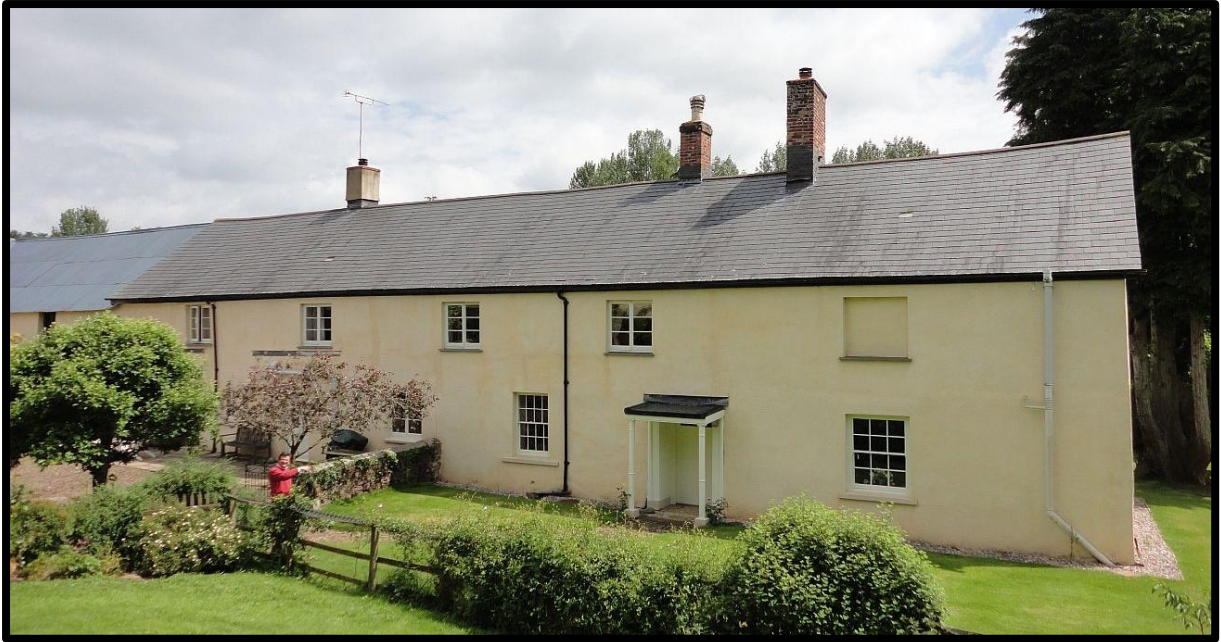
The western elevation (Fig. 4) is currently the main façade of the house and, at first floor level, is of five regular bays. The first-floor window at the southern end of the façade is now blocked, but all of the other windows at this level feature 19th-century casements or modern replacements in the same style. It is almost certain that evidence of earlier and wider window openings will survive beneath the modern render, particularly in the more important parts of the house.

Fig. 4 View of the western elevation of the farmhouse, showing the great length of the building and the relationship between the roofs of the house and the adjacent barn (extreme left).

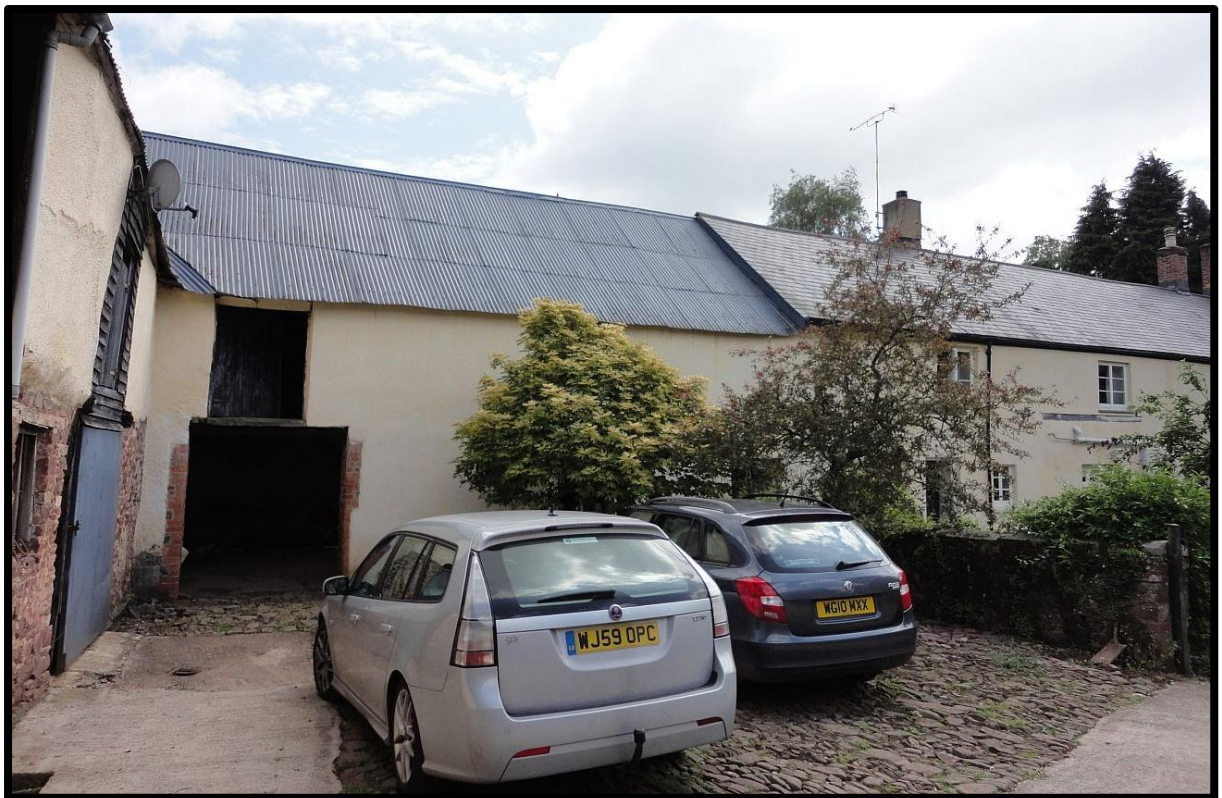
The adjoining barn has a very plain façade with small two-light windows on each storey. These openings do not appear to have been altered and their splayed embrasures seem intact. The plain, unmoulded window frames and mullions might date from the late 17th to the early 19th century. A narrow doorway with a good plank door hung on strap hinges with expanded ends opens onto to the south end of the barn and a wider entrance has been broken through the west wall close to its junction with the north range, on both storeys (Fig. 5).

Fig. 5 View of the west wall of the barn to the north of the house, showing the roofline and the modern brick jambs of the enlarged ground-floor opening. (Domestic scale window openings at the centre of the barn are obscured, here, by a tree).

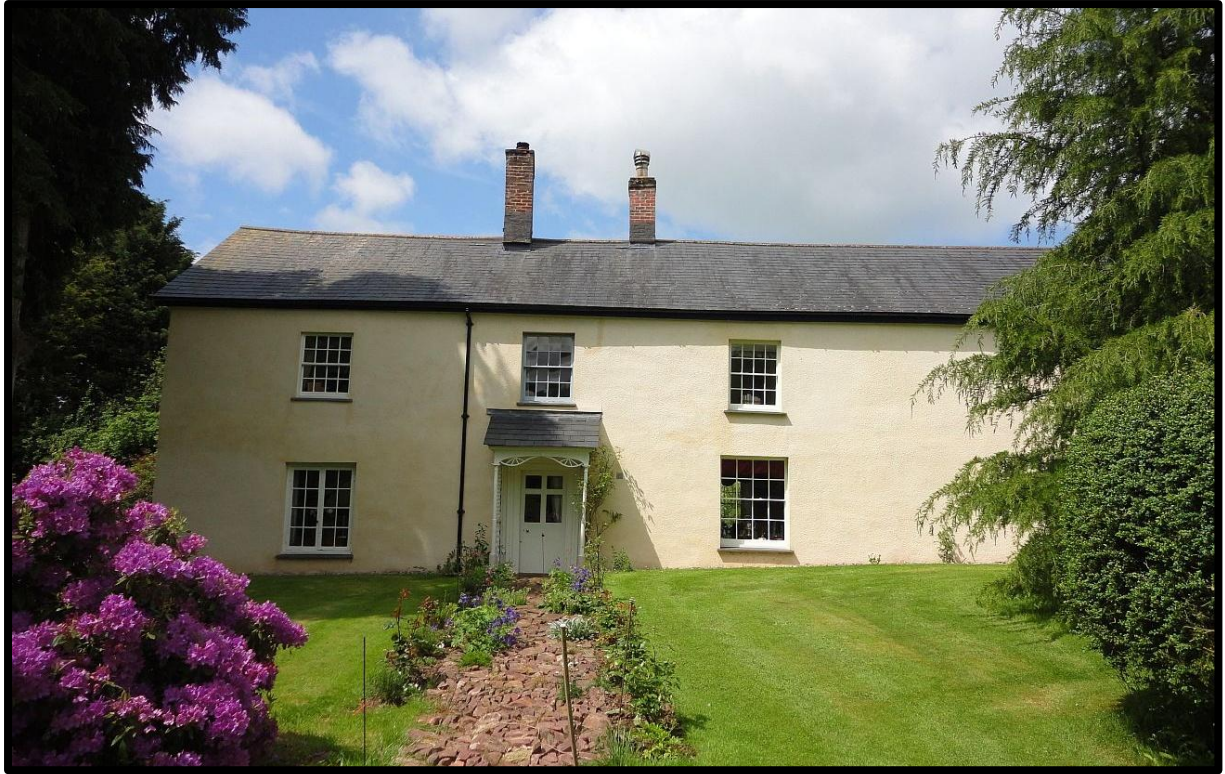
Fig. 6 View of the eastern elevation of the farmhouse showing the formal treatment of the south end and the configuration of the chimneys betraying the probable position of the original cross passage.

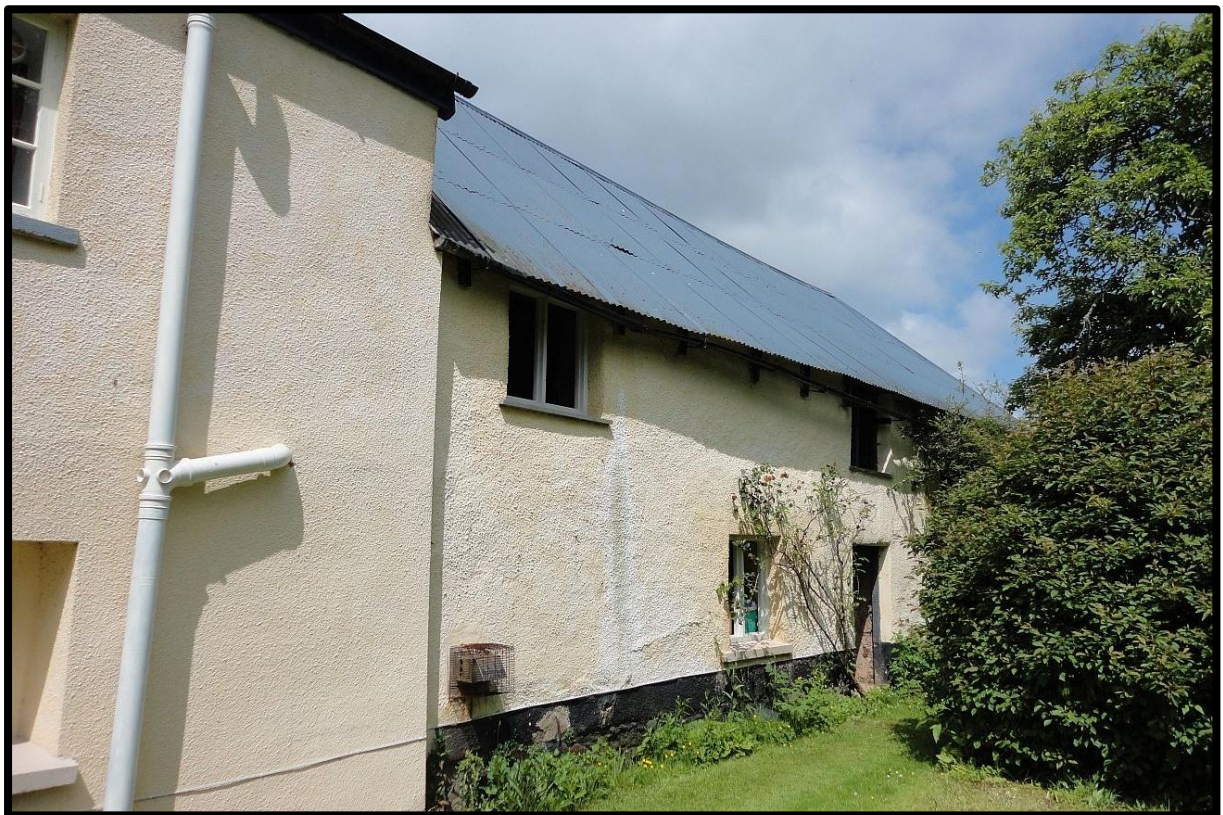
Fig. 7 View of the eastern façade of the barn from the gardens, showing the raised eaves of the main house and the small two-light windows

The eastern façade of the barn (Fig. 7) has a lower eaves level than the house, but it is clear from internal inspection that the eaves of the house have been raised and that the original eaves level and the pitch of the earlier roof matched that of the barn. The upper parts of some of the first-floor windows preserve traces of lath and plaster 'hoods', visible from the roof space internally, which may show that the first-floor windows formerly projected above eaves level and that the thatch swept over the windows in the form of 'eyebrow dormers'. Inspection of the wall tops from within the roof space, all along the length of the house, shows that much of the upper part of the east wall, perhaps as much as 1-1.5 metres in height, has been rebuilt very recently in red cored brick and concrete blockwork. This must replace earlier fabric, but of what period it is now impossible to say. The most likely interpretation is that the wall was heightened in the 19th century, perhaps in the context of replacing a formerly thatched roof with slate.

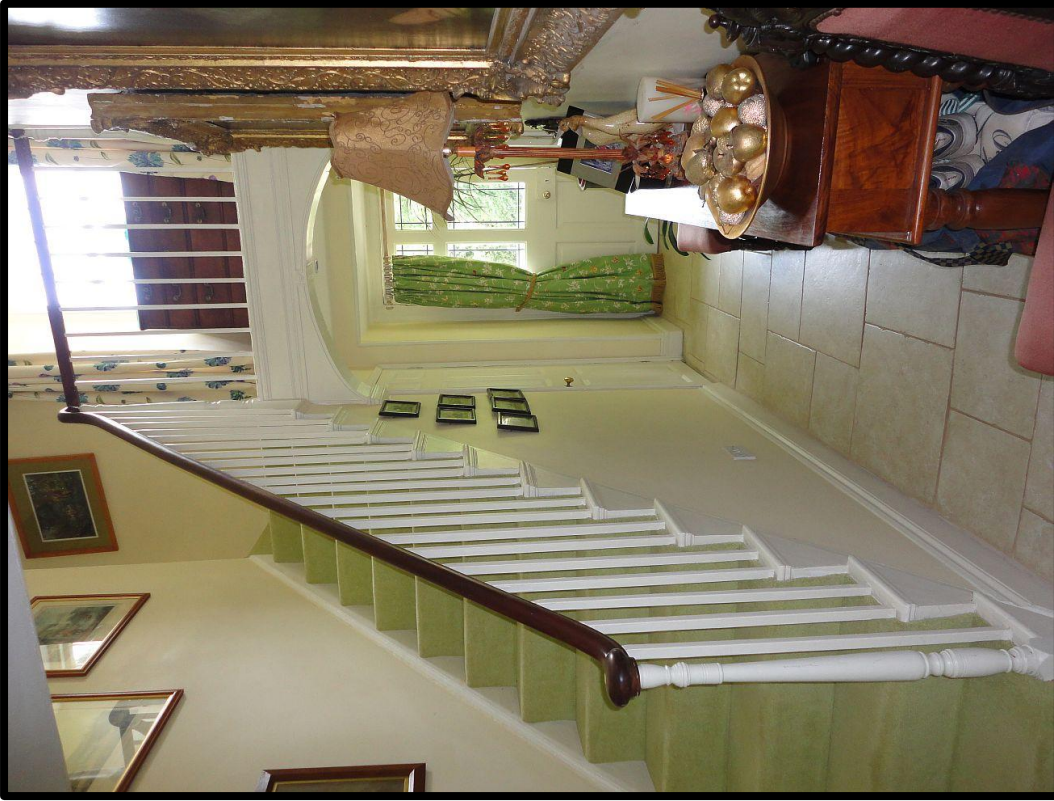
Fig. 8 Detail of the early 19th-century staircase within the entrance hall. looking east.

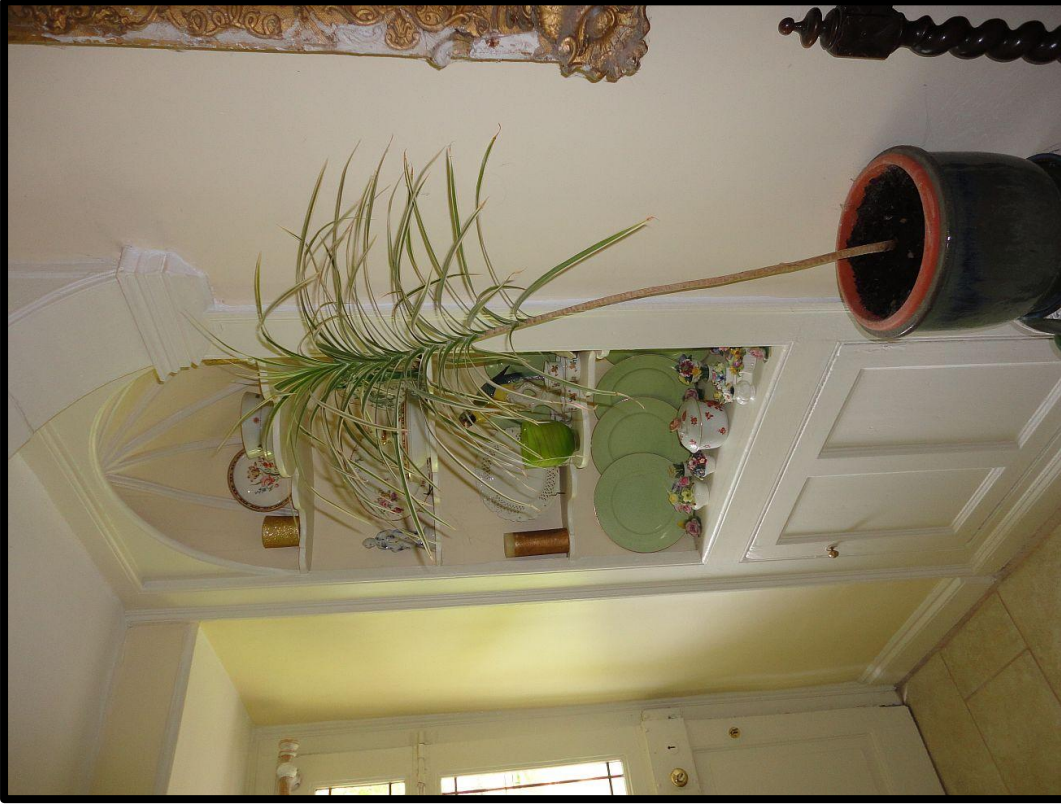
Fig. 9 detail of the china cabinet at the eastern end of the entrance hall.

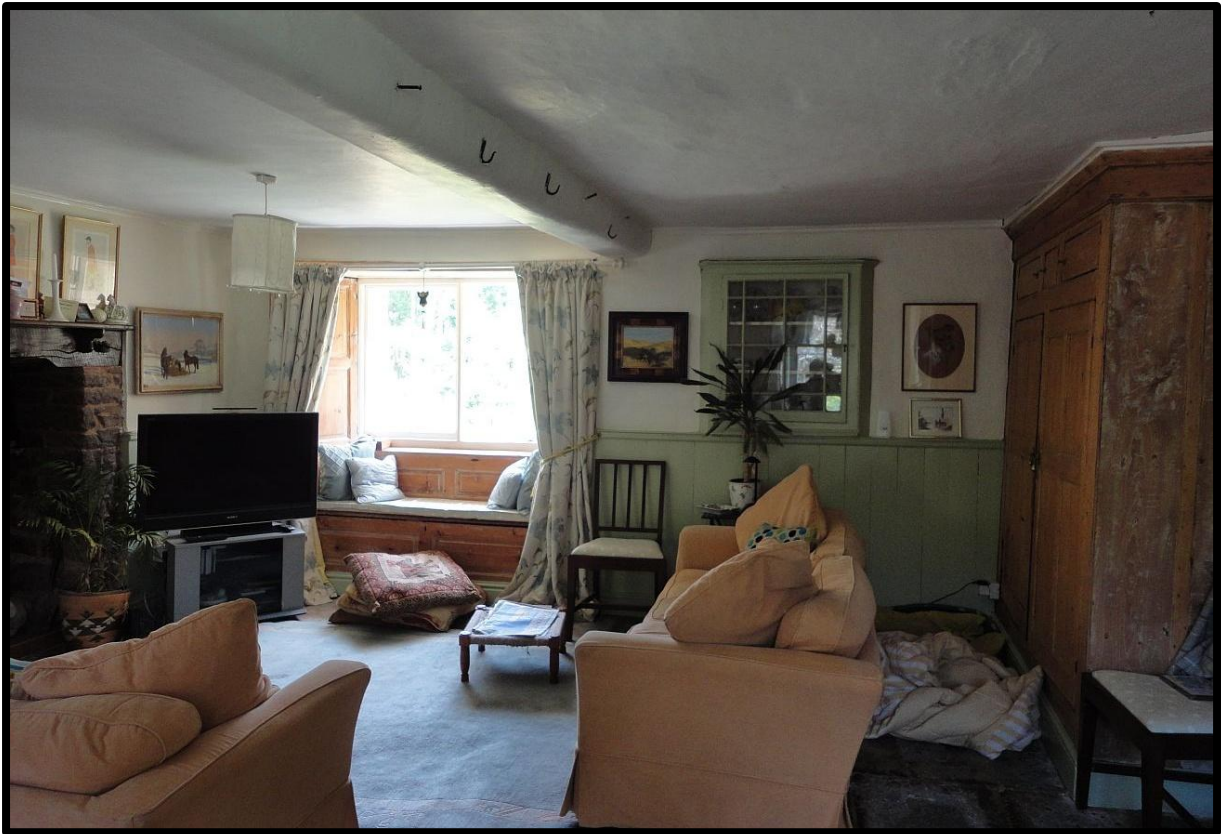
Fig. 10 View of the sitting room, looking east, showing the alignment of the ceiling beam, the meat hooks, the panelled window seat, fireplace and wall cupboard.

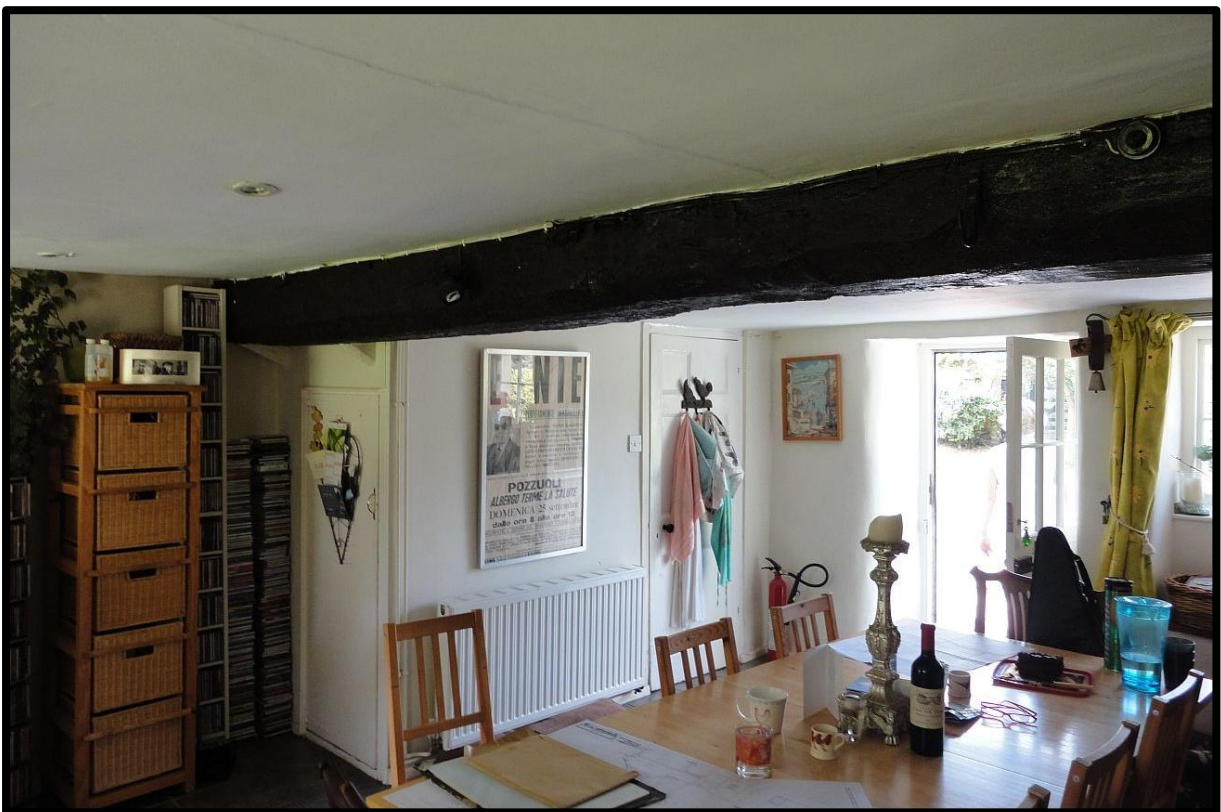
Fig. 11 View of the kitchen, looking south west, showing the massive ceiling beam, the enclosure for the service stair (centre) and the scar of a partition across the ceiling.

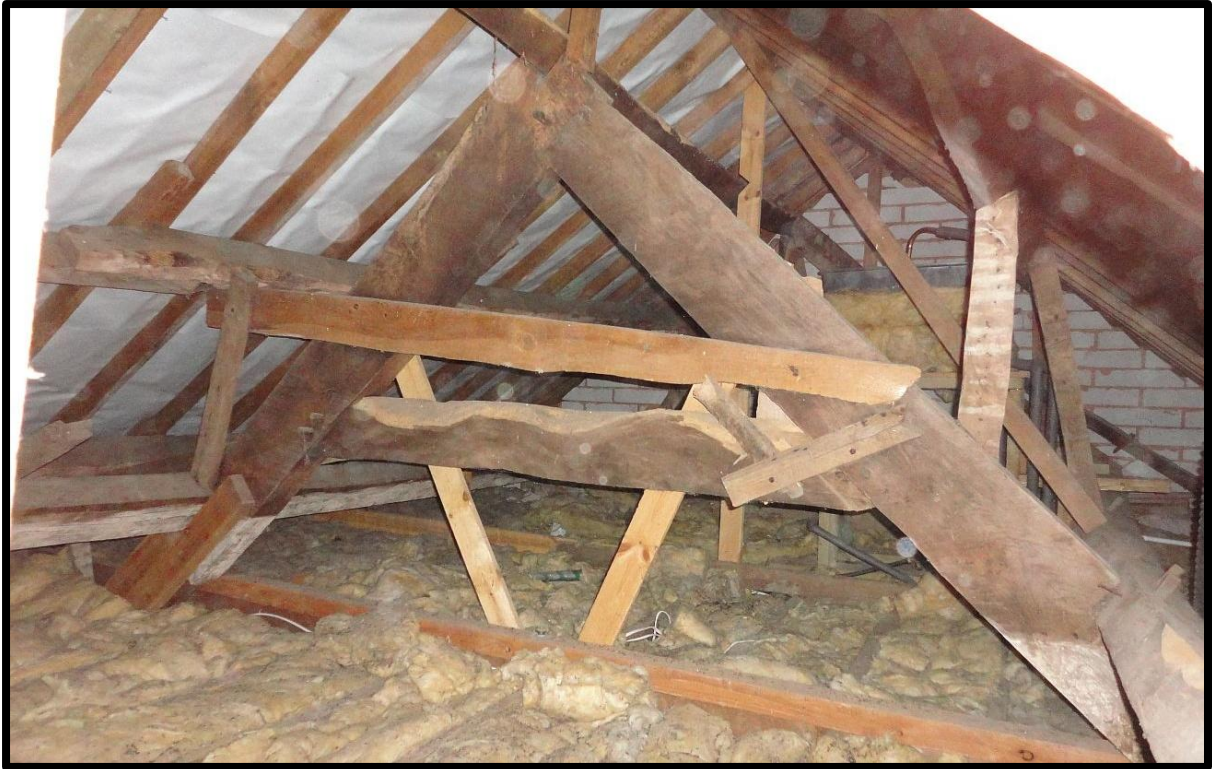
Fig. 12 View of the sole surviving late-medieval roof truss over the southern end of the house, looking south, showing its relation with the modern roof above.

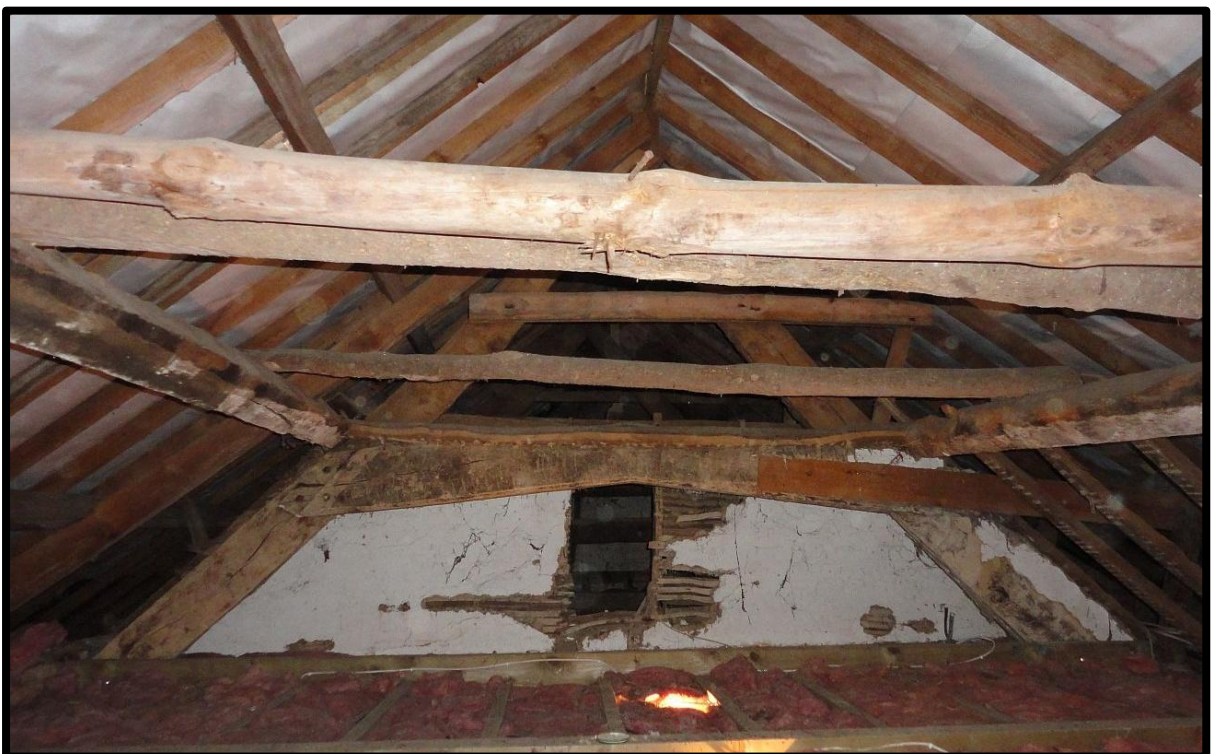
Fig. 13 View of the roof over the centre of the original house, probably the hall, looking north, showing the (reused) cranked, smoke-blackened collar of an impressive late-medieval roof and the remains of a tertiary partition beyond it relating to a chamber.

room from the sitting room, and extends into the loft space, where its surface retains plaster and whitewash (Fig. 13). This is not a medieval closed truss; it is not smoke blackened, and was probably not aligned on any of the earlier roof trusses, but must date from the rebuilding of the house in the 17th or 18th century when the existing historic roof structure was added. A small void in the centre of the partition allows access to the upper part of the chamber which, like the hall chamber, formerly had a high ceiling with canted sides, ceiled with lath and plaster. Most of the ceiling joists remain, bearing traces of lathing, and the plaster remains to the full height on the northern wall and chimney breast (Fig. 14). The existing ceiling is much lower than the original and, after the new ceiling was inserted, one of the trusses was braced with a long timber with a curved head or foot, probably a cruck post or principal from a demolished farm building. This chamber remains undivided but for the corridor running along its eastern side. The large chimney breast from the kitchen rises through this room and alongside it is a small closet, now converted into an '*ensuite*' bathroom. This has an 18th-century two-panelled door, hung on 'L'-hinges, which has been disguised as a four-panelled door by the addition of extra fillets of timber. The closet may well originally have housed a staircase rising alongside the kitchen chimney.

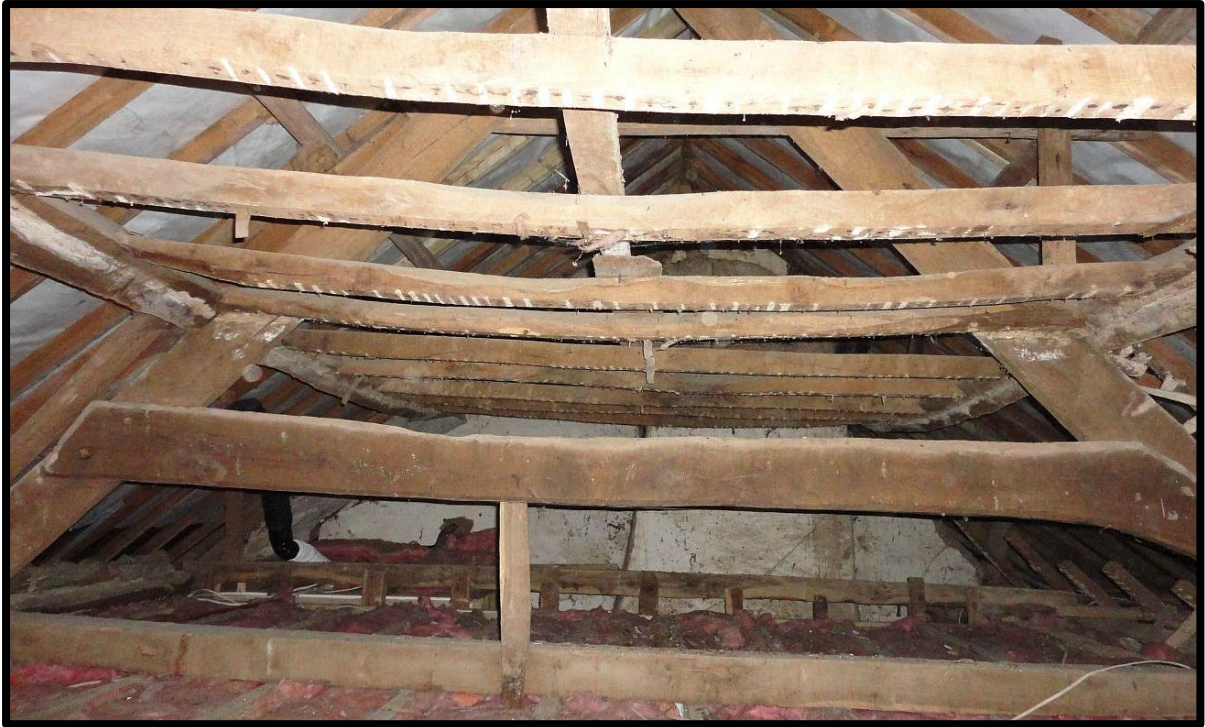
Fig. 14 View within the former chamber, looking north, showing the high-level of the former ceiling, the plastered chimney breast and a reused cruck or wall post with a curved foot added as an additional tie.

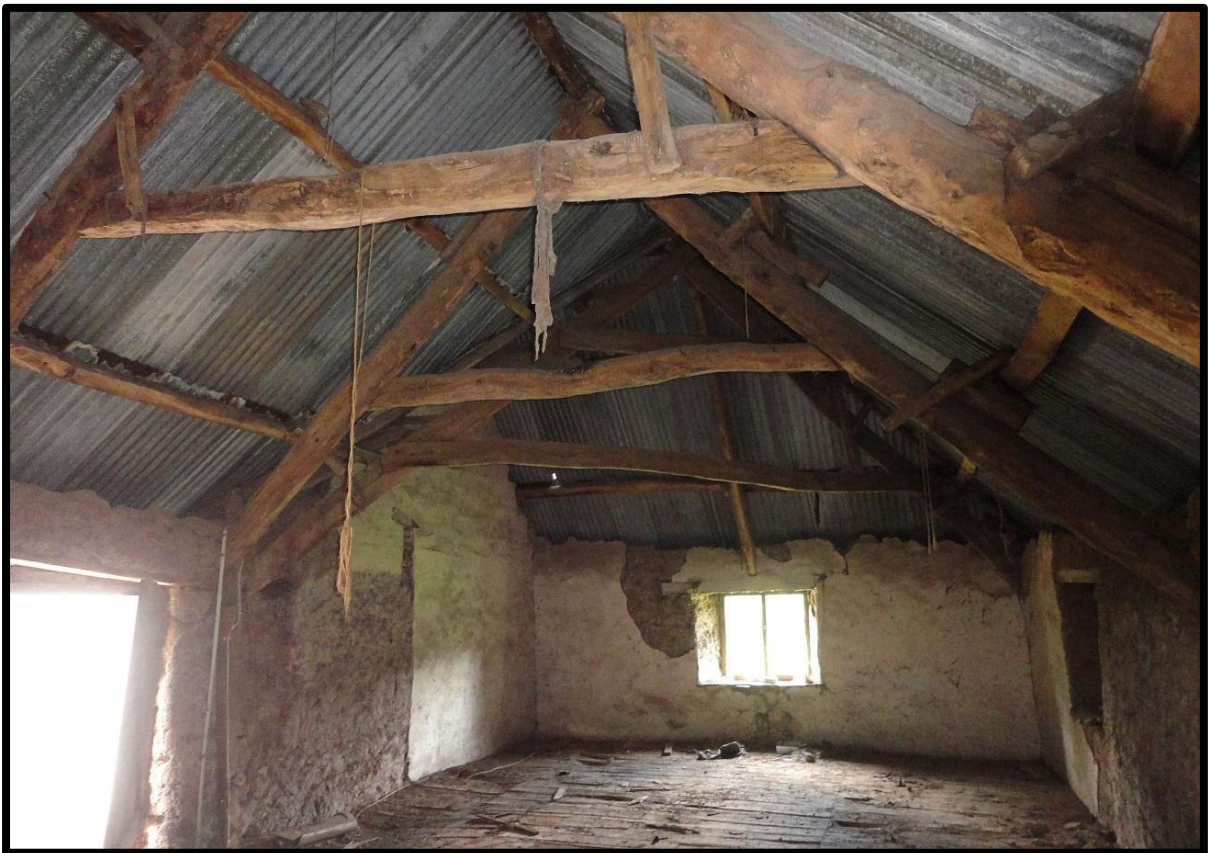
Fig. 15 View of the loft over the barn at the north end of the house, looking north, showing the plastered walls and the absence of any evidence of ceilings.

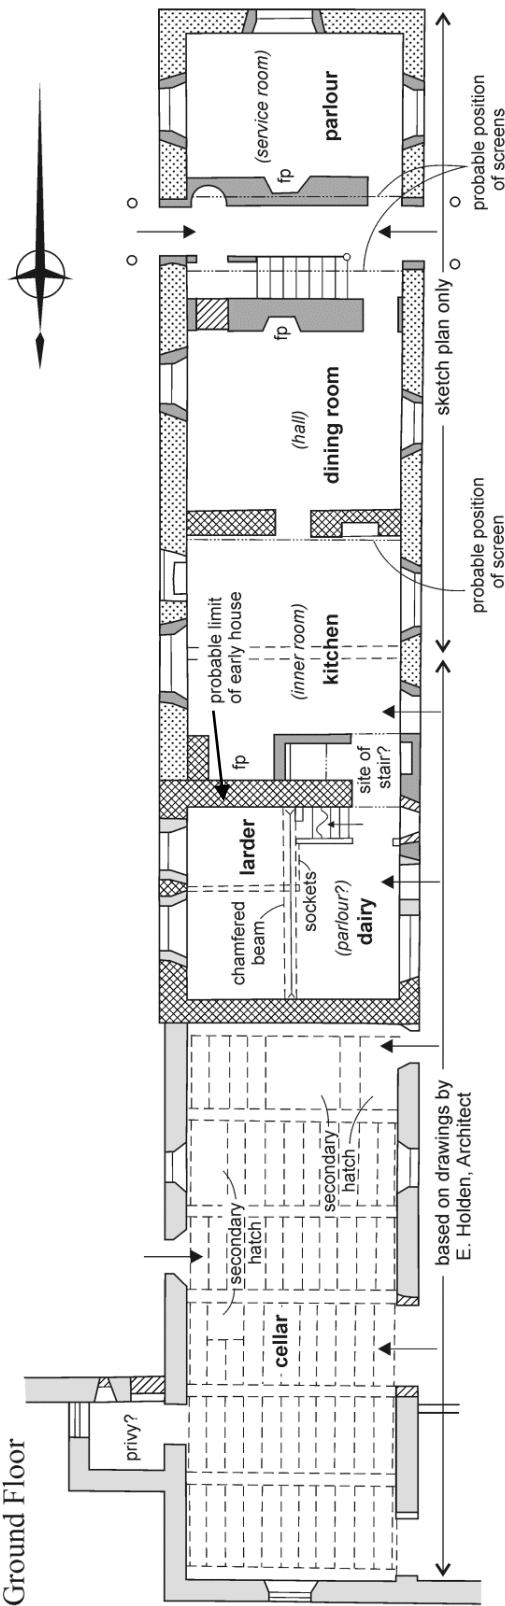
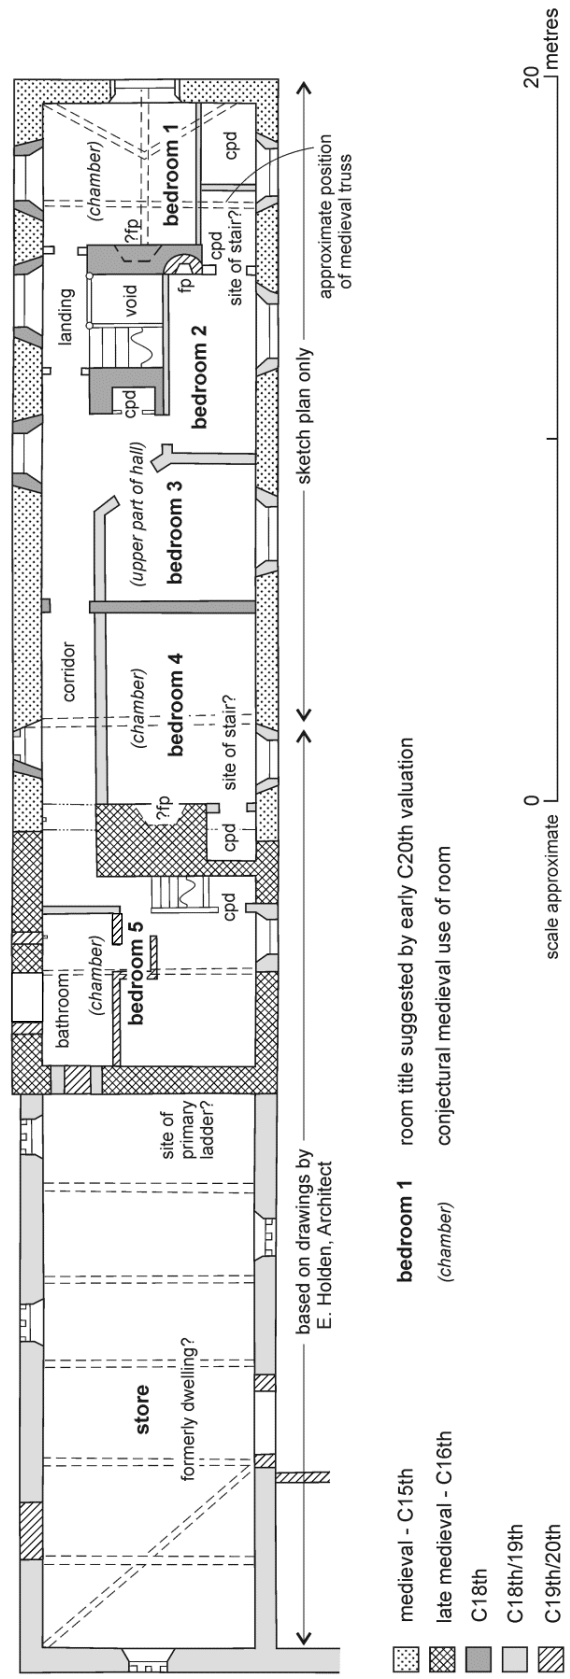
Fig. 16 Plans of the ground and first floors, based upon measured drawings by E. Holden and sketch plans by R. Parker, showing the suggested phasing of the building (digitised by Jane Read).
