Archaeological Building Survey

COTTAGES AT HIGHER THORNE, EXFORD, SOMERSET

By R. W. Parker

REPORT No. 2012.02

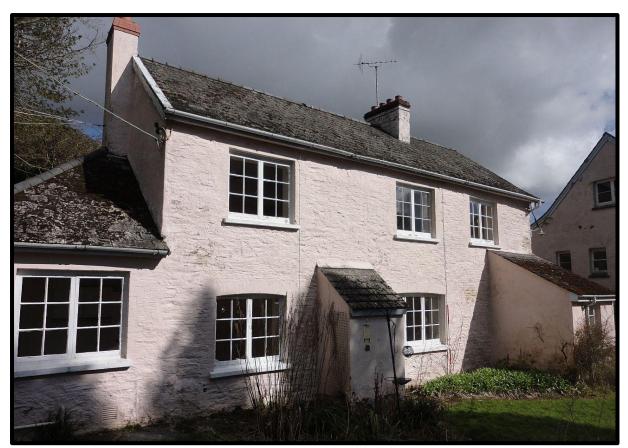
Fig. 1 Front elevation of the cottages at Higher Thorne, Looking north east.

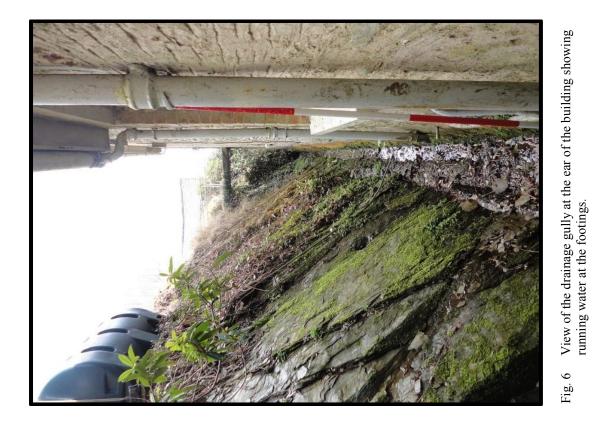
This elevation has few window openings and is separated from the hillside by a deep drainage gully (Fig. 6). There is one small ground-floor window opening, which seems certain to be inserted. This has a segmental head of red brick and a concrete window sill. There are three first-floor window openings, one of which, at the eastern end, was formerly a doorway and is now connected to the higher ground to the north by a short concrete bridge. The central opening has a timber lintel and redbrick jambs, while the western opening is lower and smaller than the others. The jambs of this latter opening appear to have been cut through earlier stonework and then repaired in concrete. All of these openings seem to have been inserted, the only trace of any earlier features are in the vicinity of the central window, on each side of which traces of vertical disturbances in the stonework may be discerned (Fig. 7). The window seems to occupy a large area of blocking, within an earlier, wide doorway at first-floor level. If this is the case there must formerly have been a bridge across the drainage gully to this doorway, or, alternatively, the hillside may have continued to the rear wall of the building, as in a 'bank barn', allowing access at ground level to the first-floor interior. There may have been an access road along the rear of the building prior to the excavation of the drainage gully. The gully may have been dug when the building was converted to residential use, possibly in an attempt to resolve issues of damp and water penetration.

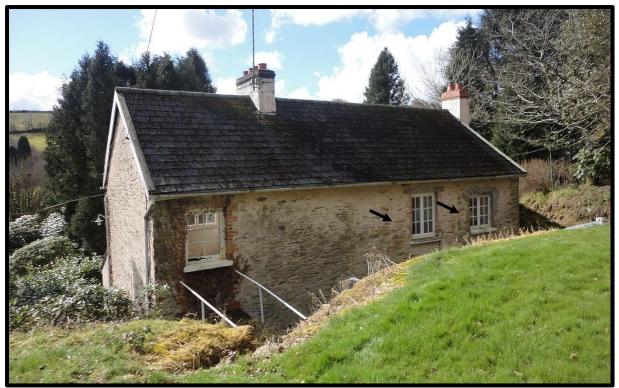
Fig. 7 View of the building from the higher ground to the north, looking south west, showing the possible jambs (indicated) of an earlier, wide loading door at first-floor level in the rear wall.

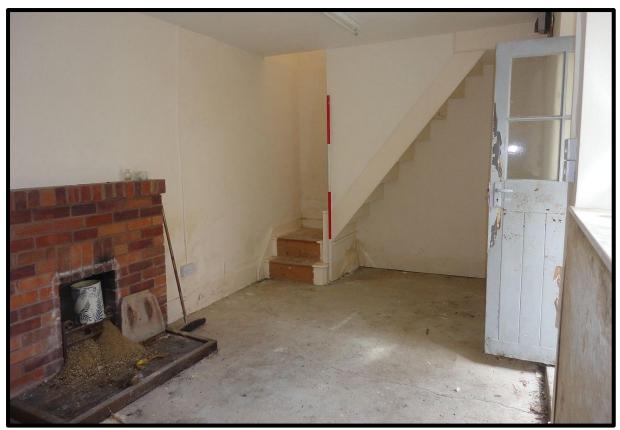
The interior of the annexe is almost entirely devoid of historic features, having been completely refurbished in the 1950s (Fig. 8). The fireplace, doors and staircase in the main ground-floor room are all of this period. The extension to the south containing a bathroom retains handsome plumbing fittings of the same period.

Fig. 8 View of the main room in the annexe showing 1950s features and staircase.

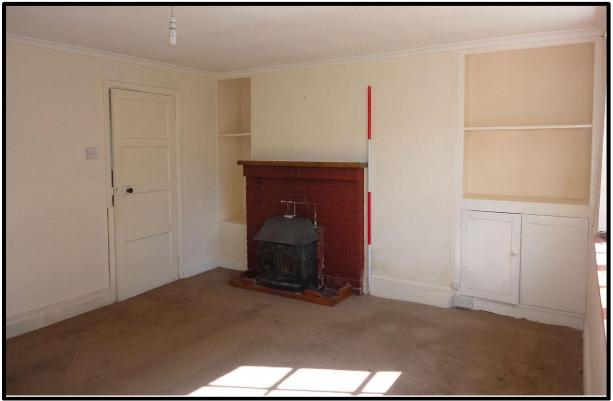
The interior of this building also shows evidence of extensive refurbishment in the mid-20th century. This shows particularly in the internal doors, many of which are horizontally-panelled four-panelled doors with Bakelite door furniture typical of the period (Fig. 9). The ground floor of the main volume of the building contains one large and one smaller room and there are two further rooms, a kitchen and bathroom, in the extension to the west. The staircase climbs from the smaller of the two ground-floor rooms over an under stair cupboard. There is no evidence to show whether or not the internal partitions pre-date the 1950s, though the presence of a domestic fitted cupboard, with plain panels, in a recess adjoining the fireplace in the principal room may suggest that the building had been in use as a residence earlier.

Fig. 9 View of the main room in the Cottage showing 1950s doors, fireplace and fitted cupboards to the right of the fireplace, possibly of earlier 20th-century date.

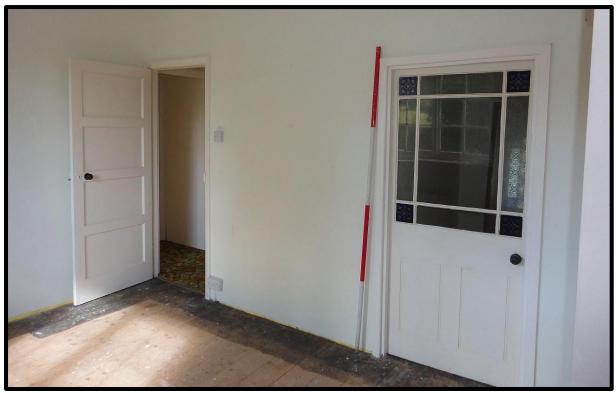
On the first floor, as below, the interior fixtures seem to date from the 1950s. Only two earlier doors survive. One has four plain panels and opens from the main landing to the western, rear, bedroom. The other is a handsome partially-glazed door with margin lights of coloured glass and glory stars at the corners (Fig. 10). This has possibly been reused from an internal porch or lobby, perhaps originally within the front door. There are no other features of historic significance.

Fig. 10 View of the eastern bedroom in the Cottage showing the character of the interior and an earlier door, possibly reused in this position.

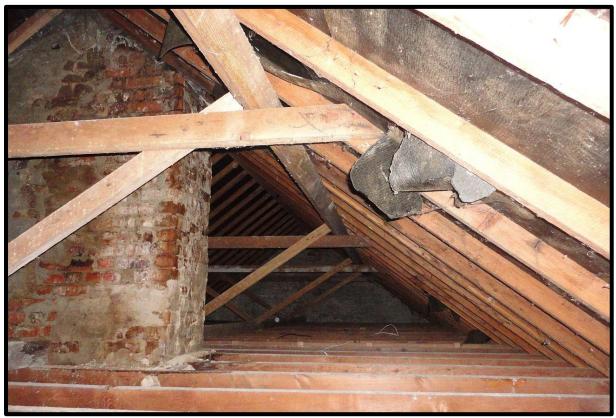
The roof void is accessed by a hatch in the ceiling above the stairs in the annexe and extends across both properties. The roof timbers (Fig. 11) are of slight scantling and consist of common rafters braced at intervals by struts to a beam running parallel with the ridge at the level of the ceiling joists. There are horizontal ties at intervals and one level of purlins on each side of the roof. There is no evidence of any earlier roofing or any part of the structure which might pre-date the late 19th or early 20th century.

Fig. 11 View of the roof structure showing the simple late 19th- or early 20th-century construction.
