Historic Building Survey

OUTBUILDINGS AT OLD MATFORD, WONFORD ROAD, EXETER

By R.W. Parker

REPORT No. 2013.05

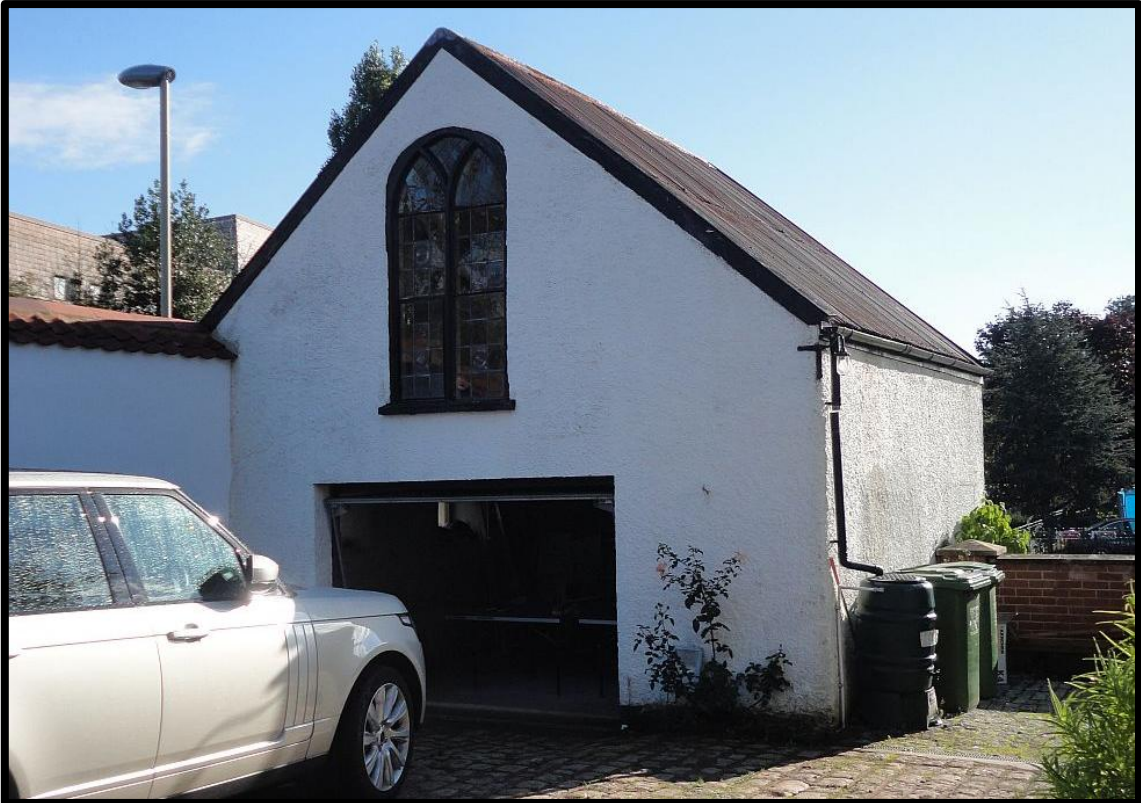
Fig. 8 General view of the garage building, looking east, showing its relationship with the site boundary wall to the north.

The outbuilding standing at the eastern corner of the site (Fig. 8) is now in use as a garage, with a loft over. This structure is largely of brick construction, rendered externally, and covered with a gabled corrugated-iron roof lying parallel to Wonford Road. This building butts against and is in part supported by the cob boundary wall fronting the roadway. The building extends beyond the modern south-eastern boundary of the gardens, which is a low modern wall constructed after the subdivision of the original, larger plot at the establishment of the adjacent church in the 1970s.

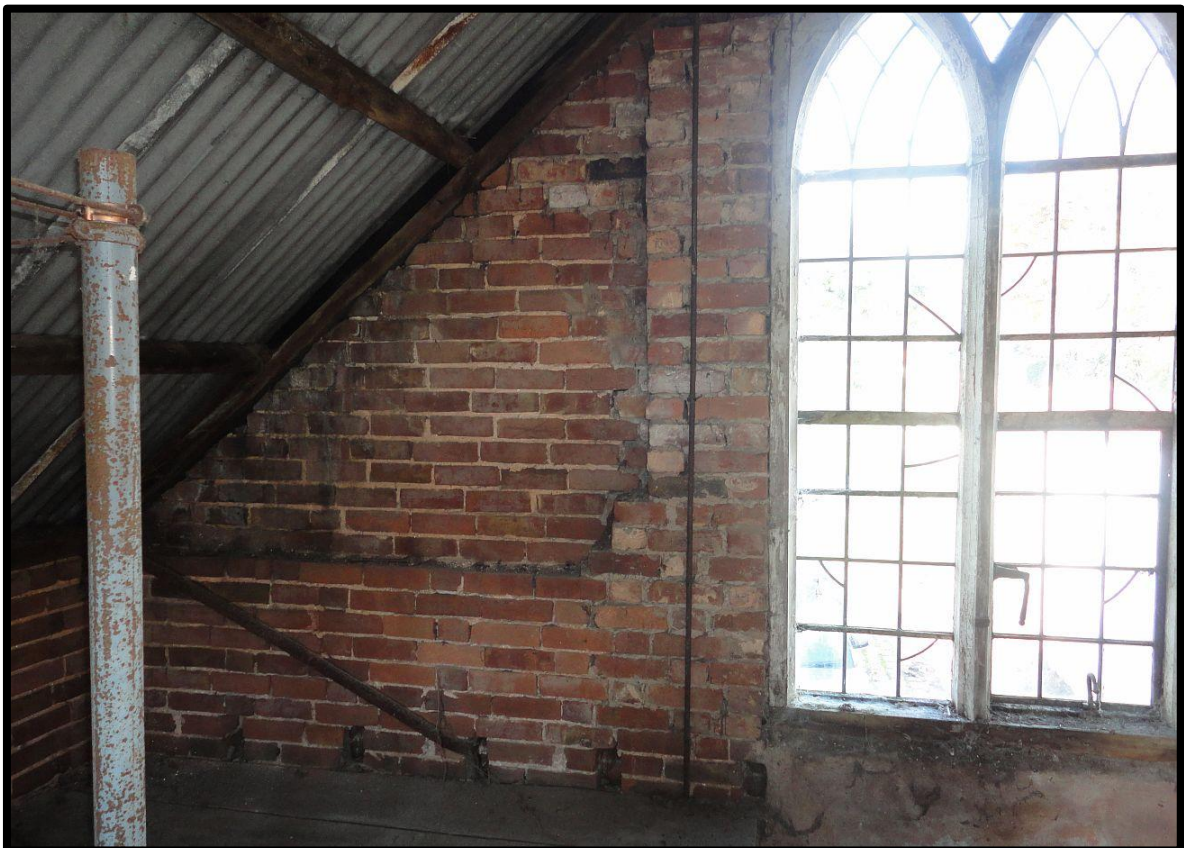
Fig. 9 Detail of the western gable wall above first-floor level showing the tall joist sockets and the evidence of insertion of the large Gothic gable window.

The lower part of this north-western wall is constructed of dark red bricks laid two bricks thick in a sandy lime mortar. The wall narrows above the internal floor level to the thickness of a single brick, above which, stretcher bond is employed (Fig. 9). The wall is stiffened by thicker brick pilasters on either side of the tall, arched window, but this arrangement seems to be an alteration as the bricks around the window are stained with mortar, as though reused. It is probable that the window, and its corresponding window in the opposite wall, were reset in the gable after the demolition of the adjacent buildings.

The floor joists are seated within the brickwork, housed in tall sockets which extend above floor level and initially seem to suggest a higher floor level than that now existing (Fig. 9; bottom left). The reason for this is uncertain. There are no corresponding sockets at this level in the opposite, south-eastern wall, for example, though this is almost certainly of the same period, having the same types of brick and mortar, and therefore the floor levels do not appear to have been altered. There are also no visible sockets in the area of the void of the stairwell; however, it is possible that sockets are concealed by render and their absence is also explained by termination of the joists at the trimmer forming the side of the stairwell, well short of the wall.

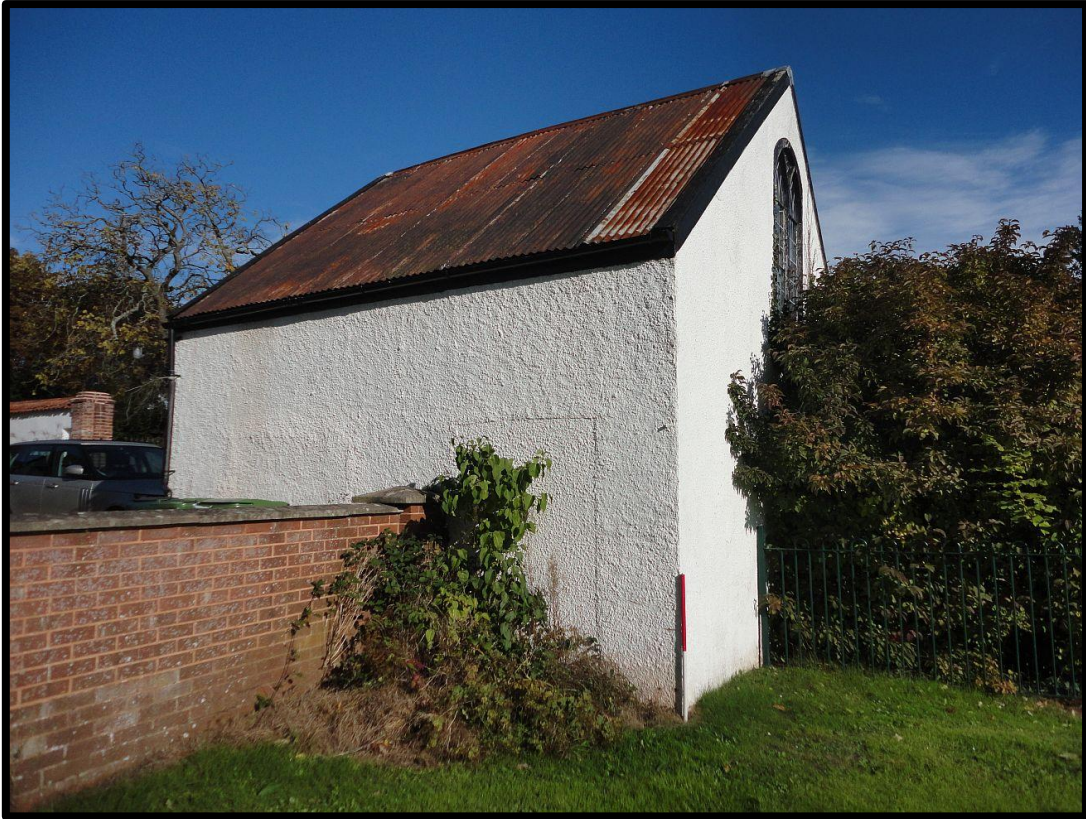
Fig. 10 Scars in the external render of the southern wall, showing the position of the original entrance (right) and a window alongside it.

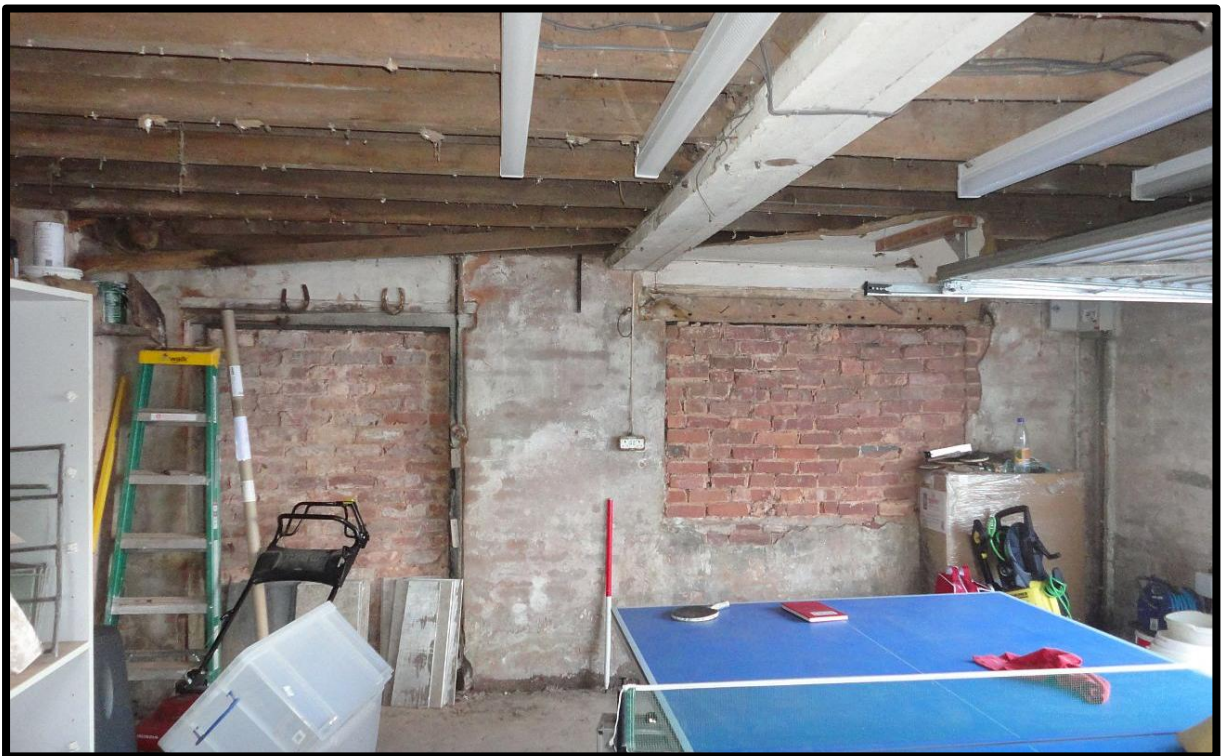
The south-western wall of the building is also constructed of red brick, though this is much obscured by internal and external render. This materials employed suggest that the wall is contemporary with the south-eastern and north-western gable walls. There were formerly two openings in the lower part of the wall; a blocked window and a blocked doorway, which are visible externally as scars in the render (Fig. 10) and remain clearly visible internally (Fig. 11). Both have been blocked in modern bricks bedded in cement mortar, though this blocking may have been done in two separate phases, since the bricks blocking the window are textured and those of the doorway are not. It seems likely that the doorway was blocked first, after the subdivision of the property in the 1970s, and that the blocking of the doorway followed later, probably when the present wide garage door was made. The original door frame remains in place, but this is without mouldings and cannot easily be dated. Pintles at both the bottom and top of the doorframe survive, showing that the door was hung on strap hinges and was not divided into upper and lower sections in the manner of a stable door.

The window frame has apparently been removed, unless it is concealed within the brick blocking, but the lintel of the window opening remains. This is clearly a reused timber; it seems to represent part of an earlier timber framed partition of substantial timbers, and features the remains of four sockets for large, vertical, timber studs. The sockets vary in size and spacing, but are around 15-16cms long and only 3 cms wide, spaced at intervals of between 31 cms and 23 cms. Two of the sockets housed tenons secured by a single small peg; the others by two pegs each. The timber is clean, unpainted and unstained by soot and appears to be of oak. It has never been obscured by plaster or whitewash. Unfortunately its provenance cannot be known.

Fig. 11 Interior of the ground floor, looking south, showing the blocked openings in the south-western wall of the building and, just visible, the pegholes for mortices in the lintel of the window.

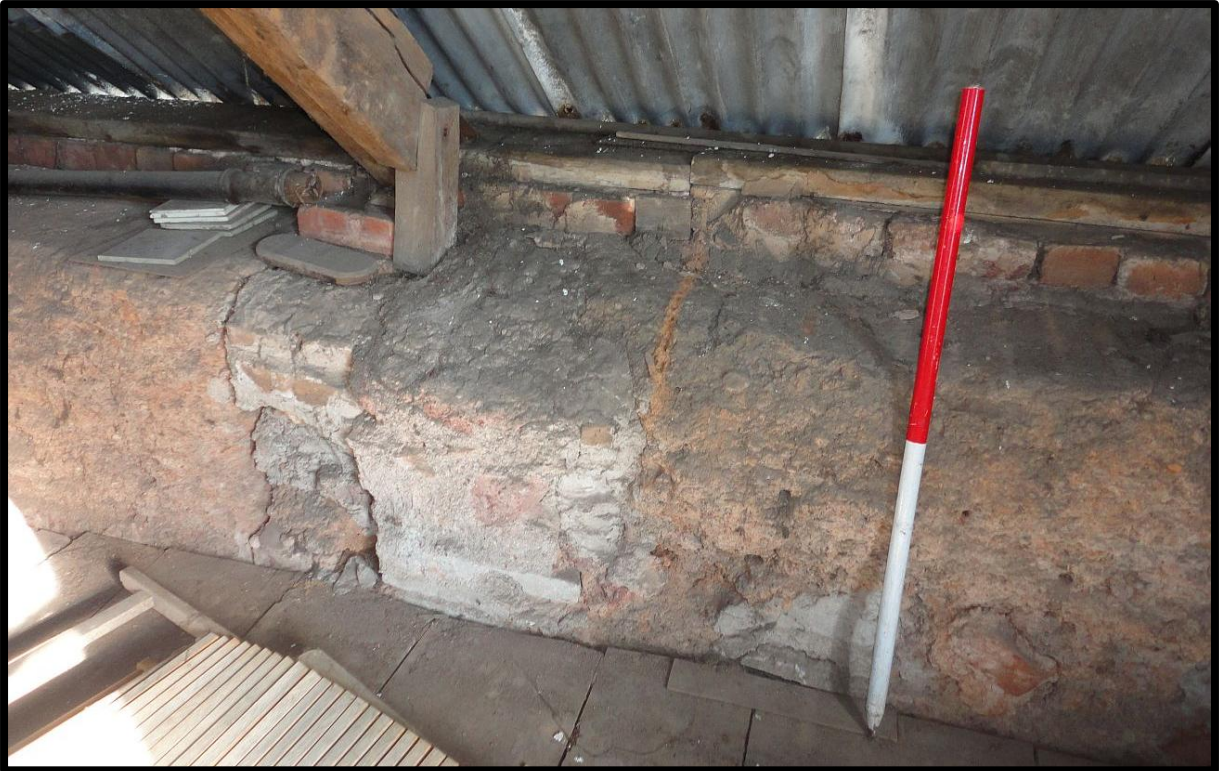
In the pier between the two windows appears an enigmatic feature; an intrusion of brick and stone blocking which appears to have been added in two phases. The brick blocking extends in a vertical strip from the eaves line of the building to a position near the sills of the windows on the ground floor (Figs 12, 13). It may extend further but this was not investigated as it would involve the removal of too much wall plaster. The central beam supporting the first floor joists appears to be seated in this brick blocking, but as it continues both below and above the beam end it is considered that the blocking must be infilling an earlier feature,

Fig. 12 View of the apparent wall scar and brick and stone intrusions above first-floor level.

Adjoining the brick intrusion is an area of infilling in stone (Figs 12, 13). This seems to represent the patching of an older wall scar or feature, which begins 1.8m above modern ground level and continues to the height of the wall. This feature, if it includes the brick patching too, may be as much as 0.67 thick, which more-or less corresponds to the thickness of the cob boundary wall along the roadside. This may support the conjecture that this represents the scar of a wall meeting the north-eastern boundary wall at right angles. The reason why this feature does not continue to the ground is not certain, but might be explained if there was a doorway or window opening close to the junction of the two walls fitted with a wooden frame which has been removed, leaving no trace. A second possibility is that the stone patching represents a beam socket, though, in a cob wall like this, one would expect some kind of stone or timber pad built into the wall to spread the weight of the beam.

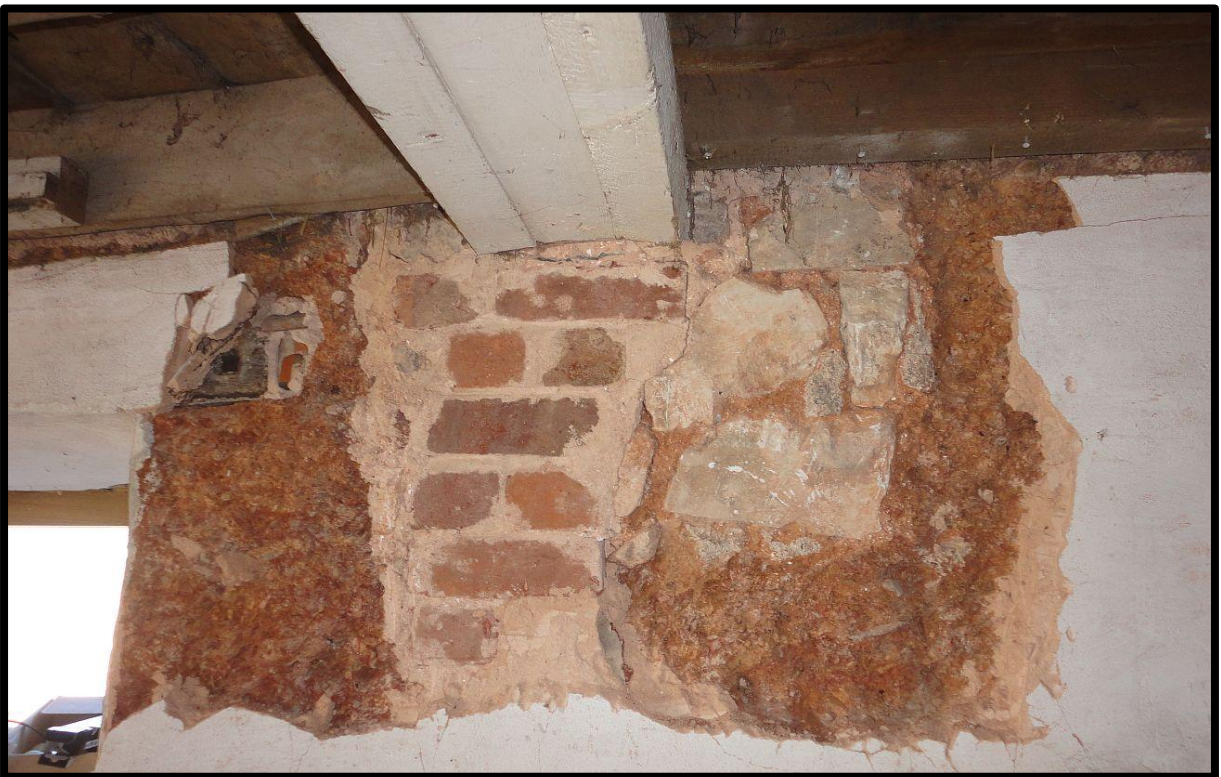
Fig. 13 View of the apparent wall scar and brick and stone intrusions below first-floor level, showing the stone patching interrupted at a height of 1.8m above floor level.

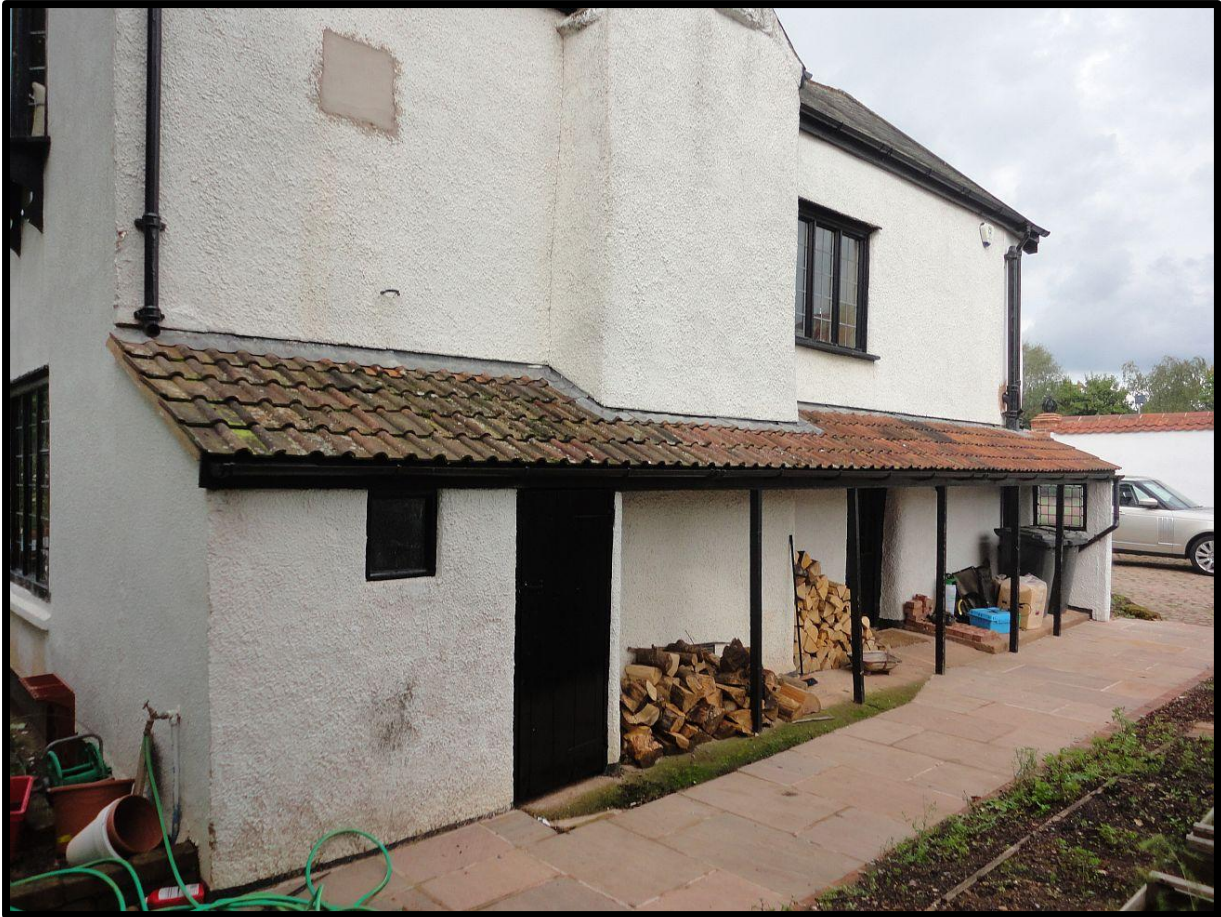
The verandah (Fig. 14) is a very simple timber-framed structure running along the base of the south-eastern wall of the house. It is supported on five timber posts and on the walls of a

small area, probably a former lavatory at the southern corner of the house. The other end of the verandah is supported on a screen wall featuring a small square window of coloured glass. The roof is covered with pan tiles. There are no obviously datable features and it is uncertain when the verandah was added. It does not appear on early views of the house; either Stockdale's 19th century view (Fig. 1) or James Crocker's view of 1879; however, a projection of a sort in this position is shown on the later 19th-century maps, though not extending the full width of the house. It is thus considered probable that the verandah is a 20th-century rebuilding replacing a late 19th-century addition to the house, of lesser extent and which does not survive.

Fig. 14 The 19th- or 20th-century verandah on the south-east side of the house.
