Archaeological Recording

**FIRE-DAMAGED BUILDINGS AT
BULLER SQUARE, CREDITON, DEVON**

By R.W. Parker, Lucy Browne & Marc Steinmetzer

REPORT No. 2021.01

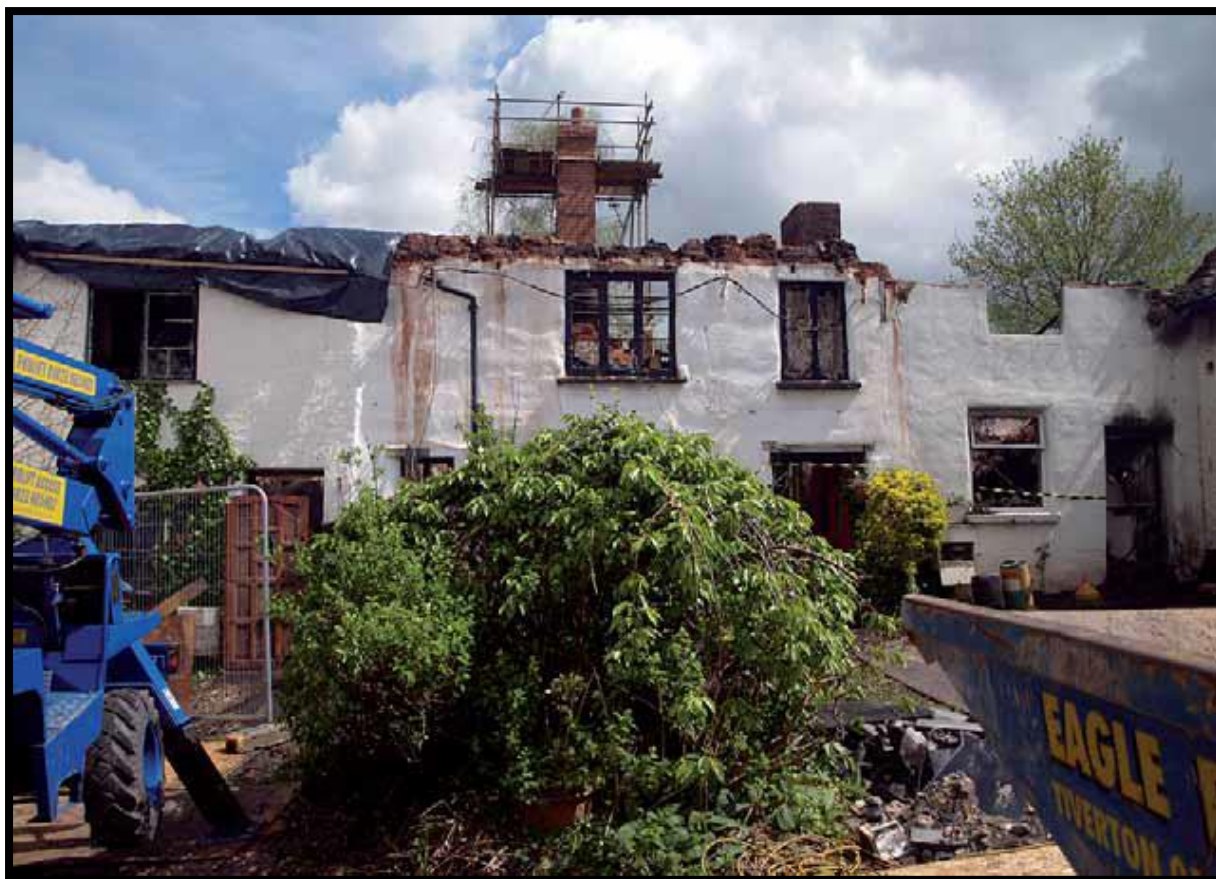
Fig. 17 Elevation of Nos 1-3 Buller square following the fire, but before demolition works, taken from the Keystone report (Keystone 2012 Report No. K823-1).

The earliest photographs of the buildings following the fire, taken by Keystone Historic Buildings Consultants in October 2012, show that the masonry structures of the buildings had survived but that the roofs and internal floors had been completely burnt out. Measures had been taken to protect the structure of No. 3 by covering it with waterproof sheeting, but Nos 1 and 2 were open to the weather. Scaffolding around the rear chimneystack of No. 2 may suggest that demolition of upstanding parts of the ruins was already in progress by this date (Fig. 17).

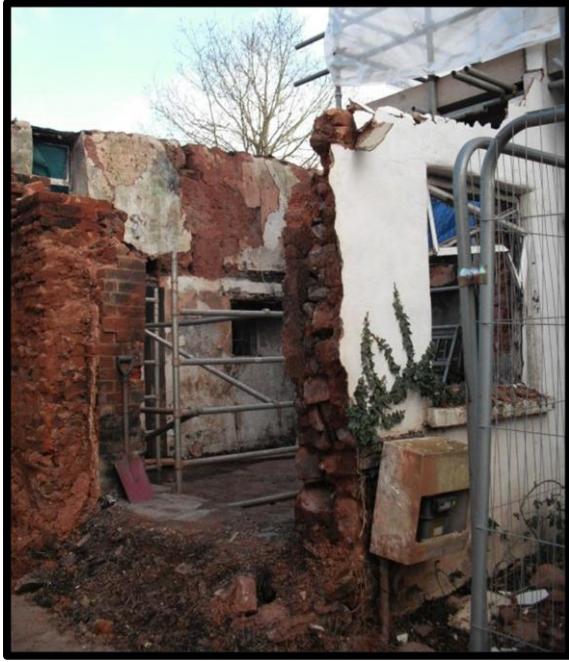
Fig. 18 The remains of No. 1, the southernmost of the two houses, looking east prior to the demolition of the remains of the front and rear walls.

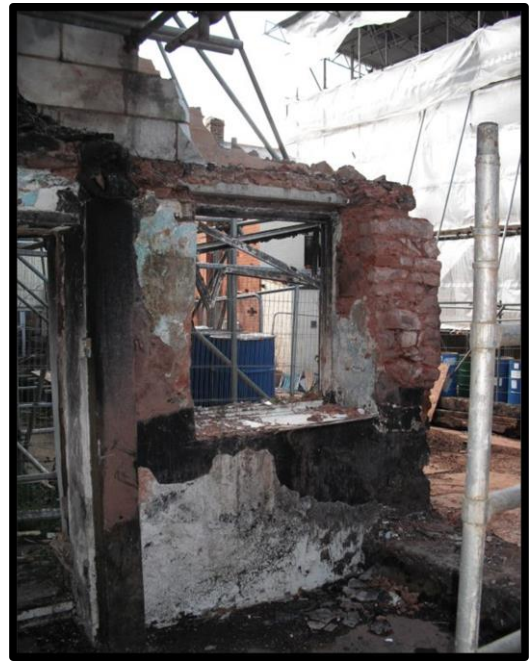
Fig. 19 View of the interior of the front wall showing the rebuilding of the jamb of the window and the post supporting a ceiling beam.

The photographs show that, above first-floor level, the front wall had been partially rebuilt with concrete blocks (Figs 19, 20). This area of modern rebuilding terminated to the south east at a good quality masonry jamb overlying the lintel of the entrance doorway of No. 1 Buller Square (Fig. 20). This must either represent the jamb of an opening or evidence of a change to a lighter form of construction for this part of the façade. The extent of rebuilding to the north west could not be determined. The Listing Description (see page 4) noted a reduction in the thickness of the wall at this point and interpreted this as 'a possible former loft doorway'. This would imply an agricultural function for the building; however, the building is known to have been in domestic use by 1911 (see page 18) and almost certainly since the 1840s (Keystone 2012, 14). It seems unlikely that a loading door would have survived in a domestic building long enough to have been blocked in modern concrete blocks.

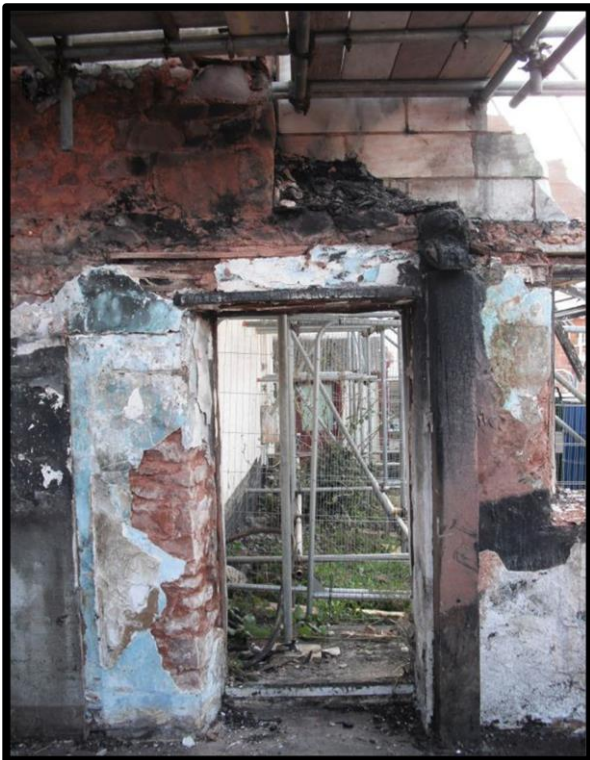
Fig. 20 The former front door of the No. 1, looking north west, showing the post and beam immediately adjacent to it.

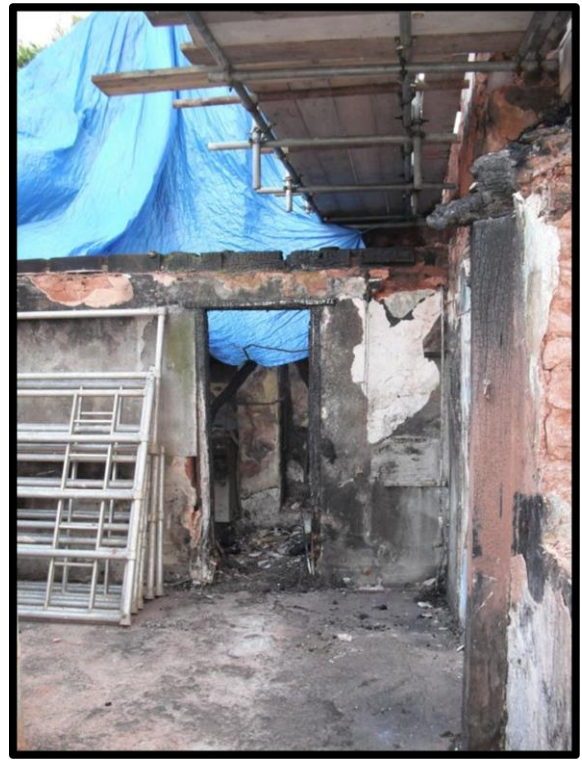
Fig. 21 The interior of No. 1, looking towards the 19th-century partition at its south-eastern end, showing the post and beam built into the north-western wall.

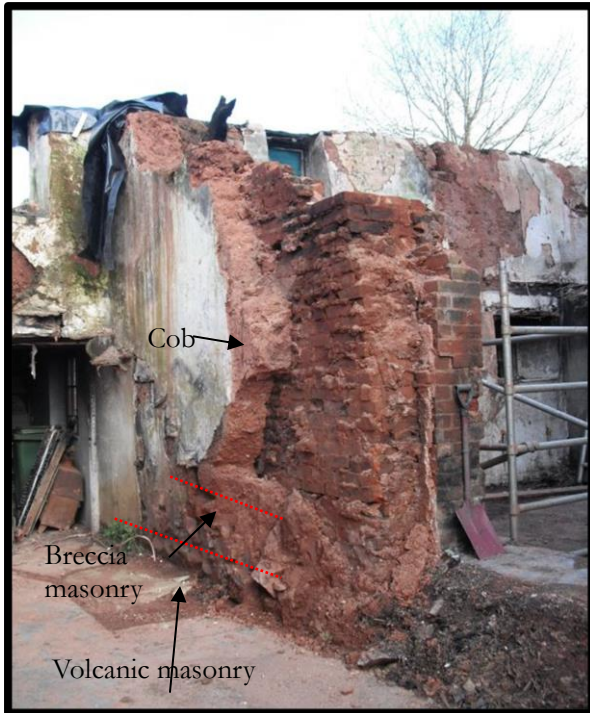
Fig. 22 View of the party wall between the houses, looking east, showing the brick chimneystack cutting the cob wall, and rubble masonry in the lower part of the wall below this.

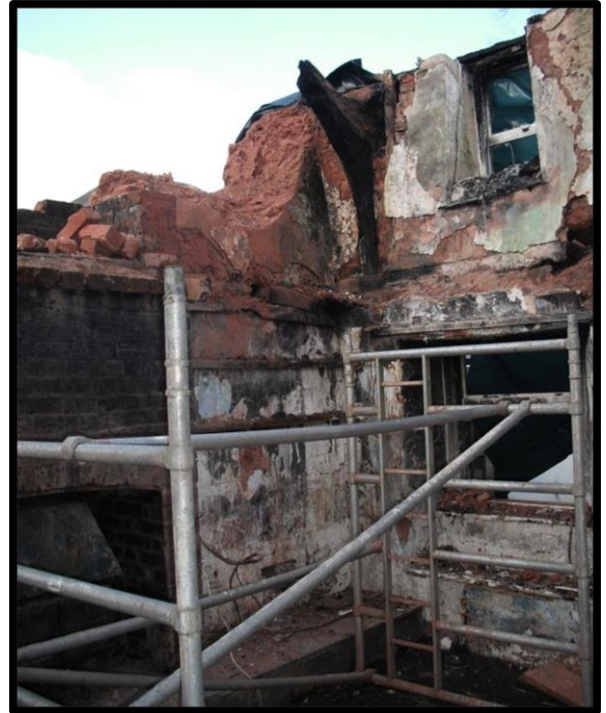
Cutting into the south-eastern face of the dividing wall was a 19th-century brick chimneystack featuring a broad segmental-arched opening supported by a metal strap. The large, red bricks appeared to date from after 1800 (Figs 23, 24). The rear parts of this stack were of much rougher construction (Fig. 22) because the bricks were built against the earlier cob walling and there was no need to do this tidily. Keystone observed that there were traces of an earlier fireplace here, with a timber clavel or lintel (Keystone 2012, 14). Keystone assumed that the wall was contemporary with the two cottages to the north and that it may have been constructed at the conversion of an earlier agricultural range into a row of dwellings in the 18th century.

Fig. 23 View within the southernmost house, looking north, showing the remains of a jointed cruck truss with a curved blade surviving in the east wall close to the dividing wall.

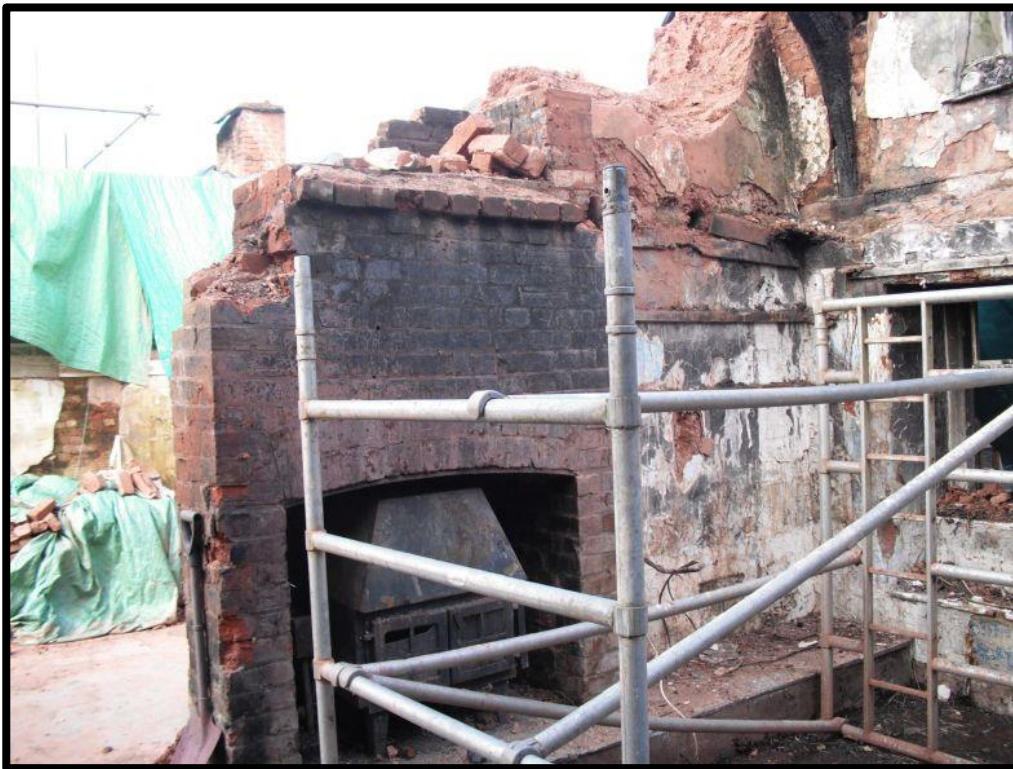
The upper, cob, sections of the wall contained sockets for substantial first-floor joists in the south-eastern parts of the house (Fig. 24), but no trace of sockets for the floor structures to the north-west. It is therefore likely that the floor structure and the beam in the bay immediately to the south east of the wall were contemporary with the dividing wall and built into it, whereas the ceiling timbers in the two cottages to the north west, which were on a different alignment with joists running from SW to NE from axial beams (Keystone 2012, 14), were inserted at a later date. This would explain the anomalous position of the jointed cruck roof truss: prior to the insertion of the dividing wall, it had spanned an open volume extending further to the north west. The height of the first-floor in relation to the curved feet of the roof trusses was very close (Figs 23, 24) and this would also seem to confirm that the floor structure was inserted into a formerly open volume. It is probable that, prior to the subdivision of the range its central section was originally open to the roof, even if its end bays were storeyed (see below).

Fig. 24 View of the fireplace in the party wall between the two houses, showing the 19th-century brick fireplace cutting into the earlier cob walling and the remains of a second fireplace embrasure at first-floor level above.

The post-medieval fireplace embrasure was later infilled with a brick structure projecting into the room (Fig. 24) and completely infilling and taking the form of the earlier embrasure, the remains of the earlier opening apparently remaining visible (*Ibid.*), perhaps in the form of parts of the earlier clavel on each side. The new brick chimney stack also provided a first-floor fireplace in one of the bedrooms; it probably dated from the 19th century and would have been typical of the domestic improvements of the period; before this, bedrooms were often unheated.

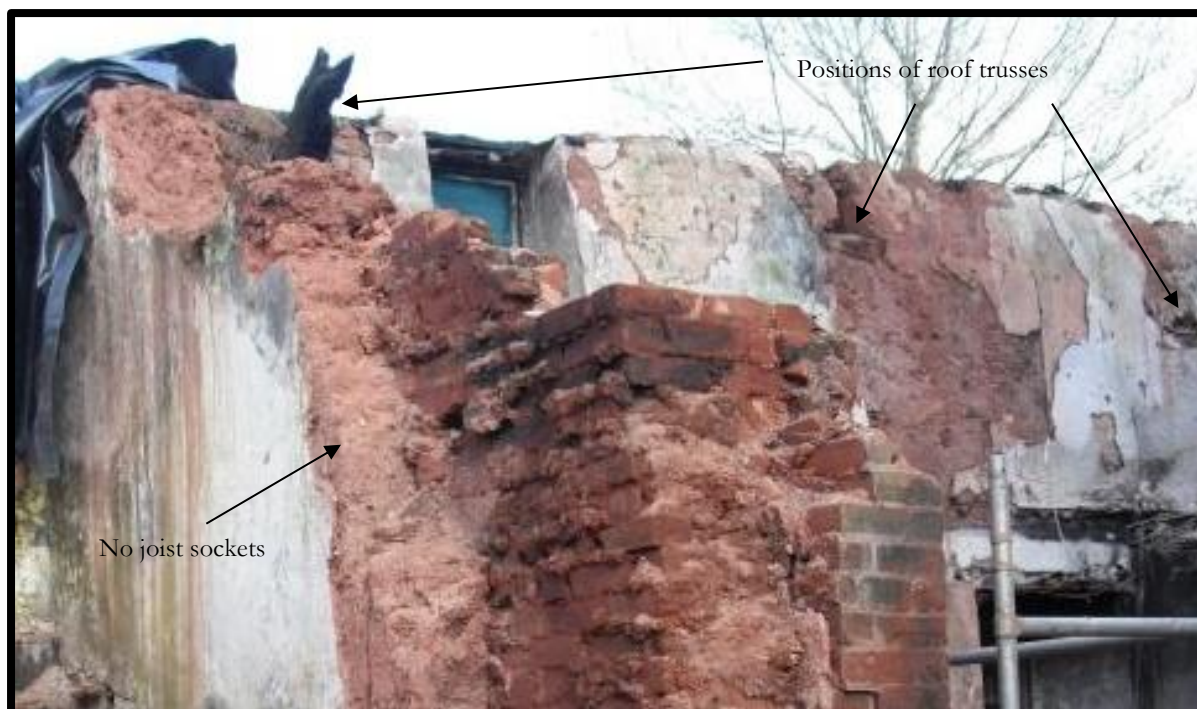
Fig. 25 Traces of three evenly-spaced roof trusses in the north-eastern wall of No. 1 Buller Square, two of which are without cruck posts (compare with Fig. 23).

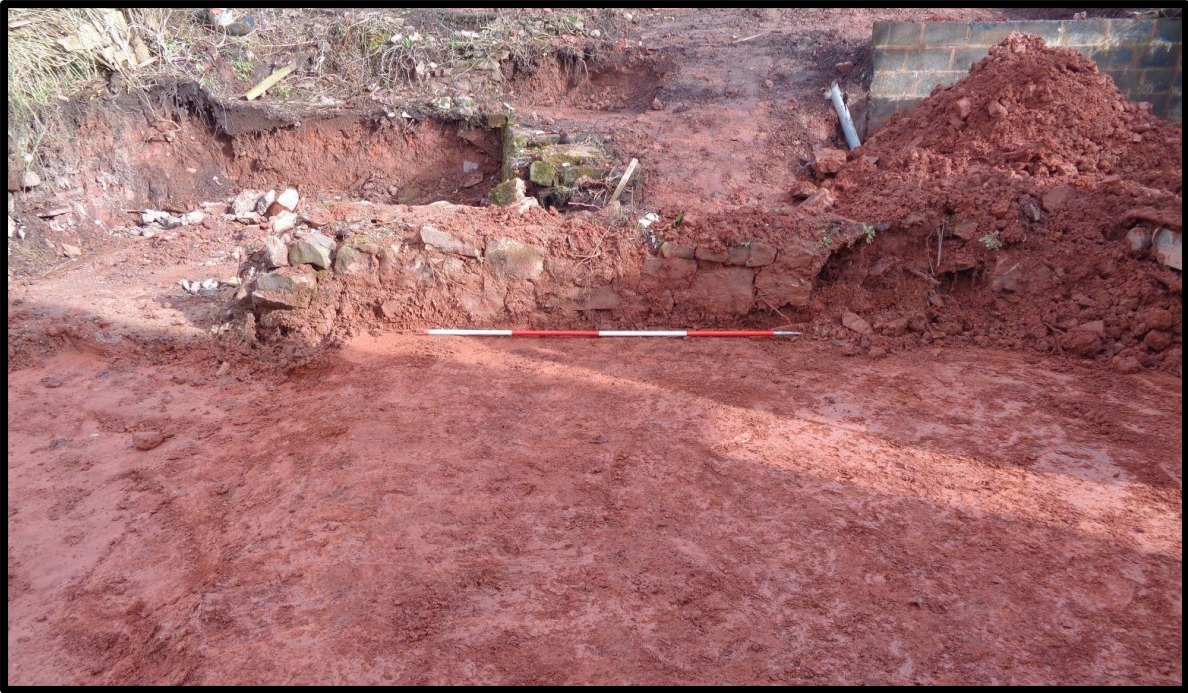
Fig. 26 The remains of the rear wall of the houses in 2020 during the reduction to the formation levels of the modern buildings, looking north east, showing the remains of stone underpinning to earlier walling, returning into the cross wall between the houses.

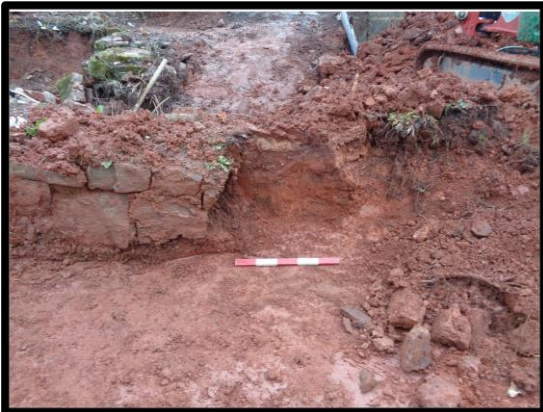
Fig. 27 Detail of the remains of the north-eastern wall during demolition showing the upstand of natural clay within the core of the wall.

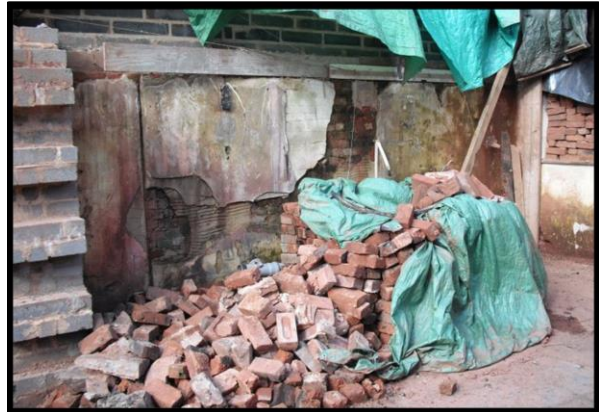
Fig. 28 The remains of the party wall with No.3 showing brick masonry, and the apparent vertical break (left) possibly allowing for a doorway.

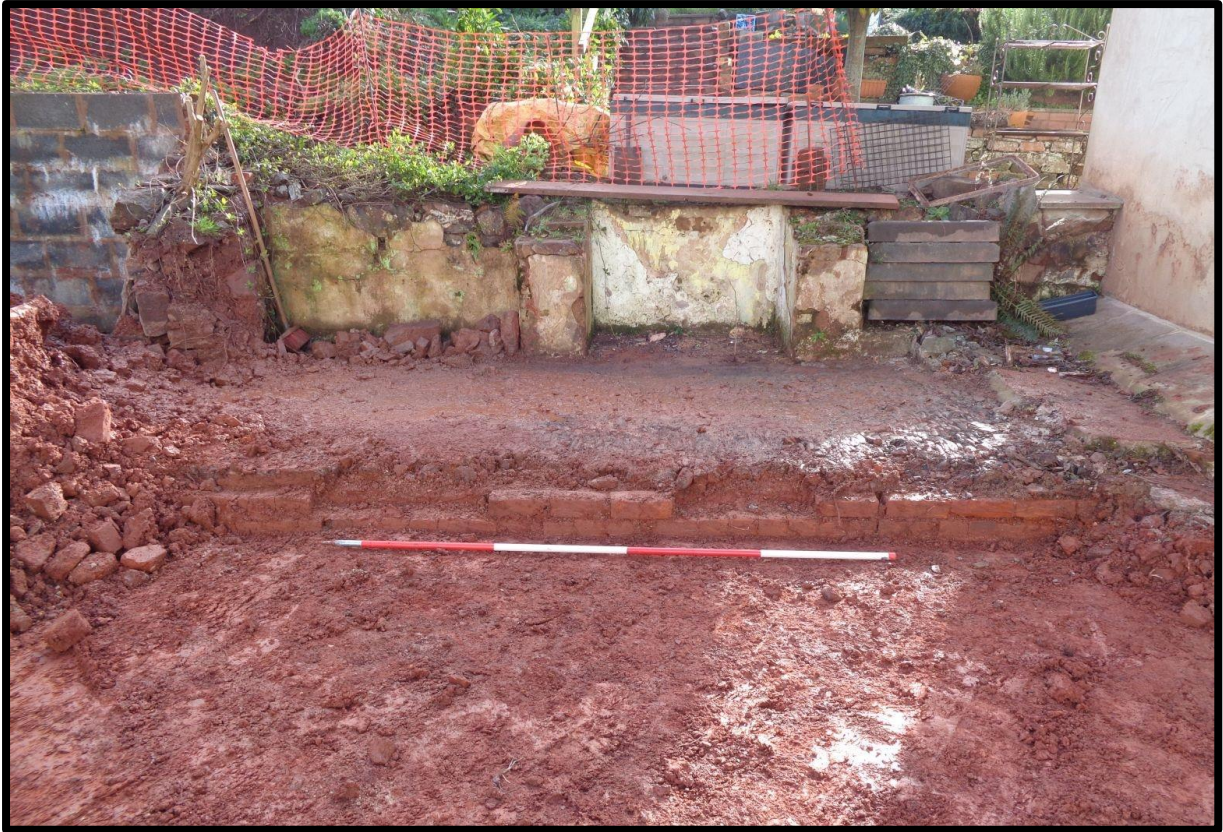
Fig. 29 The remains of the south-eastern gable wall showing the abutments for an inserted fireplace and chimney and the brick footings of a partition wall contemporary with a cobbled floor.

At the southern end of the range excavations within No. 1 Buller Square exposed the remains of a cobbled floor (105) (see Fig. 29 above). Consisting of small to medium size sub-angular worn cobbles set into the underlying natural clay the floor, extending the full width of the building, was edged with 19th-century bricks (106). This surface is contemporary with the insertion of the fireplace in the south gable sometime in the late 18th or early 19th century.

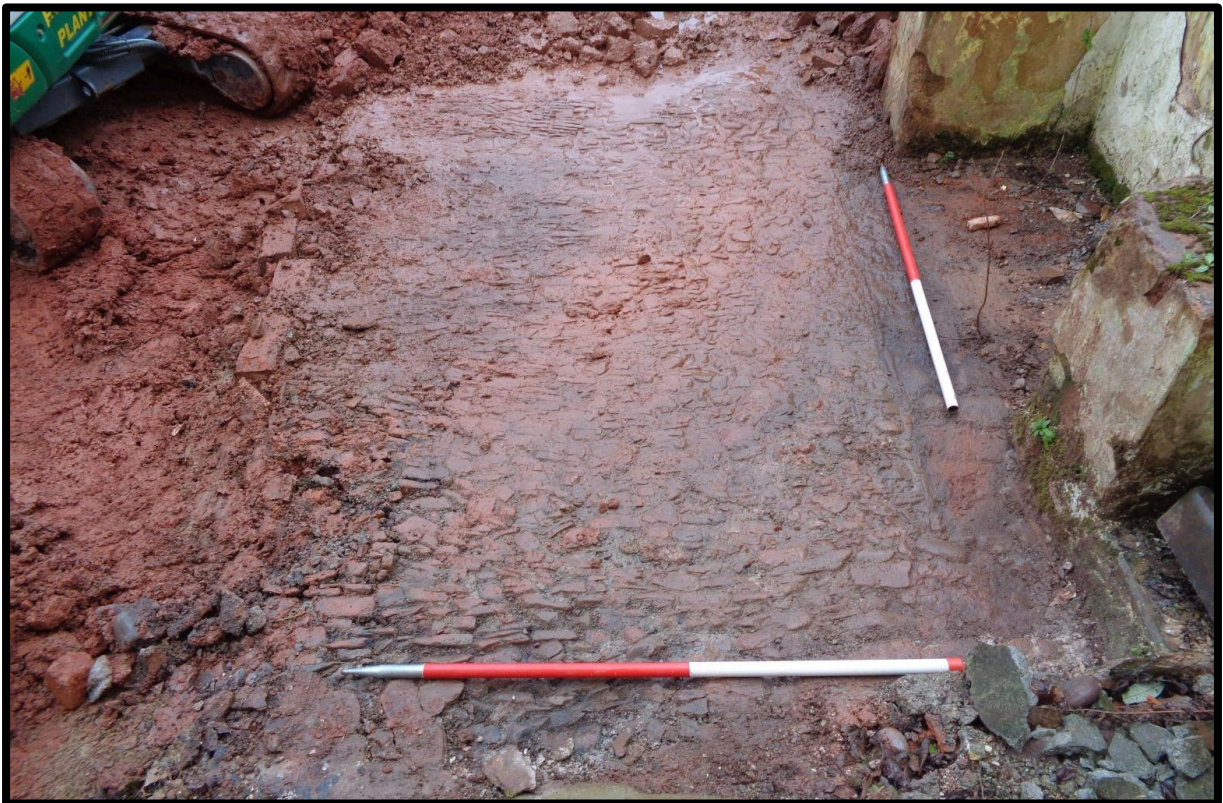
Fig. 30 Detail of the cobbled floor within the south-eastern end room of the house.

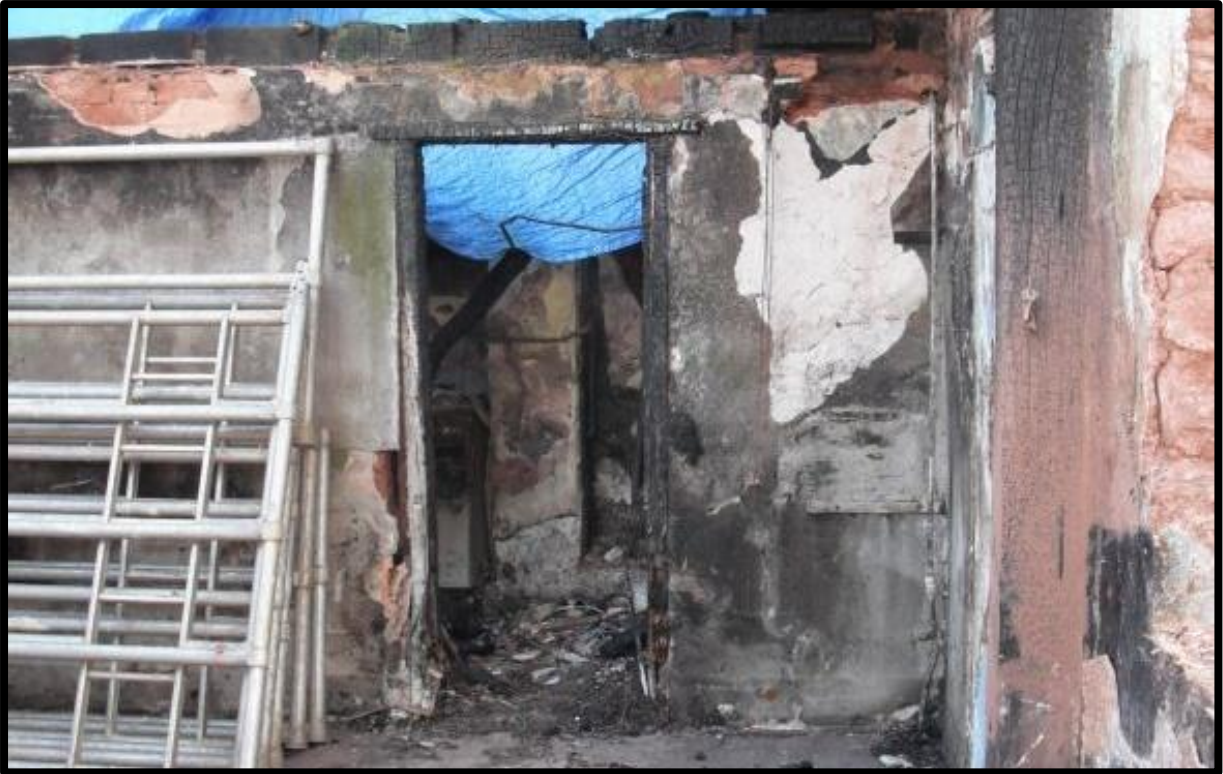
Fig. 31 Detail of the late partition defining the south-eastern room of No. 1 Buller Square.

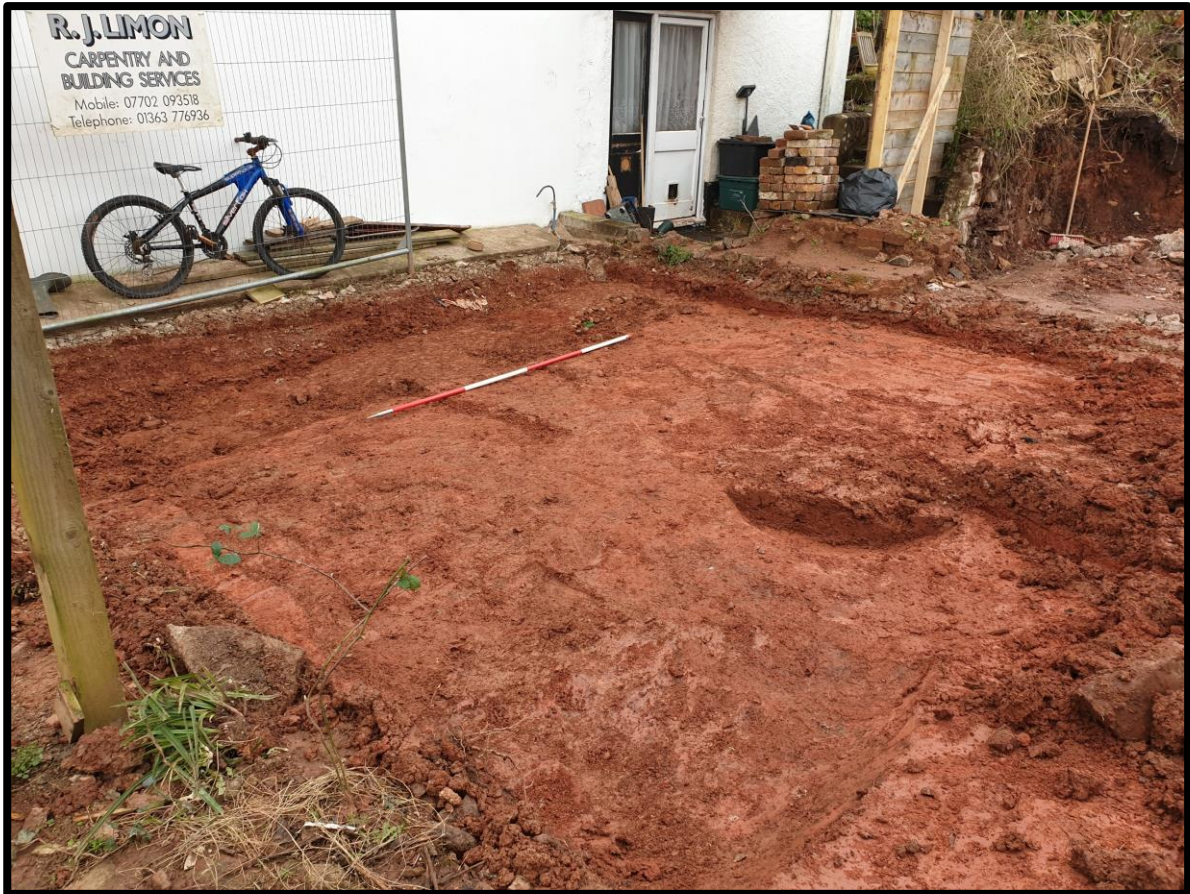
Fig. 33 General view of No. 2 Buller Square showing pit 102 in the foreground and cobbled floor (104) in the background. 2m scale. Looking north.

Surviving along the northern edge of No. 2 Buller Square were the fragmentary remains of a cobbled floor consisting of small to medium size sub-angular worn cobbles set into the underlying natural clay. Although the surviving cobbling is located at a slightly lower level to the
