Historic Building Survey
Of
ROOF STRUCTURES
AT
KILLERTON HOUSE, BROADCLYST, DEVON,

**With an Account of a Watching Brief
on Trenching in the Forecourt of the Mansion**

By R. W. Parker

REPORT No. 2020.03

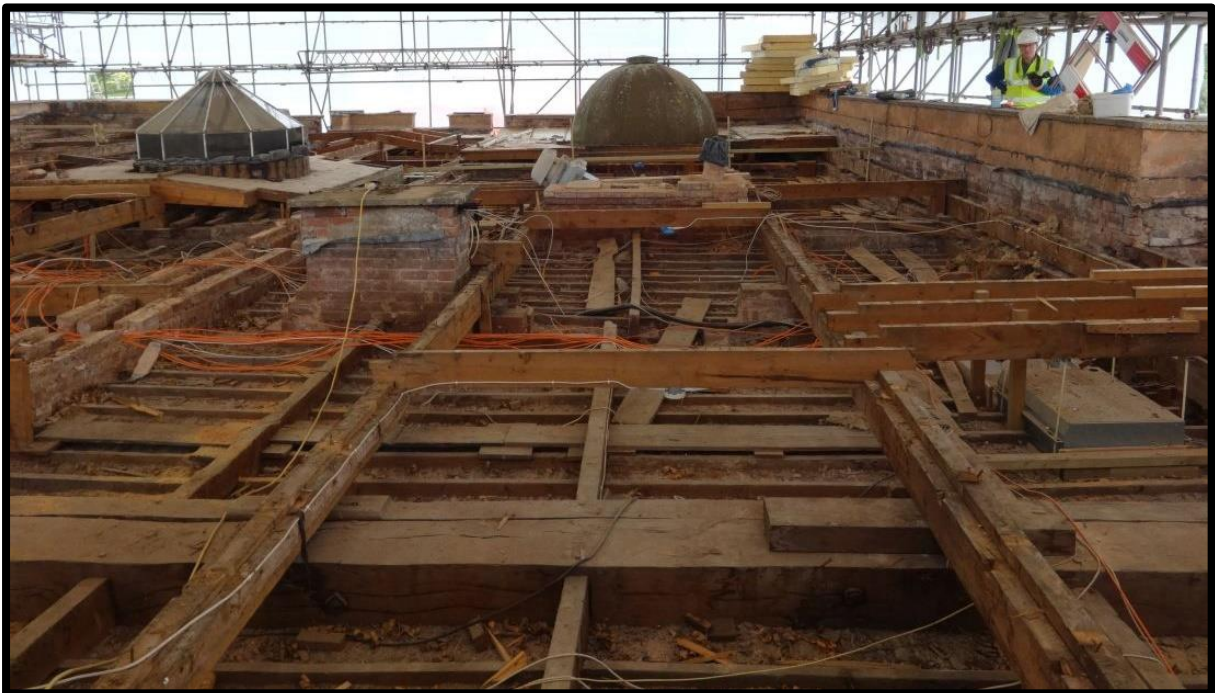
Fig. 20 The removal of the modern roof structure in April 2017, looking north, showing the remains of the modern roof represented by chases in the rendering, and beneath this an earlier structure, the joists remaining, which stepped down in three broad shallow inclines toward gutters flanking the central raised flat over the first-floor spine corridor.

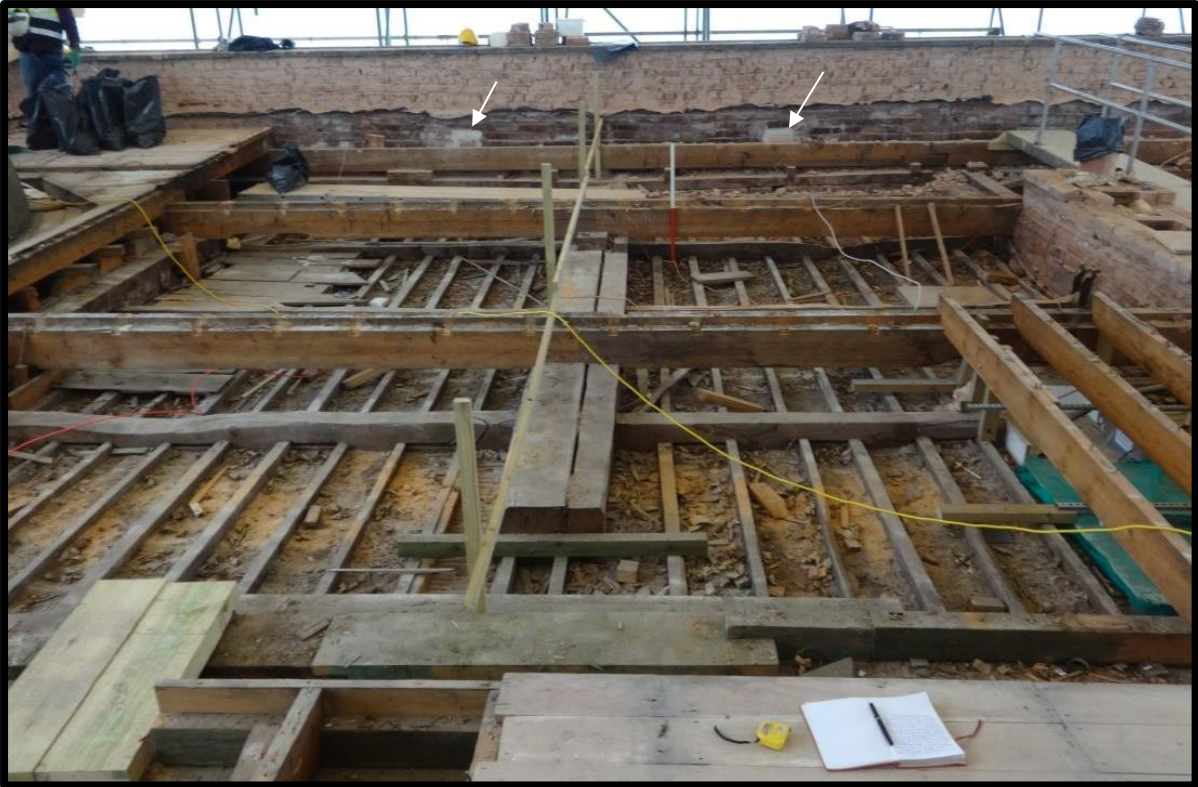
Fig. 21 The northern part of the eastern roof showing blocked sockets in the parapet wall answering to the open sockets visible in the west wall (see below). These sockets are unrelated to the flat or double-pitched roof structures and must surely have housed tie beams for an earlier phase of roofing.

The large scale of the sockets suggest that these may have supported heavy tie beams overlying the ceiling structure below. If so, these beams were removed and the sockets blocked before the 19th-century roof structure was installed, as they conflict with the longitudinal beams of that phase of roof. It is difficult to see why the beams were not retained to support the replacement roof structure, as they lie at a level which would have been consistent with its upper surface and running roof joists between these beams would have been an easy matter. It must therefore be assumed that these large tie beams had already been removed long before the flat roof was inserted over this area and that they were no longer in place to be utilised when it was conceived. The existence of the lower, pitched roof would also have been incompatible with the large ties and it seems probable that these timbers must have been removed either before the lower, pitched roof was conceived or, perhaps, in order to make way for it.

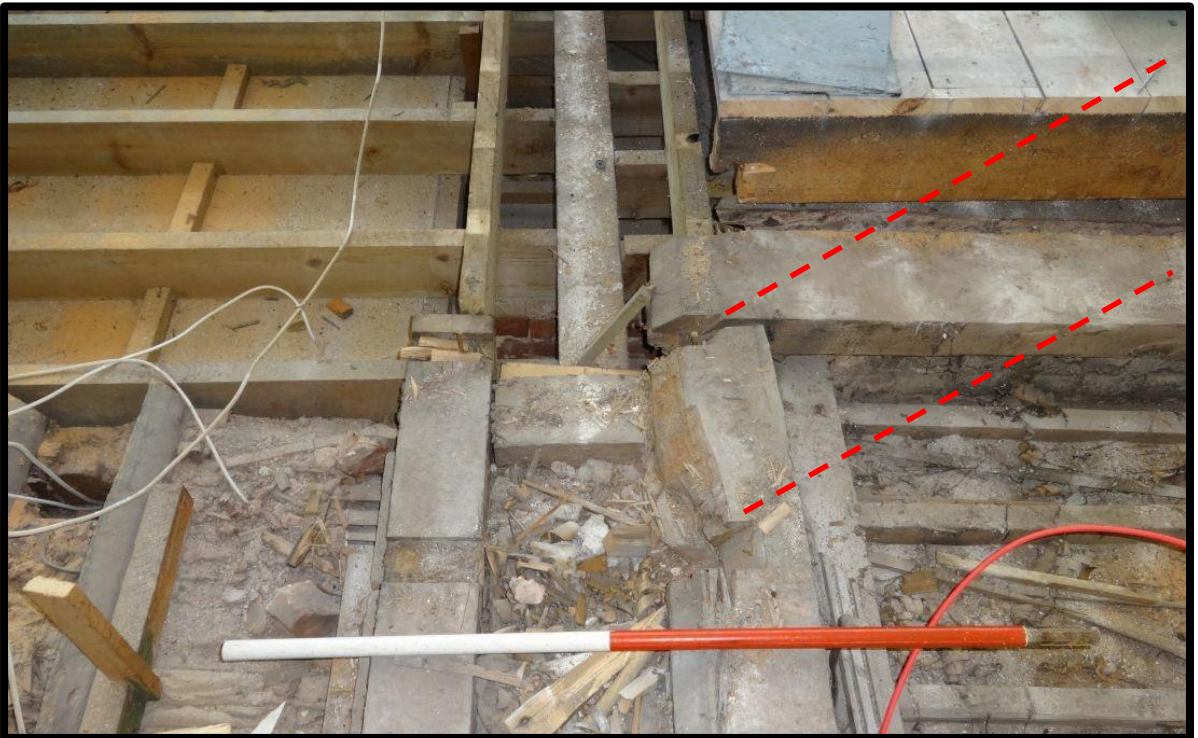
Fig. 22 Angled housings in the beams over the eastern spine wall of the first-floor corridor showing the position of the rafters of a shallow pitched roof over the east part of the house - probably a different phase from the large blocked sockets above.

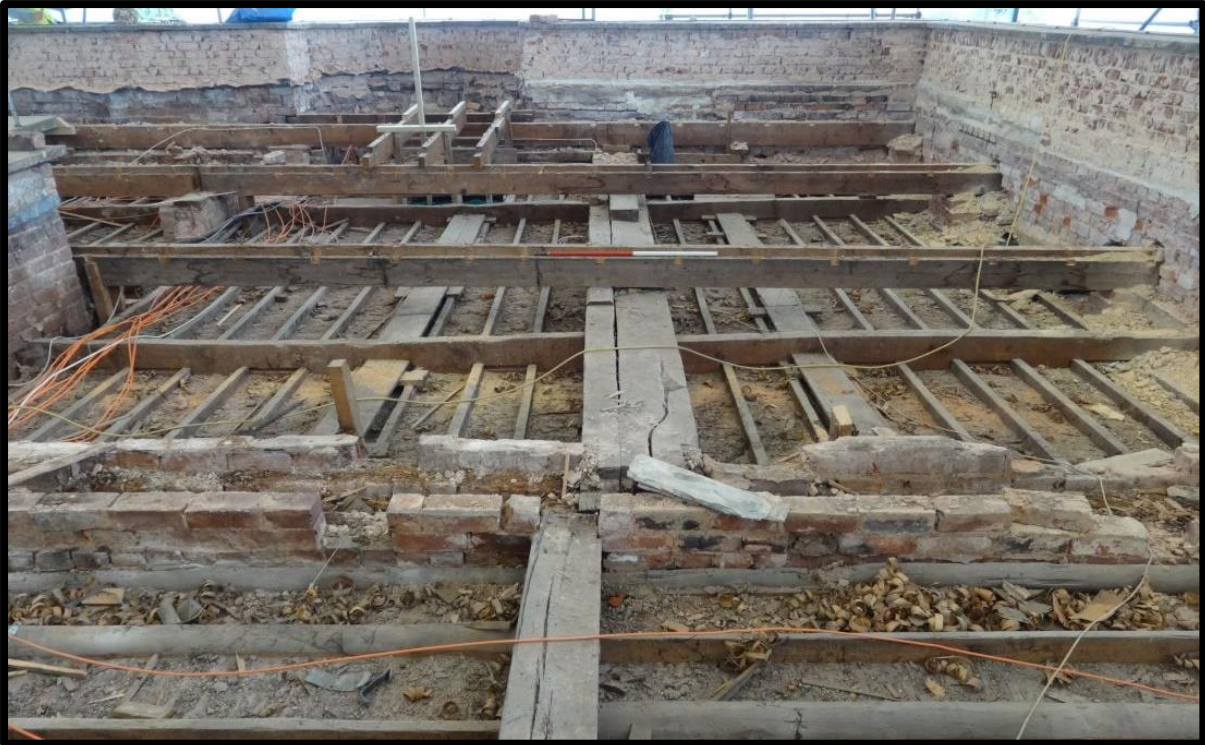
Fig. 23 The southern part of the eastern roof, looking east showing the original narrow central beam augmented by an enormous new beam alongside it, probably to strengthen the ceilings. The parapet has been much rebuilt.

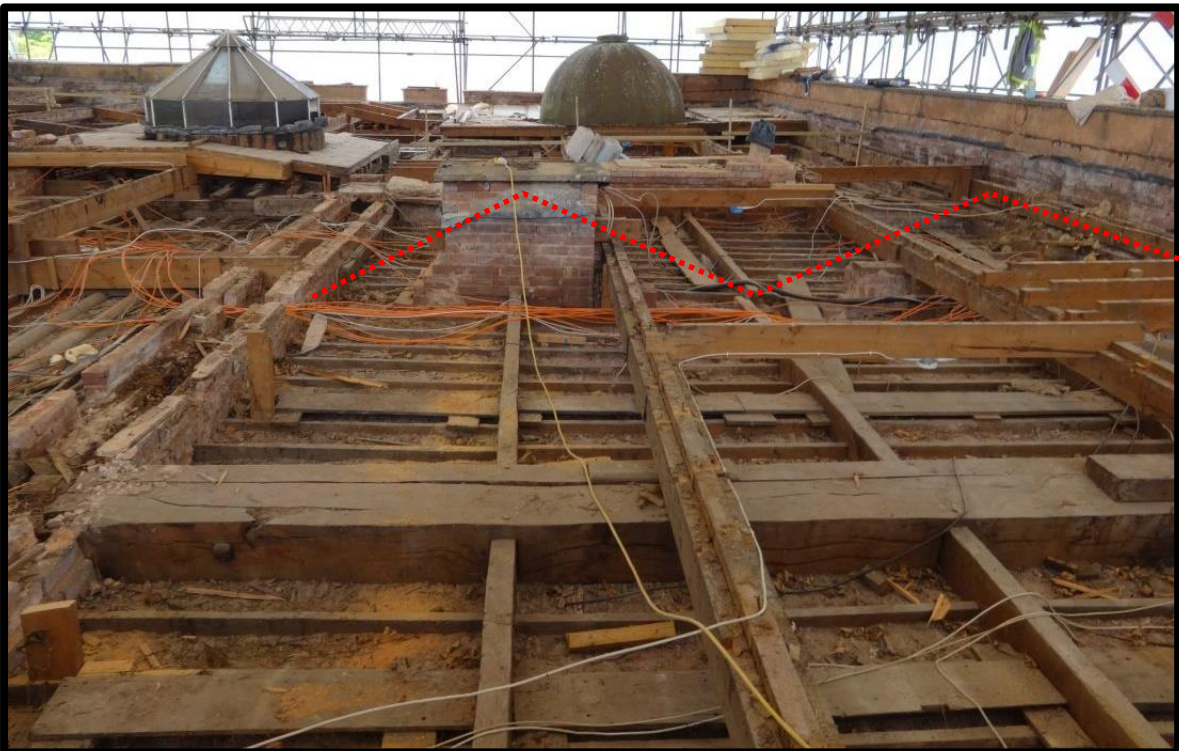
Fig. 24 View of the eastern part of the roof looking north towards the dome over the staircase, showing the scar of the double roof on the drawing room chimney and the flashing for the flat roof structure which succeeded it (the approximate profile of the pitched roof is indicated in red).

Fortunately, the scar or staining of an earlier roofline remains against the side of the drawing room chimney stack (Fig. 24), showing that the roof was formerly a shallow pitched structure springing from approximately ceiling level. This, combined with the evidence from the northern part of the roof and the western part (discussed below) allows us to conclude that at some point after the large tie beams were removed, the roofs over the eastern and western parts of the house both consisted of narrow double-pitched roofs with an 'M'-shaped profile, running from north to south. Apart from a few sockets in the side of the east-west beam over the south-eastern room, which may be connected with the supports to the valley gutters or – equally plausibly – simply mistakes in the carpentry or evidence of the reuse of structural timbers during construction, the roof on the east side appears to have been structurally independent of the ceilings

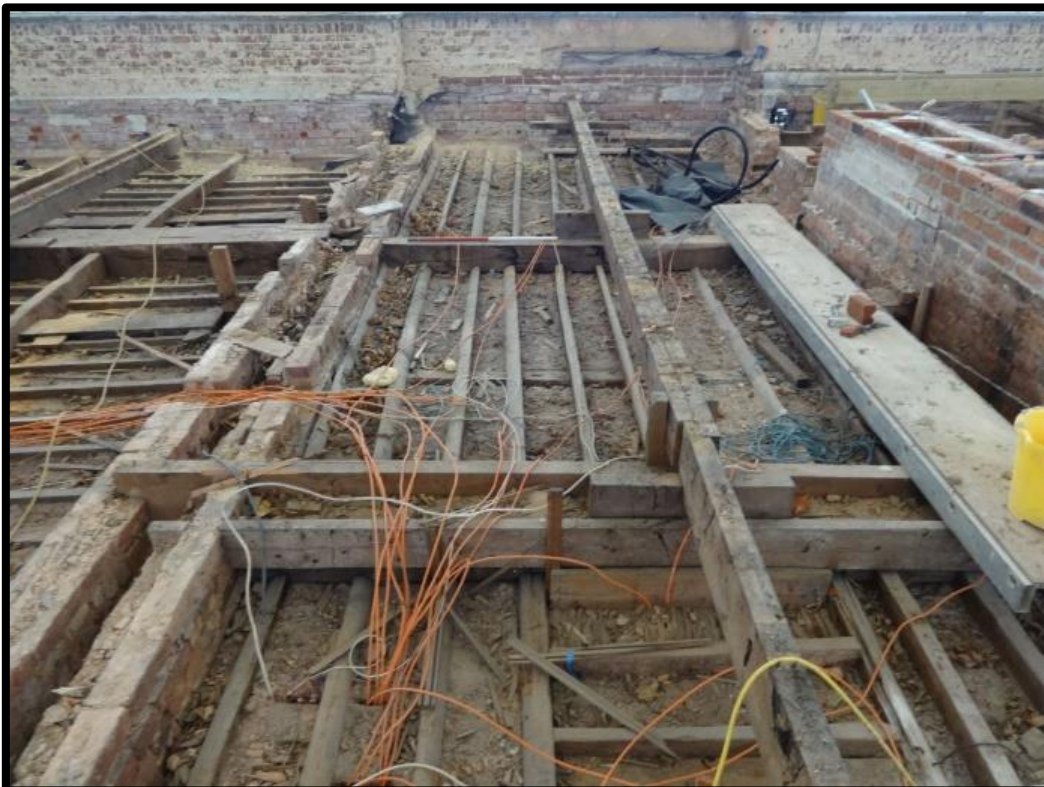
Fig. 26 The ceilings over the central spine corridor, showing the south end, with the chimney of the present library to the right. The ridge timber shown over the corridor, centre right, appears to relate to the 19th-century roof.

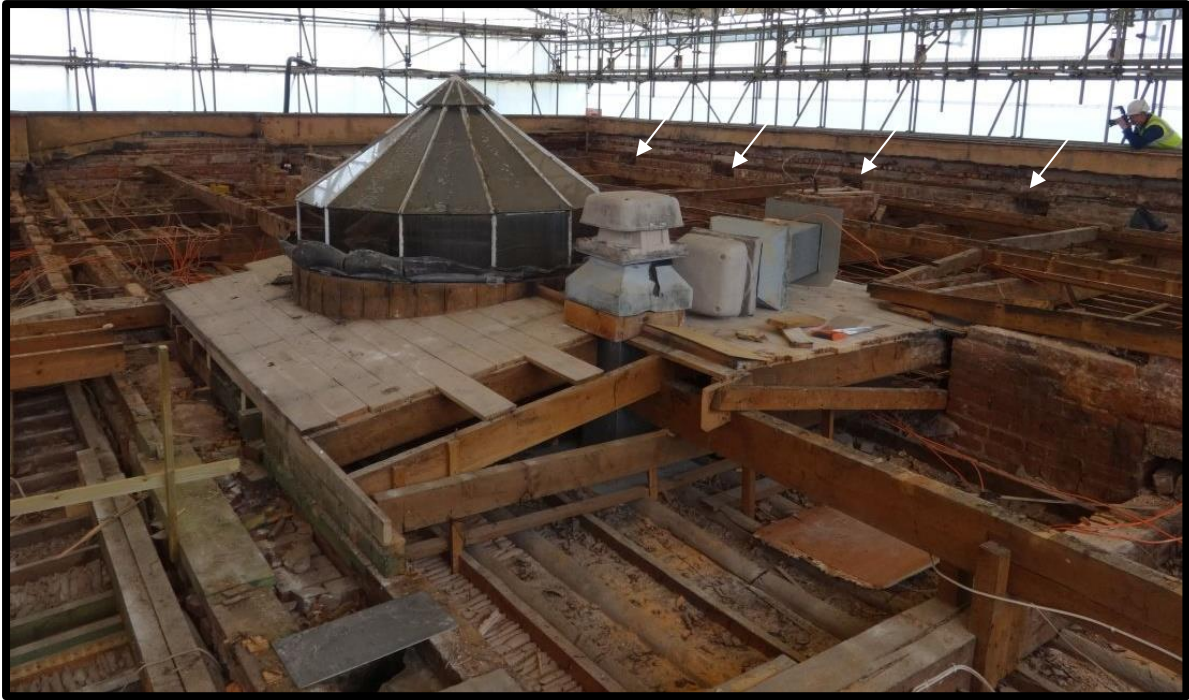
Fig. 27 General view of the south-western part of the roof looking south west, showing the central skylight of the first-floor corridor (before dismantling) and the regularly-spaced sockets (unrelated to either the 18th-century or modern roof structures) in the west wall (arrowed).

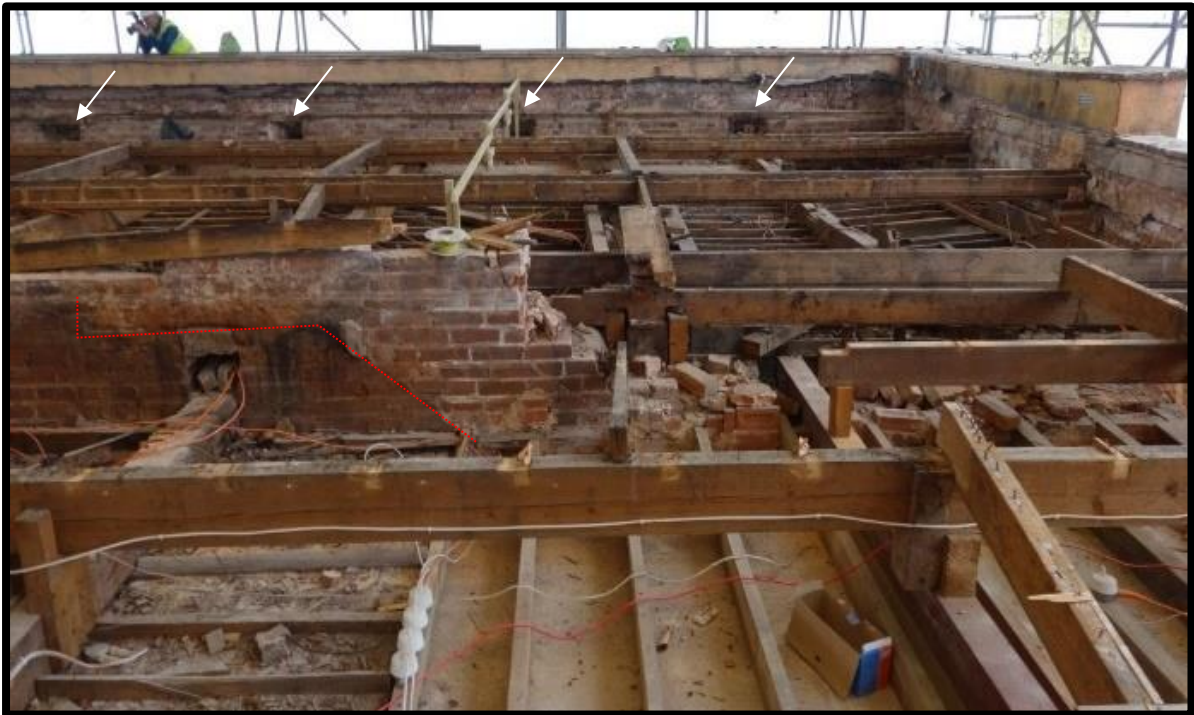
Fig. 28 General view of the north part of the roof looking west, showing modern interventions in the area of the main staircase (right foreground), a curious angled scar resembling the string of a staircase on the chimney in the spine wall, rising to a higher level than the 18th-century roofs (red) and, beyond this, regularly-spaced sockets (unrelated to either the 18th-century or modern roof structures) in the west wall beneath the later parapet (arrowed).

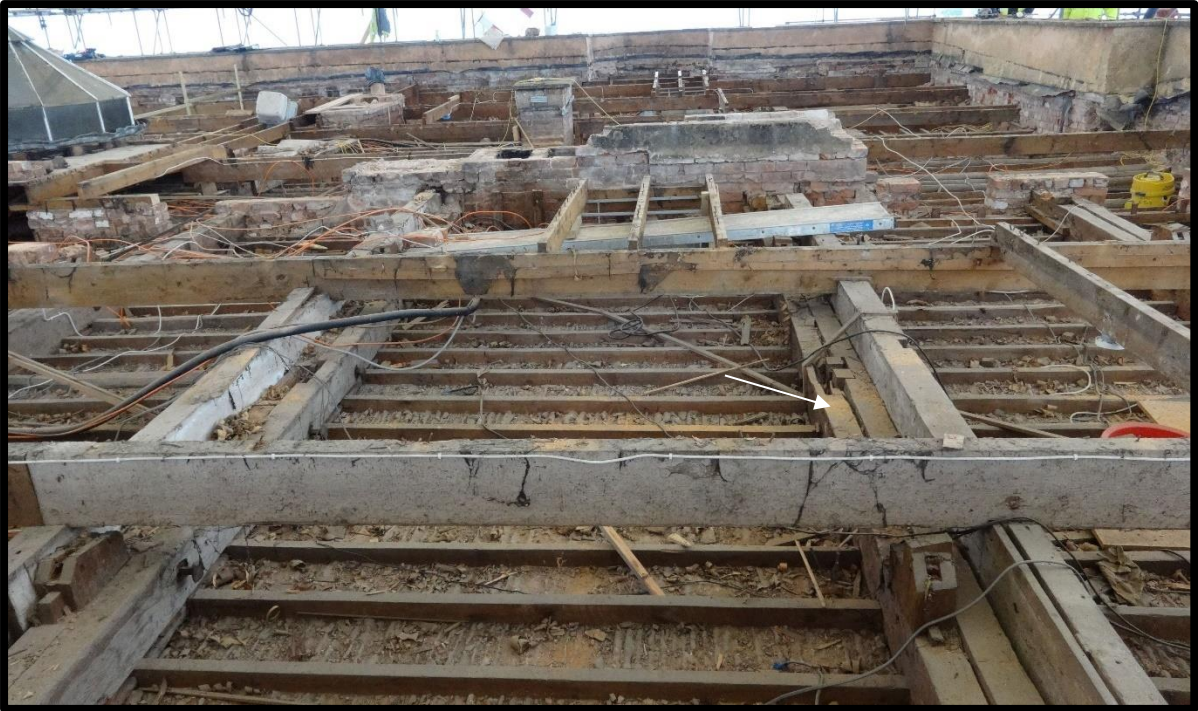
Fig. 29 General view of the south part of the western roof looking east, showing the trebled ties of successive attempts to reinforce the 18th-century roof (arrowed) and the remains of sawn-off king-posts and mortices relating to the original structure.

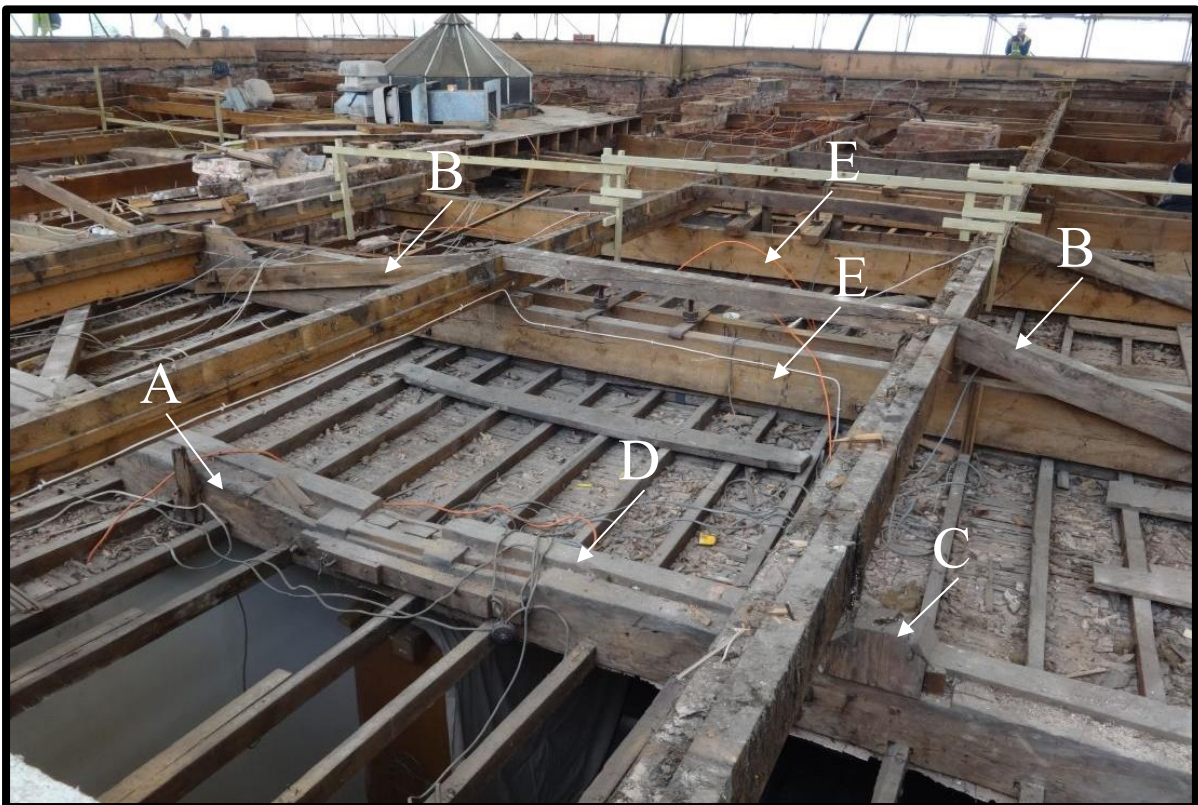
Fig. 30 General view of the western part of the roof looking south, showing the deflection of the original tie beams (A) and the weak construction at the centre due to original and later mortices; the remains of the 19th-century trapezoidal roof structures (B); the truncated king-post trusses of the 18th-century roof (C); the additional tie beams (D) and further additional ties reinforcing them (E).

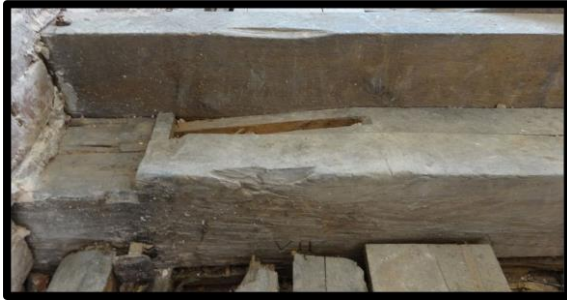
Fig. 31 The end of one of the tie beams showing the socket for one of the original principal rafters. A later tie is shown bolted against this, marked 'VII'.

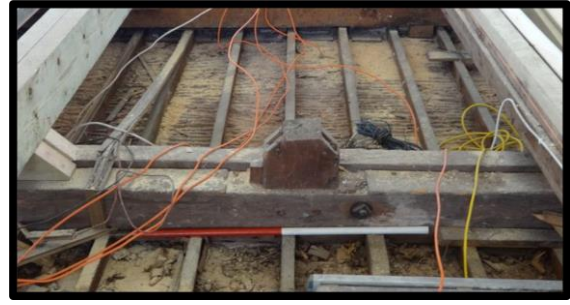
Fig. 32 Detail of one of the original king posts supporting the trusses, with sockets for diagonal braces. The later tie is shown behind the original.

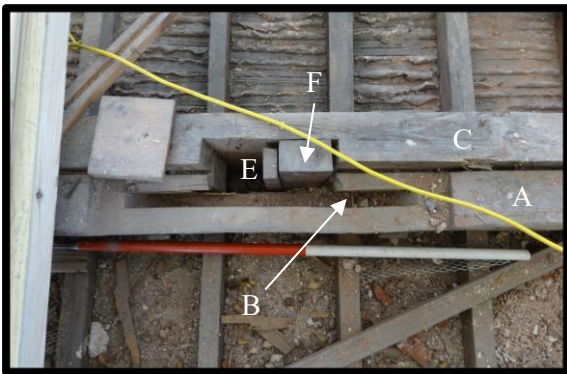
Fig. 33 One of the primary ties (A), sockets for principals (B); an additional tie laid against this (C) and the tertiary socket cut through both ties (E) and fitted with wedges (F)

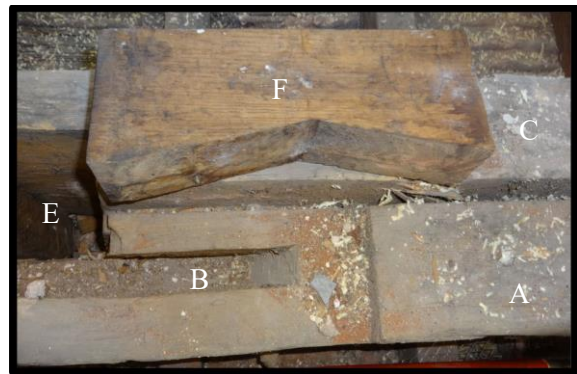
Fig. 34 One of the 'waisted' wedges (F) fitted within the tertiary sockets (E), forming vertical ties hanging the central part of the roof from a missing structural member.

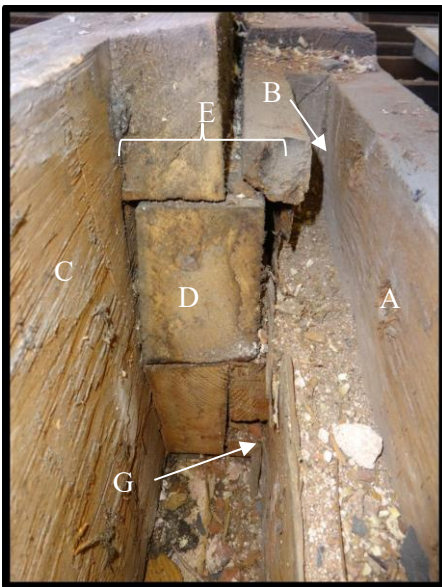
Fig. 35 View within one of the tertiary sockets (E) showing the hidden fillet (D) binding the two ties (A&B).

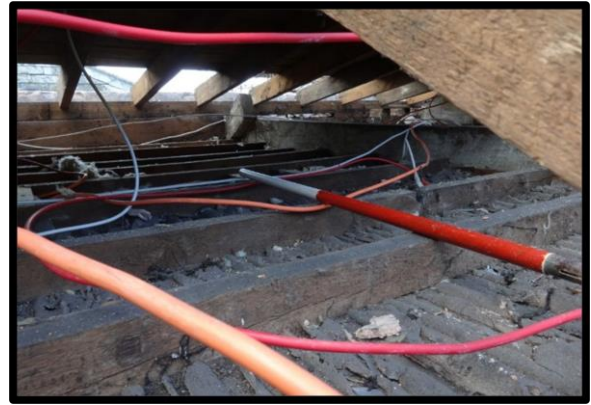
Fig. 38 Evidence of earlier trusses, sawn-off short, from a roof with two equal pitches, surviving beneath the roofline, above the 19th-century ceilings.

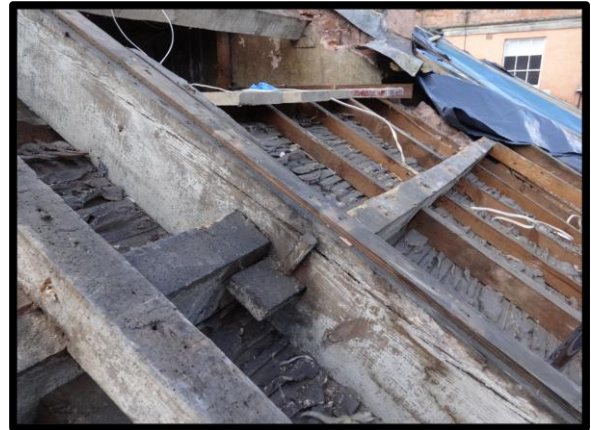
Fig. 40 The staggered purlins and plaster torching of the original roof on the northern side of the range.

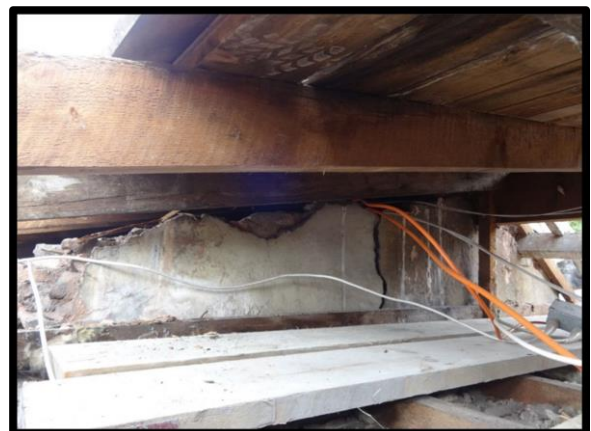
Fig. 42 The remains of wall plastering above the existing ceilings, showing that the rooms were formerly open to the roof.

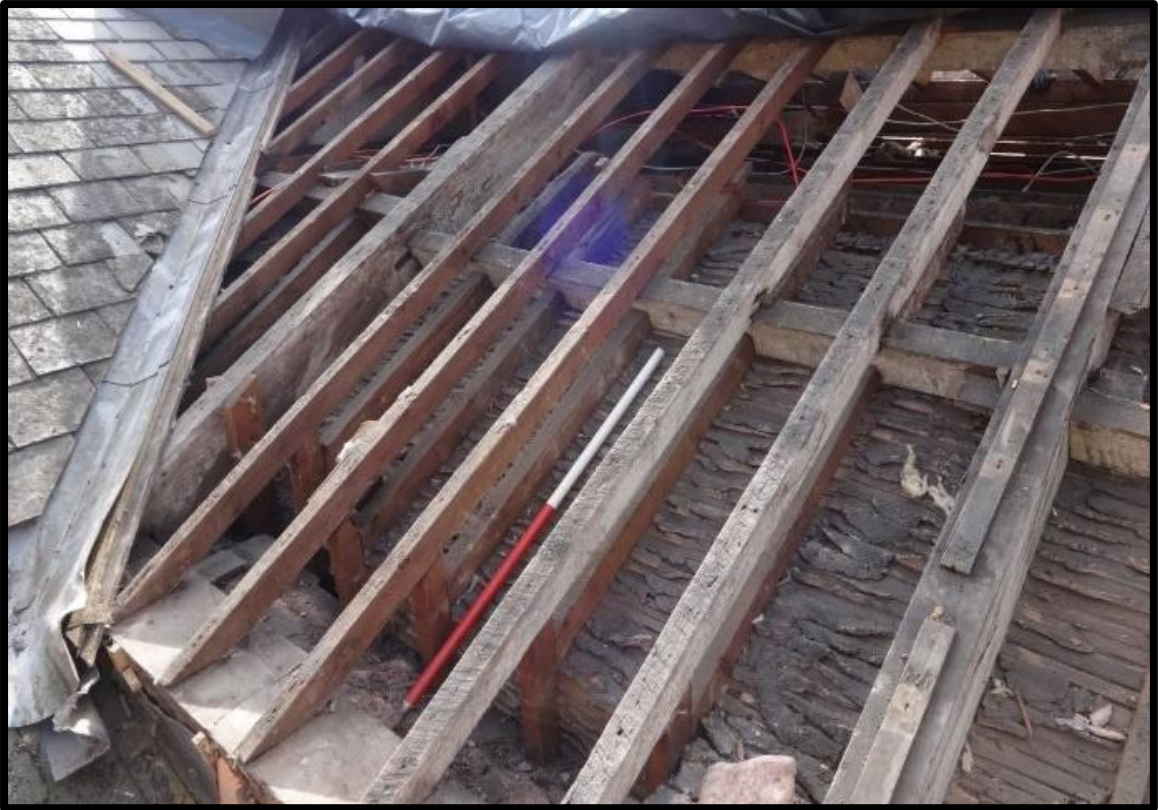
Fig. 43 Secondary rafters and plastering underlying the roof timbers of the service range at the eastern extremity of the northern plane of the roof.

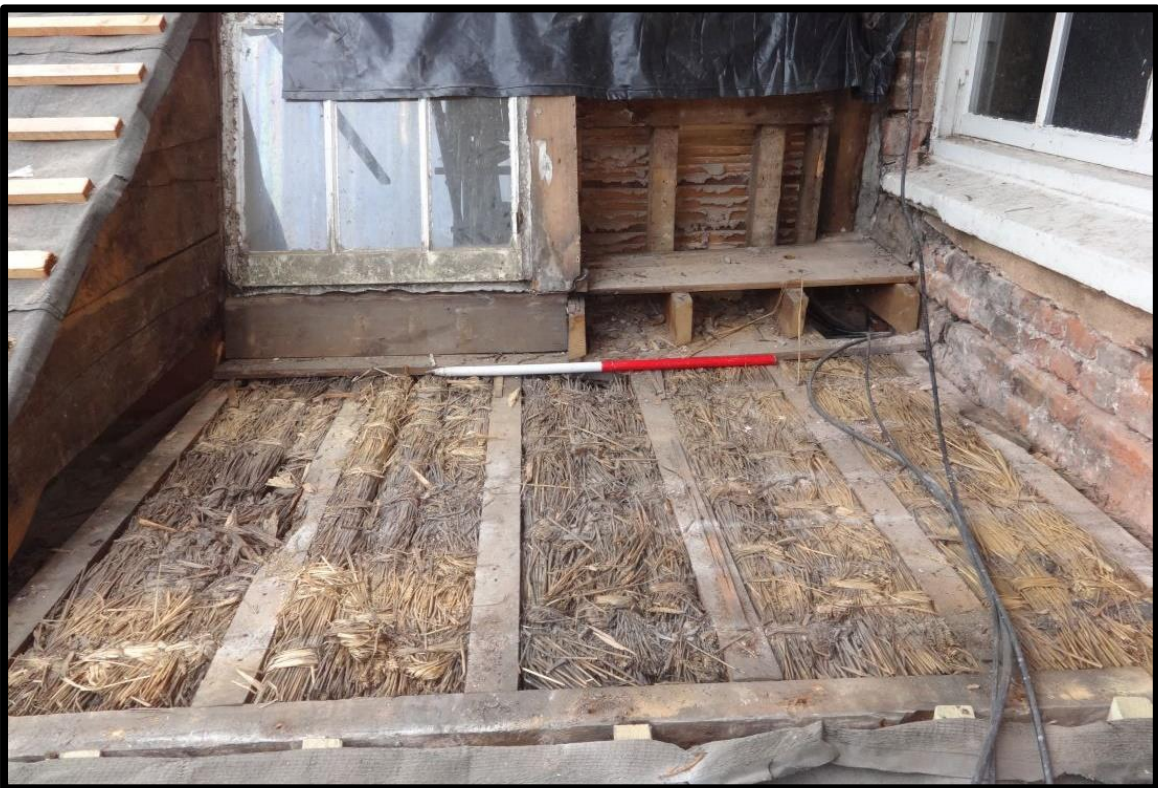
Fig 44 Straw bundles tightly packed between the joists of the flat roof at the extreme western end of the north plane of the service wing roof, presumably providing some form of insulation.

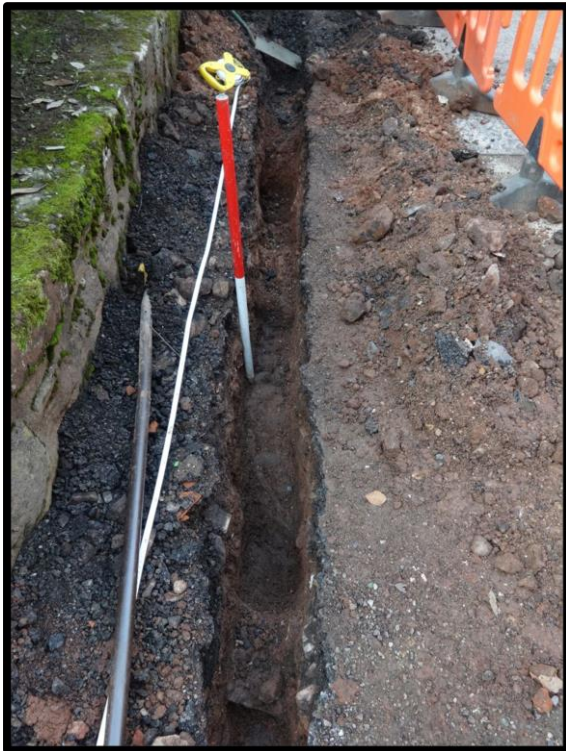
Fig. 47 A mixed cobbled and masonry feature, perhaps representing the footings of a cob wall with stone lined drains.

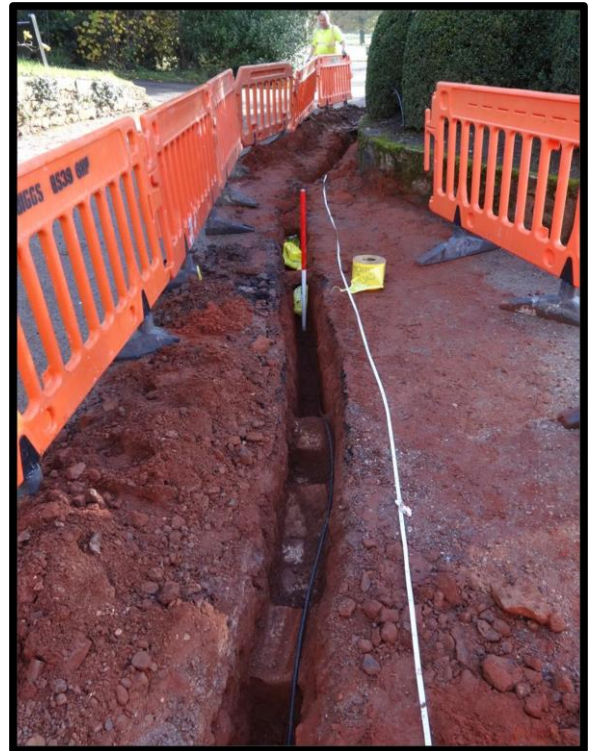
Fig. 48 A brick and stone feature lying to the north, seen looking south, interpreted as a possible culvert.
