**Haden Hill Park  
Rowley Regis  
Sandwell**

**Report on a programme  
of archaeological work**

May 2004

*Marches Archaeology Series 277*

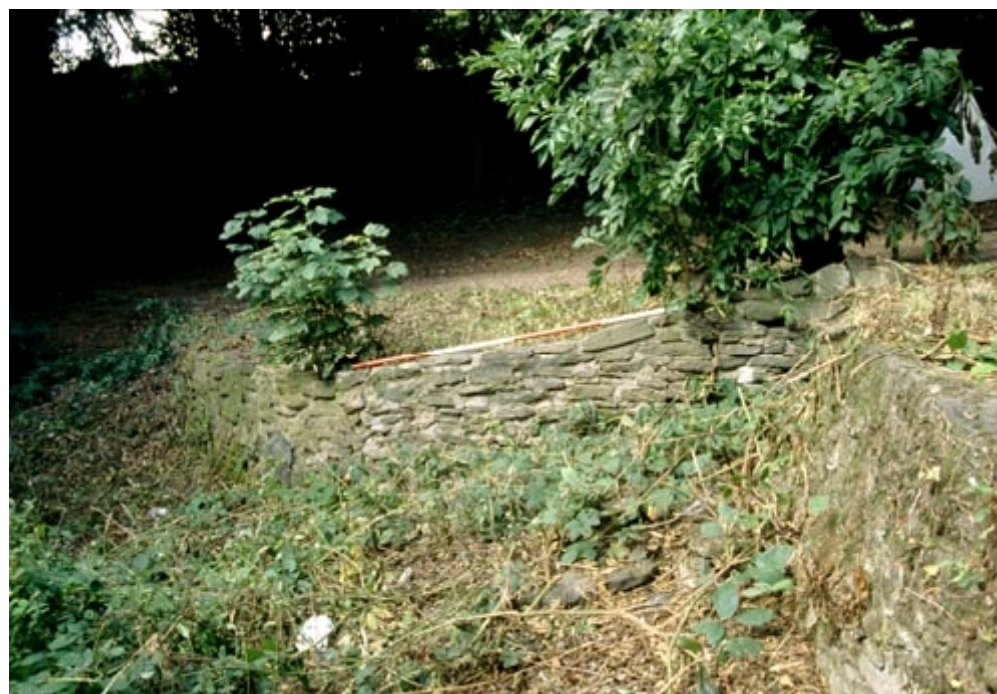
**Plate 8 HHP4.17**  
**Wall No.3**  
**(Ha-ha)**

Wall no.3, the potential 18th century retaining wall [6], which is also referred to as a ha-ha, had the vegetation cleaned off its face so that its the upper part of the structure where collapses had occurred could be re-constructed (Plates 8-12). Before repairs to the walls were completed an evaluation excavation was undertaken in an area where the face had collapsed (Fig. 6) (Plates 13-15). At 31.5m to the east of the west end of the wall a 1m square slot was excavated (Fig 7). The wall [6] was taken down to reveal the break between the face and the foundations of the wall. The wall had been re-faced, and then stone had been

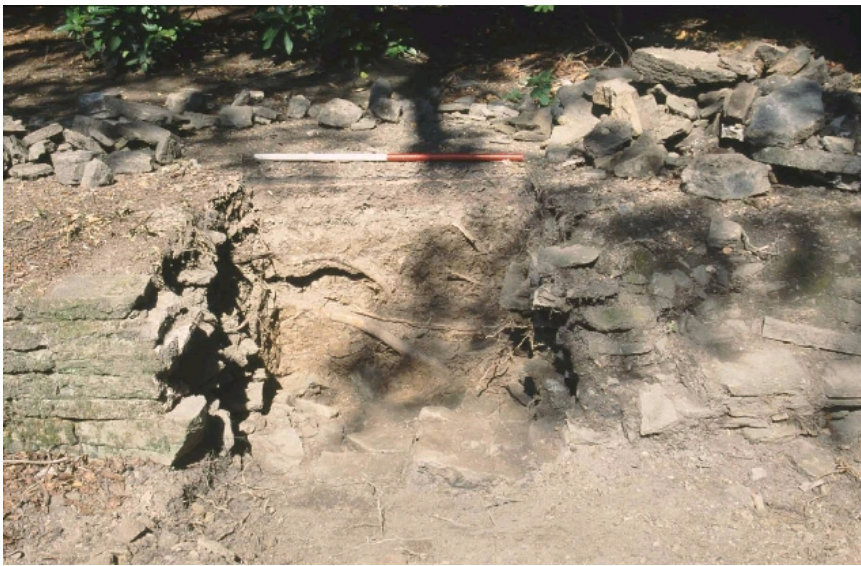
**Plate 13 HHP4.30 Slot excavated through Wall No. 3**

The 'Brief' required that further information be provided on the date and method of construction of the terrace wall (Wall No. 3). The slot through Wall No. 3, where part of the wall has already collapsed, indicated the method of construction, but it also highlighted that wall had been subject to at least one phase of rebuild or repair. The wall had been re-faced, often unsympathetically as old concrete slabs had been used amongst the stone. The face stones had been bonded together with mortar which did not fit in with the rest of the wall. The bonding and the re-facing were fairly recent events. The reason for the bonding was apparent once the wall was stripped down to level just below the current ground surface. The currently exposed face was moving southwards down the slope and was no longer on its original east-west alignment. It was not established whether the movement of the wall above ground was a phenomenon that was affecting the whole length of the wall; even where stonework on the face was not bonded and looked as if it was original.

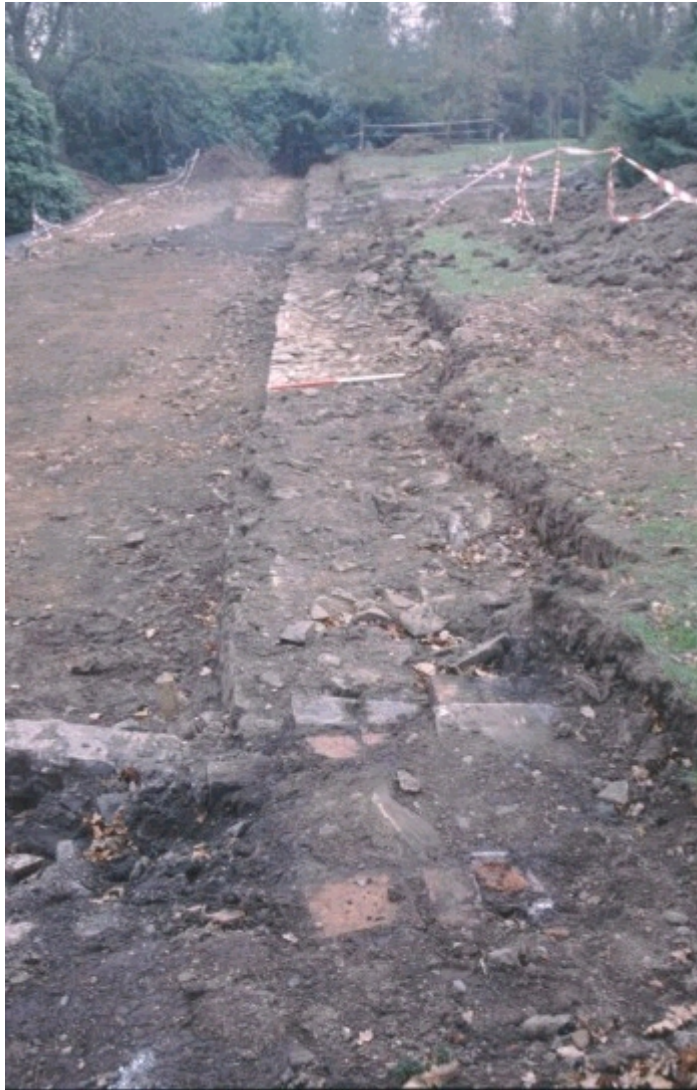
**Plate 21 A view looking south along the exposed ha-ha**

The exposed wall was found in various states of preservation. To the north of Trench 1 only a few courses survived and these were fairly loose (Plate 21 & 22). The best preservation was between Trench 1 and Trench 2, even where the foundation of the existing steps had cut the line of the wall. Here the wall had survived well, and was reasonably high (Plate 23). A

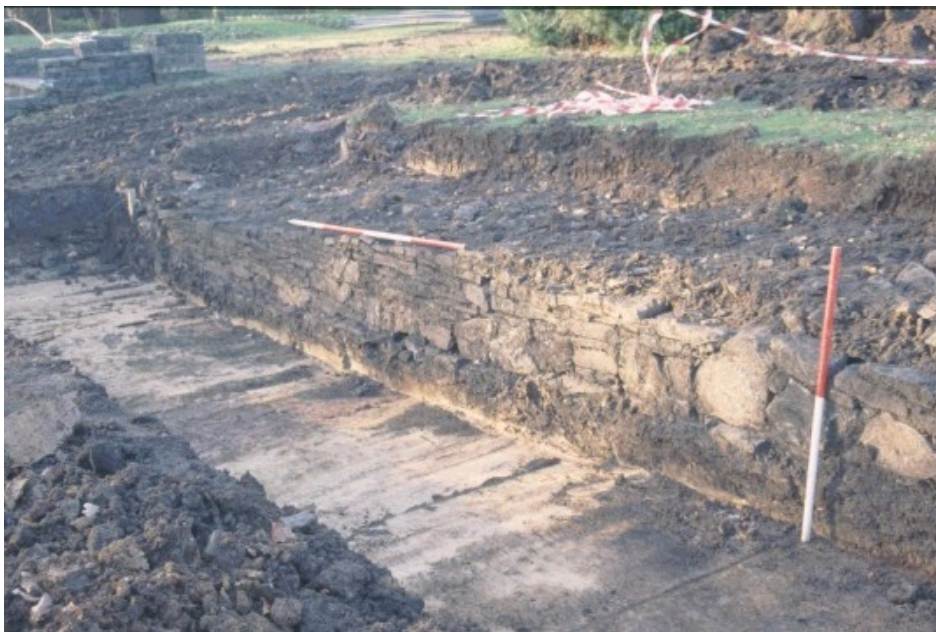
**Plate 23 The ha-ha showing initial depth of excavation looking south west**

modern drain coming from the direction of the Old Hall had removed some of the upper courses. The wall between Trench 2 and the Looped Driveway was in a poorer condition (Plate 24). When the wall was demolished in 1983/4 more of the wall had been pushed over. The tumble revealed that the wall had been repaired, as sections of the sandstone block work had been bonded together with modern mortar. A 2m wide area of the standing wall was similarly roughly repaired (Fig. 19). It is not possible to date these repairs but they are more than likely to have been done since the 1950s.

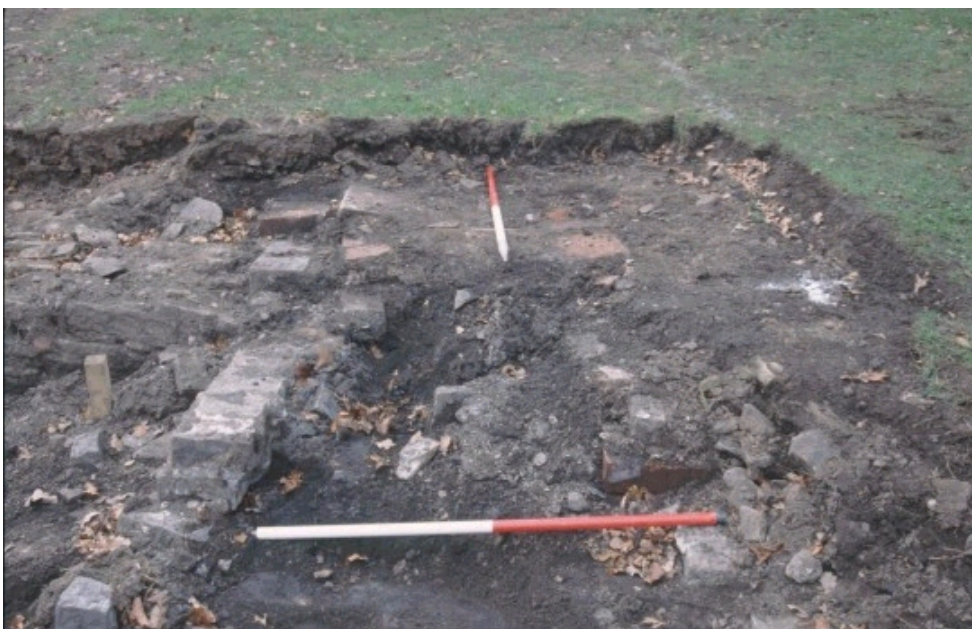
**Plate 25 The missing north steps, looking west**

Near to the northern limit of the excavated area the lost northern steps were located. These steps were one of two sets shown on the 1888 25" Ordnance Survey map (Morriss, 2002, 60). The other steps were located in the same place as the existing steps. The steps were constructed from brick and were only partially exposed (Plate 25). The contractors removed part of the steps along with part of the wall as far as the slot through trench 1. The trench created was covered by concrete before archaeological work could take place.

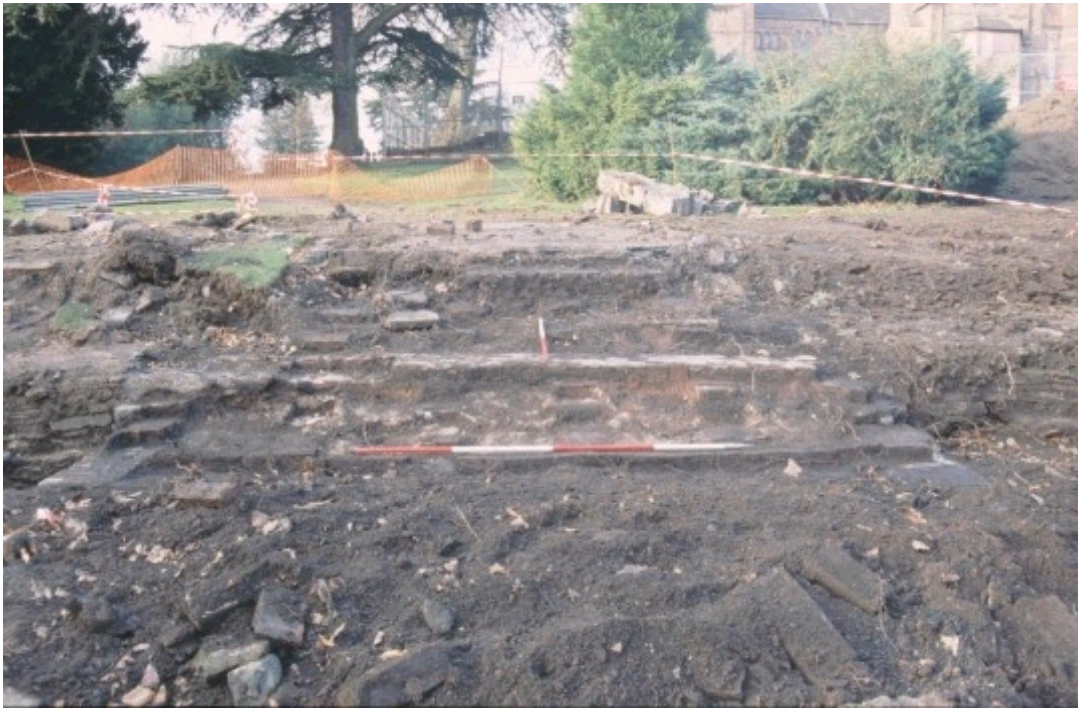
**Plate 26 The foundation utilised by the existing steps, looking west**

The existing steps were demolished down to the brick foundation. The existing steps had utilised an existing foundation that could have been part of the original steps shown on the 1888 25" Ordnance Survey Map (Morriss, 2002, 60) (Plate 26). The foundation was left *in situ* with the intention to incorporate it into the new design.

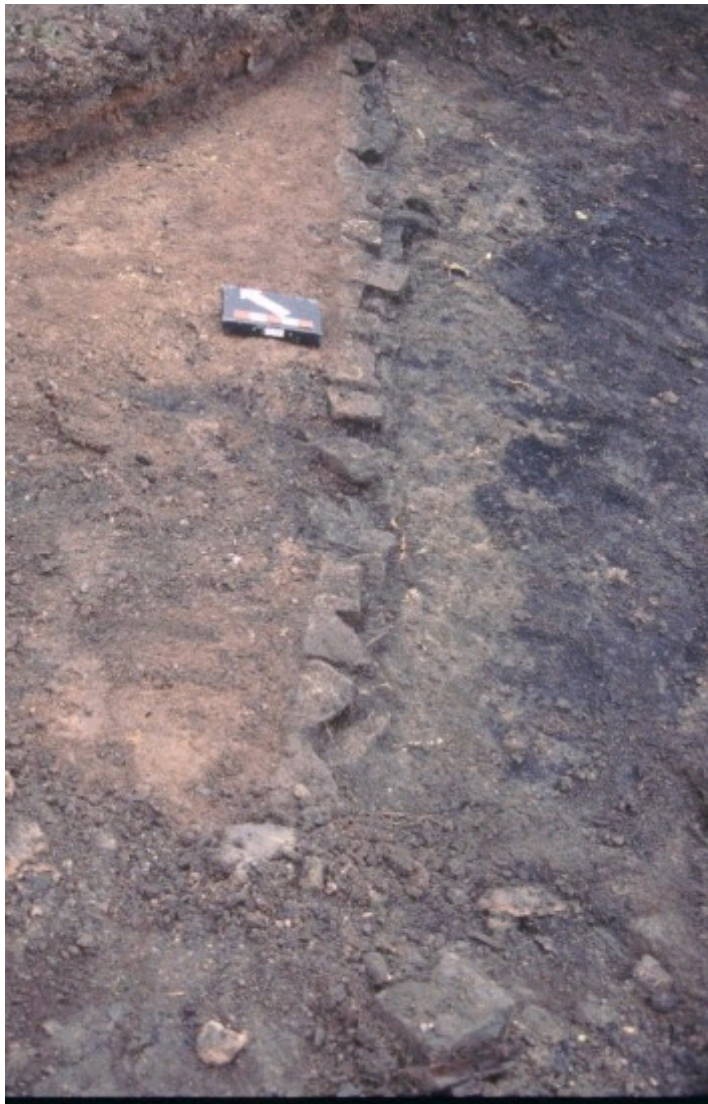
**Plate 28** The 18th century carriageway [105] & wall [107], looking north east

The wall [107] consisted of random courses of unbonded olive brown mud stone which were cut into small irregular slabs less than 100mm thick. The top of the south eastern edge of the wall was abutted by furnace waste [108] and below it, and also abutting the wall to the south, was a yellowish brown loamy clay [111] which had been deposited at the same time as the wall [107] had collapsed. It was observed that several courses of the wall had tumbled to the south, and then been incorporated into [111] before being buried under [108].

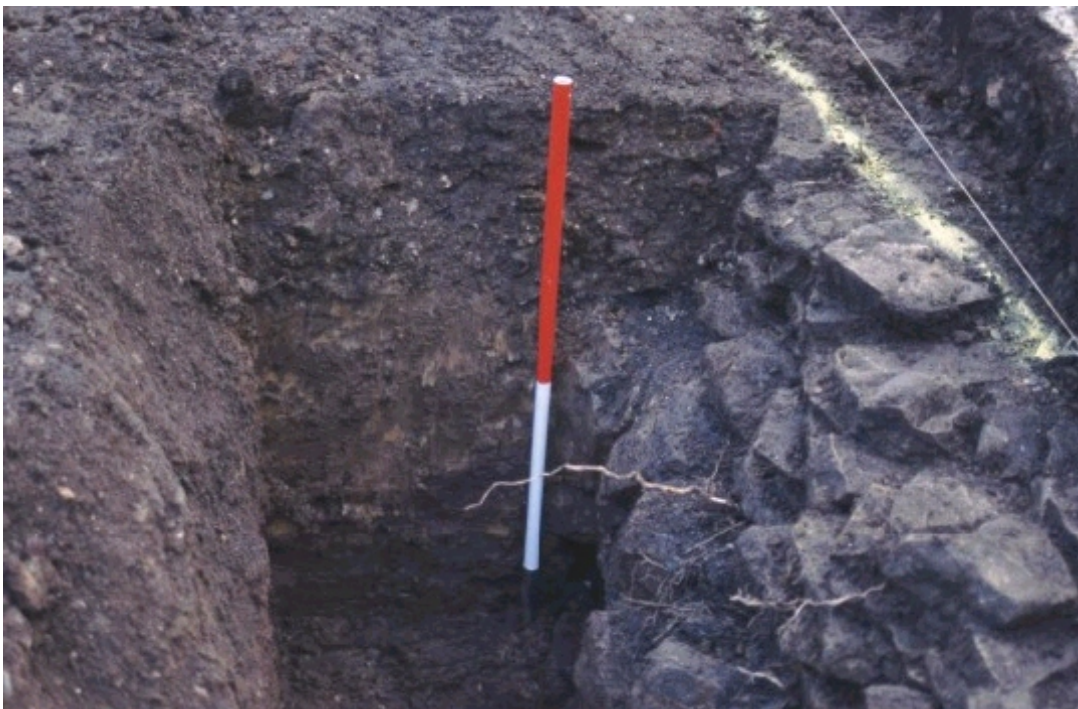
**Plate 29** Terrace wall [113], looking east

The clay dumping and buried soil appeared to be truncated by a substantial wall [113] but no cut for this feature was found (Plate 29). The northern edge of this wall was excavated and recorded by hand to a depth of 1.2m but its base was not found. The wall consisted of random courses of irregular mudstone blocks upto 0.2m square with alternating courses of greyish green tap slag. These large glassy slabs were up to 0.4m long, 0.2m wide and 0.15m thick. Other smaller lumps of slag shaped into the form of a casting mould or crucible were also found in the wall make-up. No bonding material was visible but there were lenses of ash and charcoal between the slabs. This feature was capped by a more decorative dry stone wall [112] of three to four random courses of unbonded and small mud stone slabs. This wall stood to a height of 0.32m until it was used as a base for the kerb side wall of the Looped Driveway [36]. The wall was contemporary with the topsoil layer [114] until it was buried under [108].
