The Moat Lower Brockhampton Brockhampton Herefordshire

Report on an archaeological watching brief

February 2004

Marches Archaeology Series 318

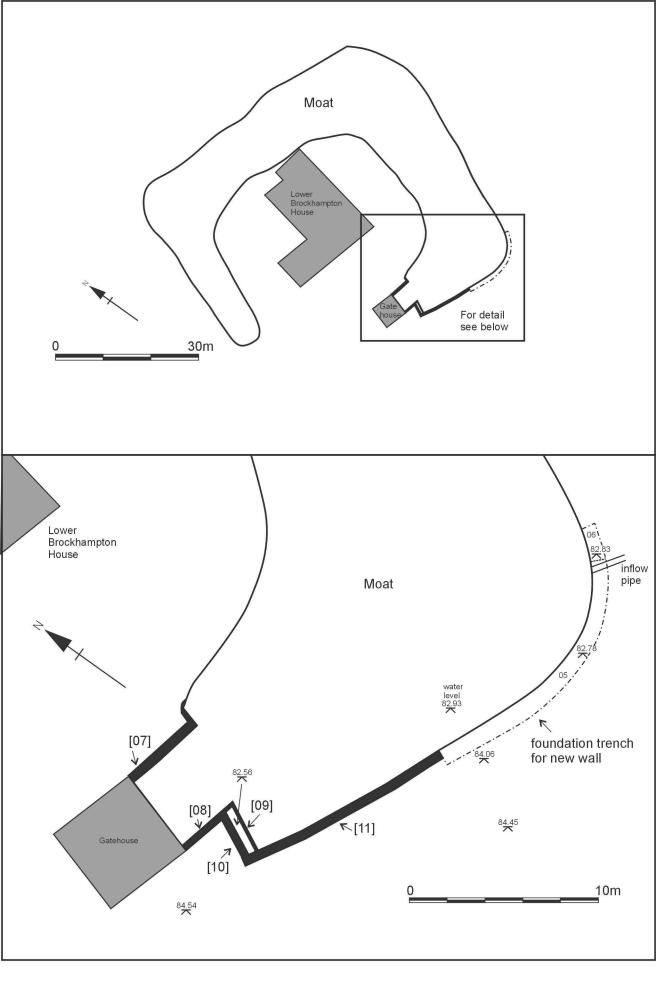
Fig. 2: Location of revetment walls and foundation trench (based on plan supplied by Frank Haywood and Associates)

The existing revetments to the moat immediately east of the gatehouse are built of local mudstone (Fig. 2, plate 1). Most of the stones are undressed, but occasional dressed pieces are included, presumably reused from an earlier structure. Where visible the original mortar was yellow or white and friable. Wall [11] (plate 2) had previously been repointed in patches, and walls [07] and [08] had lost much of their mortar, especially below water level. The low flowerbed revetment [09] is drystone build with no mortar. Walls [08], [10] and [11] have undressed, roughly triangular coping stones. Wall [07] is much lower than the others (0.8m high at the east end) and has flat slabs on top at the level of the grass. Walls [08], [09] and [10] are all bonded together and must have been built at that the same time. There is a butt joint between wall [11] and [10], so wall [11] might represent a different phase of construction. The walls passing under the gatehouse are not continuous. There is a straight butt joint between walls [07] and [08] and the stretches of wall directly under the gatehouse. Presumably the walls under the gatehouse are earlier and walls [07] and [08] are later additions or rebuilds.

Walls [07], [08], [10] and [11] were to be repointed. Some stones needed replacing at the base of wall [11]. Wall [09] needed rebuilding. It was demolished and the section behind it was recorded before rebuilding. Wall [09] was a single faced revetment built into the deposits behind it, which must have been laid down as [09] was being constructed. A core of stone [13] was built up then, when the wall was c.150mm below its finished level, topsoil [12] was deposited over and around the back of the wall stones.

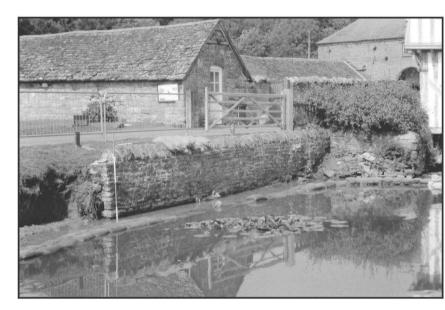
Plate 2: Revetment wall [11]

10	E facing wall, essentially continuation of 08 with same coping stones and construction. Only 0.8m high as flowerbed and reveting wall 09 juts out from its base.	Moat revetment wall
11	Revetment on S side of moat. Roughly coursed, undressed mudstone. Yellowish mortar. Roughly triangular, undressed coping stones. <i>c</i> .1.6m high. Not bonded with 10.	Moat revetment wall
12	Dark brown loam, c.150mm deep, dumped over stone layer 13	Topsoil in flower bed behind 09
13	Deposit of mudstones up to 0.3m in length and brown silty clay. 0.6m deep. Most stones are approximately horizontal but it is not coursed or built. Merges with wall core behind face 08 and extends under 10. Behind 08 and under 10 there are just voids between the stones.	Wall core

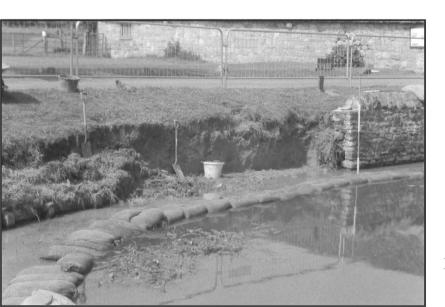
Plate 3: Digging foundation trench for new revetment wall

East of wall [11] the edge of the moat was cut back c.0.85m to a depth 150mm below the water level (approximately 82.78m OD). This cutting was the foundation trench for a new revetment wall (plate 3). In the trench the deposits on the edge of the moat could be clearly seen. The topsoil [01] was c. 0.2m thick; its surface where the trench cut it was at c.84.06m OD. Below this was another layer of dark brown clayey loam [02], but more clayey than the topsoil. This was interpreted as relict topsoil (Ap-horizon). Beneath this was c. 0.15m of brown silty clay containing c.40% stones and tile fragments [03]. It also contained one hand-made brick, bone and fragments of oyster shells. The finds were all late post-medieval in date. This appeared to be a layer of rubble and domestic rubbish laid down at the moat's edge, possibly to consolidate a muddy patch.

Layer [03] was deposited on top of a red-brown silty clay [04], more malleable than the natural clay and dirtier in colour. This seems to have been redeposited here for some purpose, but there was no dating evidence and, as it was not possible to see the deposit in plan view, its function could not be ascertained. An amorphous lump of tufa was found in deposit [04]. The interface between [03] and [04] lay at *c*. 83.57m OD. Beneath [04] was the undisturbed natural clay [05], which was a red-brown silty clay and not very malleable. It seemed to be largely composed of partially degraded mudstone. The upper interface of [05] was at *c*. 83.26m OD. At the eastern end of the foundation trench a patch of pale green-grey silty sand [06] was seen in the base of the trench at a level of *c*. 82.83m OD. This was an area of degraded sandstone, presumably bedrock.
