## **Pembridge Market Hall, Pembridge, Herefordshire**

### **Report on archaeological building recording**

November 2004

*Marches Archaeology Series 361*

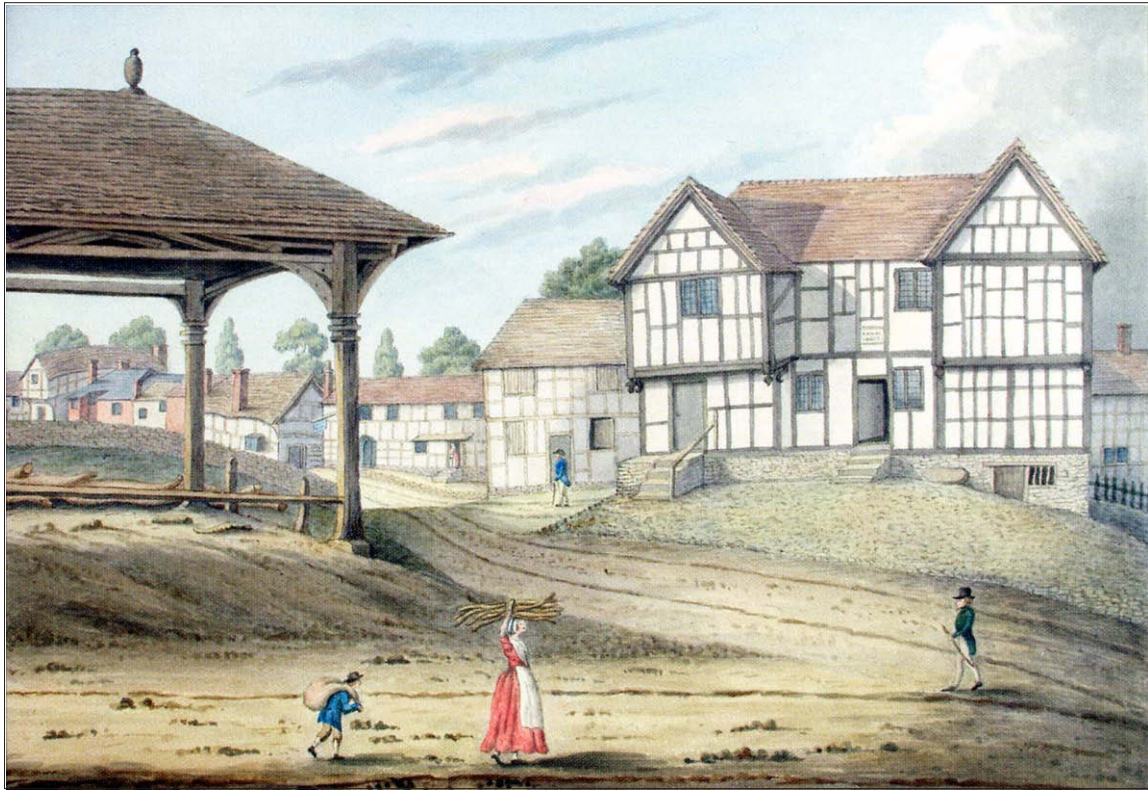
At a later date the roof of the Market Hall was largely replaced and the form of it substantially altered. The principal rafters forming the gable ends of the building were replaced with hipped rafters to form a hipped roof, the hipped ends being given additional support with the provision of longitudinal half-trusses (Figures 7 & 10, Plate 8). The rafters and purlins were replaced, and wooden battens used to fix stone roofing tiles which were graded in size from the base to the apex. At each end of the apex of the roof were wooden finials, seen in a watercolour painting of 1842 to be of an elongated urn shape (Plate 1).

Plate 1: Watercolour of Pembridge, 1842

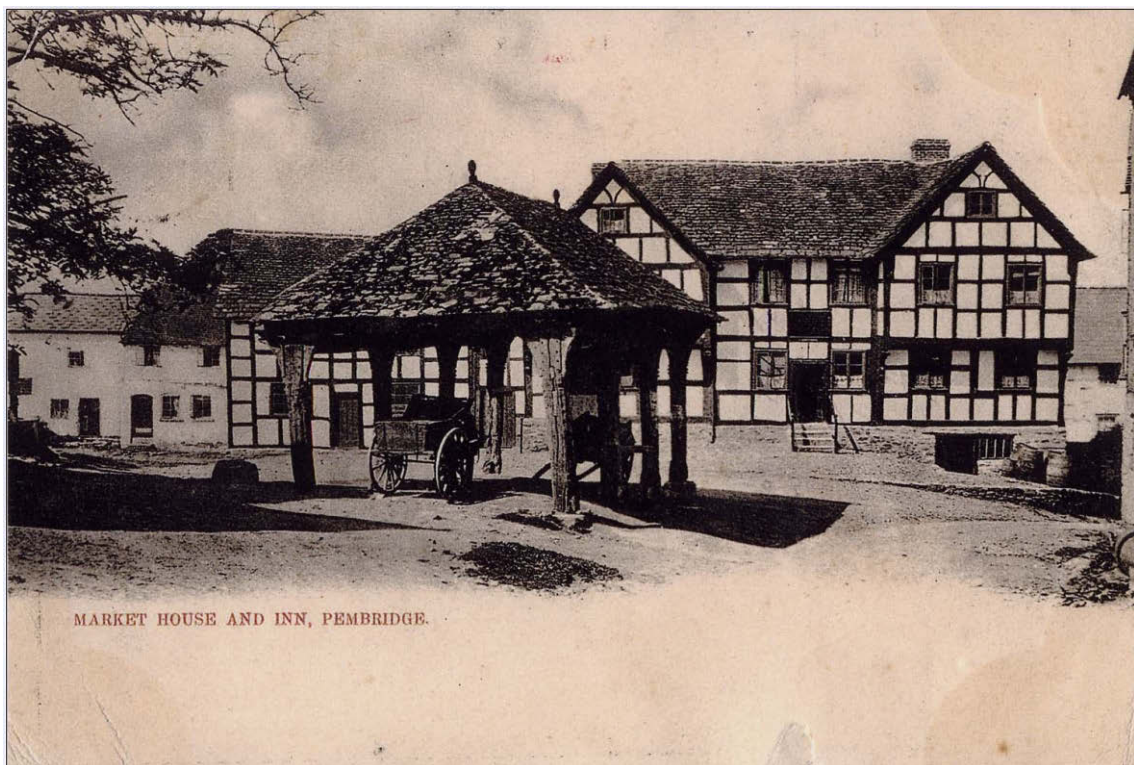
Plate 2: Photograph of the Market Hall dated 1904

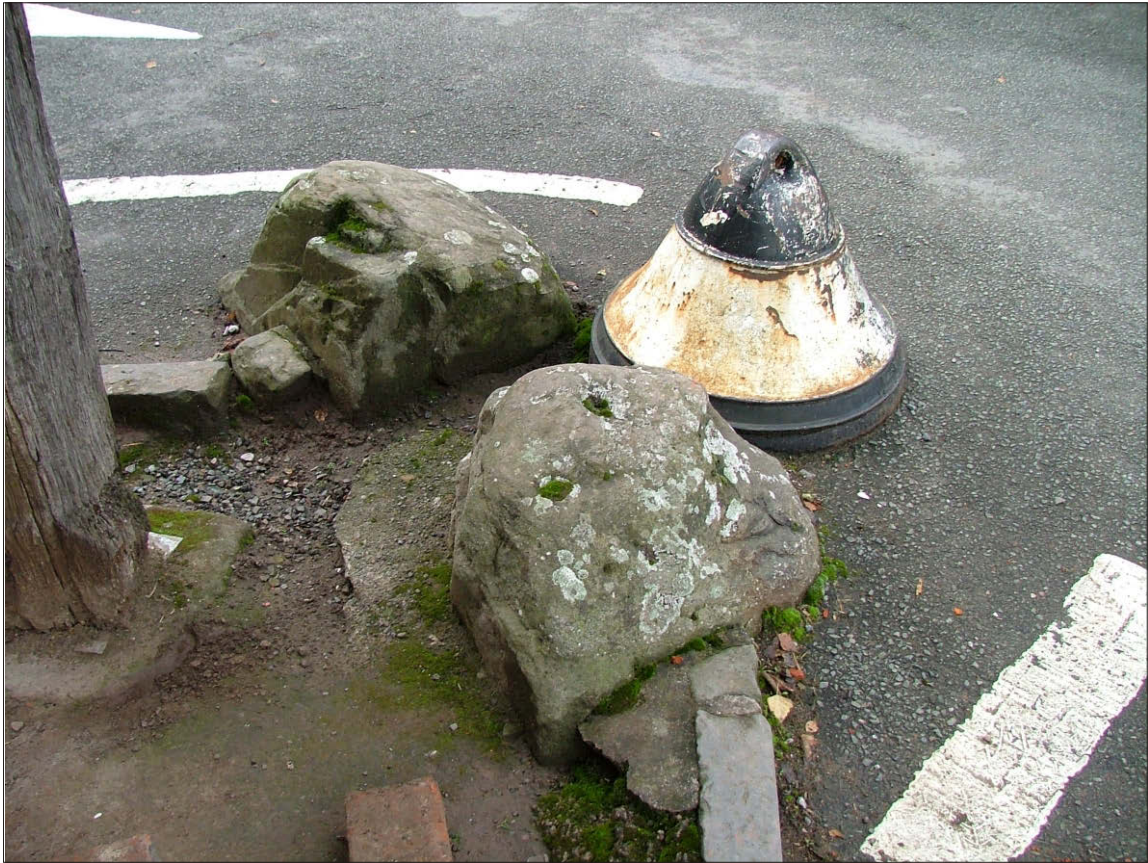
There are a number of features of the Market Hall which cannot be attributed to any particular phase of works. At the south-west corner of the site are two unworked stones known locally as mark stones. Photographic evidence places them at the site at least since the early 19<sup>th</sup> century, and also shows that they originally formed one, much larger, stone that was roughly squared. They may well be much earlier, and could pre-date or be contemporary with the Market Hall.

Plate 11: Marker stones at the south-west corner of the site

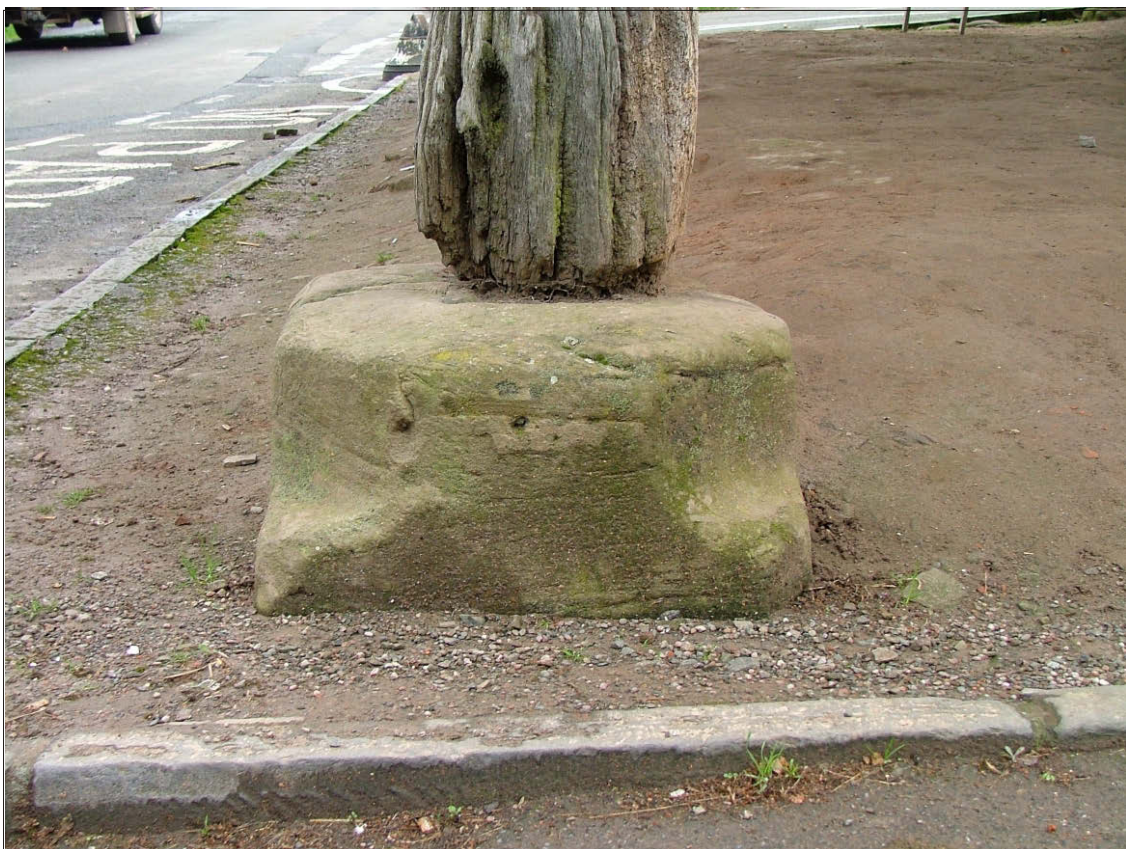
Detailed recording and analysis of the Market Hall, Pembridge has confirmed that much of the surviving structure dates to the early 16<sup>th</sup> century. The use of a medieval base, typical of those used in the construction of market crosses, may indicate that the market hall replaced a cross that previously stood in the market square. It is probable that a centre such as Pembridge would have had a market cross, but as the base does not appear to be *in situ* it cannot be directly linked to such a structure.

Plate 12: Base of possible medieval market cross forming padstone for north-east post

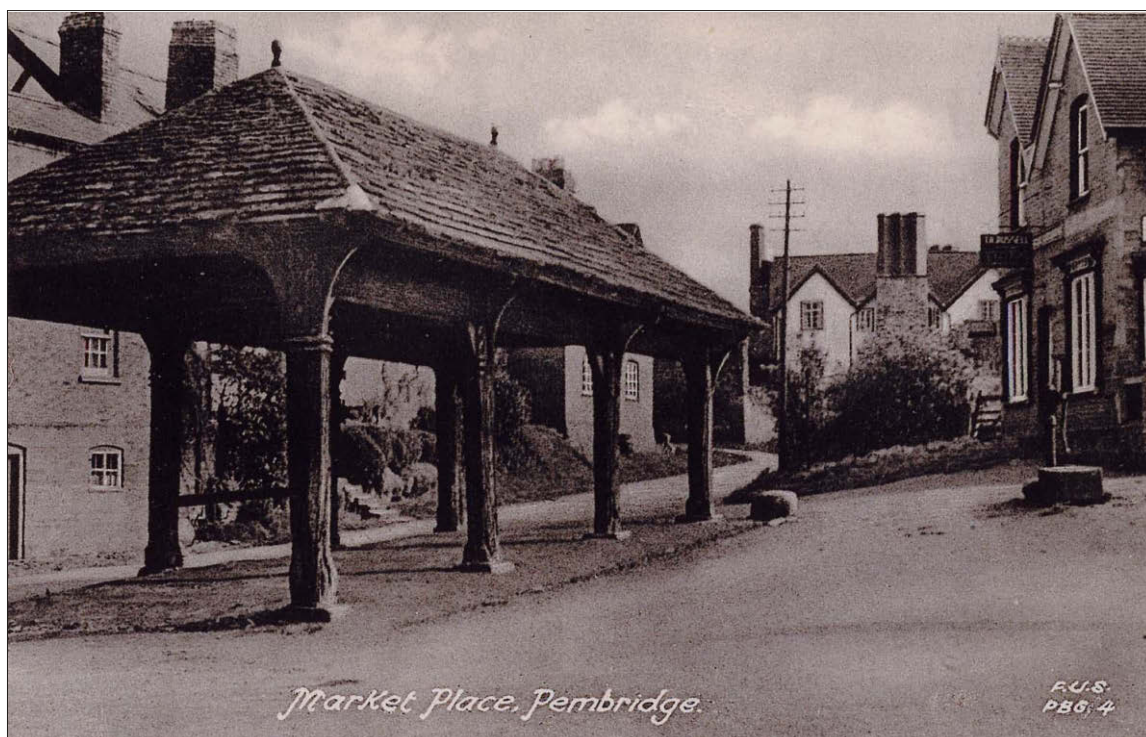
Plate 3: Photograph of Market Hall from the north-west, undated

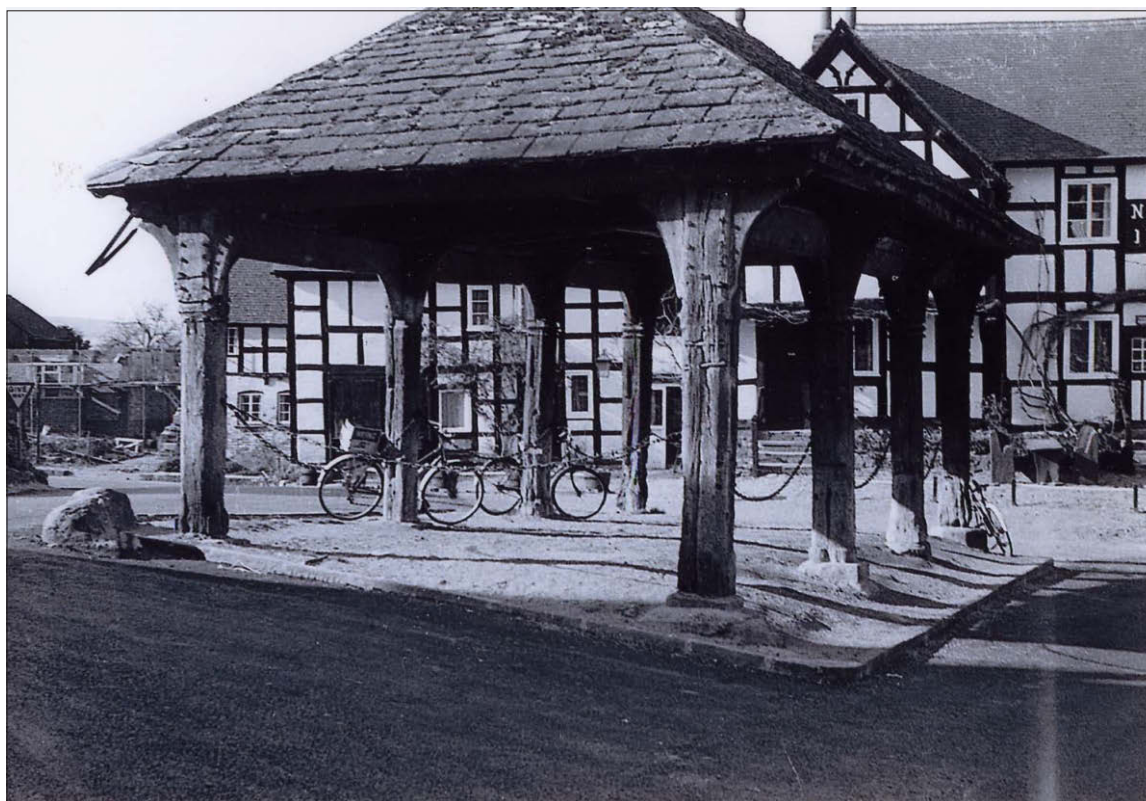
In the 1960s the possibility of further work was explored when concerns were raised about the condition of the earth floor. The Ministry of Works advised that a raised step should be instated along the centre line of the rows of posts, within which a paved floor should be 'reinstated' (although there is no evidence for, or previous reference to, a paved floor being present) as well as oak rails between the posts being replaced. This work was never carried out, although the county council did lay the present kerbstones around the outer edge of the floor (Plate 4).

In the second half of the 20<sup>th</sup> century, probably in the later 1960s or 1970s, the current line of kerbstones was laid around the outside of the building, defining the floor as it is today (Figure 2). A chain was strung between each of the posts, hung from small iron hooks attached to the inner faces of the posts and limiting access to the area (Plate 4).

Plate 4: Photograph of the Market Hall, 1960s

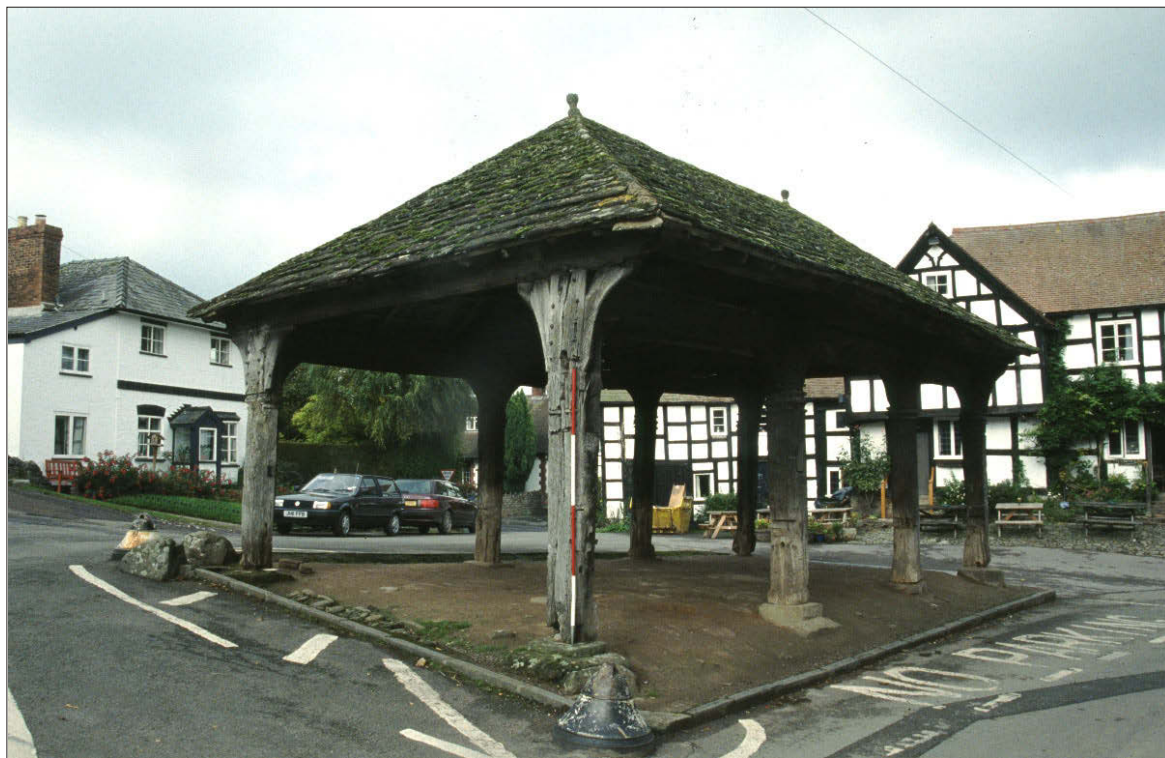
Plate 5: The Market Hall from the south-east

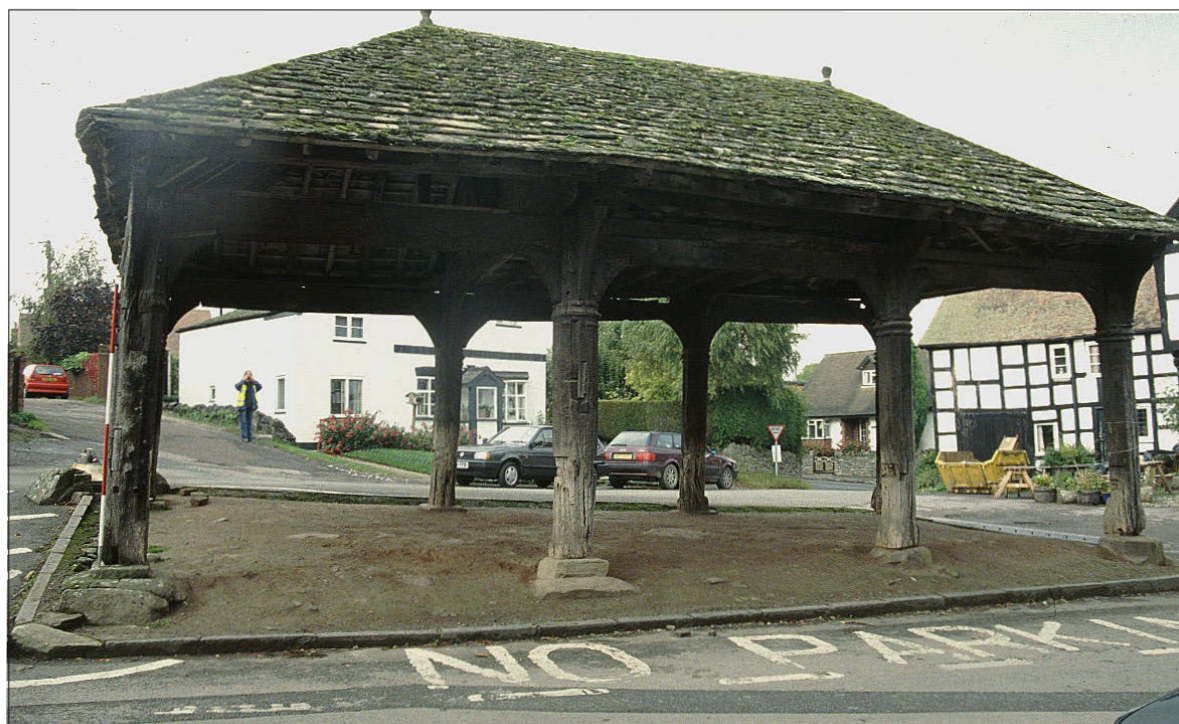
Plate 6: The Market Hall from the east

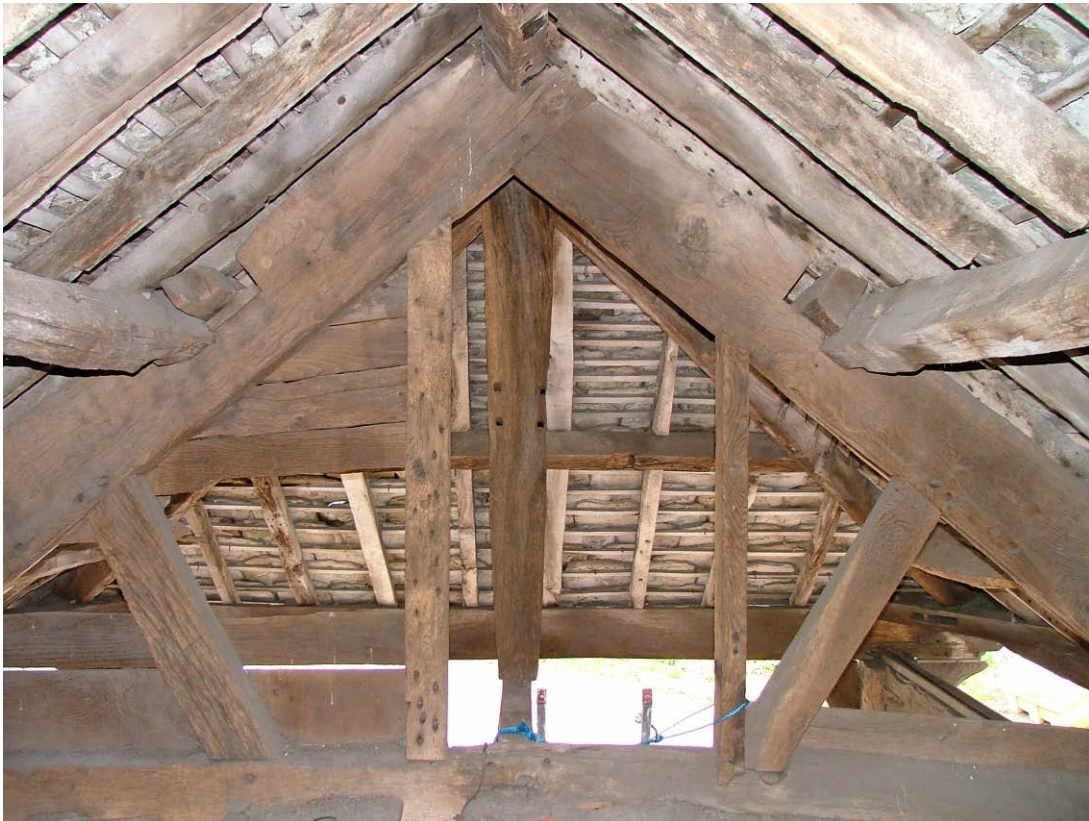
In the central bay a loft structure was created, with a bridging beam inserted between the two Phase I truss tie-beams. Longitudinal timbers were placed on top of the arcade plates within this bay, onto which the outer ends of the floor joists were notched, the inner ends notched into the central bridging beam, and overlain by oak floorboards (Figure 10a). Access to the loft was created by the removal of the collars and crown posts from the two trusses, replaced by the current raking struts (Figures 5 & 6, Plate 7).

Plate 7: Southern truss from the north

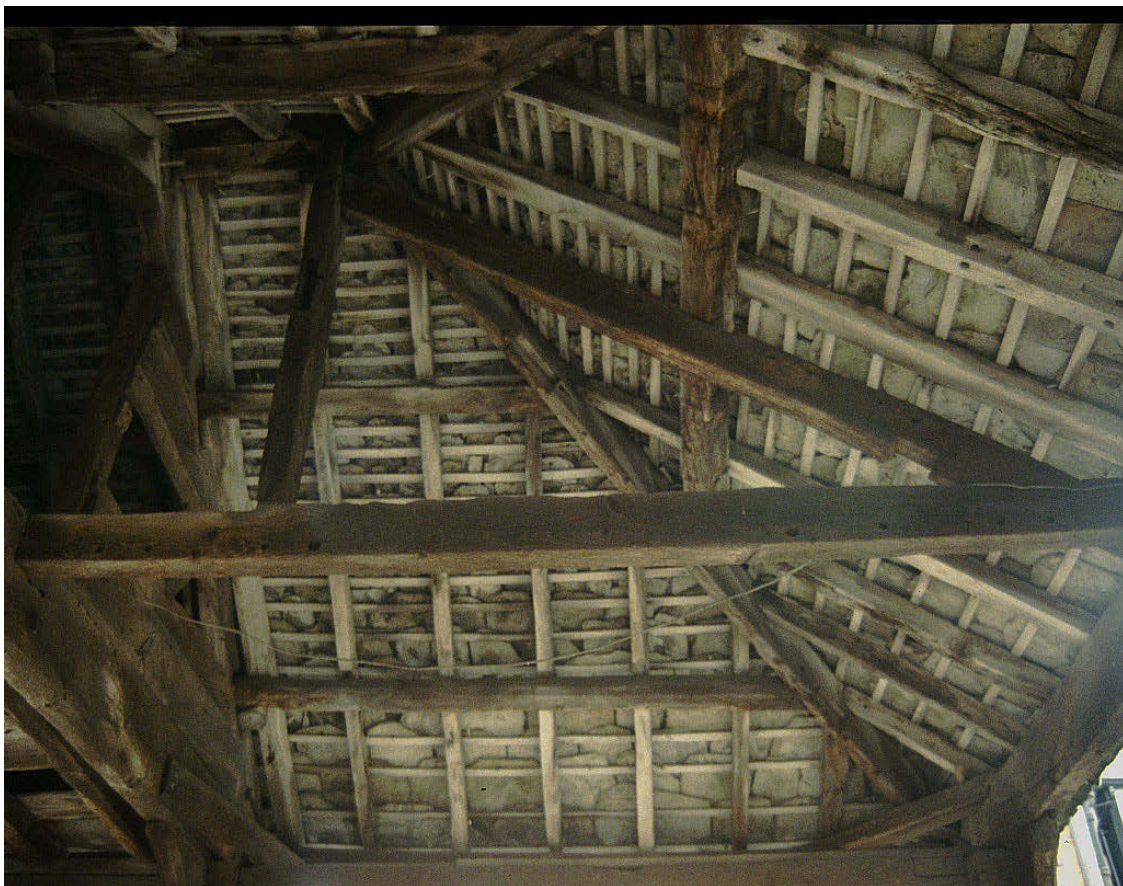
Plate 8: Half truss supporting hipped roof

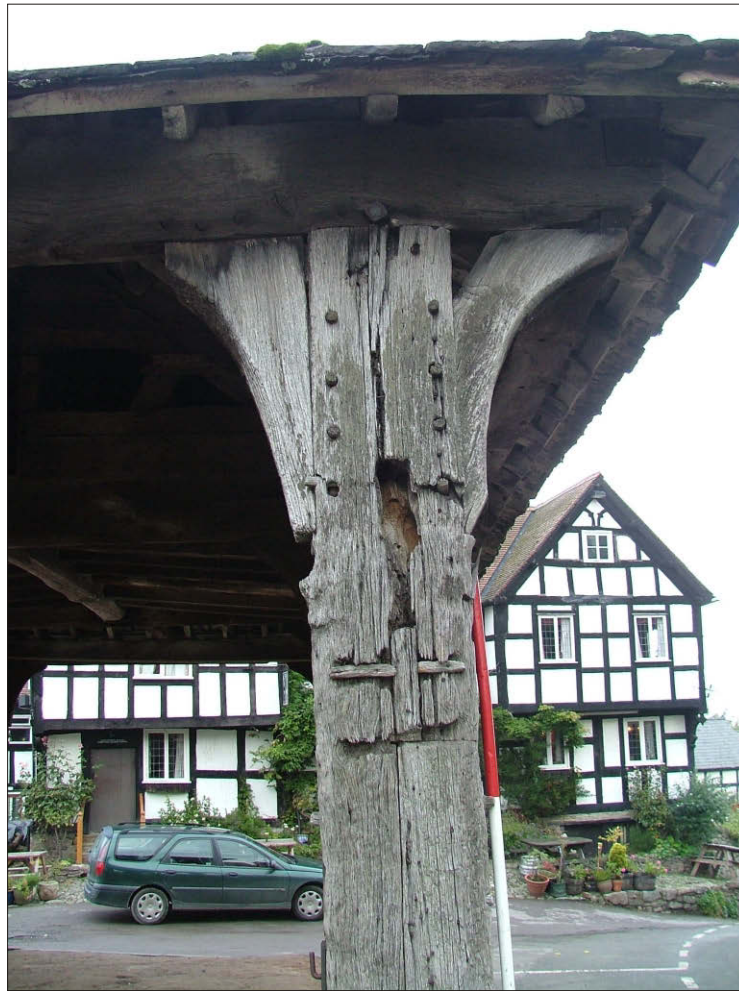
Each of the oak posts was chamfered, and decorated with moulded caps of cavetto and roll mouldings (Plates 9 & 10). Above the caps the posts supported curved brackets, tenoned and pegged into place. Each of the four inner posts supported four brackets, two providing lateral support for the tie-beams of the trusses (Figure 5 & 6) and two giving lateral support for the arcade plates (Figures 3 & 4). The four corner posts also had two brackets supporting the tie-beams for the end trusses, with a further single bracket on the inner face supporting the arcade plate. The four posts forming each side of the building were tied together by three arcade plates, which were tenoned and pegged into the tops of the posts.

remains of timbers which would have extended out from the sides of the Market Hall, possibly forming lean-to structures (Plates 9 & 10). The northern two posts each have a small notch high up on their north face, probably to house temporary supports during construction, indicating that these posts were the first to be erected (Figure 5).

Plate 9: South-east post of market hall showing Phase I and Phase IV replacement brackets together with mortice and tenon on external face

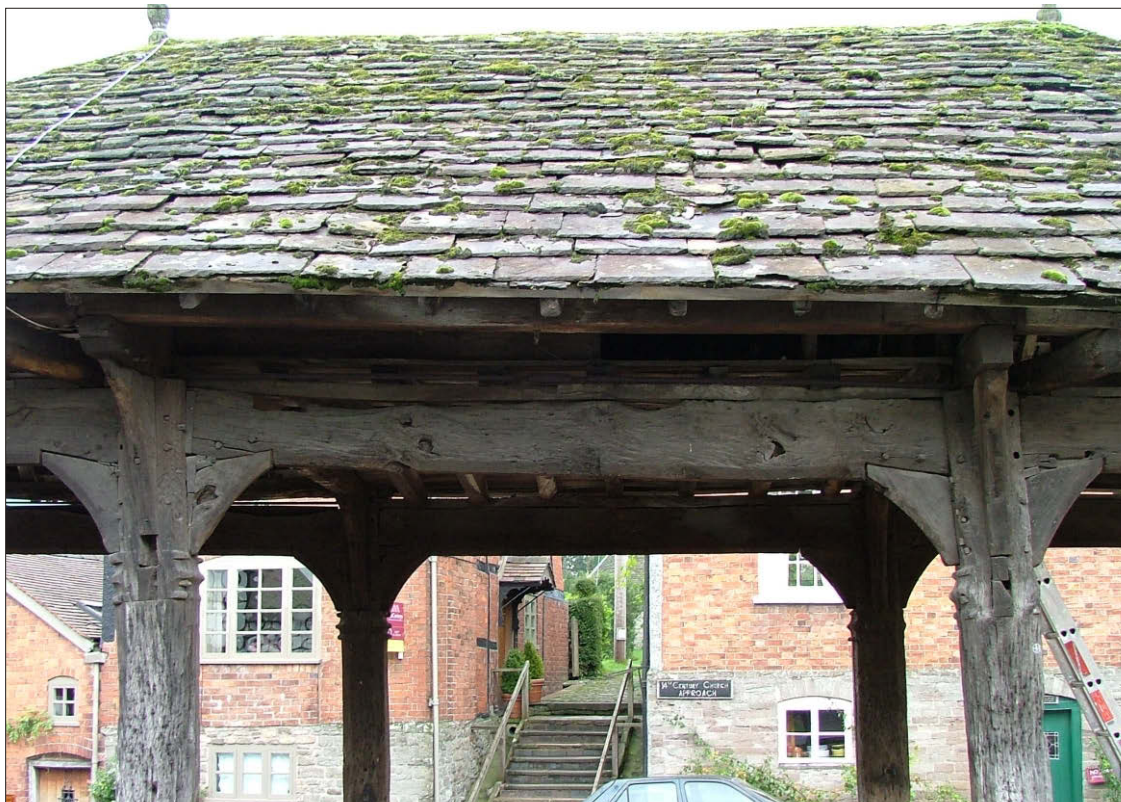
Plate 10: Remains of mortice and tenon joints in west faces of posts in the west elevation at the level of the decorative caps
