Birgham Haugh Steading

Birgham, Berwickshire

Historic Building Survey

for Douglas and Angus Estates

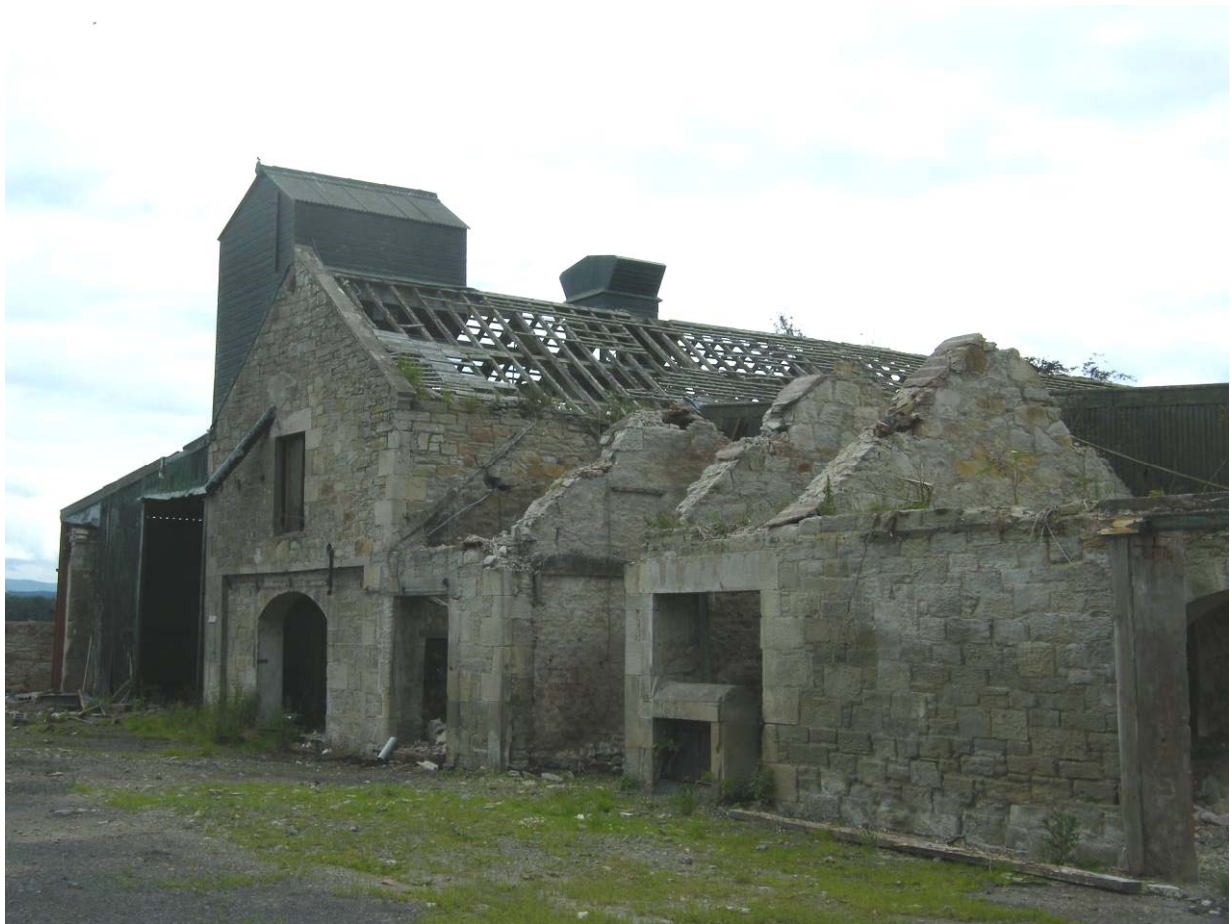
E exterior elevation of the steading complex, from the NE

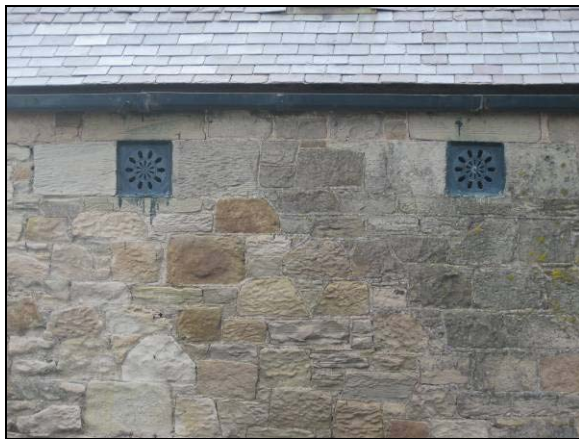
The north, street-facing façade is punctuated just below roof level with decorative iron vent grills which are set within openings defined by dressings (plate 1).

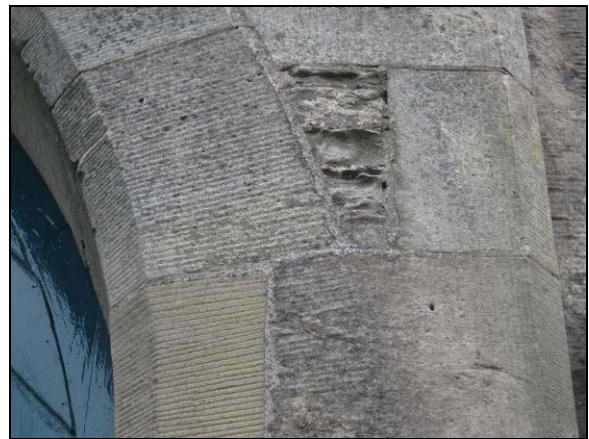
The main entrance is situated slightly to the right of centre. The gabled entrance arrangement breaks forward slightly from the general plane of the elevation. This is detailed with decorative chamfered corners and a plain shield in the centre close to the gable apex. The dressings defining the arched entrance itself have finely detailed broached tooling and a chamfer at the angle (plate 2). Paired painted timber doors are still *in situ*. The three other minor openings through this elevation have been blocked and plastered over, the latter detailed to suggest tooled stonework.

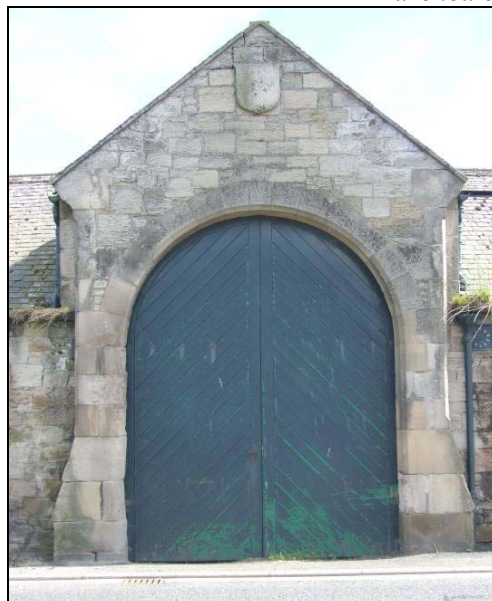
Plate 3 North elevation, main arched entrance

The mortar and indeed sandstone has been badly eroded up to around 1m from street level. There is however no evidence to suggest different phases of construction within the main façade.

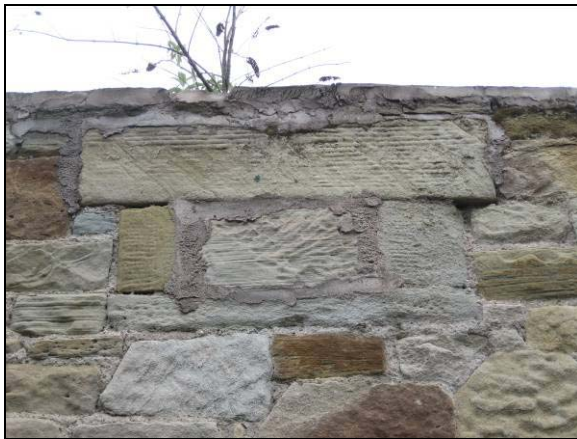
The west external elevation similarly appears to represent a single phase of construction. There are no longer any structures extant against the interior of this wall. The 1st Edition Ordnance Survey of 1862 shows a building along the western edge of the site adjacent to the lane, a more substantial building is also evident on the 2nd Edition of 1898, and later editions. The only features relating to this building are small blocked openings very similar to those housing the iron vent covers in the north elevation. They are also located at the top of the wall and have dove-dressed jambs, sills and lintels. They have been blocked with yellow sandstone pointed with lime mortar (*plate 4*).

Plate 4 West elevation, blocked vent hole

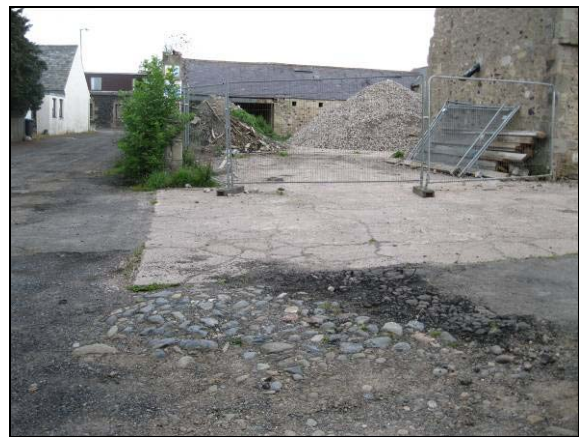
A small area of cobbles survives at the southwest corner of the steading complex; it is possible that similar such cobbles would originally have formed the surface for the entire courtyard (*plate 5*). The surviving section suggests the surface extended from the steading court to the adjacent lane.

Plate 5 South east corner of the steading court, cobbled surface

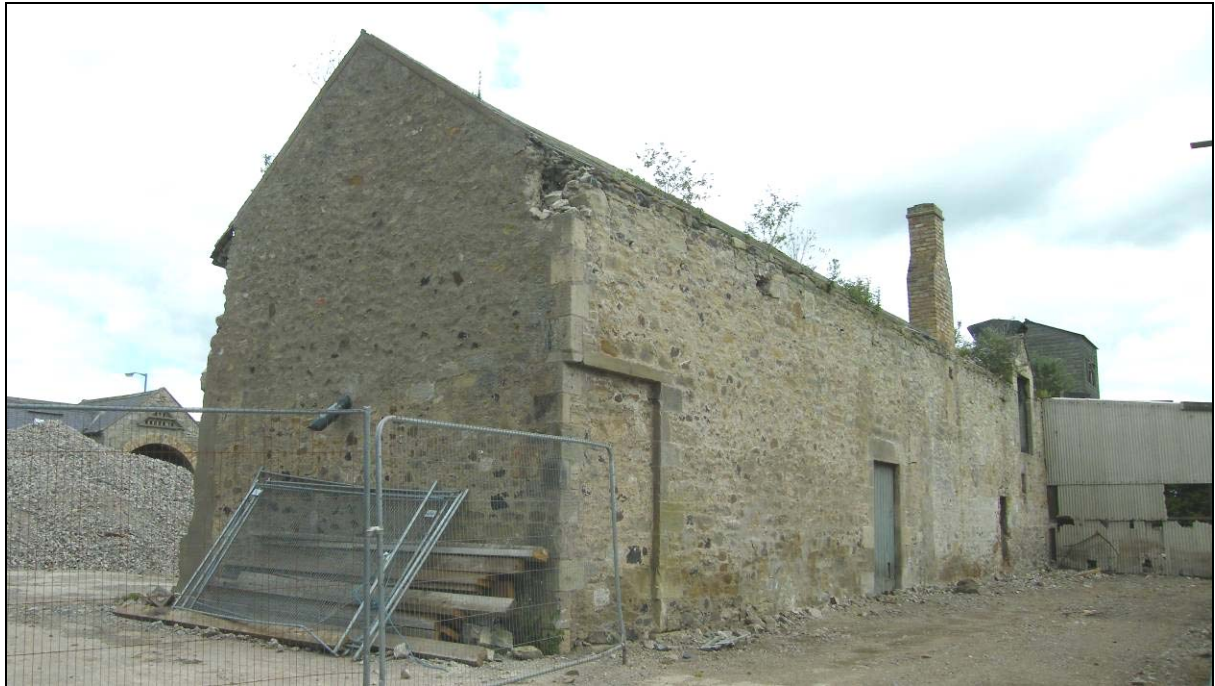
The south elevation faces onto the graveyard and beyond looking down towards the River Tweed, *plate 6*. Of the exterior elevations this displays the greatest complexity, with more than one principal phase of construction and several alterations in evidence. The arrangement of this elevation is clearly less decorative and more functional than either the north or west elevations. The openings are not symmetrically arranged and there is an upper storey with three windows just below roof height and a large dormer with double timber doors. Later lean-to structures with corrugated iron roofs and concrete floors have been built along this elevation; one is still extant. Steel joists have been inserted through the original wall to support these later constructions.

The main build is of squared yellow sandstone with dressed jambs, sills and lintels to match the other elevations. However the lower section of the wall extending up to a maximum of 1.5m is constructed from a mixture of materials, including a high percentage of river cobbles, mixed rubble, and yellow sandstone.

There are two possible explanations for this. This elevation had no principal entrance through it and was not visible from either the main road or the lane, therefore it may have been thought unnecessary to use the squared yellow sandstone for the entire construction. However if this was the case and the elevation is the result of a single phase of construction one would expect the building material to be more mixed, rather than there being a vertical distinction between the two build types. Therefore it

seems more likely that there was an earlier structure on the same alignment which was incorporated into the new south range of the steading. The random nature of the masonry of this initial building would suggest it may have been a boundary wall. There is no building indicated on the 1st Edition OS map of 1862.

Plate 6 general view of the south range of the steading complex, looking NE

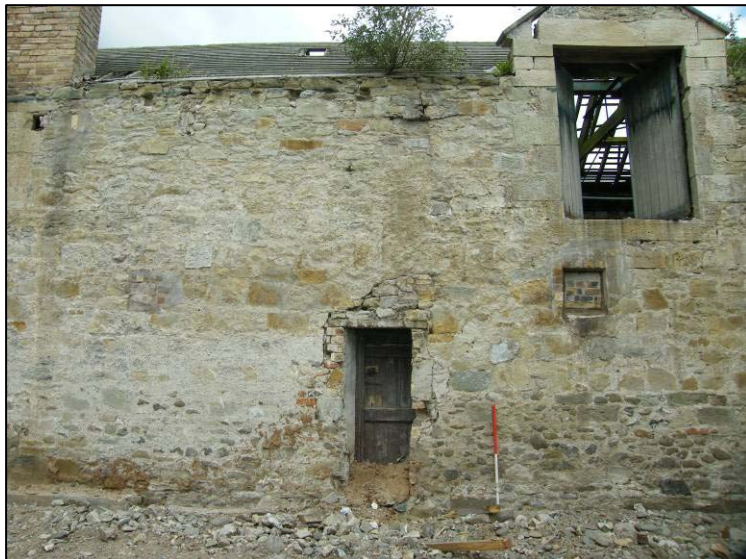
Plate 7 South wall of south range - change in build is visible to the right of the door

Further alterations include the slapping through of an oblique doorway (*plate 7*) to the right of the dormer window, and the addition of a brick chimney.

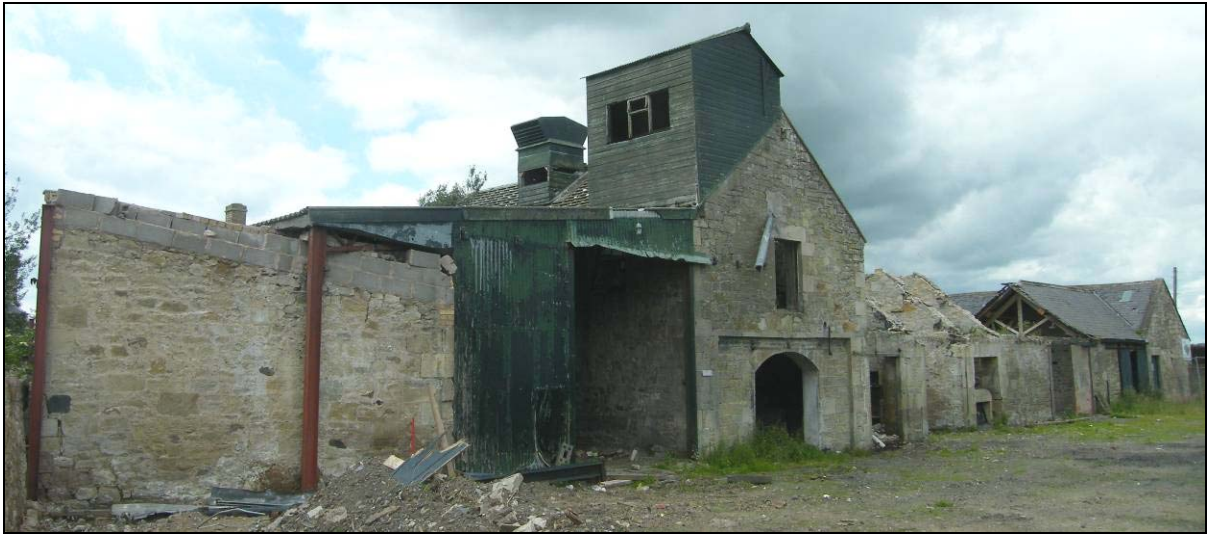
The east elevation which faces onto the rear of the farmhouse is the least uniform and most dilapidated of the external facades (*plates 8 and 9*). It is similar to the other external elevations in that the buildings are of yellow squared sandstone rubble, with dove-dressed lintels, sills, jambs and archways where present. However the overall impression is quite different due to the variety of structures, lack

Plate 8 General view of the east exterior side of the steading complex, looking NE

There was no differentiation in phasing in evidence within the masonry-built elements of the range. However the south end of the range had a large corrugated iron shed added in the 20th century.

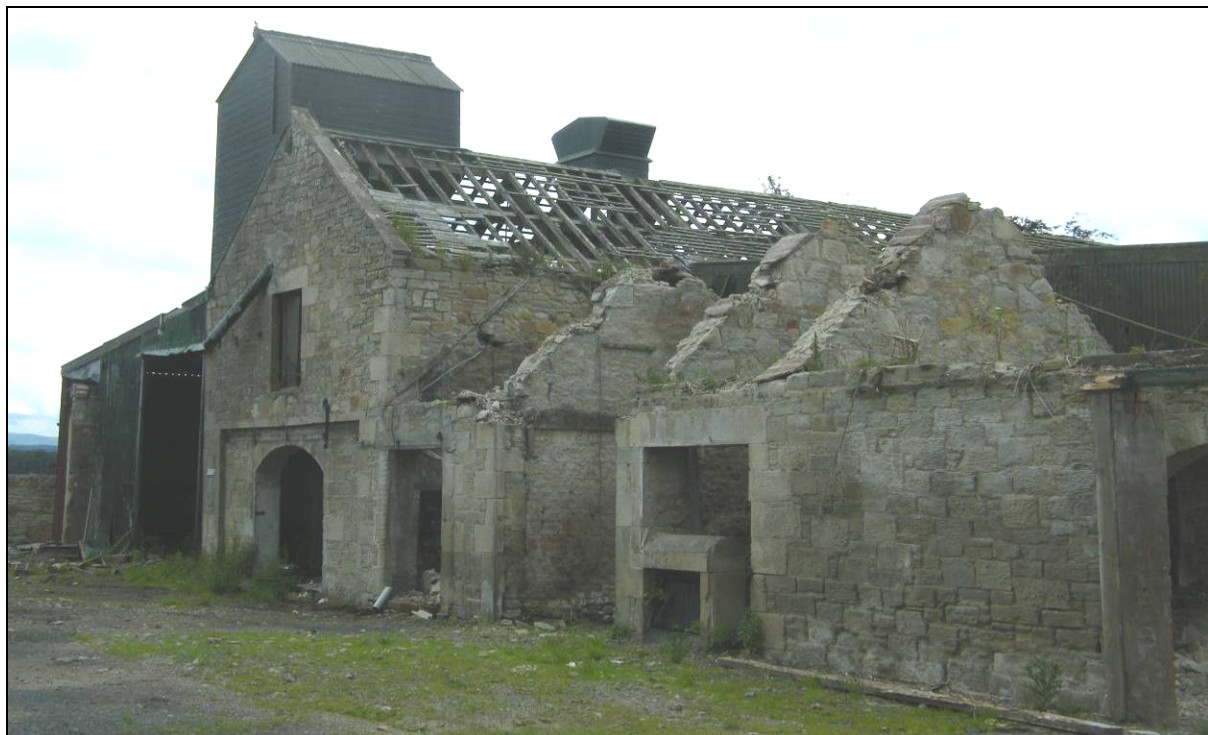
Plate 9 General view of the east exterior side of the steading complex, looking SE

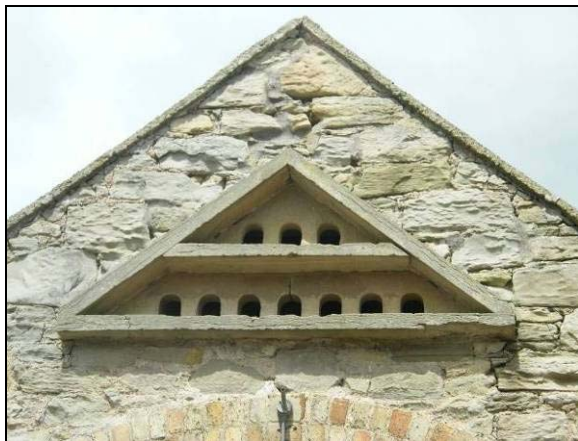
The north elevation of the courtyard is the most attractive, containing as it does the main arched entrance arrangement, this positioned to the left of centre (see *frontispiece*). Unlike the exterior arch, on the interior the opening is formed with cream brick. Above the arch are the openings into the pigeon loft above the entrance, *plate 10*. There are ten arched holes set within a pyramidal arrangement of projecting yellow sandstone cut slabs that also serve the function of alighting ledges.

Plate 10 detail of doocot entrance

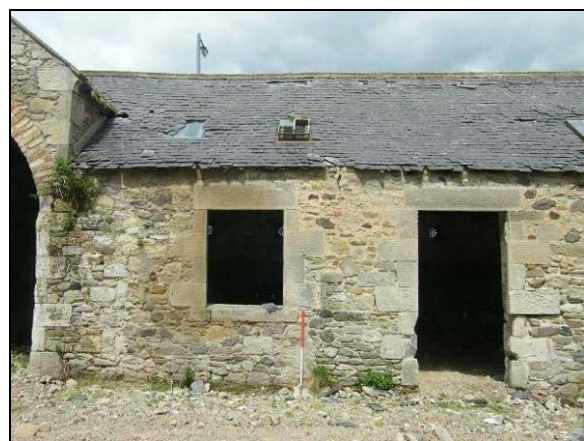
Plate 11 part of the south side of the north range

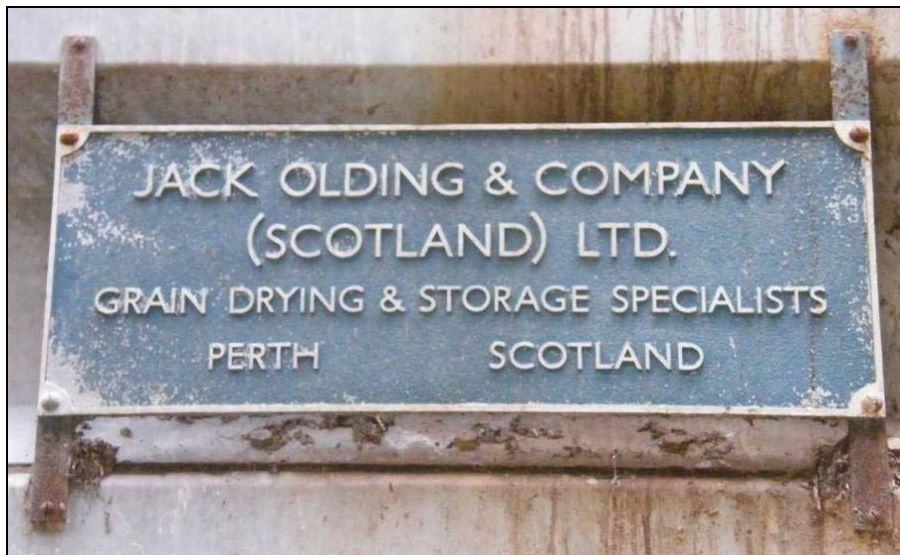
The south range has undergone some major alterations in order to accommodate the modern grain processing equipment which it still houses. Three of the original openings have been blocked with the remaining two, at either end being considerably narrowed. The western end of the range comprises a large open room whilst the east end is occupied by two large grain silos. A partial upper floor survives in this area, accessed from the south by the dormer in the south elevation. A plate detailing the manufacturer of the grain drying machinery was still present (*plate 12*).

Plate 12 plate on grain processing machinery

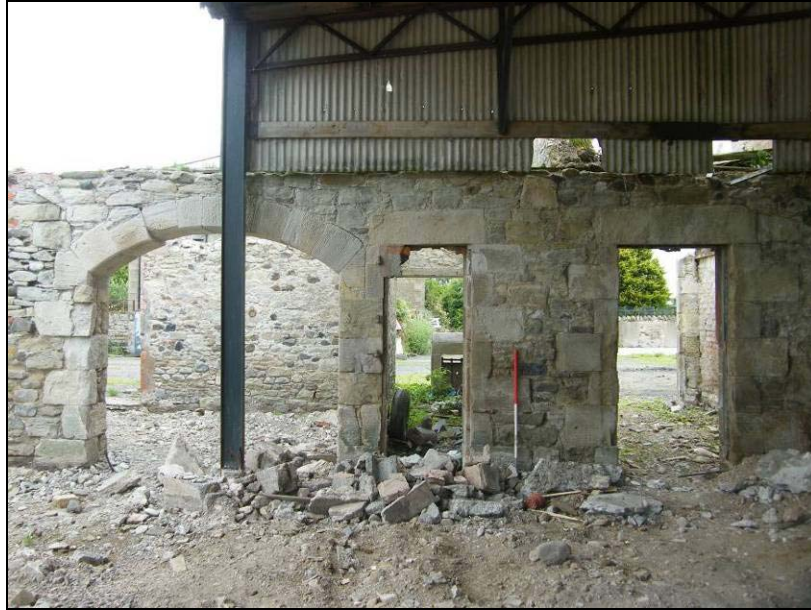
Plate 13

A large byre formed most of the remainder of the range with a small room at the north end only accessible from outside the courtyard. Evidence in the masonry and on the ground suggest that the byre was originally subdivided into two equally sized rooms which were only accessible from the interior of the courtyard (*plate 11*). At a later date this partition wall was demolished and a large opening knocked through to allow access from the east of the Steading.

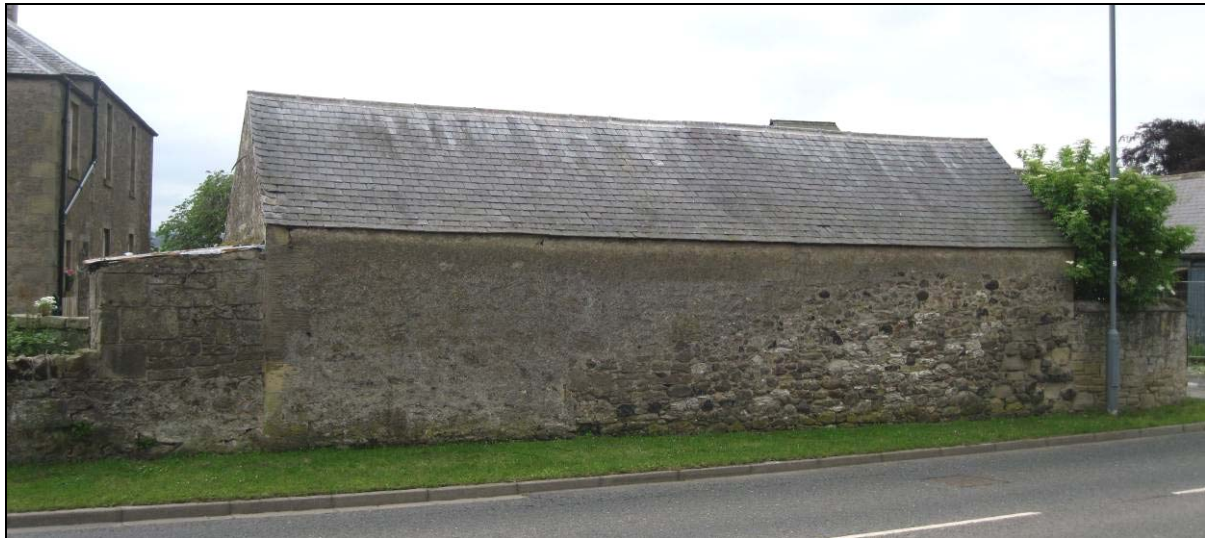
Plate 14 *general view of the rear of the bothy looking SSW*

The north elevation has no openings at present, and large parts of it are smeared with coarse lime mortar, *plate 14*. The bottom part has been heavily eroded causing damage to the stone and the pointing. There was however a broached dressed lintel and jamb which may have indicated a window or door which had been truncated and blocked, *plate 15*. There was also an indication of a joint or break in the masonry (*drawing S07*).

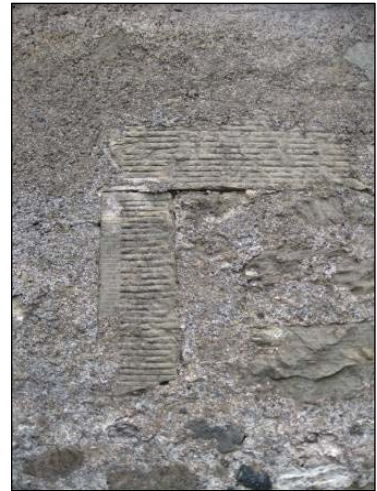
Plate 15 detail of relict dressings

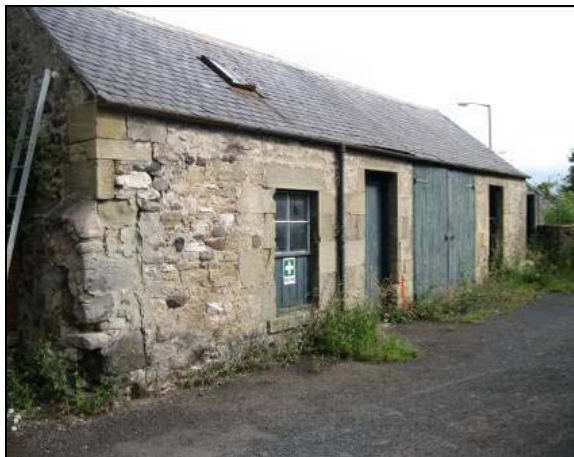
On the south façade the western end is built of poorer quality stone, with a high percentage of river cobbles, whilst the east end is predominantly built of squared yellow sandstone, *plate 16*. The latter suggests that the eastern end of the building was rebuilt, possibly around the time of the existing steading when yellow sandstone would have been readily available. At the western corner there is also evidence of a wall coming out from the main building, *plate 17*. The quoins indicate that this wall did not extend to the full height of the bothy, so may have been a boundary wall rather than part of another building.

Plate 16 south frontage of the bothy

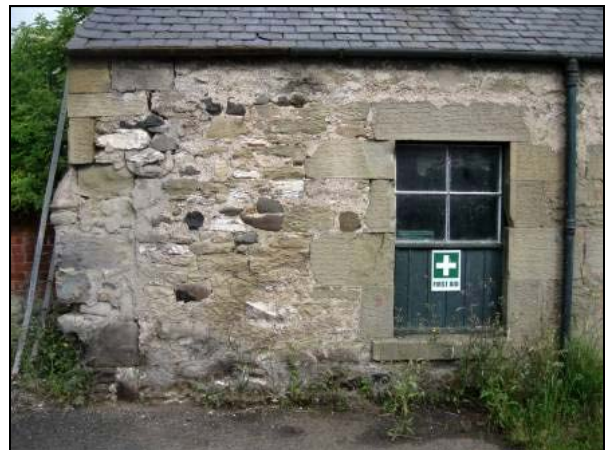
Plate 17 detail of east end of south frontage

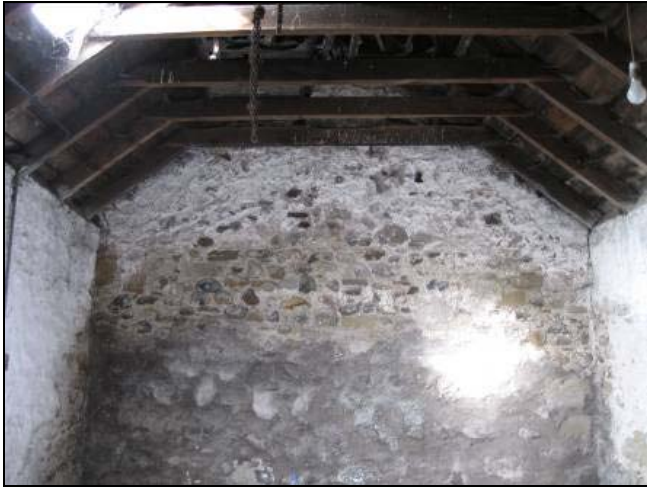
The interior of the bothy is currently a single large room, lit by a window in the east gable and one to the left of the doorway. The walls are largely obscured by mortar and white wash (*plate 18*), although it is possible to see where two partition walls would have originally divided the room into three (*plate 19*). Both of the partition walls are of similar thickness to the external walls. The westernmost partition wall demarcates a change in the height of the floor, which is now concrete.

Plate 18 general interior view, looking west

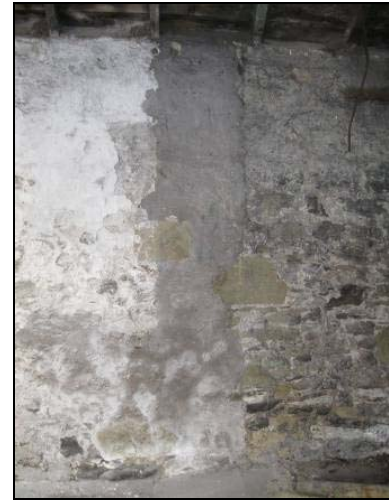
Each of the two end rooms would have been accessed by a single timber door from the south and had windows, as described. The central room had double timber doors. It was not clear if the rooms could be accessed from each other internally.

Plate 19 detail of partition scar
