Bishop Leighton's House

Culross, Fife

Historic Building Record

August 2012

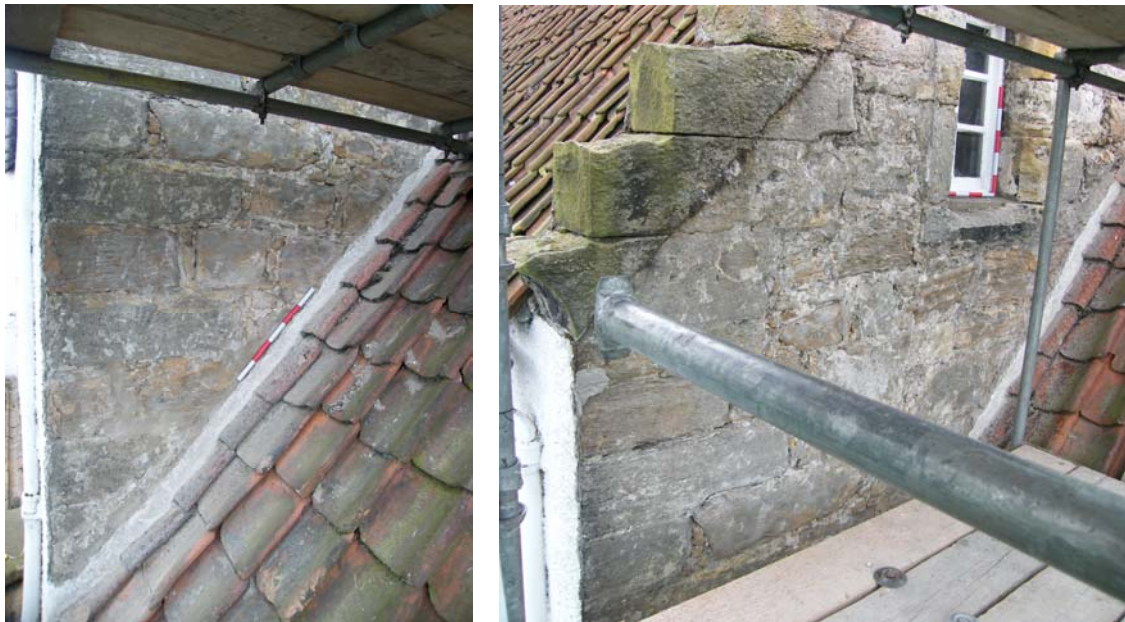
Lower west parts of gable (0.50m scale)

The masonry (024) of the gable is generally of large rough squared blocks of grey to buff coloured sandstone with the corner quoins of similar stone but better squared and neatly jointed. Between individual stones a number of differing lime pointing mortars were recorded, these were generally of a grey/white mortar with some small traces of more brown, grey and cream mortars representing patching over the years. Throughout the masonry small numbers of oysters are used as pinning's with a larger concentration noted below the sill stone of window 001.

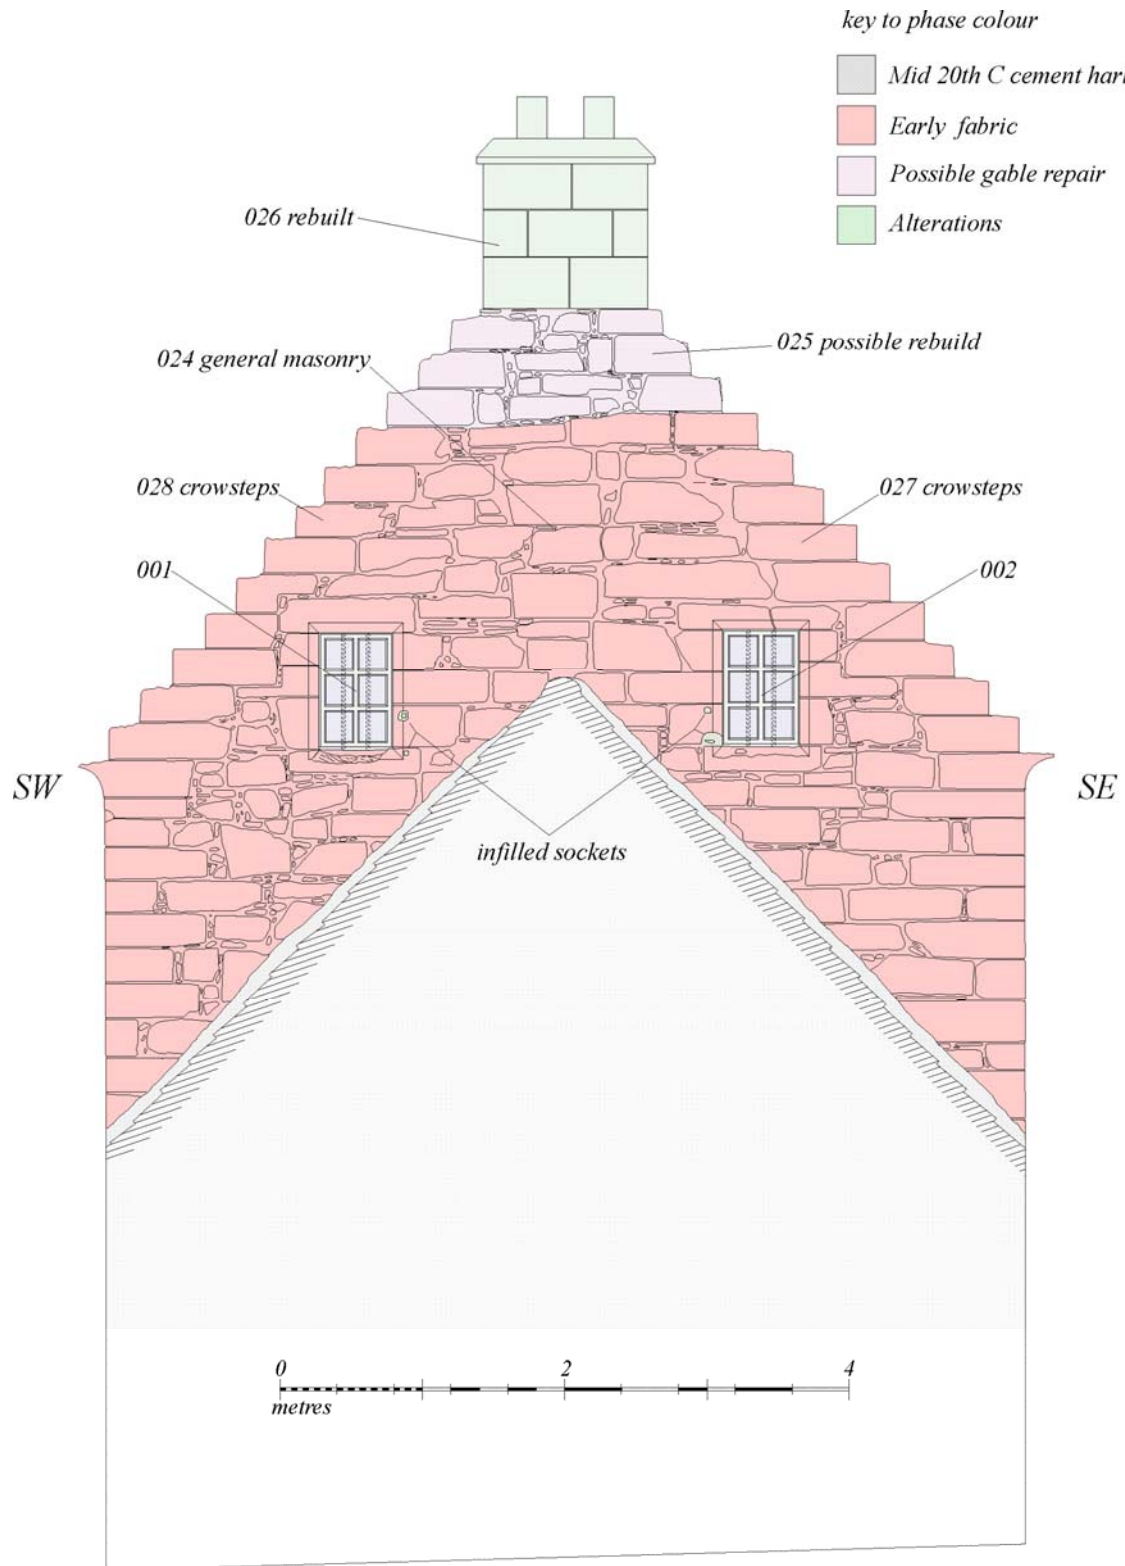
Bishop Leightons House : 7 Mid Causeway : Culross
Exposed Gable

The latest harl/pointing mortar that predates the cement harl application was represented by a hard greyish lime mortar sitting flush with the surface of the stones and forming a good base for a harl or limewash on top of this. This survived in small areas on the upper gable.

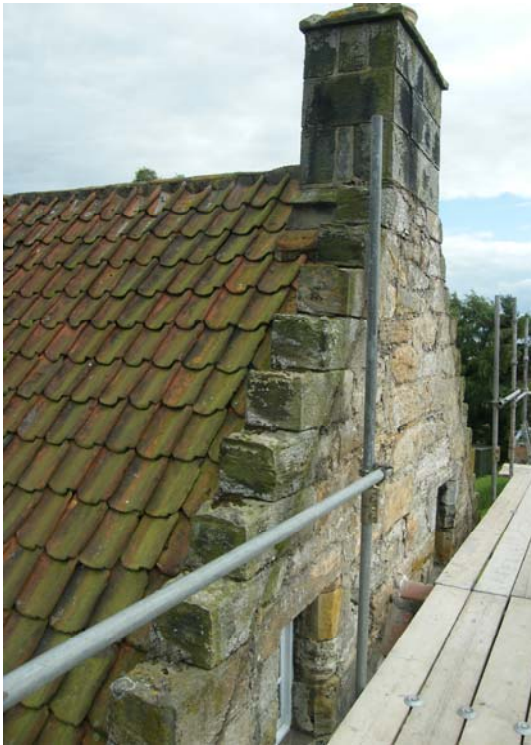
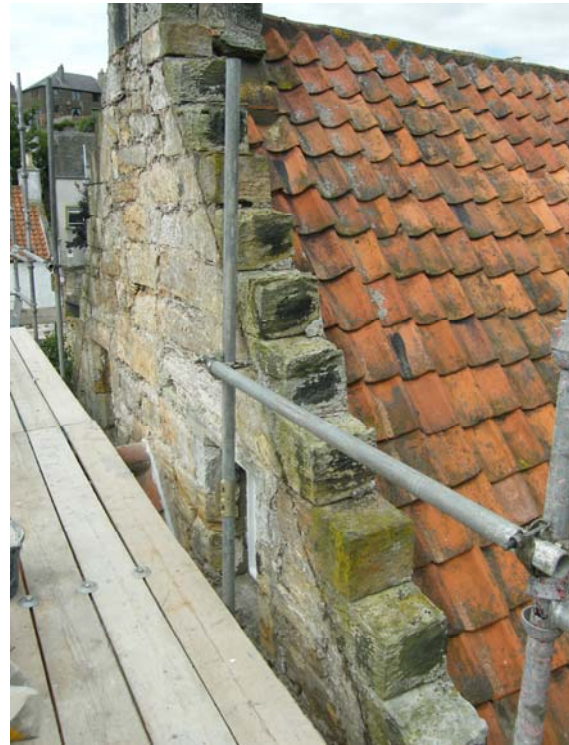
The crow-steps were deeply eroded on most of their upper surfaces but otherwise were in good condition. These were well formed from long rectangular squared sandstone blocks. The skewputt to the street frontage is on its underside carved with a date at the top, possibly 1565, and three letters below – apparently *D C A*; this stone is somewhat weathered and its nosing damaged. By contrast the rear skewputt is unadorned.

Upper parts of gable looking east (crow-steps 028) and then west (crow-steps 027), the masonry (025) associated with the top 3 crow-steps can be seen to differ in character from the main body of masonry below

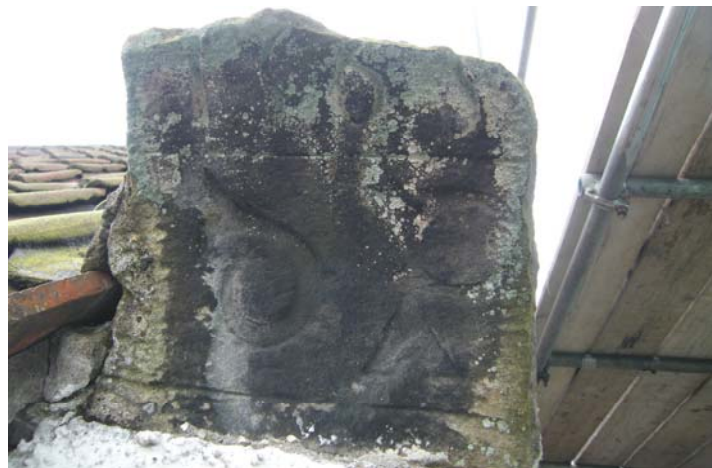
View of underside of skewputt on 028 showing date and carving below

An historical study, particularly of burgh records, would be an important addition to the understanding of this building. The initials on the dated skew-putt can likely be identified and, if so, may provide corroboration of the apparent date.

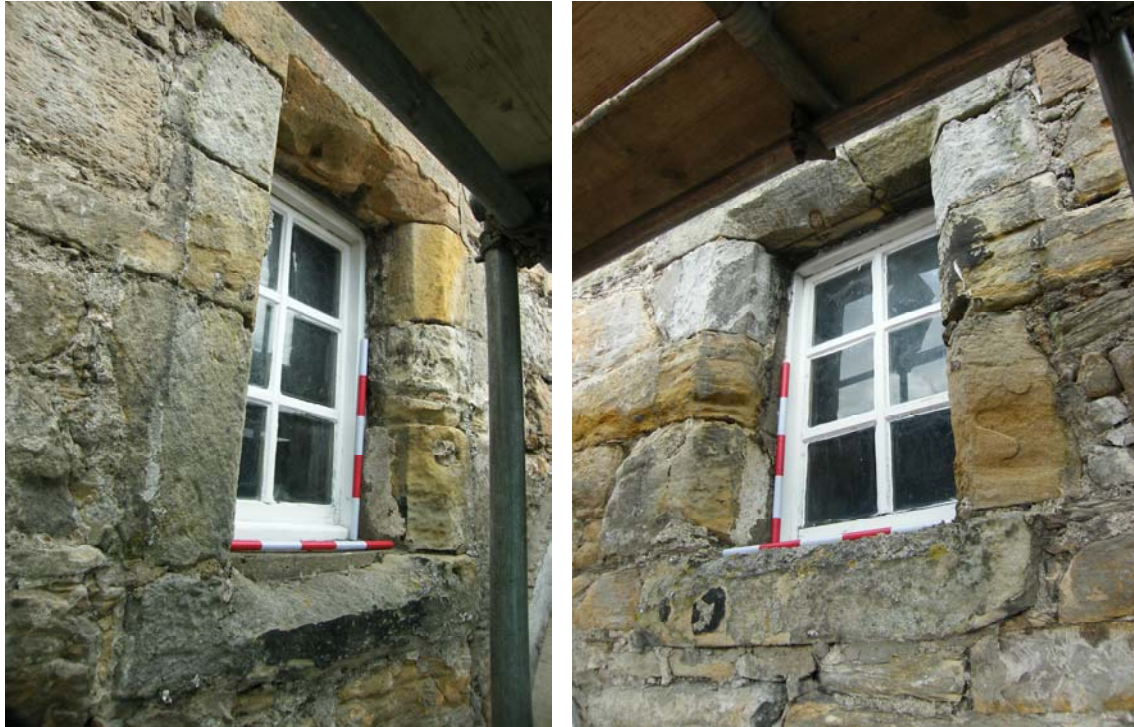
West (001) and eastern (002) window with cut sockets in the lower mid 2 jambs (0.50m scale)

The windows are of similar size and character and appear to be original to the gable masonry. In each the tail of the middle, outer jamb-stone had been indented to accommodate an adjacent crow-step. The dressings were of grey to buff sandstone, detailed with a wide chamfer on all four faces and a raised margin. Both windows have well preserved sockets in the lintel for 2 diamond-set vertical iron bars and, behind the line of these, a glazing groove. This glazing groove extends across the lintel and down the jambs, and, evidently onto the sill stones. The latter were partly obscured with later cement patchings but a small segment of the groove could be made out on the sill of 002 (as well as 2 patched up bar sockets). Upon the lower part of the inner jamb of each window had been cut pairs of rectangular seatings that had subsequently been in-filled with lime mortar. To what these seatings related remains unclear.

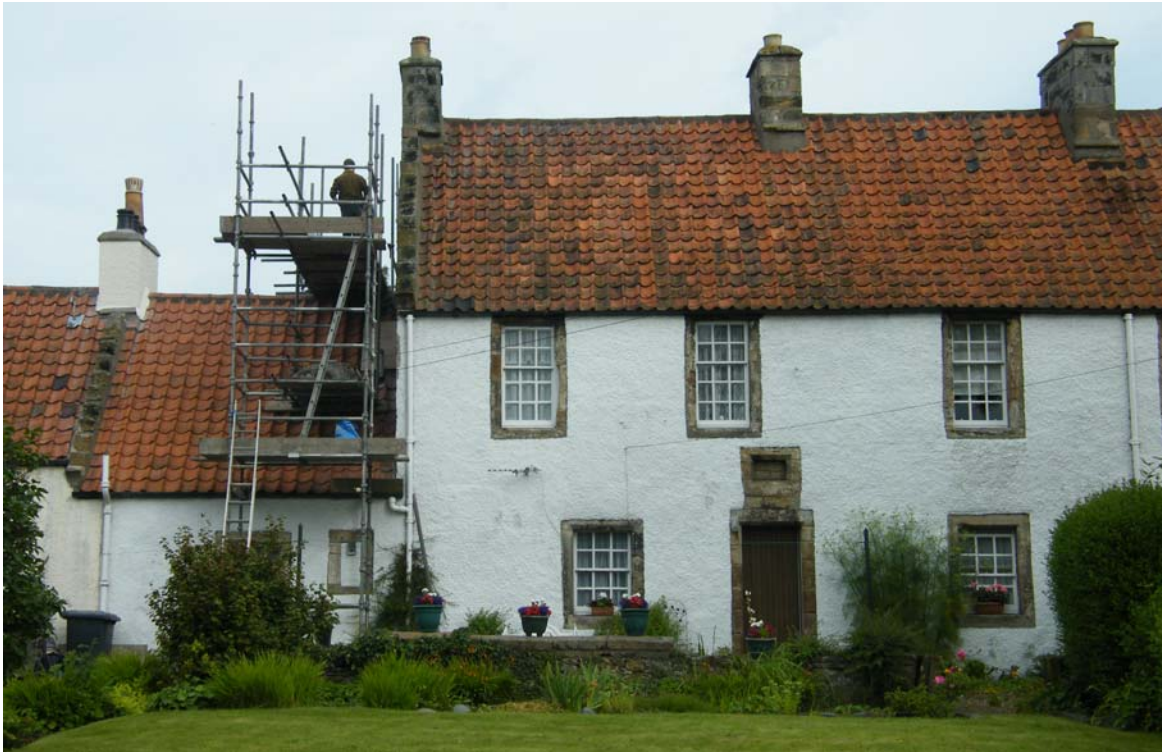
General view of the garden frontage

This elevation is still largely obscured by a thick cement harl with only the margins of the openings left uncovered, this was surveyed at 1:20, with all visible diagnostic details recorded. With the existing harl in place no authoritative interpretation of the evolution of the elevation can be attempted. However the exposed margins of the openings do show evidence for some complexity, for example entrances that are part blocked up to form windows. The following offers some brief notes on observations of the visible features.

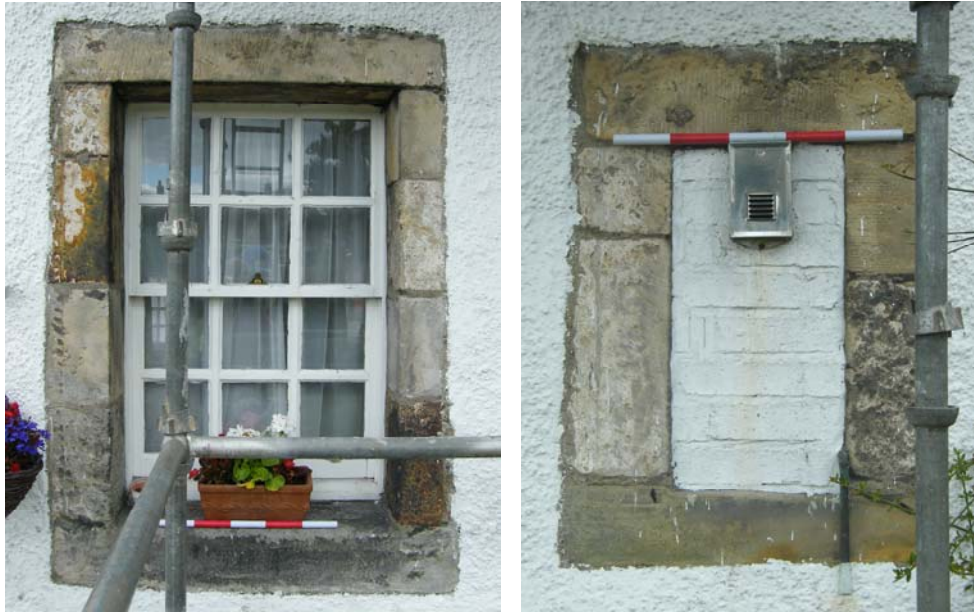
Window 003 is centrally set on the rear elevation of the 1½ storied south extension to the main range (measuring 0.78m by 1.27m). The jambs are of plain square sandstone of a couple of differing types, either the window is built reusing old jamb stones mixed with newer ones (possibly inserted?) or the jambs have been repaired. The “original” jamb stones show some weathering and have traces of lime harl and limewash on the exposed faces. A 12cm wide margin was formed around the edge, the stonework beyond lightly tooled back; the tooling of the margin and beyond is generally diagonal. The “repair” stones show little erosion and are of a fine light blond sandstone with no traces of lime harl, these are associated with more random, fresh, toothed chisel marks; some of the original stones show some limited reworking with a toothed chisel

Opening 004 is a small blocked window (0.30m by 0.62m), infilled with cemented brickwork, painted over. The jambs are plain and square, as in 003, and, similarly, some of the stones appear to be replacements, with toothed chiselling on the faces. Some stones display a raised margin. The lintel may be a worn old stone re-tooled with the toothed chiselling perhaps indicating these openings are built from a mix of reused and old stone. This may have been work of the mid 20th century.

Openings 003 and 004 (0.50m scale)

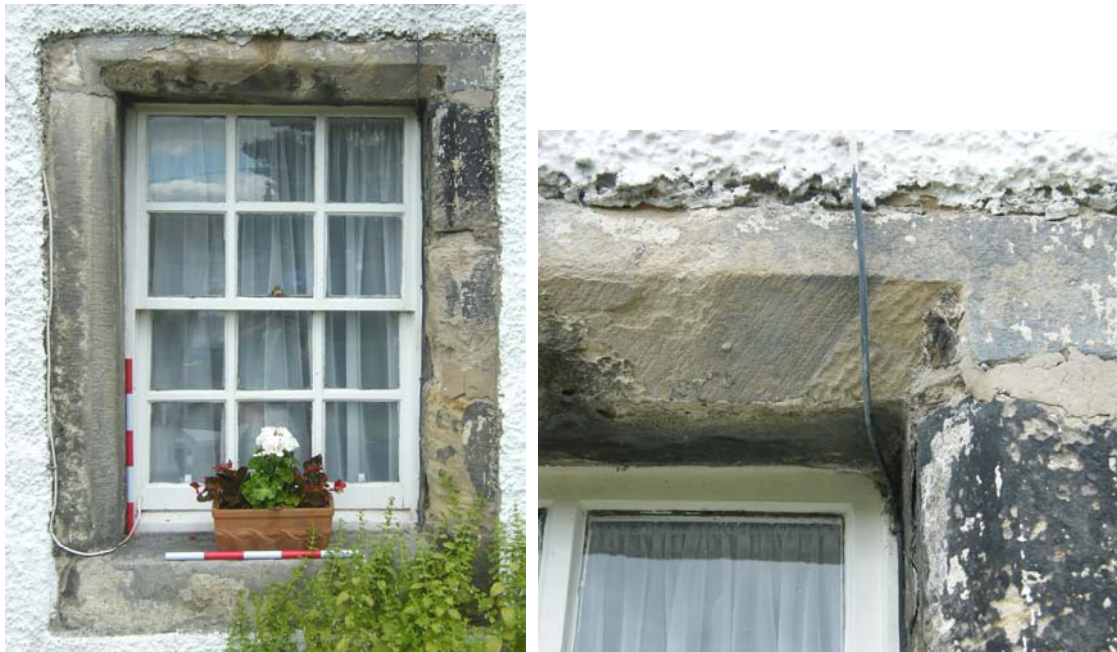
Opening 005 has seen some modification; the northern jamb is likely to be the *in situ* remnant of an older opening, possibly an entrance or a low-silled window. The individual dressings are eroded but retain a wide chamfer in places, this continues below the current sill to an unknown extent. The lintel may relate to this original opening though its chamfer has been extended on its north side and the stone evidently re-set. The opening was apparently widened to the south and formed into a window; the southern jamb (a single vertically-set stone) and the sill are later insertions. The tooling on the southern jamb is neat and horizontally aligned, this in contrast to the diagonal tooling surviving on the lintel

Opening 005 (0.50m scale); detail of modified lintel

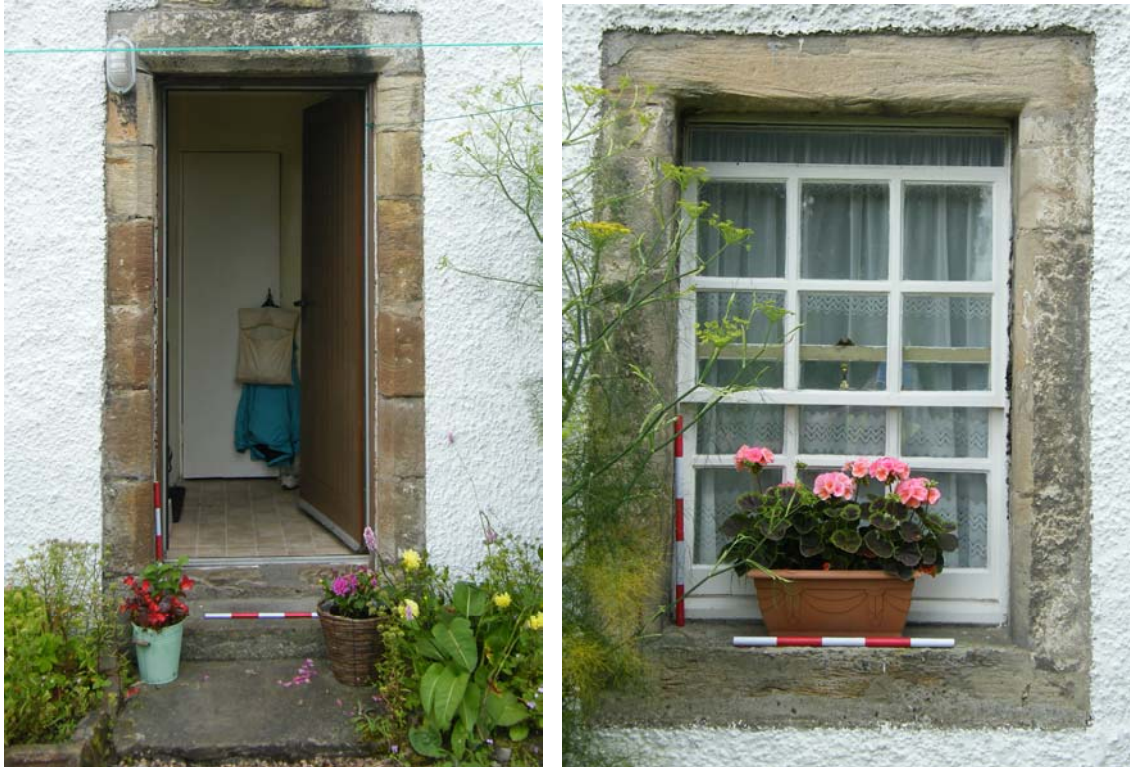
Opening 006 is the existing entrance to the rear (0.84m by 2.20m). Its dressings are detailed with a wide chamfer that terminates at a simple stop at door step height. The stones are of a rusty buff colour with the upper two jamb-stones on either side and lintel of a lighter coloured sandstone (possible replacements?).

Opening 007 is currently a window whose dressings are detailed with a narrow chamfer. The jambs and lintel are of a blonde sandstone. The chamfer continues below the level of the existing sill stone, which is a secondary insertion; this is set between the jambs but is not tied in. The exterior faces of the jambs show traces of a lime harl which ran up to the chamfer and in places onto the chamfer. The lintel is of a softer sandstone than the jambs and is more eroded

Entrance 006 and opening 007 (0.50m scale)

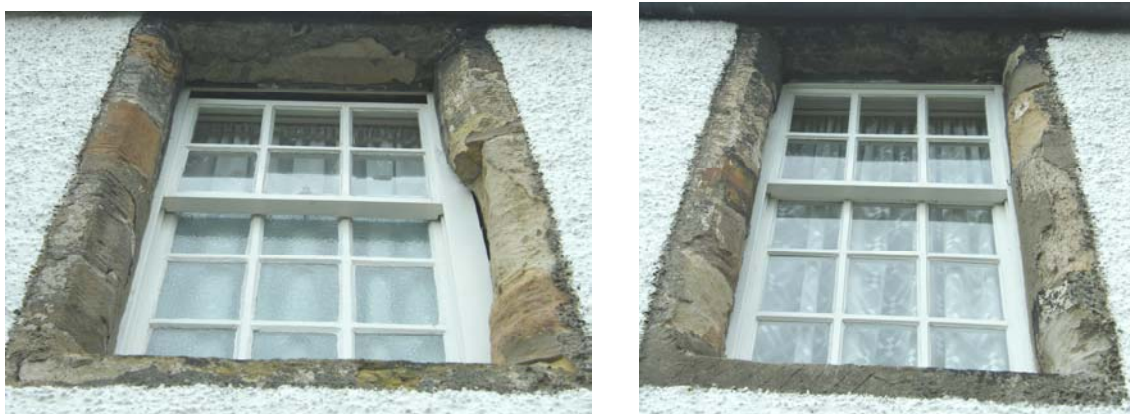
Windows 008 and 009

Opening 008 is the first of three first floor windows (approximately 0.80m by 1.50m). These are detailed with a wide chamfer that extends onto the sill. No evidence for bars or glazing grooves could be seen from the ground. The dressings stones are a mix of blond sandstone with a couple of a rusty-buff hue; the lower north jamb is heavily eroded. The further two window openings, 009 and 011, are of very similar detail, with many stones eroded and patched up with cement.

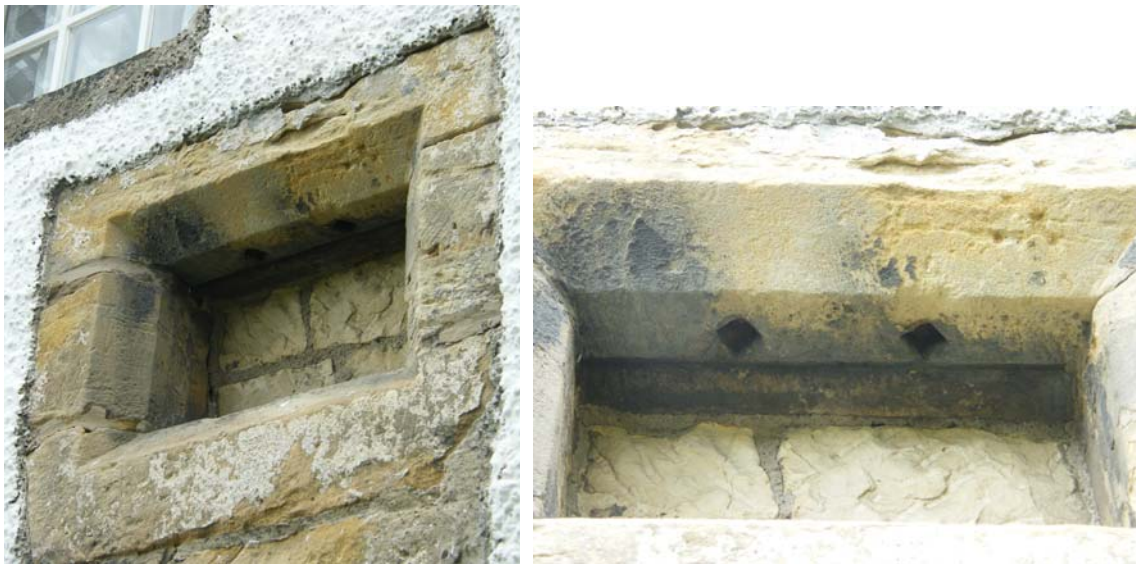
Opening 010 is located above entrance 006 (measuring 0.46m by 0.30m). Its dressings, of blonde sandstone, are detailed with a wide chamfer on all four sides; paired sockets for two diamond-set vertical bars remain, and a glazing groove is visible in the lintel. These dressings are generally less eroded than many of the apparently original jambs of the surrounding window openings; rather than suggesting this to be a secondary feature it is possible that the opening had long been blocked, and possibly re-opened during the mid 20th century works. Unblocking at this stage is suggested by the presence of the existing recessed cement-bedded squared rubble infill. Though curiously positioned above the entrance, the opening evidently provided the only lighting for the diminutive vestibule area within. Some traces of lime harl/wash survive on the exterior face.

Opening 010 above entrance 006 and detail of bar holes and glazing groove

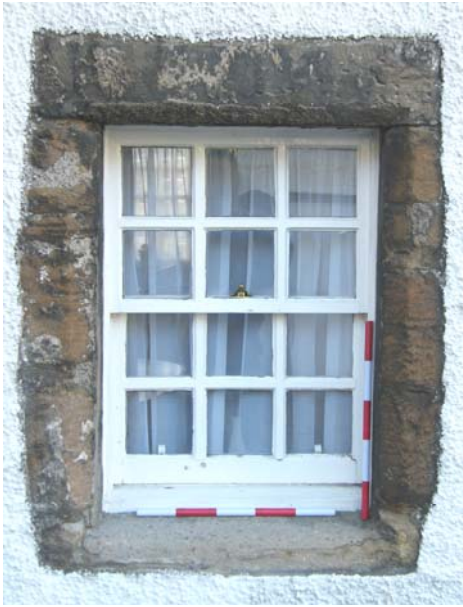
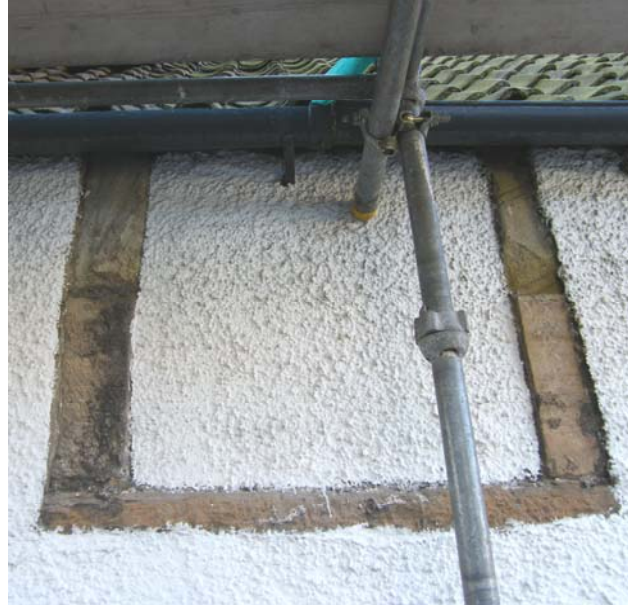
Openings 012 – 014 occur within the 1½ storied range extending out from the south gable wall of the main building. 012 is a window (0.66m by 0.95m) detailed with a chamfered lintel and jambs. Traces of lime harl overlies the jambs and continue onto the chamfer. The sill has seen some cement repair; otherwise the opening seems to be in tact. 013 is a blocked opening at the upper level (approximately 0.80m by 0.75m internally though only the margin up to a chamfered edge is visible - the real dimensions are smaller), whose chamfered surround is now partly obscured. The southern jamb stones are less eroded than the north though these appear to have similar diagonal tooling.

Opening 012 and blocked up 013 (0.50m scale)

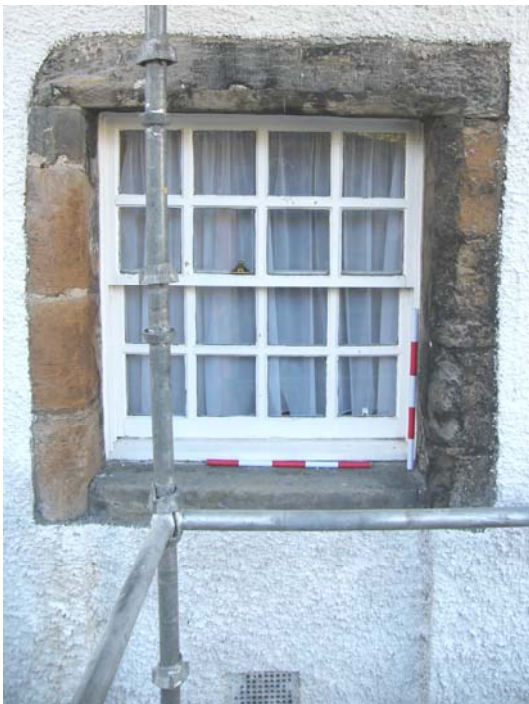
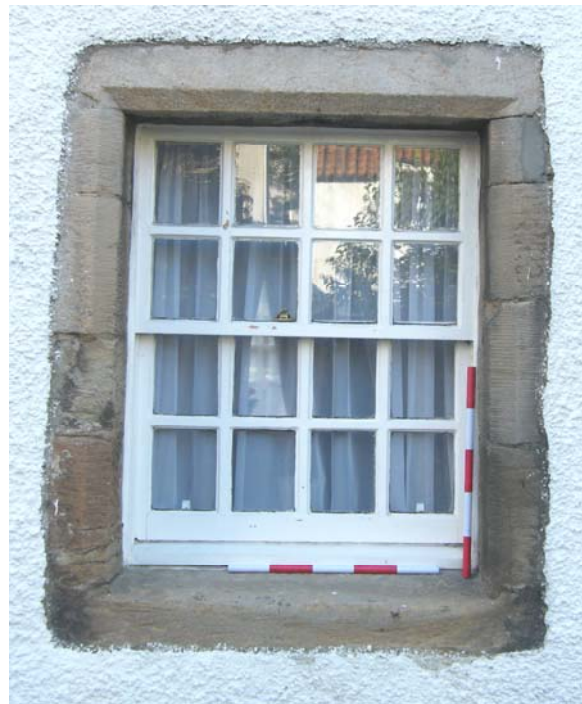
Openings 014 and 015 (0.50m scale)

Opening *014* appears to have been an entrance; this is now part-blocked to form a window. The exposed dressings are detailed with a chamfer. The lower half of the entrance is in-filled with the infill somewhat recessed to leave the outline of the lower jambs visible. The window sill stone abuts jambs on either side. Opening *015* is a window (0.66m by 0.95m) with chamfered surround to the lintel and jambs. Where visible the dressings mostly display horizontal tooling.

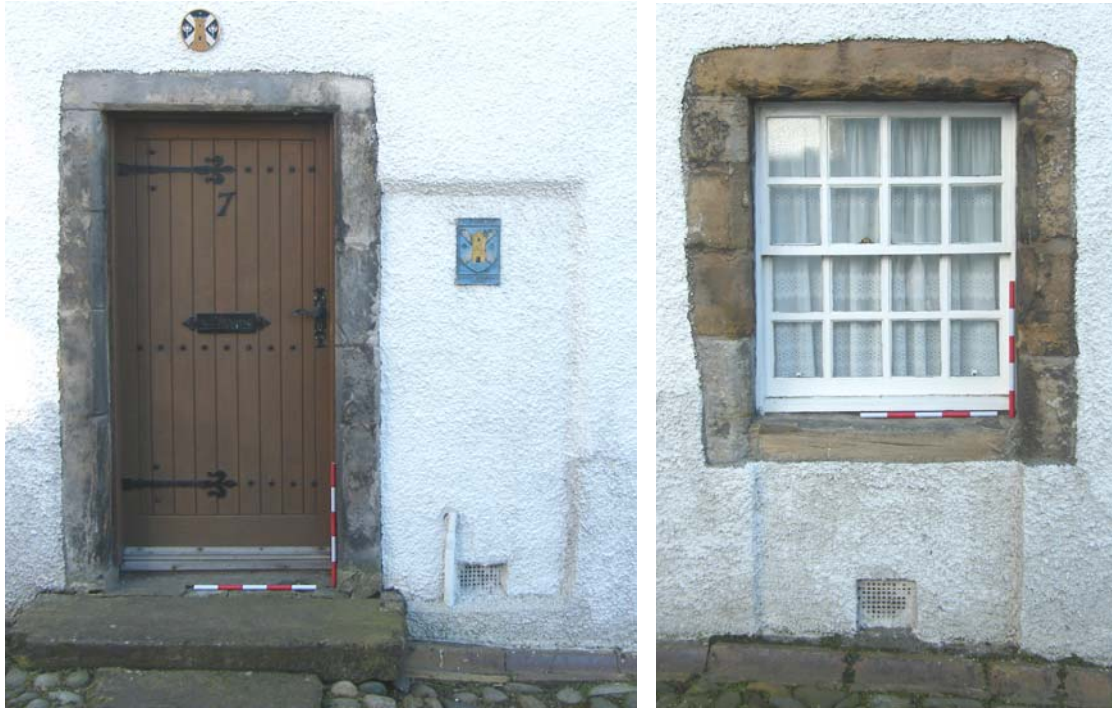
Blocked opening (?) 016 and entrance 017; and part-blocked entrance 018

Feature 016 is an apparent blocked opening visible as a recessed area within the cement harling of the frontage. This appears to represent the southern jamb and lintel of an entrance, detailed with a chamfered surround - possibly a predecessor of entrance 017 to its immediate north. On a monochrome photograph of 1953, at which stage the building is without harl, the jambs of the opening can be made out. On the interior a cupboard has been made within the ingo of the former entrance. Opening 017 (0.92 x 1.95m) is the existing principal entrance to the building off Mid Causeway. This is possibly a secondary insertion, in part truncating the north jamb of entrance 016. The jamb and lintel have a narrow chamfer and show traces of lime harl on the face continuing onto the chamfer. Opening 018, like 014, appears to have been an entrance that was later part-blocked to form a window. The sill of the window abuts the jambs on either side; the blocking below is recessed back from the surrounding wall face.

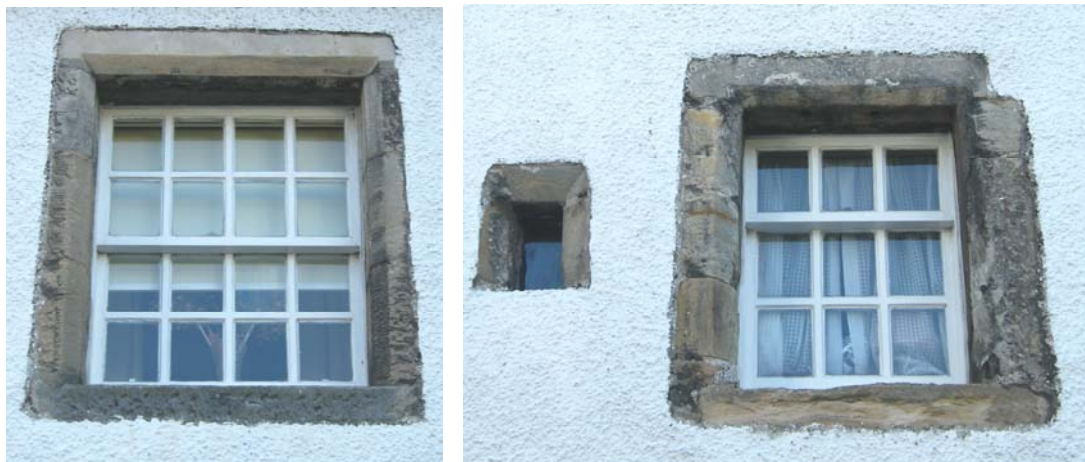
Opening 019 and 020 with small 021 to north

Opening 019 is a window (0.80m by 1.06m) with a chamfered surround; on the jambs horizontal tooling is visible. Opening 020 is a somewhat smaller window with chamfered surround (0.63m by 0.83m). The stone is more eroded than that of 019; small traces of lime harl adhere to the face and continue round onto the chamfer on the lintel. The lintel has 2 diamond-set sockets for vertical bars. The lintel is off-set to the north, however its chamfer corresponds to those of the jambs; it is possible that this opening has been widened. 021 is a small glazed opening with a wide chamfered margin, a possible single bar-socket is visible on the lintel.

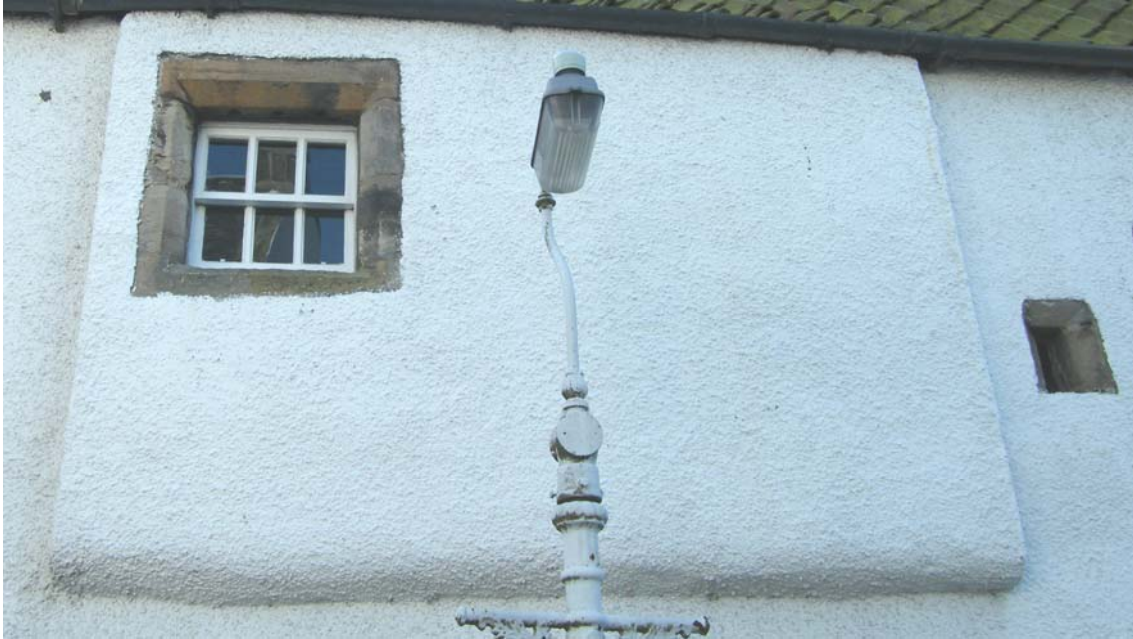
Window 022 within corbelled out masonry 023

022 is a small window (0.68m by 0.53m) within an area of corbelled out masonry, 023. Detailed with a wide chamfer, sockets for 3 vertical bars can be made out on the lintel. 023 is an area of corbelled out masonry currently covered over with cement harl.

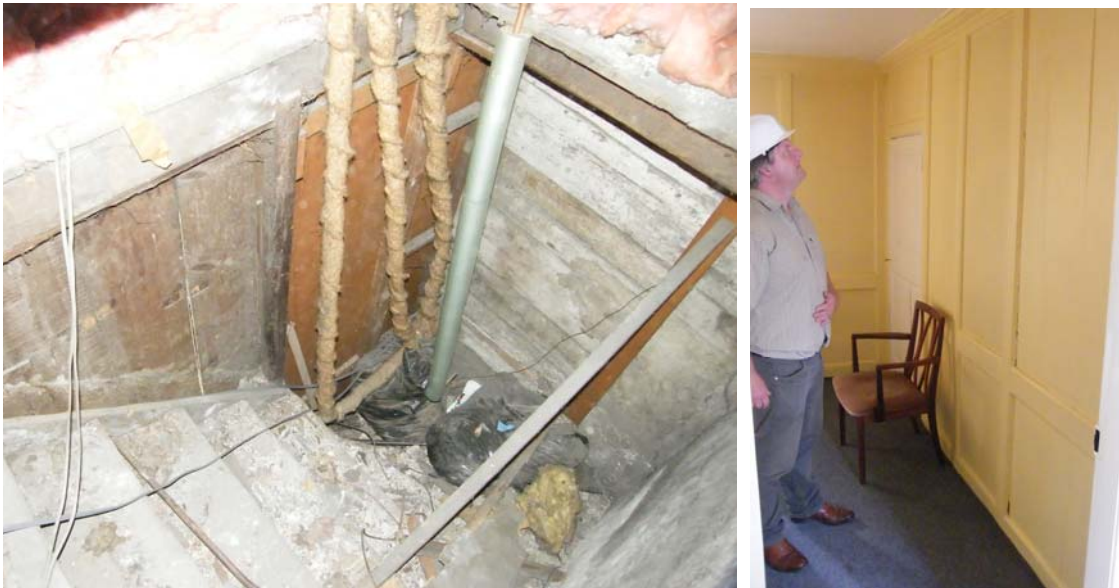
The main feature of interest visible within the roof-space was the stair that had formerly provided access to the loft area. This well-preserved feature directly corresponded to the position of the stone stairs rising from ground to first floor level. However, unlike the stone stair (which rises from west to east), the lower part of the timber stair was accessed from the first floor chamber to the south. This room – now subdivided to form a bedroom and bathroom – is panelled throughout. The panelling on its north side is in part modern work, of hardboard, though well matched to the original. Here there had existed an entrance to the loft stair that was perhaps detailed with a semi-concealed door to match the surrounding panelling. Within the roof space the interior of the stair is mostly visible and in spite of some obscuring debris, the lower stair treads clearly turn the angle to the south to meet the entrance.

The treads as seen in the limited exposure appeared to be plain timber, better access and a clean up may reveal more details. The underside of the stair is plastered over and forms the ceiling to the lower stair; this ceiling also demonstrates the turn of the lower treads. The interior of the upper stair is timber-lined to the west and south, the latter being the rear side of the room panelling.

Detail of the Stairs up to the attic, shows blocked up door and examining other side of blocked door

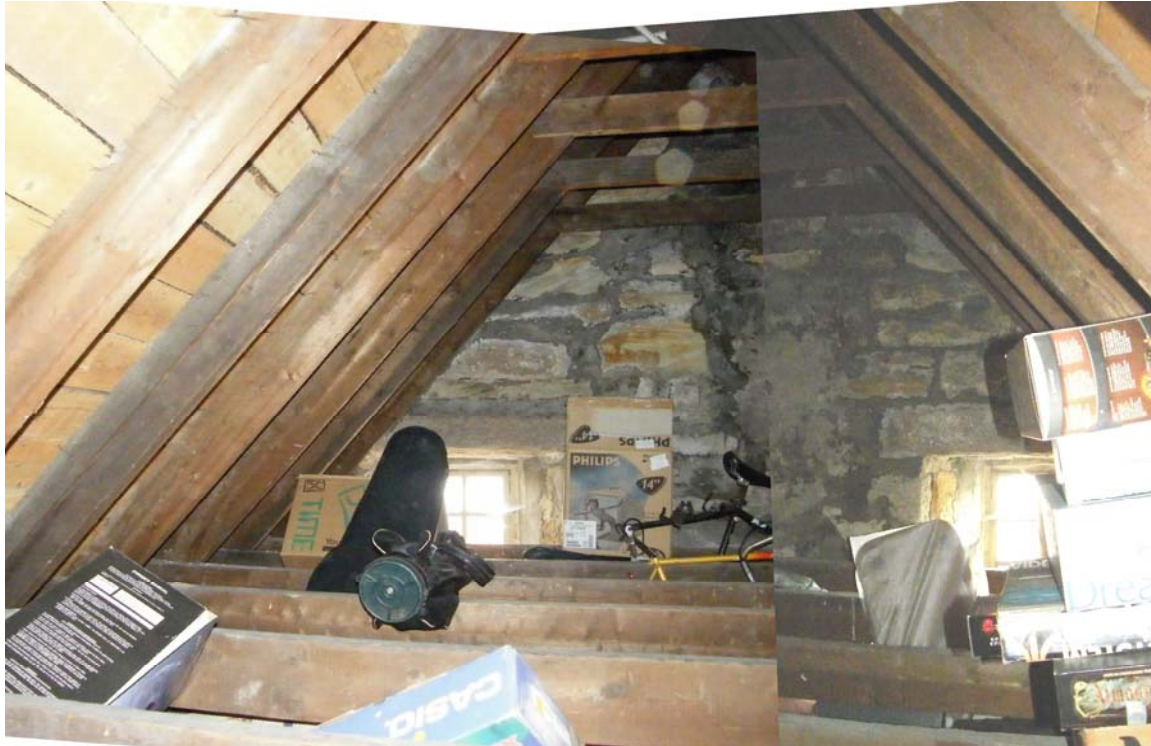
The interior of the southern gable wall was also photographed as best as could be done in the confined space. From what could be seen the gable was evidently heavily pointed up in cement, with extensive spreads of cement running up the middle of the wall - presumably sealing the flues but obscuring large areas of the masonry.

Composite photograph of the interior of the south gable and roof structure

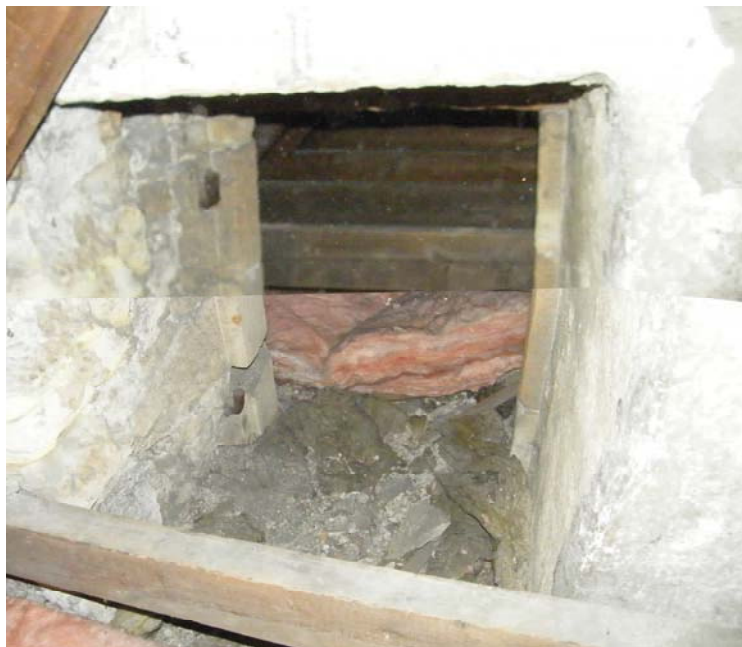
A notably low entrance through the central spine wall connects the loft level chambers; its door had been hinged on two large iron pintles still surviving on the west jamb.

Low entrance between the two loft chambers
