Sandhaven West

Culross, Fife

Historic Building Record CUR/12/3

The National Trust for Scotland

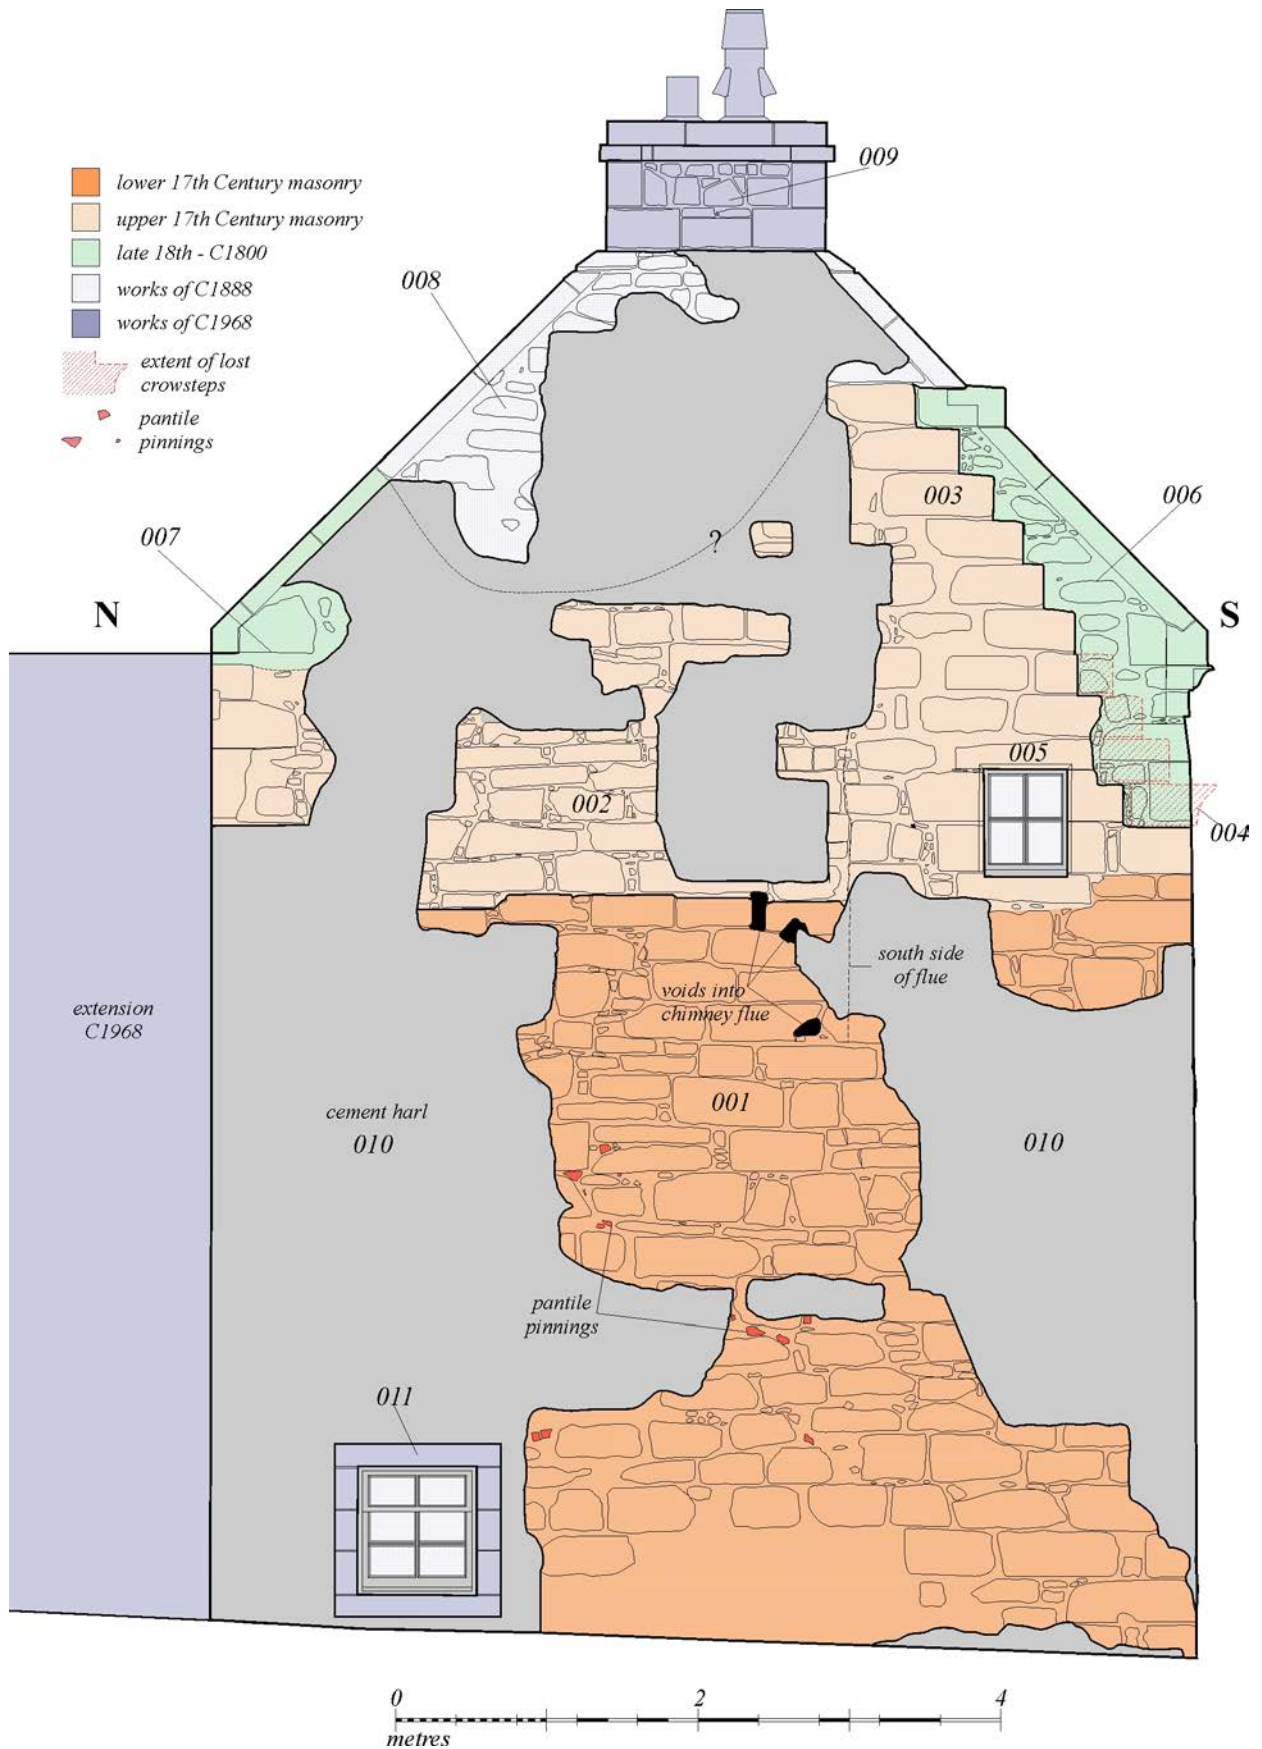
Figure 2 Phased elevation drawing of the west gable wall of Sandhaven West

The harl was tested by tapping and any that sounded loose was removed by hand by hammer and chisel, this left large areas of sound cement harl *in situ* and meant that the exposed areas of masonry were often small and isolated from one another. The resulting record drawing was thus incomplete in many areas and it is not established with certainty that the phasing of the gable was wholly understood. Any future stripping of the cement harl left *in situ* may expose more information of the phasing of the structure.

Following the stripping some areas of the masonry associated with a wide chimney flue were found to be in poor condition, with extensive voids present; some areas of this stonework will need to be replaced

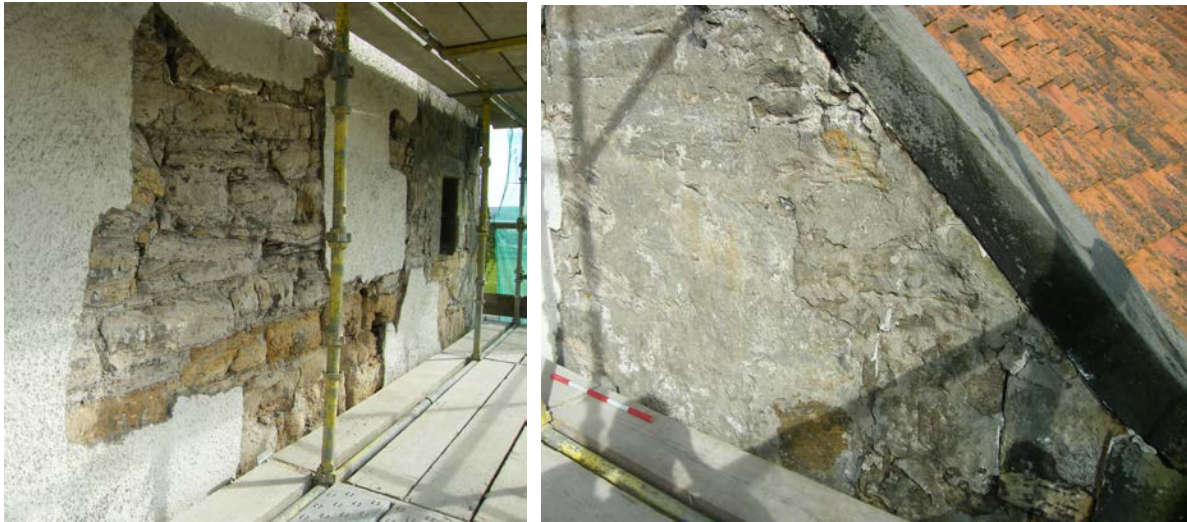
The upper parts of the original build was largely exposed on the southern side of the gable but remained poorly defined to the north where there was only limited exposure of masonry fabric. To the south the outline of a former crow-stepped gable-head was identified, 003. Six complete and two truncated crow-steps remained *in situ*, with identifiable sockets for a further one and, at the site of the former eaves, a further socket for a skew-putt, 004. All of this was over-built by the existing coped south gable head, *figure 4*; also see section *ii.b*, below.

*Figure 3 Horizontal break between the orange and pinker masonry and built over crow-steps
Figure 4 Evidence for former crow-stepped gable head as revealed*

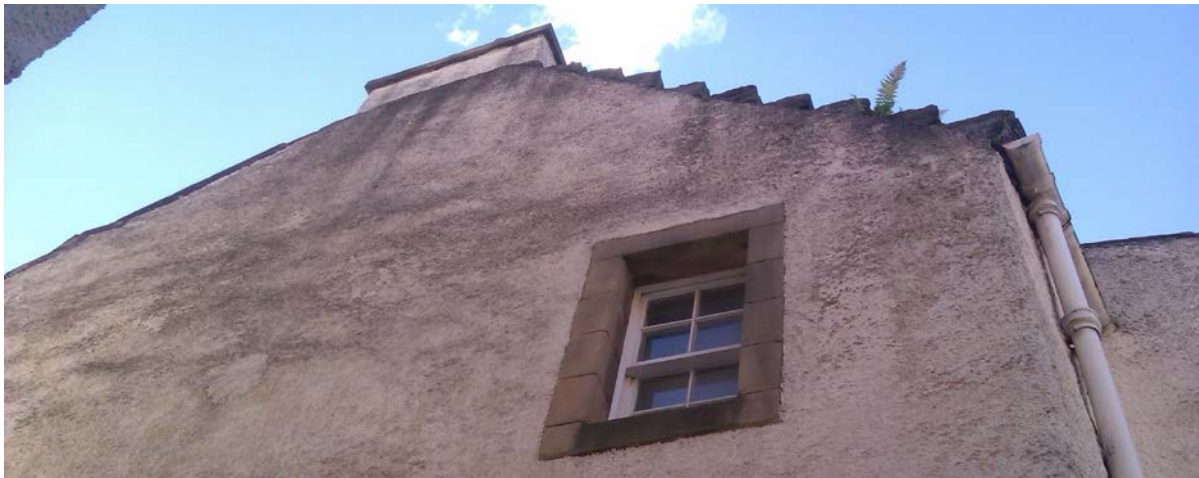
The extent of survival of the original construction of the northern pitch of the gable head remained undefined because of the limited exposure of masonry, and what was exposed was heavily pointed up in obscuring cement. It seems certain that this must also have been crow-stepped, though no physical evidence was uncovered during the present works. It should be noted that the rear pitch of the east gable wall still retains its original crow-stepped head, *figure 4*.

Figure 4 East gable wall showing surviving crow-steps on the rear pitch

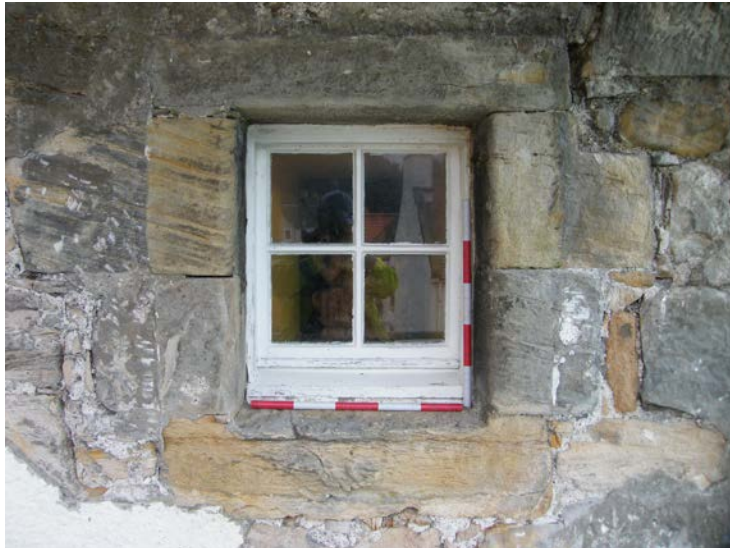
Within the upper part of the original gable, offset to the south, is a small original window (0.55m wide and 0.70m high internally), 005 – *figure 5*. The dressings of this, which are flush with the surrounding masonry, are detailed with a narrow rounded aris. The tail of the upper south jamb stone had been rebated into, presumably to fit the tail of the first of the original crow-steps. This window opening does not appear on Lindsay's as-existing drawings of the property, see *Appendix C*; it is thus probable that it was rediscovered and re-opened at the time of his works.

Figure 5 Early window, 005

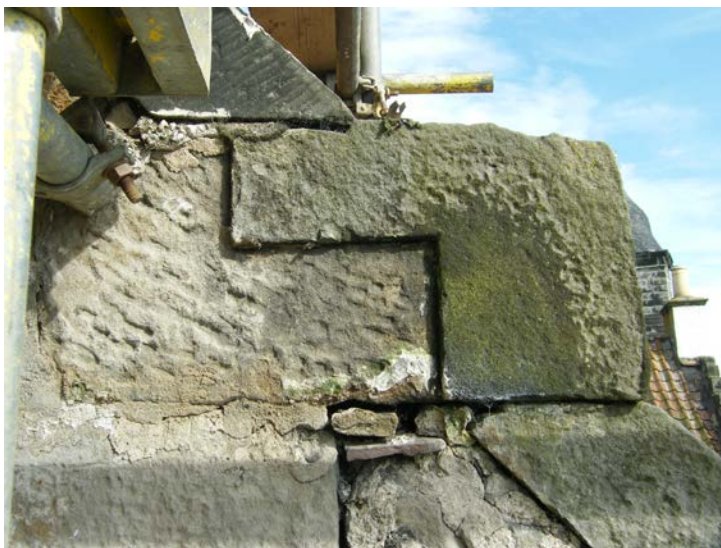
The details of the new work included a heavy projecting skew-put, large plain skew slabs (copes) and, somewhat curiously, an intermediate stone tied back into the gable masonry, but projecting in crow-step fashion half way up the pitch – *figure 6*.

Figure 6 Intermediate skew stone

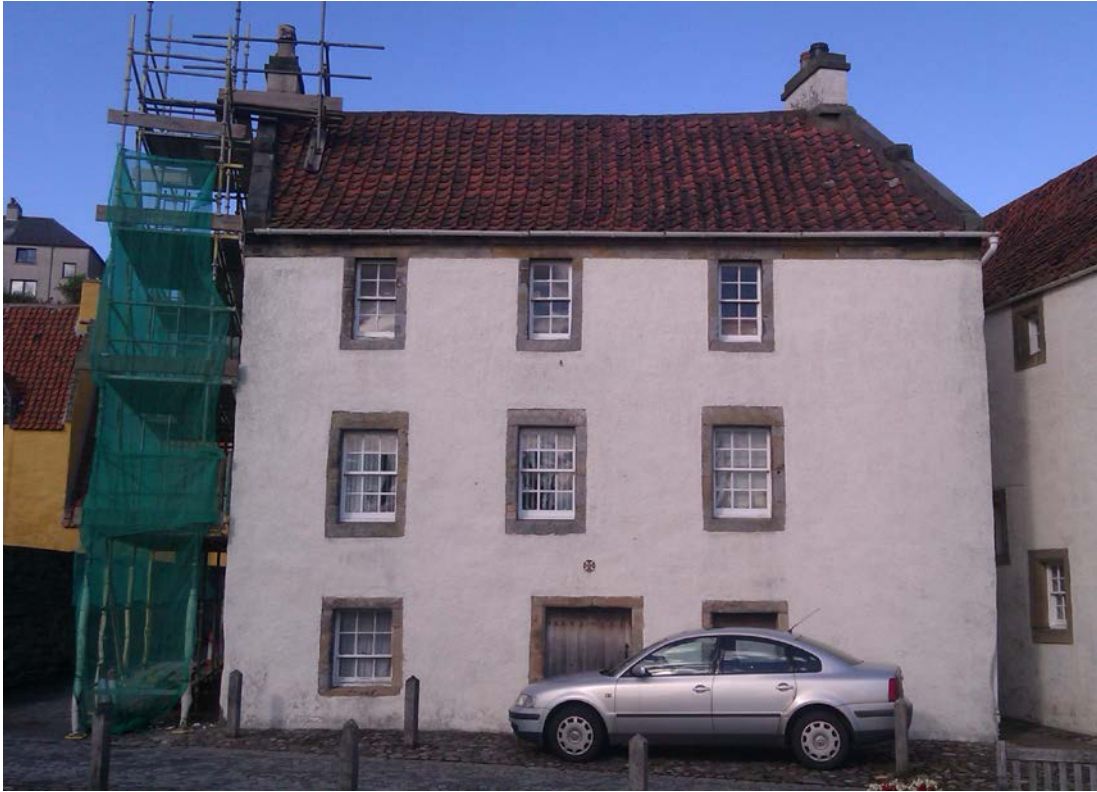
On the south elevation this operation involved the removal of the pre-existing dormers down to their sills and the raising of the eaves by about 1m, and the provision of a stone cornice above a plain wall head course. Three full windows were formed, their lintels integral to the wall head course, *figure 7*.

Figure 7 The south frontage of Sandhaven West as it is today

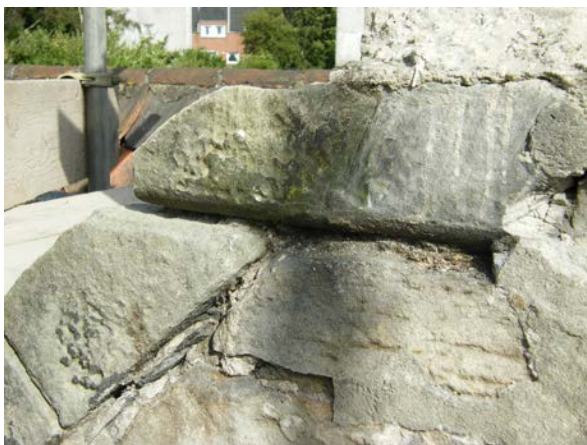
It is fortuitous that two early photographs of c.1888 in the Scottish Life Archive (see *Appendix B.i* and *ii.*) record the rebuilding of the chimney and upper west gable wall of Sandhaven West in progress. The extent of this work can approximately be made out on a later photograph, of 1951, that shows the gable wall from the west, *Appendix B.iv.* the extent of this work can be precisely defined on the gable for the south pitch, but, because of the obscuring harl, was less clear to the north. Its extent is estimated on *figure 2*, above - 008. Evidently the pre-existing skew-slabs were re-set; other reused stone were also noted, one a possible margin or lintel stone detailed with a rounded aris, *figure 8*.

Figure 8 Reused stone within the 1888 rebuilding

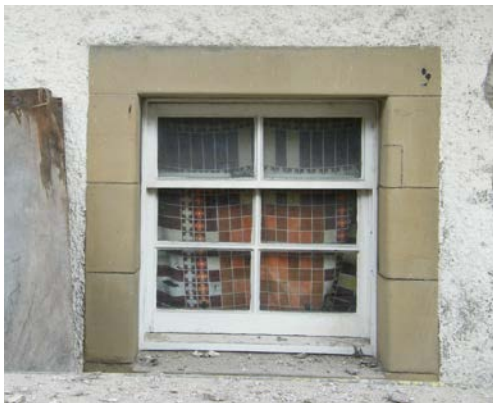
A further window at ground level, off-set to the north, is apparently of wholly modern construction, this detailed with a raised margin and rounded aris, 011, *figure 9*. This was inserted by Ian Lindsay and appears as a proposed work on his drawing set, see *Appendix C*. Whether there had been a pre-existing opening at this point remains unclear; however none is shown on Lindsay's as-existing drawings of the same time.

Figure 9 Inserted window at ground floor level
