# Shildon engine house and mine workings

Shildon by Blanchland, Northumberland

## *Archaeological recording during conservation works in 2010*

Data Structure Report

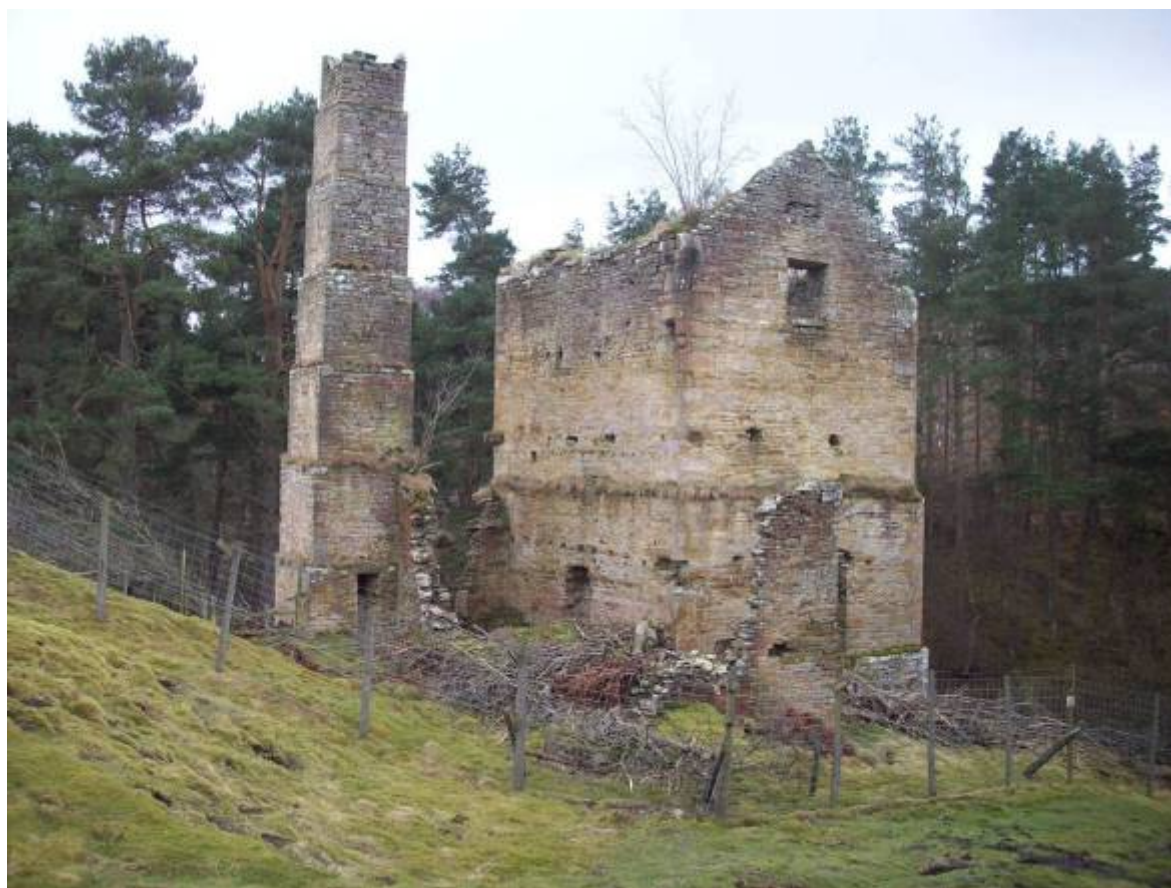
In order to allow for secure footings for the scaffolding some of the collapsed rubble around the structure of the engine house, especially within the footprint of the boilerhouse had to be removed. As part of this work the wall heads of the collapsed boiler house were also cleared of rubble and vegetation prior to consolidation (*see plate 1*). This clearance was monitored by a qualified archaeologist within a number of site visits between December 2009 and May 2010. The recording during this monitoring allowed reconstructing a phased plan of the structures following the partial clearance of the site.

*Plate 1: Pre clearance of boiler house.*

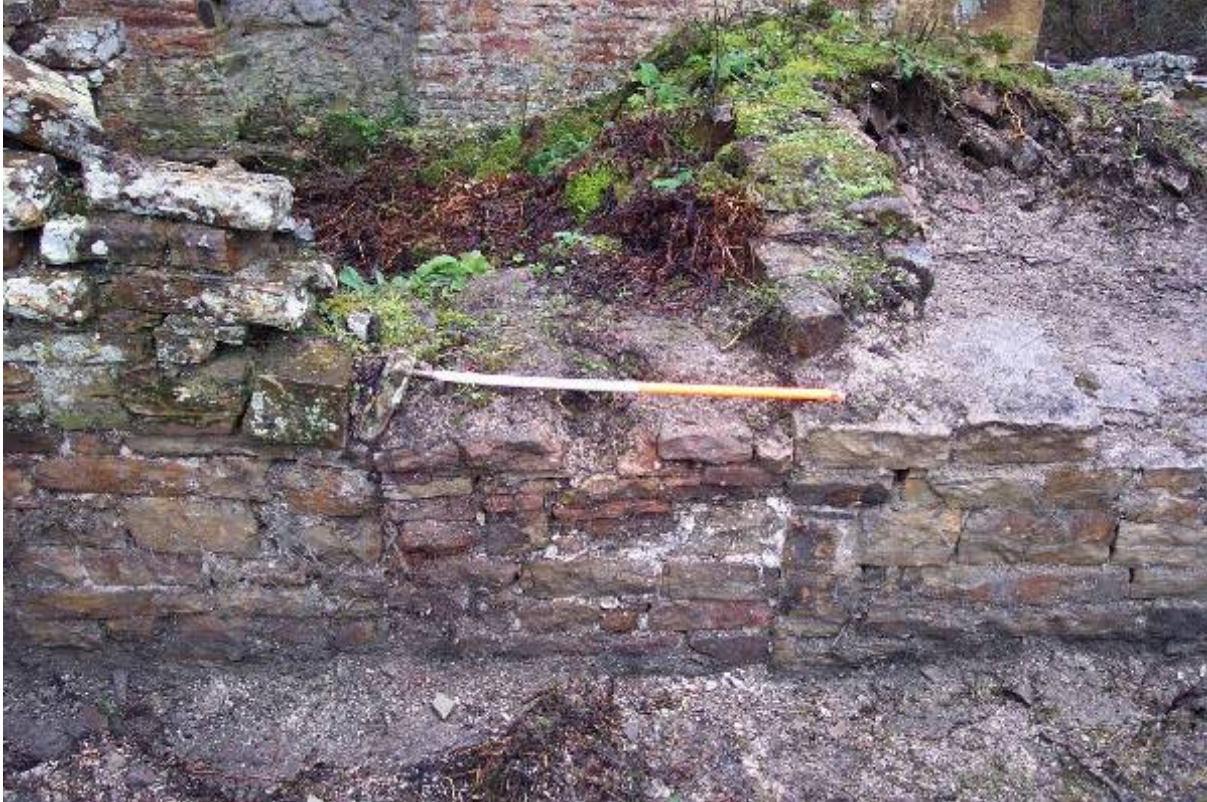
*Plate 2: Blocked door uncovered during clearance.*

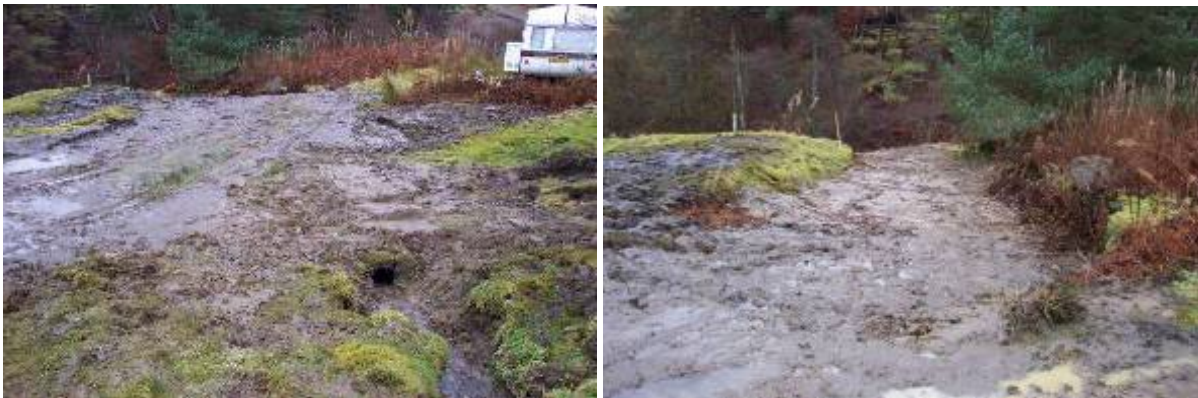
In the 20<sup>th</sup> century a minor stream had been diverted from its historic course and now runs close to the engine house by its N side, along what appears to have been an historic path through the site. It follows the contours down to the main stream. The original course is readily apparent - a gully a little further N, this confirmed to be the case from 19<sup>th</sup> century plans of the settlement and mine workings. The minor stream was diverted where it runs below an access track – it now runs through a cast concrete pipe. The original channel may have been damaged by heavy vehicle activity above.

*Plate 3 and 4: View of stream entering culvert and general view of line of culvert.*

As part of this works it was proposed that the original minor stream course could be reinstated in order to divert flowing water away from the engine house, and to improve access generally. The culverted stream to the west of the site was re-culverted without any archaeological monitoring presence; however, on inspection of the backfilled trenches, nothing of archaeological significance or interest was noted (*plates 3 & 4*).

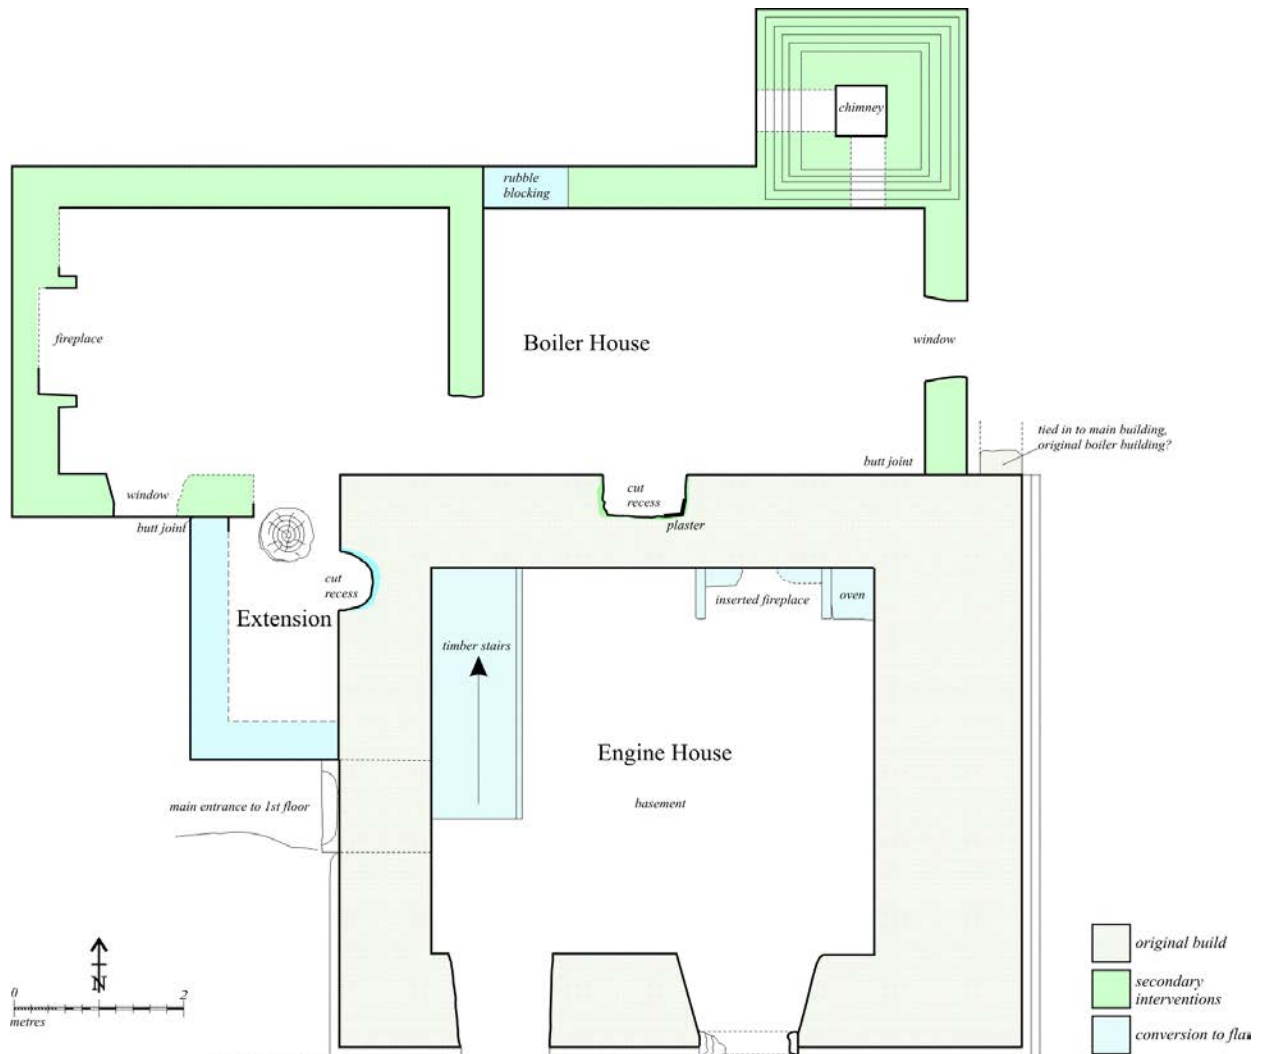
Figure 9: Phased plan of the engine house complex.

The engine house itself is generally in good condition and stands to full wall head height for most of its structure. The boiler house is far more ruinous and is largely collapsed to ground level with the main exception of the chimney and parts of the west gable wall.

Some further remains of a collapsed structure can just be made out at the south west corner of the structure.

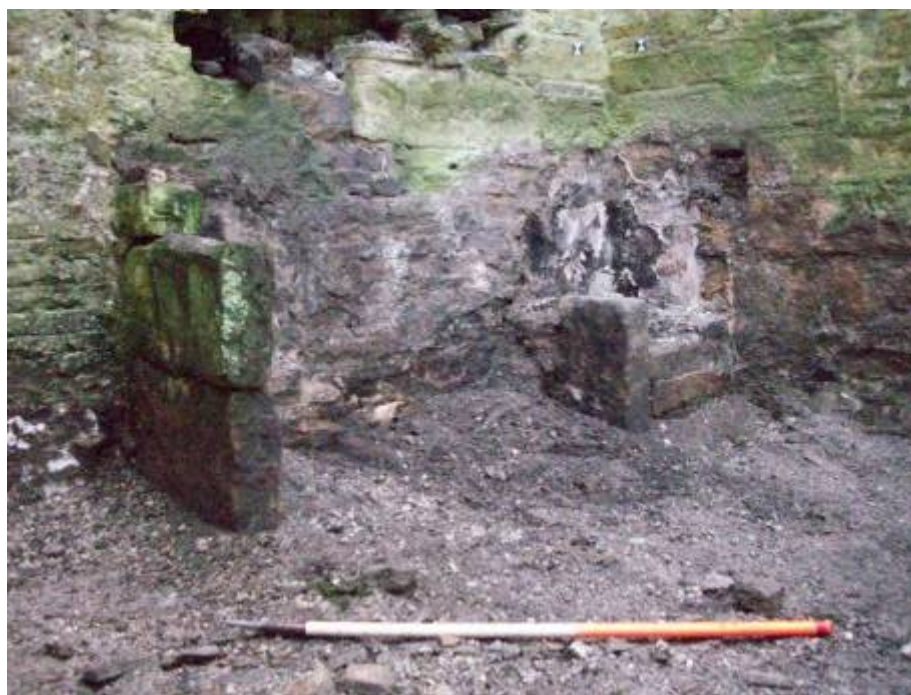
A further three floors were noted below this floor, the upper one of which was 0.70m lower than an early floor. As above the joists were aligned east/west. The next floor down was simply an apparent reuse of the early flooring but was probably now extended across the plug door opening assuming the original did not already cross this opening. The lowest timber floor level seems likely to be another reused floor from the early phase corresponding with an existing stairwell to the west as discussed above. The eastern half of the original floor has possibly been removed in order to create room for the insertion of a kitchen range in the northeast corner. Otherwise, the ceiling would have possibly been far too low, that is unless the actual ground surface at the ground floor level would have been considerably lower than it is currently, which is possible considering the rubble infill of the building and that the actual floor level has not been exposed yet. The kitchen range was inserted against the north and east elevations with a double flue for the cooking range (*plate 5*) built against the masonry of the north elevation.

*Plate 5: Inserted kitchen range in NE corner*

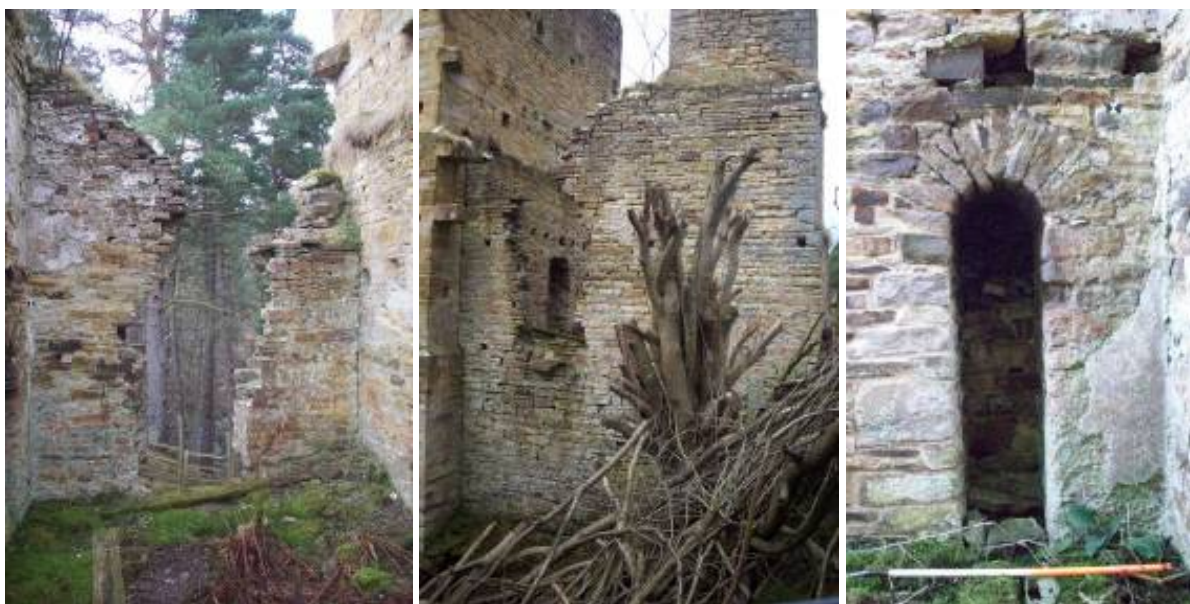
The eastern chamber was 5.20m x 3.15m, aligned east / west. Surviving on the east elevation were the remains of a 0.90m wide window with a splayed imbricated arch which overlooked the mine shaft (*plates 6 and 7*). Its lintel has failed, causing the rubble wall above to collapse with it. The masonry of this elevation continues a full story below the infilled interior on the exterior. Where exposed, some interior plaster was noted *in situ* to the north.

The north wall had a doorway in its west end, latterly blocked up with rubble work. The chimney structure to the east was accessed via a narrow, arch-headed opening as seen in *plate 8*. Some plaster existed *in situ* above this opening.

*Plates 6, 7 and 8: Interior and exterior of east gable and access to chimney*

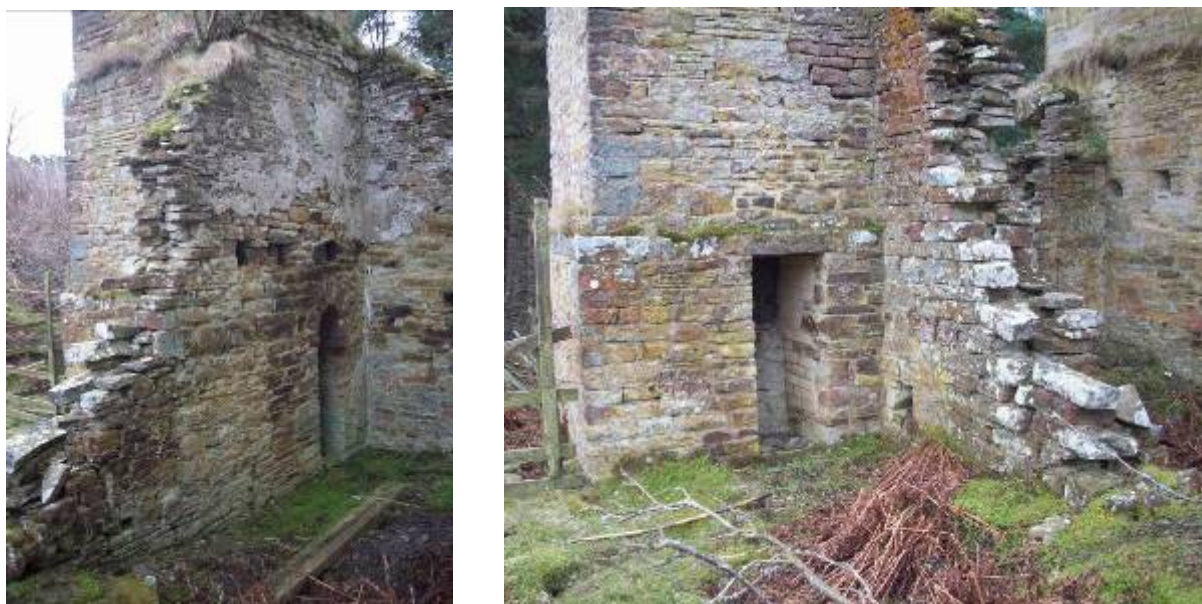
The chimney had two access points at the base, both tall and narrow openings, leading into the centre. One opening leads in from within the boiler house and is arch-headed (*plates 8 and 9*), presumably to vent the boilers. The other opening from the west side leads in from the exterior into the boiler house (*plate 10*); this is lintelled over, perhaps a revision opening to allow cleaning of the flue.

*Plate 9 and 10: Arched interior opening and lintelled exterior*

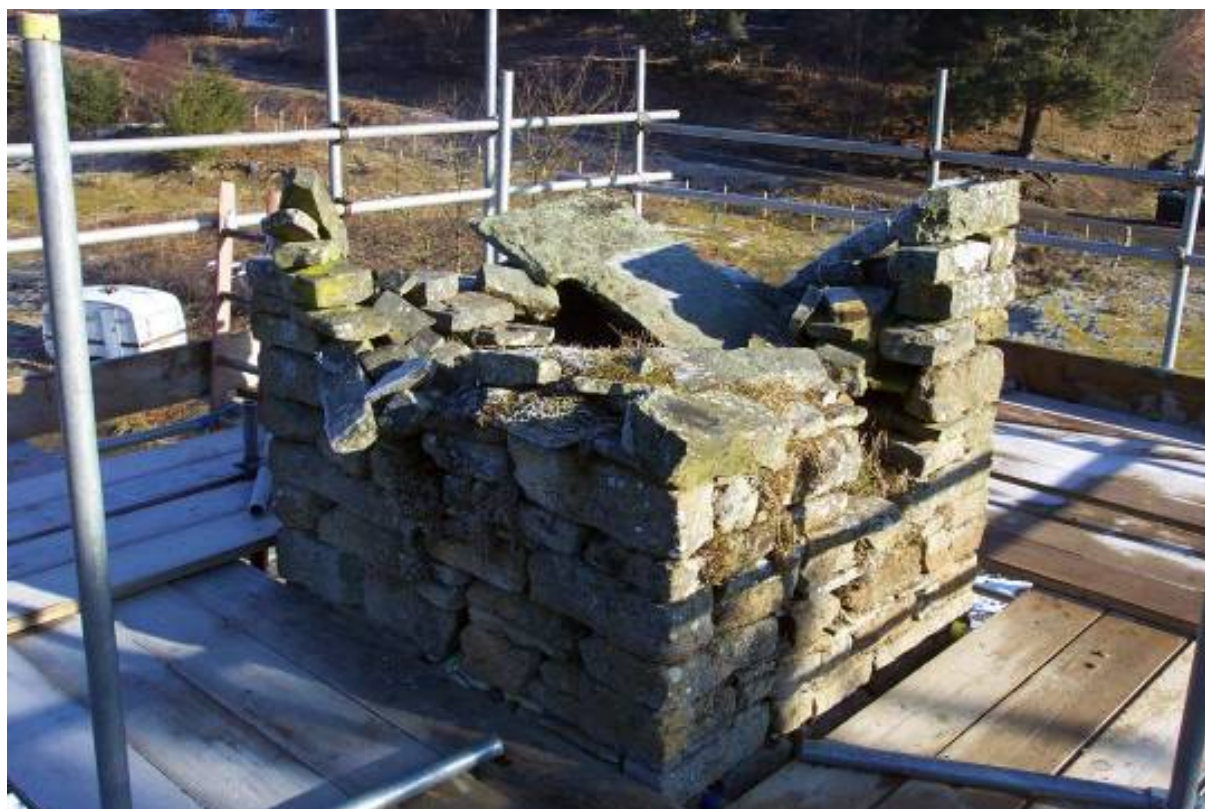
The chimney was in good condition apart from loose parts noted at the wall top.

*Plate 11: Top of chimney from scaffolding*
