29-31 High Street, Jedburgh

Historic Building Survey and Archaeological Monitoring : October 2012 – February 2013

Data Structure Report (AA.2013)

The Scottish Borders Council

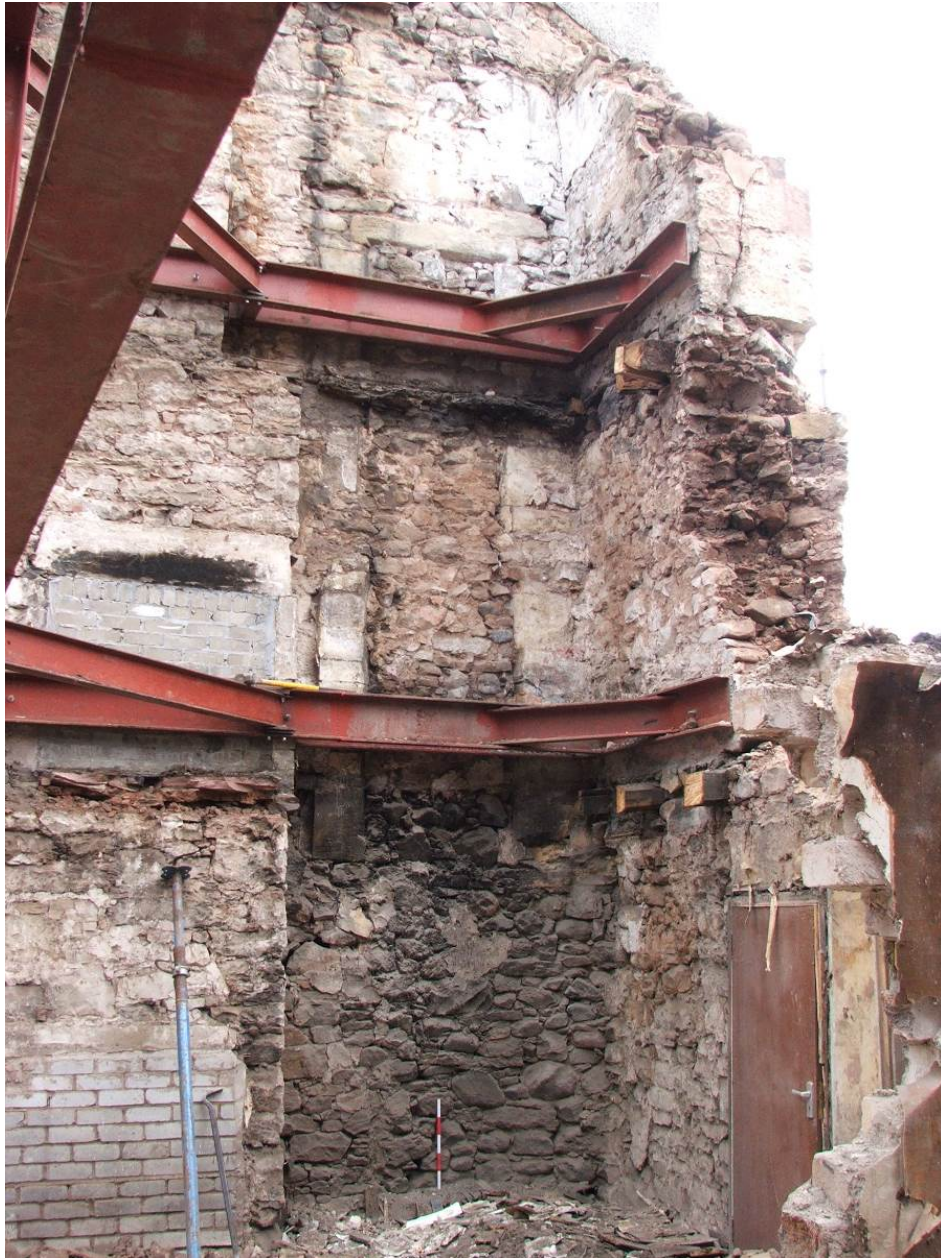
Plate 3 Remains of the turnpike stair at the east angle of the main range – note entrances behind the new steelwork and the curvature of the lower part of the stairwell to the right of the scale pole.

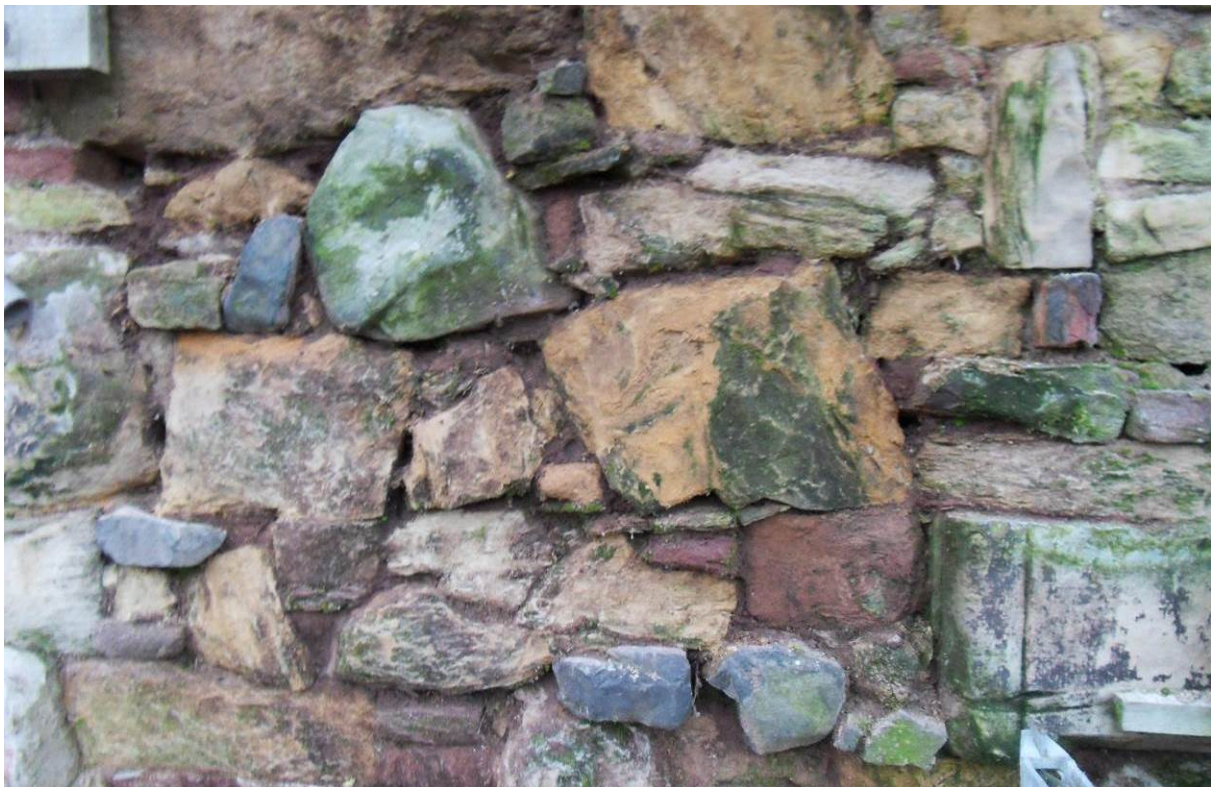
Plate 5 An illustration of the mixed nature of the stone employed in much of the phase II construction including a variety of sandstone types and some whin; some if not most of the of the former are evidently recycled from other structures – e.g. block to lower right; rear wall (context 127)

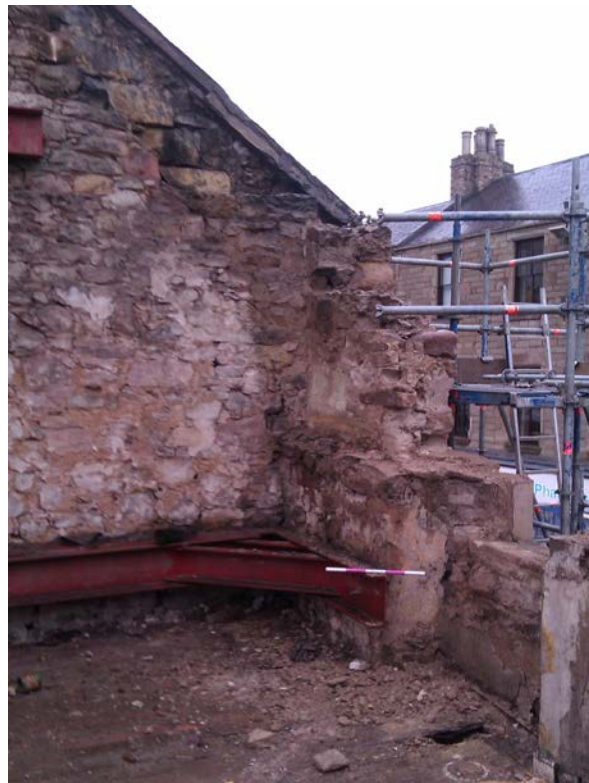
Plate 6 SW end of the frontage wall, interior at second floor level, showing the internal off-set; note also the embedded crow-steps and gable head in the adjacent SW wall; looking west

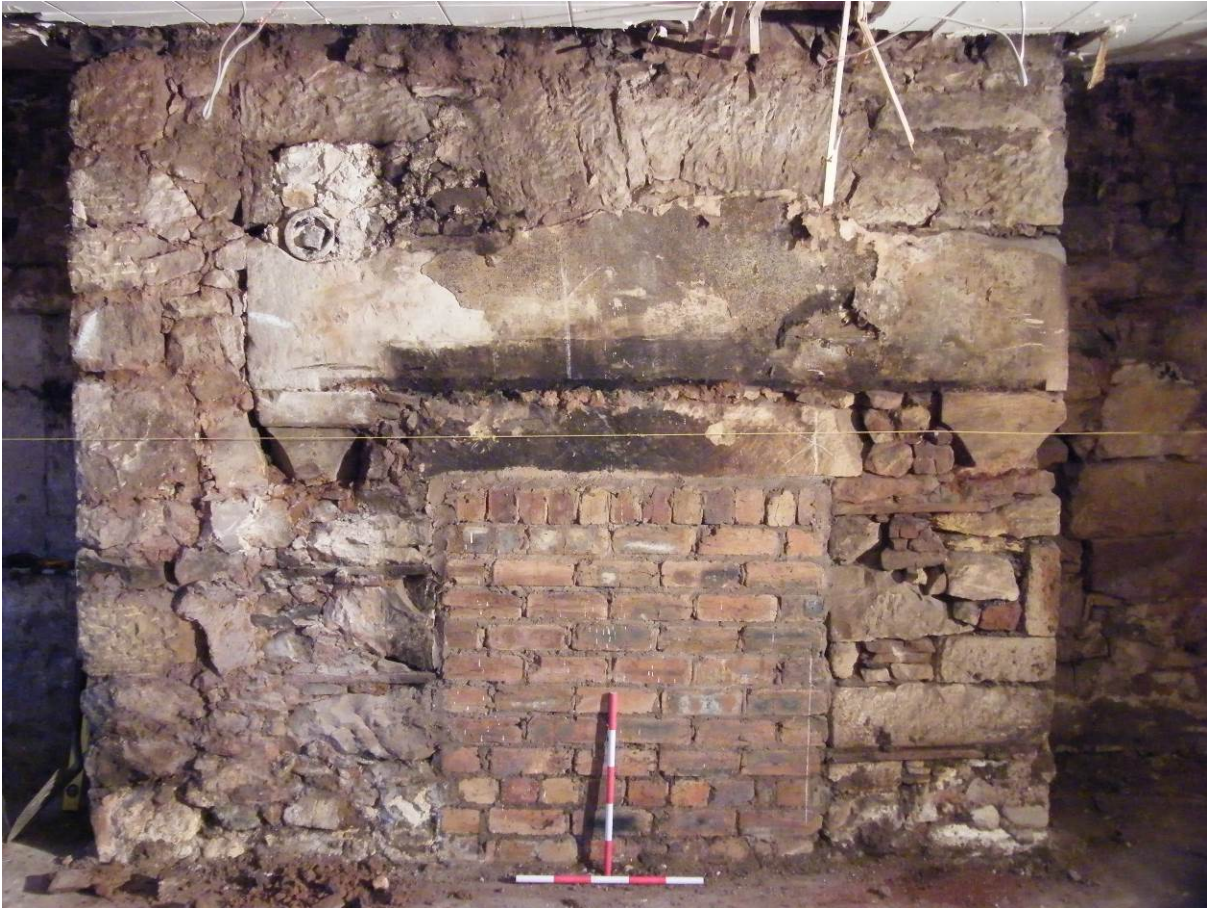
Within the SW chimneybreast there survived fireplaces at ground, first and second floor levels, 076 – 078 respectively. The uppermost parts of the chimneybreast and the chimney itself were removed when the existing roof structure was erected – see phase III. One of the more notable discoveries made during the project works was the constructional detail of the fireplace at ground floor level, 078, *plate 8*; also see *plate 36*. This had been largely constructed of recycled architectural stonework. The latter included many squared ashlar blocks but, more significantly, a very substantial lintel stone detailed with a chamfer (085) and, supporting this, two former engaged capitals recycled as corbels, though embedded into the piers forming the jambs of the fireplace (083) and (084) – also see *plates 37* and *38*, below. Though it appeared that these jambs were secondary to the formation of the fireplace, the lintel and chimneybreast above and that the corbels had originally been fully exposed it was judged that all related to the single construction. The same was true for a section of masonry along the SW side of the chimneybreast, an apparent extension, (082), but in fact a stage in construction and providing support for the SW side of the chimneybreast above. The fireplace lintel retained a relieving arch over and some original plaster adhering.

Plate 8 The remarkable fireplace within the lower stage of the SW chimneybreast

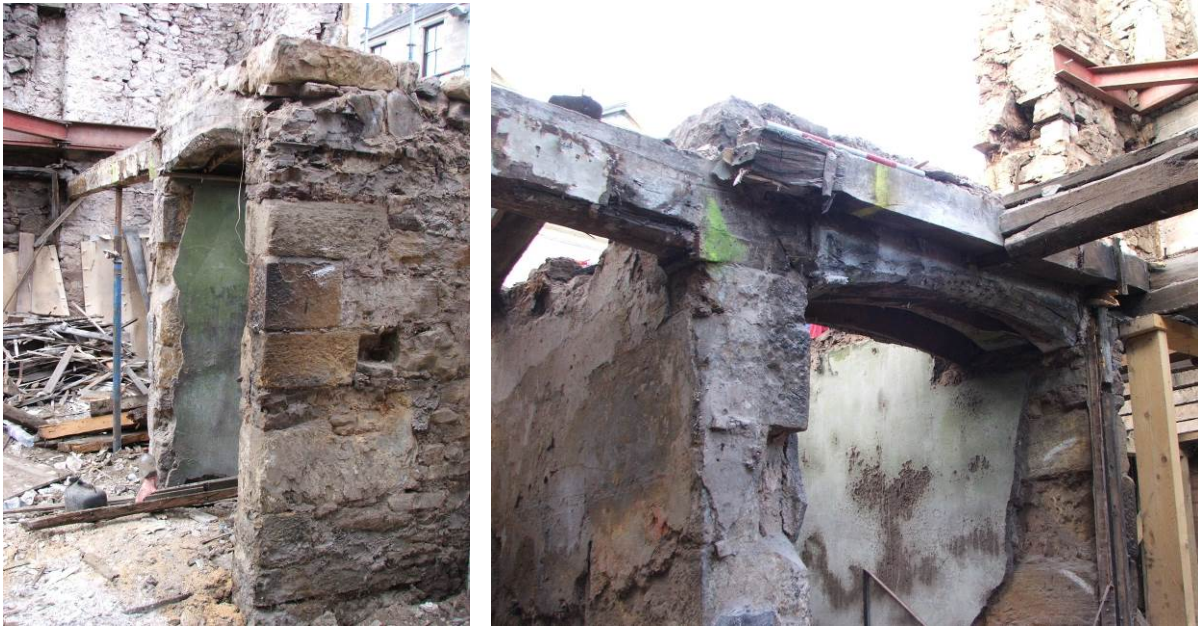
The pend was evidently a feature of the phase II construction. Running back from the street frontage the first 2.8m of the pend was masonry-walled, this mostly of rubble construction with recycled cut stones employed at the inner jambs, some of these evidently of medieval date (plate 9). Towards their rear ends these wall sections supported an arch formed of stout naturally curved oak sections (timbers (064) – (066)) that in turn supported a masonry pier that ran up to second floor floor level, plates 9 and 10. This walling / pier provided support for the inner ends of the principal joists that supported the floor structures at first and second floor levels – see below. The rear arch timber (066) on either end is scarf jointed with the principal joists to either side - (063) to the SW surviving, that to the NE now lost.

Plates 9 and 10 Pend walling showing timber arch; a remaining early principal joist 063 can be seen beyond to the left

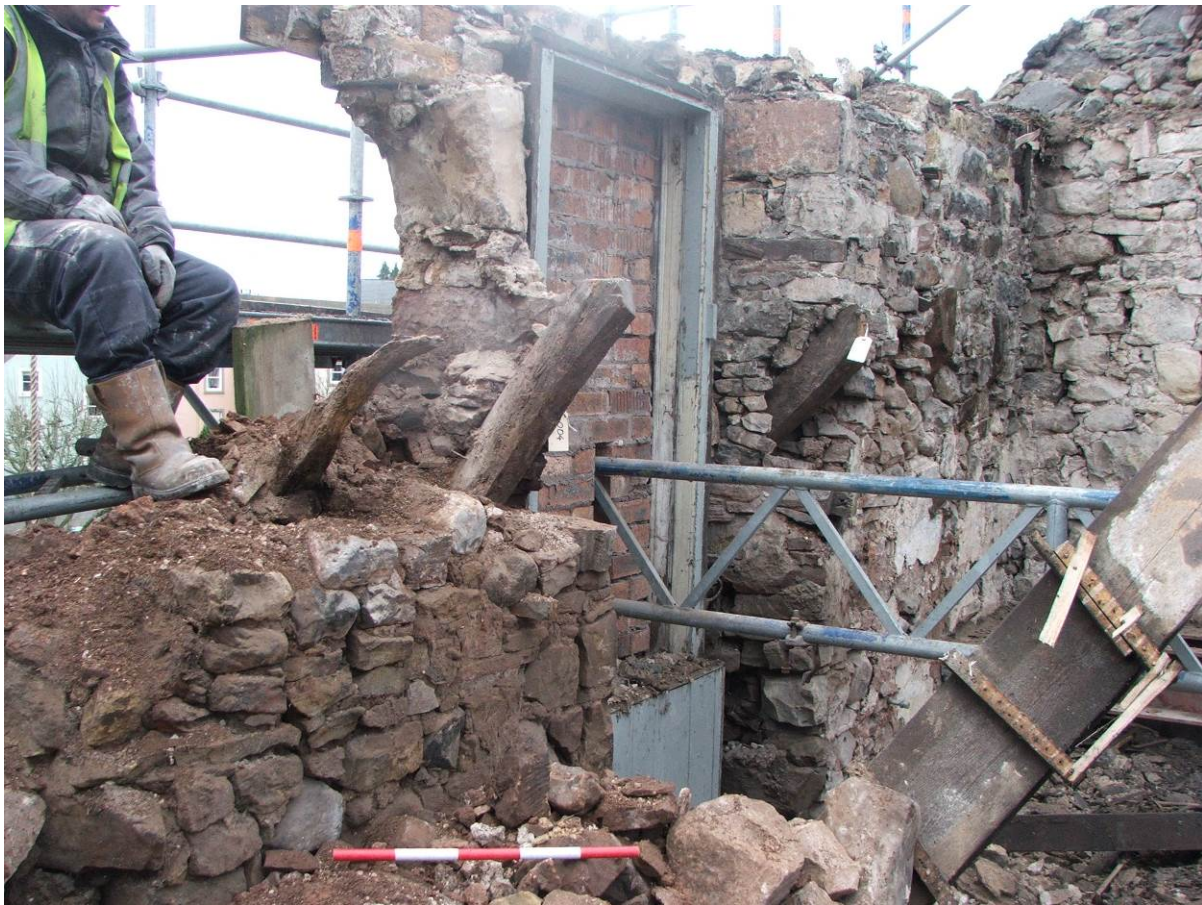
The dismantling of the rear wall afforded the opportunity to examine the former wall head in detail. Each of the rafter foot assemblies was still articulated, the rafter tenoned into the ashlar pieces and pegged. They varied slightly in their details, one retained a sprocket. The timber used, principally oak, varied in quality; some of it was apparently reused (relict peg-holes, mortices, etc). The rafters were set at a relatively steep pitch, in the order of 50°-55°, which corresponded well with the fossilised gable profiles embedded in each side wall of the building. The angle between the rafters and the early wall head had been built up flush with the internal wall face with clay-bonded masonry, (143).

Plate 21 The rafter foot assemblies as partially exposed during early stages of demolition

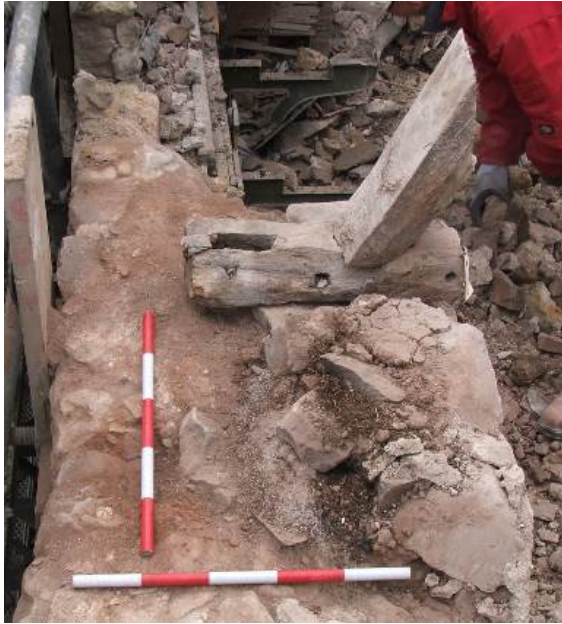
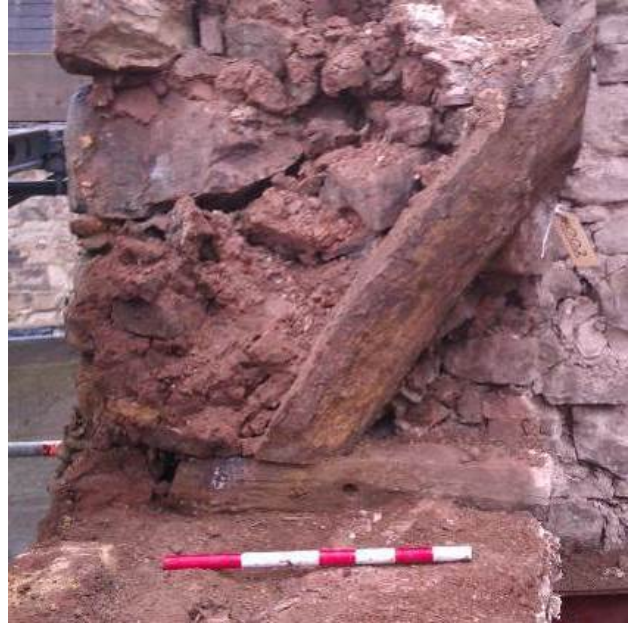
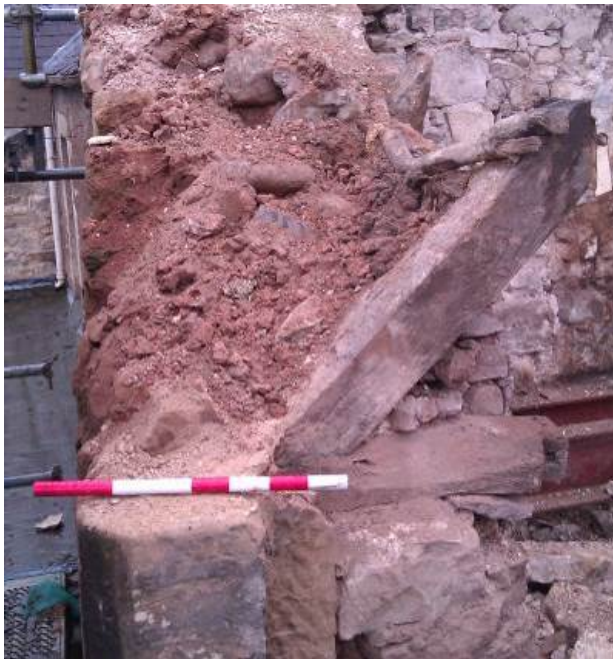
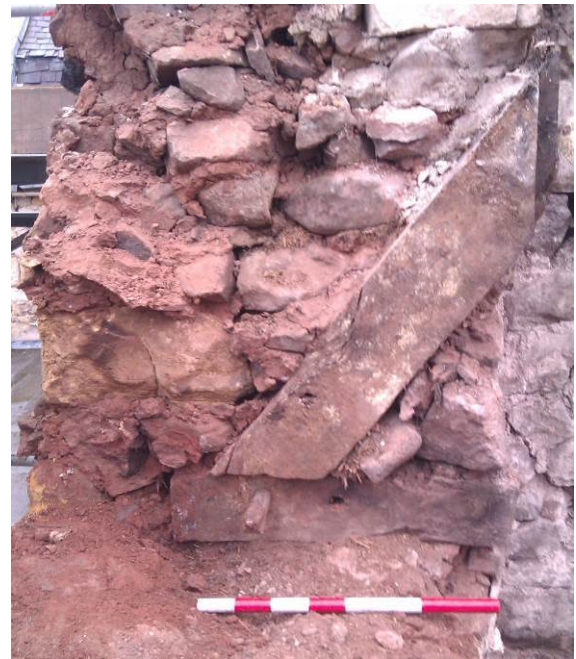
Plates 22-25 Four of the surviving rafter foot assemblies embedded within the rear wall, during demolition

With the dismantling of the rear wall it was possible to recover all of the rafter-foot assemblies *in toto* and still articulated and put them in safe storage for recording, further study and controlled dendrochronological assessment and sampling.

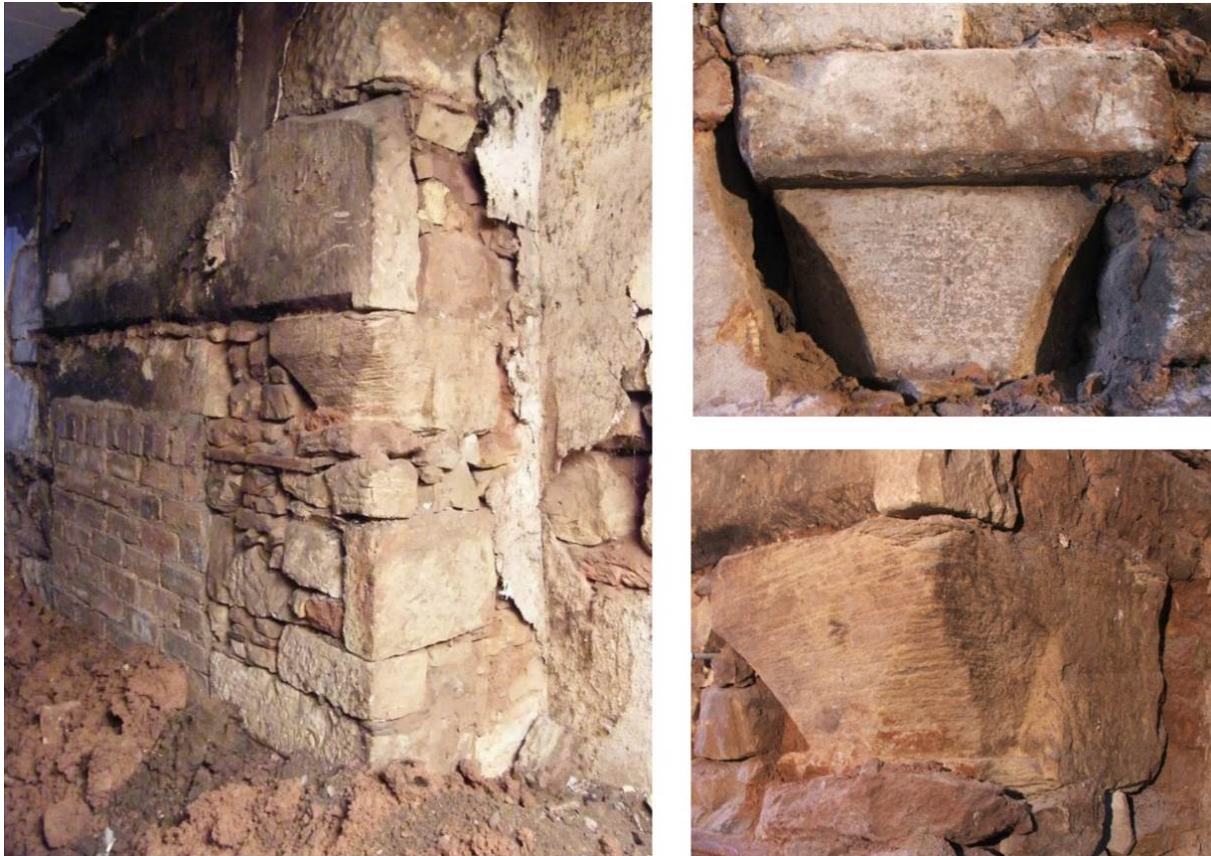
The walling of this phase incorporated a considerable number of recycled dressed stones within its general masonry fabric. Many of these displayed fine diagonal tooling most likely indicative of a medieval date. As noted in *section iii.d*, above, a concentration of such stones was recorded within the masonry of the projecting chimneybreast within the SW wall. At ground floor level these included a very substantial lintel with chamfered aris and two recycled engaged capitals of ecclesiastical character – of later 12th or earlier 13th century date and not dissimilar to some of those remaining *in situ* at Jedburgh Abbey.² One of these displayed a mason's mark (*plate 37*).

Plate 36 Lower stage of the chimneybreast within SW gable wall (074), showing extensive use of recycled architectural stonework, including the substantial lintel (085)

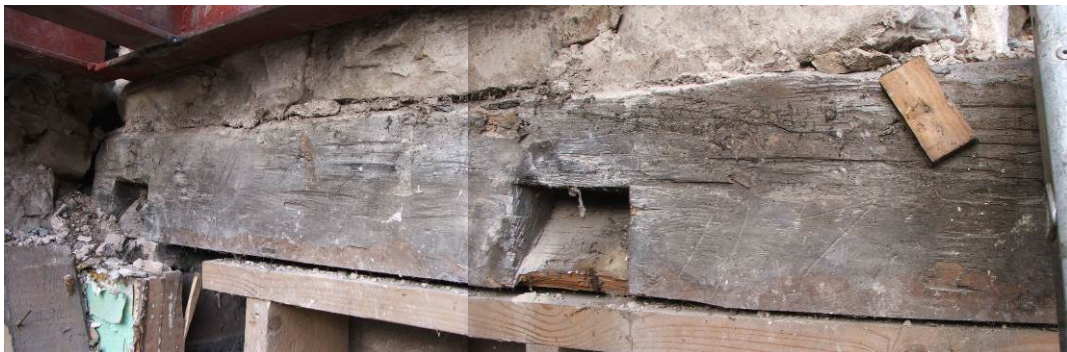
It was not clear when the shop fronts were inserted, whether at Phase II or later in the 19th century. Internally their insertion involved supporting the pre-existing upper frontage by very substantial safe lintels of pine. One of the lintels was notable for the presence of incised race marks, *plate 48* and *figure 8*.

Plate 48 Timber lintel displaying shipping marks incised with a rase-knife

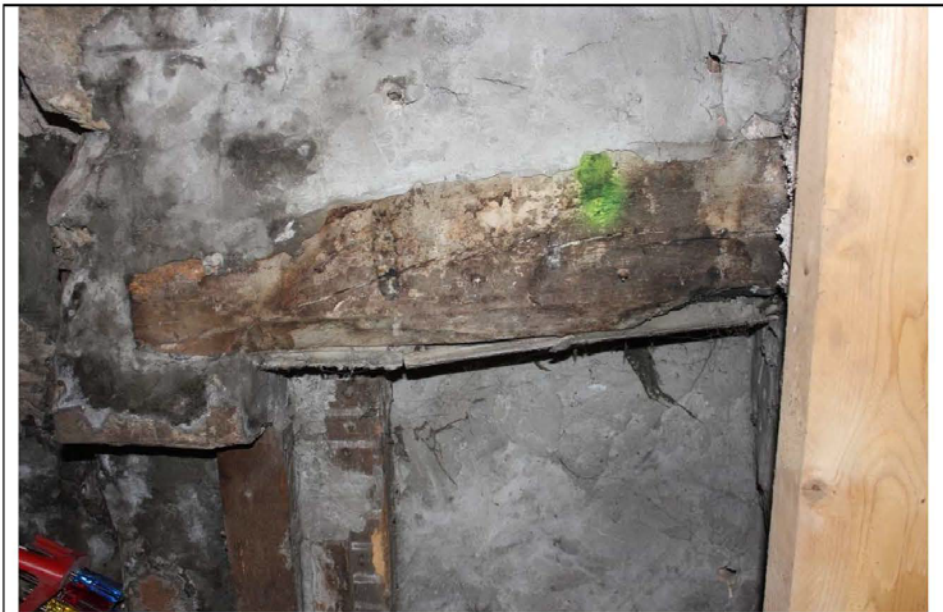
Item 6: oak lintel, ground floor fireplace, NE side wall

6 A substantial oak lintel rests over the fireplace on the ground floor NE side wall. Photo: C Mills.

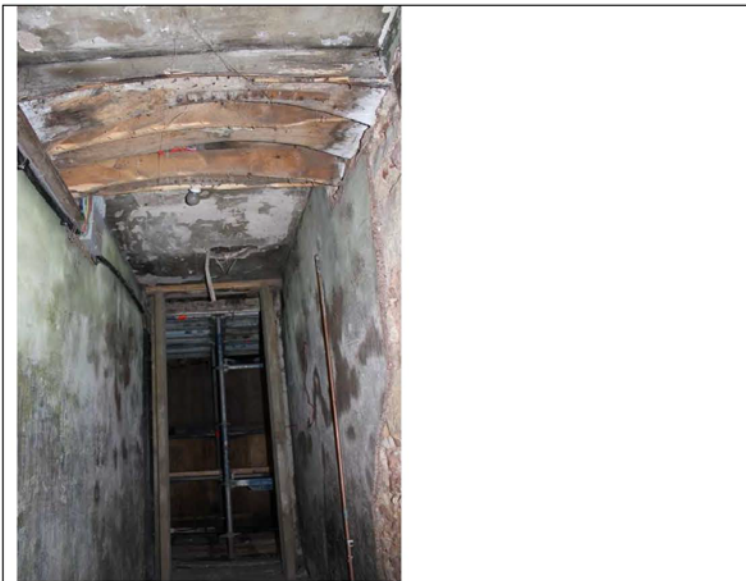
Group 4: Curved ash (?) in arched ceiling to pend

4 Curved ash (TBC) forming arched ceiling in part of central pend. There are 3 whole sections of ash (?) stems and some probably later inserted boards. Photo: C Mills.

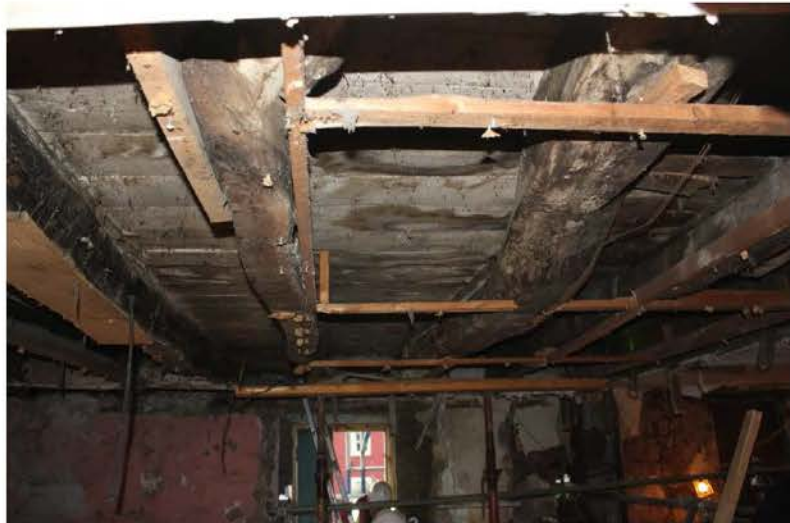
Joists of crooked and branched oak revealed in 1st floor ceiling; potentially a very rare native oak structure of late medieval or early post-medieval date. Relicts of Jed Forest? Just one example of the remarkable timber assemblage in this building. Dendrochronological analysis is recommended for dating the structure and characterising and dendro-provenancing the timber (Photo: C Mills)

Further dendrochronological work is recommended on the main timber groups seen so far. Further visits and guidance on sampling are advised when (1) more is revealed (the roof space especially) and (2) to set-up sampling procedures when stripping out and sub-sampling of timbers starts, ideally under Addyman Archaeology's supervision, before providing (3) a fully costed and prioritised dendro-assessment when all of the samples have been obtained, prioritizing the groups of samples, eliminating unsuitable samples and identifying the funding requirements for (4) dendrochronological analysis of the retrieved groups of timber samples.

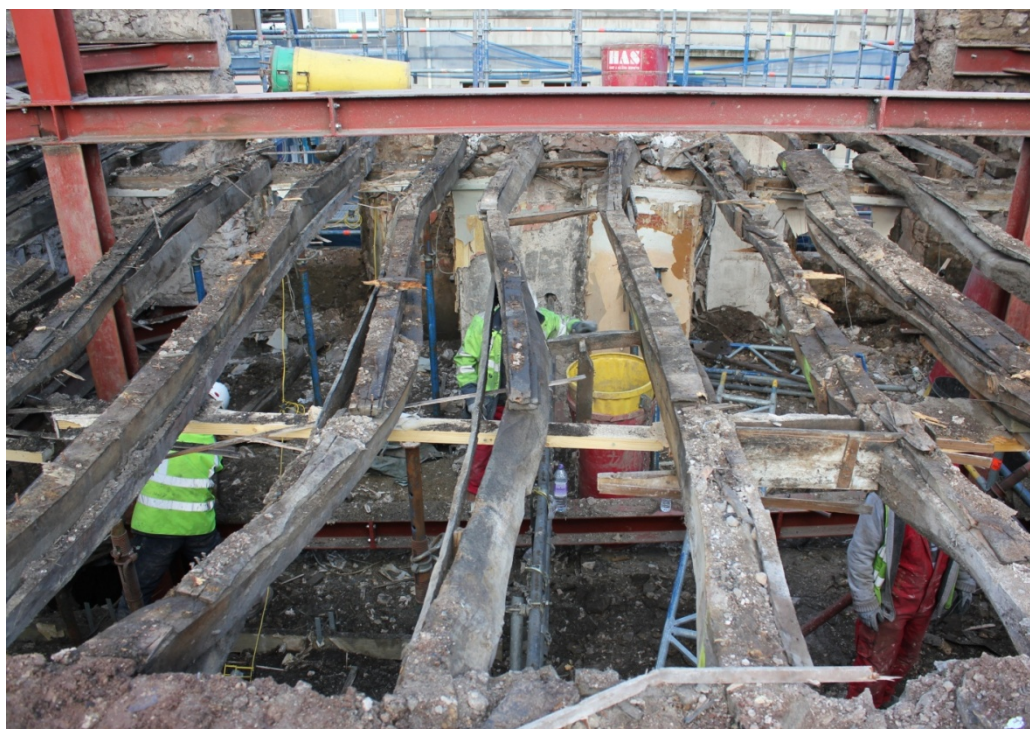
Plate 1 Group A Joists of crooked and branched oak revealed in 1st floor ceiling; potentially a very rare native oak structure of late medieval or early post-medieval date. Relicts of Jed Forest perhaps?

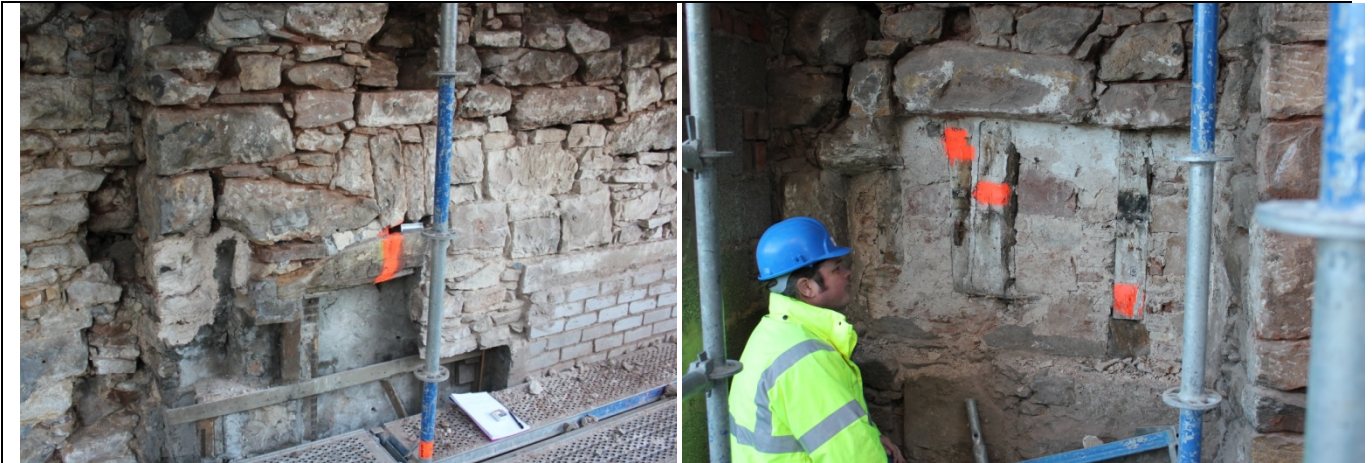
Plate 6 (L) Oak lintel F100, marked for extraction with orange paint, in the ground floor fireplace in the East gable wall. The fireplace may be one of the earliest surviving features. The fireplace and its lintel have been cut through by later modifications to this side wall. (R) Studs in F110, on the West gable wall, marked for extraction prior to gable rendering.
