The Temple, Dumfries House Estate by Auchinleck, East Ayrshire

Historic Building Survey and Analytical Assessment

for The Great Steward of Scotland's Dumfries House Trust

March 2014

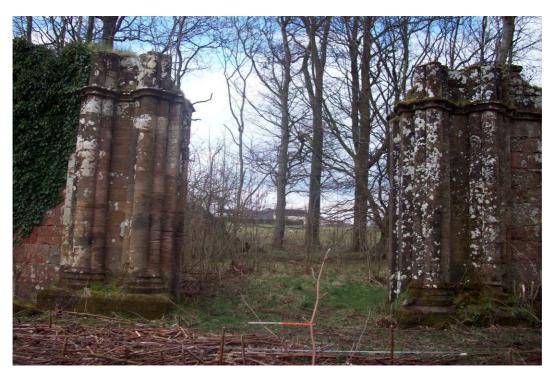
Plate 4 The substantial piers that formerly supported the central archway looking N (2008 - Photograph 199)

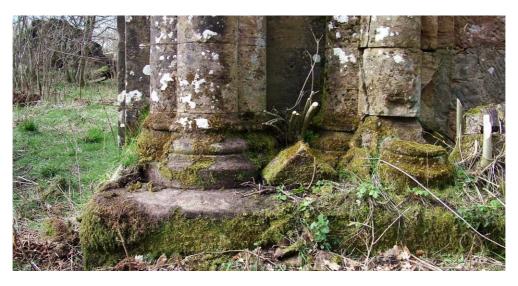
Plate 5 Detail of damage at column base, (2008 – Photograph 205)

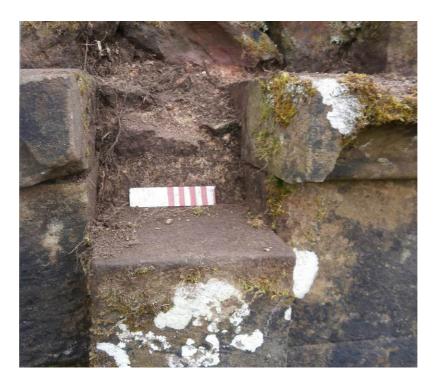
When the tops of the piers were cleared of accumulated soil and vegetation it was hoped that further pintles or fixing points would be revealed, but this was not the case. These had probably been set in to the underside of the flying lintel that had extended between the capitals of the gate piers but now lost. The sockets for the missing lintel were cleaned in the hope of better understanding its details, construction and, possibly, material. Plain squared sockets were revealed, but there was no indication of material or specialised fixing detail, *plate* 8.

Plate 8 Detail of socket for flying lintel in top of gate pier (2014 – Photograph 350)

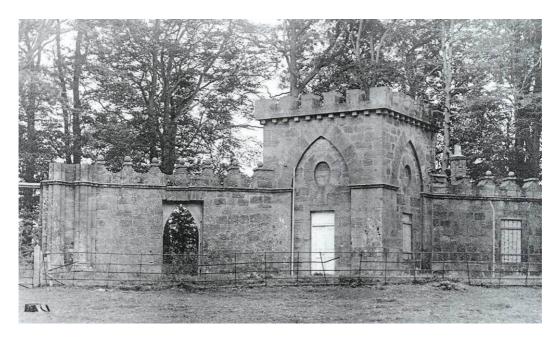
Plate 13 c.1970s-80s? image showing former condition of pavilion and flanking walls. NMRS

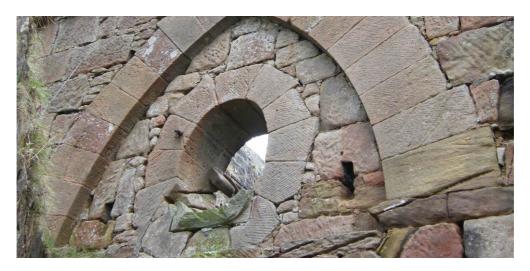
Plate 15 Western pavilion, detail of broken spout, (2008 – Photograph 032)

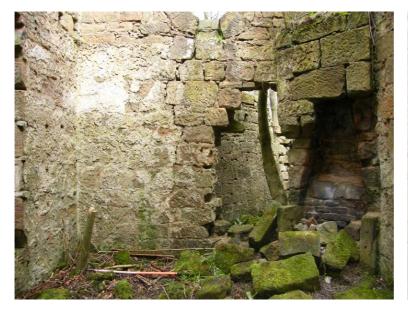
Plate 16 The NE wall of the East Pavilion interior before clearance (2008 – Photograph 133)

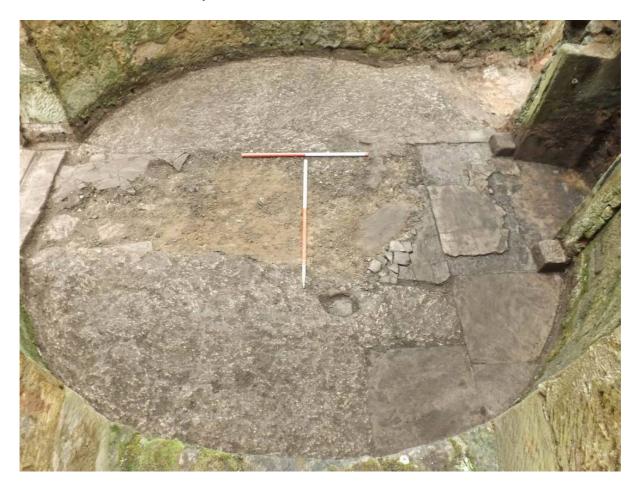
As seen in *Plate 29*, clearance of the interior in 2014 revealed remnants of finely jointed sandstone flag floor, with the better surviving area to the N, on the NE side of the fireplace. Here three sandstone flags survived near enough intact, respecting the neatly laid outer hearth stone in front of the fireplace. One large flagstone sits directly in front of the fireplace, overlain by the remnants of a concrete surface. Evidently most of the flags had been taken up, perhaps because of long-term wear and cracking; only the less worn, better preserved stones were left in place. In the remaining area a new lime concrete flooring was laid over. That this had occurred at the time when the west wing was being roofed was indicated by the new flooring running into the area to the SW where the new entrance had been broken through to the wing. On cleaning this area the original curvature of the interior wall face could be easily discerned.

Plate 29 General view of the interior following clearance, looking south; note surviving flags to lower right and secondary lime concrete flooring running into the inserted opening to upper right (2014 – Photograph 452)

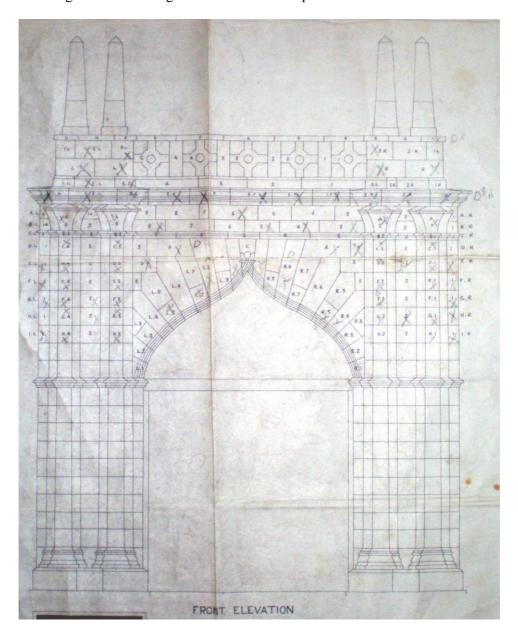
Site inspection revealed that the numbered stones correlate precisely to the maximum extent of down taking of the arch. The dismantled stones were carefully taken down and stacked behind the temple on its N side at the angle of the flanking wall and the western pavilion.

Figure 4 c.1960s drawing of arch with stones detailed and numbered, Dumfires House archive

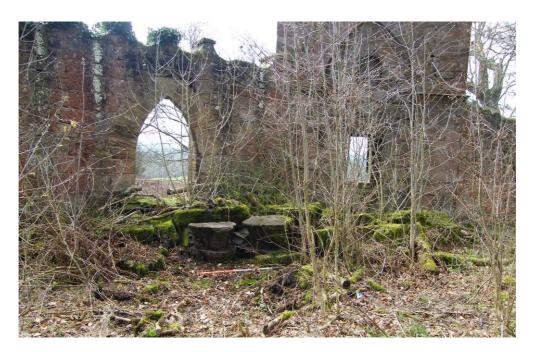
The volume of stones suggests that most of the dismantled arch can still be accounted for. Amongst the stones all of the majority of the elements used to form the arch are visible, including sections of the four obelisks, cornice sections, capitals relating to the piers, and so on. In 2008 the pile did show signs of disturbance, suggesting that some of the stones may have been dispersed and/or removed. The extent of survival will become apparent when the cleaned stones are laid out and catalogued prior to reconstruction.

Plate 54 Dismantled arch stones (2008 – Photograph 092)

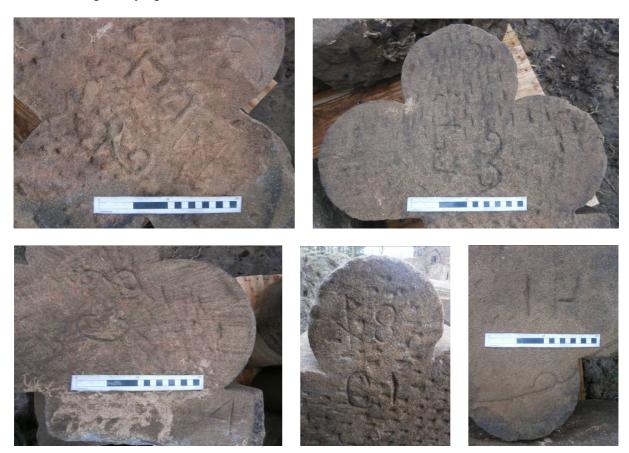
To aid in their future identification numbers had been cut into faces of the stones at the time of the dismantling of the arch, cut on faces that would not be visible when reconstructed. These numbers correlate precisely to the annotated elevation drawings. With such records the reliable reconstruction would seem to be possible, and a relatively straightforward exercise to reassemble the stones in their correct positions. However some individual elements certainly seem to be missing, the most obvious absentee being the flying lintel from within the arch.

Plate 58 Carved stones from the dismantled archway showing numbering (E2, E3, C3, C1, H1) applied in the 1960s, and earlier numbering and masons' marks (2014 – Photographs 330, 332, 335, 339 and 336)
