Mavisbank Estate

Loanhead, Midlothian

Archaeological Watching Brief

Data Structure Report

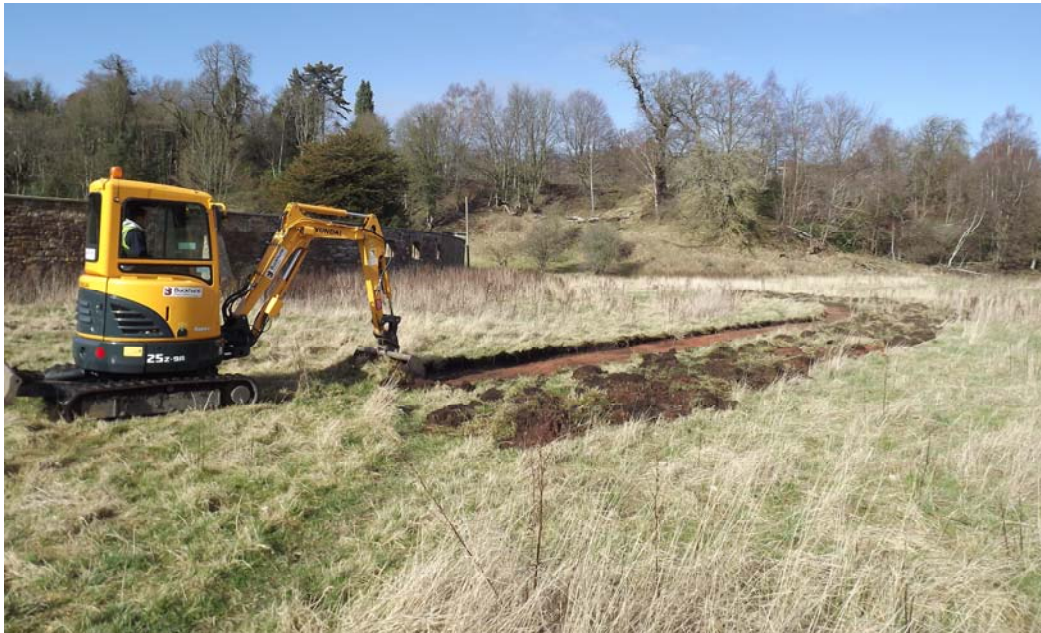
Plate 2 Working shot looking west. Note the red blaze (107) being revealed across the route of the path (Photograph 015)

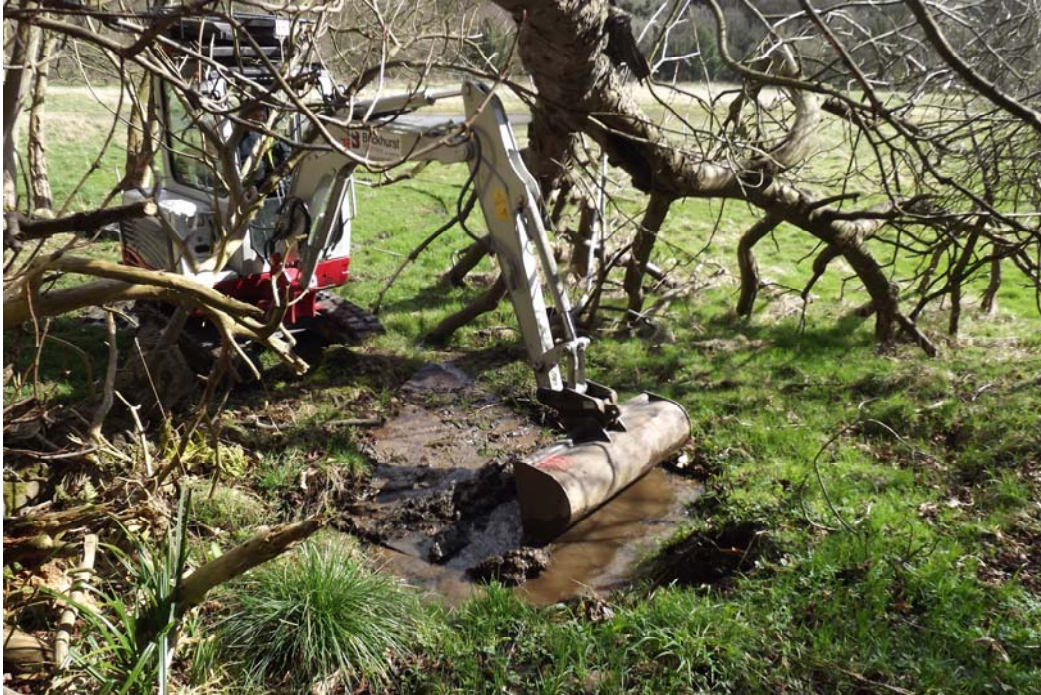
At this stage the archaeological involvement involved monitoring during the opening of a large brick lined drainage tank which had been covered with a large Fe plate (*Plate 3*). This was lifted by the mechanical excavator and the water filled interior cleared by use of the machine's bucket. The feature was then photographed.

Plate 3 Removing the Fe plate from atop the brick lined drainage feature (Photograph 037)

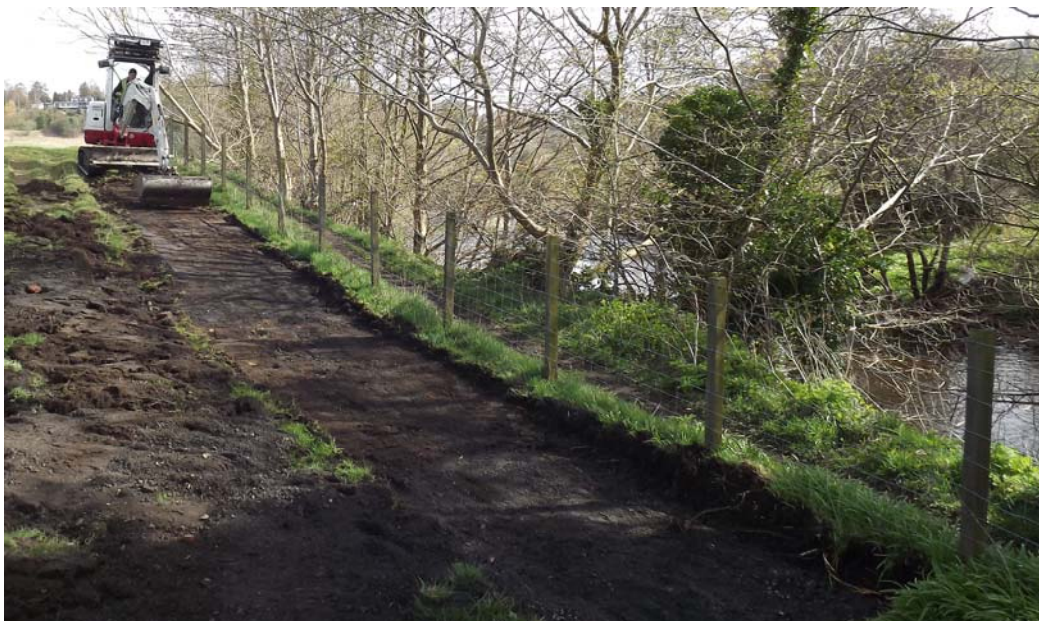
At the southern end of Path2 where it met the cricket pitch, a deposit of firmly compact mid black and grey ash and grit was recorded below the topsoil. This was recorded as (109) and contained a quantity of un-frogged, red bricks and fragments of Fe slag. This industrial deposit extended c.15m northwards, into the field beyond the cricket pitch before petering out at the top of a small rise. It likely relates to landscaping or levelling of a quantity of dumped mining material from nearby workings.

Plate 5 Working shot showing the industrial deposit (109) being revealed at the start of Path 2 within the policies (Photograph 052)

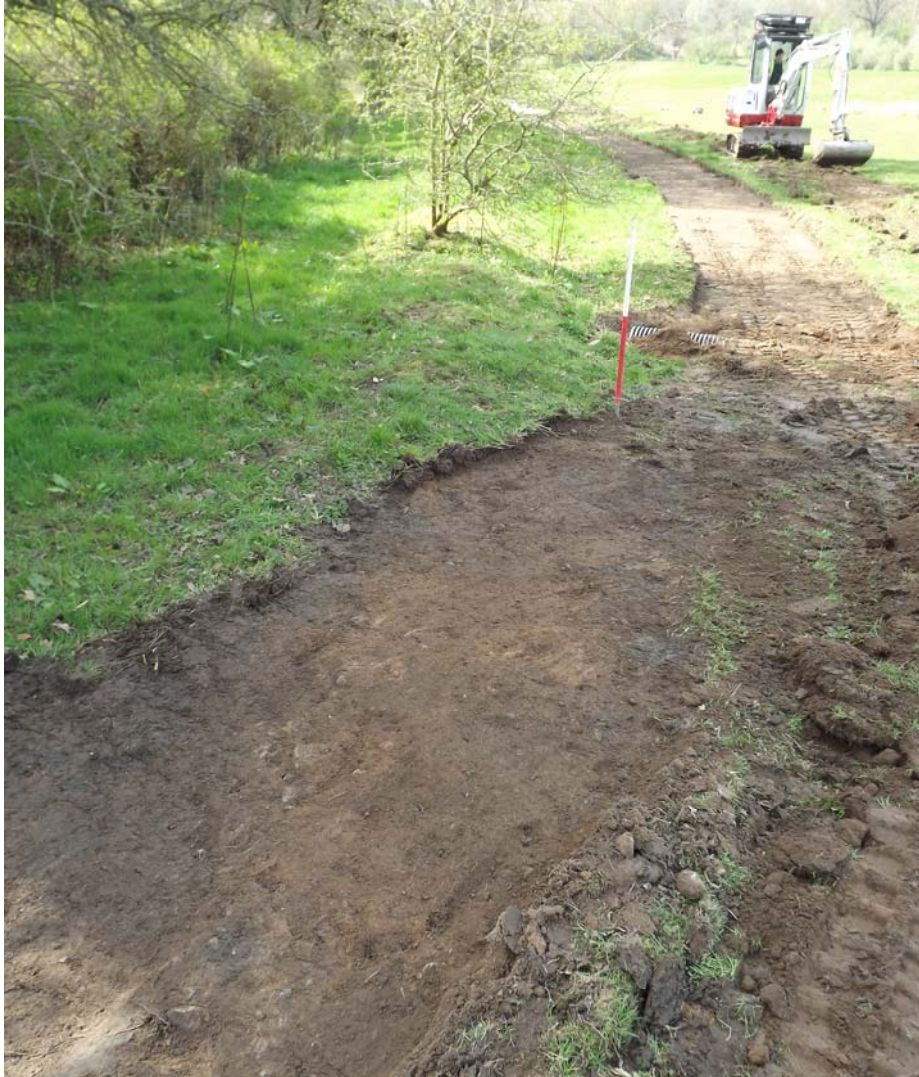
At the northern limit of Path 2 just prior to the route once again crossing out of the Scheduled Area, the path crossed a linear bank (*Plate 6*). This feature had been visible alongside the path on its south east side for c.26m, with a maximum height of up to 0.20m. For some of the length, a ditch could be discerned on the south east side, but it is unclear whether this is a drainage feature or related to some form of designed landscaping. The location on the edge of the site, mirroring the field boundary to the south east makes the former seem more likely.

As the path crossed (*110*), it only required the removal of some 0.10m of topsoil, essentially leaving the feature intact. (*110*) was comprised of firmly compact orange brown silty sand, clearly a re-deposited natural subsoil. At its highest point (*110*) was c.0.20m high with a width that seems to have slumped to c.1.50m.

Plate 6 Looking along (110) to the south west (Photograph 084)

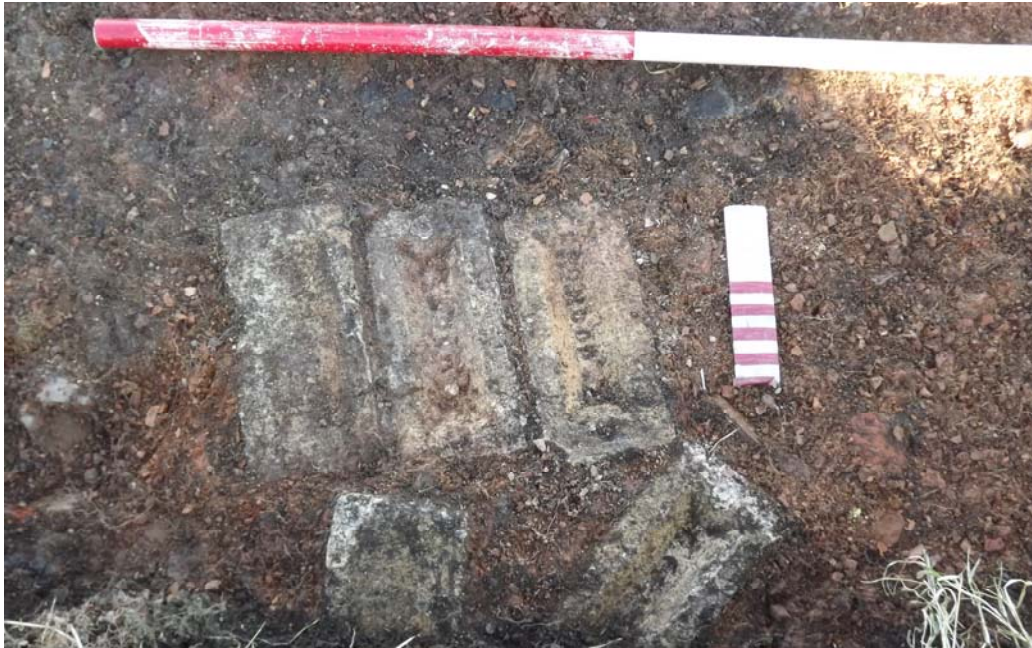
The excavations across the cricket pitch (Path 3) at Mavisbank essentially involved the removal of around 0.20-0.30m of topsoil. This very quickly revealed a series of firmly compact grit and gravel levelling layers. Initially it was thought that these may represent the remains of earlier path networks, but it quickly became apparent that a major landscaping event had occurred across the route of the pathway, with firm deposits of stone, grit and gravel packed across the area. Much of this deposit comprised red blaise (107) into which five white bricks were clearly set (Plate 7).

Plate 7 Detail of bricks stamped 'Hood' set within the red blaise deposit (107) (Photograph 022)

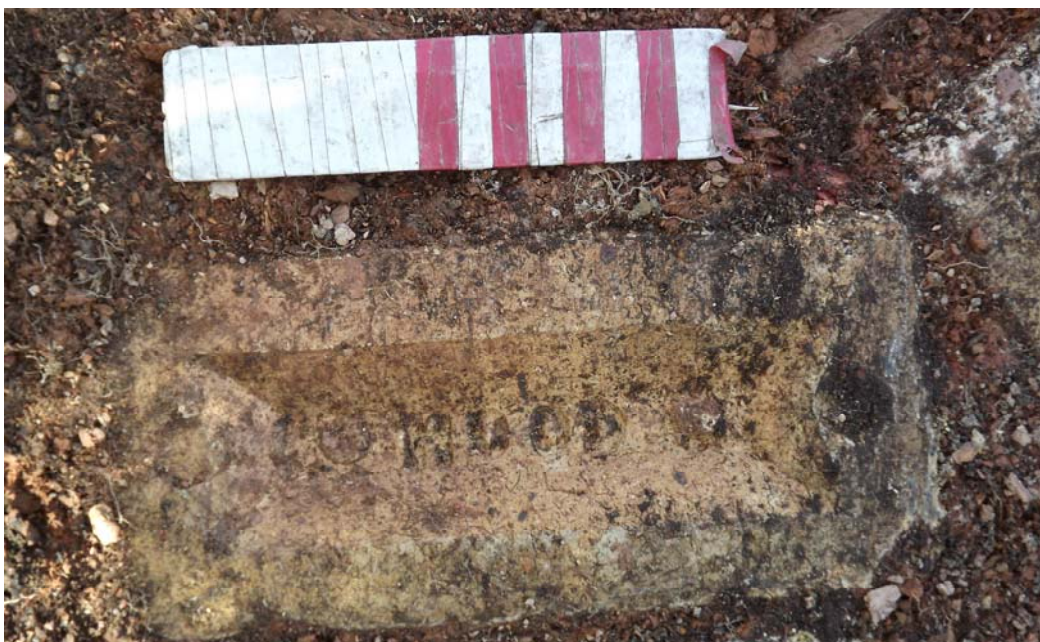
Plate 8 Detailed view of bricks stamped 'Hood' within (107) (Photograph 024)

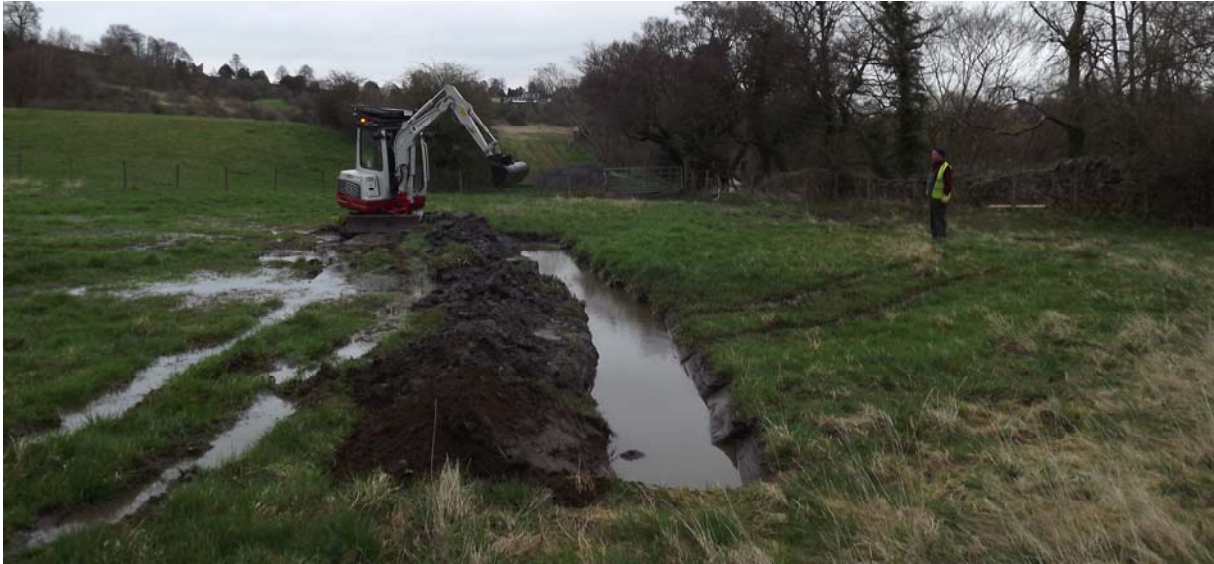
Plate 9 Temporary drainage in the north eastern corner of the Cricket Pitch (Photograph 049)

Proposals to complete work on the stone lined drain, known to exist at the northern end of the Cricket Pitch, had been held up, and as a result it was agreed to excavate a temporary drainage ditch in a north-south direction in this area, to facilitate drainage of the Cricket Pitch and to allow the area east of this to dry out in preparation for future work.

Dug with a bladed bucket, the drainage trench quickly filled with standing water, making it near impossible to assess for archaeological features.

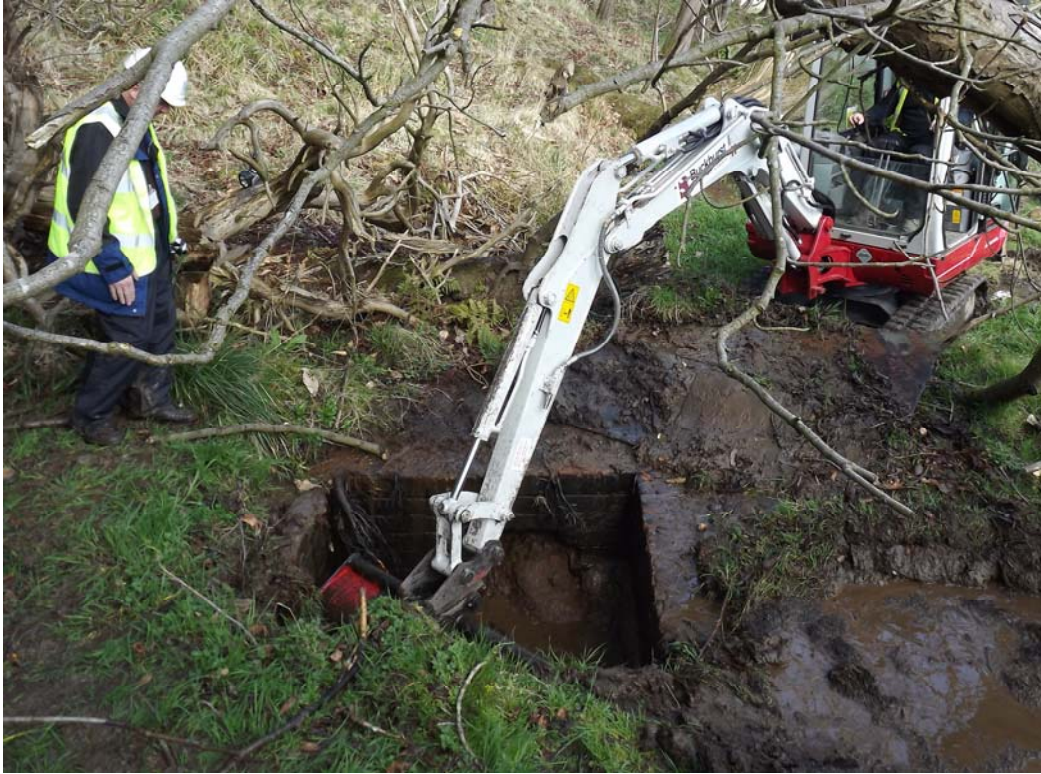
The chamber had sides of 1.50m length and once the water was removed, proved to have a depth 0.60-0.80m before the silty accumulated fill was reached. An opening, clogged with silt was revealed in the north side of the chamber, lining up with the visible drainage ditch running north eastwards along the base of the slope. Although it was not possible to remove all the water and silt from the feature, probing with arranging rod revealed a further aperture beneath the water line along the western side. It was not possible to identify any names stamped on the bricks.

Plate 10 Opening the brick lined chamber (Photograph 042)

It was assumed that this feature acted as a settlement tank for water drained off the hill, with the water entering via the lower aperture on the west side, and the cleaner water exiting on the higher drain to the north, with the silt settling in the base.

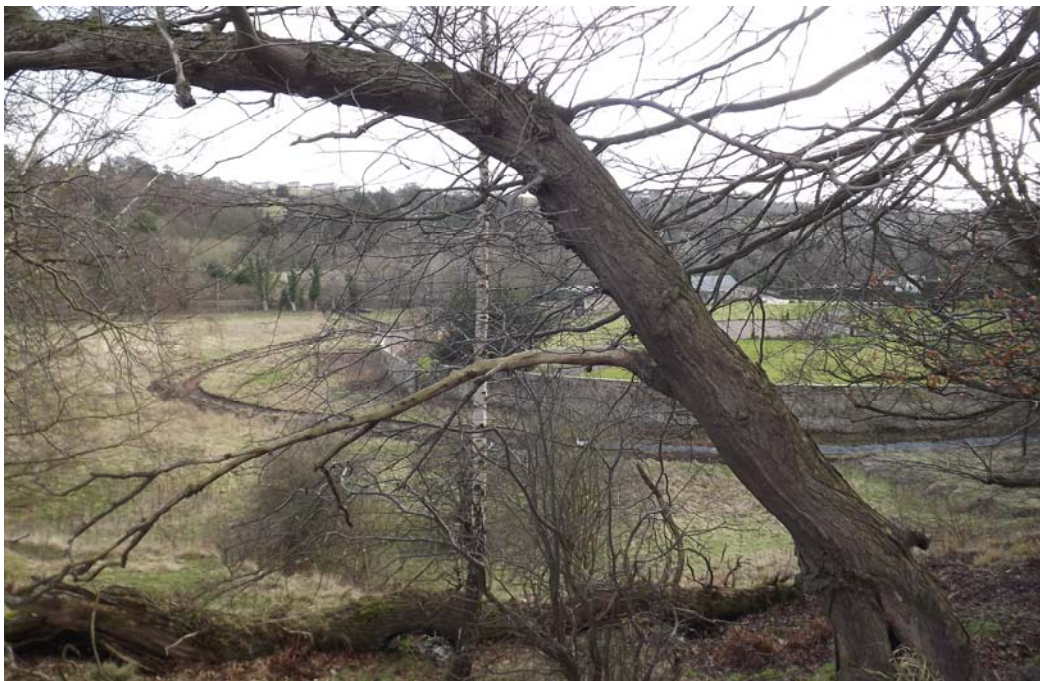
The watching brief on the cricket pitch at Mavisbank revealed no indication of important archaeological features. It is possible that features associated with the policies and designed landscape may have survived the 20th century levelling event in the area of the walled garden, but these will be buried beneath the topsoil and the overlying red blaise deposit.

Plate 11 Post-excavation view of the route of the path across the cricket pitch taken from the hill to the north west (Photograph 030)

Although any future work on the Scheduled Monument will require archaeological supervision, no further work is recommended as part of this phase of works in relation to the installation of the paths around the cricket pitch.
