Panmure House

Canongate, City of Edinburgh

Historic Building Survey and Analytical Assessment

for Edinburgh Business School

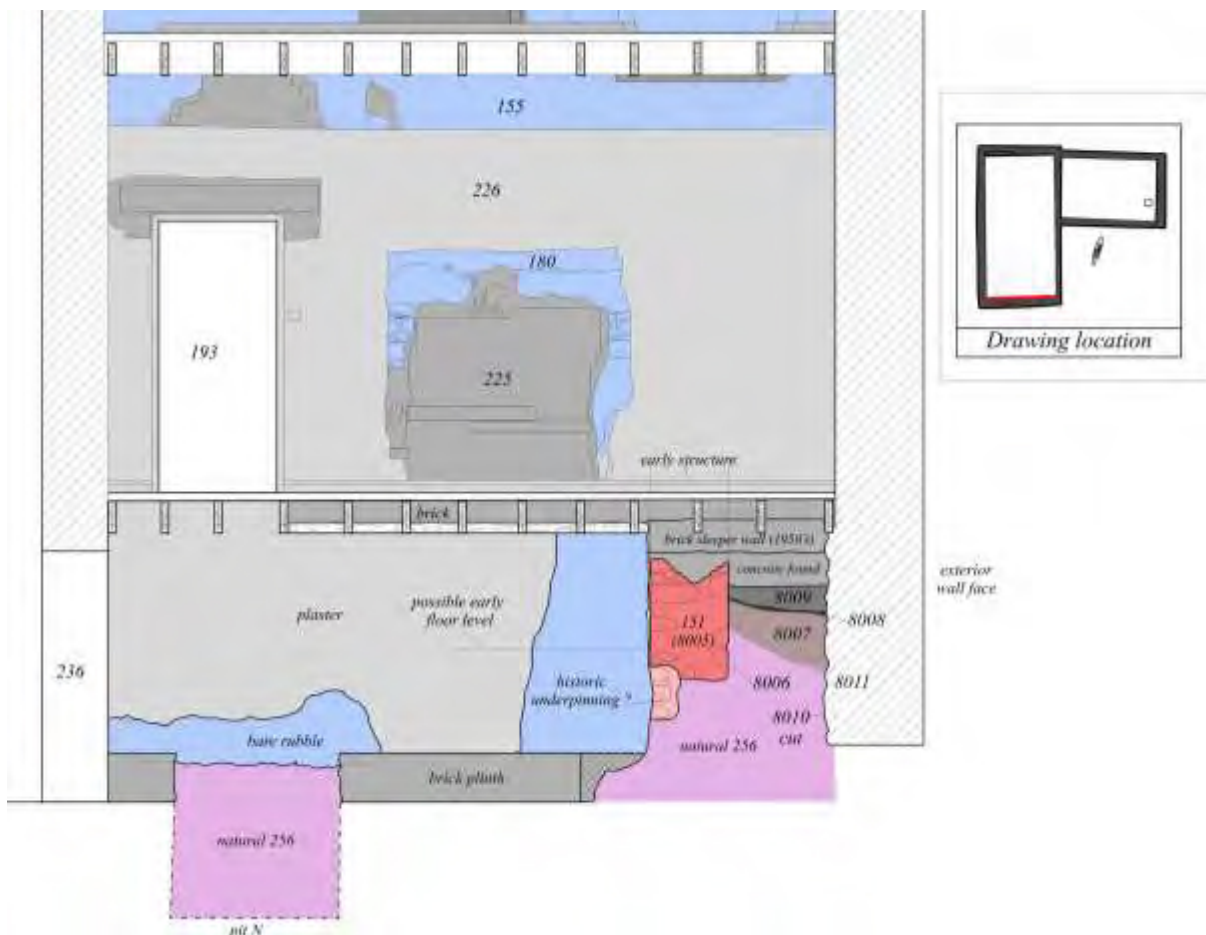
Figure 3 Interior of the south wall of the principal range at basement and entrance level showing remains of earlier structure in section (red), associated deposits, and walling related to the construction of Panmure House in c.1690 (blue); areas obscured or modern in grey

Evidence recorded during the dismantling of the baulk revealed the earlier building to have been terraced into the slope of the ground, *figure 3*. On its east (interior) side this had involved cutting down into natural deposits including the upper parts of underlying bedrock. In later times, especially during the 1950s works, the interior floor levels were further greatly reduced (by 1m or more) and the surrounding walls underpinned, operations that eradicated evidence for early floor structures or occupation deposits.

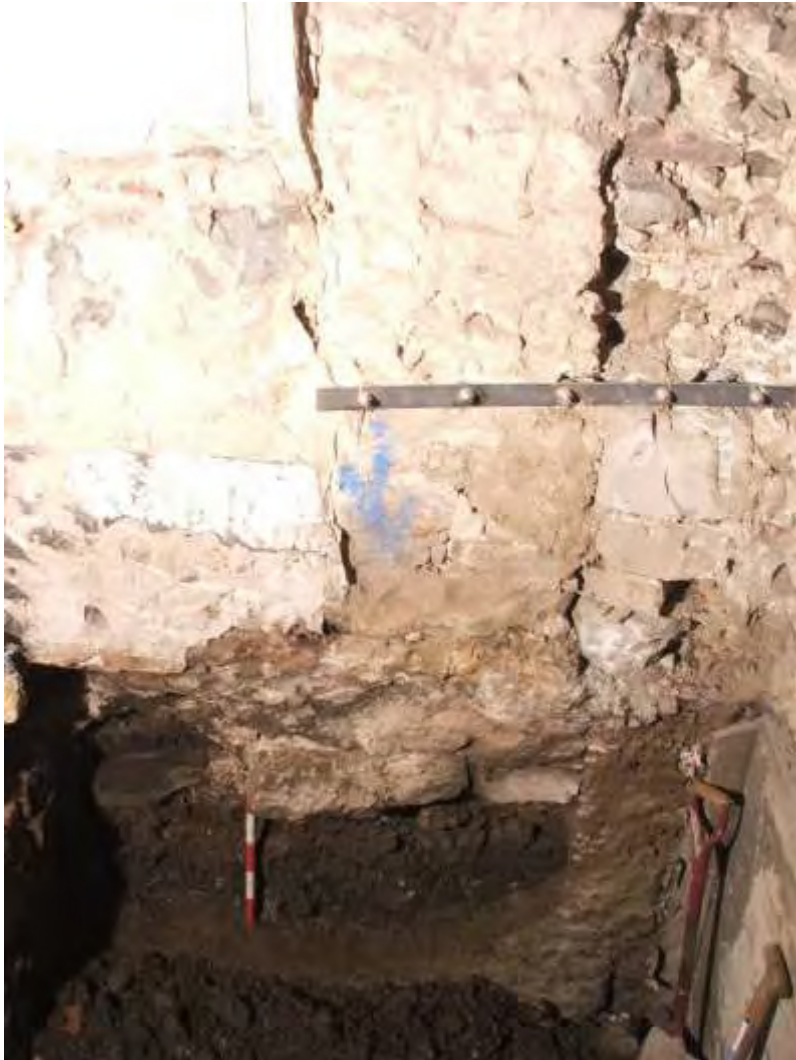
Plate 2 North wall of Panmure House at basement level, northeast corner. 1690 masonry to left and reduced masonry of boundary wall to right; the vertical butt joint between the two can clearly be seen behind the metal strap; also visible in section below are cultivated soils on the west side of the boundary wall; looking north

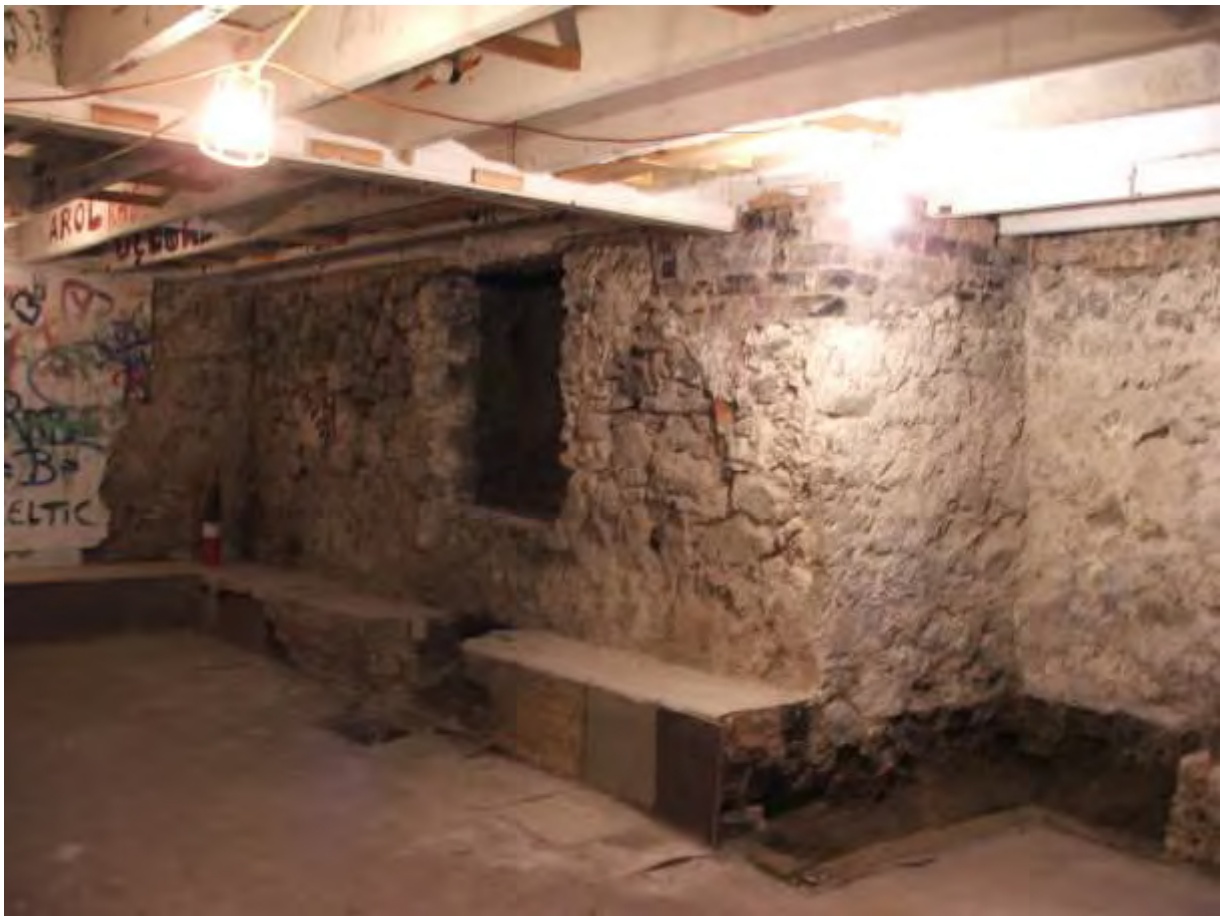
Plate 4 Wall stub 151 within the SW part of the basement (Room 1), looking SW

Remains of pre-existing masonry within the south wall and the SW part of the room were described in the previous section – 151. The masonry of the c.1690 phase was built over and around this. The projecting baulk of surviving early masonry was dressed back and made good with new lime-bonded rubble. Possibly as part of this an opening was cut through the central part of the earlier masonry baulk and into the retained natural deposits beyond, in order to form a recess, 156. The jambs and back of this recess was made good with lime bonded masonry. The truncated northern end of the 151 masonry was also made good with lime bonded masonry, 157, and formed into a return to the west to join into the new western frontage, *plate 4*.

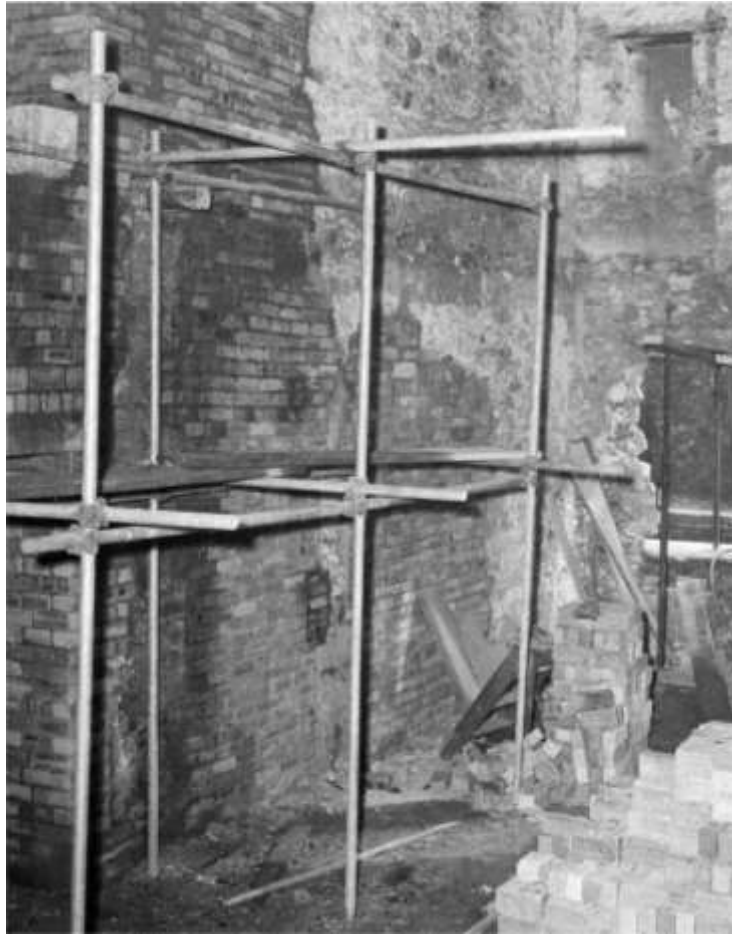
Plate 7 ground and first floor SE corner 1950 works; note aumbry to upper right of image, 220

On the south wall at this level there survived the remains of a central fireplace, 202, now blocked up. A window exists at the west end of the wall, 203; this is generally well preserved, but its safe lintels replaced with concrete internally. To the east of the fireplace a small area of secondary brickwork indicated the position of a blocked opening, 220, an aumbry-like feature as is evident from a photograph taken during the 1950s works at which state it retained its timber safe lintels, *plate 7*.

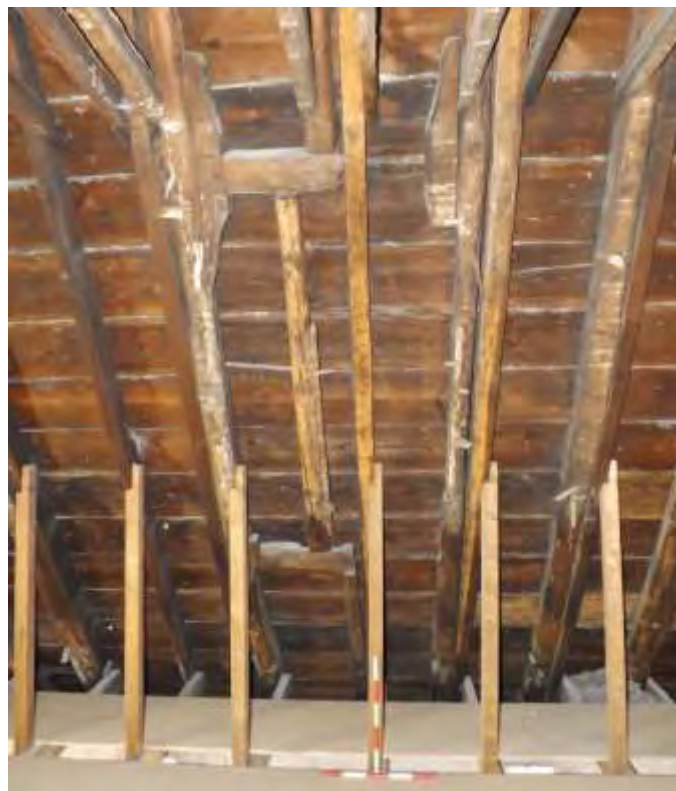
Plate 11 Framing for dormer window, 023

On the west pitch between frames 006 and 008 there survived the framing of an early dormer window, 023, *plate 11*. The lower part of the dormer framing was formed from a horizontal bridle beam half lapped onto the top of the adjacent rafters, and the upper part a further beam tennoned and doweled into spreaders which were then spiked onto the joists. Evidence for two more such dormers was recorded further north on the west pitch. These of similar construction detail but less well preserved, sometimes only the shadow of the removed spreaders and the associated spike holes was evident, along with the half lap joint on top of the rafters indicating the position of the lower bridle. The second dormer 024 was between frames 014 and 016. Some lath and plaster remnants, 027, survived upon the ingo of the former dormer 024, trapped between the joist 014 and a secondary roof structure element.

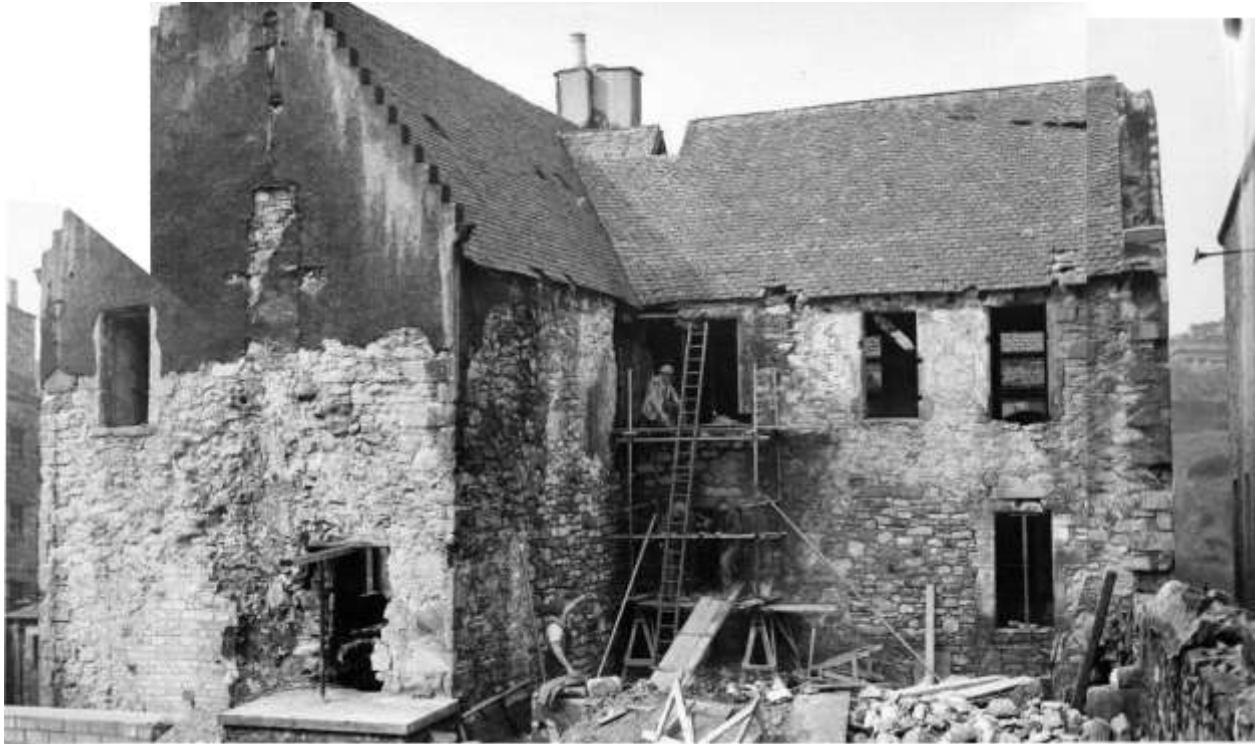
Plate 16 composite photograph of 1950s works showing south elevation works of 1956-7 in progress (SCRAN / The Scotsman)

Extensive areas of the original masonry were replaced/repared in cemented brick, the most extensive area of this was concentrated around the blocking up of the doors slapped into the now demolished stairwell. Many of the fireplaces were blocked up with brick at this stage and areas around windows were patched up – all timber safe lintels were replaced in concrete. A number of openings were opened up between the main range and the east range. This was possibly undertaken in two stages as some differences in the brick types might suggest; however in a few places both brick types coexist in the same infill. The interior was re-plastered throughout in a thick build-up of cement, in places up to 6cm deep.

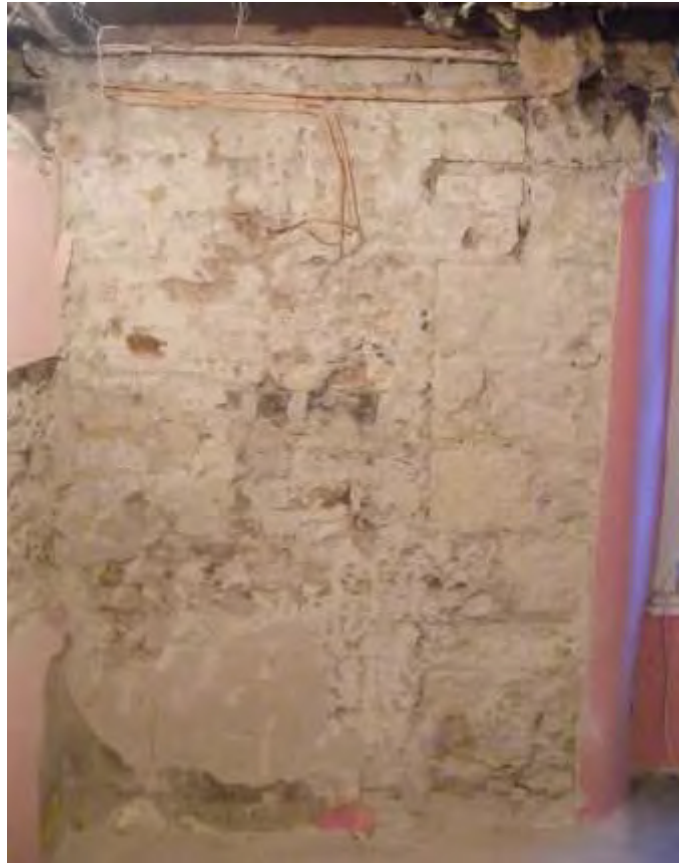
Plate 23 opening 201 (jamb to right) infilled with cemented brick 225

These openings appear to be within lime bonded rubble masonry 196 and associated with a basement floor opening 201 this opening where it survives is a much better constructed opening arched over with a rubble half arch abutting the western range on the exterior. Any quoining of the opening on the exterior has been lost in later robbing or slapping's but on the interior the eastern jamb is intact. This is of very square cut and plain blocks of fine blond sandstone unlike any masonry seen in the rest of the building.

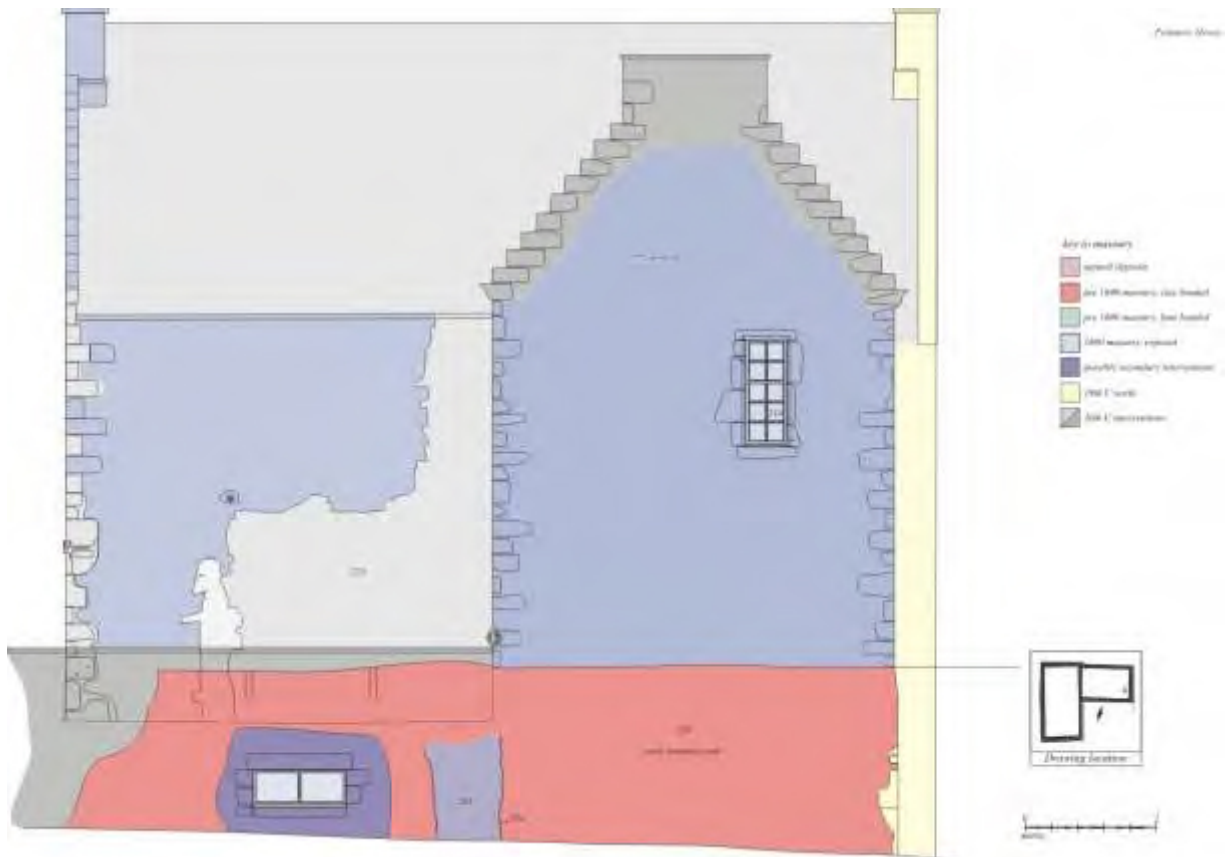
Figure 8 phased east exterior

The masonry east gable of the east range was once the cement coating had been removed was found to be heavily degraded and this was stripped and patched up in segments. Very little diagnostic could be seen within this fabric, a series of patching's on the interior gave the possibility that there was a series of windows down this elevation but no evidence for any more windows other than window 214 could be seen on the exterior .

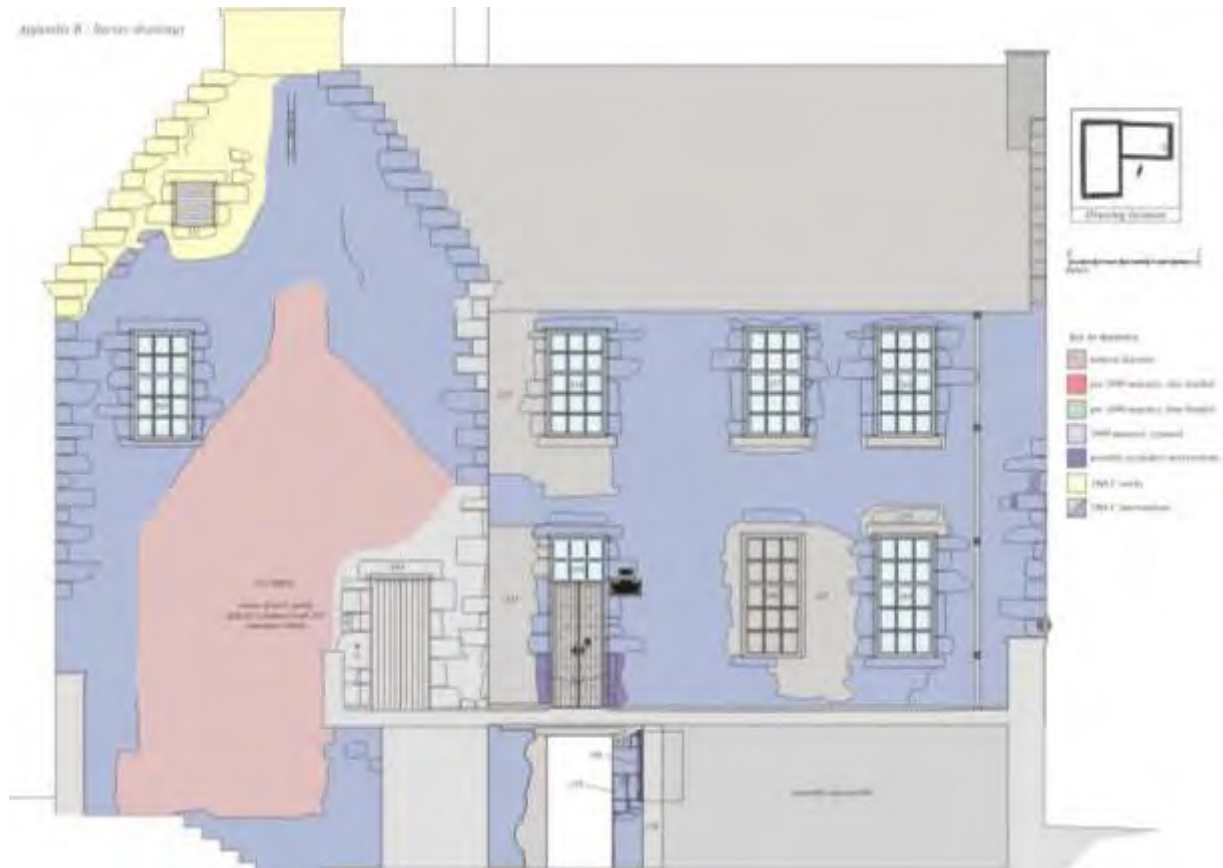
Figure 9 Phased south elevation

Following the demolition of the rest of the early range the gable was preserved within the south gable of Panmure house, the masonry of this early gable was then harled over and would still have been quite visible as a bulge in the gable. Photographs from the 1950s works show this gable part stripped. The clay bonded masonry appears to be in a poor state of repair at that time.

The 1950s works were extensive , on the south gable the degraded masonry of the clay bonded 8005 early range was reskinned in cement bonded rubble as part of this an opening possibly a window was converted into a door 193 .some quoining was also replaced at this time.
