Fluthers Cottage

Earlston, The Scottish Borders

Historic Building Recording and Archaeological Evaluation :

Job number 2117

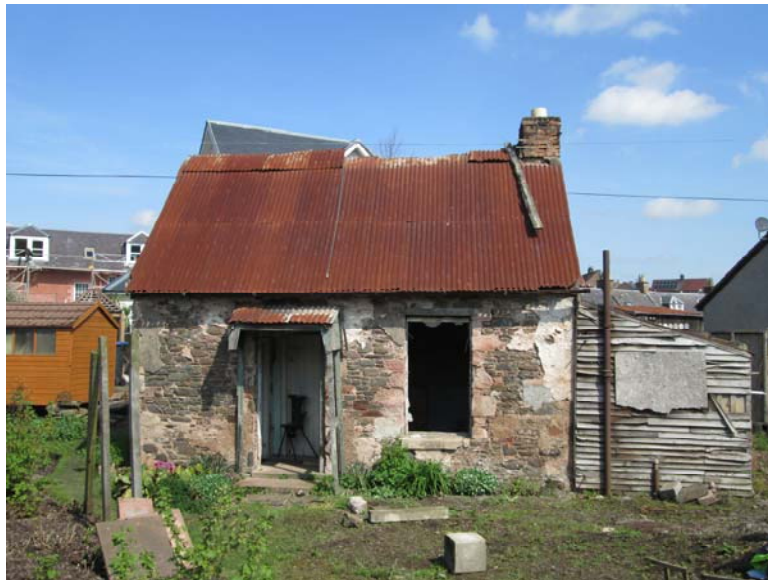
The front elevation, as with the rest of the cottage was predominately built from grey whin field stone rubble, with occasional roughly squared red sandstone (*plate 3*). The masonry was roughly coursed and bonded with coarse lime mortar. There were surviving areas of a coarse levelling layer of lime harl (002) with a finer course (003) applied on top. The wall stood to a single storey and had two large openings. The door was off set to the left with a timber lintel over. An open timber porch (007) had been built over the door (006) with a corrugated iron roof. The jambs were formed from the same rough rubble stones as the rest of the elevation mixed with some sandstone. The single window (005) was to the right of centre and appeared oversized in relation to the rest of the cottage. The jambs were of rough pink sandstone with a timber lintel. There was no check for the window frame, which together with the disproportionate size of the window (022) may suggest that the aperture was formed to fit an existing salvaged window frame.

Both the door and window are secondary features slapped through the early elevation.

Plate 3 General view of south elevation (061)

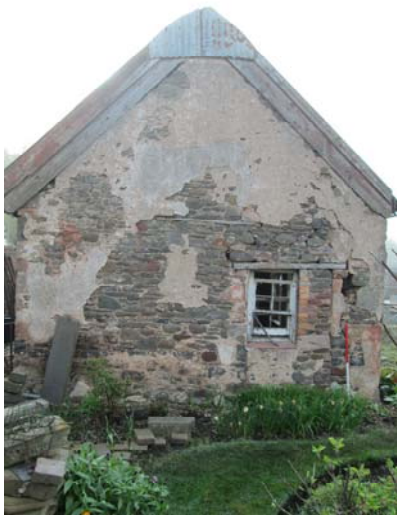
The west elevation was built of the same materials as the frontage (*plate 4*). Some of the quoins were squared sandstone, whilst others were rougher whin. A larger proportion of the west gable was covered in harl and due to the unstable condition of the masonry it was not possible to safely remove the harl. At the south side of the gable evidence survived of the original doorway (*014*). The jambs could be seen running down to the ground: the upper parts of the jambs on both sides were formed from pink sandstone, with the lower parts whin rubble (*plate 5*). The first edition OS map (*figure 3*) shows the cottage's main approach from the west, presumably leading to this door. The lower part of the doorway was subsequently blocked (*015*) with whin rubble, the same as the main fabric of the building.

Plate 4 General view of west elevation (011)

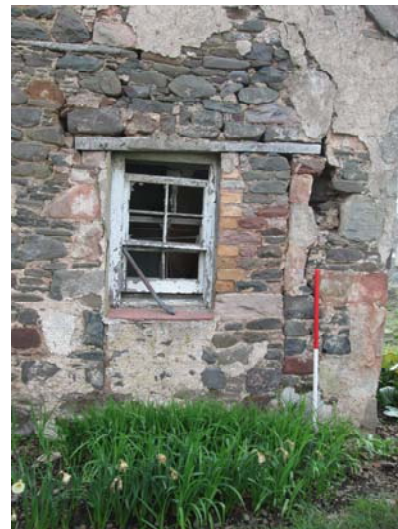
The opening was further built up (*016*), to form a narrower window (*017*), using small rubble with the south jamb built from brick. Brick had also been used to build up the wall head at the north side (*020*), possibly at the time the corrugated iron was added to the roof. It is possible that this was carried out at the same time as the window alterations and the rebuilding of the chimney in brick as part of general improvements to the property.

Plate 5 Detail of blocking around window (013)

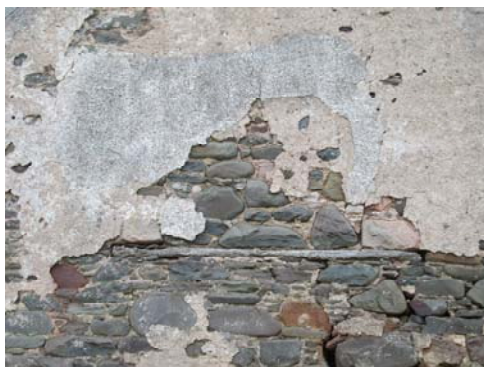
A second window (*018*), now blocked (*019*), was partially visible in the centre of the gable at attic level (*plate 6*). The lower squared sandstone jambs and a thin timber sill were all that could be seen due to the covering of harl. Further evidence for this window could be seen on the interior, where the upper sandstone jambs and timber lintel were visible (*plate 7*). The height of the window in relation to the current roof structure suggested that the present ceiling must have been added after or at the same time as the window was blocked.

Plate 6 Blocked attic window exterior (014)

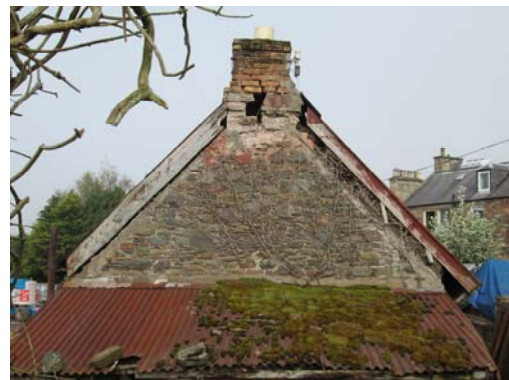
Plate 11 Upper section of east gable (021)

The base of the east gable was obscured by the timber lean to; the exposed masonry was identical to that observed elsewhere in the building, and there were only very slight traces of harl visible (*plate 10*). The base of the chimney as seen on the exterior was built from squared sandstone. The upper part of the chimney had been rebuilt in brick, similar to that used in the blocking and wall head rebuilding in

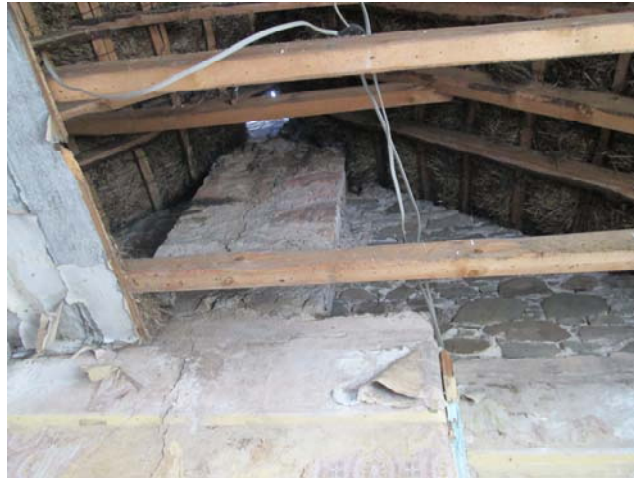
the east elevation (*plate 11*). Internally the chimney could be seen to abut the whin masonry of the gable, showing it was a later addition (*plate 12*).

Plate 12 East elevation showing later chimney (043)

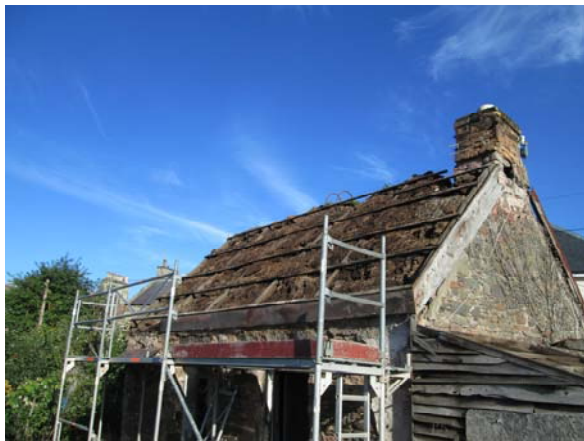
The condition of the thatch was varied across the roof structure. In general the south pitch of the roof was in poor condition (*plate 19*). The thatch was more degraded and had been further damaged by birds' nests and extensive rat runs beneath the corrugated iron covering (*plate 20*). This side of the roof would have been subject to the prevailing wind and weather and be more at risk of damage.

Plate 19 general view of thatch, south side (090).

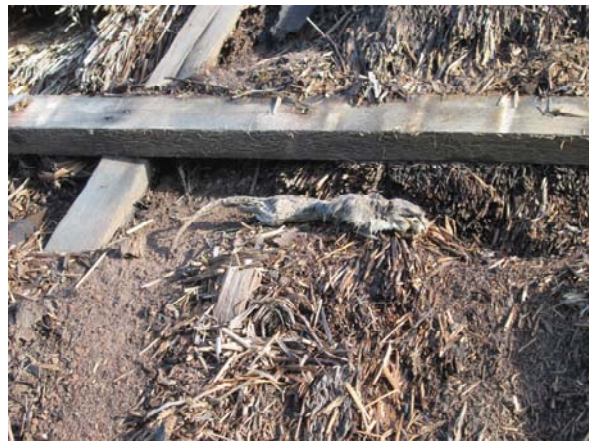
Plate 20 Rat runs within the Thatch (100).

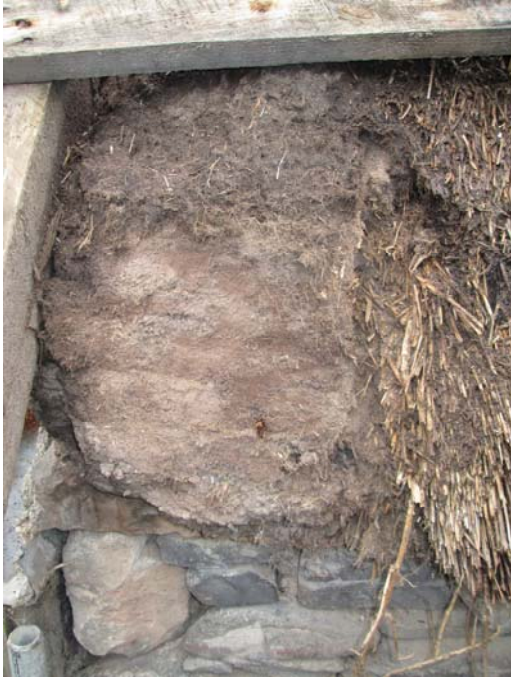
On the north pitch of the roof the western skew was entirely eroded away, whilst the eastern skew on the same side of the roof was the best preserved. A section through the thatch was excavated at the western skew to clarify the relationship between the skew and the thatch. Here turf skew appeared to have been built then the thatch butted against it (*plate 21*). This was different to the technique used on the south pitch of the roof. Although badly eroded, both skews survived on the south pitch and were excavated to understand the relationships. Here the turfs were interleaved with the straw of the thatch. At the west end, in places the straw completely covered the turf. It would seem that the thatch and turf were laid together, with a row of thatch topped at the skews with turf, then the next row of thatch laid again with a turf at the skews (*plate 22*).

Plate 21 Turf Skew with abutting thatch north side (175).

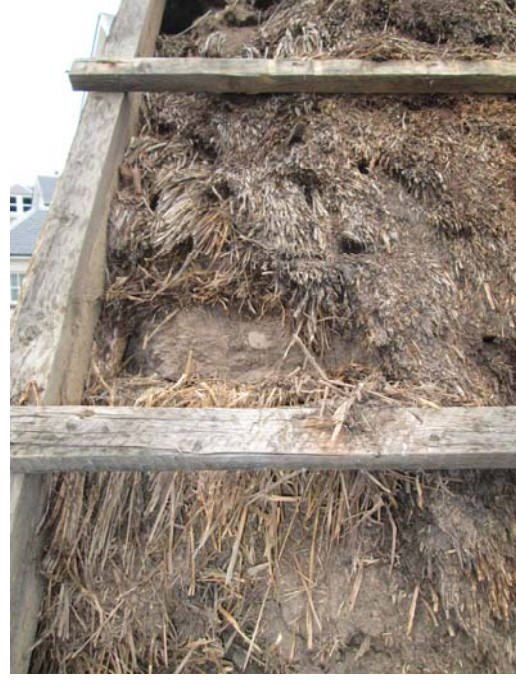
Plate 22 Turf and thatch skew, south side (173).

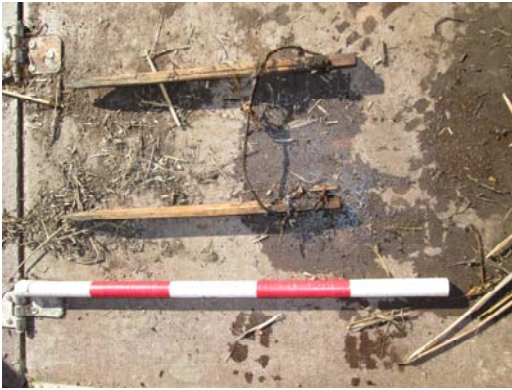
As described above, there were two distinct sizes/styles of straw bundles used in the thatch. There were also two distinct methods of fixing the thatch to the roof. From the underside it was possible to see that the bundles of straw were tied to the batons with a thick twine most probably made by twisting bramble stems after removing the outer layer. The upper layer of thatch was mostly held in place by straight sharpened pegs which looked to have been made from splitting left over timber from the construction of the roof. The pegs were in pairs and joined at the top by a length of the twine described above. These were then pushed into the thatch with the twine running along the surface. This form of fixing was used on the south pitch of the roof and the east end of the north pitch. The turfs forming the skews on the south pitch were also pinned together by the same form of pegs (*plate 23*).

Plate 23 Timber pegs with twine (125).

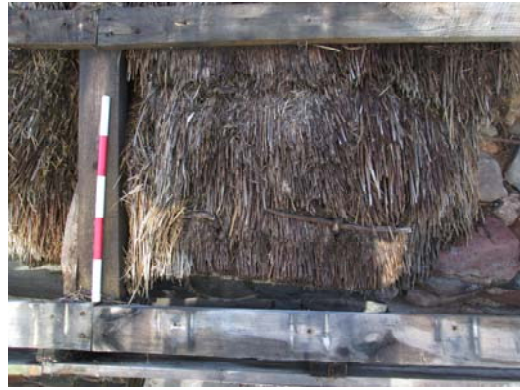
A groove running down the thatch from ridge to eaves was visible towards the east end of the north pitch. To the east of this the thatch was in a much poorer condition and to the west was a different form of fixing the top layer of thatch. This was done using hazel canes or twigs twisted and bent into hairpin shapes known as scobs; these were pushed into the thatch to secure it in place (*plate 24*). One of the scobs retained a short length of hazel which lay along the surface of the thatch to hold it in place; long lengths of hazel were often held in place by scobs to retain the upper layer of thatch.

Plate 24 Scob and hazel rod holding down thatch (113).

It seems likely that this difference in technique indicates that the thatch was replaced along the west end of the north elevation at some point and the thatcher carrying out the repairs used his own preferred technique, perhaps an older tradition.

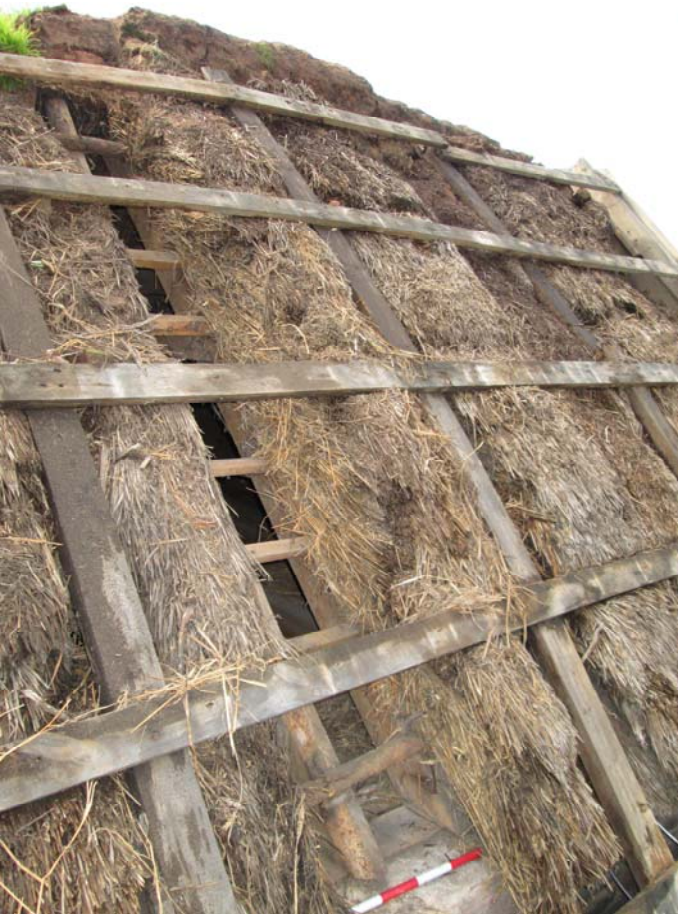
The thatch itself was predominantly wheat straw, with some barley straw also present. The lengths of straw were largely complete from base to seed head. They had been folded in half and twisted to form a knot which was tied to the roof with the loose ends of the straw forming the visible part of the thatch. These varied in length from 0.7m at the longest to 0.5m; the longer lengths were more common. Along the north side of the roof where preservation was best, at the eaves the thatch had been tightly compacted and trimmed at an angle of 45°. Where the section through the thatch was excavated there was only one layer of thatch (see below), and evidence that the thatch had been entirely replaced in the western half of the north pitch (*plates 25 and 26*).

Plate 25 section through thatch

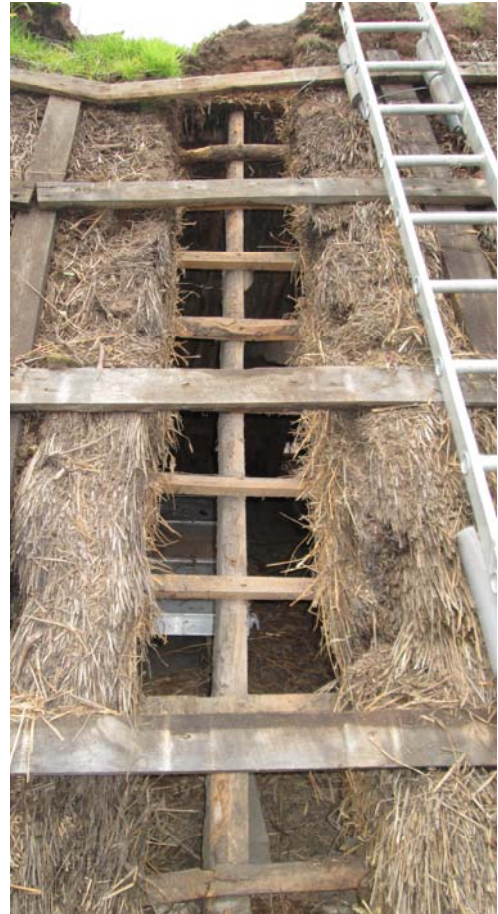
Plate 26 section through thatch
