The Gates, Durham

Historic Building Assessment

April 2015

Nathaniel Litchfield & Partners on behalf of Milburngate Durham Ltd

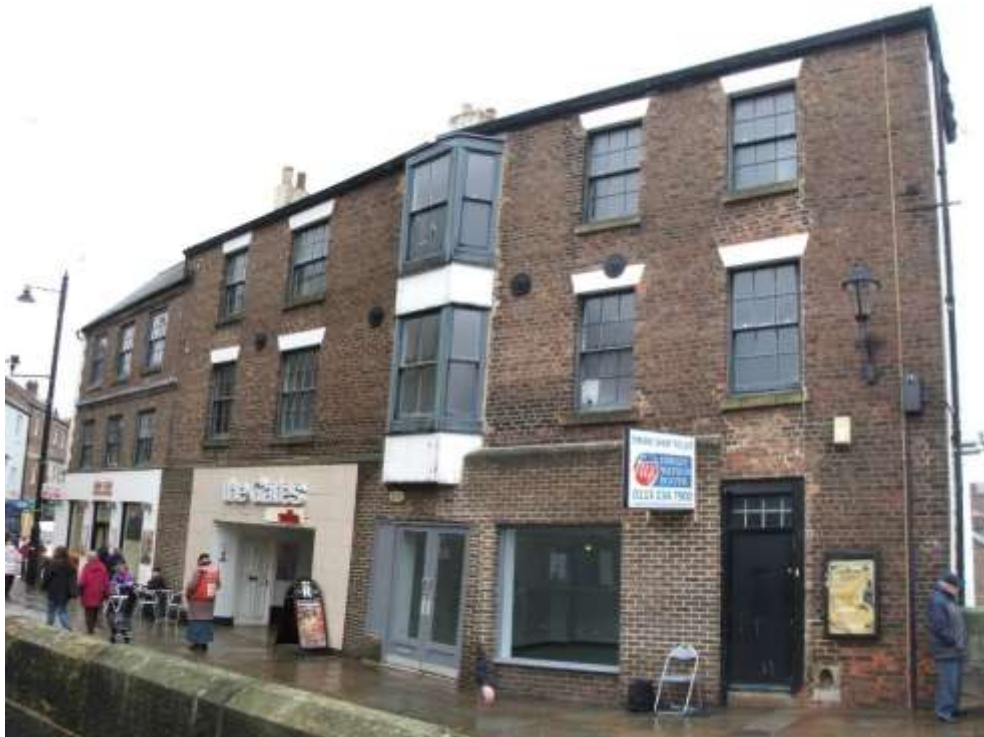
Plate 3 The south (street) frontage of No.1 Framwellgate Bridge

Overall the structure is of five bays width, of three storeys, built of brick with a comparatively low-pitched roof slated in Welsh slate. The brick employed is of hand-made narrow low/medium-fired terracotta. The central bay of the south-facing street frontage has a double-height oriel window. The ground floor has clearly been rebuilt in modern time with brick, forming slightly projecting fascia (by about 0.20m – 0.25m) to create the ground-floor frontage, and then covered with tiles in the area of the entrance to The Gates Shopping Centre.

The five bays are not entirely symmetrical, with two larger windows in the bay to the west of the central oriel (containing 8-over-8 paned sashes, opposed to the 6-over-6 elsewhere) and different spacing between windows. Apart from the oriel which seems to be a secondary insertion the façade appears to have been built at one time. The asymmetrical arrangement perhaps suggests a more complex earlier structural history; however there is no point within the building where this possibility can presently be investigated. Overall the building is of c.1800 - early 19th century character although the windows have been replaced, in what seems to have been a careful repetition of the 19th century glazing patterns.

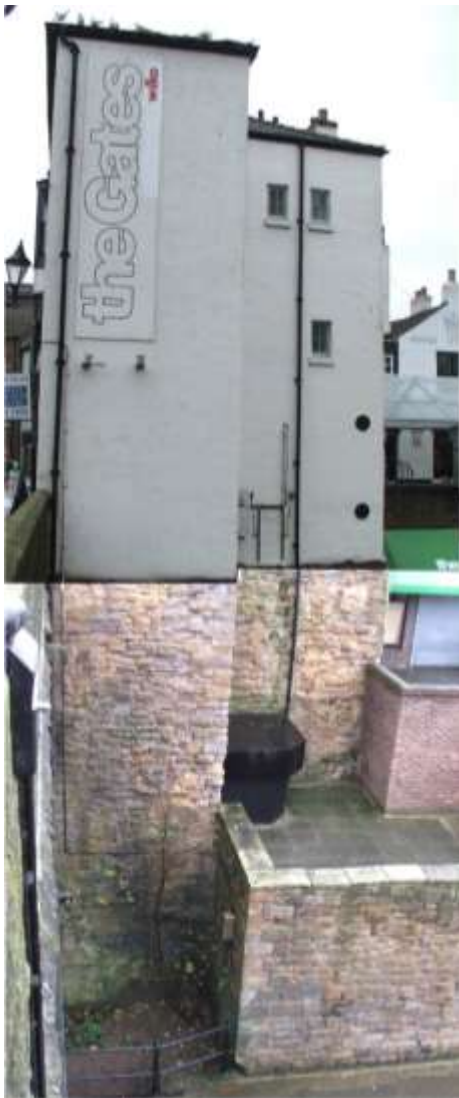
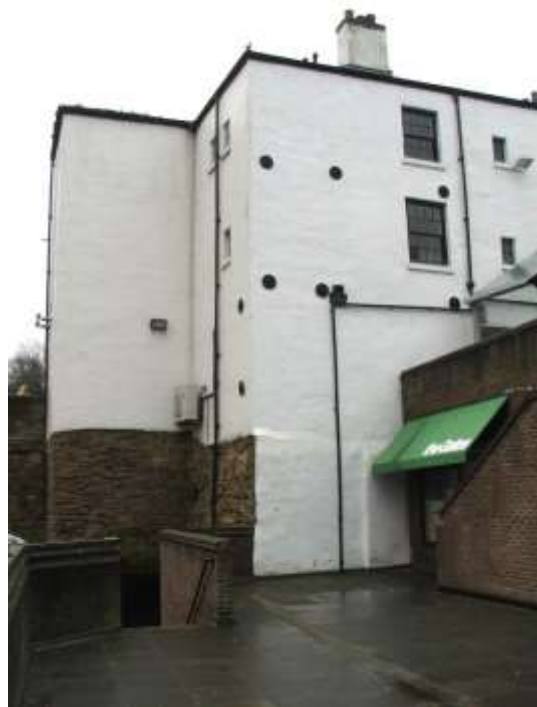
Plate 4 and Plate 5 The east side and rear of 1 Framwellgate Bridge, showing the junction of the superstructure and the masonry-built sub-structure, looking west and south respectively

The building does not come to a full gable next to Framwellgate Bridge but is of half-width, the last bay of the structure having evidently been purposefully constructed as a stair tower. However as will be described below the base of this part of the structure, below bridge parapet level, is masonry-built and apparently largely or wholly part of a pre-existing structure, possibly mostly of medieval construction and likely associated with the bridge.

The eastern side wall and rear walling of the property that backs on to the existing entrance court to The Gates is presently rendered in cement and painted white. One historic photograph of the mid-20th century shows the east side of No.1 – a larger area of the upper walling of the main range's east elevation is free of render; here the general wall fabric is visible where it is now obscured, *plate x*. this appears to be of homogenous and regular construction but whether of brick or stone is not clear.

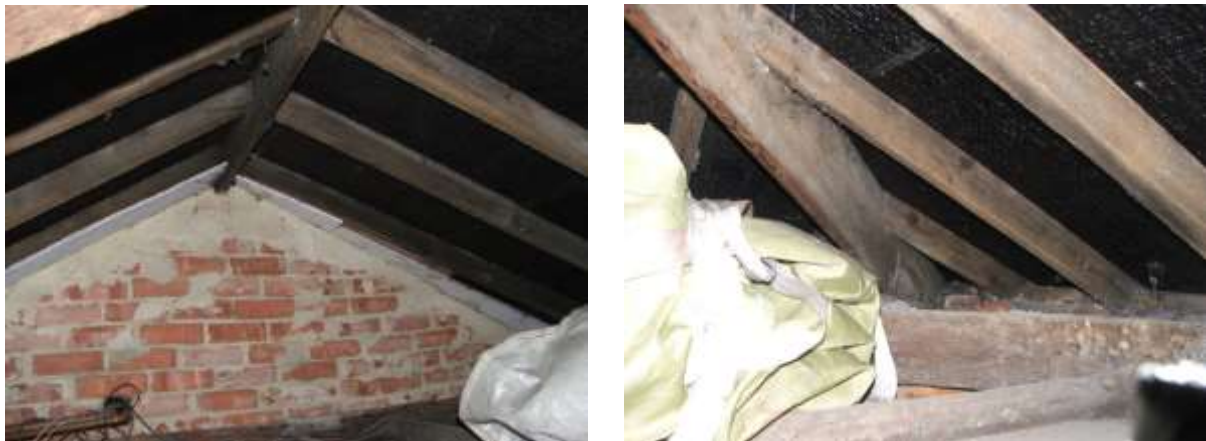
Inspection was made of the roof space. Here it was possible to determine the form and details of the roof structure, which was found to be largely intact historic fabric. Overall this had been formed of sawn pine of narrow rectangular section. The stair tower is hipped to the east, with hip rafters and common rafters rising from a wall plate to meet at a narrow ridge-piece. It is possible that this roof was in part a secondary rebuild, this suggested by the use of extruded bricks of later 19th century character at the head of the cross wall rising up within the roof space on the west side.

Plate 7 and Plate 8 No.1 Framwellgate Bridge - details of the stair tower roof structure

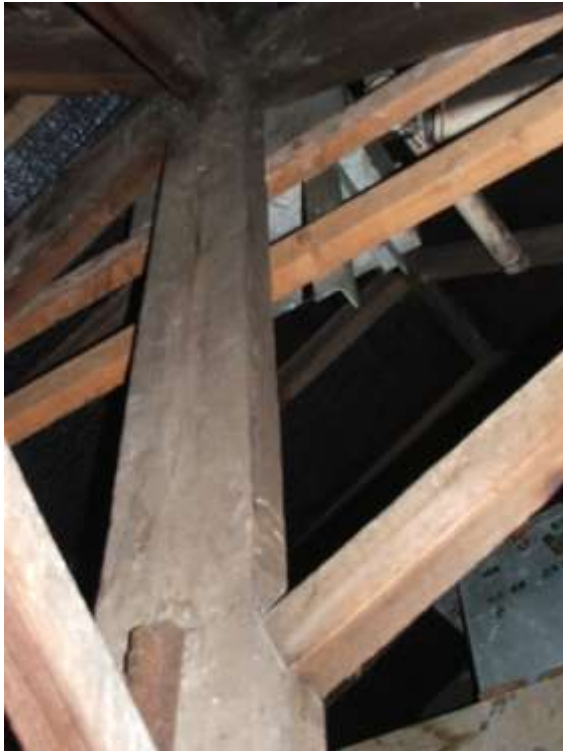
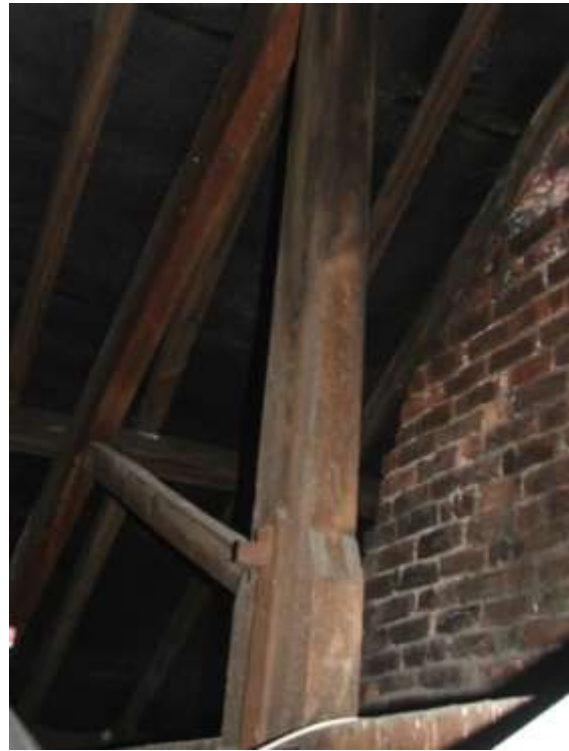
The main roof is supported by king-post trusses of typical later 18th century-early 19th century type. From the jowled bases of the king posts rise upward braces. The junction of the king-post and tie is secured by substantial iron stirrups, bolted on. Purlins support the common joisting of the upper structure. These roofs had been stripped of slates, sheeted and re-slatted at the time that The Gates shopping centre was built.

Plate 9 and Plate 10 No.1 Framwellgate Bridge - details of the king-post roof structure of the main range

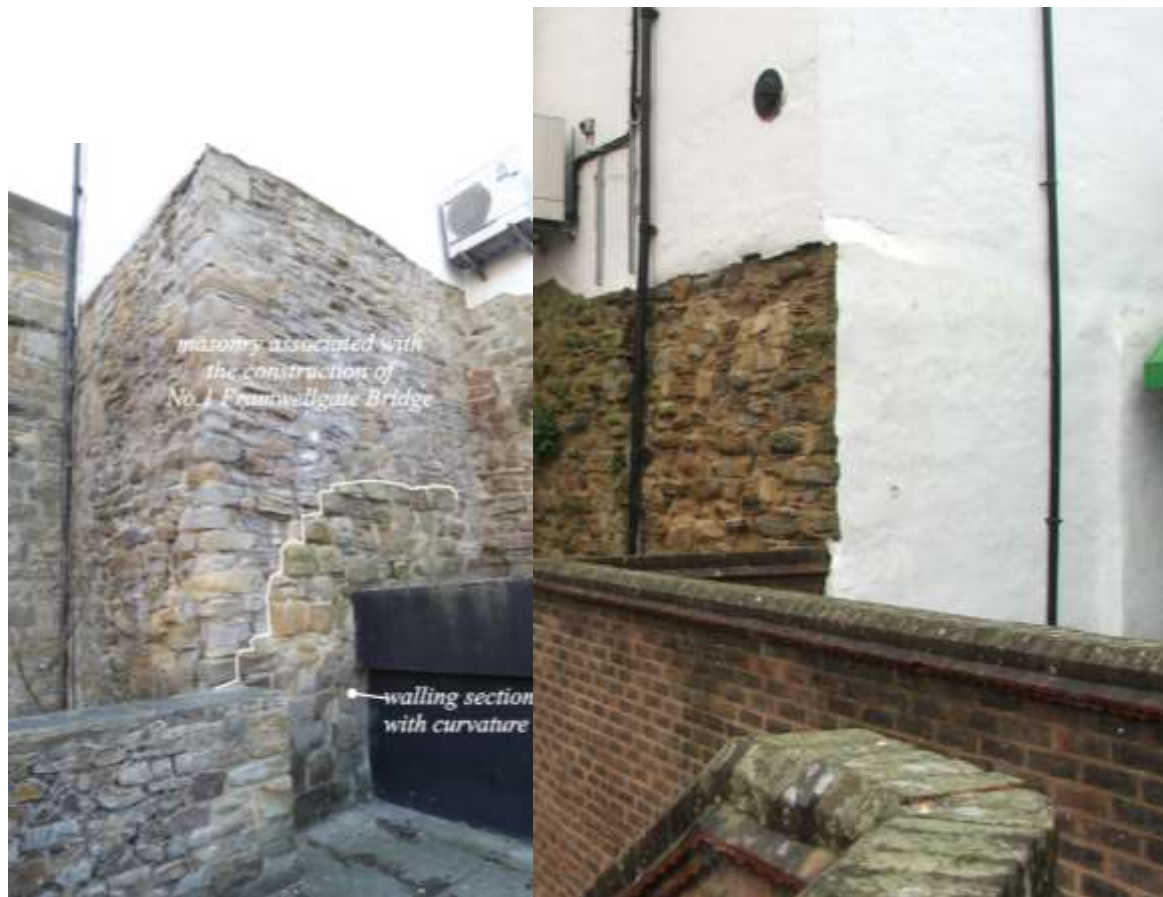
Self-evidently the lower parts of No.1 Framwellgate Bridge incorporate earlier structural fabric, this immediately apparent to the east, where the upper walling of rendered brickwork abruptly gives way to rubble sandstone masonry. The junction occurs at the base of the parapet of the bridge. The visible area of masonry rises for almost the full height of the bridge itself, over two stories overall. It comprises a number of individual builds. The upper part of the structure seems to be a rebuilding of whatever had existed previously. The rebuilding seems to be associated with the existing building above, the purpose to create a suitable construction platform for the brick superstructure. Sandstone available seems to have been recycled, this evident from the mixed nature of the quoining at the exposed NE angle and the rubble more generally, where stone both of a pale purplish hue and of a honey colour are both apparent. The break in construction between this work and the pre-existing masonry below is particularly noticeable on the north side. The lower walling in this area is of quite different character, being formed of squarer blocks. Part of the lower section is formed to a curvature the possible significance of which remains unclear, *plate 11*.

The corresponding break is less clearly defined on the east side. Here the mid wall area has seen various patchings and repairs though is predominantly of squared blocks of similar character or somewhat larger. There seems to be some indication of former features in this area – aligned stones, possible blockings, etc. though given the extent of patching it is presently hard to make much of these without detailed survey.

Plate 11 The lower parts of the existing stair tower of No.1 Framwellgate Bridge (centre-left), showing the exposed section of its north side; to right is the base of the main block of No.1; looking SSW (bridge at left side)

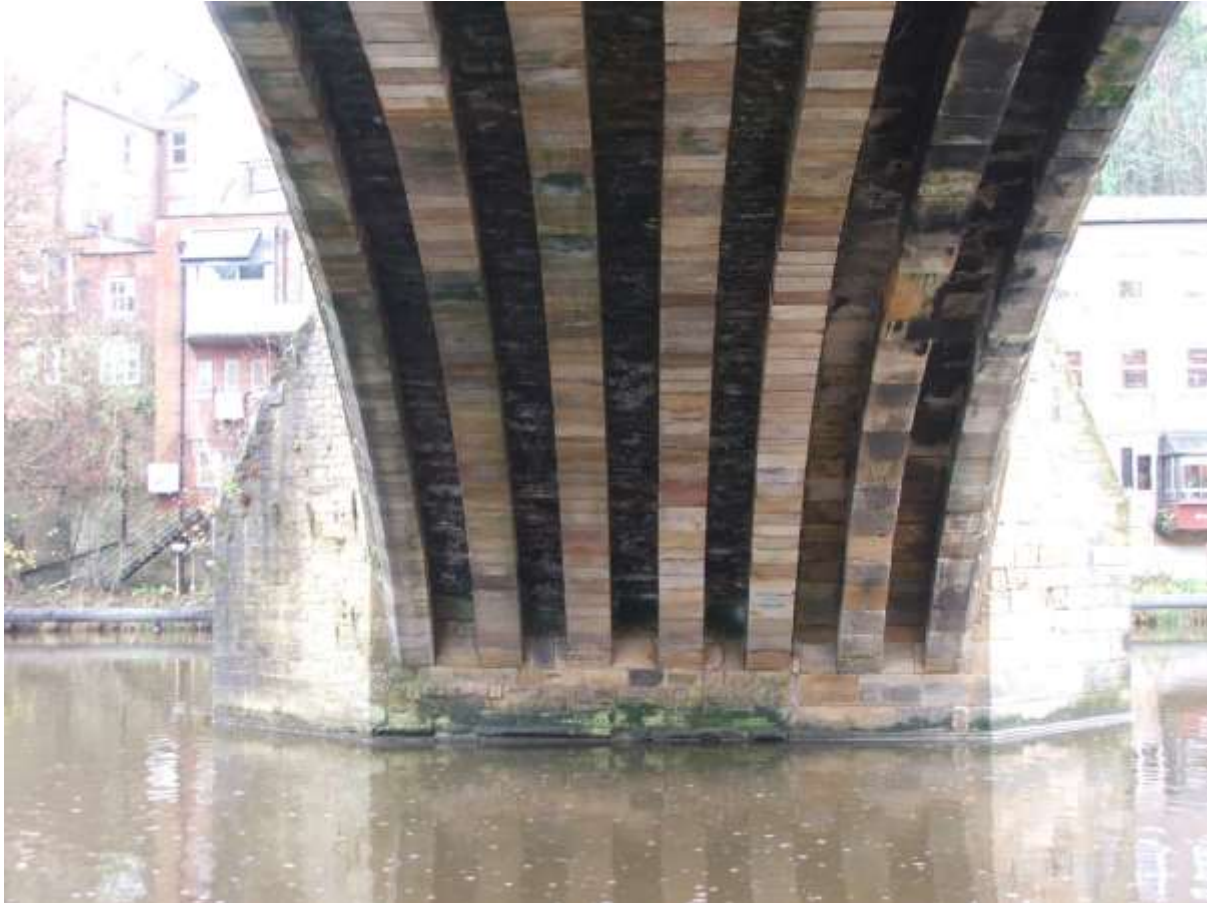
Plate 12 Opposite abutment of the western arch of Framwellgate Bridge, looking east; note the two southern ribs (to right) are part of a bridge-widening scheme of the mid-19th century

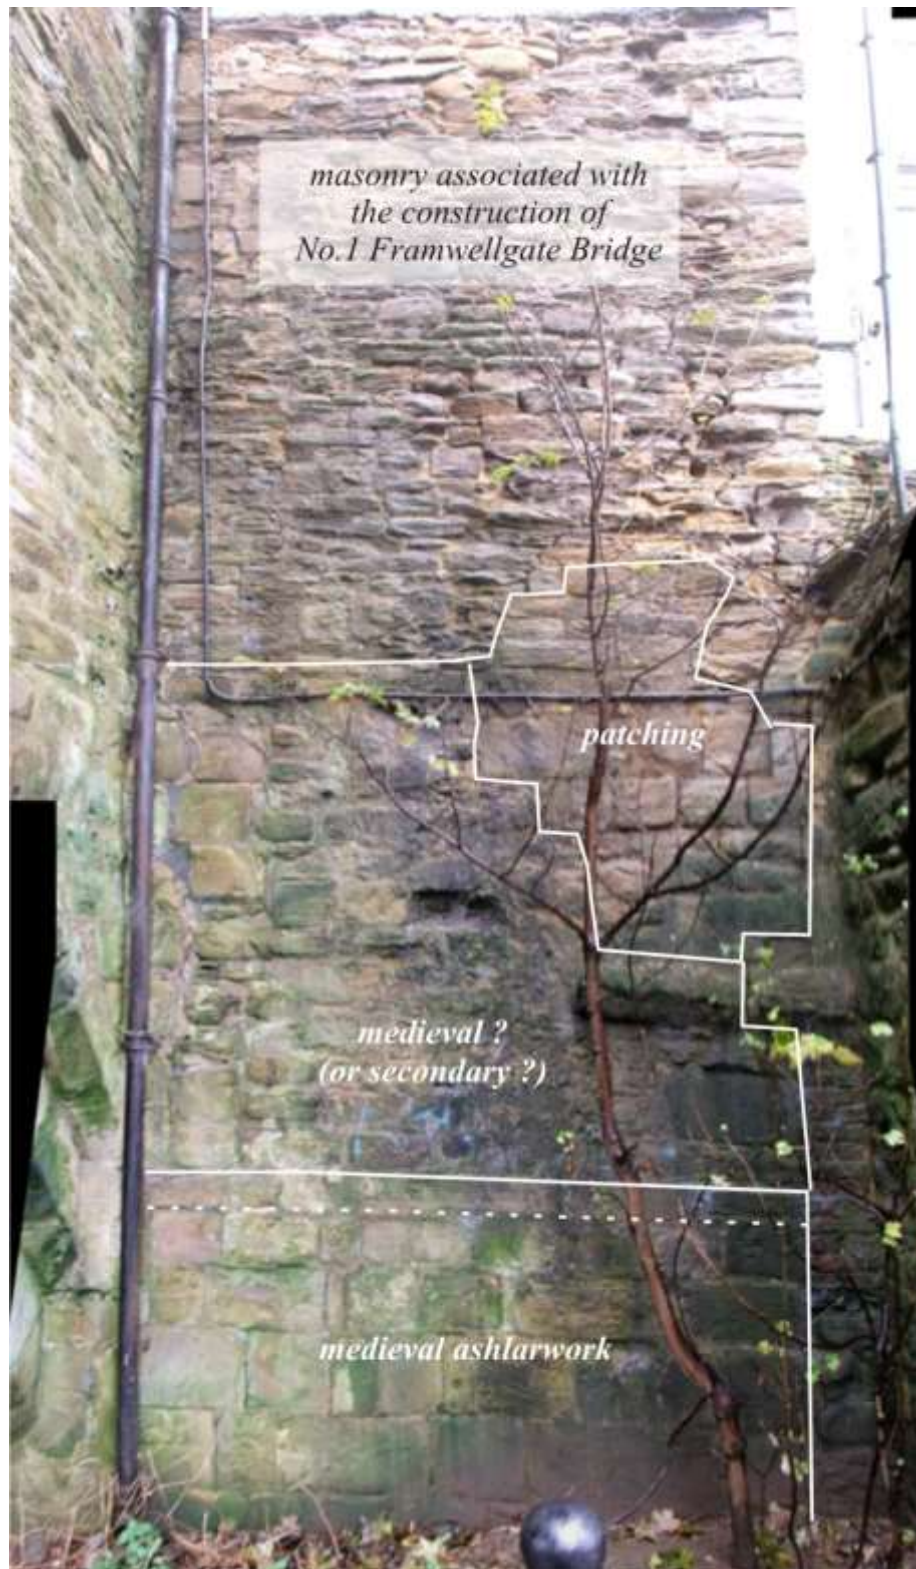
Plate 13 The east-facing side of the bridge abutment (bridge arch springing from left) showing indicative phasing / phase breaks (pending more detailed survey)

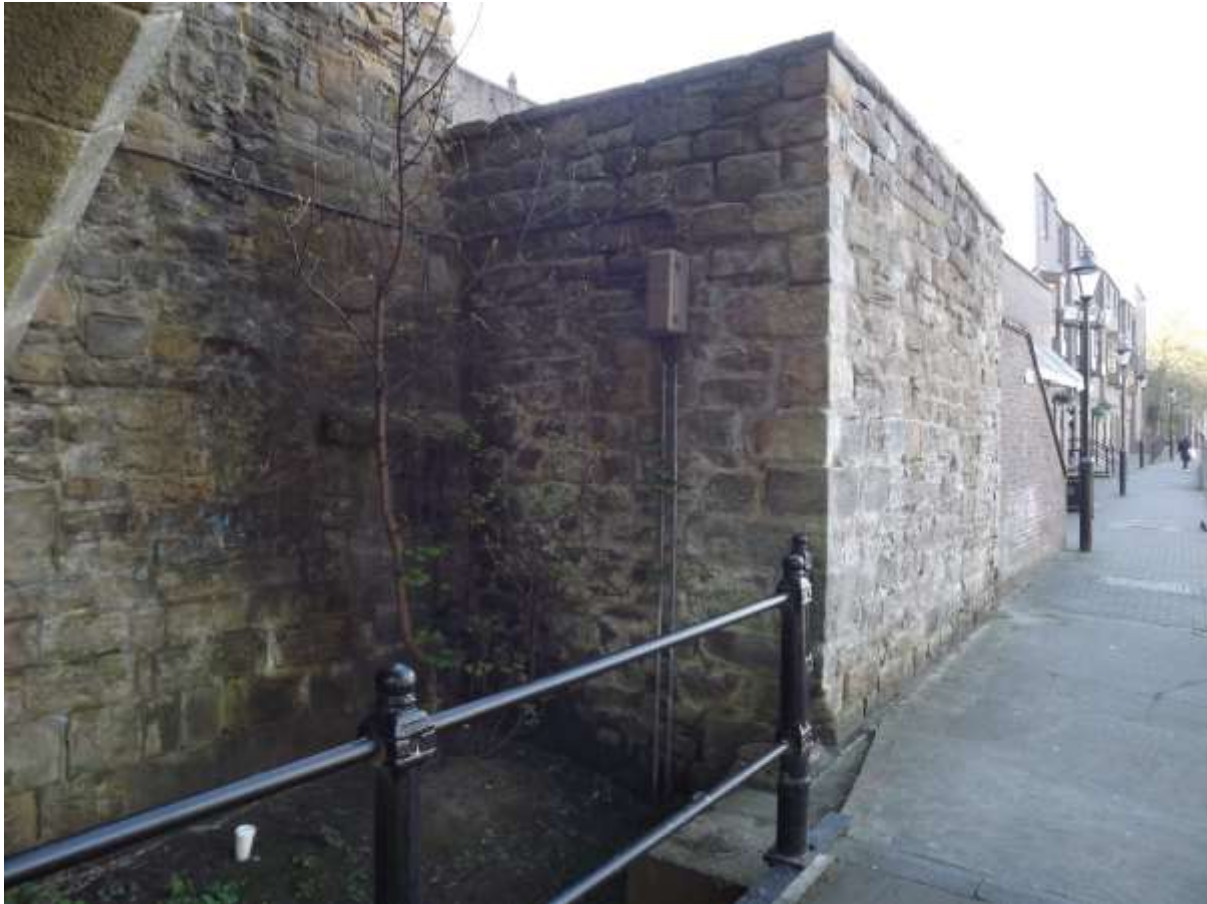
Just beyond the bridge abutment to the north its masonry is overlain by the lower parts of a further historic structure. Rubble-built with regular quoining, this appears to be the remains of a 19th century structure. This will not be affected by proposed development.

Plate 14 Secondary structure just beyond the bridge abutment, partly overlying it, looking NNW

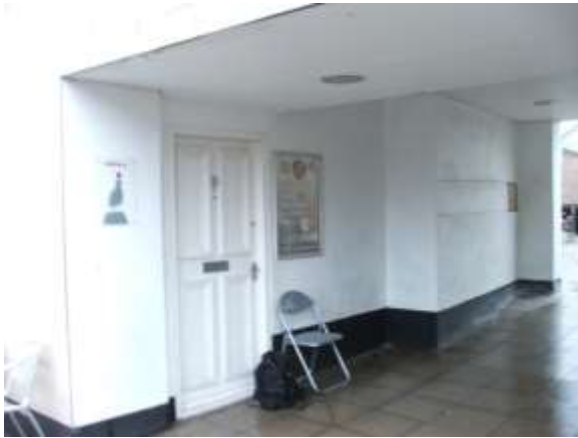
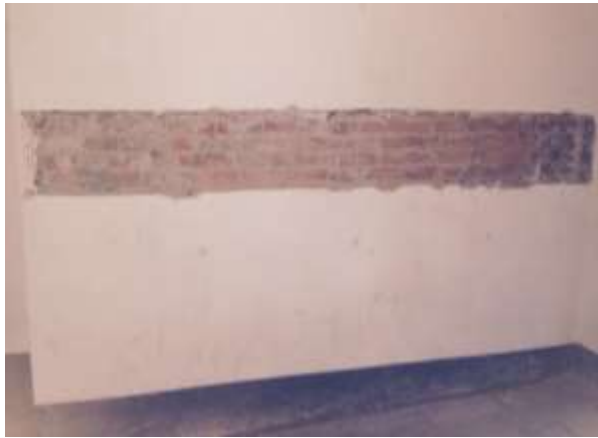
Investigation of the side wall of the entrance passage revealed it to be constructed wholly of cemented brickwork where exposed. This was evidently work relating to the 1970s Gates centre redevelopment.

Plate 15 and Plate 16 South entrance to the Gates – pedestrian passage; investigation on the side wall of No.2

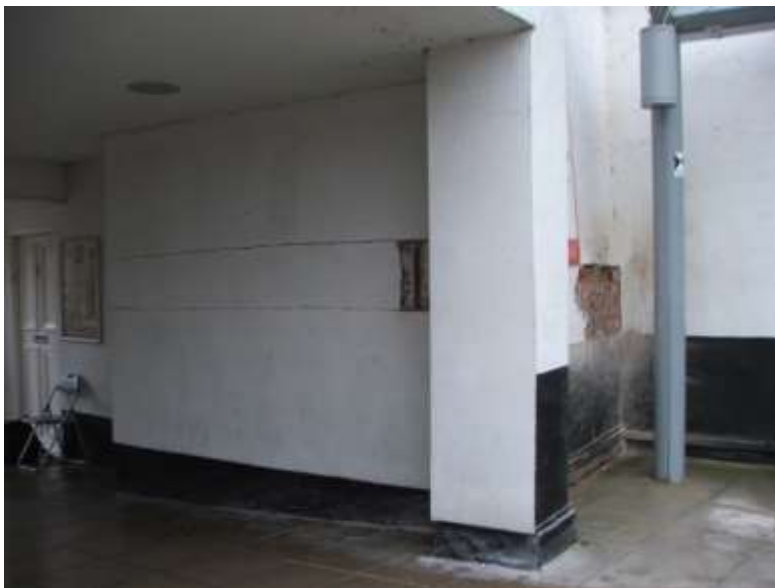
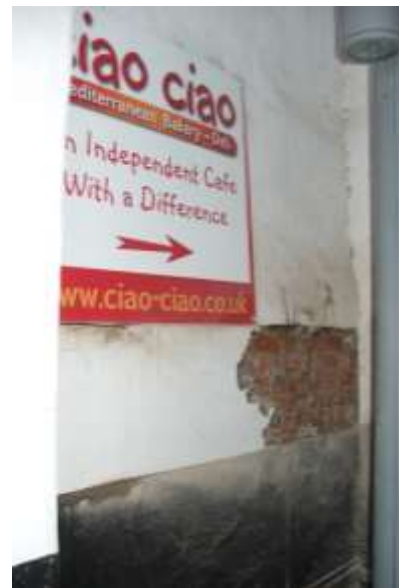
Investigation of the rear wall of No.2 revealed historic brickwork along the length of the exposure. The bricks were mortar-bedded brickwork of 19th century character. A notable irregularity of the vertical plane of the wall-face, more pronounced towards the west end of the wall section, was further investigated by extending the investigation area upwards for a further 0.5m. This revealed that the brickwork terminated, giving way to mortar-bedded sandstone rubble construction. It was concluded that the brickwork was either a re-facing or making-good exercise, replacing earlier stone rubble facings.

Plate 17 and Plate 18 South entrance to the Gates – pedestrian passage; investigation on the side and rear wall of No.2

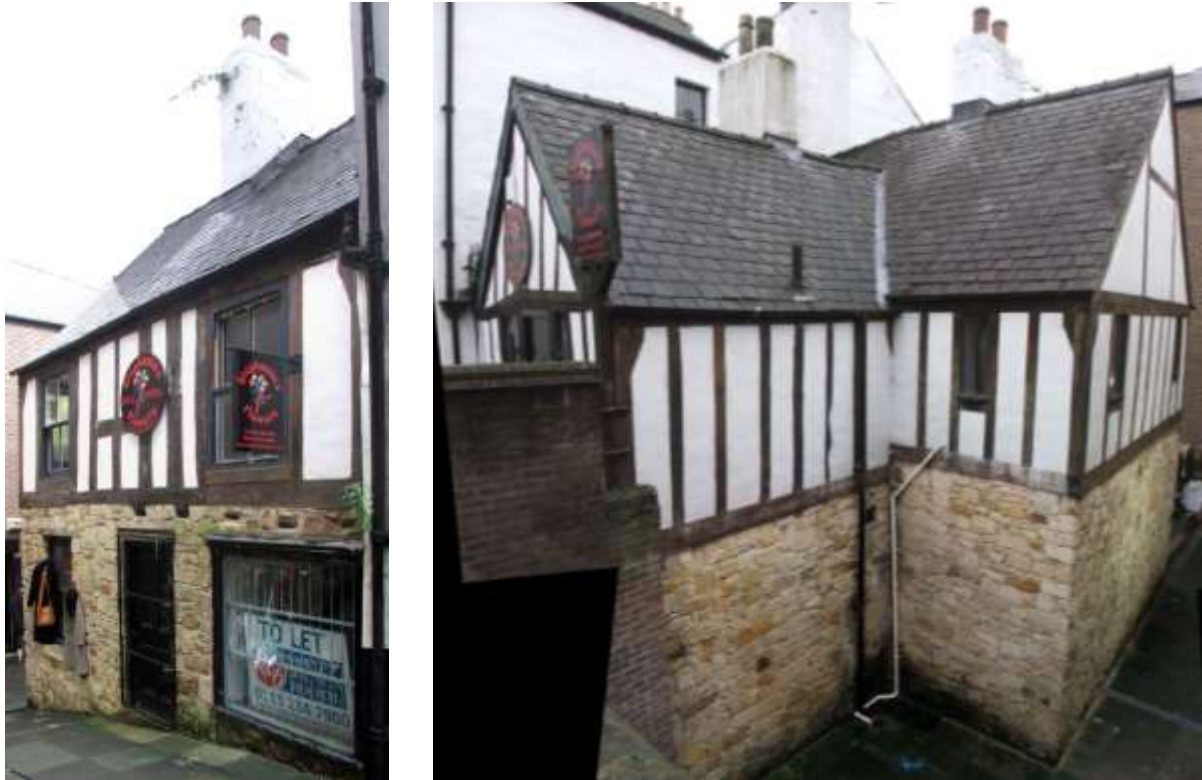
Plate 25 and Plate 26 No.5 Framwellgate Bridge (the former 129 Milburngate) – (left) the street (west) frontage, looking NE (right) the rear of the building looking SE

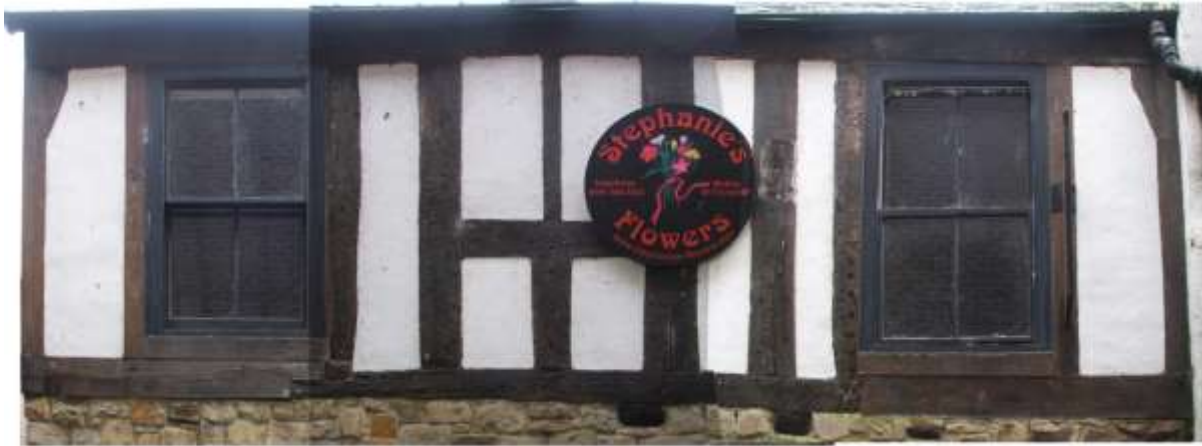
The original framing of much of the upper wall survives on the street frontage on the west side, this mostly complete between the remaining cross-frames (the central bay as existing), *plate 21*. The early wall plate extends further southwards, beyond frame *V*. The well preserved section between the two original cross-frames retains an early window opening, later blocked. The southern jowl-post (the northern side of the existing southern window) displays multiple peg-holes that suggest the former presence of a bracing element.

Plate 27 The framed upper part of the principal (west) frontage, with embedded jetty beams visible below

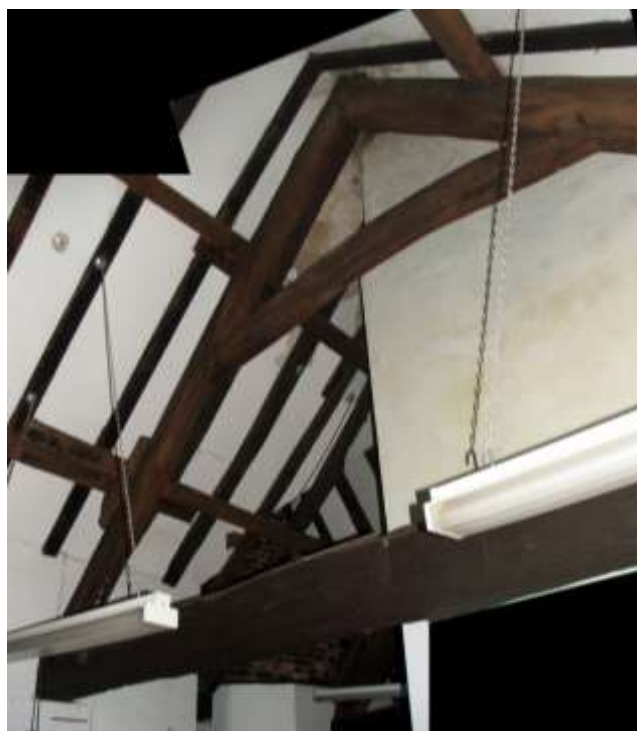
Plate 28 Principal range roof structure – northern surviving truss (truss III) and secondary flue stack of plastered brick, looking SSE

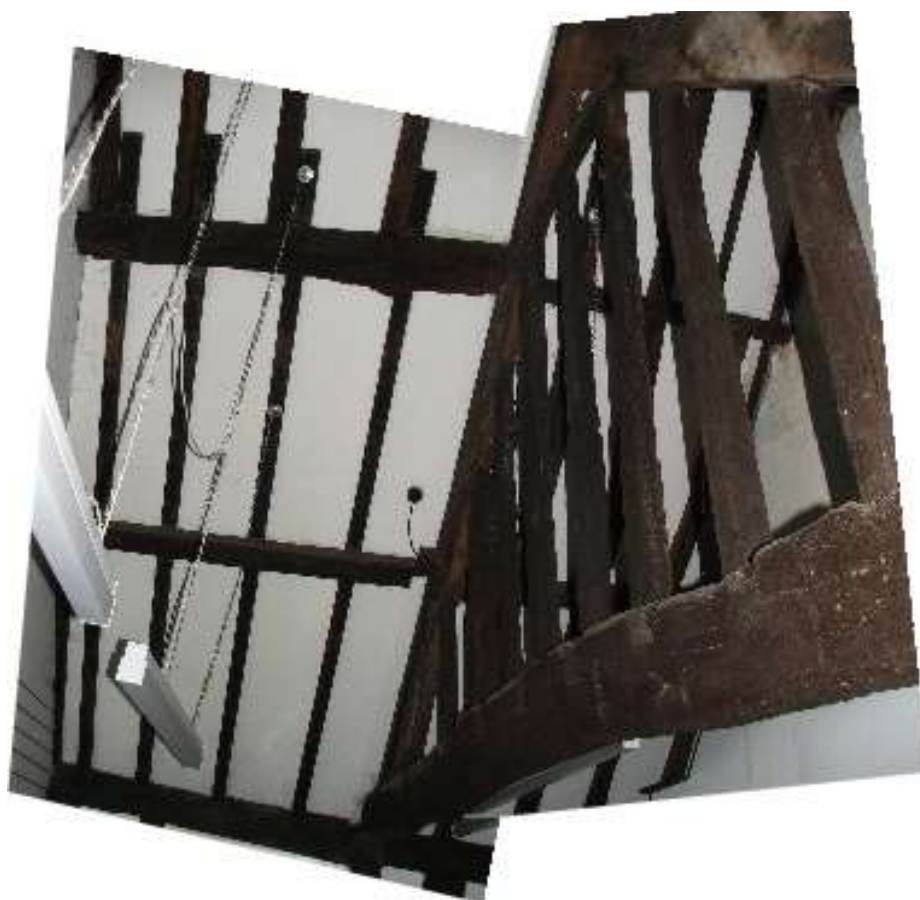
Plate 31 Principal range roof structure – northern surviving truss (truss V), note floor structure mortices; looking WNW

Truss *V* preserves vertical studs rising from the tie-beam, these for a wattle and daub partition. Mortice sockets on the south side of the tie indicate the former presence of a floor structure, probably of the original phase of construction, on that side.

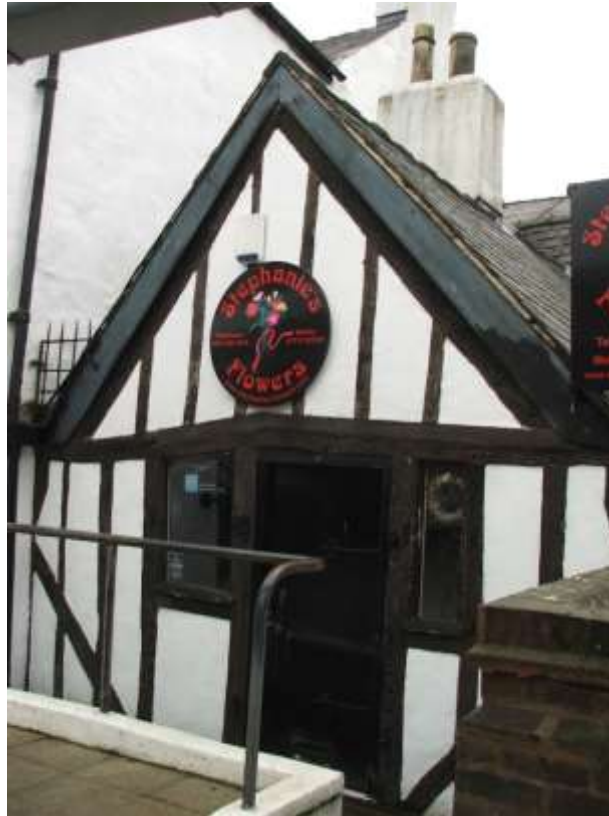
Plate 32 The eastern gable wall of the rear wing, looking WSW

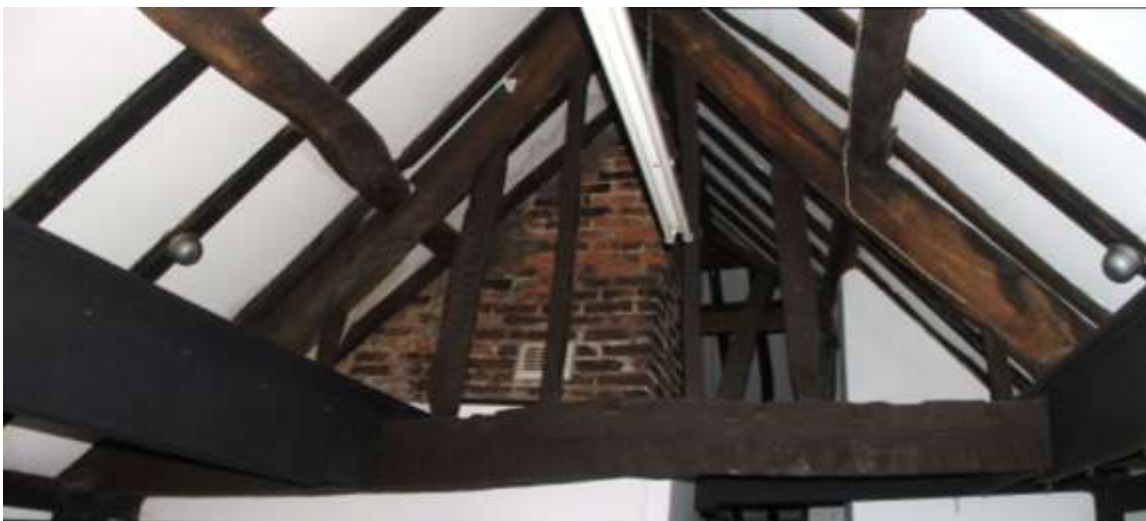
Plate 33 Rear range roof structure showing the central truss and secondary fire-stack, looking west

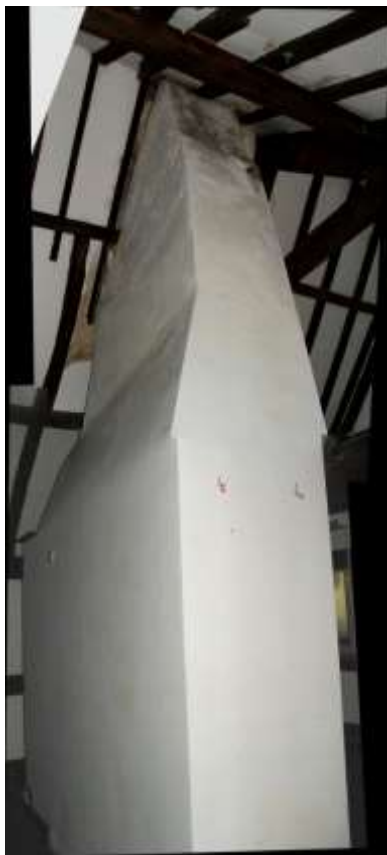
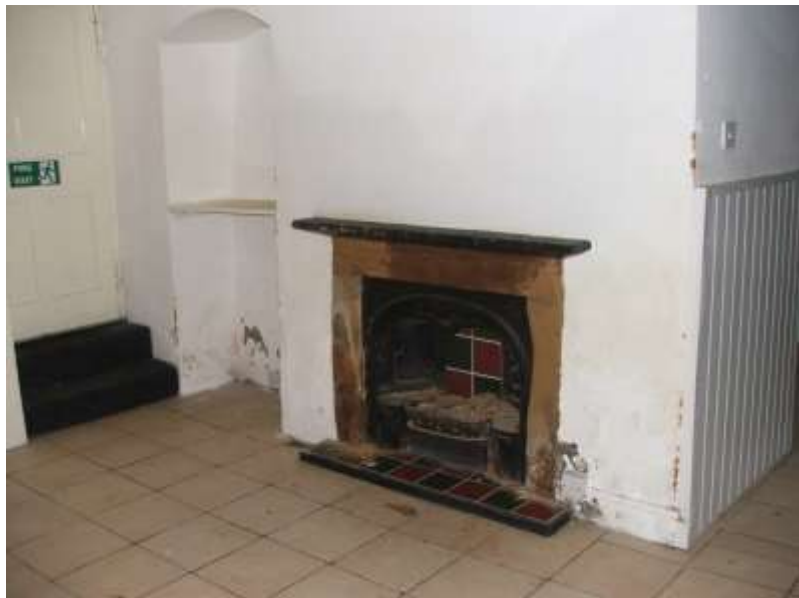
The second fire-stack rises from the rear wall of the frontage range and runs up through the southern pitch of the roof of the rear range at its junction with the roof of the main range, see *plates 26 and 27*, above. Internally the bricks from which it is constructed are visible, these are narrow hand-made bricks, low-fired and orange-red hue. The visible brickwork of the stack rise from a more substantial chimneybreast that perhaps suggests an earlier fabric; however this is now wholly obscured by later plaster, linings, etc. This flue seems to have served two fireplaces though these is now covered over.

Plate 34 (right) secondary fire-stack rising within the principal range upper level; looking NW
Plate 35 (left) the fireplace and lower part of the stack as visible at ground floor level; looking NW
