# The Law School, Old College Quadrangle University of Edinburgh

Phase 1 Watching Brief and Historic Building Record

## Data Structure Report

## Project AA.2132

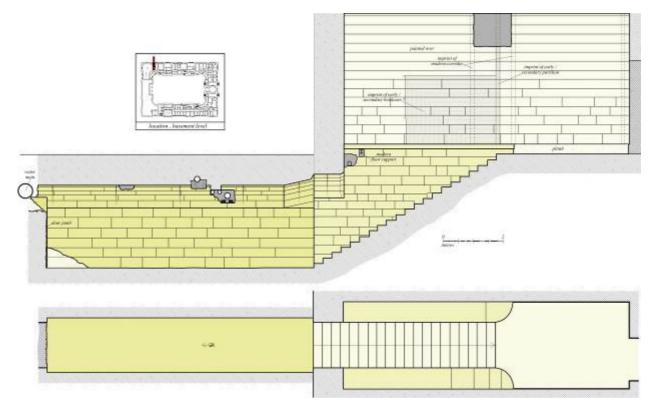
Figure 3 Plan and elevation of steps and tunnel

Closer examination of the floor revealed that it was part sandstone and part timber. The sandstone represented the copes of the sides of a set of stone stairs heading down to the north; these were latterly accessed via a hatch in the timber floor. The stairs were in good condition measuring 1.52m

wide and formed with the same tooled ashlar as the room above, but unpainted. The main elevations of the room had a narrow stone plinth running round the base; this extended into the southern door and was at the same height as the stair side copes (*plate 1*). The former ground level associated with these steps was approximately 0.30m below the top of the cope stones and the current timber floor.

The flight of steps led down to an arched over opening in the exterior elevation. This opening led into a 9m long, vaulted over tunnel 1.82 m wide and at least in part floored with flags (*figure 3*). At the north end the tunnel was blocked with lime bonded rubble but jambs of a similar opening as the south door were seen framing the blocking. This showed that the tunnel survived for its full extent and that the northern end is on the frontage line of a range of former buildings on the other side of Chambers Street; the map evidence confirms this (*figure 4*). These building were demolished in the 19<sup>th</sup> century and the road massively widened, presumably this was when the tunnel was blocked up (*figure 5*).

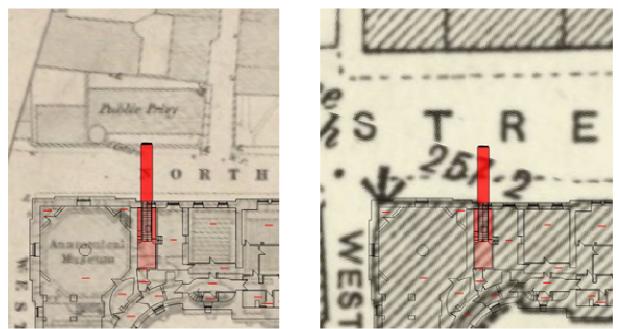
Figure 4 First edition OS 1852 with tunnel plan overlain

On the first edition Ordnance Survey (OS) map of 1852 the tunnel can be seen to cross North College Street and enter the buildings across the road (*figure 4*). By this time the building is marked as public privy but historical sources suggest that the tunnel allowed cadavers to be discretely brought from that building into the university anatomy theatre above, for public dissection. This may explain the bare stonework of the room and tunnel (*plate 2, 3 & 4*) as the stone would have helped keep the room cool, important for the preservation of the cadavers and it would also have been easier to keep clean.

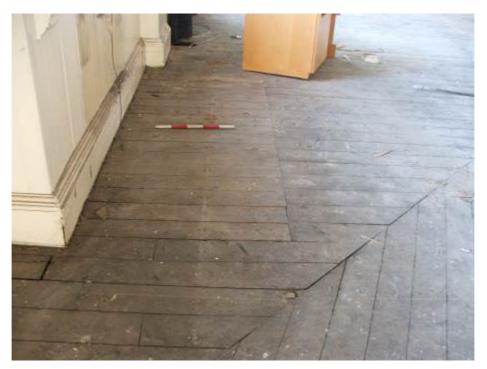
To the north-east of Room G160 was a rectangular patching of the flooring; this may relate to the former spiral stairwell that passed through this floor up to the second floor (*plate 9*). It does not appear from the historic plan that there was an access to the stair from this floor.

Plate 9 Rectangular patch in the floor in the area of the former stairwell

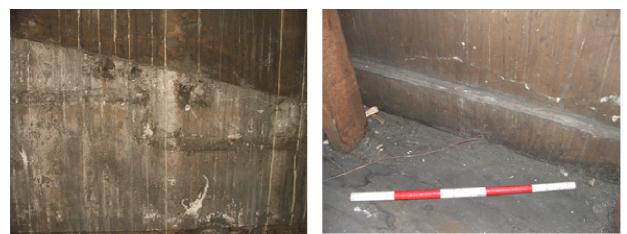
The outline of this was exposed impressed into the wall plaster of the west elevation (*figure 7; plate 10*). The plaster must have been still fairly wet when the seating was constructed as the ends of individual boards can be made out in the impressions. There were eleven rows of tiered seating. The steps were constructed from approximately 1 inch thick boards with three horizontal and one vertical back for each step.

Plate 10 Impressions of timber seating in plaster on Plate 11 original skirting in situ on north elevation west elevation

Descending from the top of the tiers evidence for a timber skirting can be seen following the sloping profile of the tiers (*plate 11*). Holes for timber dooks were cut into the plaster and masonry behind, perhaps suggesting a secondary addition. The plaster appeared to be darkly painted down to the top of the skirting, although this could be degraded pigments and dirt. In the early wall plaster above can be seen a faint outline of possible panelling associated with the seating.

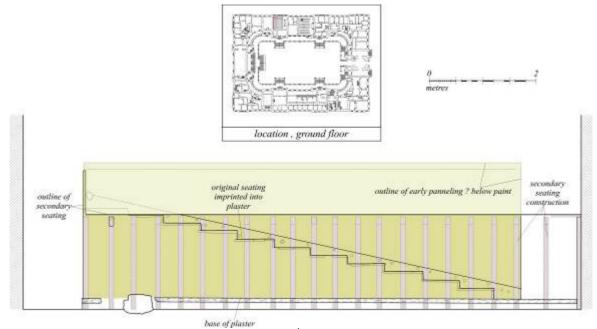
Figure 7 Section imprints of 18th C lecture seating on wall plaster

The original lecture room layout was thus eleven rows of tiered seating facing north with the lecturer likely in the middle of the three windows; there may have been an access passage along the east wall to reach the seating.

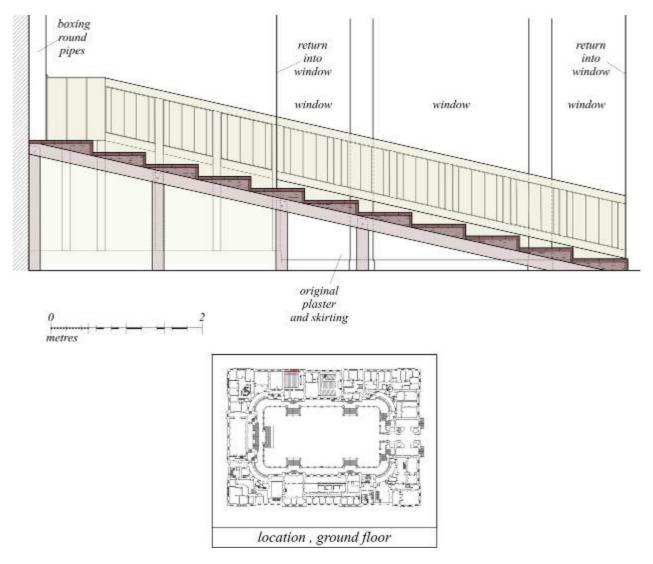
Figure 8 Section through 19th C seating

The original  $18^{th}$  Century lecture room was removed and replaced with a new tiered seating rotated  $90^{\circ}$  to the east so the seating faced to the east, with again eleven rows of seating bounded with panelled sides (*figure 8; plates 12 & 13*). The main seat supports were supported by four vertical uprights of similar timber morticed and tennoned into the main beams. It seemed probable that these were the same timbers from the original seating reused.

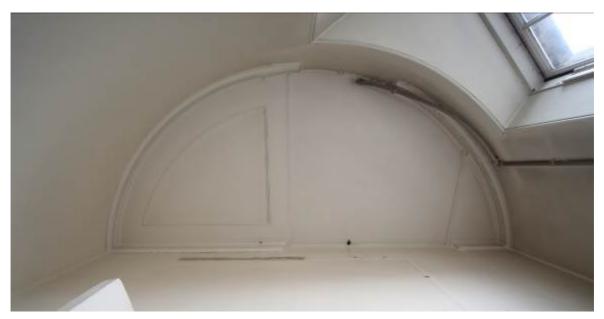
Plate 15 Infilled spiral stairwell void, middle of roof looking up

The main evidence surviving for the spiral stairwell was seen in the ceiling where there was an infilled panel representing the patched up void of the former stair (*plate 15*). A spiral crack/linear depression extending up the eastern masonry may be related to the actual stairs running around the room.

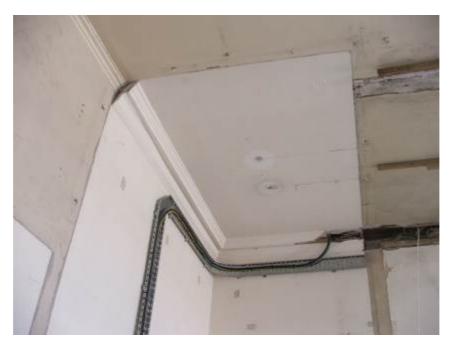
Plate 16 Secondary plaster cornice within partitioned area

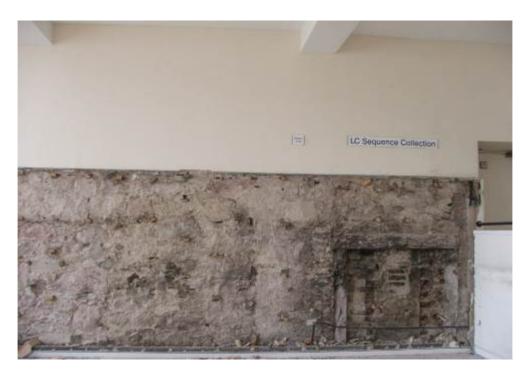
Following removal of wall lining (panelling?) of the lower half of the east elevation a historic fireplace was exposed offset to the south (*plate 17; figure 10*). This had apparently been inserted in its position; a large similarly sized patch of masonry to the north and central to the room may be the original location.

The stone jambs of the fireplace had been clawed back flush to the wall face and some evidence for a raised margin survived on the lintel, but was mostly clawed back. Latterly, a substantial brick fireplace was constructed within the earlier one, completely infilling it. Traces of a fire back were made out flush with the wall face and projecting brick jambs either side of this had also been cut back flush.

Plate 17 Room 1.274 east elevation showing fireplace

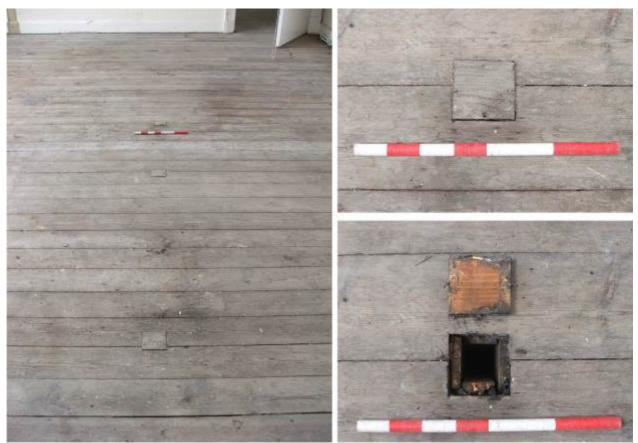
In this room, following the removal of partitions, a series of square timber patchings were noted in the flooring (*figure 12; plates 18, 19 & 20*). These formed four rows east-west and six rows north-south. The patchings/cappings were approximately 10cm square and cut from timber similar to the floorboards. Many of the sockets cut across two floorboards the cappings to these were nailed down with square-cut nails.

When the capping was lifted a vertical timber lined shaft was seen in each, the sides of which showed some polishing from wear. These shafts were approximately 7cm square internally and up to 0.40m deep. The bases were obscured by a debris build up.

What these relate to is not entirely clear, but the even pattern across the room may suggest they were for removable lecture room seating or similar.

Plate 18 Plate 19 Plate 20 Details of timber sockets

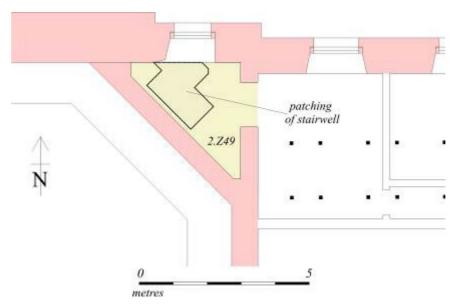
Figure 13 Room 2.Z49 evidence for stairwell

A former spiral stair running up from the basement terminated at this level (*figures 13 & 14; plate 21*). The outline of the irregular stair void was visible in the floor boards as patching; no other evidence for the stairs survived. The stair void was patched up with similar floorboards to those surrounding.

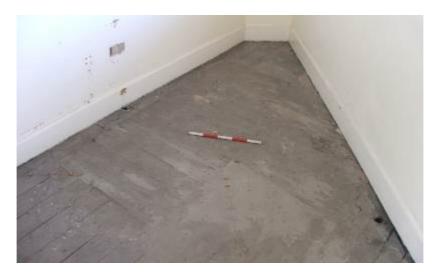
Plate 21 Room 2.Z49 floorboard evidence for stairwell

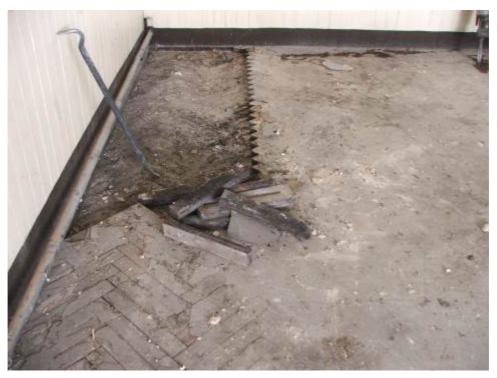
The overlying herring bone pattern timber floor was removed, exposing a poured concrete foundation 201 below, as previously noted in the evaluation trench (*plate 24*).

Plate 24 Herring bone floor being lifted

These timber floor blocks were shallower in depth along the east wall than in the rest of the room and may represent a later replacement, perhaps relating to underlying brick *202*. Alternatively and perhaps more likely the bricks predate the timber floor and the timber blocks were thinned in this area to fit over the bricks. The timber blocks were bedded into a tarry bitumen-like material, overlying concrete.

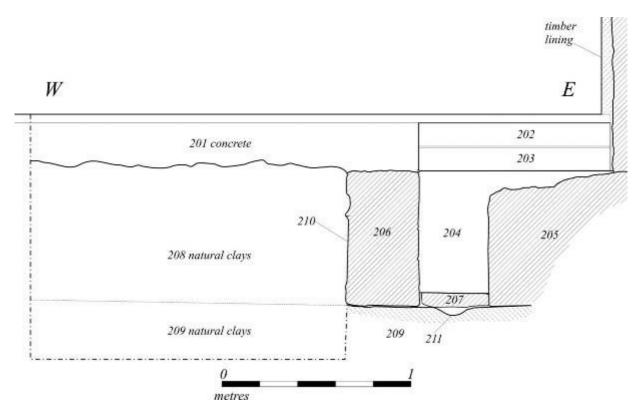
#### Figure 16 Lift pit trench north section

Within the western half of the trench this concrete was up to 0.25m deep and directly overlay solid natural clays 208 (*figure 16*).

Within the eastern half of the trench the concrete was much shallower, perhaps only a few centimetres deep and overlay a solid brick surface 202

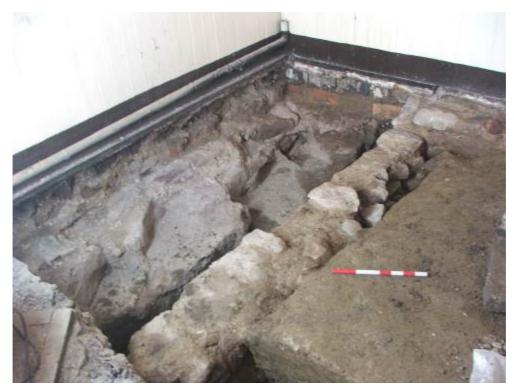
To the west of this were the remnants of a stone built drain 206. This was a 0.35-0.40m wide channel extending along the wall foot of 205 (*plate 25*). The western side of the drain was constructed from lime bonded rubble 0.35m wide and surviving to a height of 0.70m. This was built directly against the drain cut 210 into natural 208 (*plate 27*).

Plate 25 Wall found 205 and drain 206 (40cm scale)

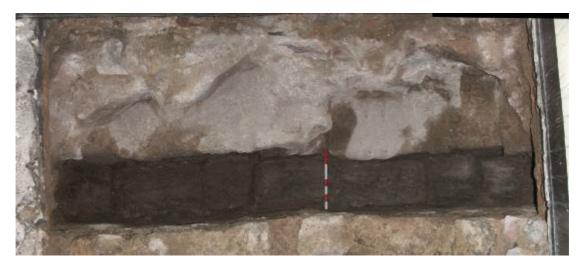
The base of the drain 207 is made up from roughly squared sandstone slabs 0.05-0.06m deep (*plate 26*). These were set into a little redeposited clay and mortar dropping from the construction of 206. The drain sloped down towards the north and was only very lightly silted on the interior.

Plate 26 Wall found 205 and drain base 207 (40cm scale)

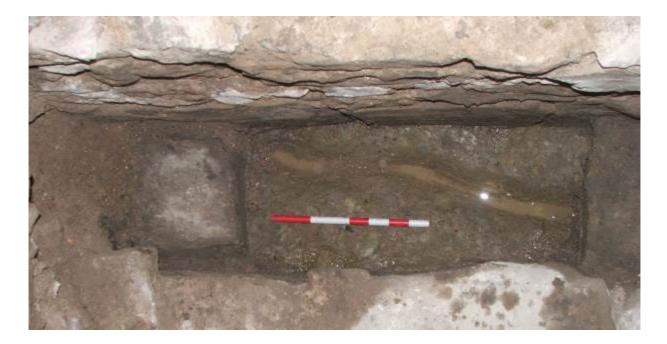
Removal of the base slabs and bedding of redeposited clay exposed *in situ* solid natural clay 209. Cleaning this deposit uncovered a shallow channel cut 211 into the natural clay209 along the base of the drain beneath the slab base 207 (*plate 28; figure 19*). This clearly related to the drain and was interpreted as a working drainage channel during the drains construction to keep workers' feet drier. Even though at the time of exposure it had not rained for many days, as soon as the cut channel was exposed it began to flow with water. The cut channel was part infilled with mortar dropping from the drain's construction, as well as redeposited clay bottoming for the base slabs 207.

Plate 28 Drain base 207 part removed exposing cut 211 (40cm scale)

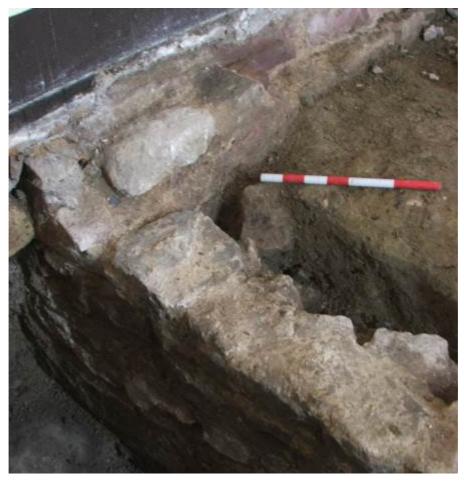
Further well-constructed rubble masonry 212 was noted extending along the south section of the trench (*figures 17 & 18*). This could be related to the current partition wall built upon it, but as the eastern end of the masonry terminated as part of the drain 206, masonry 212 is likely to predate the current structure (*plate 29*). The north face of the masonry stepped out from the current partition and had been trimmed back to flush with the later partition along much of its exposed length. This was presumably done as part of the general ground reduction in order to fit flooring.

Plate 29 Junction of masonry 212 and drain 206 (foreground) (40 cm scale)

What this represents is not readily apparent. It may be an internal partition within the early building respecting the drain and was possibly bridged over the drain in its upper parts, which have now been lost. Alternatively it could represent a return of the drain to the west.
